Profile/Photo Observation Report

Date:	04/17/2018	Weather:		Coding:	PACP 6.0
Pipe Length (ft):	147.1	Owner:	NA	Pre Clean:	Not Known
P.O.#:		Surveyor:	Byrd Fitzgerald	PSR:	P-804-004-003
Customer:		Clean Date:	01/01/1900	Shape:	C

Street:	Jackson St. Alley	Flow Control:	Not Controlled
City:	Hobart, IN	Year Renewed:	
Location:	Other	Tape/Media #:	
Purpose:	Not Known	Dia/Height:	8"
Use:	Sanitary	Material:	PVC
Drain Area:	NA	Lining:	
Category:	NA		
Comment:

Location Details:		Direction of Survey:	Upstream
US MH:	M-804-003	DS MH:	M-804-004
		Total Length Surveyed (ft):	84.0

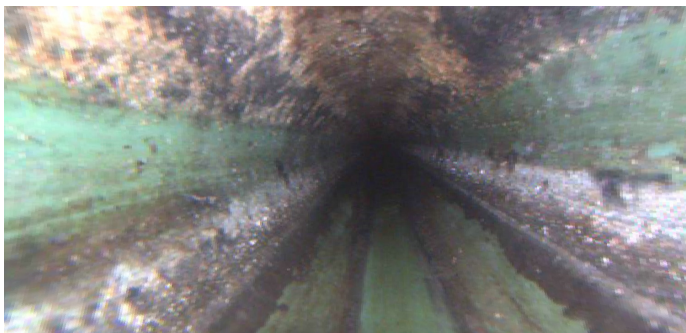
Code: **AMH**
Description: **Manhole**

Distance (ft): **.0**
Structural Grade: **0**
O&M Grade: **0**
Clock Start/From:
Clock To:
1st Value:
2nd Value:
Value Percent:
Continuous Index:
Within 8" of Joint: **NO**
Remarks: **M-804-004**

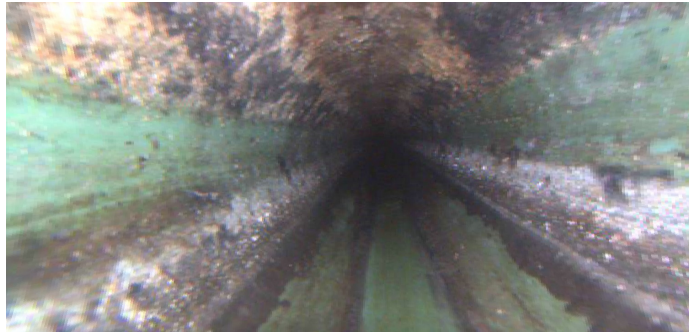
Code: **MWL**
Description: **Water Level**

Distance (ft): **.0**
Structural Grade: **0**
O&M Grade: **0**
Clock Start/From:
Clock To:
1st Value:
2nd Value:
Value Percent: **5.000**
Continuous Index:
Within 8" of Joint: **NO**
Remarks:

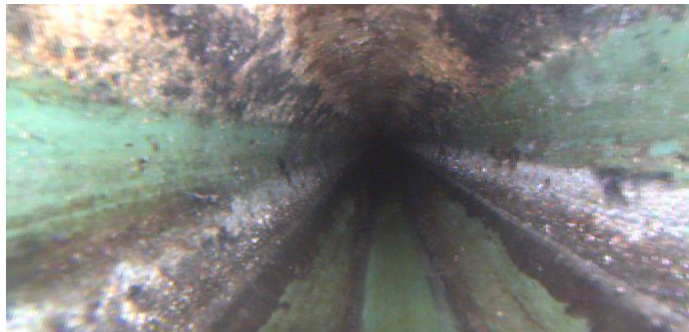
Code: **DAGS**
Description: **Deposits Attached Grease**

Distance (ft): **.0**
Structural Grade: **0**
O&M Grade: **2**
Clock Start/From: **7**
Clock To: **5**
1st Value:
2nd Value:
Value Percent: **5.000**
Continuous Index: **S01**
Within 8" of Joint: **NO**
Remarks:

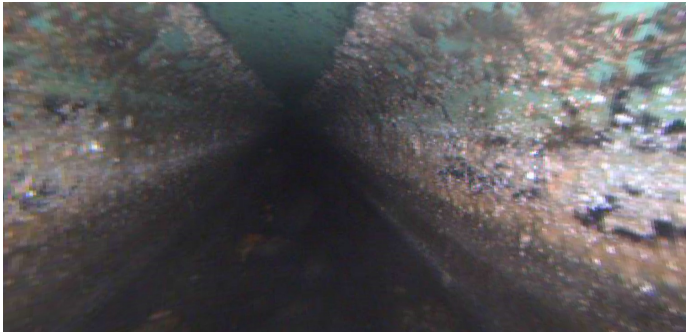
Code: **DSZ**
Description: **Deposits Settled Other**

Distance (ft): **23.9**
Structural Grade: **0**
O&M Grade: **2**
Clock Start/From: **6**
Clock To:
1st Value:
2nd Value:
Value Percent: **5.000**
Continuous Index: **S02**
Within 8" of Joint: **NO**
Remarks: **debris**

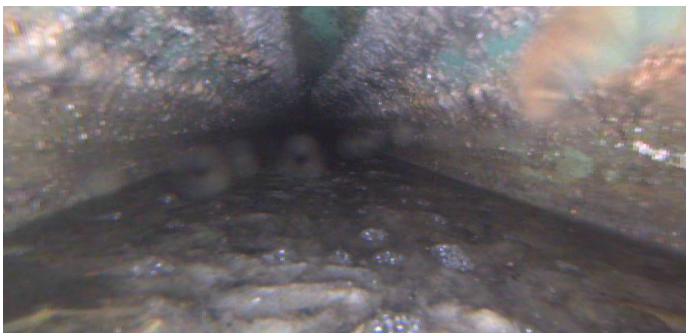
Code: **MWL**
Description: **Water Level**

Distance (ft): **84.0**
Structural Grade: **0**
O&M Grade: **0**
Clock Start/From:
Clock To:
1st Value:
2nd Value:
Value Percent: **50.000**
Continuous Index:
Within 8" of Joint: **NO**
Remarks:

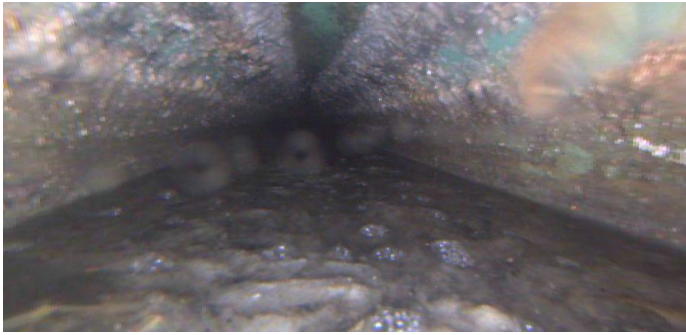
Code: **MSA**
Description: **Abandoned Survey**

Distance (ft): **84.0**
Structural Grade: **0**
O&M Grade: **0**
Clock Start/From:
Clock To:
1st Value:
2nd Value:
Value Percent:
Continuous Index:
Within 8" of Joint: **NO**
Remarks: **no blockage**

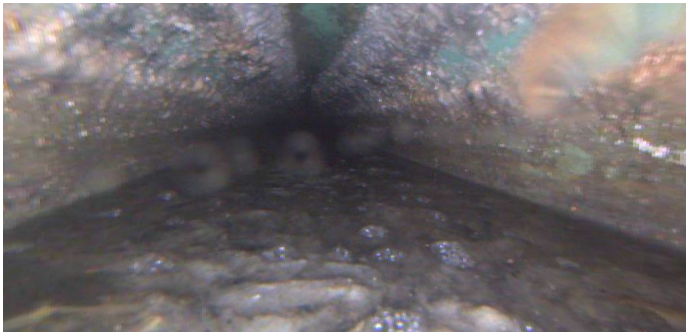
Code: **DSZ**
Description: **Deposits Settled Other**

Distance (ft): **84.0**
Structural Grade: **0**
O&M Grade: **2**
Clock Start/From: **6**
Clock To:
1st Value:
2nd Value:
Value Percent: **5.000**
Continuous Index: **F02**
Within 8" of Joint: **NO**
Remarks: **debris**

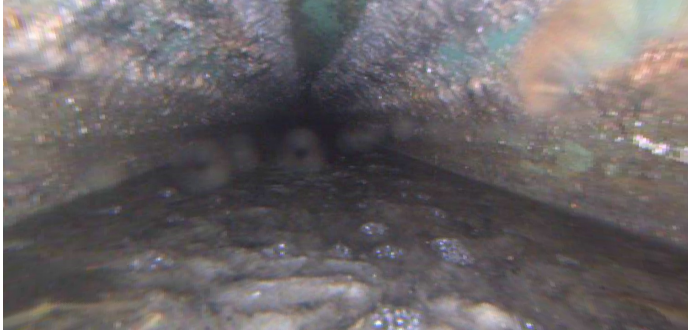
Code:	DAGS
Description:	Deposits Attached Grease
Distance (ft):	84.0
Structural Grade:	0
O&M Grade:	2
Clock Start/From:	7
Clock To:	5
1st Value:	
2nd Value:	
Value Percent:	5.000
Continuous Index:	F01
Within 8" of Joint:	NO
Remarks:
