Profile/Photo Observation Report

Street:	E CLEVELAND AVE	Flow Control:	Not Controlled
City:	Hobart, IN	Year Renewed:	
Location:	Other	Tape/Media #:	
Purpose:	Not Known	Dia/Height:	8"
Use:	Sanitary	Material:	PVC
Drain Area:	NA	Lining:	
Category:	NA		
Comment:

Location Details:		Direction of Survey:	Downstream
US MH:	M-804-003	DS MH:	M-804-009
		Total Length Surveyed (ft):	3.6

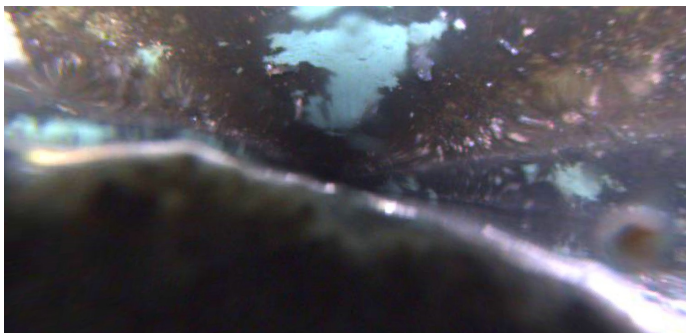
Code: **AMH**
Description: **Manhole**

Distance (ft): **.0**
Structural Grade: **0**
O&M Grade: **0**
Clock Start/From:
Clock To:
1st Value:
2nd Value:
Value Percent:
Continuous Index:
Within 8" of Joint: **NO**
Remarks: **M-804-003**

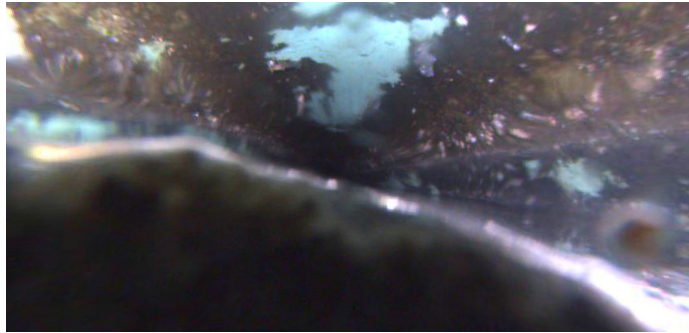
Code: **MWL**
Description: **Water Level**

Distance (ft): **.0**
Structural Grade: **0**
O&M Grade: **0**
Clock Start/From:
Clock To:
1st Value:
2nd Value:
Value Percent: **40.000**
Continuous Index:
Within 8" of Joint: **NO**
Remarks:

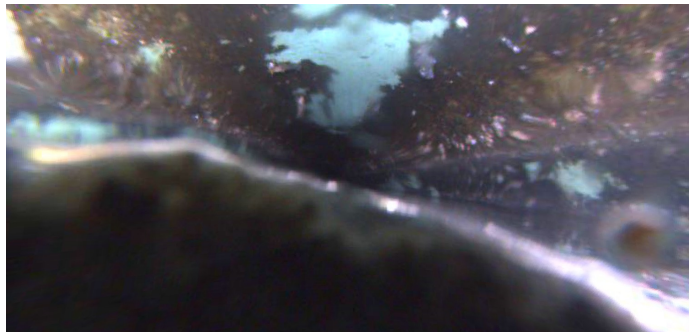
Code: **DAGS**
Description: **Deposits Attached Grease**

Distance (ft): **.0**
Structural Grade: **0**
O&M Grade: **2**
Clock Start/From: **8**
Clock To: **4**
1st Value:
2nd Value:
Value Percent: **5.000**
Continuous Index:
Within 8" of Joint: **NO**
Remarks:
