## Profile/Photo Observation Report

Street:	<b>E Cleveland Ave.</b>	Flow Control:	<b>Not Controlled</b>
City:	<b>Hobart, IN</b>	Year Renewed:	
Location:	<b>Other</b>	Tape/Media #:	
Purpose:	<b>Not Known</b>	Dia/Height:	<b>8"</b>
Use:	<b>Sanitary</b>	Material:	<b>PVC</b>
Drain Area:	<b>NA</b>	Lining:	
Category:	<b>NA</b>		
Comment:

Location Details:		Direction of Survey:	<b>Downstream</b>
US MH:	<b>M-804-003</b>	DS MH:	<b>M-804-009</b>
		Total Length Surveyed (ft):	<b>3.6</b>

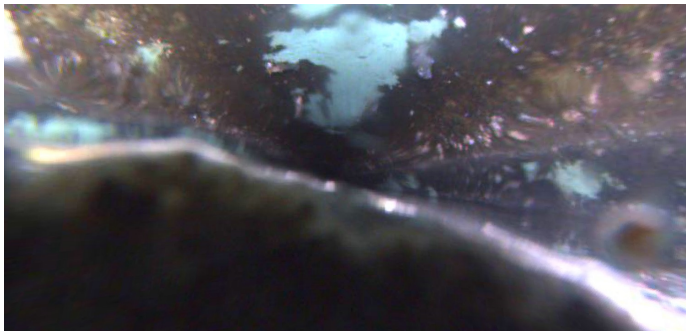
Code: **AMH**  
Description: **Manhole**

Distance (ft): **.0**  
Structural Grade: **0**  
O&M Grade: **0**  
Clock Start/From:  
Clock To:  
1st Value:  
2nd Value:  
Value Percent:  
Continuous Index:  
Within 8" of Joint: **NO**  
Remarks: **M-804-003**

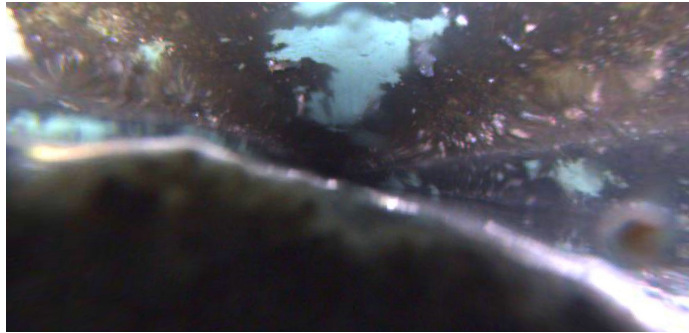
Code: **MWL**  
Description: **Water Level**

Distance (ft): **.0**  
Structural Grade: **0**  
O&M Grade: **0**  
Clock Start/From:  
Clock To:  
1st Value:  
2nd Value:  
Value Percent: **40.000**  
Continuous Index:  
Within 8" of Joint: **NO**  
Remarks:

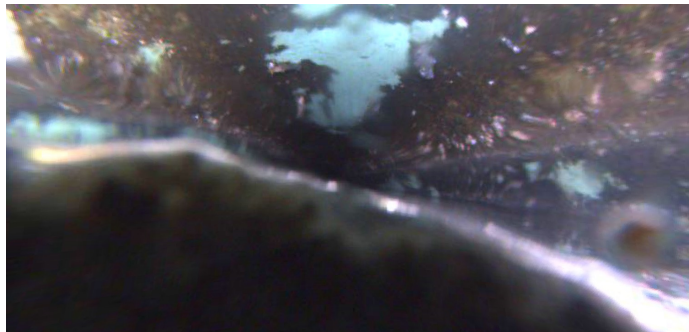
Code: **DAGS**  
Description: **Deposits Attached Grease**

Distance (ft): **.0**  
Structural Grade: **0**  
O&M Grade: **2**  
Clock Start/From: **8**  
Clock To: **4**  
1st Value:  
2nd Value:  
Value Percent: **5.000**  
Continuous Index:  
Within 8" of Joint: **NO**  
Remarks:
