## Profile/Photo Observation Report

Street:	<b>ALLEY OFF E CLEVELAND AVE</b>	Flow Control:	<b>Not Controlled</b>
City:	<b>Hobart, IN</b>	Year Renewed:	
Location:	<b>Other</b>	Tape/Media #:	
Purpose:	<b>Not Known</b>	Dia/Height:	<b>8"</b>
Use:	<b>Sanitary</b>	Material:	<b>VCP</b>
Drain Area:	<b>NA</b>	Lining:	
Category:	<b>NA</b>		
Comment:	<b>NULL - MH-M-804-006 Debris at entrance</b>

Location Details:		Direction of Survey:	<b>Downstream</b>
US MH:	<b>M-804-004</b>	DS MH:	<b>M-804-005</b>
		Total Length Surveyed (ft):	<b>46.5</b>

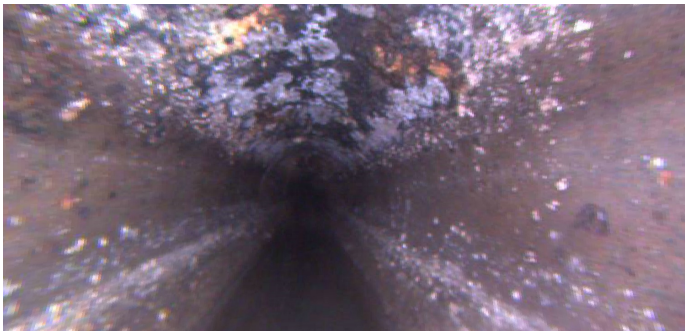
Code: **AMH**  
Description: **Manhole**

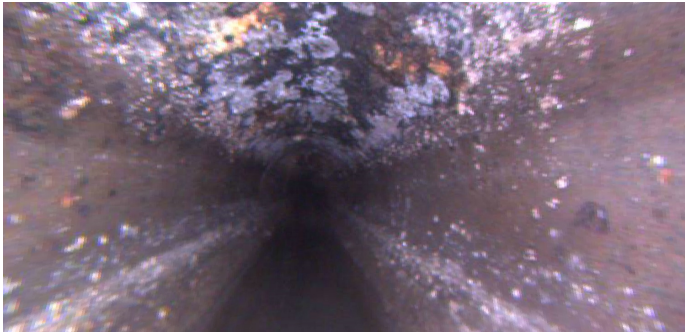
Code:	<b>MWL</b>
Description:	<b>Water Level</b>

Distance (ft):	<b>.0</b>
Structural Grade:	<b>0</b>
O&M Grade:	<b>0</b>
Clock Start/From:	
Clock To:	
1st Value:	
2nd Value:	
Value Percent:	<b>5.000</b>
Continuous Index:	
Within 8" of Joint:	<b>NO</b>
Remarks:

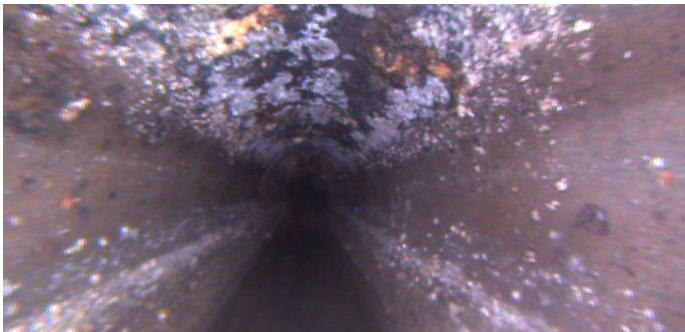
Code:	<b>DAZ</b>
Description:	<b>Deposits Attached Other</b>

Distance (ft):	<b>.0</b>
Structural Grade:	<b>0</b>
O&M Grade:	<b>2</b>
Clock Start/From:	<b>11</b>
Clock To:	<b>1</b>
1st Value:	
2nd Value:	
Value Percent:	<b>5.000</b>
Continuous Index:	<b>S01</b>
Within 8" of Joint:	<b>NO</b>
Remarks:

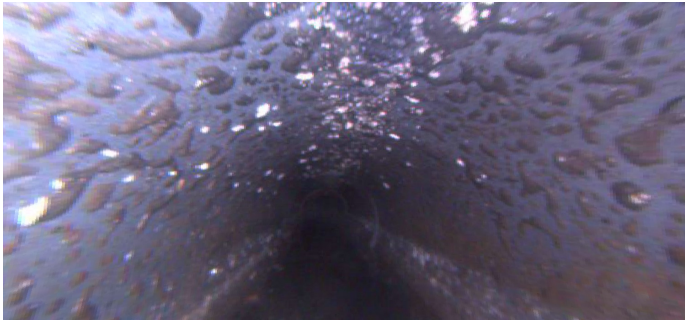
Code: **DAZ**  
Description: **Deposits Attached Other**

Distance (ft): **11.3**  
Structural Grade: **0**  
O&M Grade: **2**  
Clock Start/From: **11**  
Clock To: **1**  
1st Value:  
2nd Value:  
Value Percent: **5.000**  
Continuous Index: **F01**  
Within 8" of Joint: **NO**  
Remarks:

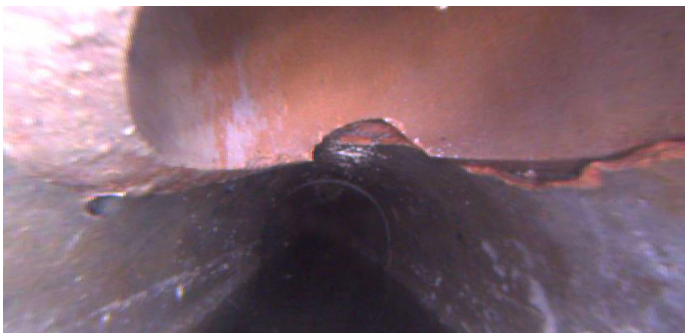
Code: **TB**  
Description: **Tap Break-in**

Distance (ft): **15.8**  
Structural Grade: **0**  
O&M Grade: **0**  
Clock Start/From: **12**  
Clock To:  
1st Value: **6.000**  
2nd Value:  
Value Percent:  
Continuous Index:  
Within 8" of Joint:  
Remarks:

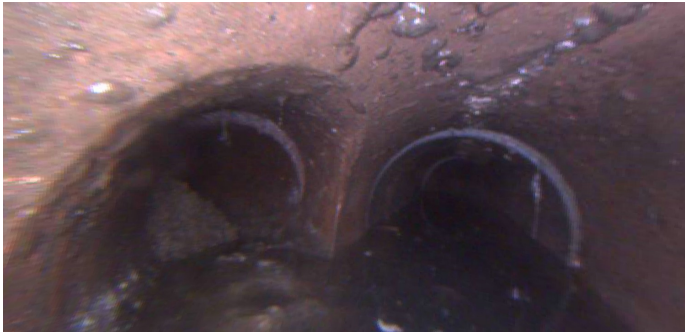
Code: **TFD**  
Description: **Tap Factory Defective**

Distance (ft): **24.3**  
Structural Grade: **0**  
O&M Grade: **2**  
Clock Start/From: **9**  
Clock To:  
1st Value: **4.000**  
2nd Value:  
Value Percent:  
Continuous Index:  
Within 8" of Joint: **YES**  
Remarks: **partially blocked**

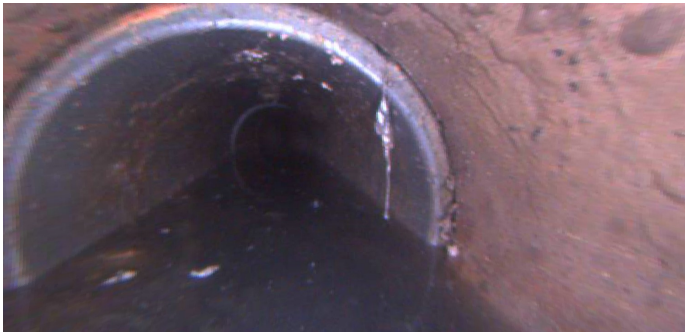
Code: **RFJ**  
Description: **Roots Fine Joint**

Distance (ft): **24.9**  
Structural Grade: **0**  
O&M Grade: **1**  
Clock Start/From: **1**  
Clock To:  
1st Value:  
2nd Value:  
Value Percent:  
Continuous Index:  
Within 8" of Joint: **YES**  
Remarks:

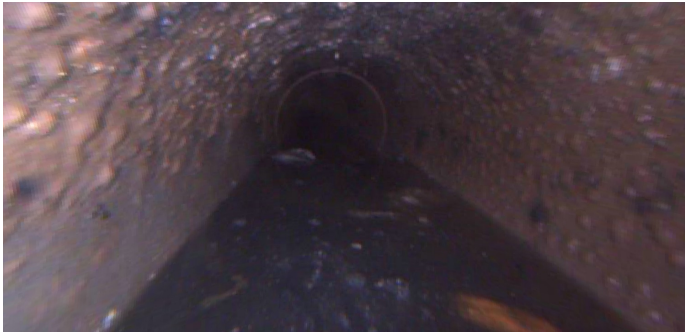
Code: **DSZ**  
Description: **Deposits Settled Other**

Distance (ft): **41.8**  
Structural Grade: **0**  
O&M Grade: **2**  
Clock Start/From: **6**  
Clock To:  
1st Value:  
2nd Value:  
Value Percent: **5.000**  
Continuous Index: **S02**  
Within 8" of Joint: **NO**  
Remarks: **debris**

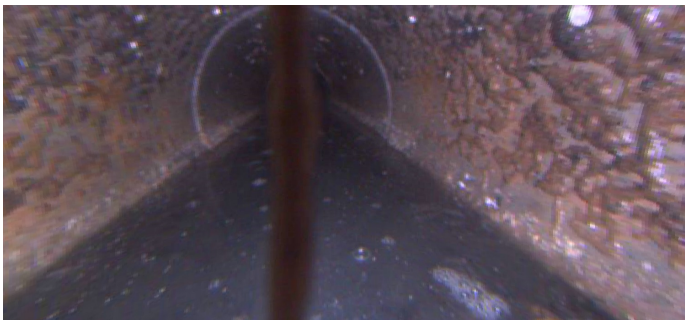
Code: **MSA**  
Description: **Abandoned Survey**

Distance (ft): **46.5**  
Structural Grade: **0**  
O&M Grade: **0**  
Clock Start/From:  
Clock To:  
1st Value:  
2nd Value:  
Value Percent:  
Continuous Index:  
Within 8" of Joint: **NO**  
Remarks: **no blockage**

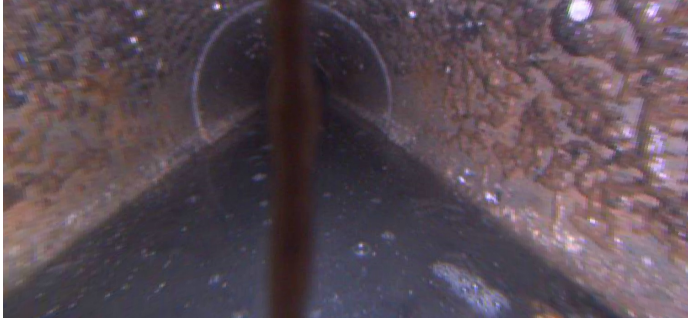
Code:	<b>DSZ</b>
Description:	<b>Deposits Settled Other</b>
Distance (ft):	<b>46.5</b>
Structural Grade:	<b>0</b>
O&M Grade:	<b>2</b>
Clock Start/From:	<b>6</b>
Clock To:	
1st Value:	
2nd Value:	
Value Percent:	<b>5.000</b>
Continuous Index:	<b>F02</b>
Within 8" of Joint:	<b>NO</b>
Remarks:	<b>debris</b>
