## Profile/Photo Observation Report

Street:	<b>Jackson St. Alley</b>	Flow Control:	<b>Not Controlled</b>
City:	<b>Hobart, IN</b>	Year Renewed:	
Location:	<b>Other</b>	Tape/Media #:	
Purpose:	<b>Not Known</b>	Dia/Height:	<b>8"</b>
Use:	<b>Sanitary</b>	Material:	<b>VCP</b>
Drain Area:	<b>NA</b>	Lining:	
Category:	<b>NA</b>		
Comment:	<b>NULL - MH-M-804-006 Debris at entrance</b>

Location Details:		Direction of Survey:	<b>Downstream</b>
US MH:	<b>M-804-004</b>	DS MH:	<b>M-804-005</b>
		Total Length Surveyed (ft):	<b>46.5</b>

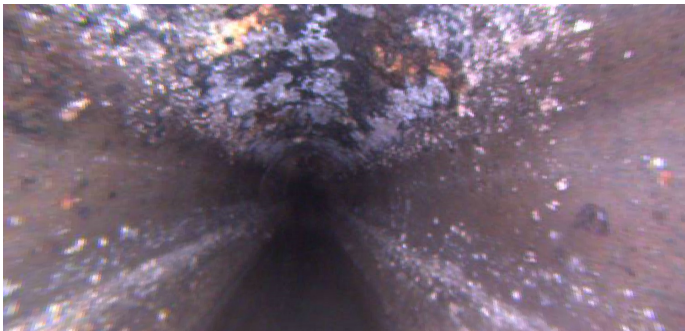
Code: **AMH**  
Description: **Manhole**

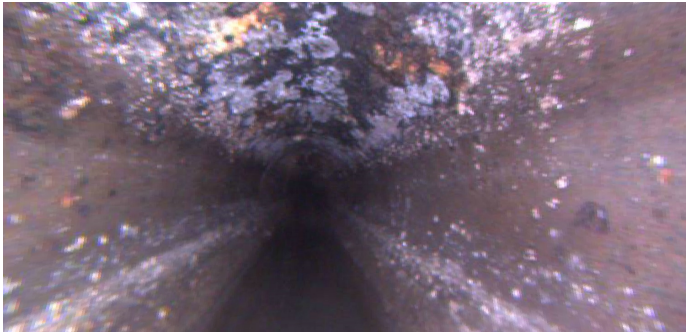
Code:	<b>MWL</b>
Description:	<b>Water Level</b>

Distance (ft):	<b>.0</b>
Structural Grade:	<b>0</b>
O&M Grade:	<b>0</b>
Clock Start/From:	
Clock To:	
1st Value:	
2nd Value:	
Value Percent:	<b>5.000</b>
Continuous Index:	
Within 8" of Joint:	<b>NO</b>
Remarks:

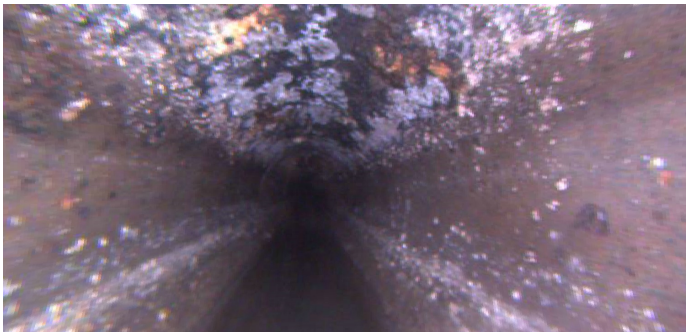
Code:	<b>DAZ</b>
Description:	<b>Deposits Attached Other</b>

Distance (ft):	<b>.0</b>
Structural Grade:	<b>0</b>
O&M Grade:	<b>2</b>
Clock Start/From:	<b>11</b>
Clock To:	<b>1</b>
1st Value:	
2nd Value:	
Value Percent:	<b>5.000</b>
Continuous Index:	<b>S01</b>
Within 8" of Joint:	<b>NO</b>
Remarks:

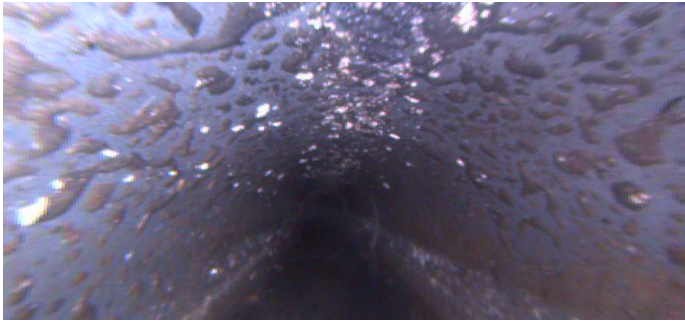
Code: **DAZ**  
Description: **Deposits Attached Other**

Distance (ft): **11.3**  
Structural Grade: **0**  
O&M Grade: **2**  
Clock Start/From: **11**  
Clock To: **1**  
1st Value:  
2nd Value:  
Value Percent: **5.000**  
Continuous Index: **F01**  
Within 8" of Joint: **NO**  
Remarks:

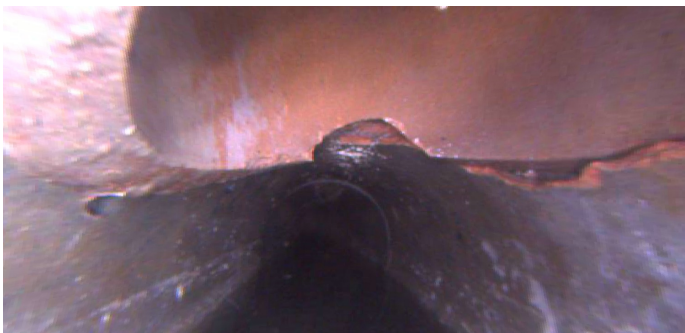
Code: **TB**  
Description: **Tap Break-in**

Distance (ft): **15.8**  
Structural Grade: **0**  
O&M Grade: **0**  
Clock Start/From: **12**  
Clock To:  
1st Value: **6.000**  
2nd Value:  
Value Percent:  
Continuous Index:  
Within 8" of Joint:  
Remarks:

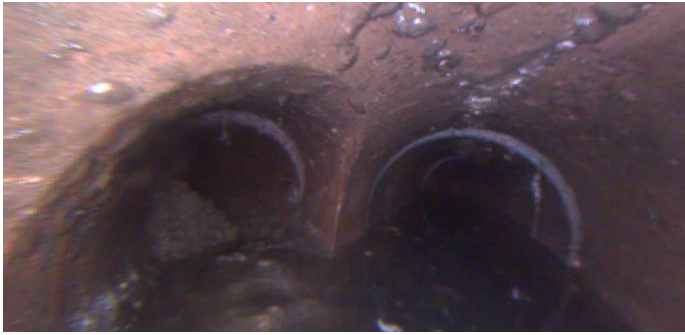
Code: **TFD**  
Description: **Tap Factory Defective**

Distance (ft): **24.3**  
Structural Grade: **0**  
O&M Grade: **2**  
Clock Start/From: **9**  
Clock To:  
1st Value: **4.000**  
2nd Value:  
Value Percent:  
Continuous Index:  
Within 8" of Joint: **YES**  
Remarks: **partially blocked**

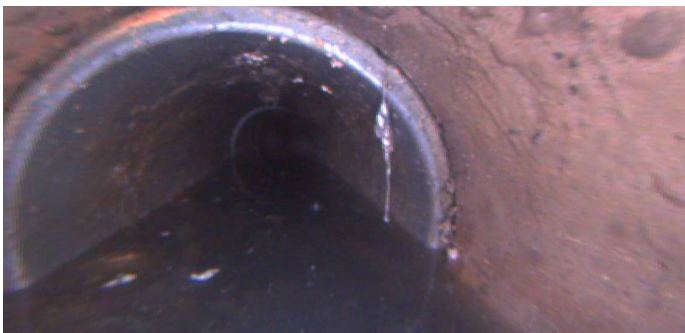
Code: **RFJ**  
Description: **Roots Fine Joint**

Distance (ft): **24.9**  
Structural Grade: **0**  
O&M Grade: **1**  
Clock Start/From: **1**  
Clock To:  
1st Value:  
2nd Value:  
Value Percent:  
Continuous Index:  
Within 8" of Joint: **YES**  
Remarks:

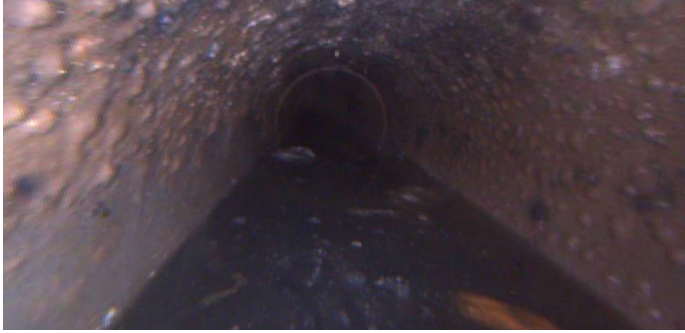
Code: **DSZ**  
Description: **Deposits Settled Other**

Distance (ft): **41.8**  
Structural Grade: **0**  
O&M Grade: **2**  
Clock Start/From: **6**  
Clock To:  
1st Value:  
2nd Value:  
Value Percent: **5.000**  
Continuous Index: **S02**  
Within 8" of Joint: **NO**  
Remarks: **debris**

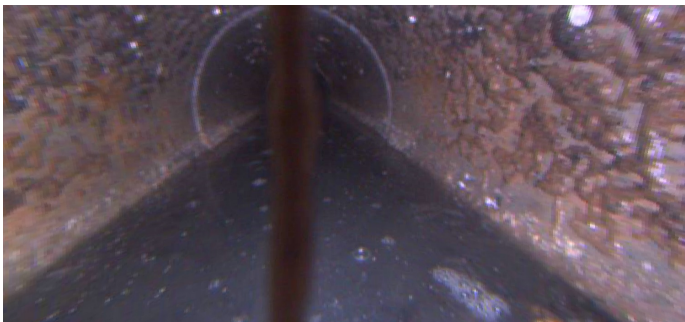
Code: **MSA**  
Description: **Abandoned Survey**

Distance (ft): **46.5**  
Structural Grade: **0**  
O&M Grade: **0**  
Clock Start/From:  
Clock To:  
1st Value:  
2nd Value:  
Value Percent:  
Continuous Index:  
Within 8" of Joint: **NO**  
Remarks: **no blockage**

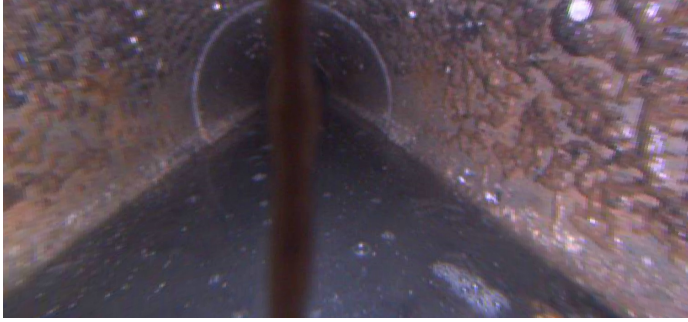
Code:	<b>DSZ</b>
Description:	<b>Deposits Settled Other</b>
Distance (ft):	<b>46.5</b>
Structural Grade:	<b>0</b>
O&M Grade:	<b>2</b>
Clock Start/From:	<b>6</b>
Clock To:	
1st Value:	
2nd Value:	
Value Percent:	<b>5.000</b>
Continuous Index:	<b>F02</b>
Within 8" of Joint:	<b>NO</b>
Remarks:	<b>debris</b>
