## Profile/Photo Observation Report

Date:	03/09/2024	Weather:		Coding:	PACP 7.0
Pipe Length (ft):	160.0	Owner:	City of Hobart	Pre Clean:	Heavy Cleaning
P.O.#:		Surveyor:	S. Bucklin	PSR:	P-804-006-005
Customer:	City of Hobart	Clean Date:	11/13/2022	Shape:	C

Street:	JACKSON ST	Flow Control:	Not Controlled
City:	Hobart, IN	Year Renewed:	
Location:	Alley	Tape/Media #:	
Purpose:	Sewer System Evaluation Survey (SS	Dia/Height:	8"
Use:	Sanitary Sewage Pipe	Material:	VCP
Drain Area:		Lining:	None
Category:	NA		
Comment:			
Location Details:		Direction of Survey:	Upstream
US MH:	M-804-005	DS MH:	M-804-006
		Total Length Surveyed (ft):	160.7

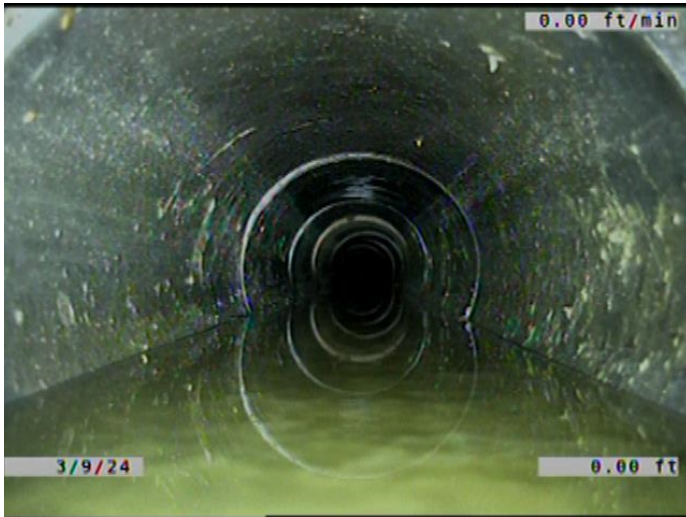
Code: **DSF**  
 Description: **Deposits Settled Fine**

Distance (ft): **.0**  
 Structural Grade: **0**  
 O&M Grade: **2**  
 Clock Start/From: **5**  
 Clock To: **7**  
 1st Value:  
 2nd Value:  
 Value Percent: **5.000**  
 Continuous Index: **S01**  
 Within 8" of Joint: **YES**  
 Remarks:

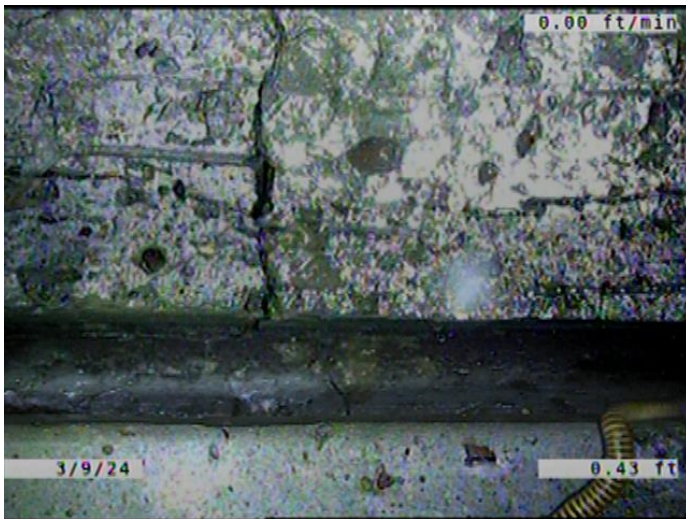
Code: **B**  
 Description: **Broken**

Distance (ft): **.4**  
 Structural Grade: **4**  
 O&M Grade: **0**  
 Clock Start/From: **8**  
 Clock To: **4**  
 1st Value:  
 2nd Value:  
 Value Percent:  
 Continuous Index:  
 Within 8" of Joint: **YES**  
 Remarks:

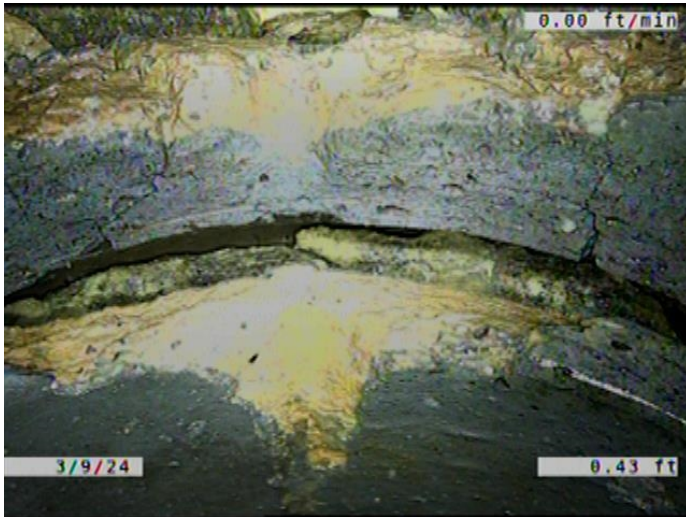
Code: **JOMD**  
Description: **Joint Offset Medium Defective**

Distance (ft): **.4**  
Structural Grade: **3**  
O&M Grade: **0**  
Clock Start/From:  
Clock To:  
1st Value:  
2nd Value:  
Value Percent:  
Continuous Index:  
Within 8" of Joint: **NO**  
Remarks:

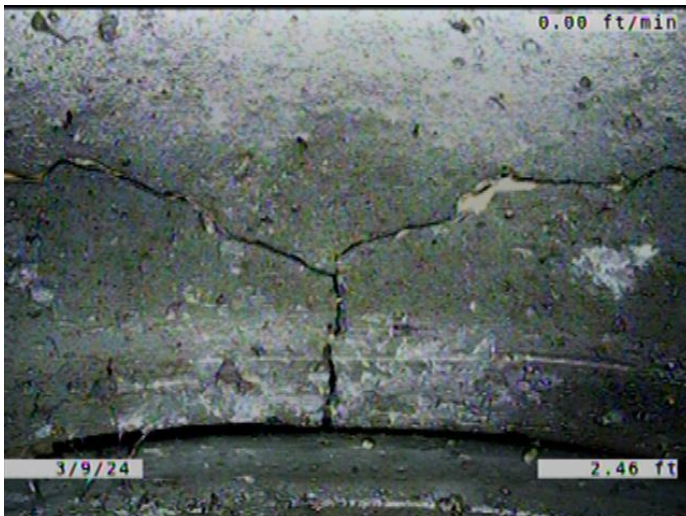
Code: **FM**  
Description: **Fracture Multiple**

Distance (ft): **2.5**  
Structural Grade: **4**  
O&M Grade: **0**  
Clock Start/From: **8**  
Clock To: **4**  
1st Value:  
2nd Value:  
Value Percent:  
Continuous Index: **S02**  
Within 8" of Joint: **YES**  
Remarks:

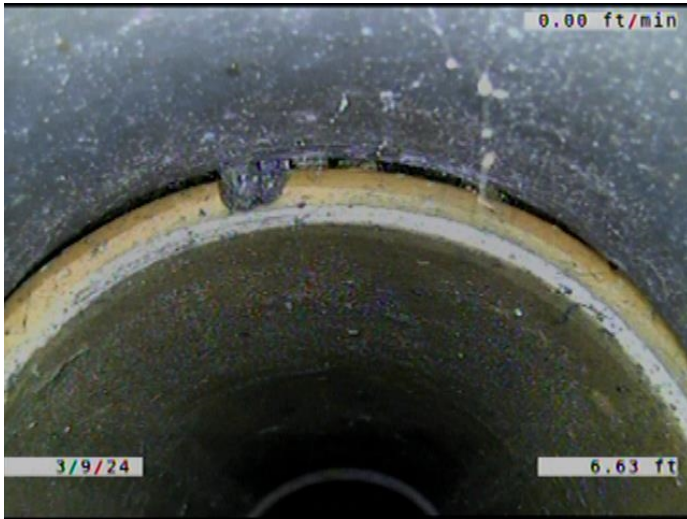
Code: **JOMD**  
Description: **Joint Offset Medium Defective**

Distance (ft): **6.6**  
Structural Grade: **3**  
O&M Grade: **0**  
Clock Start/From:  
Clock To:  
1st Value:  
2nd Value:  
Value Percent:  
Continuous Index:  
Within 8" of Joint: **NO**  
Remarks: **SOIL VISIBLE**

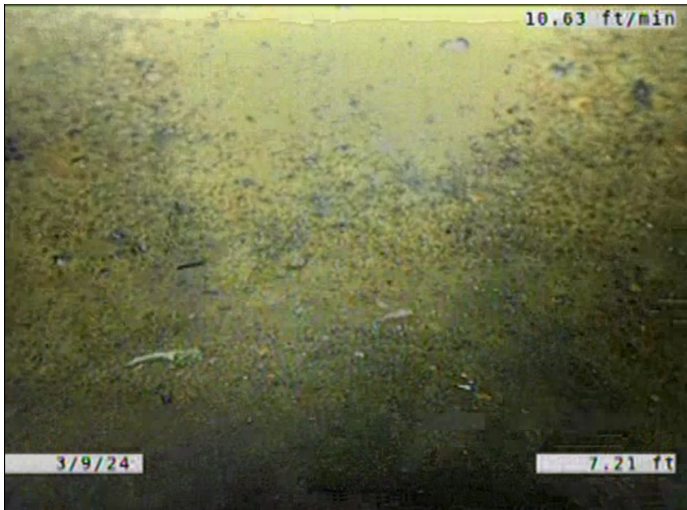
Code: **FM**  
Description: **Fracture Multiple**

Distance (ft): **7.7**  
Structural Grade: **4**  
O&M Grade: **0**  
Clock Start/From: **8**  
Clock To: **4**  
1st Value:  
2nd Value:  
Value Percent:  
Continuous Index: **F02**  
Within 8" of Joint: **YES**  
Remarks:

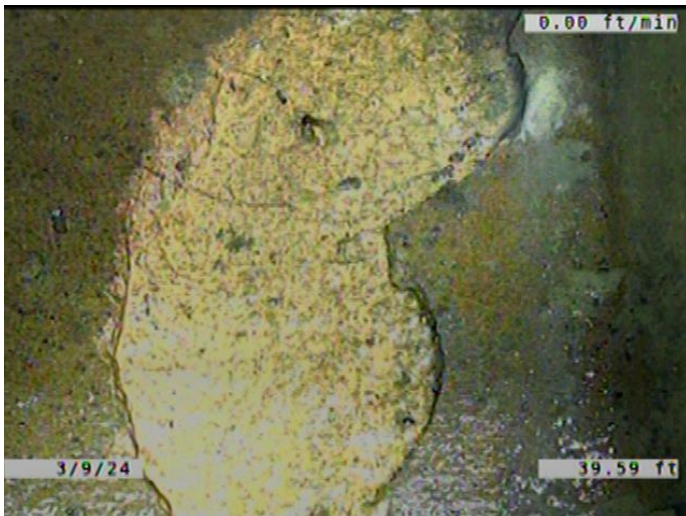
Code: **SSC**  
Description: **Surface Spalling of Damage Coating**

Distance (ft): **39.6**  
Structural Grade: **1**  
O&M Grade: **0**  
Clock Start/From: **8**  
Clock To: **9**  
1st Value:  
2nd Value:  
Value Percent:  
Continuous Index:  
Within 8" of Joint: **YES**  
Remarks:

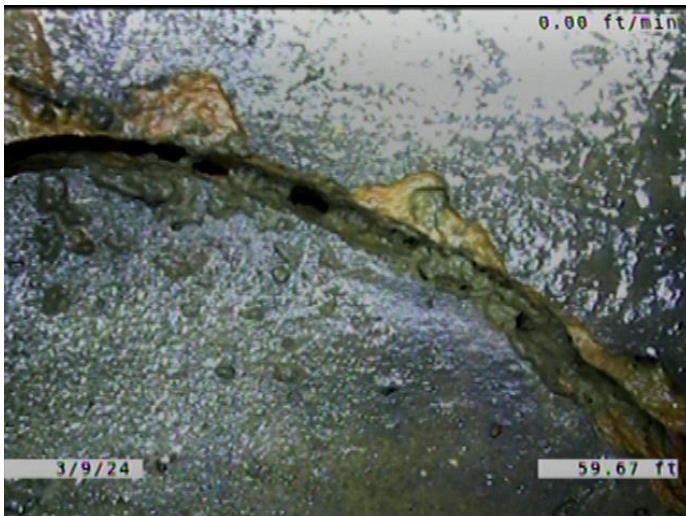
Code: **BSV**  
 Description: **Broken Soil Visible**

Distance (ft): **59.7**  
 Structural Grade: **5**  
 O&M Grade: **0**  
 Clock Start/From: **8**  
 Clock To: **12**  
 1st Value:  
 2nd Value:  
 Value Percent:  
 Continuous Index:  
 Within 8" of Joint: **YES**  
 Remarks:

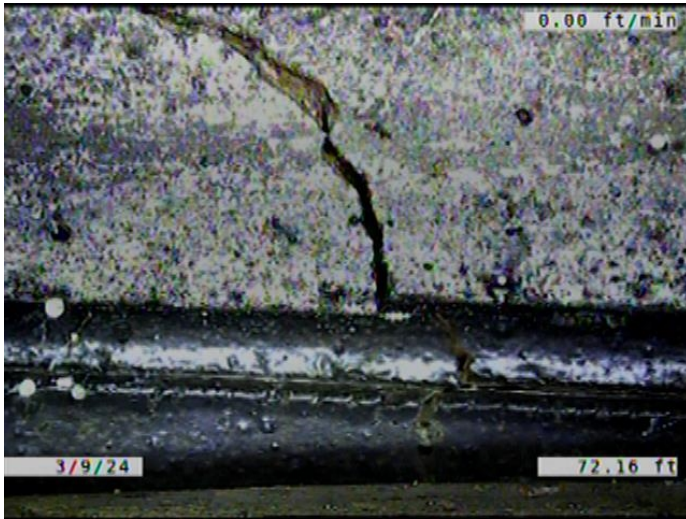
Code: **B**  
Description: **Broken**

Distance (ft): **72.2**  
Structural Grade: **4**  
O&M Grade: **0**  
Clock Start/From: **8**  
Clock To: **3**  
1st Value:  
2nd Value:  
Value Percent:  
Continuous Index:  
Within 8" of Joint: **YES**  
Remarks:

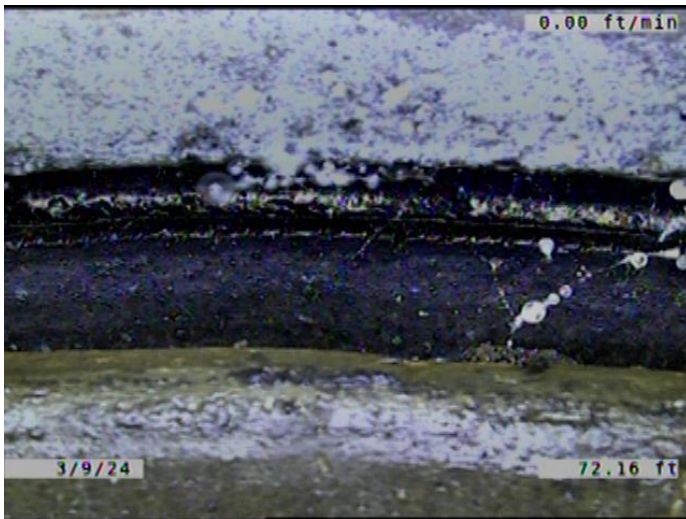
Code: **JAM**  
Description: **Joint Angular Medium**

Distance (ft): **72.2**  
Structural Grade: **3**  
O&M Grade: **0**  
Clock Start/From:  
Clock To:  
1st Value:  
2nd Value:  
Value Percent:  
Continuous Index:  
Within 8" of Joint: **NO**  
Remarks: **SOIL VISIBLE.**

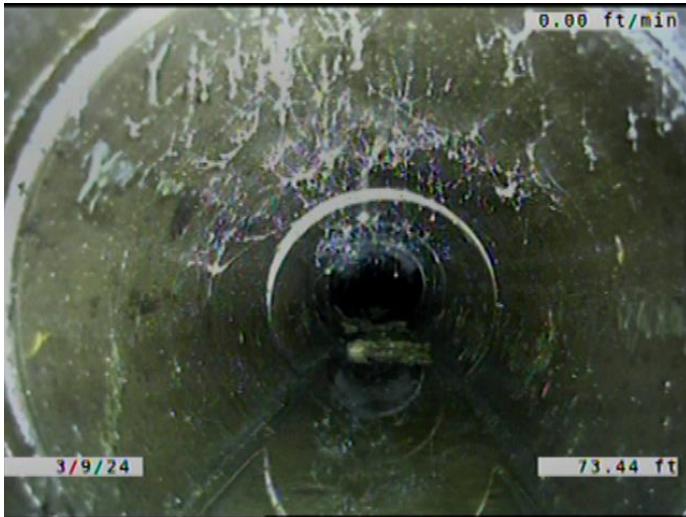
Code: **MWLS**  
Description: **Miscellaneous Water Level Sag**

Distance (ft): **73.4**  
Structural Grade: **2**  
O&M Grade: **0**  
Clock Start/From:  
Clock To:  
1st Value:  
2nd Value:  
Value Percent: **10.000**  
Continuous Index: **S03**  
Within 8" of Joint: **NO**  
Remarks:

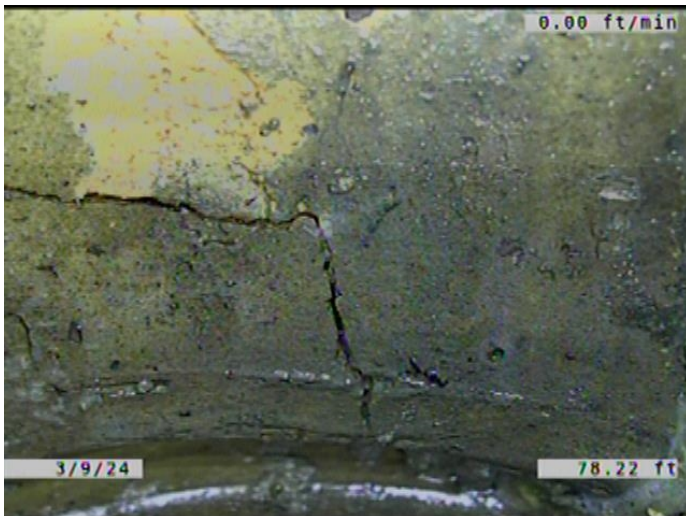
Code: **FM**  
Description: **Fracture Multiple**

Distance (ft): **78.2**  
Structural Grade: **4**  
O&M Grade: **0**  
Clock Start/From: **8**  
Clock To: **4**  
1st Value:  
2nd Value:  
Value Percent:  
Continuous Index:  
Within 8" of Joint: **YES**  
Remarks:

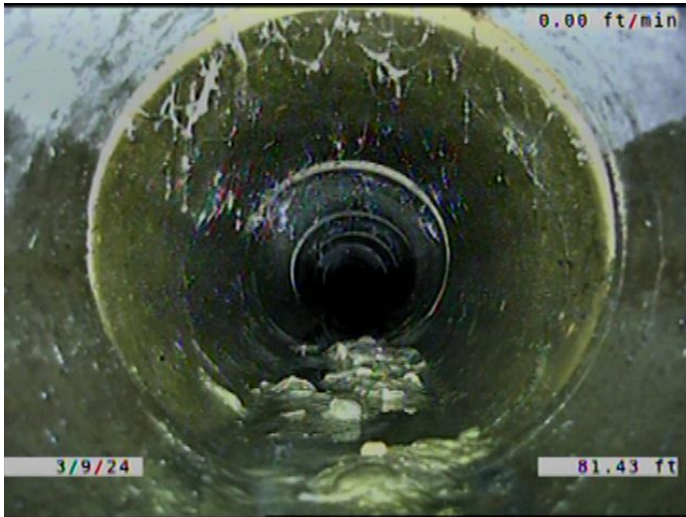
Code: **MWLS**  
Description: **Miscellaneous Water Level Sag**

Distance (ft): **81.4**  
Structural Grade: **2**  
O&M Grade: **0**  
Clock Start/From:  
Clock To:  
1st Value:  
2nd Value:  
Value Percent: **10.000**  
Continuous Index: **F03**  
Within 8" of Joint: **NO**  
Remarks:

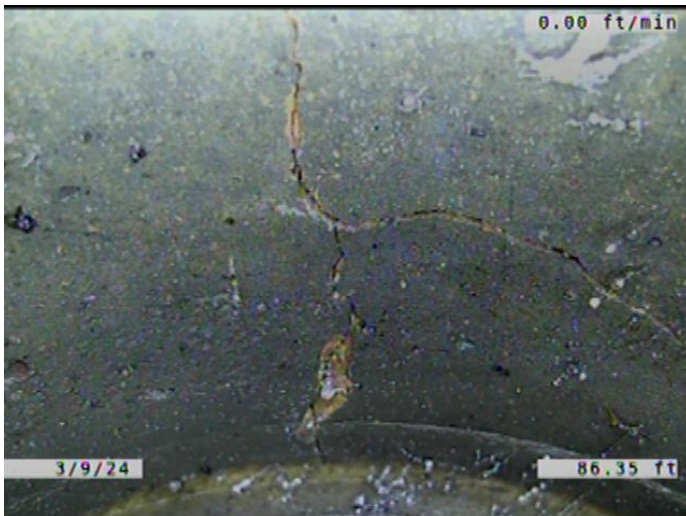
Code: **FM**  
Description: **Fracture Multiple**

Distance (ft): **86.4**  
Structural Grade: **4**  
O&M Grade: **0**  
Clock Start/From: **8**  
Clock To: **2**  
1st Value:  
2nd Value:  
Value Percent:  
Continuous Index:  
Within 8" of Joint: **YES**  
Remarks:

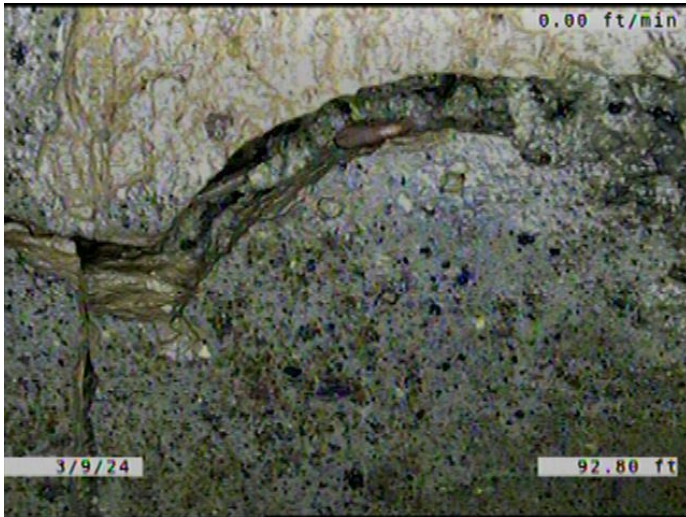
Code: **BSV**  
 Description: **Broken Soil Visible**

Distance (ft): **92.8**  
 Structural Grade: **5**  
 O&M Grade: **0**  
 Clock Start/From: **9**  
 Clock To: **5**  
 1st Value:  
 2nd Value:  
 Value Percent:  
 Continuous Index:  
 Within 8" of Joint: **YES**  
 Remarks:

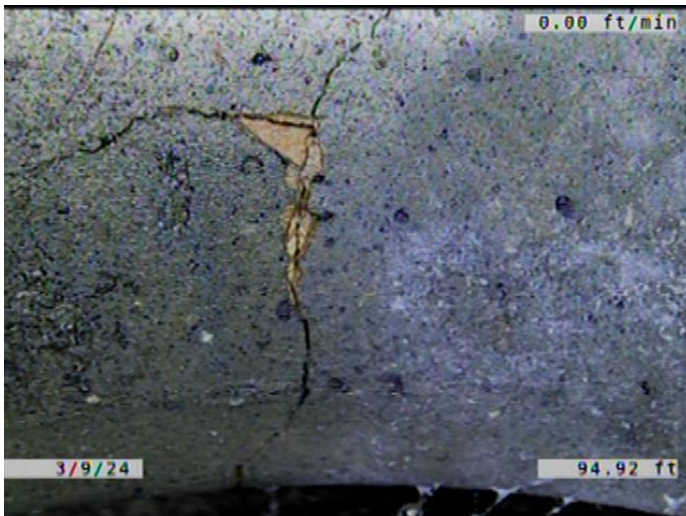
Code: **FM**  
 Description: **Fracture Multiple**

Distance (ft): **94.9**  
 Structural Grade: **4**  
 O&M Grade: **0**  
 Clock Start/From: **8**  
 Clock To: **11**  
 1st Value:  
 2nd Value:  
 Value Percent:  
 Continuous Index:  
 Within 8" of Joint: **YES**  
 Remarks:

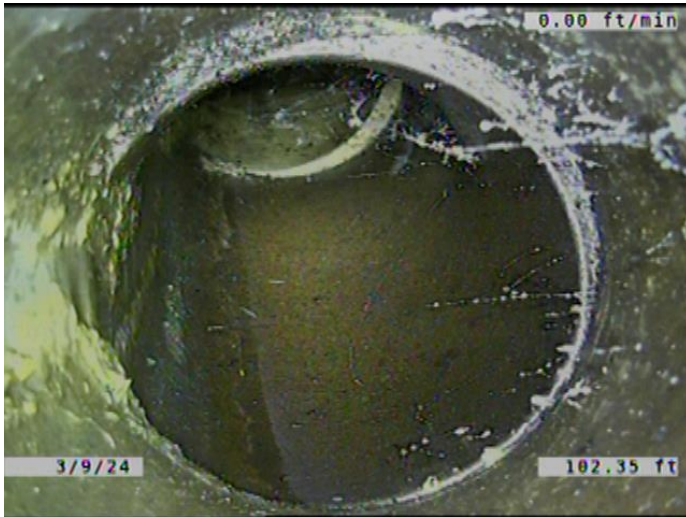
Code: **TF**  
Description: **Tap Factory**

Distance (ft): **102.4**  
Structural Grade: **0**  
O&M Grade: **0**  
Clock Start/From: **9**  
Clock To:  
1st Value: **6.000**  
2nd Value:  
Value Percent:  
Continuous Index:  
Within 8" of Joint: **YES**  
Remarks: **SERVICE OFFSET.**

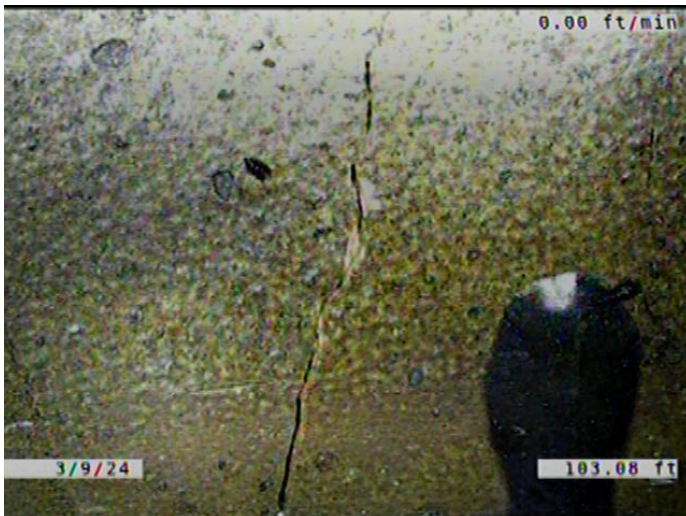
Code: **FL**  
Description: **Fracture Longitudinal**

Distance (ft): **103.1**  
Structural Grade: **3**  
O&M Grade: **0**  
Clock Start/From: **10**  
Clock To:  
1st Value:  
2nd Value:  
Value Percent:  
Continuous Index:  
Within 8" of Joint: **YES**  
Remarks:

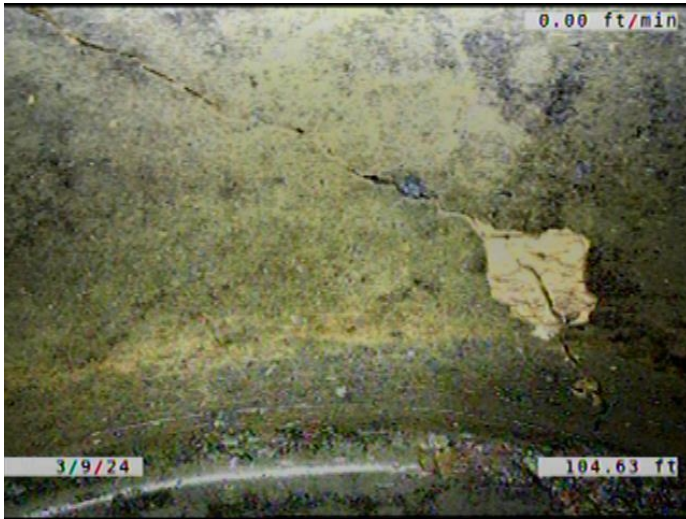
Code: **FM**  
 Description: **Fracture Multiple**

Distance (ft): **104.6**  
 Structural Grade: **4**  
 O&M Grade: **0**  
 Clock Start/From: **9**  
 Clock To: **1**  
 1st Value:  
 2nd Value:  
 Value Percent:  
 Continuous Index:  
 Within 8" of Joint: **YES**  
 Remarks:

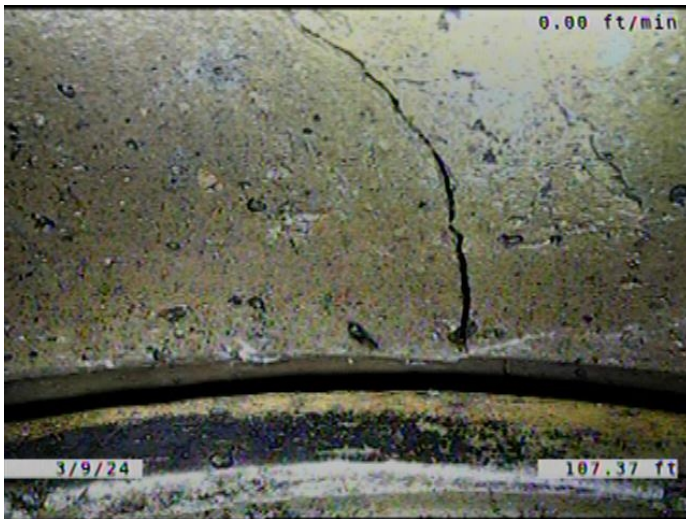
Code: **FM**  
 Description: **Fracture Multiple**

Distance (ft): **107.4**  
 Structural Grade: **4**  
 O&M Grade: **0**  
 Clock Start/From: **10**  
 Clock To: **2**  
 1st Value:  
 2nd Value:  
 Value Percent:  
 Continuous Index:  
 Within 8" of Joint: **YES**  
 Remarks:

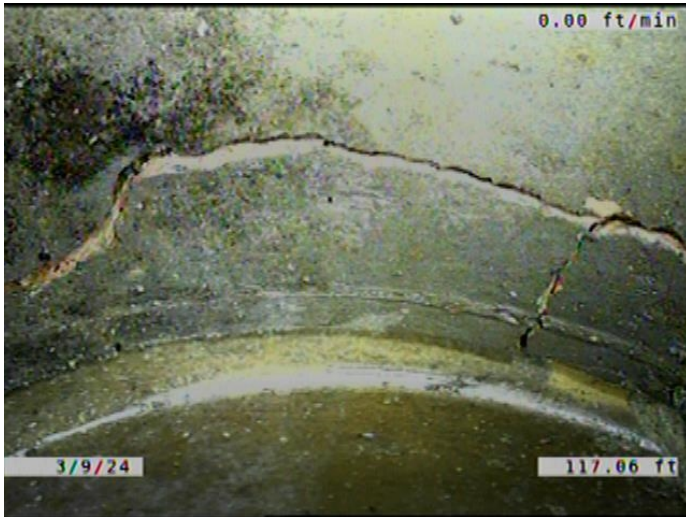
Code: **B**  
Description: **Broken**

Distance (ft): **117.1**  
Structural Grade: **4**  
O&M Grade: **0**  
Clock Start/From: **8**  
Clock To: **4**  
1st Value:  
2nd Value:  
Value Percent:  
Continuous Index:  
Within 8" of Joint: **YES**  
Remarks:

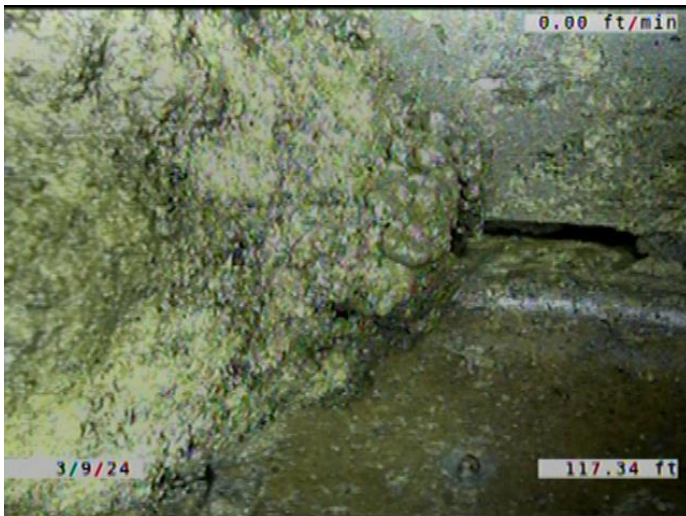
Code: **DAE**  
Description: **Deposits Attached Encrustation**

Distance (ft): **117.3**  
Structural Grade: **0**  
O&M Grade: **2**  
Clock Start/From: **7**  
Clock To: **5**  
1st Value:  
2nd Value:  
Value Percent: **5.000**  
Continuous Index:  
Within 8" of Joint: **YES**  
Remarks:

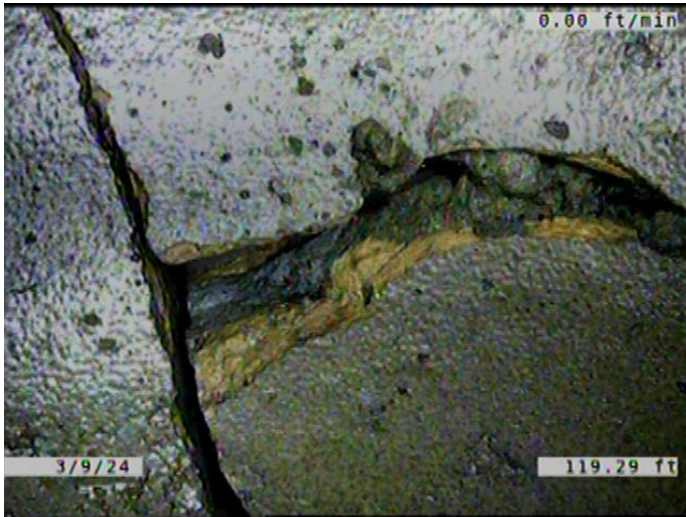
Code: **BSV**  
Description: **Broken Soil Visible**

Distance (ft): **119.3**  
Structural Grade: **5**  
O&M Grade: **0**  
Clock Start/From: **8**  
Clock To: **4**  
1st Value:  
2nd Value:  
Value Percent:  
Continuous Index:  
Within 8" of Joint: **YES**  
Remarks:

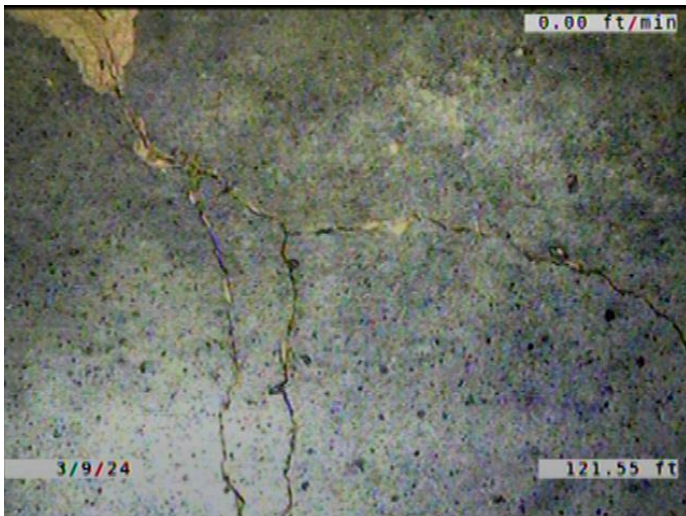
Code: **FM**  
Description: **Fracture Multiple**

Distance (ft): **121.5**  
Structural Grade: **4**  
O&M Grade: **0**  
Clock Start/From: **8**  
Clock To: **5**  
1st Value:  
2nd Value:  
Value Percent:  
Continuous Index:  
Within 8" of Joint: **YES**  
Remarks:

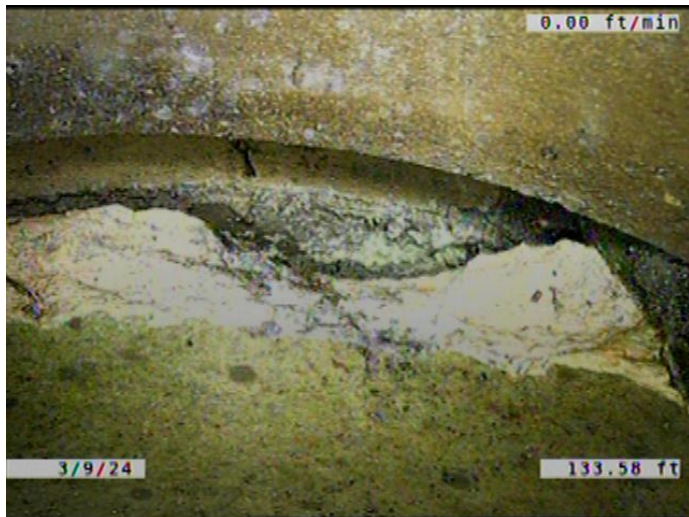
Code: **SZ**  
 Description: **Surface Damage Other**

Distance (ft): **133.6**  
 Structural Grade: **0**  
 O&M Grade: **0**  
 Clock Start/From: **2**  
 Clock To: **4**  
 1st Value:  
 2nd Value:  
 Value Percent:  
 Continuous Index:  
 Within 8" of Joint: **YES**  
 Remarks: **A PIECE CHIPPED AWAY FROM THE JOINT.**

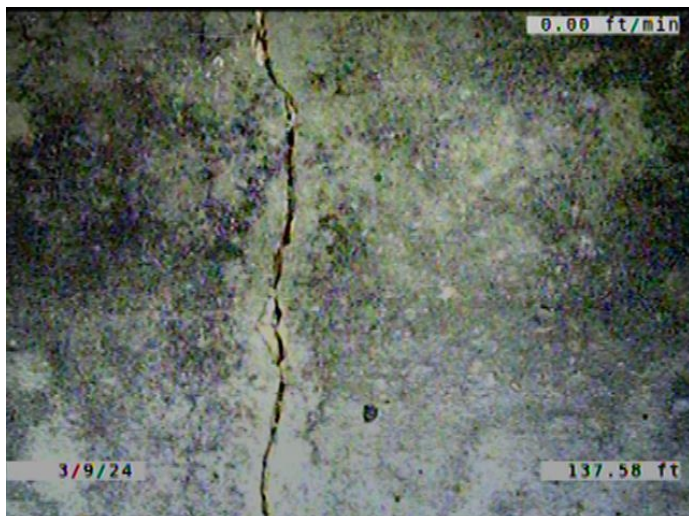
Code: **B**  
 Description: **Broken**

Distance (ft): **137.6**  
 Structural Grade: **4**  
 O&M Grade: **0**  
 Clock Start/From: **12**  
 Clock To: **12**  
 1st Value:  
 2nd Value:  
 Value Percent:  
 Continuous Index:  
 Within 8" of Joint: **YES**  
 Remarks:

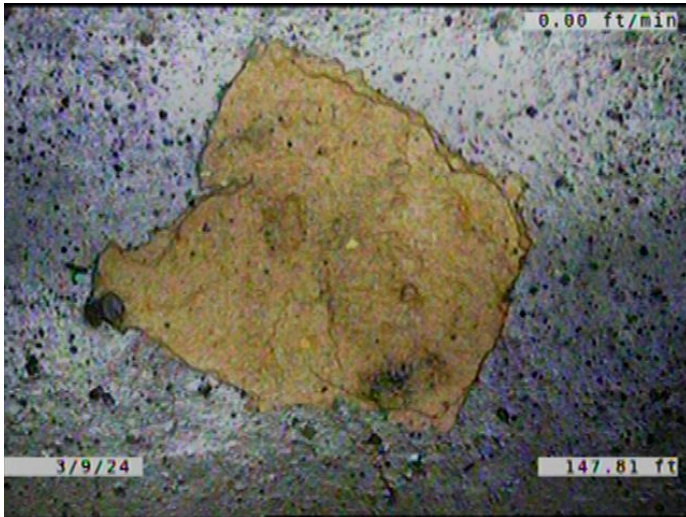
Code:	<b>SSC</b>
Description:	<b>Surface Spalling of Damage Coating</b>
Distance (ft):	<b>147.8</b>
Structural Grade:	<b>1</b>
O&M Grade:	<b>0</b>
Clock Start/From:	<b>1</b>
Clock To:	<b>2</b>
1st Value:	
2nd Value:	
Value Percent:	
Continuous Index:	
Within 8" of Joint:	<b>YES</b>
Remarks:

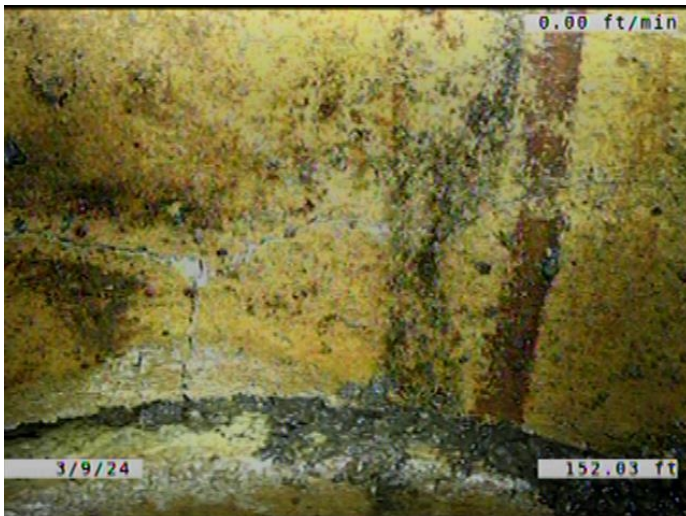
Code:	<b>FM</b>
Description:	<b>Fracture Multiple</b>
Distance (ft):	<b>152.0</b>
Structural Grade:	<b>4</b>
O&M Grade:	<b>0</b>
Clock Start/From:	<b>9</b>
Clock To:	<b>5</b>
1st Value:	
2nd Value:	
Value Percent:	
Continuous Index:	
Within 8" of Joint:	<b>YES</b>
Remarks:

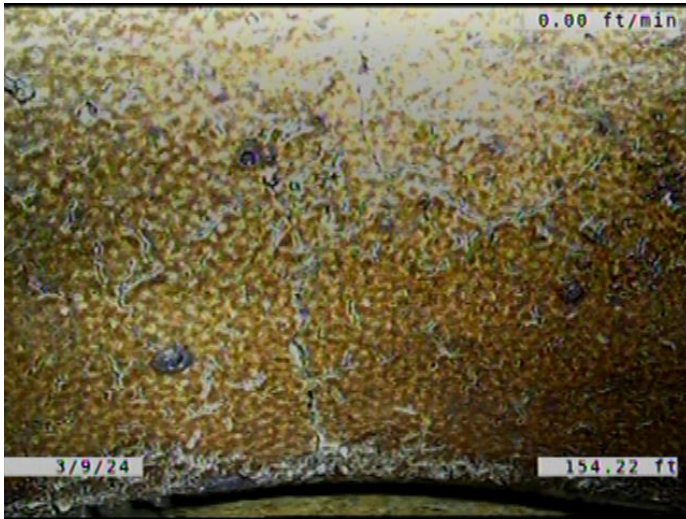
Code: **CM**  
Description: **Crack Multiple**

Distance (ft): **154.2**  
Structural Grade: **3**  
O&M Grade: **0**  
Clock Start/From: **10**  
Clock To: **4**  
1st Value:  
2nd Value:  
Value Percent:  
Continuous Index:  
Within 8" of Joint: **YES**  
Remarks:

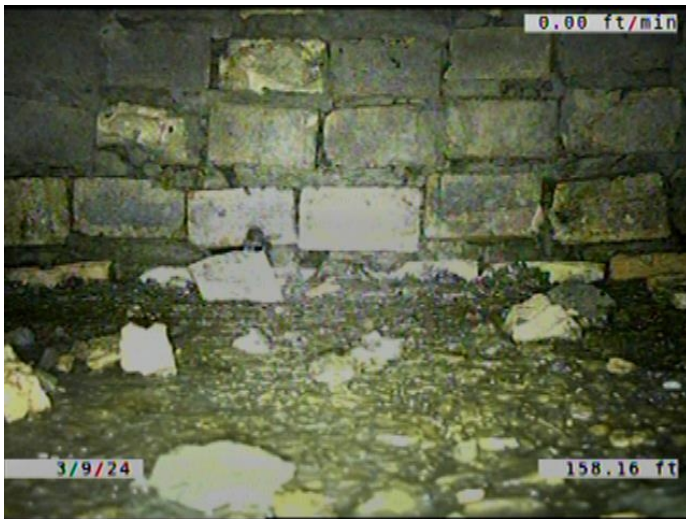
Code: **DSF**  
Description: **Deposits Settled Fine**

Distance (ft): **158.2**  
Structural Grade: **0**  
O&M Grade: **2**  
Clock Start/From: **5**  
Clock To: **7**  
1st Value:  
2nd Value:  
Value Percent: **5.000**  
Continuous Index: **F01**  
Within 8" of Joint: **YES**  
Remarks:
