Profile/Photo Observation Report

Date:	08/04/2023	Weather:		Coding:	PACP 7.0
Pipe Length (ft):	388.0	Owner:	City of Hobart	Pre Clean:	Heavy Cleaning
P.O.#:	YES502259	Surveyor:	S. Bucklin	PSR:	P-804-009-010
Customer:	City of Hobart	Clean Date:	11/15/2022	Shape:	C

Street:	East Cleveland Avenue	Flow Control:	Not Controlled
City:	Hobart, IN	Year Renewed:	
Location:	Local rural streets with light traffic, t	Tape/Media #:	
Purpose:	Routine Assessment	Dia/Height:	8"
Use:	Sanitary Sewage Pipe	Material:	VCP
Drain Area:		Lining:	None
Category:	NA		
Comment:			
Location Details:		Direction of Survey:	Downstream
US MH:	M-804-009	DS MH:	M-804-010
		Total Length Surveyed (ft):	179.2

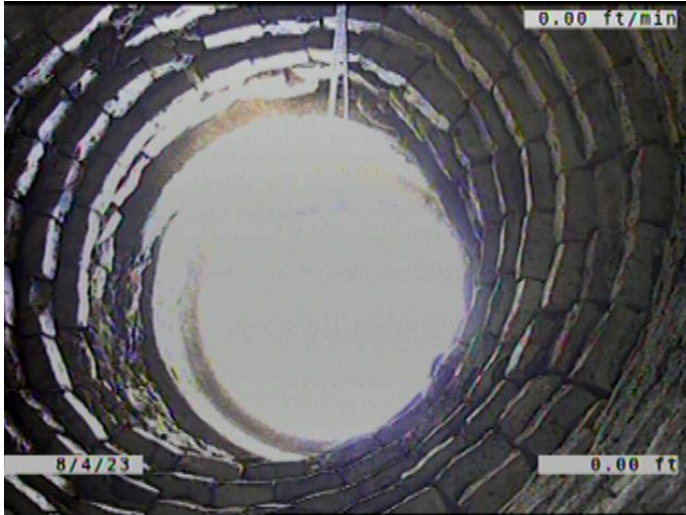
Code: **AMH**
Description: **Manhole**

Distance (ft): **.0**
Structural Grade: **0**
O&M Grade: **0**
Clock Start/From:
Clock To:
1st Value:
2nd Value:
Value Percent:
Continuous Index:
Within 8" of Joint: **NO**
Remarks: **M-804-009**

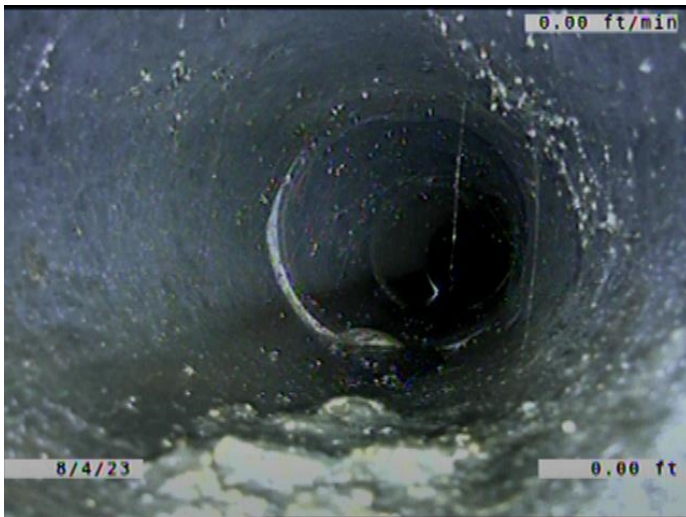
Code: **MWL**
Description: **Miscellaneous Water Level**

Distance (ft): **.0**
Structural Grade: **0**
O&M Grade: **0**
Clock Start/From:
Clock To:
1st Value:
2nd Value:
Value Percent: **5.000**
Continuous Index:
Within 8" of Joint: **NO**
Remarks:

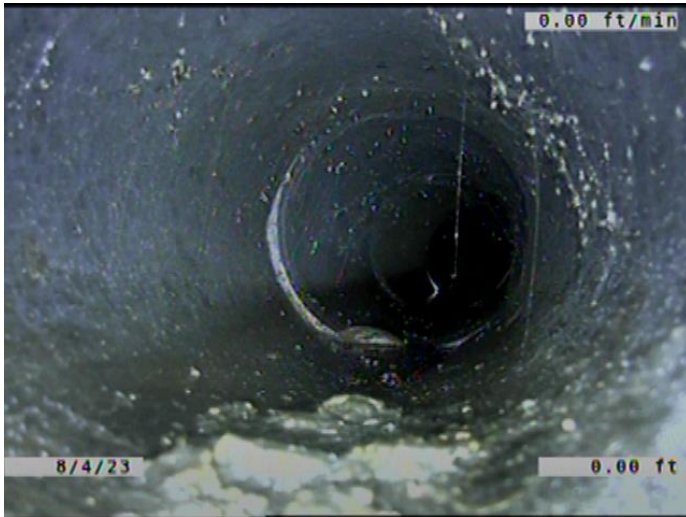
Code: **DSF**
Description: **Deposits Settled Fine**

Distance (ft): **.0**
Structural Grade: **0**
O&M Grade: **2**
Clock Start/From: **5**
Clock To: **7**
1st Value:
2nd Value:
Value Percent: **5.000**
Continuous Index: **S01**
Within 8" of Joint: **YES**
Remarks:

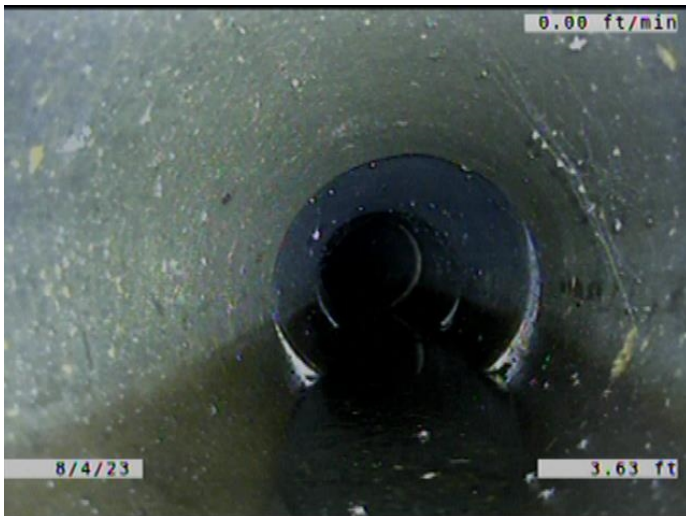
Code: **MWLS**
Description: **Miscellaneous Water Level Sag**

Distance (ft): **3.6**
Structural Grade: **2**
O&M Grade: **0**
Clock Start/From:
Clock To:
1st Value:
2nd Value:
Value Percent: **10.000**
Continuous Index: **S02**
Within 8" of Joint: **NO**
Remarks:

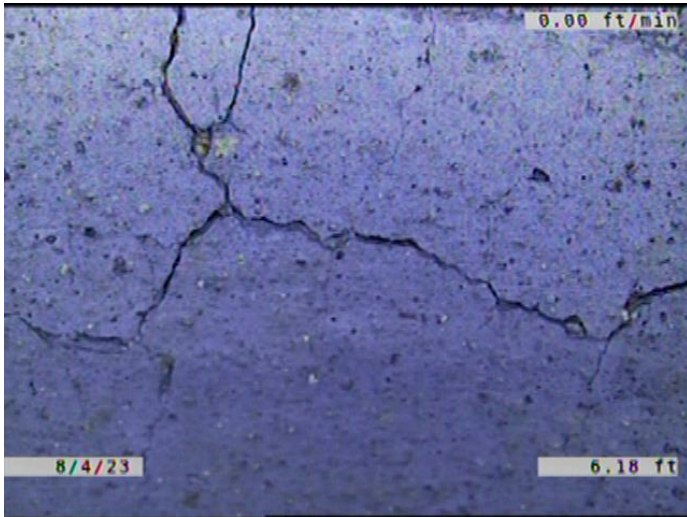
Code: **FM**
Description: **Fracture Multiple**

Distance (ft): **6.2**
Structural Grade: **4**
O&M Grade: **0**
Clock Start/From: **8**
Clock To: **4**
1st Value:
2nd Value:
Value Percent:
Continuous Index: **S03**
Within 8" of Joint: **YES**
Remarks: **Wandering**

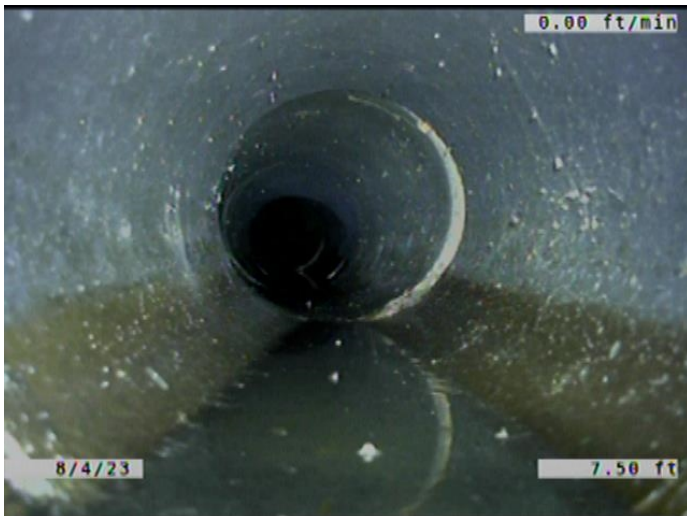
Code: **LL**
Description: **Line Left**

Distance (ft): **7.5**
Structural Grade: **0**
O&M Grade: **1**
Clock Start/From:
Clock To:
1st Value:
2nd Value:
Value Percent: **10.000**
Continuous Index:
Within 8" of Joint: **NO**
Remarks:

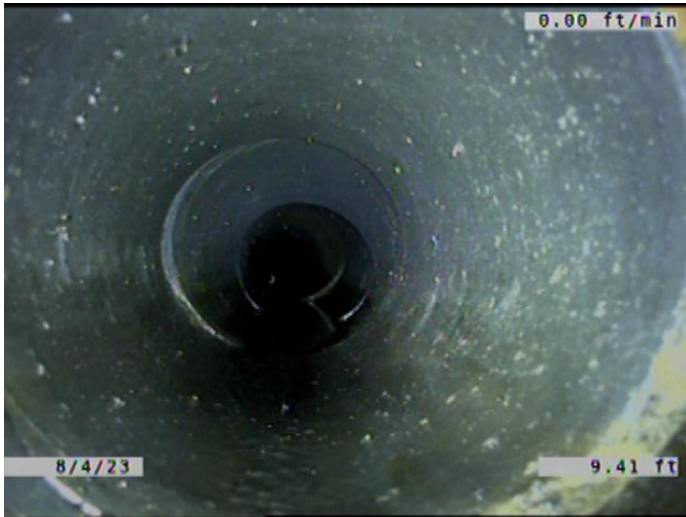
Code: **MWLS**
Description: **Miscellaneous Water Level Sag**

Distance (ft): **9.4**
Structural Grade: **2**
O&M Grade: **0**
Clock Start/From:
Clock To:
1st Value:
2nd Value:
Value Percent: **10.000**
Continuous Index: **F02**
Within 8" of Joint: **NO**
Remarks:

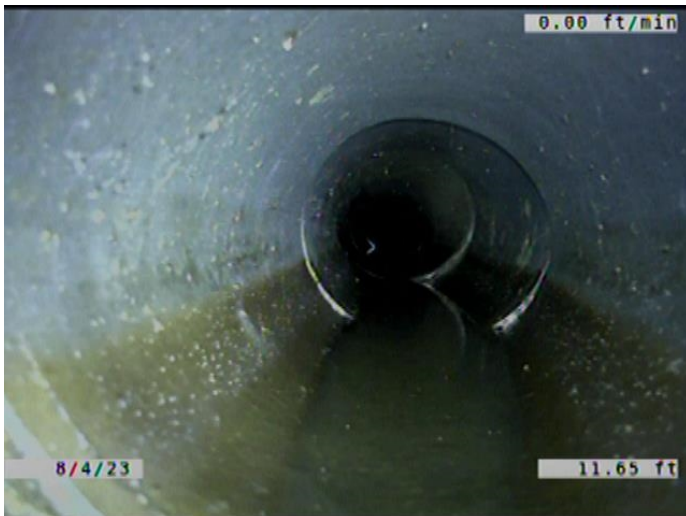
Code: **MWLS**
Description: **Miscellaneous Water Level Sag**

Distance (ft): **11.7**
Structural Grade: **2**
O&M Grade: **0**
Clock Start/From:
Clock To:
1st Value:
2nd Value:
Value Percent: **10.000**
Continuous Index: **S04**
Within 8" of Joint: **NO**
Remarks:

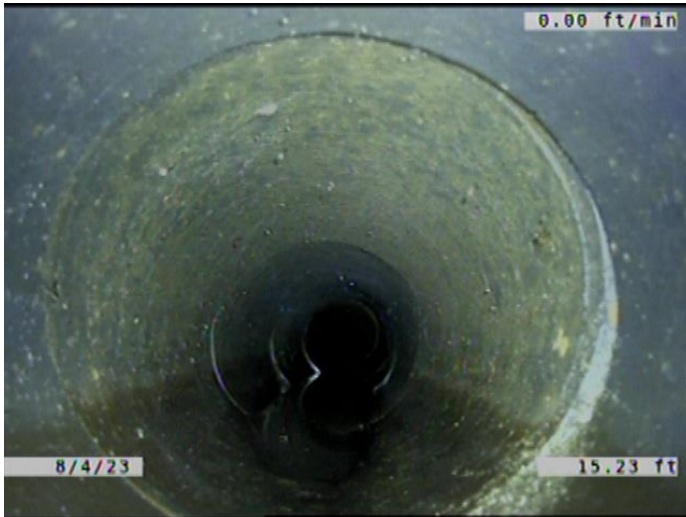
Code: **MWLS**
Description: **Miscellaneous Water Level Sag**

Distance (ft): **15.2**
Structural Grade: **2**
O&M Grade: **0**
Clock Start/From:
Clock To:
1st Value:
2nd Value:
Value Percent: **10.000**
Continuous Index: **F04**
Within 8" of Joint: **NO**
Remarks:

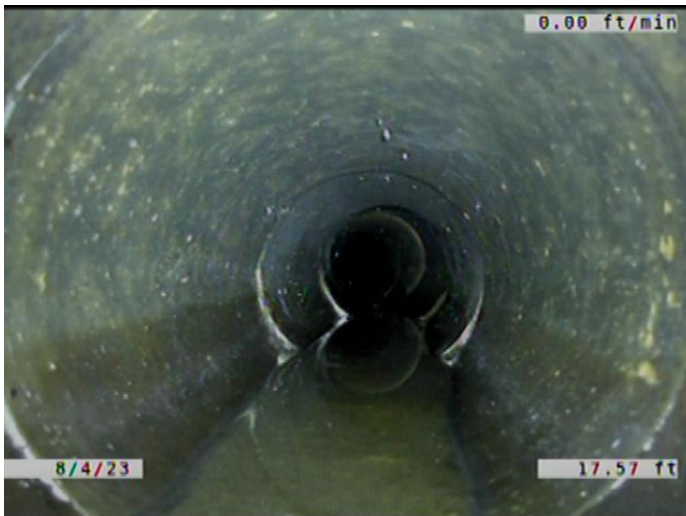
Code: **MWLS**
Description: **Miscellaneous Water Level Sag**

Distance (ft): **17.6**
Structural Grade: **2**
O&M Grade: **0**
Clock Start/From:
Clock To:
1st Value:
2nd Value:
Value Percent: **10.000**
Continuous Index: **S05**
Within 8" of Joint: **NO**
Remarks:

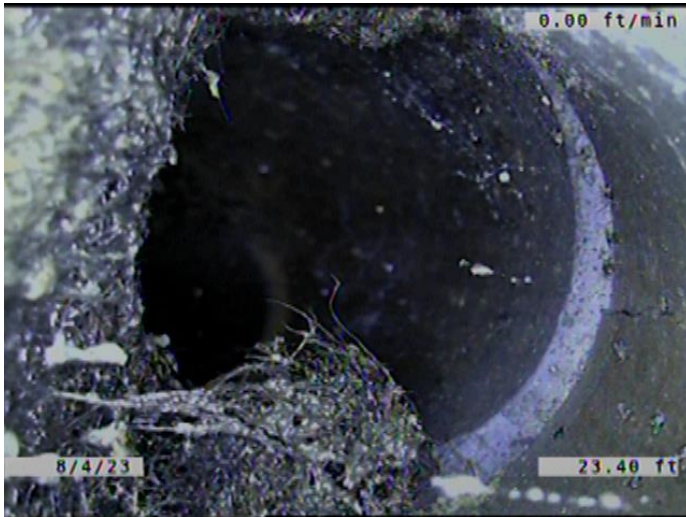
Code:	TFD
Description:	Tap Factory Defective
Distance (ft):	23.4
Structural Grade:	0
O&M Grade:	3
Clock Start/From:	10
Clock To:	
1st Value:	6.000
2nd Value:	
Value Percent:	
Continuous Index:	
Within 8" of Joint:	YES
Remarks:	TAP BROKEN. SERVICE BROKEN. ROOTS GROWING IN THE SERVICE T

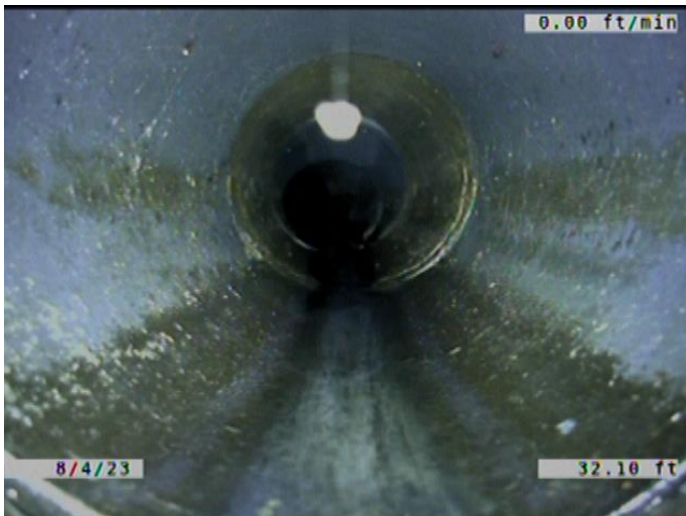
Code:	MWLS
Description:	Miscellaneous Water Level Sag
Distance (ft):	32.1
Structural Grade:	2
O&M Grade:	0
Clock Start/From:	
Clock To:	
1st Value:	
2nd Value:	
Value Percent:	10.000
Continuous Index:	F05
Within 8" of Joint:	NO
Remarks:

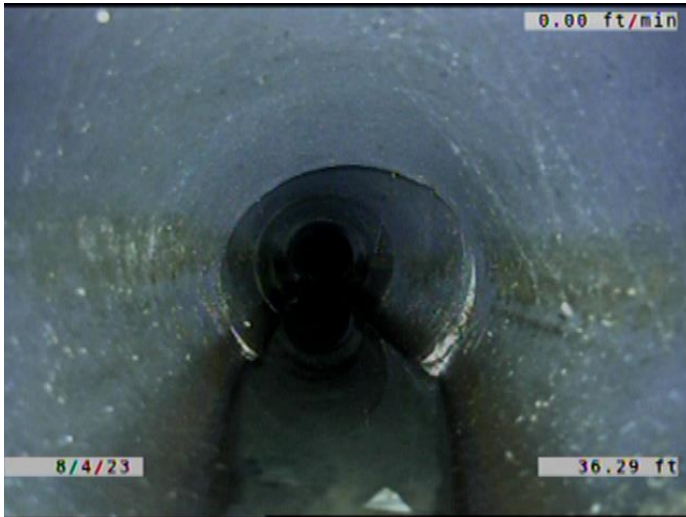
Code: **MWLS**
Description: **Miscellaneous Water Level Sag**

Distance (ft): **36.3**
Structural Grade: **2**
O&M Grade: **0**
Clock Start/From:
Clock To:
1st Value:
2nd Value:
Value Percent: **10.000**
Continuous Index: **S06**
Within 8" of Joint: **NO**
Remarks:

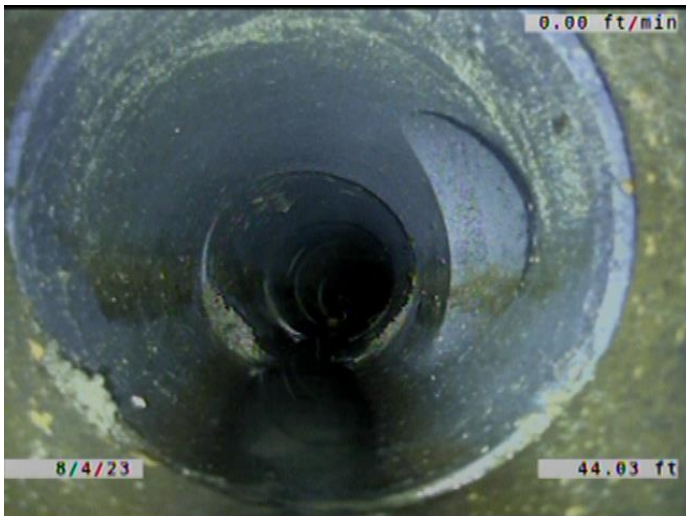
Code: **MWLS**
Description: **Miscellaneous Water Level Sag**

Distance (ft): **44.0**
Structural Grade: **2**
O&M Grade: **0**
Clock Start/From:
Clock To:
1st Value:
2nd Value:
Value Percent: **10.000**
Continuous Index: **F06**
Within 8" of Joint: **NO**
Remarks:

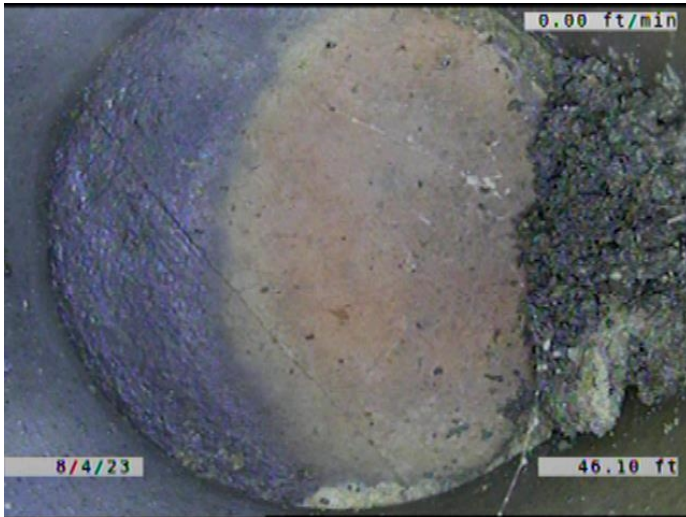
Code:	TFD
Description:	Tap Factory Defective
Distance (ft):	46.1
Structural Grade:	0
O&M Grade:	3
Clock Start/From:	2
Clock To:	
1st Value:	6.000
2nd Value:	
Value Percent:	
Continuous Index:	
Within 8" of Joint:	YES
Remarks:	CAPPED. CAP CRACKED. TAP BROKEN.

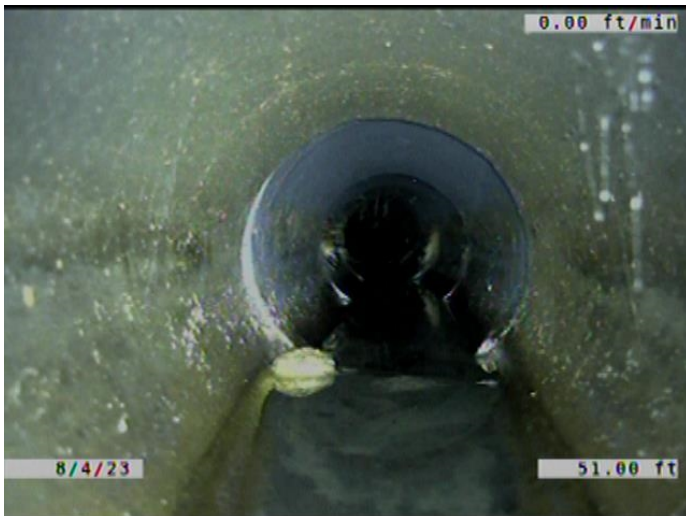
Code:	MWLS
Description:	Miscellaneous Water Level Sag
Distance (ft):	51.0
Structural Grade:	2
O&M Grade:	0
Clock Start/From:	
Clock To:	
1st Value:	
2nd Value:	
Value Percent:	10.000
Continuous Index:	S07
Within 8" of Joint:	NO
Remarks:

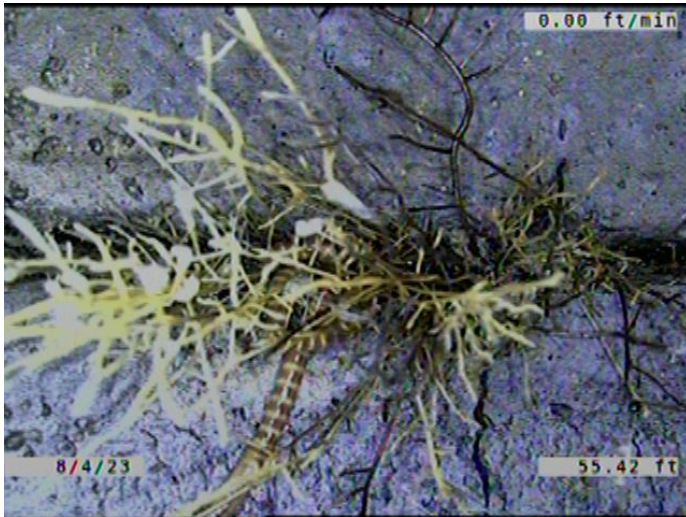
Code: **RFJ**
Description: **Roots Fine Joint**

Distance (ft): **55.4**
Structural Grade: **0**
O&M Grade: **1**
Clock Start/From: **8**
Clock To: **4**
1st Value:
2nd Value:
Value Percent:
Continuous Index: **S08**
Within 8" of Joint: **YES**
Remarks:

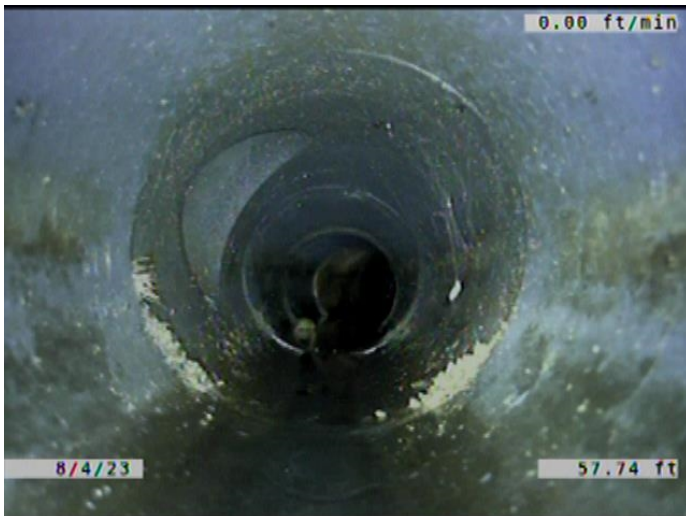
Code: **MWLS**
Description: **Miscellaneous Water Level Sag**

Distance (ft): **57.7**
Structural Grade: **2**
O&M Grade: **0**
Clock Start/From:
Clock To:
1st Value:
2nd Value:
Value Percent: **10.000**
Continuous Index: **F07**
Within 8" of Joint: **NO**
Remarks:

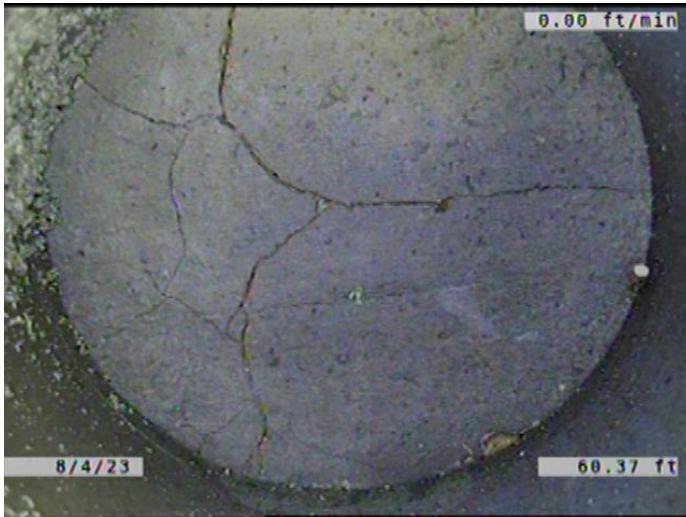
Code: **TFD**
Description: **Tap Factory Defective**

Distance (ft): **60.4**
Structural Grade: **0**
O&M Grade: **3**
Clock Start/From: **10**
Clock To:
1st Value: **6.000**
2nd Value:
Value Percent:
Continuous Index:
Within 8" of Joint: **YES**
Remarks: **CAPPED. CAP BROKEN.**

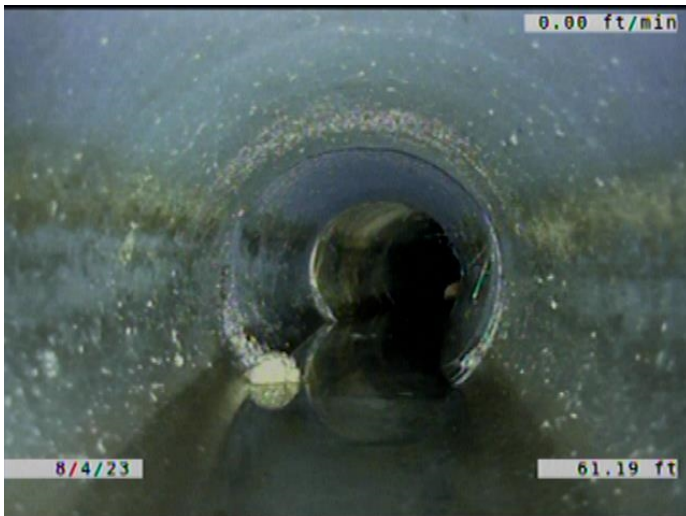
Code: **MWLS**
Description: **Miscellaneous Water Level Sag**

Distance (ft): **61.2**
Structural Grade: **2**
O&M Grade: **0**
Clock Start/From:
Clock To:
1st Value:
2nd Value:
Value Percent: **10.000**
Continuous Index: **S09**
Within 8" of Joint: **NO**
Remarks:

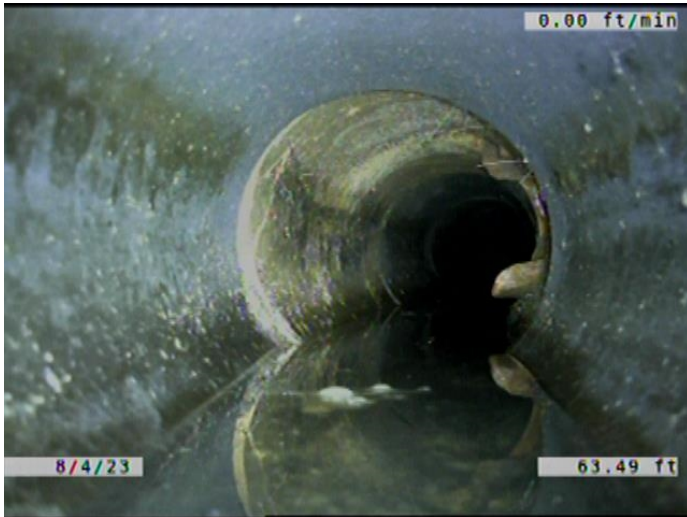
Code: **LR**
Description: **Line Right**

Distance (ft): **63.5**
Structural Grade: **0**
O&M Grade: **1**
Clock Start/From:
Clock To:
1st Value:
2nd Value:
Value Percent: **10.000**
Continuous Index:
Within 8" of Joint: **NO**
Remarks:

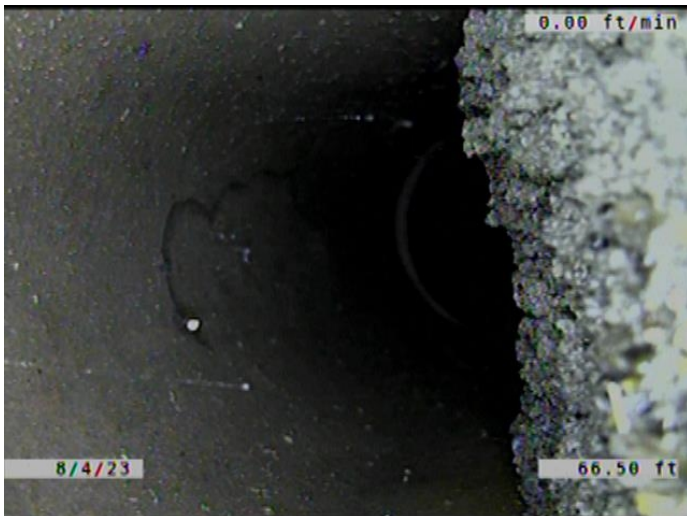
Code: **TBI**
Description: **Tap Break-in Intruding**

Distance (ft): **66.5**
Structural Grade: **0**
O&M Grade: **2**
Clock Start/From: **2**
Clock To:
1st Value: **6.000**
2nd Value: **2.000**
Value Percent:
Continuous Index:
Within 8" of Joint: **YES**
Remarks: **SERVICE BROKEN. MAIN BROKEN. VOID AND SOIL VISIBLE. SOIL ENTERI**

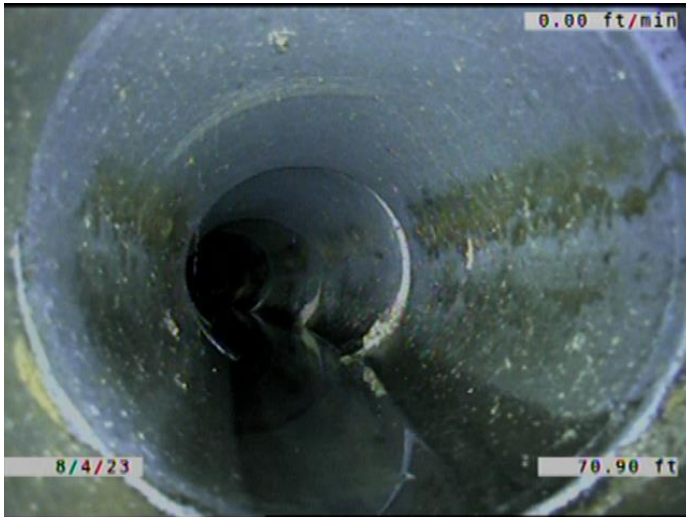
Code: **MWLS**
Description: **Miscellaneous Water Level Sag**

Distance (ft): **70.9**
Structural Grade: **2**
O&M Grade: **0**
Clock Start/From:
Clock To:
1st Value:
2nd Value:
Value Percent: **10.000**
Continuous Index: **F09**
Within 8" of Joint: **NO**
Remarks:

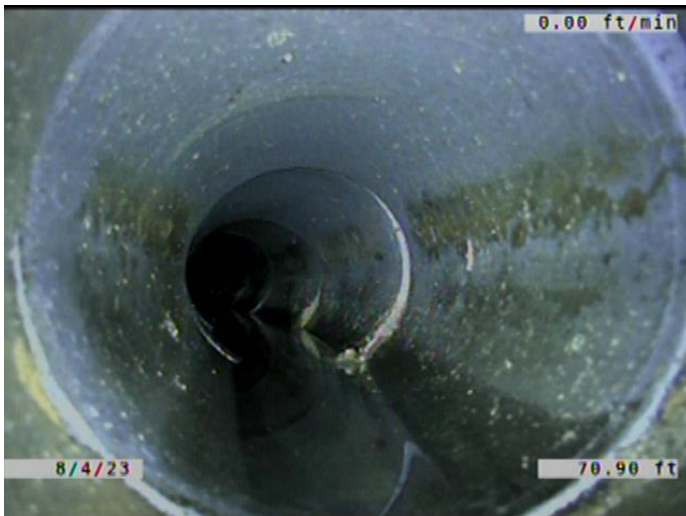
Code: **LL**
Description: **Line Left**

Distance (ft): **70.9**
Structural Grade: **0**
O&M Grade: **2**
Clock Start/From:
Clock To:
1st Value:
2nd Value:
Value Percent: **15.000**
Continuous Index: **S10**
Within 8" of Joint: **NO**
Remarks:

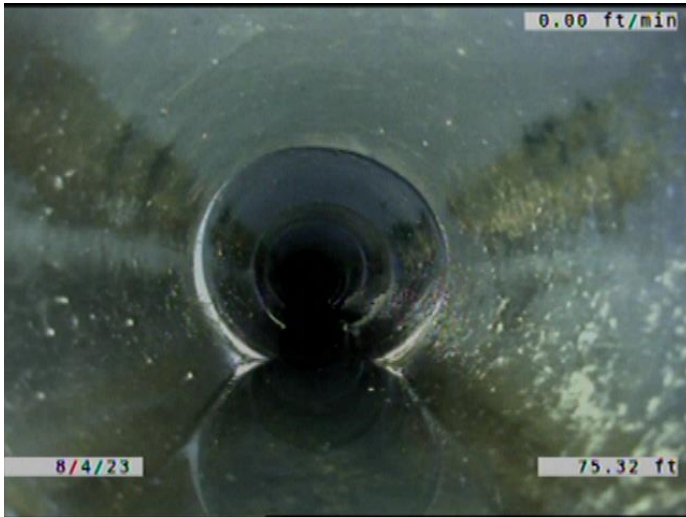
Code: **LL**
Description: **Line Left**

Distance (ft): **75.3**
Structural Grade: **0**
O&M Grade: **2**
Clock Start/From:
Clock To:
1st Value:
2nd Value:
Value Percent: **15.000**
Continuous Index: **F10**
Within 8" of Joint: **NO**
Remarks:

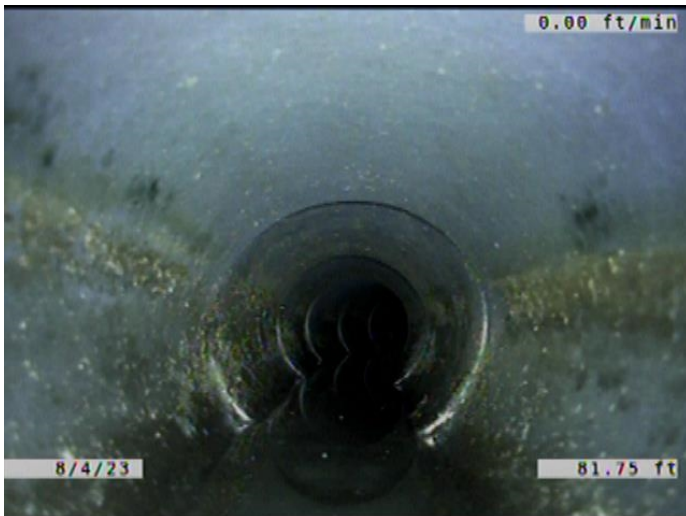
Code: **MWLS**
Description: **Miscellaneous Water Level Sag**

Distance (ft): **81.8**
Structural Grade: **3**
O&M Grade: **0**
Clock Start/From:
Clock To:
1st Value:
2nd Value:
Value Percent: **35.000**
Continuous Index: **S11**
Within 8" of Joint: **NO**
Remarks:

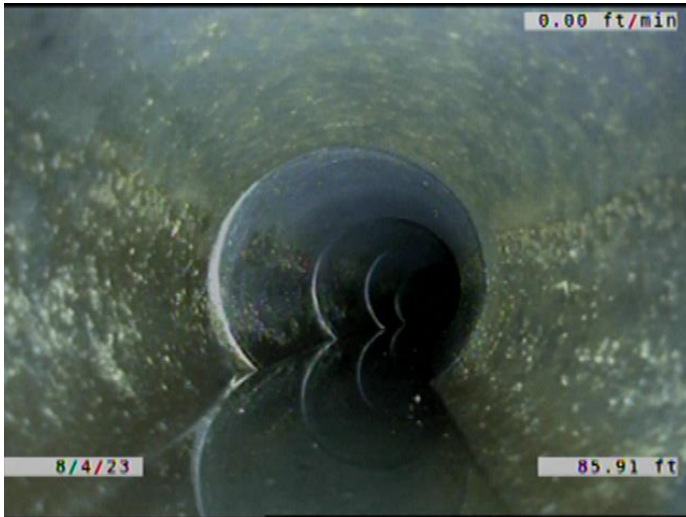
Code: **LL**
Description: **Line Left**

Distance (ft): **85.9**
Structural Grade: **0**
O&M Grade: **1**
Clock Start/From:
Clock To:
1st Value:
2nd Value:
Value Percent: **10.000**
Continuous Index: **S12**
Within 8" of Joint: **NO**
Remarks:

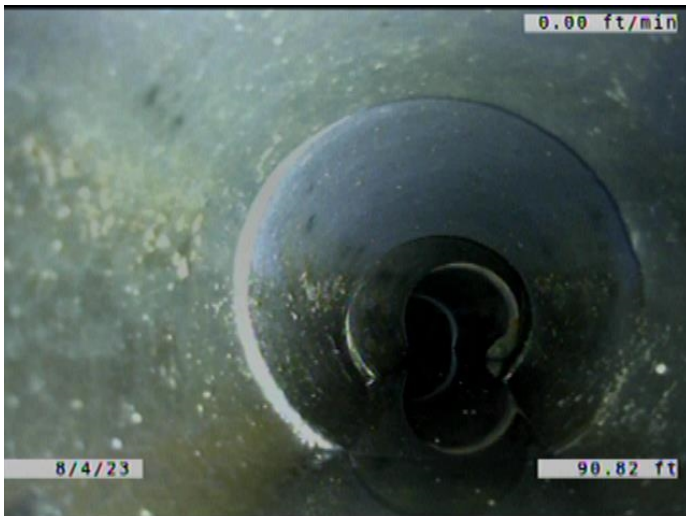
Code: **LL**
Description: **Line Left**

Distance (ft): **90.8**
Structural Grade: **0**
O&M Grade: **1**
Clock Start/From:
Clock To:
1st Value:
2nd Value:
Value Percent: **10.000**
Continuous Index: **F12**
Within 8" of Joint: **NO**
Remarks:

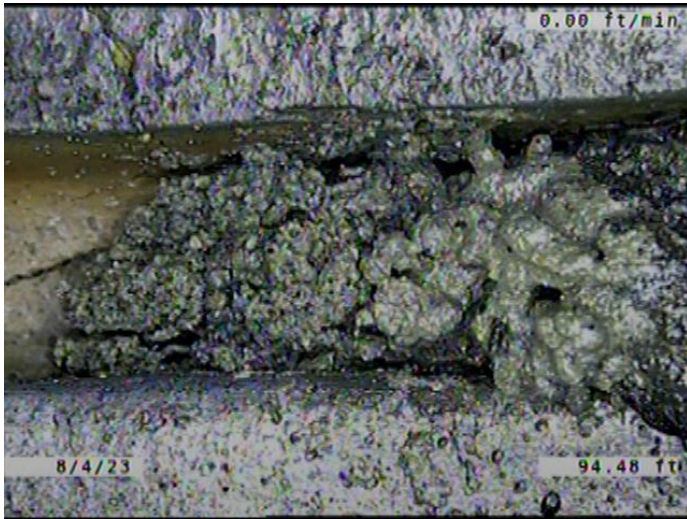
Code: **JAM**
Description: **Joint Angular Medium**

Distance (ft): **94.5**
Structural Grade: **3**
O&M Grade: **0**
Clock Start/From:
Clock To:
1st Value:
2nd Value:
Value Percent:
Continuous Index:
Within 8" of Joint: **NO**
Remarks:

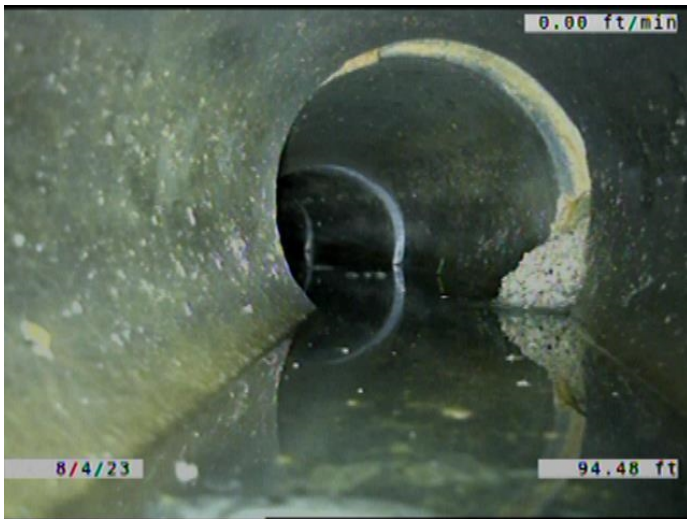
Code: **LR**
Description: **Line Right**

Distance (ft): **94.5**
Structural Grade: **0**
O&M Grade: **1**
Clock Start/From:
Clock To:
1st Value:
2nd Value:
Value Percent: **5.000**
Continuous Index:
Within 8" of Joint: **NO**
Remarks:

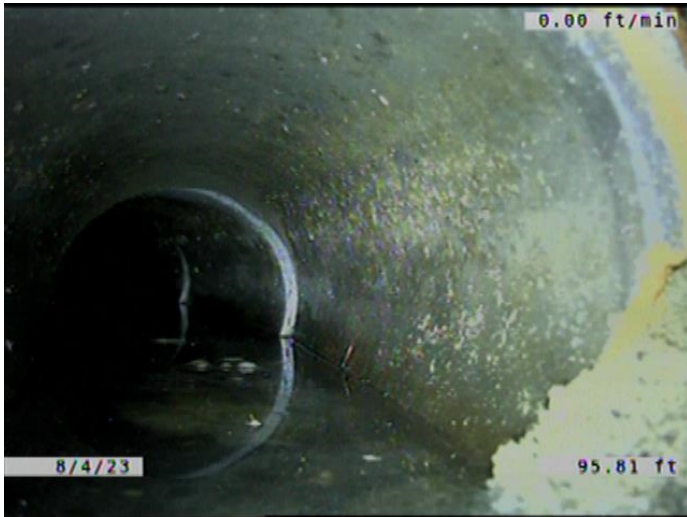
Code: **LL**
 Description: **Line Left**

Distance (ft): **95.8**
 Structural Grade: **0**
 O&M Grade: **4**
 Clock Start/From:
 Clock To:
 1st Value:
 2nd Value:
 Value Percent: **25.000**
 Continuous Index:
 Within 8" of Joint: **NO**
 Remarks:

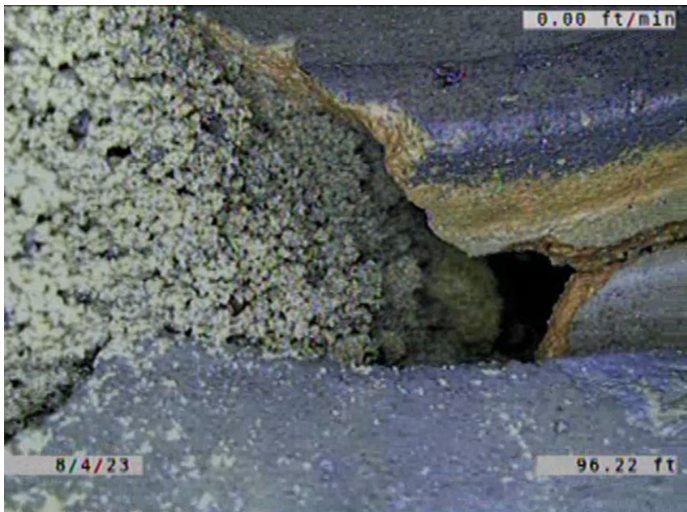
Code: **B**
 Description: **Broken**

Distance (ft): **96.2**
 Structural Grade: **4**
 O&M Grade: **0**
 Clock Start/From: **10**
 Clock To: **3**
 1st Value:
 2nd Value:
 Value Percent:
 Continuous Index:
 Within 8" of Joint: **YES**
 Remarks:

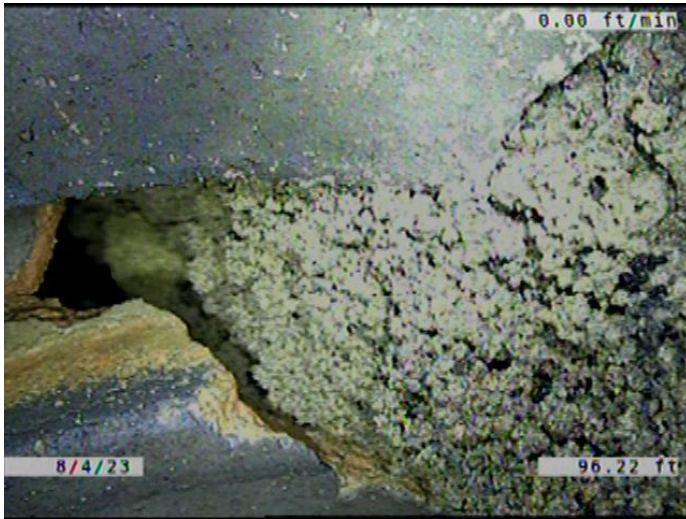
Code: **SMW**
Description: **Surface Damage Missing Wall**

Distance (ft): **96.2**
Structural Grade: **5**
O&M Grade: **0**
Clock Start/From: **2**
Clock To: **5**
1st Value:
2nd Value:
Value Percent:
Continuous Index:
Within 8" of Joint: **YES**
Remarks:

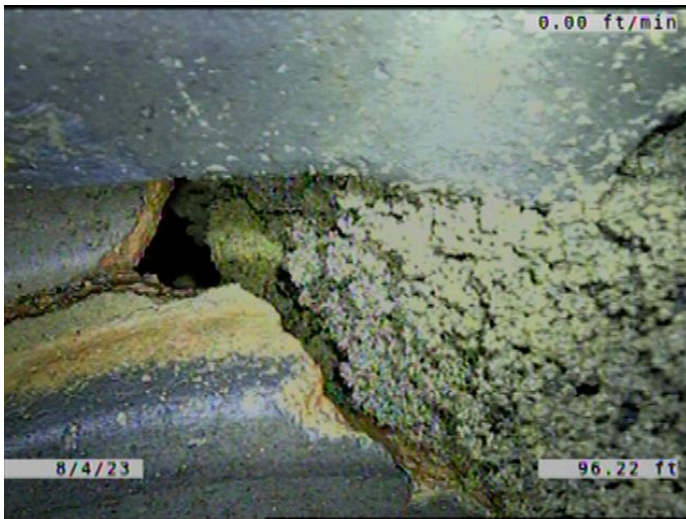
Code: **BVV**
Description: **Broken Void Visible**

Distance (ft): **96.2**
Structural Grade: **5**
O&M Grade: **0**
Clock Start/From: **12**
Clock To: **12**
1st Value:
2nd Value:
Value Percent:
Continuous Index:
Within 8" of Joint: **YES**
Remarks: **SOIL VISIBLE ALSO.**

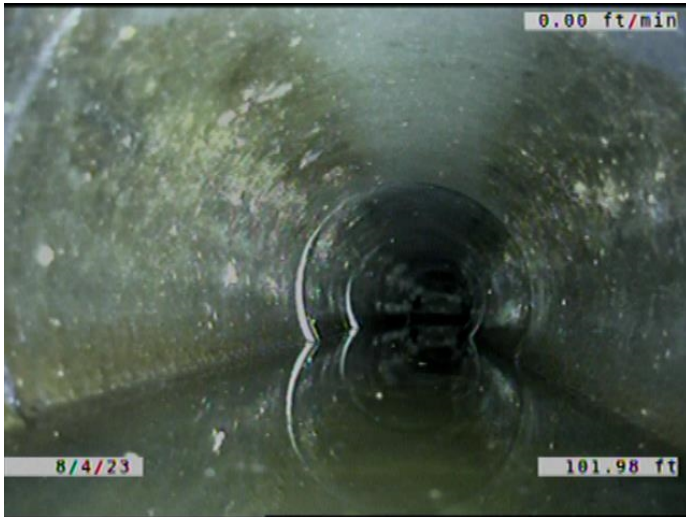
Code: **RFJ**
Description: **Roots Fine Joint**

Distance (ft): **102.0**
Structural Grade: **0**
O&M Grade: **1**
Clock Start/From: **8**
Clock To: **4**
1st Value:
2nd Value:
Value Percent:
Continuous Index: **F08**
Within 8" of Joint: **YES**
Remarks:

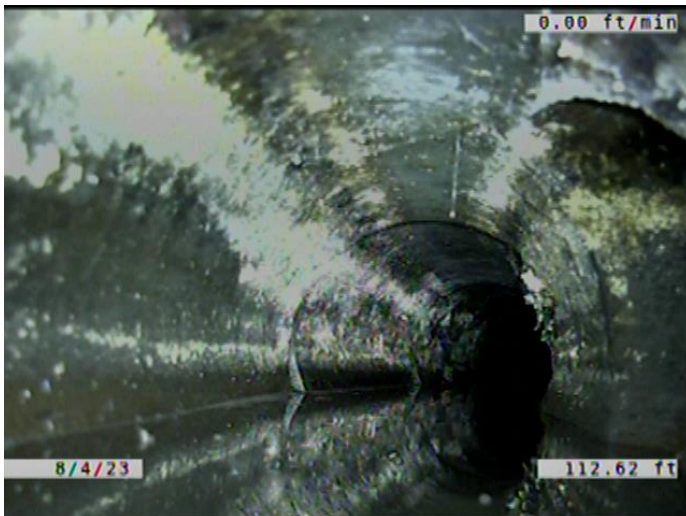
Code: **LR**
Description: **Line Right**

Distance (ft): **112.6**
Structural Grade: **0**
O&M Grade: **2**
Clock Start/From:
Clock To:
1st Value:
2nd Value:
Value Percent: **15.000**
Continuous Index:
Within 8" of Joint: **NO**
Remarks:

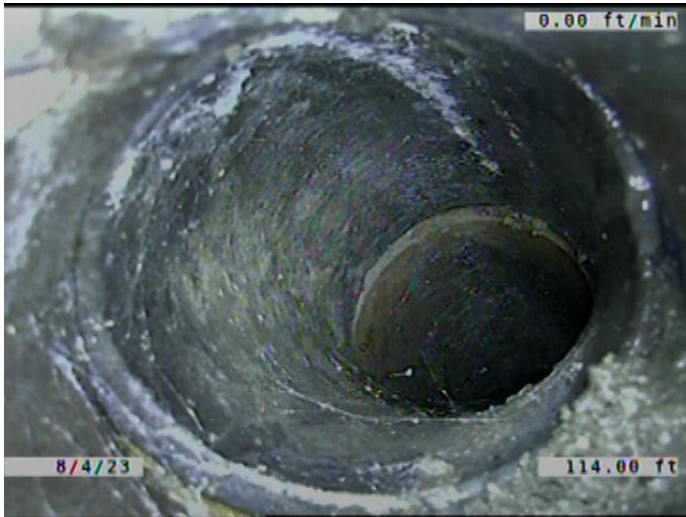
Code:	TFD
Description:	Tap Factory Defective
Distance (ft):	114.0
Structural Grade:	0
O&M Grade:	3
Clock Start/From:	2
Clock To:	
1st Value:	6.000
2nd Value:	
Value Percent:	
Continuous Index:	
Within 8" of Joint:	YES
Remarks:	TAP BROKEN. SERVICE OFFSET. SOIL VISIBLE AROUND THE SERVICE.

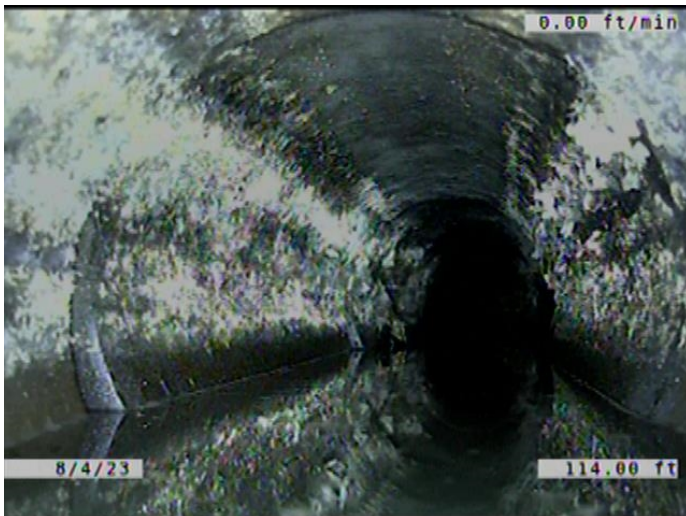
Code:	DAGS
Description:	Deposits Attached Grease
Distance (ft):	114.0
Structural Grade:	0
O&M Grade:	2
Clock Start/From:	8
Clock To:	4
1st Value:	
2nd Value:	
Value Percent:	5.000
Continuous Index:	S13
Within 8" of Joint:	YES
Remarks:

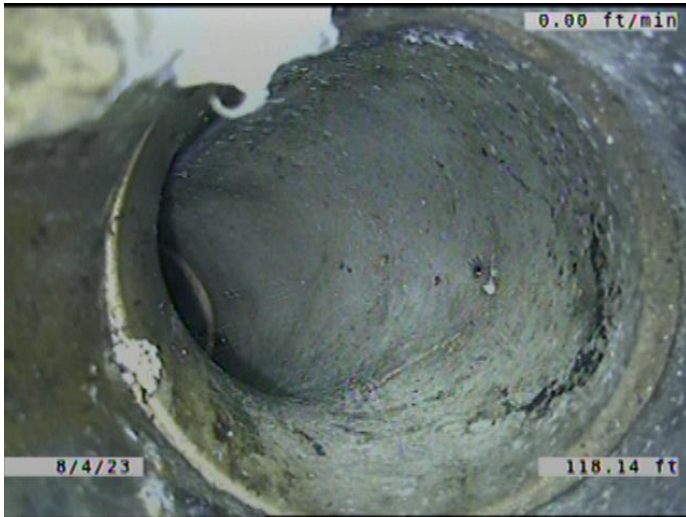
Code:	TFD
Description:	Tap Factory Defective
Distance (ft):	118.1
Structural Grade:	0
O&M Grade:	3
Clock Start/From:	10
Clock To:	
1st Value:	6.000
2nd Value:	
Value Percent:	
Continuous Index:	
Within 8" of Joint:	YES
Remarks:	TAP BROKEN.

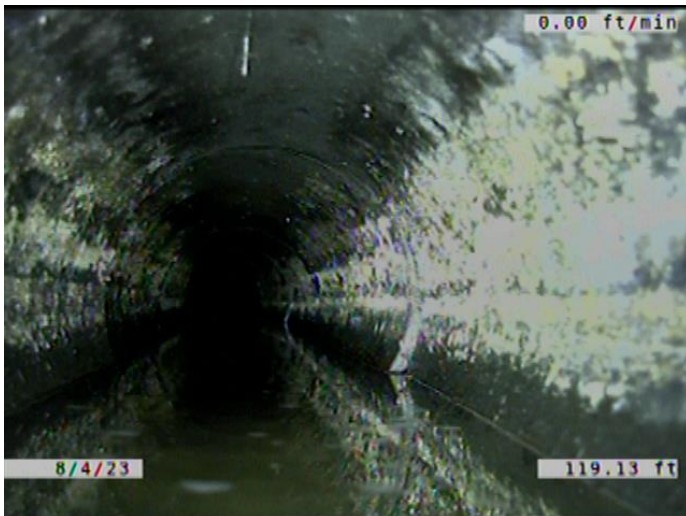
Code:	LL
Description:	Line Left
Distance (ft):	119.1
Structural Grade:	0
O&M Grade:	1
Clock Start/From:	
Clock To:	
1st Value:	
2nd Value:	
Value Percent:	5.000
Continuous Index:	
Within 8" of Joint:	NO
Remarks:

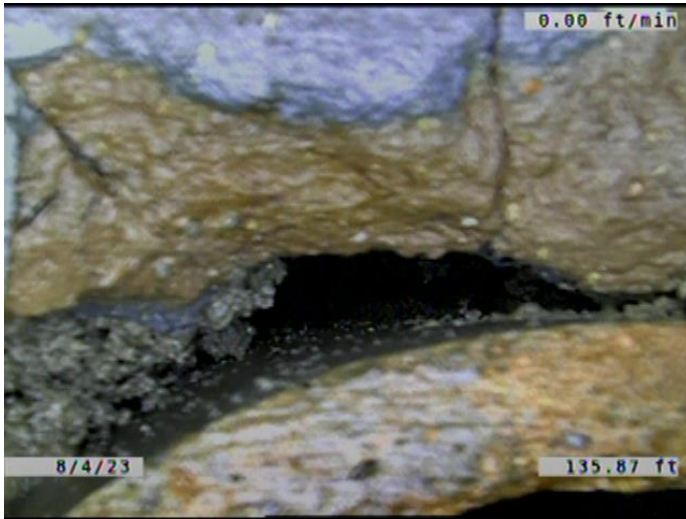
Code: **BVV**
Description: **Broken Void Visible**

Distance (ft): **135.9**
Structural Grade: **5**
O&M Grade: **0**
Clock Start/From: **8**
Clock To: **11**
1st Value:
2nd Value:
Value Percent:
Continuous Index:
Within 8" of Joint: **YES**
Remarks: **SOIL VISIBLE TOO.**

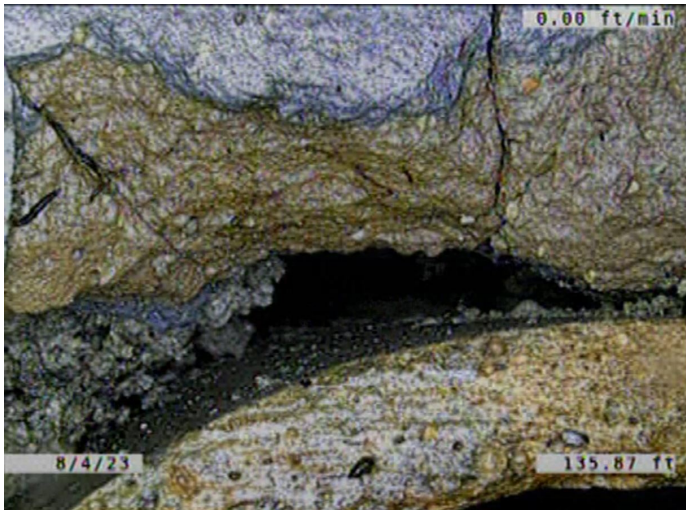
Code: **SSS**
Description: **Surface Damage Surface Spalling**

Distance (ft): **135.9**
Structural Grade: **2**
O&M Grade: **0**
Clock Start/From: **9**
Clock To: **11**
1st Value:
2nd Value:
Value Percent:
Continuous Index:
Within 8" of Joint: **NO**
Remarks:

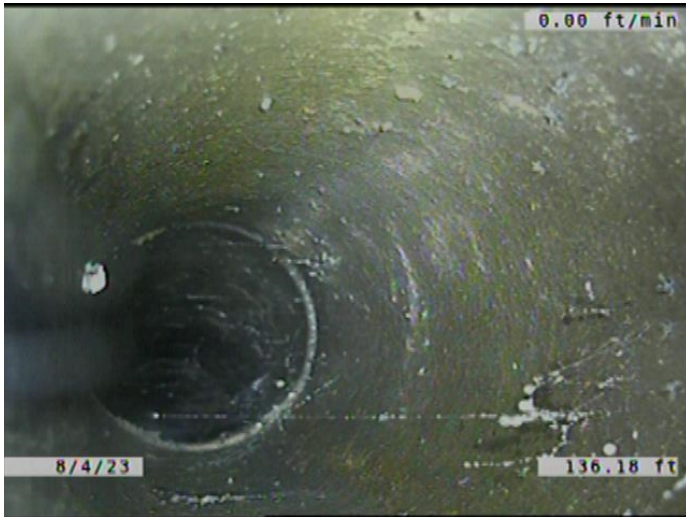
Code: **TBI**
Description: **Tap Break-in Intruding**

Distance (ft): **136.2**
Structural Grade: **0**
O&M Grade: **2**
Clock Start/From: **10**
Clock To:
1st Value: **6.000**
2nd Value: **2.000**
Value Percent:
Continuous Index:
Within 8" of Joint: **YES**
Remarks: **CONSTANTLY RUNNING WATER.**

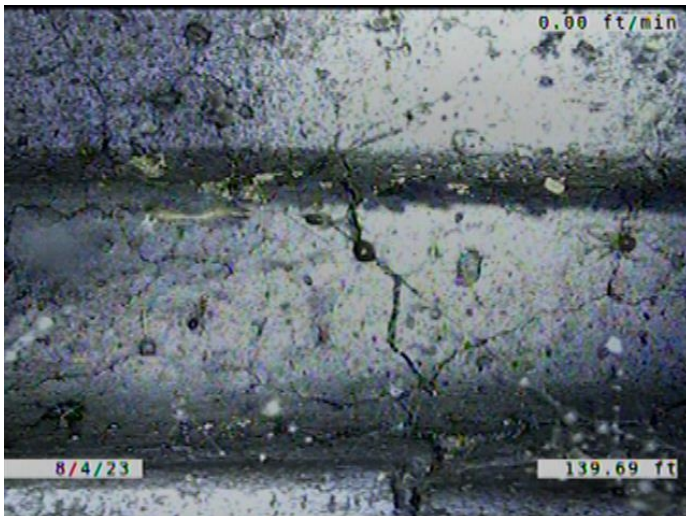
Code: **JAL**
Description: **Joint Angular Large**

Distance (ft): **139.7**
Structural Grade: **4**
O&M Grade: **0**
Clock Start/From:
Clock To:
1st Value:
2nd Value:
Value Percent:
Continuous Index:
Within 8" of Joint: **NO**
Remarks:

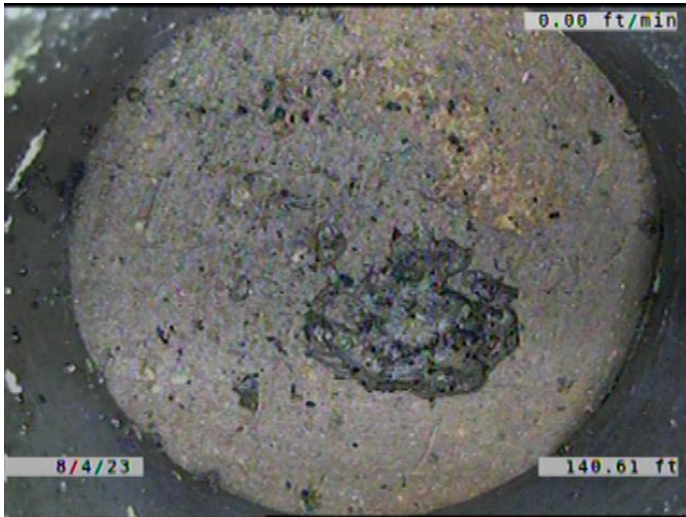
Code: **TFD**
Description: **Tap Factory Defective**

Distance (ft): **140.6**
Structural Grade: **0**
O&M Grade: **3**
Clock Start/From: **10**
Clock To:
1st Value: **6.000**
2nd Value:
Value Percent:
Continuous Index:
Within 8" of Joint: **YES**
Remarks: **CAPPED. TAP BROKEN.**

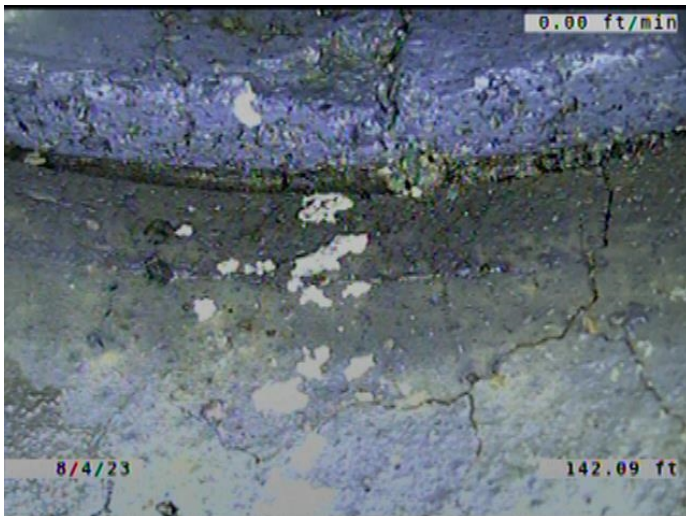
Code: **JOMD**
Description: **Joint Offset Medium Defective**

Distance (ft): **142.1**
Structural Grade: **3**
O&M Grade: **0**
Clock Start/From:
Clock To:
1st Value:
2nd Value:
Value Percent:
Continuous Index:
Within 8" of Joint: **NO**
Remarks: **SOIL VISIBLE.**

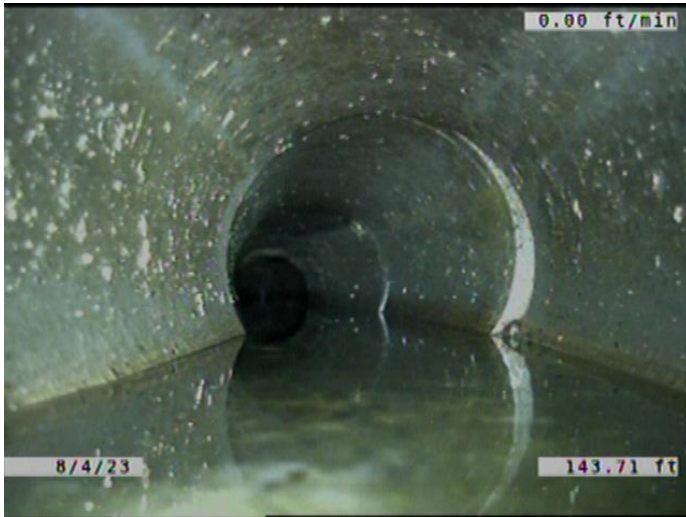
Code: **DAGS**
Description: **Deposits Attached Grease**

Distance (ft): **143.7**
Structural Grade: **0**
O&M Grade: **2**
Clock Start/From: **8**
Clock To: **4**
1st Value:
2nd Value:
Value Percent: **5.000**
Continuous Index: **F13**
Within 8" of Joint: **YES**
Remarks:

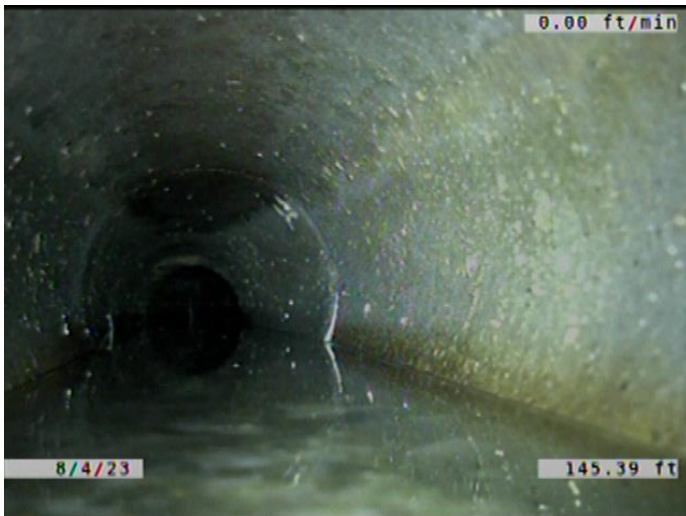
Code: **LL**
Description: **Line Left**

Distance (ft): **145.4**
Structural Grade: **0**
O&M Grade: **1**
Clock Start/From:
Clock To:
1st Value:
2nd Value:
Value Percent: **10.000**
Continuous Index:
Within 8" of Joint: **NO**
Remarks:

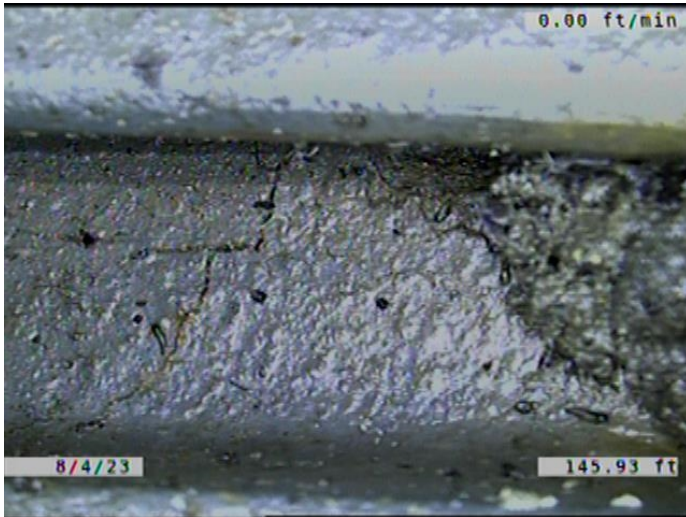
Code: **JAL**
Description: **Joint Angular Large**

Distance (ft): **145.9**
Structural Grade: **4**
O&M Grade: **0**
Clock Start/From:
Clock To:
1st Value:
2nd Value:
Value Percent:
Continuous Index:
Within 8" of Joint: **NO**
Remarks:

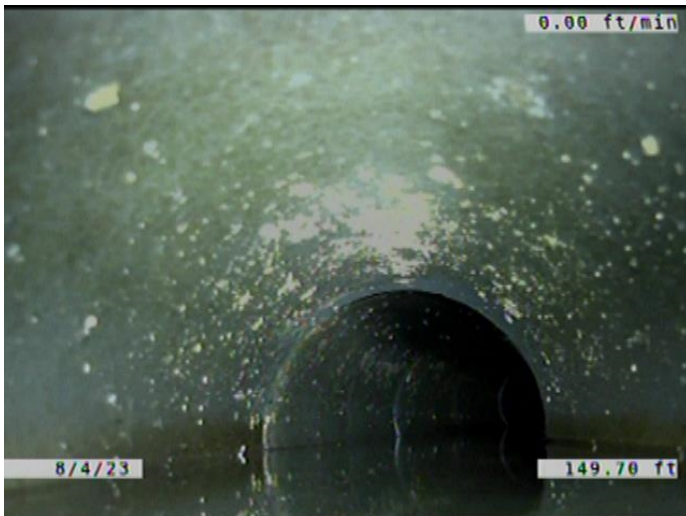
Code: **LR**
Description: **Line Right**

Distance (ft): **149.7**
Structural Grade: **0**
O&M Grade: **2**
Clock Start/From:
Clock To:
1st Value:
2nd Value:
Value Percent: **15.000**
Continuous Index: **S14**
Within 8" of Joint: **NO**
Remarks:

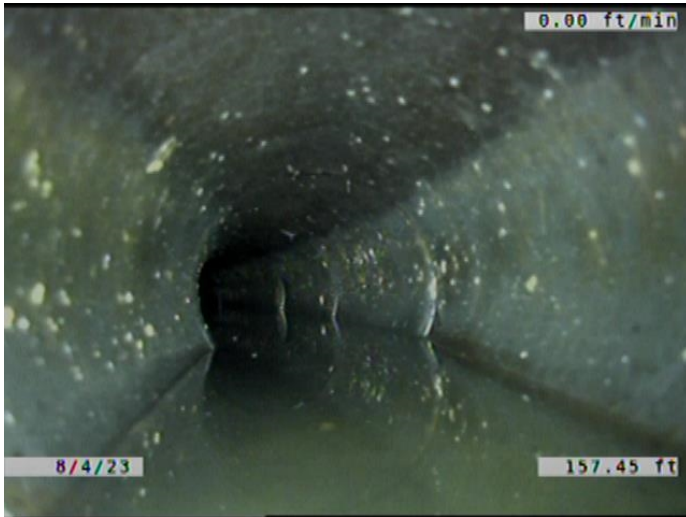
Code: **LR**
Description: **Line Right**

Distance (ft): **157.5**
Structural Grade: **0**
O&M Grade: **2**
Clock Start/From:
Clock To:
1st Value:
2nd Value:
Value Percent: **15.000**
Continuous Index: **F14**
Within 8" of Joint: **NO**
Remarks:

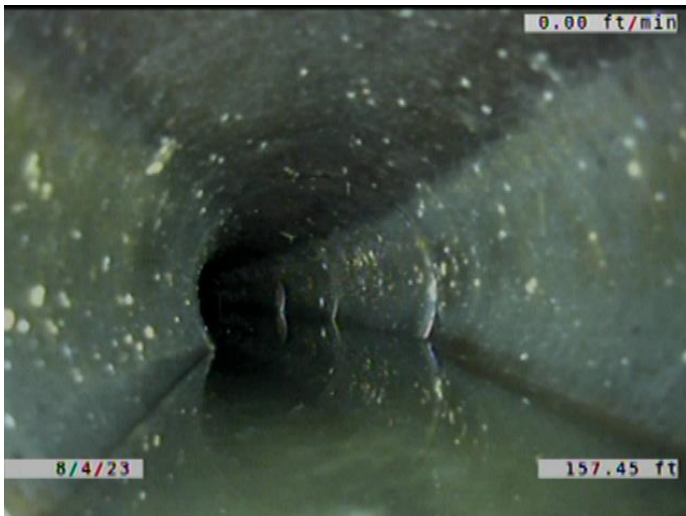
Code: **LL**
Description: **Line Left**

Distance (ft): **157.5**
Structural Grade: **0**
O&M Grade: **4**
Clock Start/From:
Clock To:
1st Value:
2nd Value:
Value Percent: **25.000**
Continuous Index: **S15**
Within 8" of Joint: **NO**
Remarks:

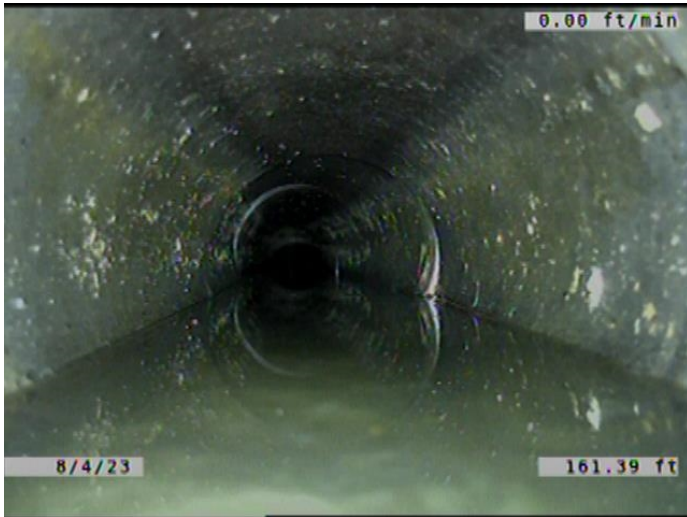
Code: **LL**
Description: **Line Left**

Distance (ft): **161.4**
Structural Grade: **0**
O&M Grade: **4**
Clock Start/From:
Clock To:
1st Value:
2nd Value:
Value Percent: **25.000**
Continuous Index: **F15**
Within 8" of Joint: **NO**
Remarks:
