Profile/Photo Observation Report

Date:	08/04/2023	Weather:		Coding:	PACP 7.0
Pipe Length (ft):	388.0	Owner:	City of Hobart	Pre Clean:	Heavy Cleaning
P.O.#:	YES502259	Surveyor:	S. Bucklin	PSR:	P-804-009-010
Customer:	City of Hobart	Clean Date:	11/15/2022	Shape:	C

Street:	East Cleveland Avenue	Flow Control:	Not Controlled
City:	Hobart, IN	Year Renewed:	
Location:	Local rural streets with light traffic, t	Tape/Media #:	
Purpose:	Routine Assessment	Dia/Height:	8"
Use:	Sanitary Sewage Pipe	Material:	VCP
Drain Area:		Lining:	None
Category:	NA		
Comment:			
Location Details:		Direction of Survey:	Downstream
US MH:	M-804-009	DS MH:	M-804-010
		Total Length Surveyed (ft):	179.2

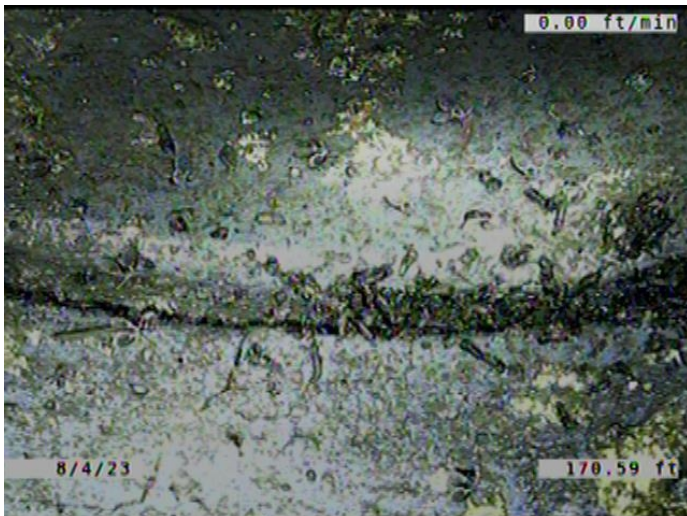
Code: **JOMD**
Description: **Joint Offset Medium Defective**

Distance (ft): **170.6**
Structural Grade: **3**
O&M Grade: **0**
Clock Start/From:
Clock To:
1st Value:
2nd Value:
Value Percent:
Continuous Index:
Within 8" of Joint: **NO**
Remarks:

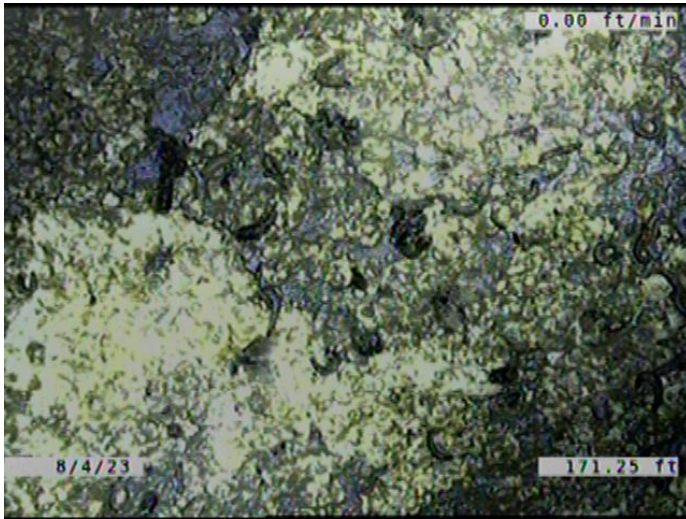
Code: **DAGS**
Description: **Deposits Attached Grease**

Distance (ft): **171.3**
Structural Grade: **0**
O&M Grade: **2**
Clock Start/From: **9**
Clock To: **3**
1st Value:
2nd Value:
Value Percent: **5.000**
Continuous Index: **S16**
Within 8" of Joint: **YES**
Remarks:

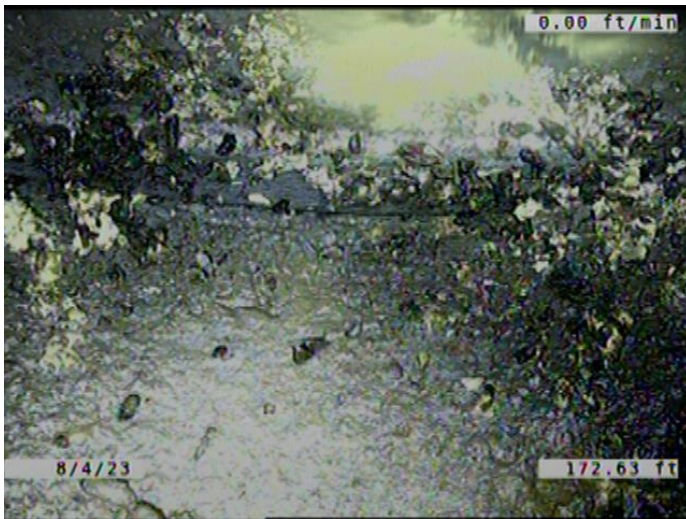
Code: **JOMD**
Description: **Joint Offset Medium Defective**

Distance (ft): **172.6**
Structural Grade: **3**
O&M Grade: **0**
Clock Start/From:
Clock To:
1st Value:
2nd Value:
Value Percent:
Continuous Index:
Within 8" of Joint: **NO**
Remarks:

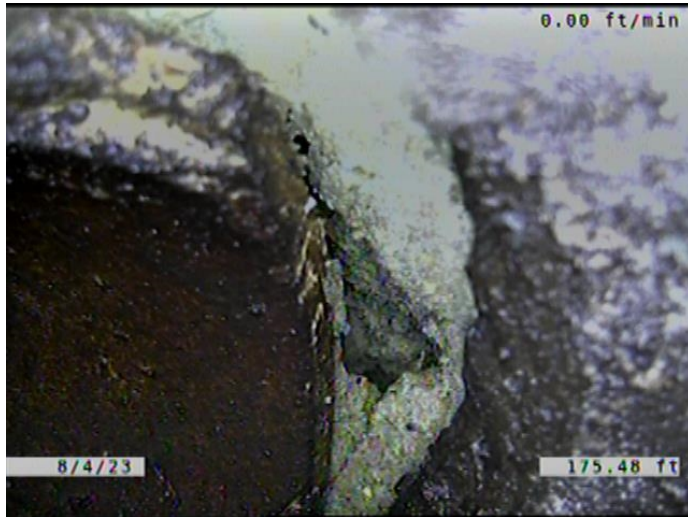
Code: **BVV**
 Description: **Broken Void Visible**

Distance (ft): **175.5**
 Structural Grade: **5**
 O&M Grade: **0**
 Clock Start/From: **8**
 Clock To: **12**
 1st Value:
 2nd Value:
 Value Percent:
 Continuous Index:
 Within 8" of Joint: **YES**
 Remarks: **SOIL VISIBLE TOO.**

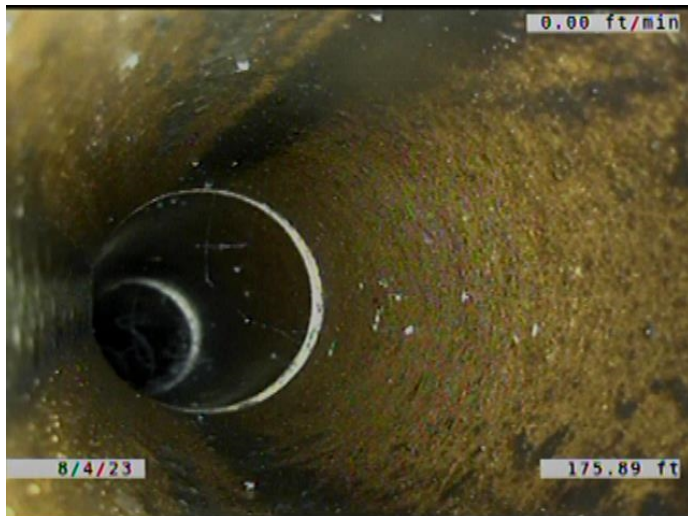
Code: **TBD**
 Description: **Tap Break-in/Hammer Defective**

Distance (ft): **175.9**
 Structural Grade: **0**
 O&M Grade: **3**
 Clock Start/From: **10**
 Clock To:
 1st Value: **6.000**
 2nd Value:
 Value Percent:
 Continuous Index:
 Within 8" of Joint: **YES**
 Remarks: **Defective**

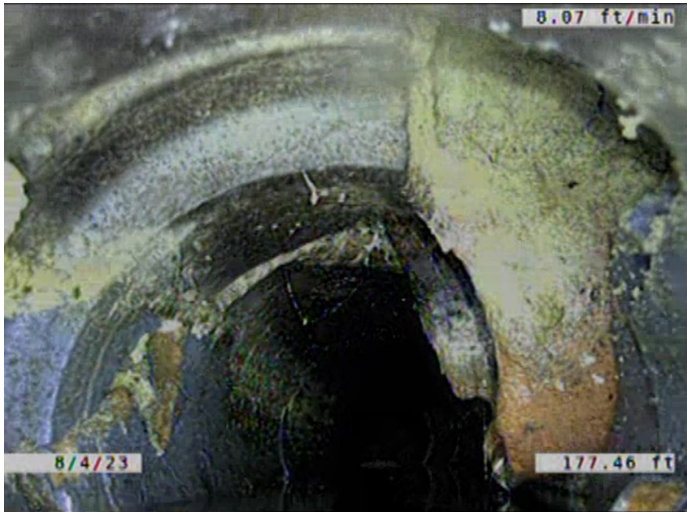
Code: **FM**
Description: **Fracture Multiple**

Distance (ft): **177.5**
Structural Grade: **4**
O&M Grade: **0**
Clock Start/From: **8**
Clock To: **4**
1st Value:
2nd Value:
Value Percent:
Continuous Index: **F03**
Within 8" of Joint: **YES**
Remarks:

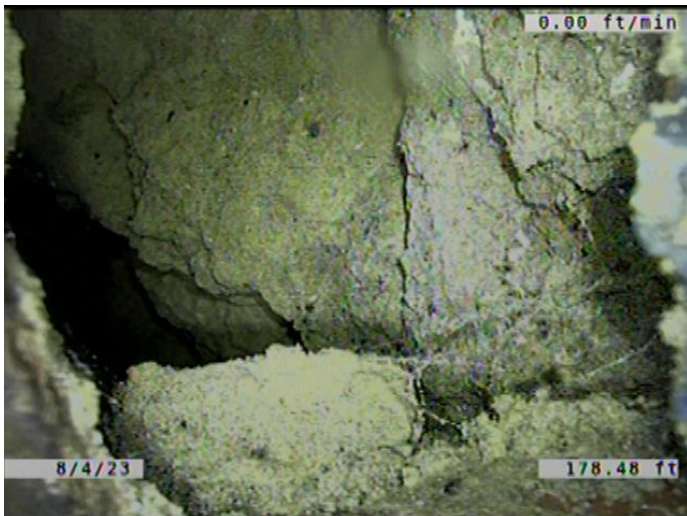
Code: **SMW**
Description: **Surface Damage Missing Wall**

Distance (ft): **178.5**
Structural Grade: **5**
O&M Grade: **0**
Clock Start/From: **9**
Clock To: **3**
1st Value:
2nd Value:
Value Percent:
Continuous Index:
Within 8" of Joint: **YES**
Remarks: **LARGE VOID AND SOIL VISIBLE.**

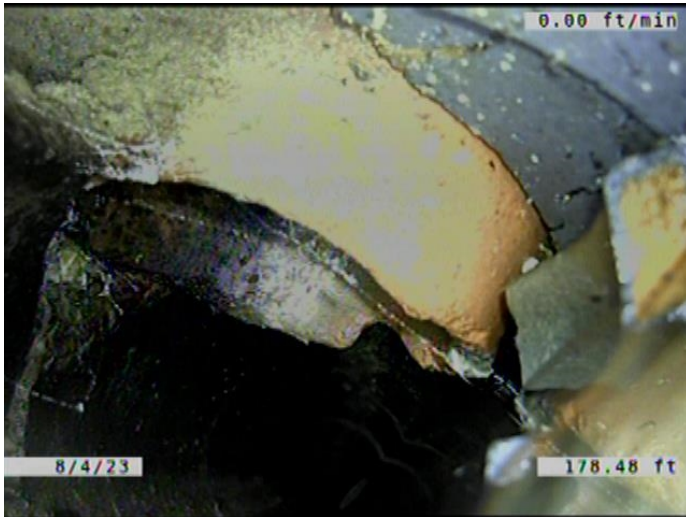
Code:	OBM
Description:	Obstruction Pipe Material in Invert
Distance (ft):	178.5
Structural Grade:	0
O&M Grade:	2
Clock Start/From:	4
Clock To:	6
1st Value:	
2nd Value:	
Value Percent:	10.000
Continuous Index:	
Within 8" of Joint:	YES
Remarks:

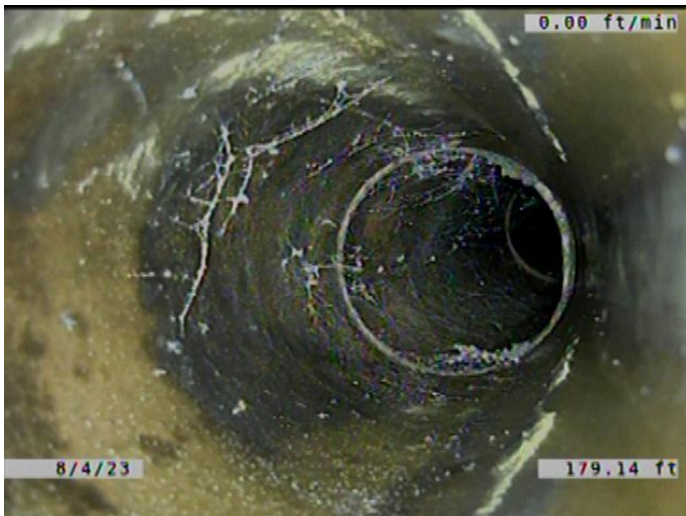
Code:	TBI
Description:	Tap Break-in Intruding
Distance (ft):	179.1
Structural Grade:	0
O&M Grade:	2
Clock Start/From:	2
Clock To:	
1st Value:	6.000
2nd Value:	2.000
Value Percent:	
Continuous Index:	
Within 8" of Joint:	YES
Remarks:

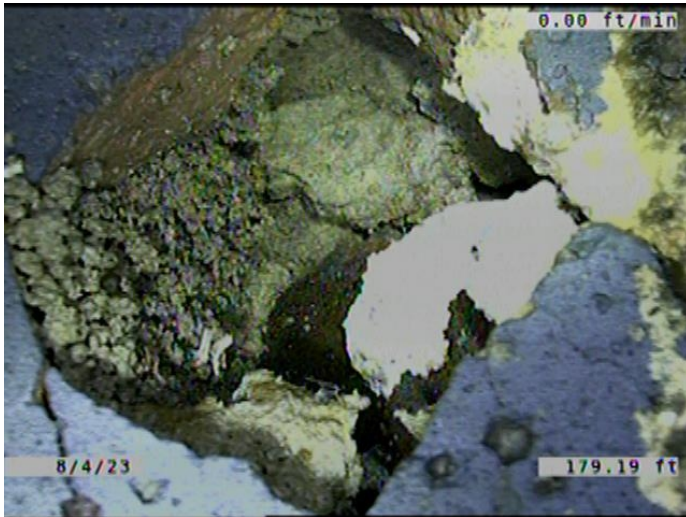
Code:	SMW
Description:	Surface Damage Missing Wall
Distance (ft):	179.2
Structural Grade:	5
O&M Grade:	0
Clock Start/From:	9
Clock To:	10
1st Value:	
2nd Value:	
Value Percent:	
Continuous Index:	
Within 8" of Joint:	YES
Remarks:	VOID AND SOIL VISIBLE.

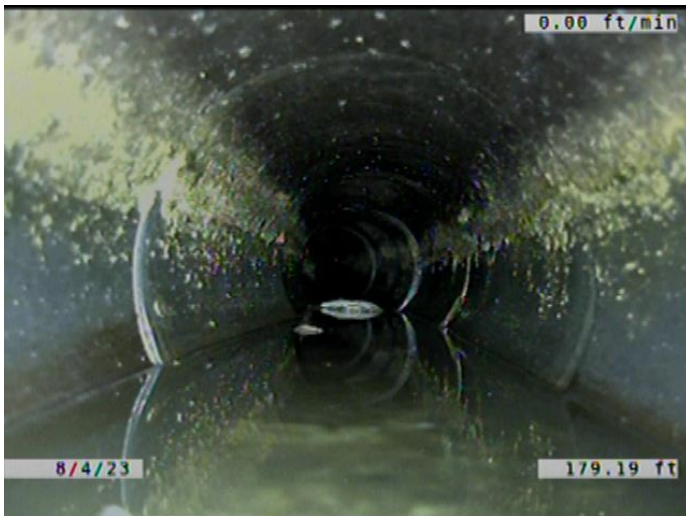
Code:	DSF
Description:	Deposits Settled Fine
Distance (ft):	179.2
Structural Grade:	0
O&M Grade:	2
Clock Start/From:	5
Clock To:	7
1st Value:	
2nd Value:	
Value Percent:	5.000
Continuous Index:	F01
Within 8" of Joint:	YES
Remarks:

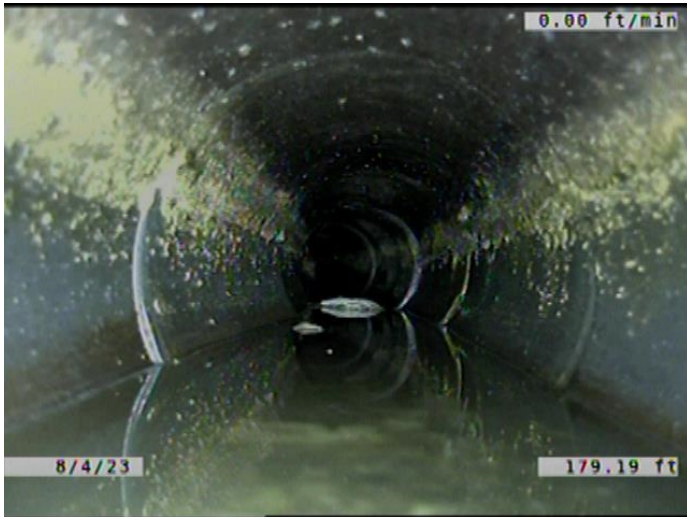
Code: **B**
Description: **Broken**

Distance (ft): **179.2**
Structural Grade: **4**
O&M Grade: **0**
Clock Start/From: **8**
Clock To: **4**
1st Value:
2nd Value:
Value Percent:
Continuous Index:
Within 8" of Joint: **YES**
Remarks:

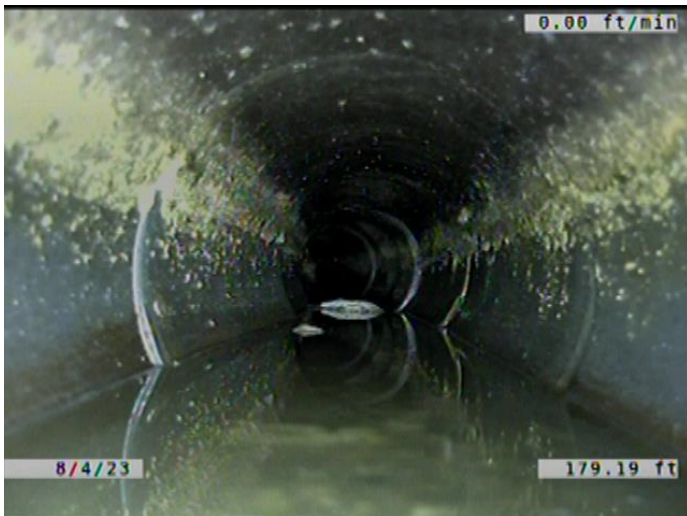
Code: **MWLS**
Description: **Miscellaneous Water Level Sag**

Distance (ft): **179.2**
Structural Grade: **3**
O&M Grade: **0**
Clock Start/From:
Clock To:
1st Value:
2nd Value:
Value Percent: **35.000**
Continuous Index: **F11**
Within 8" of Joint: **NO**
Remarks:

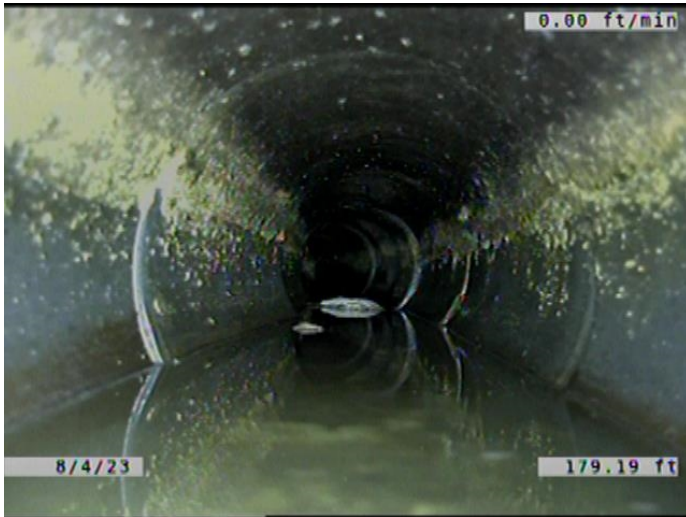
Code: **DAGS**
 Description: **Deposits Attached Grease**

Distance (ft): **179.2**
 Structural Grade: **0**
 O&M Grade: **2**
 Clock Start/From: **9**
 Clock To: **3**
 1st Value:
 2nd Value:
 Value Percent: **5.000**
 Continuous Index: **F16**
 Within 8" of Joint: **YES**
 Remarks:

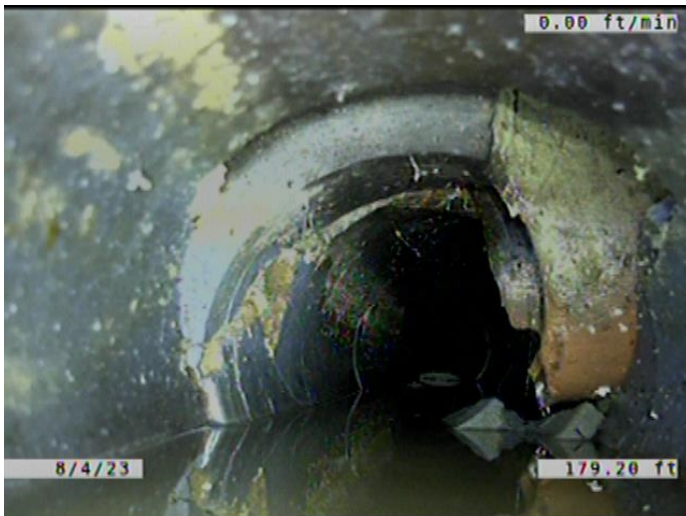
Code: **MSA**
 Description: **Miscellaneous Survey Abandoned**

Distance (ft): **179.2**
 Structural Grade: **0**
 O&M Grade: **0**
 Clock Start/From:
 Clock To:
 1st Value:
 2nd Value:
 Value Percent:
 Continuous Index:
 Within 8" of Joint: **NO**
 Remarks: **CAMERA CANT MAKE IT PAST PROTRUDING TAP AND BROKEN. PIP**
