Profile/Photo Observation Report

| Date: | 09/11/2024 | Weather: | | Coding: | PACP 7.0 |

| Street: | East Cleveland Avenue | Flow Control: | Not Controlled |
| US MH: | M-804-009 | DS MH: | M-804-010 |

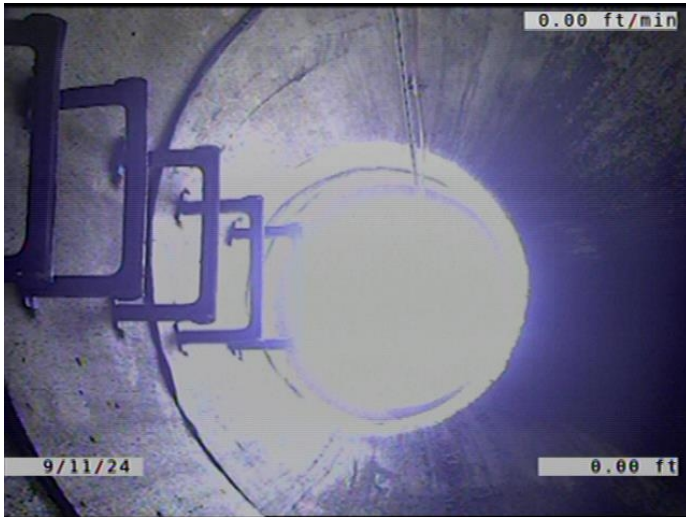
Code: **AMH**
Description: **Manhole**

Distance (ft): **.0**
Structural Grade: **0**
O&M Grade: **0**
Clock Start/From:
Clock To:
1st Value:
2nd Value:
Value Percent:
Continuous Index:
Within 8" of Joint: **NO**
Remarks: **M-804-010**

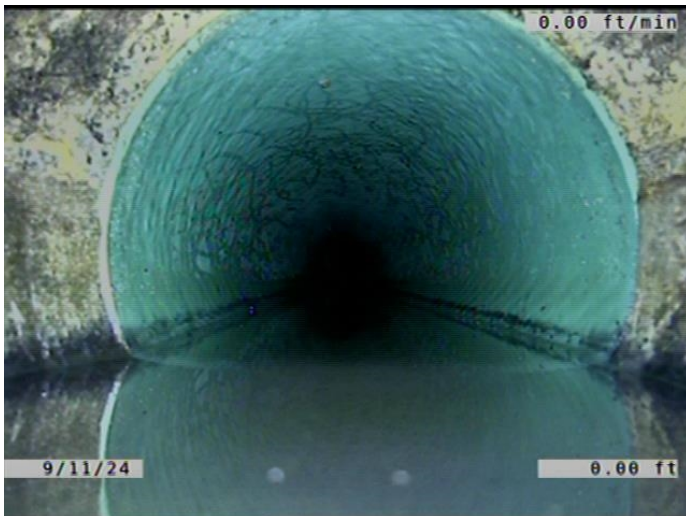
Code: **MWL**
Description: **Miscellaneous Water Level**

Distance (ft): **.0**
Structural Grade: **0**
O&M Grade: **0**
Clock Start/From:
Clock To:
1st Value:
2nd Value:
Value Percent: **15.000**
Continuous Index:
Within 8" of Joint: **NO**
Remarks:

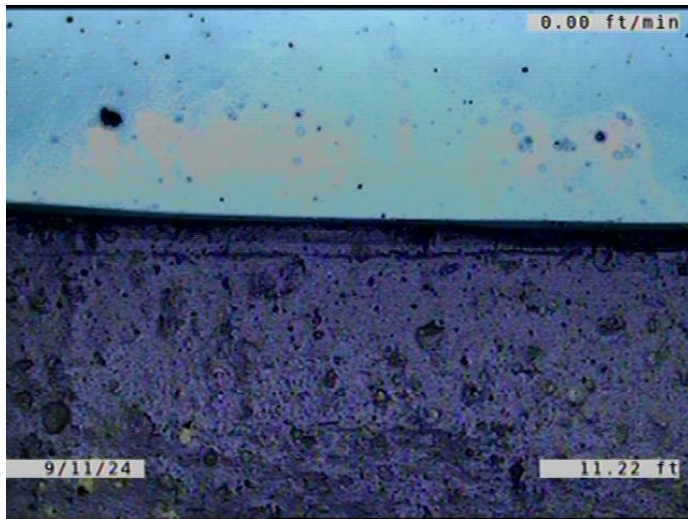
| Description: | Miscellaneous Material Change |
| Remarks: | PVC TO VCP |

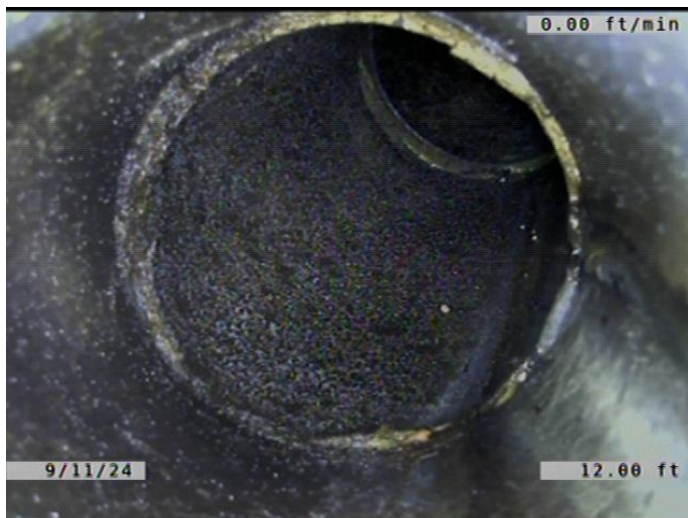
| Description: | Tap Factory |

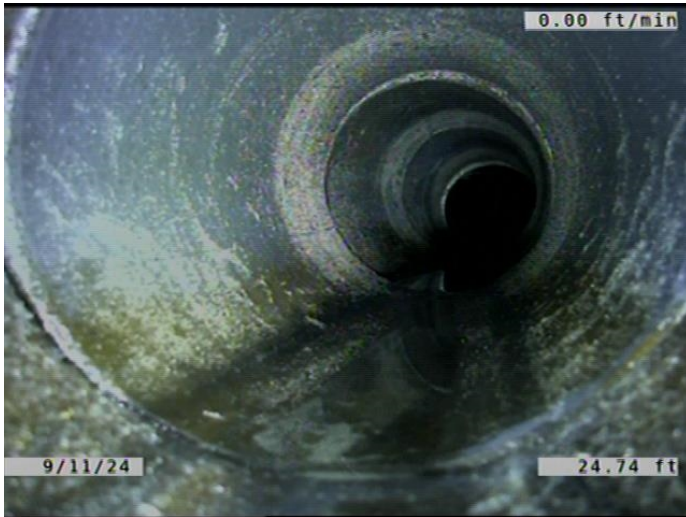
Code: **MWL**
Description: **Miscellaneous Water Level**

Distance (ft): **24.7**
Structural Grade: **0**
O&M Grade: **0**
Clock Start/From:
Clock To:
1st Value:
2nd Value:
Value Percent: **5.000**
Continuous Index:
Within 8" of Joint: **NO**
Remarks:

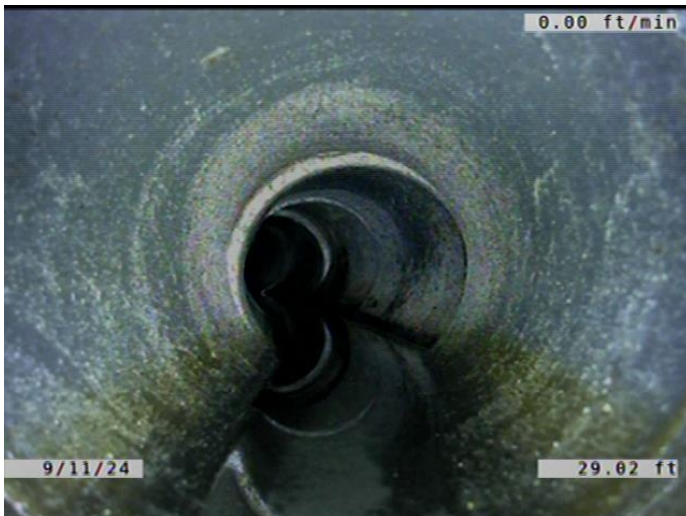
Code: **MWLS**
Description: **Miscellaneous Water Level Sag**

Distance (ft): **29.0**
Structural Grade: **2**
O&M Grade: **0**
Clock Start/From:
Clock To:
1st Value:
2nd Value:
Value Percent: **10.000**
Continuous Index: **S01**
Within 8" of Joint: **NO**
Remarks:

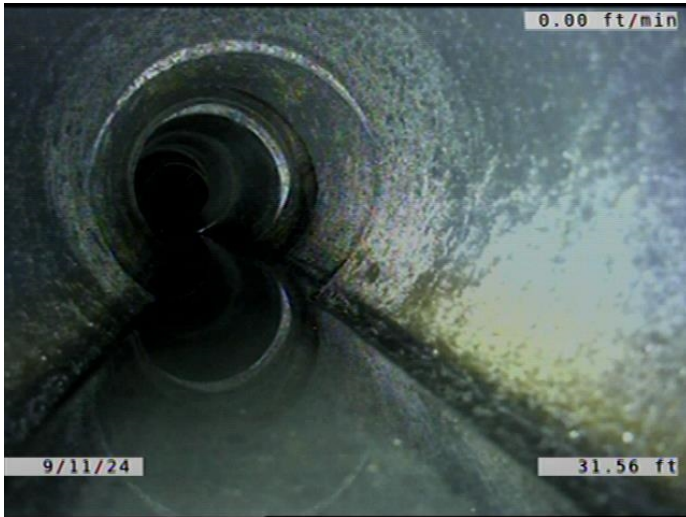
Code: **LL**
Description: **Line Left**

Distance (ft): **31.6**
Structural Grade: **0**
O&M Grade: **2**
Clock Start/From:
Clock To:
1st Value:
2nd Value:
Value Percent: **15.000**
Continuous Index:
Within 8" of Joint: **NO**
Remarks:

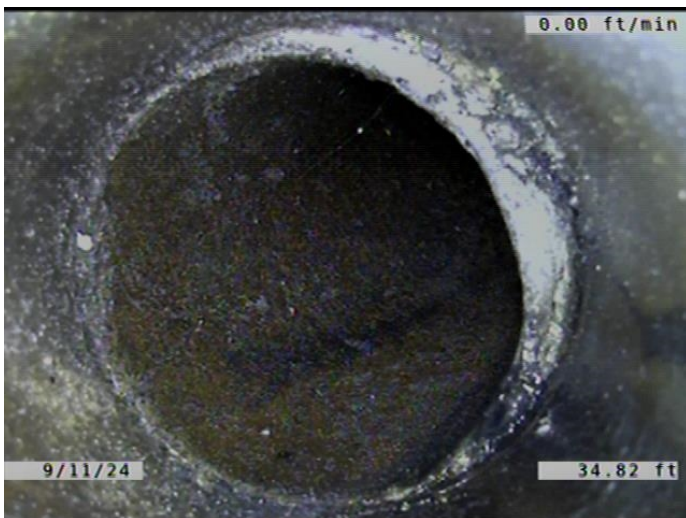
Code: **TF**
Description: **Tap Factory**

Distance (ft): **34.8**
Structural Grade: **0**
O&M Grade: **0**
Clock Start/From: **2**
Clock To:
1st Value: **6.000**
2nd Value:
Value Percent:
Continuous Index:
Within 8" of Joint: **YES**
Remarks: **SERVICE ANGLED.**

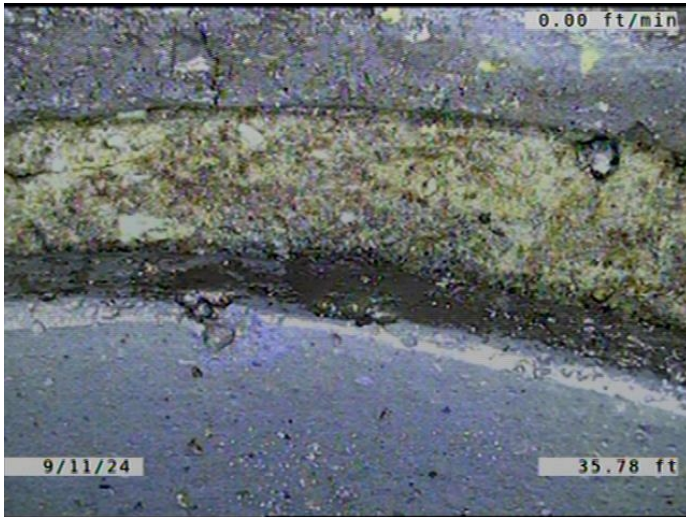
Code: **JAM**
Description: **Joint Angular Medium**

Distance (ft): **35.8**
Structural Grade: **3**
O&M Grade: **0**
Clock Start/From:
Clock To:
1st Value:
2nd Value:
Value Percent:
Continuous Index:
Within 8" of Joint: **NO**
Remarks:

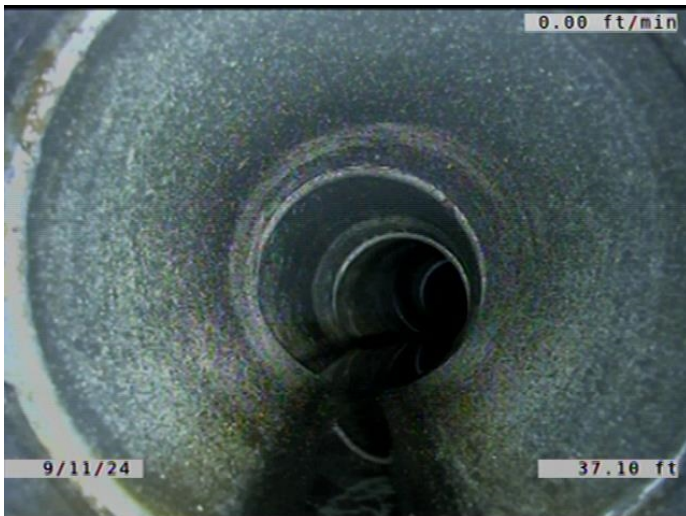
Code: **MWLS**
Description: **Miscellaneous Water Level Sag**

Distance (ft): **37.1**
Structural Grade: **2**
O&M Grade: **0**
Clock Start/From:
Clock To:
1st Value:
2nd Value:
Value Percent: **10.000**
Continuous Index: **F01**
Within 8" of Joint: **NO**
Remarks:

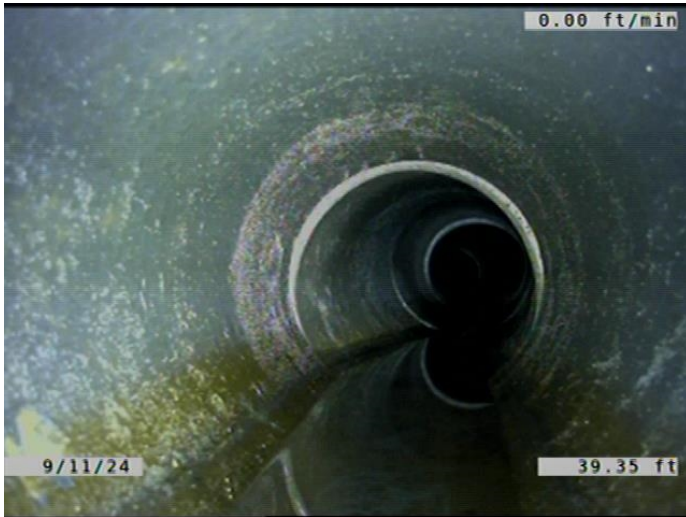
Code: **MWLS**
Description: **Miscellaneous Water Level Sag**

Distance (ft): **39.3**
Structural Grade: **2**
O&M Grade: **0**
Clock Start/From:
Clock To:
1st Value:
2nd Value:
Value Percent: **10.000**
Continuous Index: **S02**
Within 8" of Joint: **NO**
Remarks:

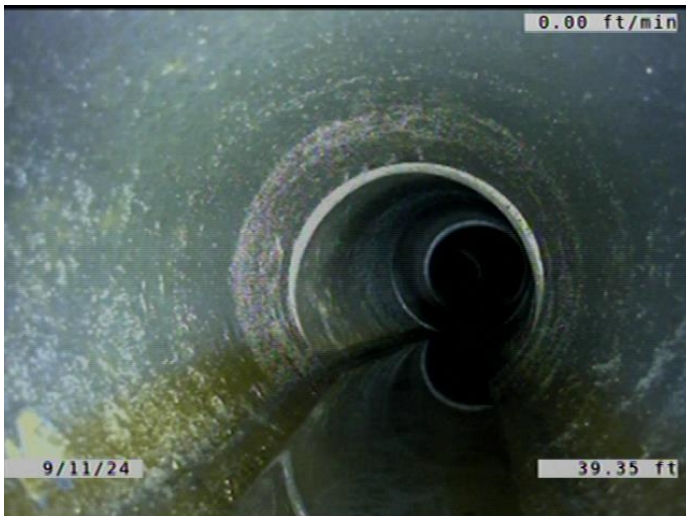
Code: **LR**
Description: **Line Right**

Distance (ft): **39.4**
Structural Grade: **0**
O&M Grade: **1**
Clock Start/From:
Clock To:
1st Value:
2nd Value:
Value Percent: **5.000**
Continuous Index:
Within 8" of Joint: **NO**
Remarks:

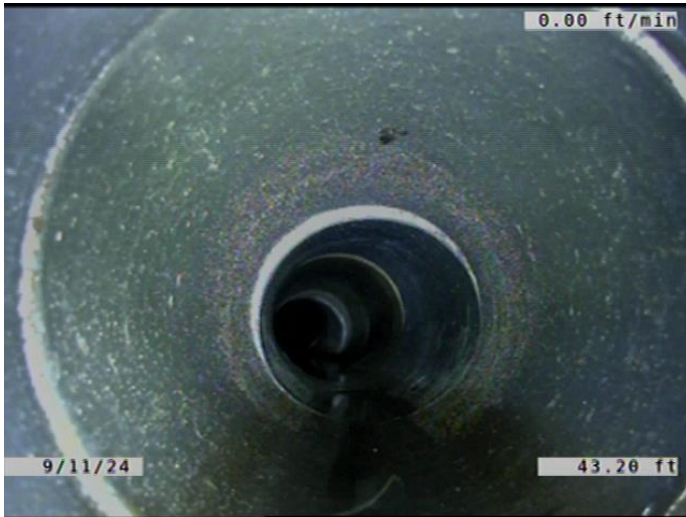
Code: **MWLS**
Description: **Miscellaneous Water Level Sag**

Distance (ft): **43.2**
Structural Grade: **2**
O&M Grade: **0**
Clock Start/From:
Clock To:
1st Value:
2nd Value:
Value Percent: **10.000**
Continuous Index: **F02**
Within 8" of Joint: **NO**
Remarks:

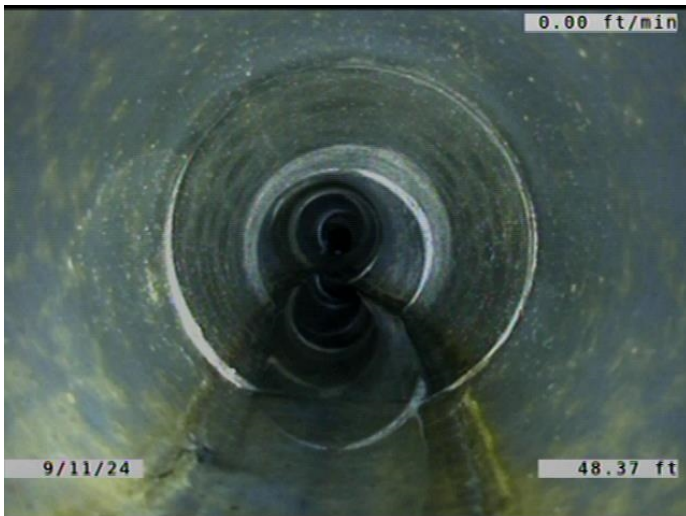
Code: **MWLS**
Description: **Miscellaneous Water Level Sag**

Distance (ft): **48.4**
Structural Grade: **2**
O&M Grade: **0**
Clock Start/From:
Clock To:
1st Value:
2nd Value:
Value Percent: **10.000**
Continuous Index: **S03**
Within 8" of Joint: **NO**
Remarks:

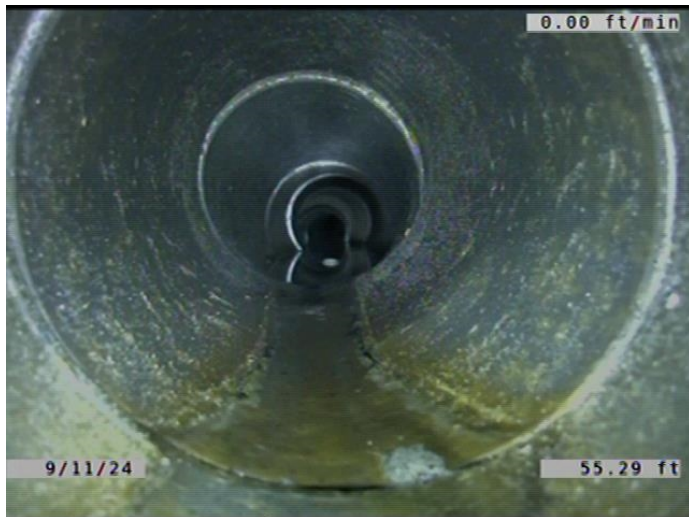
Code: **MWLS**
Description: **Miscellaneous Water Level Sag**

Distance (ft): **55.3**
Structural Grade: **2**
O&M Grade: **0**
Clock Start/From:
Clock To:
1st Value:
2nd Value:
Value Percent: **10.000**
Continuous Index: **F03**
Within 8" of Joint: **NO**
Remarks:

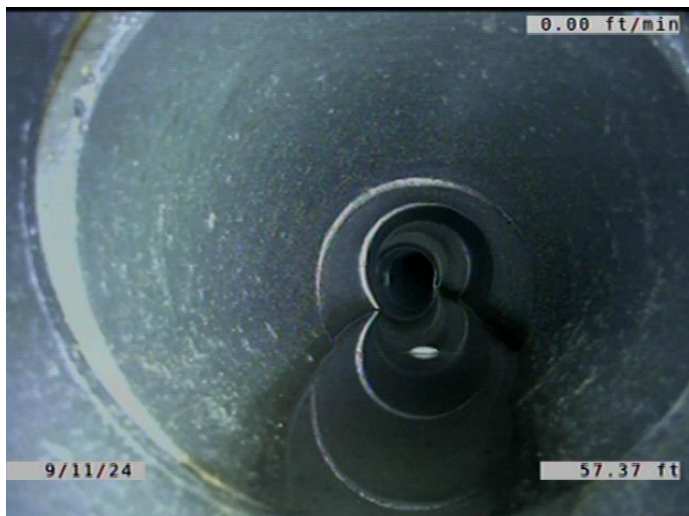
Code: **MWLS**
Description: **Miscellaneous Water Level Sag**

Distance (ft): **57.4**
Structural Grade: **2**
O&M Grade: **0**
Clock Start/From:
Clock To:
1st Value:
2nd Value:
Value Percent: **15.000**
Continuous Index: **S04**
Within 8" of Joint: **NO**
Remarks:

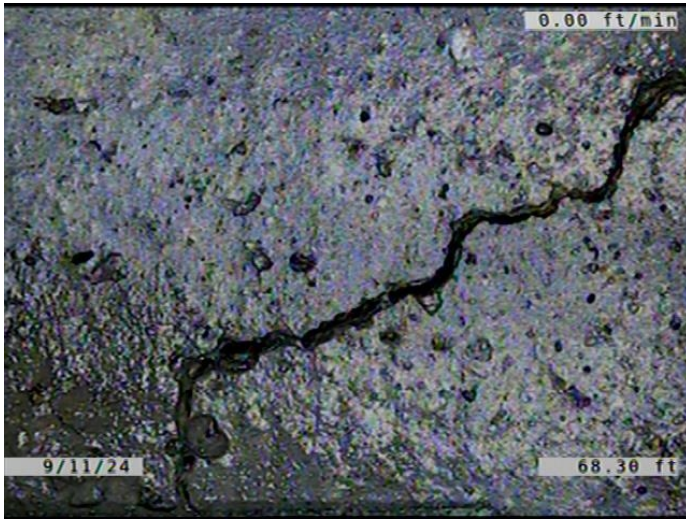
Code: **FM**
Description: **Fracture Multiple**

Distance (ft): **68.3**
Structural Grade: **4**
O&M Grade: **0**
Clock Start/From: **2**
Clock To: **4**
1st Value:
2nd Value:
Value Percent:
Continuous Index:
Within 8" of Joint: **YES**
Remarks:

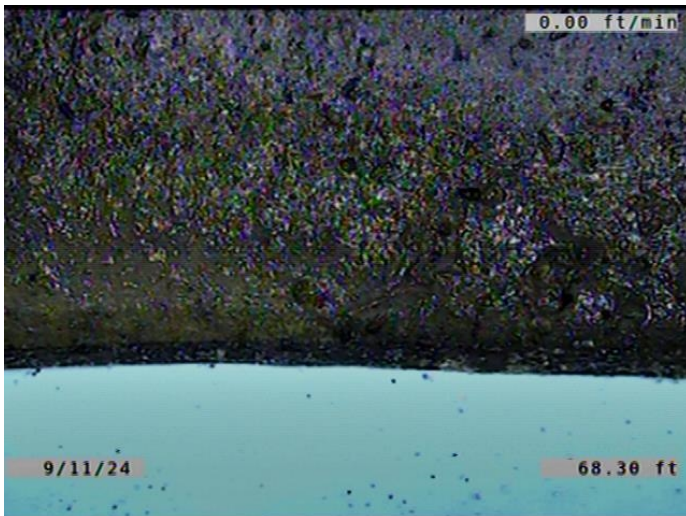
Code: **RPR**
Description: **Point Repair Replacement**

Distance (ft): **68.3**
Structural Grade: **0**
O&M Grade: **0**
Clock Start/From:
Clock To:
1st Value:
2nd Value:
Value Percent:
Continuous Index: **S05**
Within 8" of Joint: **YES**
Remarks: **PIPE REPLACED WITH PVC.**

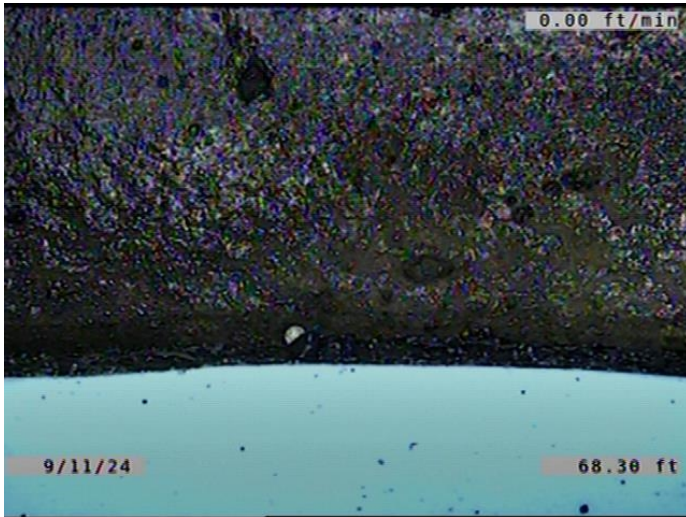
Code: **JOM**
Description: **Joint Offset Medium**

Distance (ft): **68.3**
Structural Grade: **3**
O&M Grade: **0**
Clock Start/From:
Clock To:
1st Value:
2nd Value:
Value Percent:
Continuous Index:
Within 8" of Joint: **NO**
Remarks:

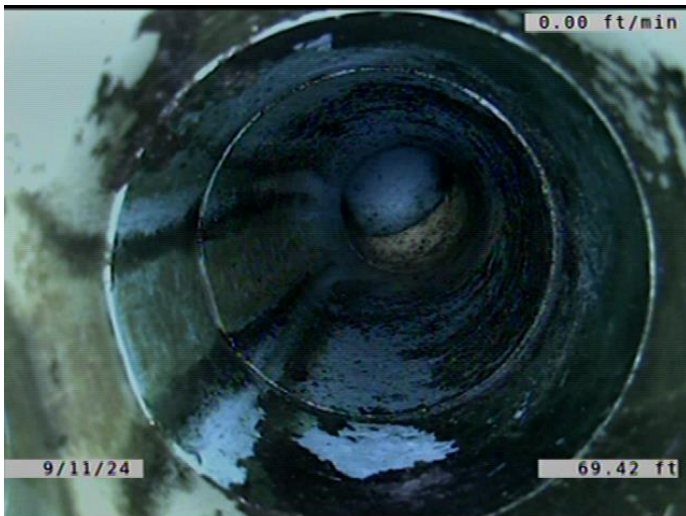
Code: **TF**
Description: **Tap Factory**

Distance (ft): **69.4**
Structural Grade: **0**
O&M Grade: **0**
Clock Start/From: **10**
Clock To:
1st Value: **6.000**
2nd Value:
Value Percent:
Continuous Index:
Within 8" of Joint: **YES**
Remarks: **SERVICE IS PVC.**

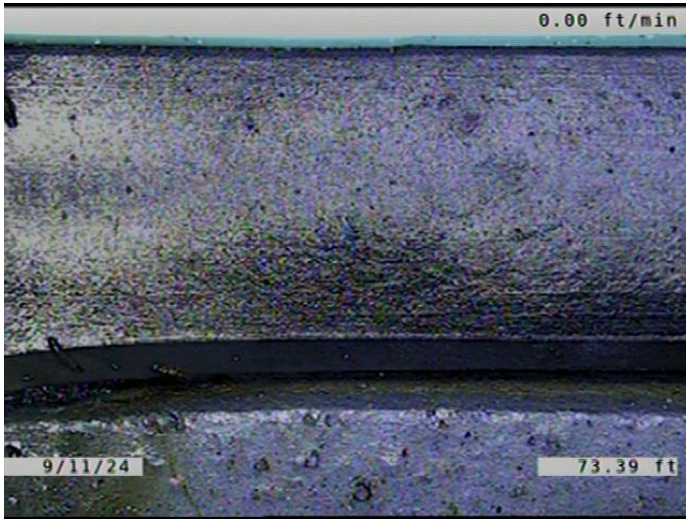
Code: **RPR**
Description: **Point Repair Replacement**

Distance (ft): **73.4**
Structural Grade: **0**
O&M Grade: **0**
Clock Start/From:
Clock To:
1st Value:
2nd Value:
Value Percent:
Continuous Index: **F05**
Within 8" of Joint: **YES**
Remarks: **PIPE REPLACED WITH PVC.**

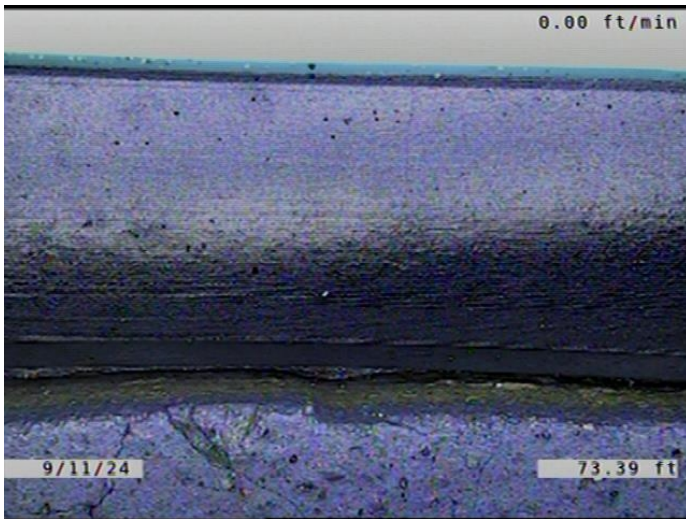
Code: **JSL**
Description: **Joint Separated Large**

Distance (ft): **73.4**
Structural Grade: **4**
O&M Grade: **0**
Clock Start/From:
Clock To:
1st Value:
2nd Value:
Value Percent:
Continuous Index:
Within 8" of Joint: **NO**
Remarks:

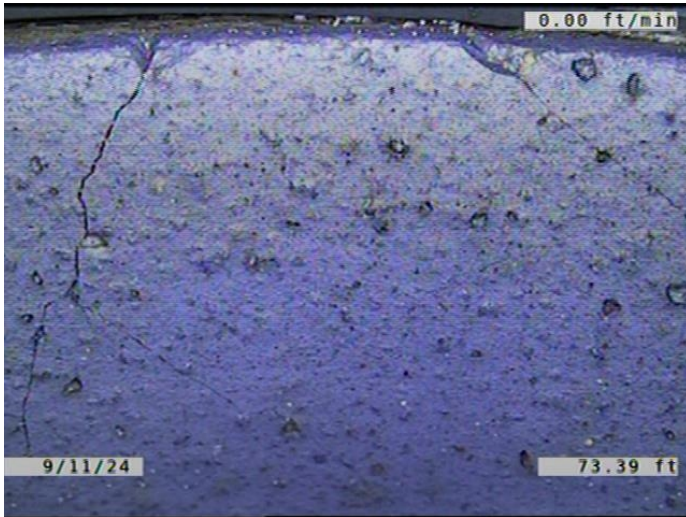
Code: **CM**
Description: **Crack Multiple**

Distance (ft): **73.4**
Structural Grade: **3**
O&M Grade: **0**
Clock Start/From: **12**
Clock To: **12**
1st Value:
2nd Value:
Value Percent:
Continuous Index: **S06**
Within 8" of Joint: **YES**
Remarks:

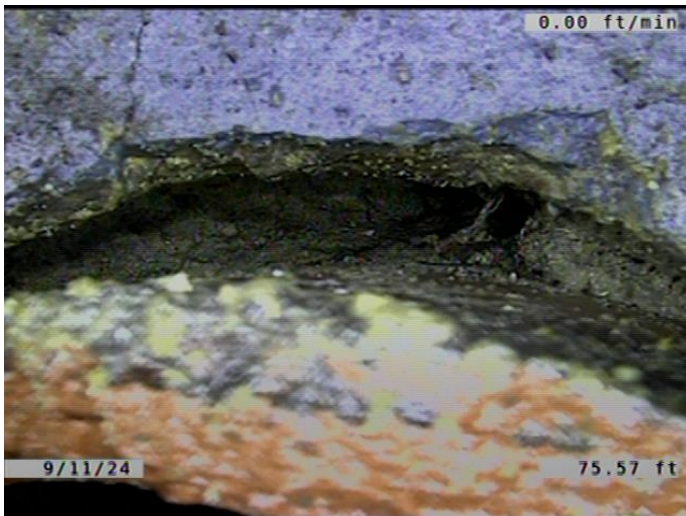
Code: **CM**
Description: **Crack Multiple**

Distance (ft): **75.6**
Structural Grade: **3**
O&M Grade: **0**
Clock Start/From: **1**
Clock To: **5**
1st Value:
2nd Value:
Value Percent:
Continuous Index:
Within 8" of Joint: **YES**
Remarks:

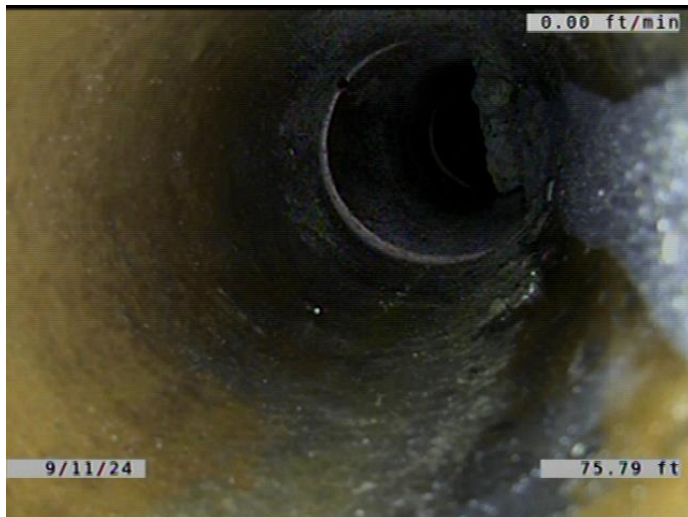
Code: **TBI**
Description: **Tap Break-in Intruding**

Distance (ft): **75.8**
Structural Grade: **0**
O&M Grade: **2**
Clock Start/From: **2**
Clock To:
1st Value: **6.000**
2nd Value: **2.000**
Value Percent:
Continuous Index:
Within 8" of Joint: **YES**
Remarks: **SOIL IN THE SERVICE.**

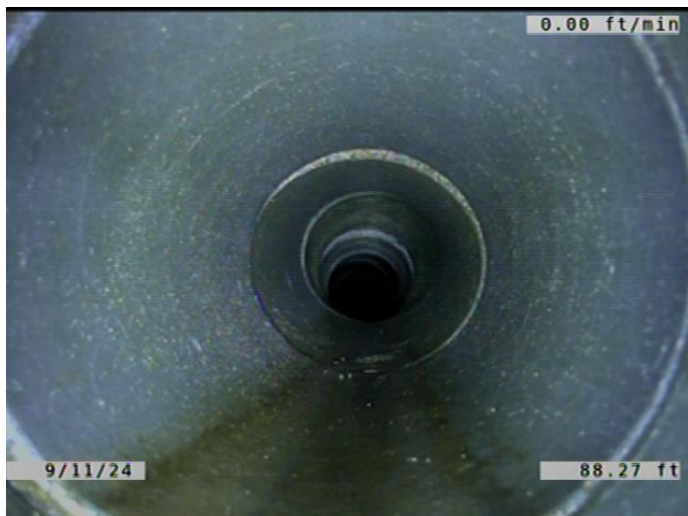
Code: **MWLS**
Description: **Miscellaneous Water Level Sag**

Distance (ft): **88.3**
Structural Grade: **2**
O&M Grade: **0**
Clock Start/From:
Clock To:
1st Value:
2nd Value:
Value Percent: **15.000**
Continuous Index: **F04**
Within 8" of Joint: **NO**
Remarks:

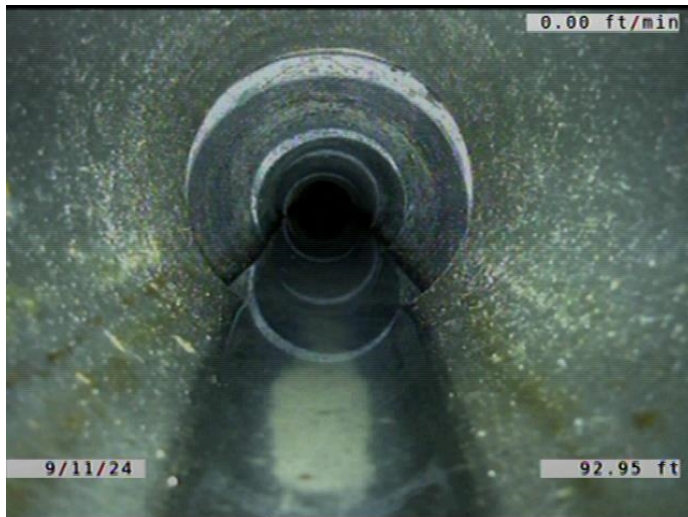
Code: **MWLS**
Description: **Miscellaneous Water Level Sag**

Distance (ft): **93.0**
Structural Grade: **2**
O&M Grade: **0**
Clock Start/From:
Clock To:
1st Value:
2nd Value:
Value Percent: **20.000**
Continuous Index: **S07**
Within 8" of Joint: **NO**
Remarks:

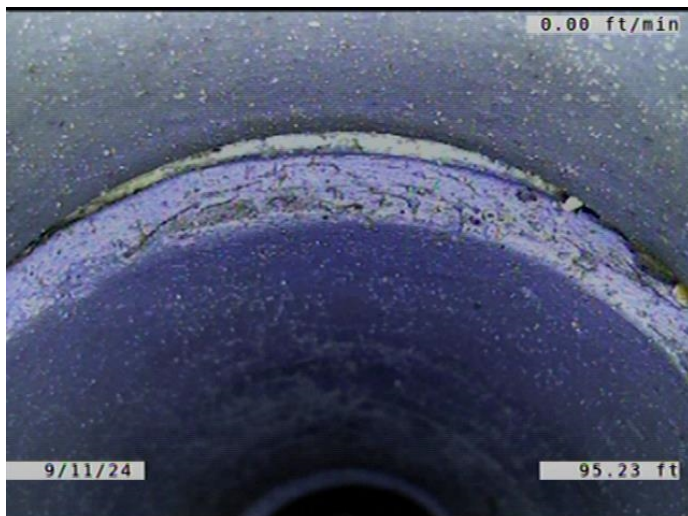
Code: **JOMD**
Description: **Joint Offset Medium Defective**

Distance (ft): **95.2**
Structural Grade: **3**
O&M Grade: **0**
Clock Start/From:
Clock To:
1st Value:
2nd Value:
Value Percent:
Continuous Index:
Within 8" of Joint: **NO**
Remarks:

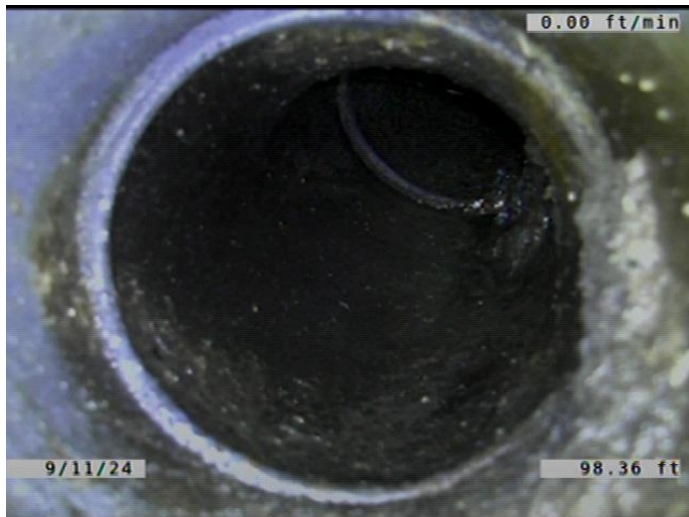
Code: **TF**
Description: **Tap Factory**

Distance (ft): **98.4**
Structural Grade: **0**
O&M Grade: **0**
Clock Start/From: **2**
Clock To:
1st Value: **6.000**
2nd Value:
Value Percent:
Continuous Index:
Within 8" of Joint: **YES**
Remarks:

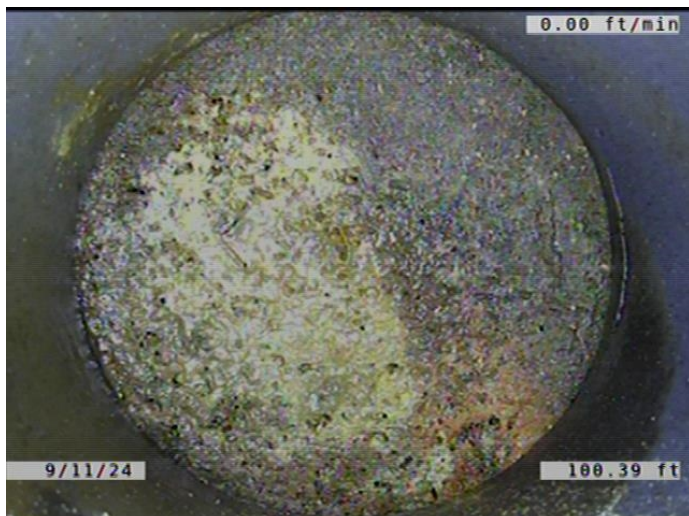
Code: **TFC**
Description: **Tap Factory Capped**

Distance (ft): **100.4**
Structural Grade: **0**
O&M Grade: **0**
Clock Start/From: **10**
Clock To:
1st Value: **6.000**
2nd Value:
Value Percent:
Continuous Index:
Within 8" of Joint: **YES**
Remarks:

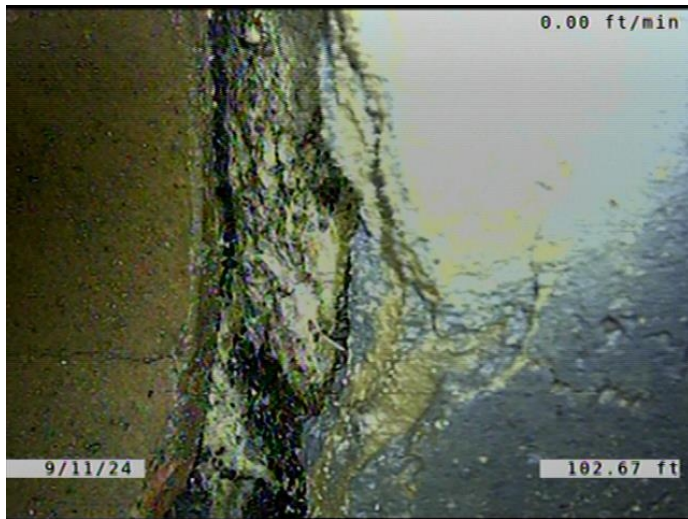
Code: **CM**
 Description: **Crack Multiple**

Distance (ft): **102.7**
 Structural Grade: **3**
 O&M Grade: **0**
 Clock Start/From: **8**
 Clock To: **12**
 1st Value:
 2nd Value:
 Value Percent:
 Continuous Index:
 Within 8" of Joint: **YES**
 Remarks:

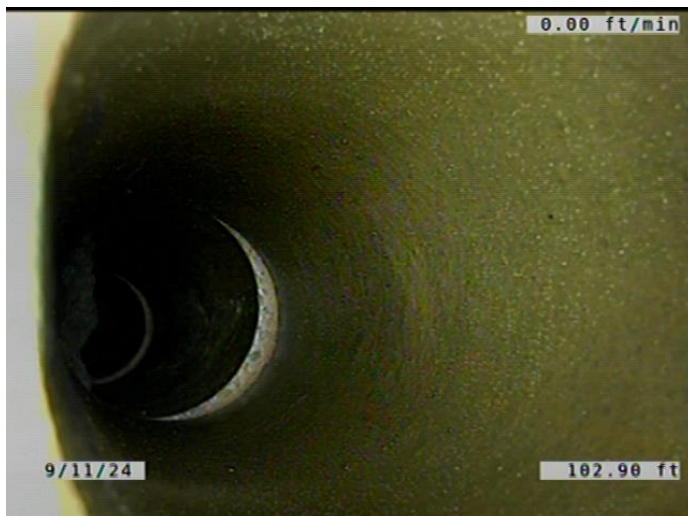
Code: **TBI**
 Description: **Tap Break-in Intruding**

Distance (ft): **102.9**
 Structural Grade: **0**
 O&M Grade: **2**
 Clock Start/From: **10**
 Clock To:
 1st Value: **6.000**
 2nd Value: **1.000**
 Value Percent:
 Continuous Index:
 Within 8" of Joint: **YES**
 Remarks: **SOIL IN THE SERVICE.**

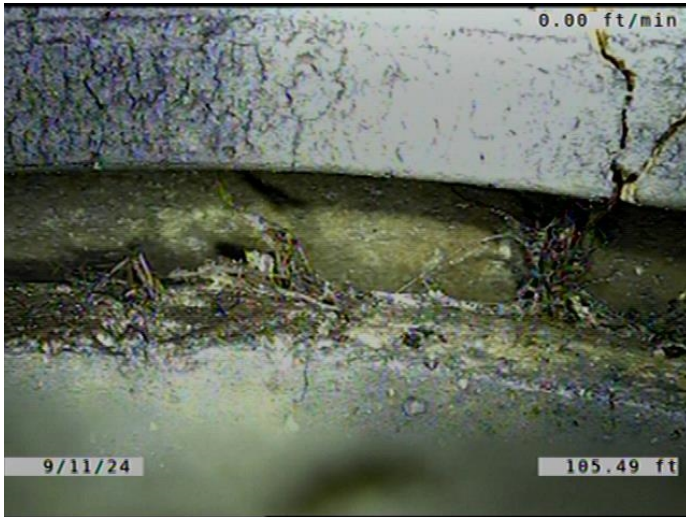
Code: **RFJ**
Description: **Roots Fine Joint**

Distance (ft): **105.5**
Structural Grade: **0**
O&M Grade: **1**
Clock Start/From: **9**
Clock To: **3**
1st Value:
2nd Value:
Value Percent:
Continuous Index:
Within 8" of Joint: **YES**
Remarks:

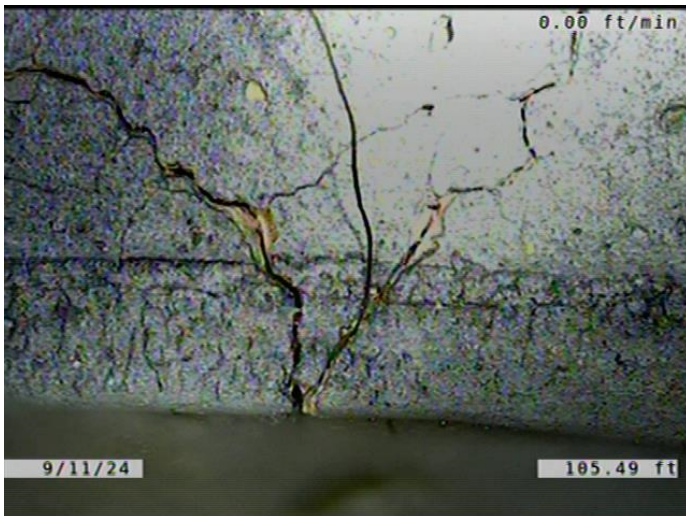
Code: **B**
Description: **Broken**

Distance (ft): **105.5**
Structural Grade: **4**
O&M Grade: **0**
Clock Start/From: **9**
Clock To: **3**
1st Value:
2nd Value:
Value Percent:
Continuous Index:
Within 8" of Joint: **YES**
Remarks:

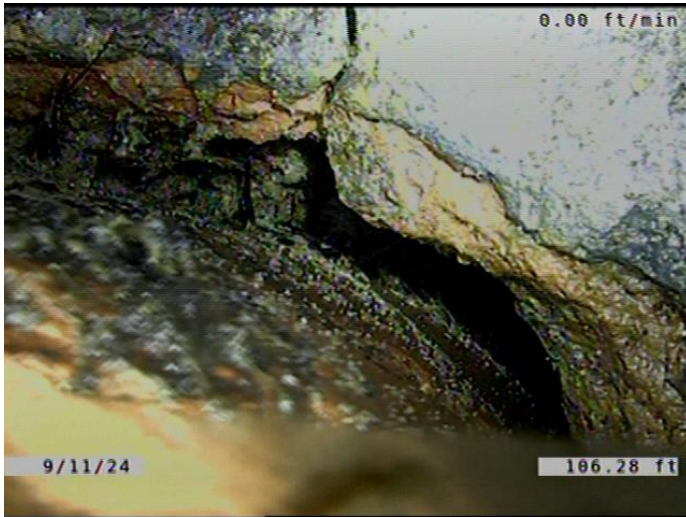
Code: **FM**
Description: **Fracture Multiple**

Distance (ft): **106.3**
Structural Grade: **4**
O&M Grade: **0**
Clock Start/From: **12**
Clock To: **4**
1st Value:
2nd Value:
Value Percent:
Continuous Index:
Within 8" of Joint: **YES**
Remarks:

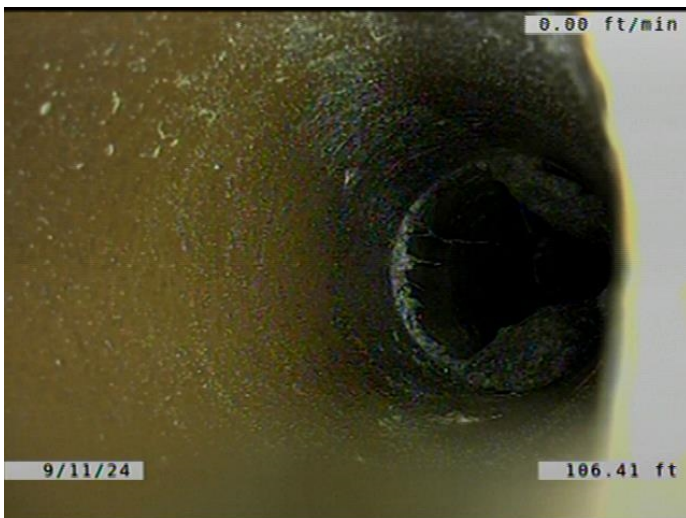
Code: **TBI**
Description: **Tap Break-in Intruding**

Distance (ft): **106.4**
Structural Grade: **0**
O&M Grade: **2**
Clock Start/From: **2**
Clock To:
1st Value: **6.000**
2nd Value: **3.000**
Value Percent:
Continuous Index:
Within 8" of Joint: **YES**
Remarks: **ROOTS GROWING IN THE JOINTS OF THE SERVICE.**

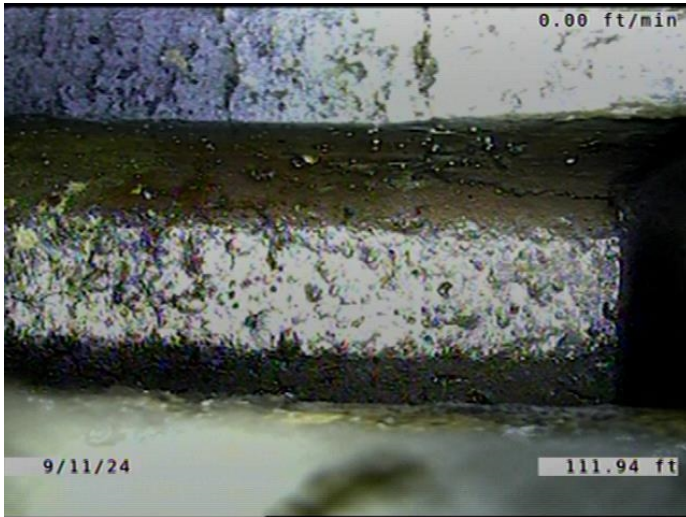
Code: **JAM**
Description: **Joint Angular Medium**

Distance (ft): **111.9**
Structural Grade: **3**
O&M Grade: **0**
Clock Start/From:
Clock To:
1st Value:
2nd Value:
Value Percent:
Continuous Index:
Within 8" of Joint: **NO**
Remarks:

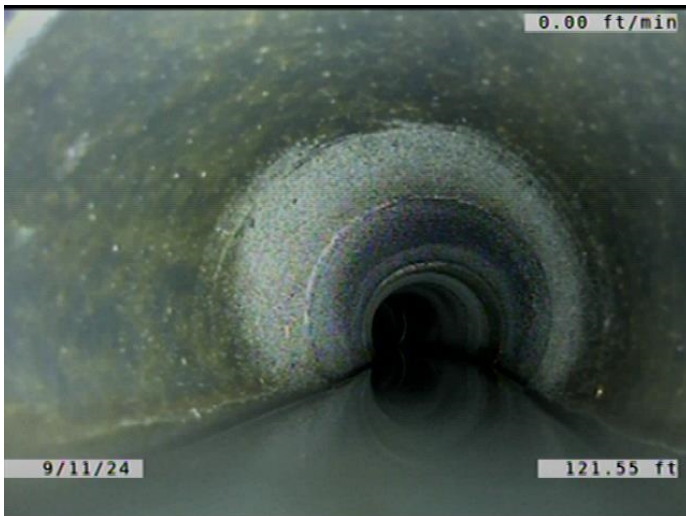
Code: **LR**
Description: **Line Right**

Distance (ft): **121.6**
Structural Grade: **0**
O&M Grade: **1**
Clock Start/From:
Clock To:
1st Value:
2nd Value:
Value Percent: **10.000**
Continuous Index:
Within 8" of Joint: **NO**
Remarks:

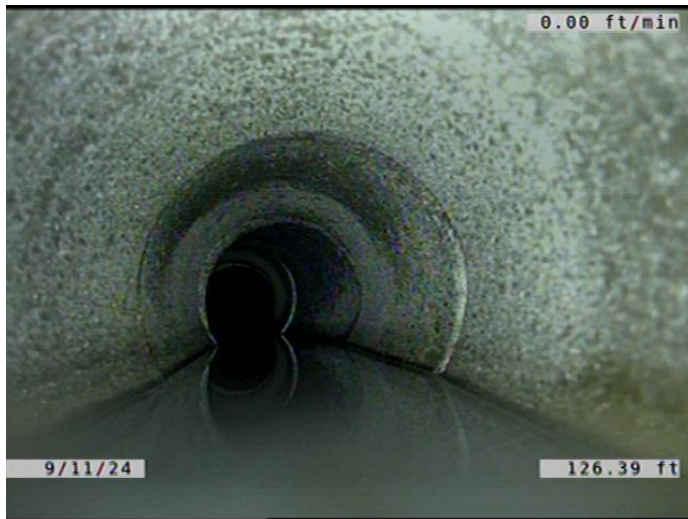
Code: **LL**
Description: **Line Left**

Distance (ft): **126.4**
Structural Grade: **0**
O&M Grade: **1**
Clock Start/From:
Clock To:
1st Value:
2nd Value:
Value Percent: **5.000**
Continuous Index: **S08**
Within 8" of Joint: **NO**
Remarks:

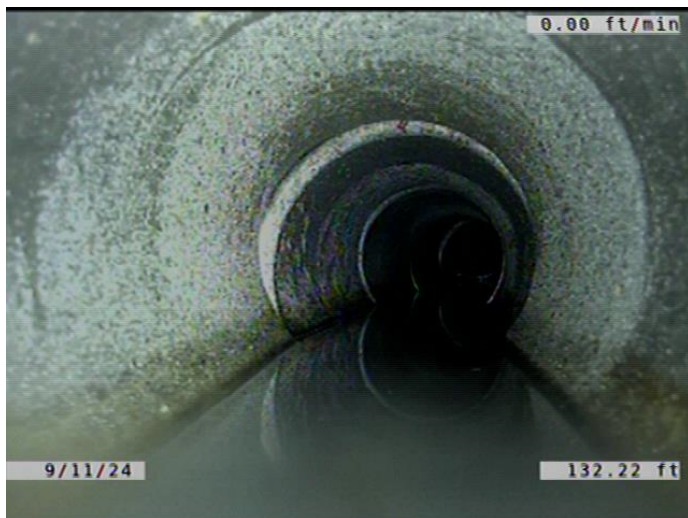
Code: **LL**
Description: **Line Left**

Distance (ft): **132.2**
Structural Grade: **0**
O&M Grade: **1**
Clock Start/From:
Clock To:
1st Value:
2nd Value:
Value Percent: **5.000**
Continuous Index: **F08**
Within 8" of Joint: **NO**
Remarks:

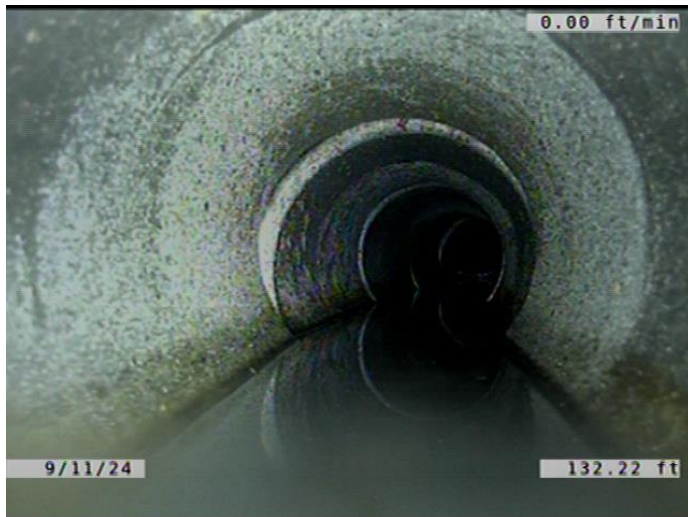
Code: **LR**
Description: **Line Right**

Distance (ft): **132.2**
Structural Grade: **0**
O&M Grade: **1**
Clock Start/From:
Clock To:
1st Value:
2nd Value:
Value Percent: **5.000**
Continuous Index:
Within 8" of Joint: **NO**
Remarks:

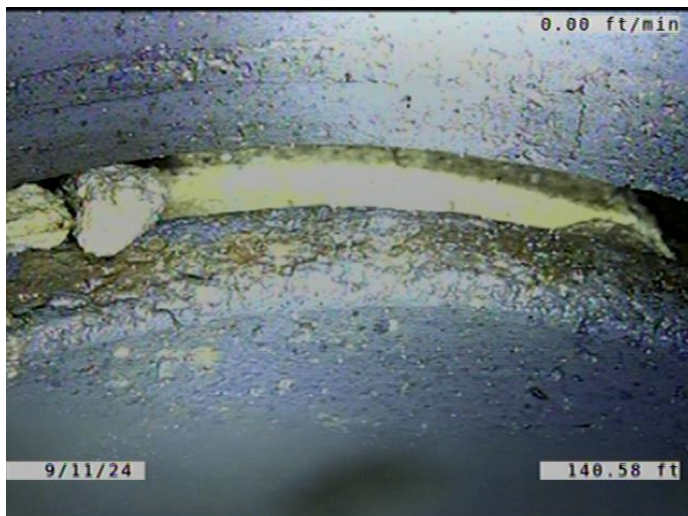
Code: **JOMD**
Description: **Joint Offset Medium Defective**

Distance (ft): **140.6**
Structural Grade: **3**
O&M Grade: **0**
Clock Start/From:
Clock To:
1st Value:
2nd Value:
Value Percent:
Continuous Index:
Within 8" of Joint: **NO**
Remarks:

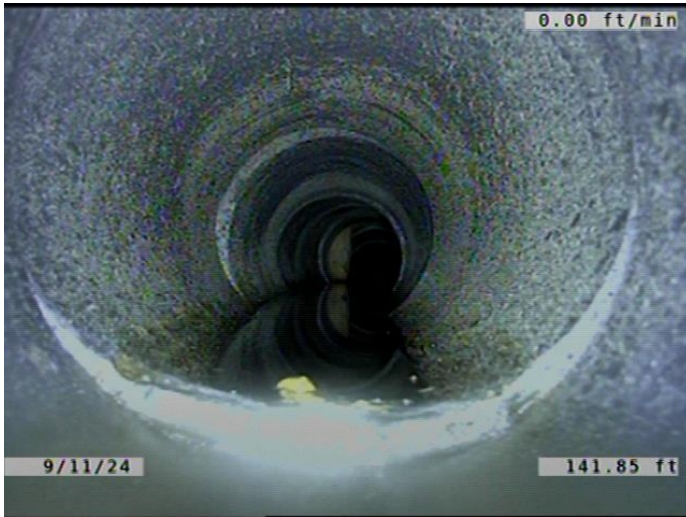
Code: **MWLS**
Description: **Miscellaneous Water Level Sag**

Distance (ft): **141.8**
Structural Grade: **2**
O&M Grade: **0**
Clock Start/From:
Clock To:
1st Value:
2nd Value:
Value Percent: **20.000**
Continuous Index: **F07**
Within 8" of Joint: **NO**
Remarks:

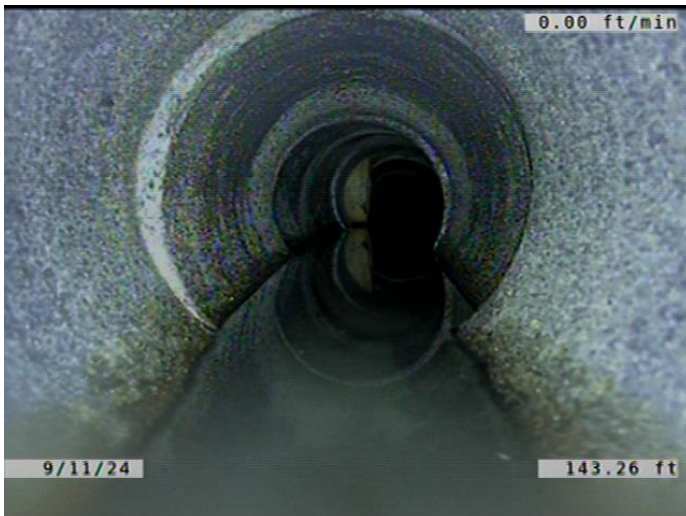
Code: **MWLS**
Description: **Miscellaneous Water Level Sag**

Distance (ft): **143.3**
Structural Grade: **2**
O&M Grade: **0**
Clock Start/From:
Clock To:
1st Value:
2nd Value:
Value Percent: **20.000**
Continuous Index: **S09**
Within 8" of Joint: **NO**
Remarks:

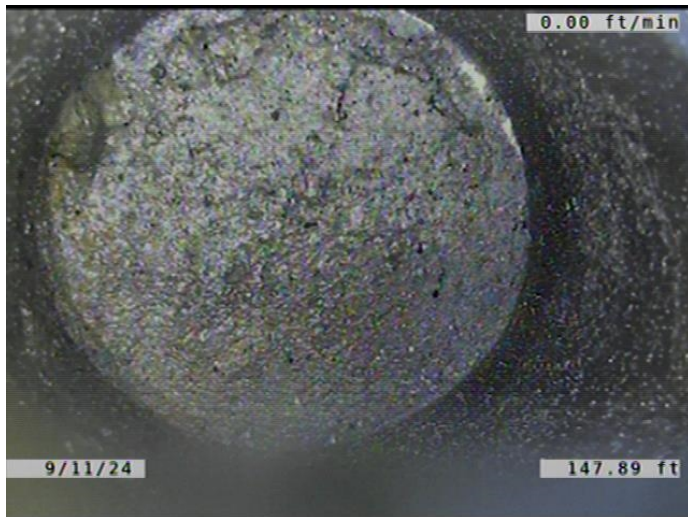
Code: **TFC**
Description: **Tap Factory Capped**

Distance (ft): **147.9**
Structural Grade: **0**
O&M Grade: **0**
Clock Start/From: **10**
Clock To:
1st Value: **6.000**
2nd Value:
Value Percent:
Continuous Index:
Within 8" of Joint: **YES**
Remarks:

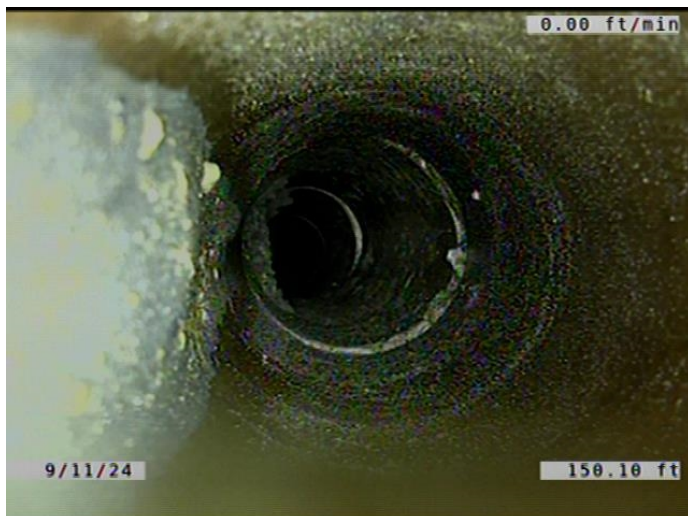
Code: **TBI**
Description: **Tap Break-in Intruding**

Distance (ft): **150.1**
Structural Grade: **0**
O&M Grade: **2**
Clock Start/From: **9**
Clock To:
1st Value: **6.000**
2nd Value: **3.000**
Value Percent:
Continuous Index:
Within 8" of Joint: **YES**
Remarks: **SOIL IN THE SERVICE.**

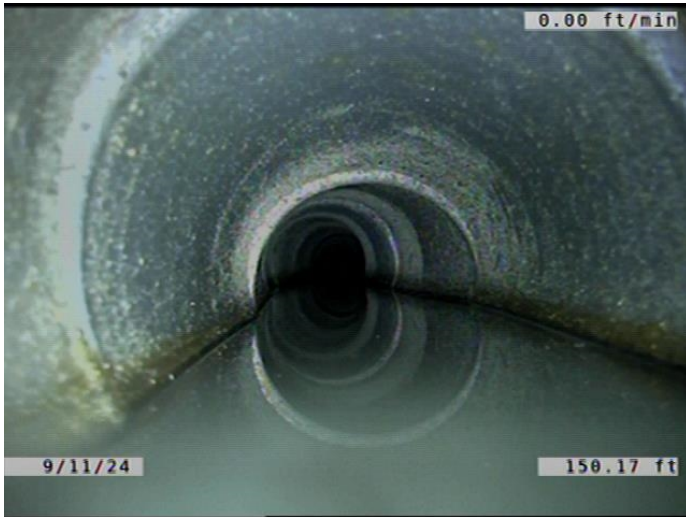
Code: **CM**
Description: **Crack Multiple**

Distance (ft): **150.2**
Structural Grade: **3**
O&M Grade: **0**
Clock Start/From: **12**
Clock To: **12**
1st Value:
2nd Value:
Value Percent:
Continuous Index: **F06**
Within 8" of Joint: **YES**
Remarks:

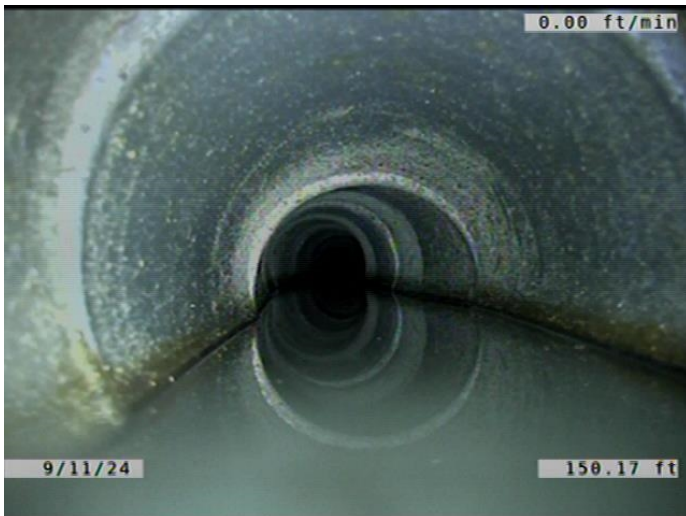
Code: **MWLS**
Description: **Miscellaneous Water Level Sag**

Distance (ft): **150.2**
Structural Grade: **2**
O&M Grade: **0**
Clock Start/From:
Clock To:
1st Value:
2nd Value:
Value Percent: **20.000**
Continuous Index: **F09**
Within 8" of Joint: **NO**
Remarks:

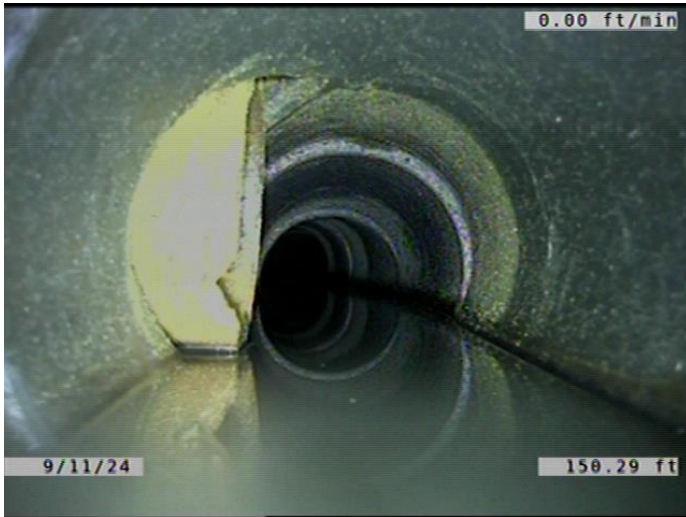
| Description: | Miscellaneous Survey Abandoned |
| Remarks: | CAMERA CANT MAKE IT PAST PROTRUDING TAP. |
