## Profile/Photo Observation Report

Street:	<b>E CLEVELAND AVE</b>	Flow Control:	<b>Not Controlled</b>
City:	<b>Hobart, IN</b>	Year Renewed:	
Location:	<b>Other</b>	Tape/Media #:	
Purpose:	<b>Not Known</b>	Dia/Height:	<b>8"</b>
Use:	<b>Sanitary</b>	Material:	<b>VCP</b>
Drain Area:	<b>NA</b>	Lining:	
Category:	<b>NA</b>		
Comment:

Location Details:		Direction of Survey:	<b>Upstream</b>
US MH:	<b>M-804-010</b>	DS MH:	<b>M-804-011</b>
		Total Length Surveyed (ft):	<b>334.2</b>

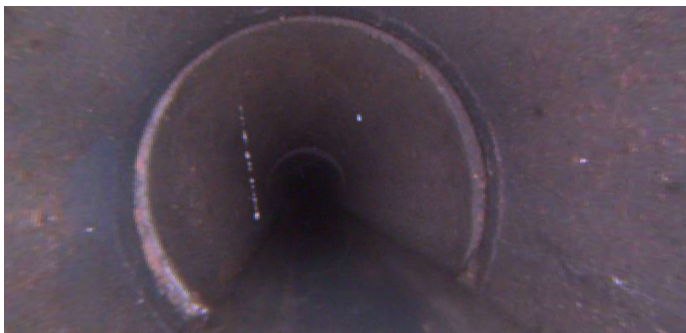
Code: **AMH**  
Description: **Manhole**

Distance (ft): **.0**  
Structural Grade: **0**  
O&M Grade: **0**  
Clock Start/From:  
Clock To:  
1st Value:  
2nd Value:  
Value Percent:  
Continuous Index:  
Within 8" of Joint: **NO**  
Remarks: **M-804-011**

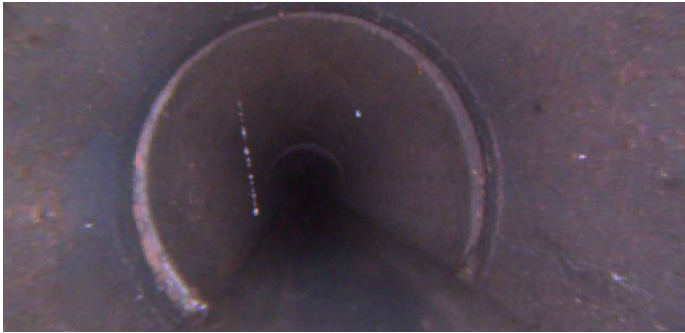
Code:	<b>MWL</b>
Description:	<b>Water Level</b>

Distance (ft):	<b>.0</b>
Structural Grade:	<b>0</b>
O&M Grade:	<b>0</b>
Clock Start/From:	
Clock To:	
1st Value:	
2nd Value:	
Value Percent:	<b>5.000</b>
Continuous Index:	
Within 8" of Joint:	<b>NO</b>
Remarks:

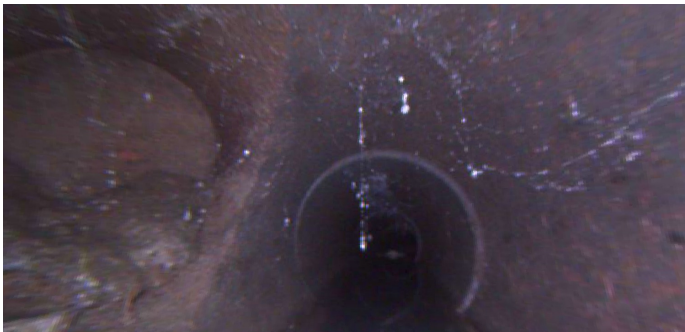
Code:	<b>TFC</b>
Description:	<b>Tap Factory Capped</b>

Distance (ft):	<b>10.7</b>
Structural Grade:	<b>0</b>
O&M Grade:	<b>0</b>
Clock Start/From:	<b>10</b>
Clock To:	
1st Value:	<b>4.000</b>
2nd Value:	
Value Percent:	
Continuous Index:	
Within 8" of Joint:	<b>YES</b>
Remarks:

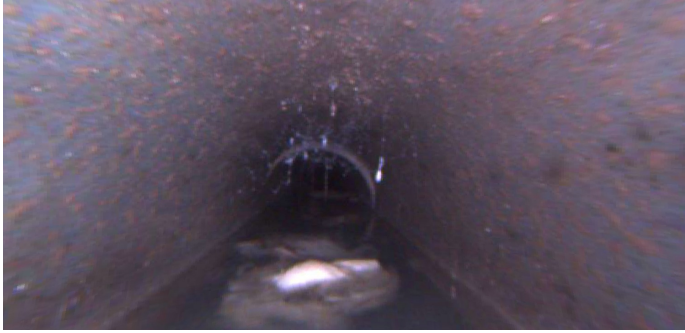
Code: **DSZ**  
Description: **Deposits Settled Other**

Distance (ft): **14.0**  
Structural Grade: **0**  
O&M Grade: **2**  
Clock Start/From: **6**  
Clock To:  
1st Value:  
2nd Value:  
Value Percent: **5.000**  
Continuous Index: **S01**  
Within 8" of Joint: **NO**  
Remarks: **tissue**

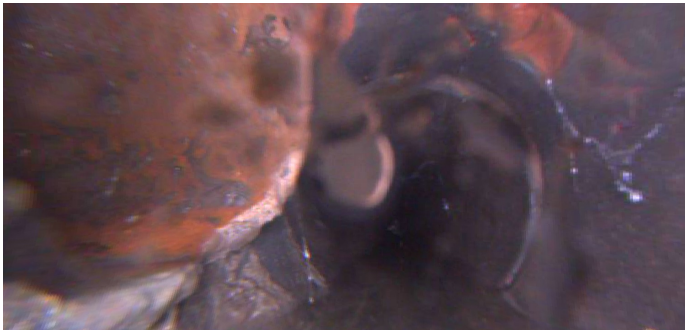
Code: **TB**  
Description: **Tap Break-in**

Distance (ft): **19.0**  
Structural Grade: **0**  
O&M Grade: **0**  
Clock Start/From: **9**  
Clock To:  
1st Value: **8.000**  
2nd Value:  
Value Percent:  
Continuous Index:  
Within 8" of Joint: **YES**  
Remarks:

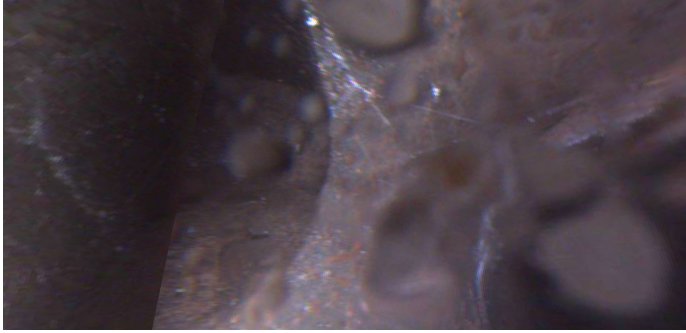
Code: **TF**  
Description: **Tap Factory**

Distance (ft): **37.5**  
Structural Grade: **0**  
O&M Grade: **0**  
Clock Start/From: **10**  
Clock To:  
1st Value: **4.000**  
2nd Value:  
Value Percent:  
Continuous Index:  
Within 8" of Joint: **YES**  
Remarks:

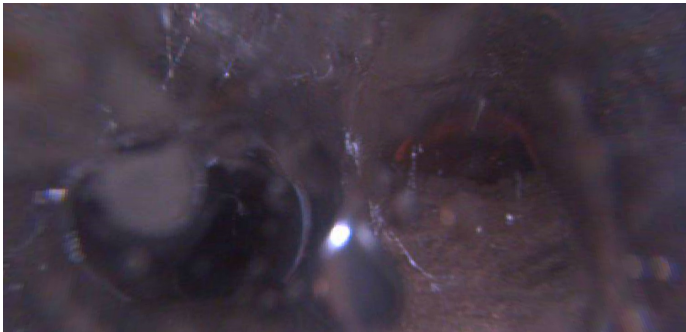
Code: **TFD**  
Description: **Tap Factory Defective**

Distance (ft): **53.4**  
Structural Grade: **0**  
O&M Grade: **2**  
Clock Start/From: **2**  
Clock To:  
1st Value: **4.000**  
2nd Value:  
Value Percent:  
Continuous Index:  
Within 8" of Joint: **YES**  
Remarks: **blocked by deposits**

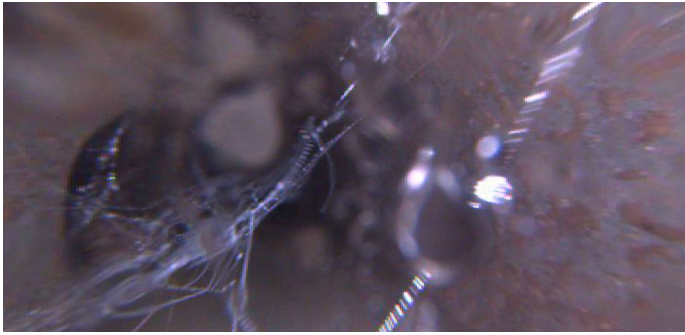
Code: **TF**  
Description: **Tap Factory**

Distance (ft): **77.4**  
Structural Grade: **0**  
O&M Grade: **0**  
Clock Start/From: **9**  
Clock To:  
1st Value: **4.000**  
2nd Value:  
Value Percent:  
Continuous Index:  
Within 8" of Joint:  
Remarks:

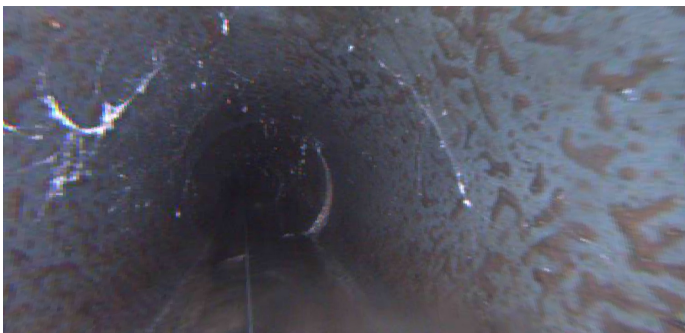
Code: **MGO**  
Description: **General Observation**

Distance (ft): **91.1**  
Structural Grade: **0**  
O&M Grade: **0**  
Clock Start/From:  
Clock To:  
1st Value:  
2nd Value:  
Value Percent:  
Continuous Index:  
Within 8" of Joint: **NO**  
Remarks: **rear camera/cob webs**

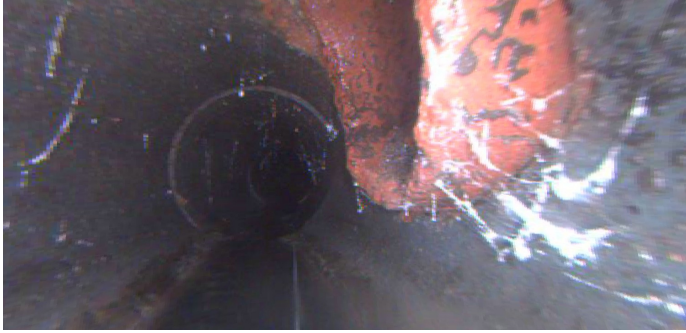
Code: **TB**  
Description: **Tap Break-in**

Distance (ft): **97.1**  
Structural Grade: **0**  
O&M Grade: **0**  
Clock Start/From: **10**  
Clock To:  
1st Value: **8.000**  
2nd Value:  
Value Percent:  
Continuous Index:  
Within 8" of Joint:  
Remarks:

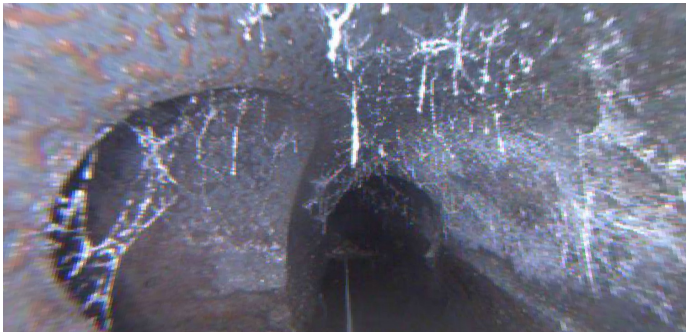
Code: **TF**  
Description: **Tap Factory**

Distance (ft): **105.8**  
Structural Grade: **0**  
O&M Grade: **0**  
Clock Start/From: **3**  
Clock To:  
1st Value: **6.000**  
2nd Value:  
Value Percent:  
Continuous Index:  
Within 8" of Joint:  
Remarks:

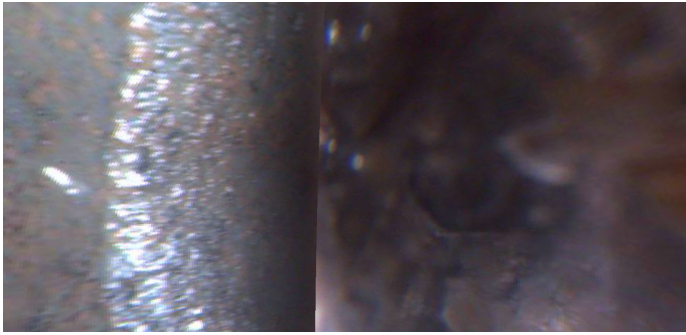
Code: **TF**  
Description: **Tap Factory**

Distance (ft): **158.7**  
Structural Grade: **0**  
O&M Grade: **0**  
Clock Start/From: **10**  
Clock To:  
1st Value: **4.000**  
2nd Value:  
Value Percent:  
Continuous Index:  
Within 8" of Joint: **YES**  
Remarks:

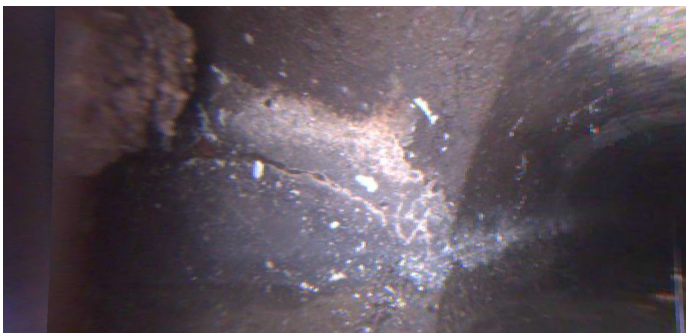
Code: **TFD**  
Description: **Tap Factory Defective**

Distance (ft): **196.1**  
Structural Grade: **0**  
O&M Grade: **2**  
Clock Start/From: **3**  
Clock To:  
1st Value: **4.000**  
2nd Value:  
Value Percent:  
Continuous Index:  
Within 8" of Joint:  
Remarks: **blocked**

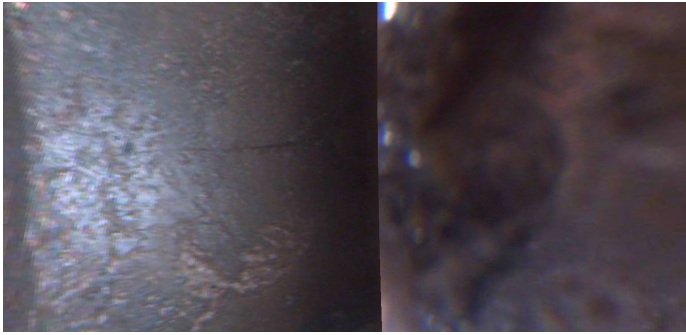
Code: **TF**  
Description: **Tap Factory**

Distance (ft): **218.7**  
Structural Grade: **0**  
O&M Grade: **0**  
Clock Start/From: **10**  
Clock To:  
1st Value: **4.000**  
2nd Value:  
Value Percent:  
Continuous Index:  
Within 8" of Joint: **YES**  
Remarks:

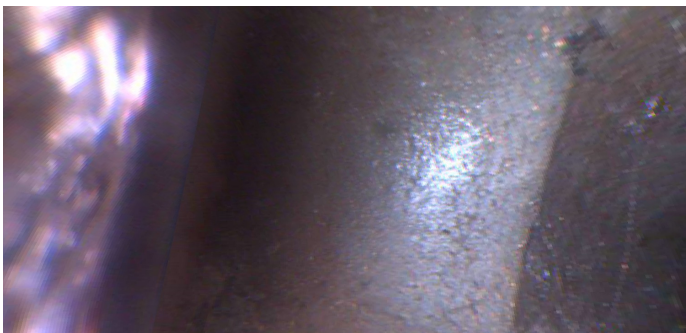
Code: **TF**  
Description: **Tap Factory**

Distance (ft): **241.4**  
Structural Grade: **0**  
O&M Grade: **0**  
Clock Start/From: **3**  
Clock To:  
1st Value: **4.000**  
2nd Value:  
Value Percent:  
Continuous Index:  
Within 8" of Joint: **YES**  
Remarks:

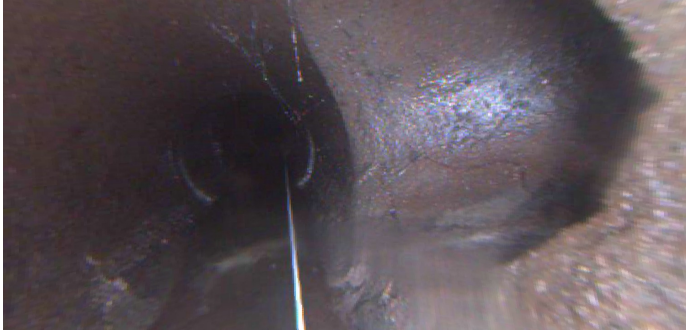
Code: **TF**  
Description: **Tap Factory**

Distance (ft): **254.1**  
Structural Grade: **0**  
O&M Grade: **0**  
Clock Start/From: **9**  
Clock To:  
1st Value: **4.000**  
2nd Value:  
Value Percent:  
Continuous Index:  
Within 8" of Joint: **YES**  
Remarks:

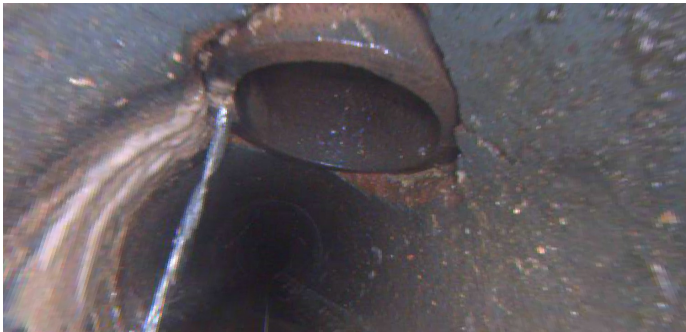
Code: **TBA**  
Description: **Tap Break-in Active**

Distance (ft): **262.7**  
Structural Grade: **0**  
O&M Grade: **0**  
Clock Start/From: **12**  
Clock To:  
1st Value: **4.000**  
2nd Value:  
Value Percent:  
Continuous Index:  
Within 8" of Joint:  
Remarks:

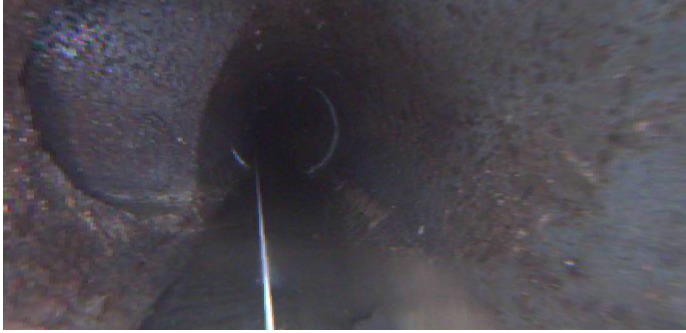
Code: **TF**  
Description: **Tap Factory**

Distance (ft): **277.1**  
Structural Grade: **0**  
O&M Grade: **0**  
Clock Start/From: **9**  
Clock To:  
1st Value: **4.000**  
2nd Value:  
Value Percent:  
Continuous Index:  
Within 8" of Joint:  
Remarks:

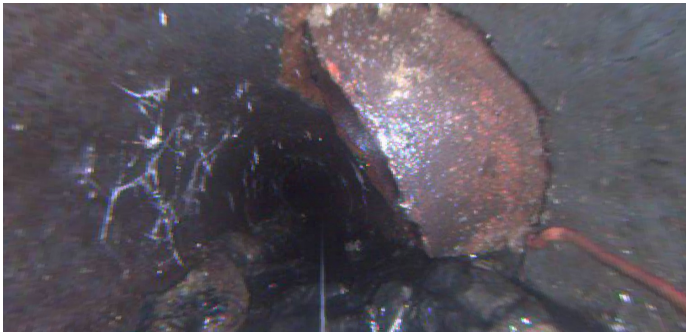
Code: **TBI**  
Description: **Tap Break-in Intruding**

Distance (ft): **305.2**  
Structural Grade: **0**  
O&M Grade: **2**  
Clock Start/From: **3**  
Clock To:  
1st Value: **6.000**  
2nd Value: **2.000**  
Value Percent:  
Continuous Index:  
Within 8" of Joint:  
Remarks:

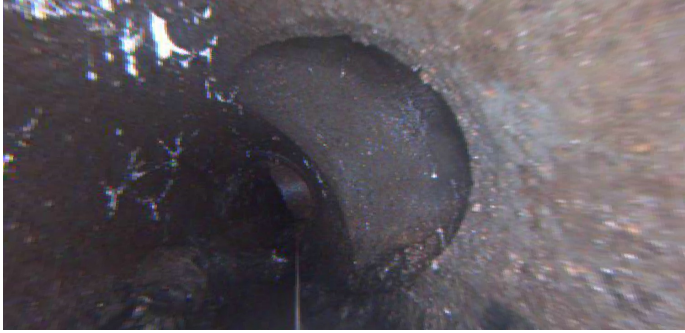
Code: **TF**  
Description: **Tap Factory**

Distance (ft): **307.0**  
Structural Grade: **0**  
O&M Grade: **0**  
Clock Start/From: **9**  
Clock To:  
1st Value: **4.000**  
2nd Value:  
Value Percent:  
Continuous Index:  
Within 8" of Joint:  
Remarks:

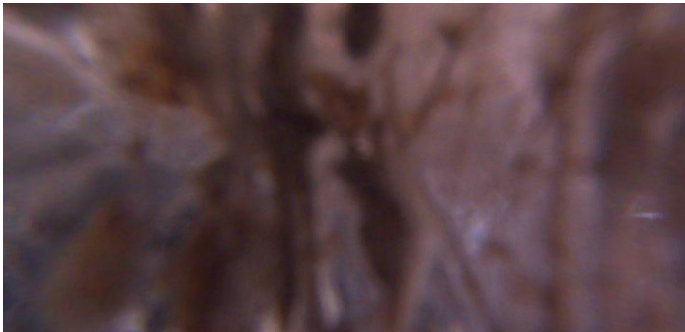
Code: **MSA**  
Description: **Abandoned Survey**

Distance (ft): **334.2**  
Structural Grade: **0**  
O&M Grade: **0**  
Clock Start/From:  
Clock To:  
1st Value:  
2nd Value:  
Value Percent:  
Continuous Index:  
Within 8" of Joint: **NO**  
Remarks: **camera stopped reason unknown**

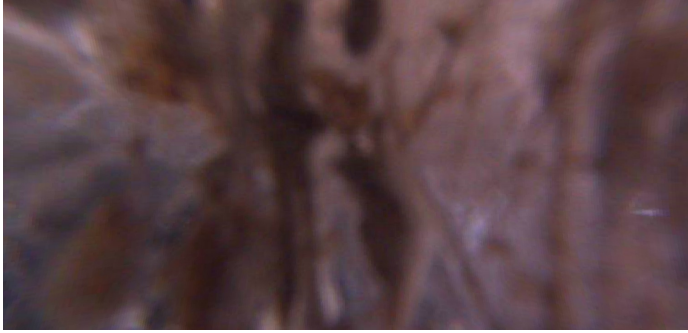
Code:	<b>DSZ</b>
Description:	<b>Deposits Settled Other</b>
Distance (ft):	<b>334.2</b>
Structural Grade:	<b>0</b>
O&M Grade:	<b>2</b>
Clock Start/From:	<b>6</b>
Clock To:	
1st Value:	
2nd Value:	
Value Percent:	<b>5.000</b>
Continuous Index:	<b>F01</b>
Within 8" of Joint:	<b>NO</b>
Remarks:	<b>tissue</b>
