Profile/Photo Observation Report

Date:	04/22/2018	Weather:		Coding:	PACP 6.0
Pipe Length (ft):	413.8	Owner:	NA	Pre Clean:	Not Known
P.O.#:		Surveyor:	Byrd Fitzgerald	PSR:	P-804-010-011
Customer:		Clean Date:	01/01/1900	Shape:	C

Street:	E Cleveland Ave.	Flow Control:	Not Controlled
City:	Hobart, IN	Year Renewed:	
Location:	Other	Tape/Media #:	
Purpose:	Not Known	Dia/Height:	8"
Use:	Sanitary	Material:	VCP
Drain Area:	NA	Lining:	
Category:	NA		
Comment:

Location Details:		Direction of Survey:	Upstream
US MH:	M-804-010	DS MH:	M-804-011
		Total Length Surveyed (ft):	334.2

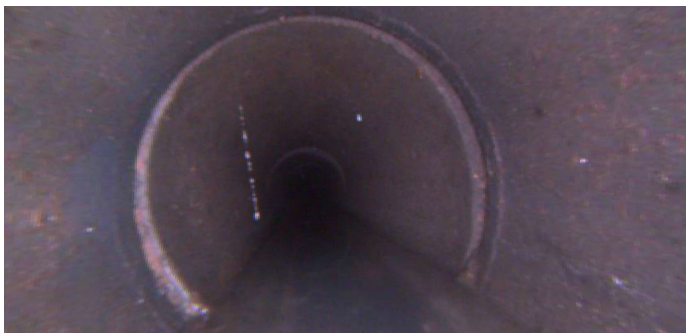
Code: **AMH**
Description: **Manhole**

Distance (ft): **.0**
Structural Grade: **0**
O&M Grade: **0**
Clock Start/From:
Clock To:
1st Value:
2nd Value:
Value Percent:
Continuous Index:
Within 8" of Joint: **NO**
Remarks: **M-804-011**

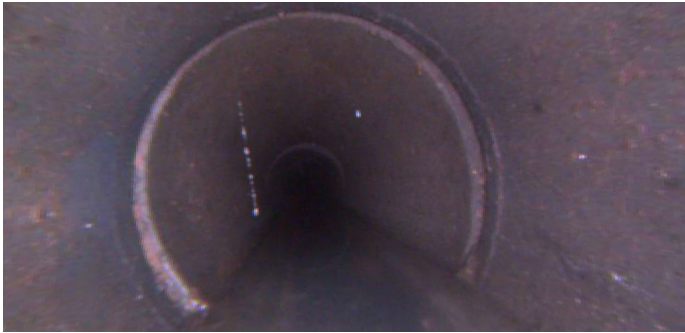
Code:	MWL
Description:	Water Level

Distance (ft):	.0
Structural Grade:	0
O&M Grade:	0
Clock Start/From:	
Clock To:	
1st Value:	
2nd Value:	
Value Percent:	5.000
Continuous Index:	
Within 8" of Joint:	NO
Remarks:

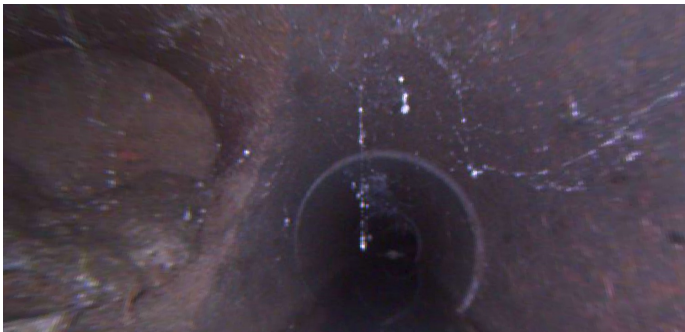
Code:	TFC
Description:	Tap Factory Capped

Distance (ft):	10.7
Structural Grade:	0
O&M Grade:	0
Clock Start/From:	10
Clock To:	
1st Value:	4.000
2nd Value:	
Value Percent:	
Continuous Index:	
Within 8" of Joint:	YES
Remarks:

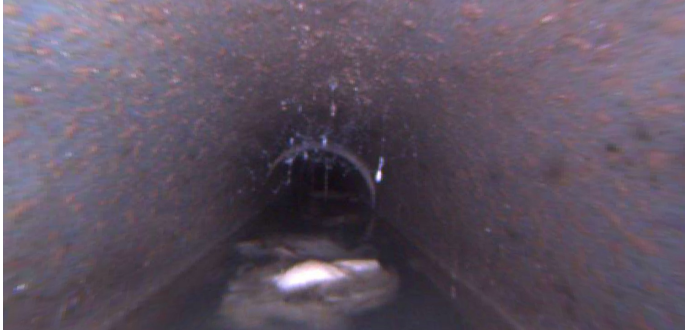
Code: **DSZ**
Description: **Deposits Settled Other**

Distance (ft): **14.0**
Structural Grade: **0**
O&M Grade: **2**
Clock Start/From: **6**
Clock To:
1st Value:
2nd Value:
Value Percent: **5.000**
Continuous Index: **S01**
Within 8" of Joint: **NO**
Remarks: **tissue**

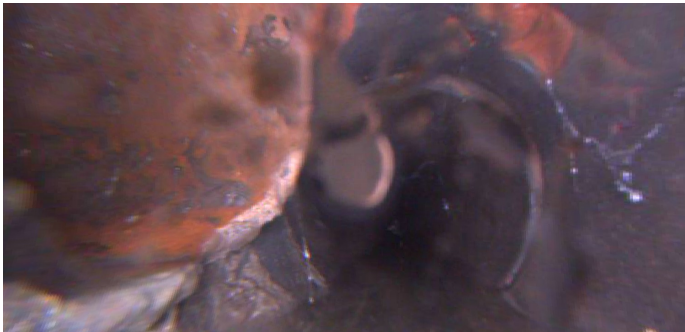
Code: **TB**
Description: **Tap Break-in**

Distance (ft): **19.0**
Structural Grade: **0**
O&M Grade: **0**
Clock Start/From: **9**
Clock To:
1st Value: **8.000**
2nd Value:
Value Percent:
Continuous Index:
Within 8" of Joint: **YES**
Remarks:

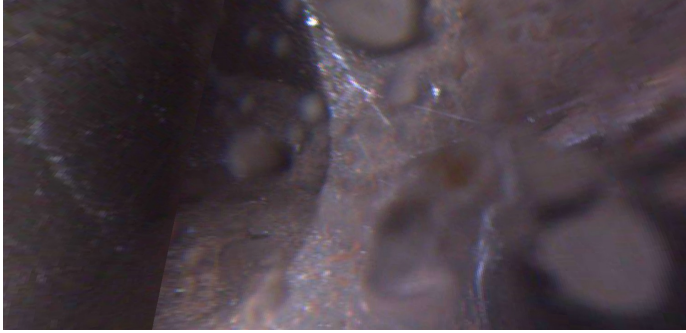
Code: **TF**
Description: **Tap Factory**

Distance (ft): **37.5**
Structural Grade: **0**
O&M Grade: **0**
Clock Start/From: **10**
Clock To:
1st Value: **4.000**
2nd Value:
Value Percent:
Continuous Index:
Within 8" of Joint: **YES**
Remarks:

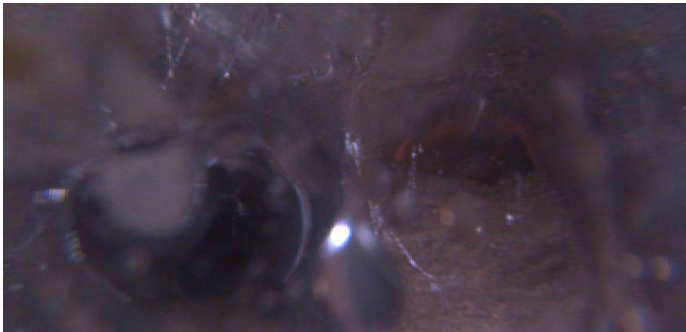
Code: **TFD**
Description: **Tap Factory Defective**

Distance (ft): **53.4**
Structural Grade: **0**
O&M Grade: **2**
Clock Start/From: **2**
Clock To:
1st Value: **4.000**
2nd Value:
Value Percent:
Continuous Index:
Within 8" of Joint: **YES**
Remarks: **blocked by deposits**

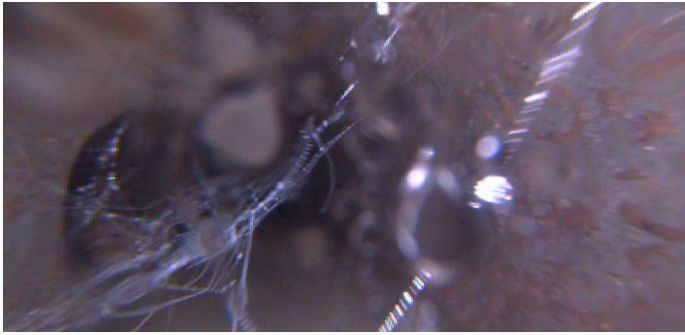
Code: **TF**
Description: **Tap Factory**

Distance (ft): **77.4**
Structural Grade: **0**
O&M Grade: **0**
Clock Start/From: **9**
Clock To:
1st Value: **4.000**
2nd Value:
Value Percent:
Continuous Index:
Within 8" of Joint:
Remarks:

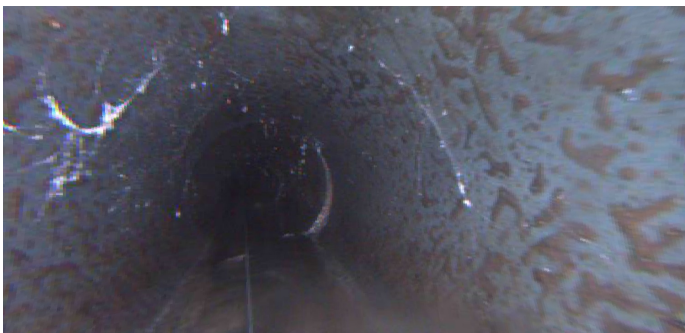
Code: **MGO**
Description: **General Observation**

Distance (ft): **91.1**
Structural Grade: **0**
O&M Grade: **0**
Clock Start/From:
Clock To:
1st Value:
2nd Value:
Value Percent:
Continuous Index:
Within 8" of Joint: **NO**
Remarks: **rear camera/cob webs**

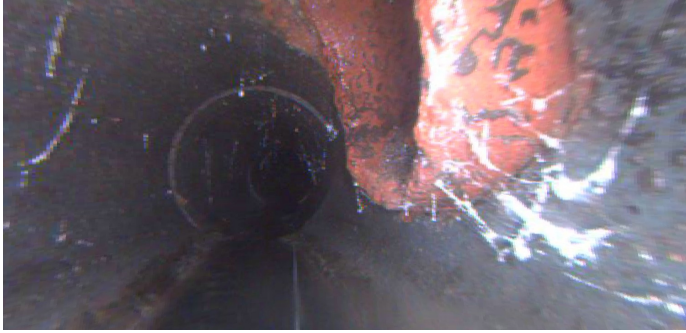
Code: **TB**
Description: **Tap Break-in**

Distance (ft): **97.1**
Structural Grade: **0**
O&M Grade: **0**
Clock Start/From: **10**
Clock To:
1st Value: **8.000**
2nd Value:
Value Percent:
Continuous Index:
Within 8" of Joint:
Remarks:

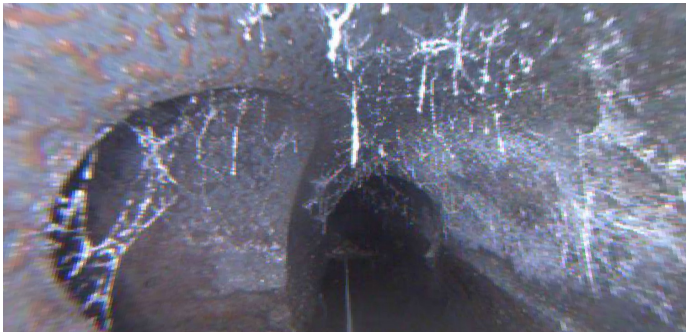
Code: **TF**
Description: **Tap Factory**

Distance (ft): **105.8**
Structural Grade: **0**
O&M Grade: **0**
Clock Start/From: **3**
Clock To:
1st Value: **6.000**
2nd Value:
Value Percent:
Continuous Index:
Within 8" of Joint:
Remarks:

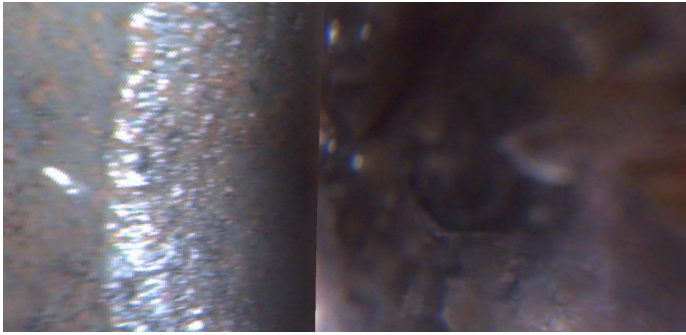
Code: **TF**
Description: **Tap Factory**

Distance (ft): **158.7**
Structural Grade: **0**
O&M Grade: **0**
Clock Start/From: **10**
Clock To:
1st Value: **4.000**
2nd Value:
Value Percent:
Continuous Index:
Within 8" of Joint: **YES**
Remarks:

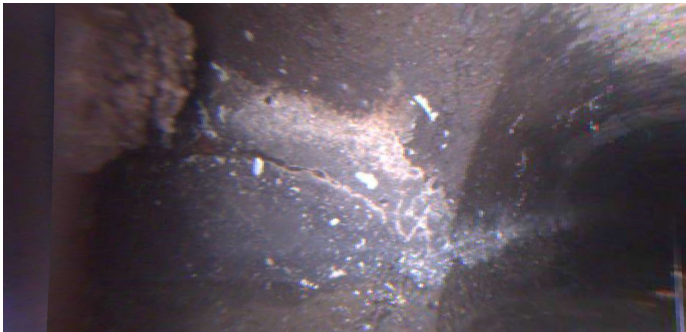
Code: **TFD**
Description: **Tap Factory Defective**

Distance (ft): **196.1**
Structural Grade: **0**
O&M Grade: **2**
Clock Start/From: **3**
Clock To:
1st Value: **4.000**
2nd Value:
Value Percent:
Continuous Index:
Within 8" of Joint:
Remarks: **blocked**

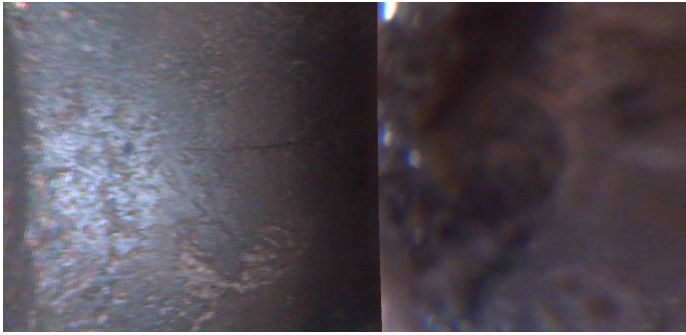
Code: **TF**
Description: **Tap Factory**

Distance (ft): **218.7**
Structural Grade: **0**
O&M Grade: **0**
Clock Start/From: **10**
Clock To:
1st Value: **4.000**
2nd Value:
Value Percent:
Continuous Index:
Within 8" of Joint: **YES**
Remarks:

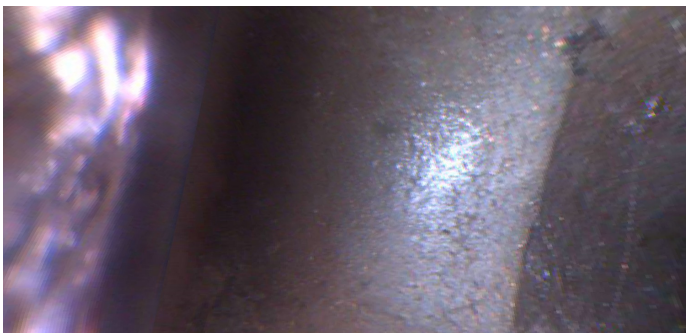
Code: **TF**
Description: **Tap Factory**

Distance (ft): **241.4**
Structural Grade: **0**
O&M Grade: **0**
Clock Start/From: **3**
Clock To:
1st Value: **4.000**
2nd Value:
Value Percent:
Continuous Index:
Within 8" of Joint: **YES**
Remarks:

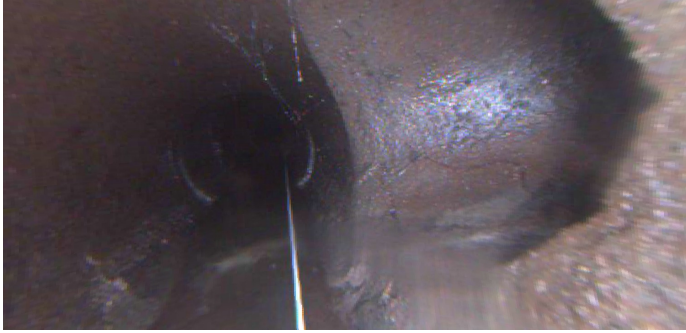
Code: **TF**
Description: **Tap Factory**

Distance (ft): **254.1**
Structural Grade: **0**
O&M Grade: **0**
Clock Start/From: **9**
Clock To:
1st Value: **4.000**
2nd Value:
Value Percent:
Continuous Index:
Within 8" of Joint: **YES**
Remarks:

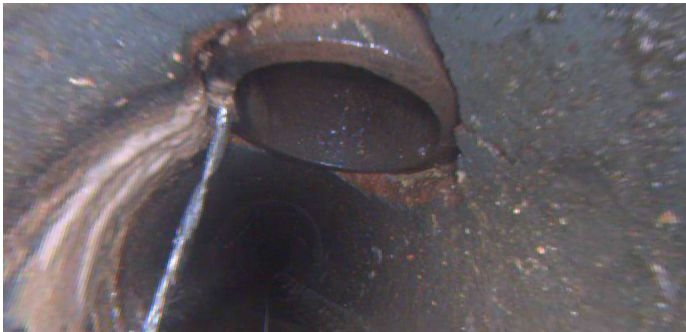
Code: **TBA**
Description: **Tap Break-in Active**

Distance (ft): **262.7**
Structural Grade: **0**
O&M Grade: **0**
Clock Start/From: **12**
Clock To:
1st Value: **4.000**
2nd Value:
Value Percent:
Continuous Index:
Within 8" of Joint:
Remarks:

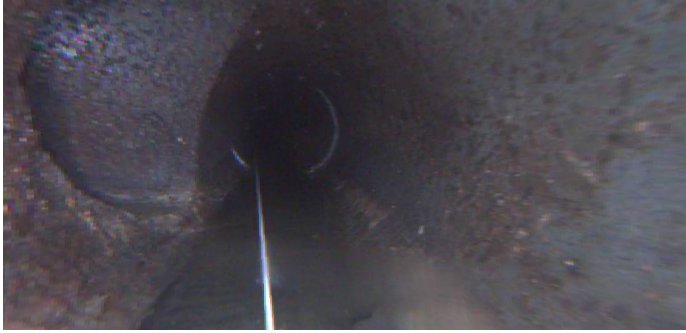
Code: **TF**
Description: **Tap Factory**

Distance (ft): **277.1**
Structural Grade: **0**
O&M Grade: **0**
Clock Start/From: **9**
Clock To:
1st Value: **4.000**
2nd Value:
Value Percent:
Continuous Index:
Within 8" of Joint:
Remarks:

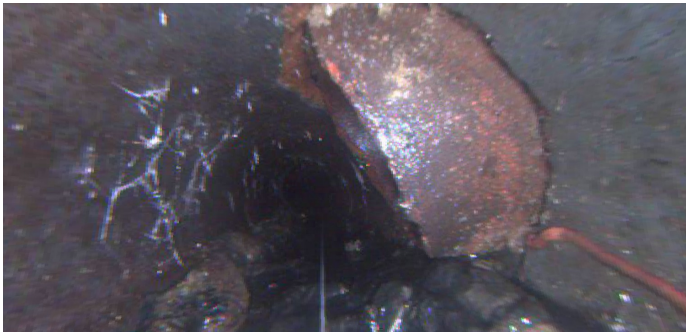
Code: **TBI**
Description: **Tap Break-in Intruding**

Distance (ft): **305.2**
Structural Grade: **0**
O&M Grade: **2**
Clock Start/From: **3**
Clock To:
1st Value: **6.000**
2nd Value: **2.000**
Value Percent:
Continuous Index:
Within 8" of Joint:
Remarks:

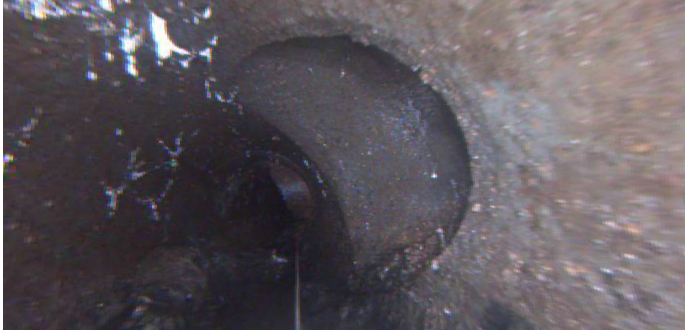
Code: **TF**
Description: **Tap Factory**

Distance (ft): **307.0**
Structural Grade: **0**
O&M Grade: **0**
Clock Start/From: **9**
Clock To:
1st Value: **4.000**
2nd Value:
Value Percent:
Continuous Index:
Within 8" of Joint:
Remarks:

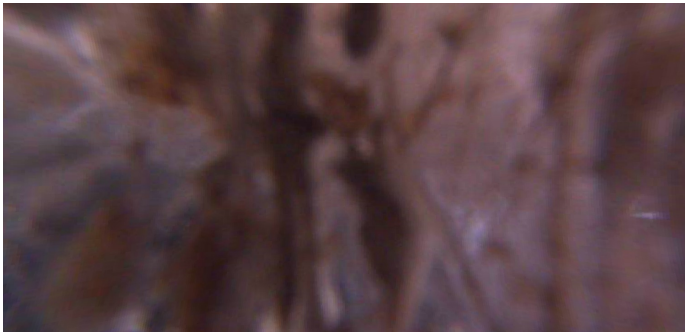
Code: **MSA**
Description: **Abandoned Survey**

Distance (ft): **334.2**
Structural Grade: **0**
O&M Grade: **0**
Clock Start/From:
Clock To:
1st Value:
2nd Value:
Value Percent:
Continuous Index:
Within 8" of Joint: **NO**
Remarks: **camera stopped reason unknown**

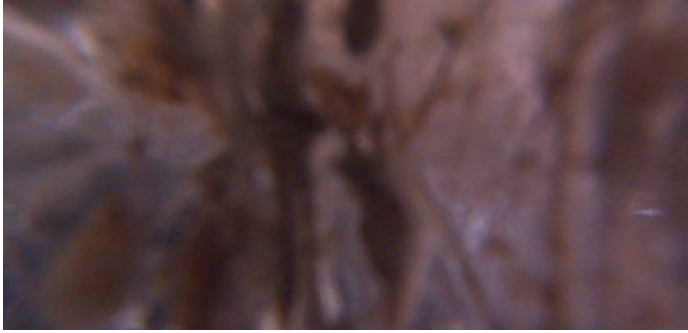
Code:	DSZ
Description:	Deposits Settled Other
Distance (ft):	334.2
Structural Grade:	0
O&M Grade:	2
Clock Start/From:	6
Clock To:	
1st Value:	
2nd Value:	
Value Percent:	5.000
Continuous Index:	F01
Within 8" of Joint:	NO
Remarks:	tissue
