Profile/Photo Observation Report

Street:	East Cleveland Avenue	Flow Control:	Not Controlled
City:	Hobart, IN	Year Renewed:	
Location:	Local rural streets with light traffic, t	Tape/Media #:	
Purpose:	Routine Assessment	Dia/Height:	8"
Use:	Sanitary Sewage Pipe	Material:	VCP
Drain Area:		Lining:	None
Category:	NA		
Comment:			
Location Details:		Direction of Survey:	Upstream
US MH:	M-804-010	DS MH:	M-804-011
		Total Length Surveyed (ft):	305.4

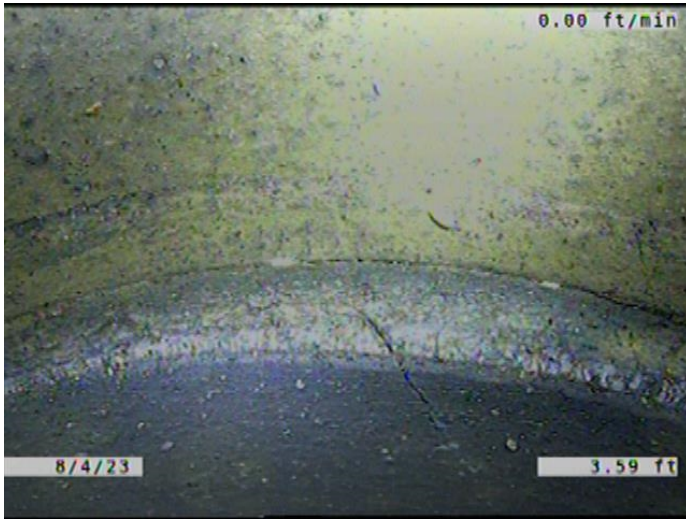
Code: **JOMD**
Description: **Joint Offset Medium Defective**

Distance (ft): **3.6**
Structural Grade: **3**
O&M Grade: **0**
Clock Start/From:
Clock To:
1st Value:
2nd Value:
Value Percent:
Continuous Index:
Within 8" of Joint: **NO**
Remarks:

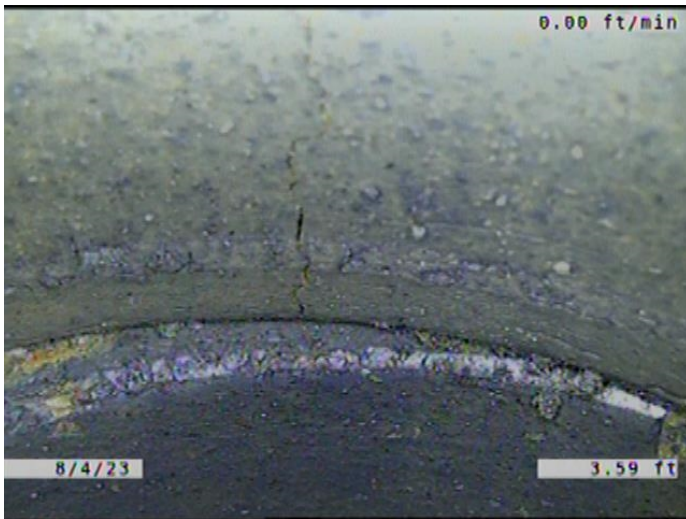
Code: **CM**
Description: **Crack Multiple**

Distance (ft): **3.6**
Structural Grade: **3**
O&M Grade: **0**
Clock Start/From: **12**
Clock To: **12**
1st Value:
2nd Value:
Value Percent:
Continuous Index:
Within 8" of Joint: **YES**
Remarks:

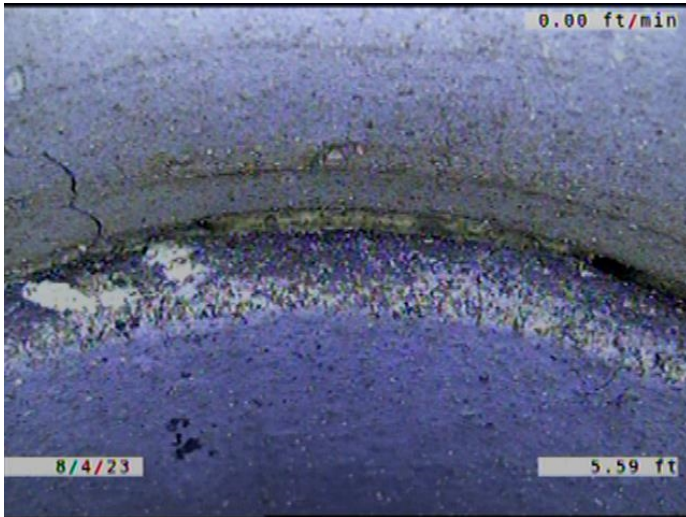
Code: **JOMD**
Description: **Joint Offset Medium Defective**

Distance (ft): **5.6**
Structural Grade: **3**
O&M Grade: **0**
Clock Start/From:
Clock To:
1st Value:
2nd Value:
Value Percent:
Continuous Index:
Within 8" of Joint: **NO**
Remarks: **SOIL AND VOID VISIBLE.**

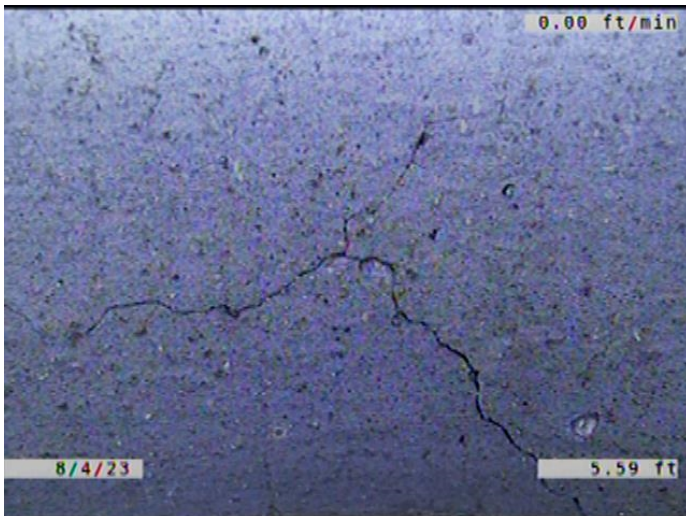
Code: **CM**
Description: **Crack Multiple**

Distance (ft): **5.6**
Structural Grade: **3**
O&M Grade: **0**
Clock Start/From: **12**
Clock To: **12**
1st Value:
2nd Value:
Value Percent:
Continuous Index:
Within 8" of Joint: **YES**
Remarks:

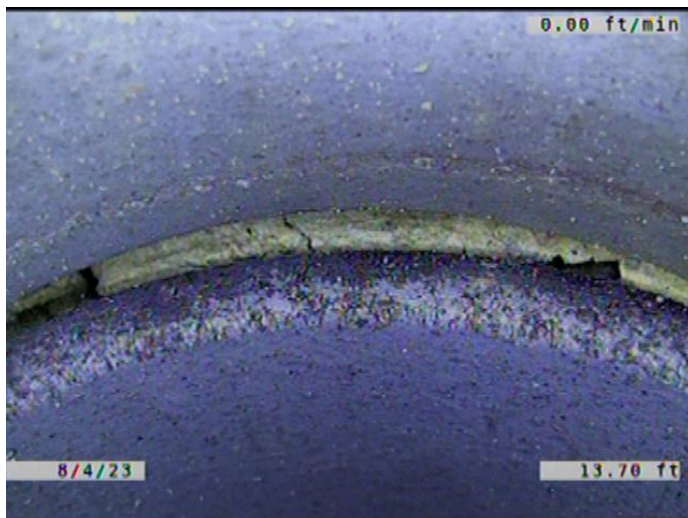
Code: **JOMD**
Description: **Joint Offset Medium Defective**

Distance (ft): **13.7**
Structural Grade: **3**
O&M Grade: **0**
Clock Start/From:
Clock To:
1st Value:
2nd Value:
Value Percent:
Continuous Index: **S02**
Within 8" of Joint: **NO**
Remarks: **VOID AND SOIL VISIBLE.**

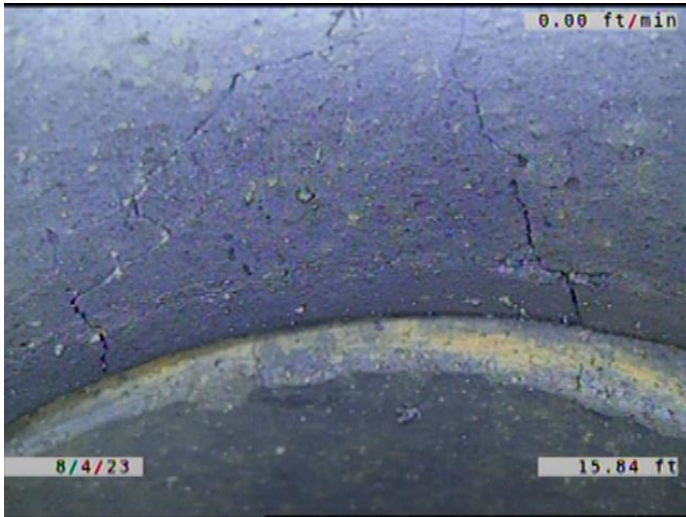
Code: **CM**
Description: **Crack Multiple**

Distance (ft): **15.8**
Structural Grade: **3**
O&M Grade: **0**
Clock Start/From: **8**
Clock To: **4**
1st Value:
2nd Value:
Value Percent:
Continuous Index: **S03**
Within 8" of Joint: **YES**
Remarks:

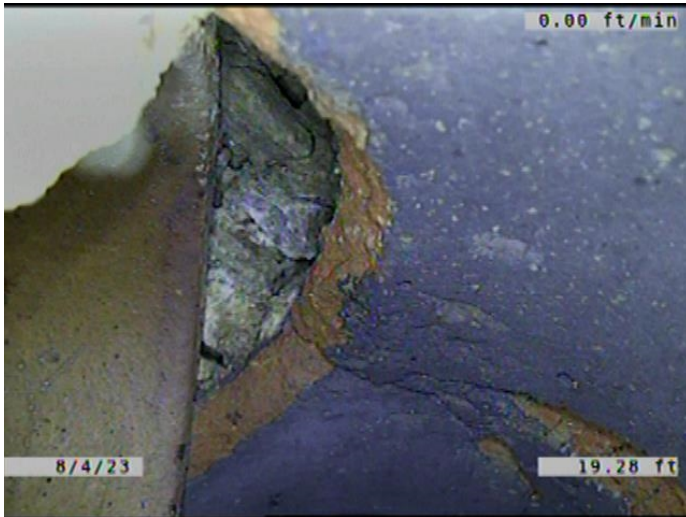
Code: **BVV**
Description: **Broken Void Visible**

Distance (ft): **19.3**
Structural Grade: **5**
O&M Grade: **0**
Clock Start/From: **9**
Clock To: **1**
1st Value:
2nd Value:
Value Percent:
Continuous Index:
Within 8" of Joint: **YES**
Remarks: **SOIL VISIBLE ALSO.**

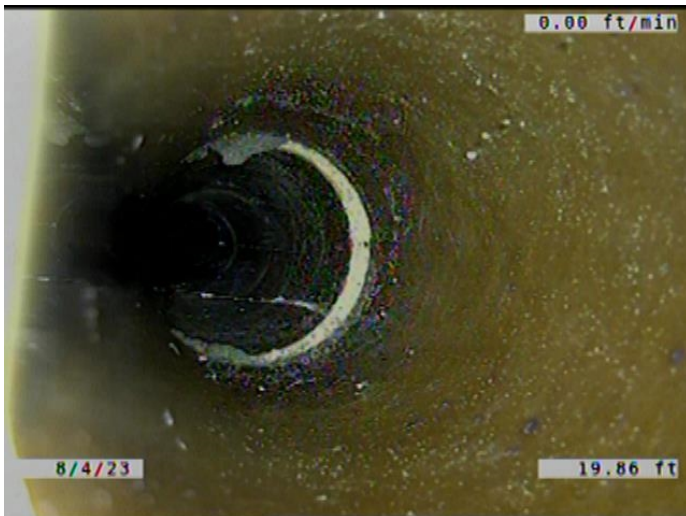
Code: **TBI**
Description: **Tap Break-in Intruding**

Distance (ft): **19.9**
Structural Grade: **0**
O&M Grade: **2**
Clock Start/From: **10**
Clock To:
1st Value: **6.000**
2nd Value: **2.000**
Value Percent:
Continuous Index:
Within 8" of Joint: **YES**
Remarks:

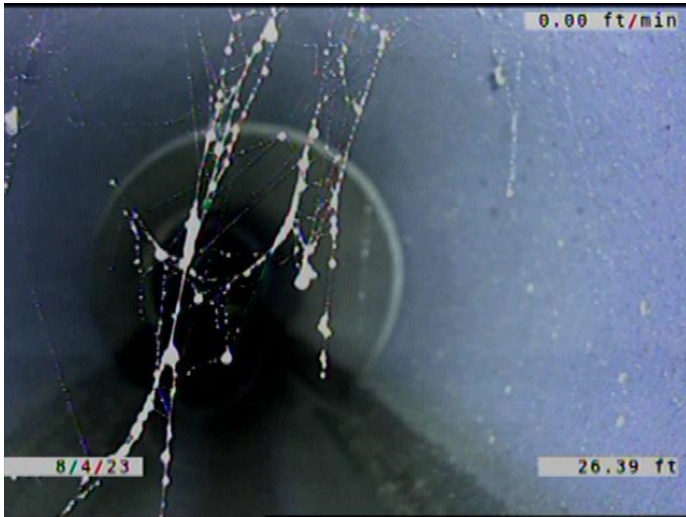
Code: **CM**
Description: **Crack Multiple**

Distance (ft): **26.4**
Structural Grade: **3**
O&M Grade: **0**
Clock Start/From: **8**
Clock To: **4**
1st Value:
2nd Value:
Value Percent:
Continuous Index: **F03**
Within 8" of Joint: **YES**
Remarks:

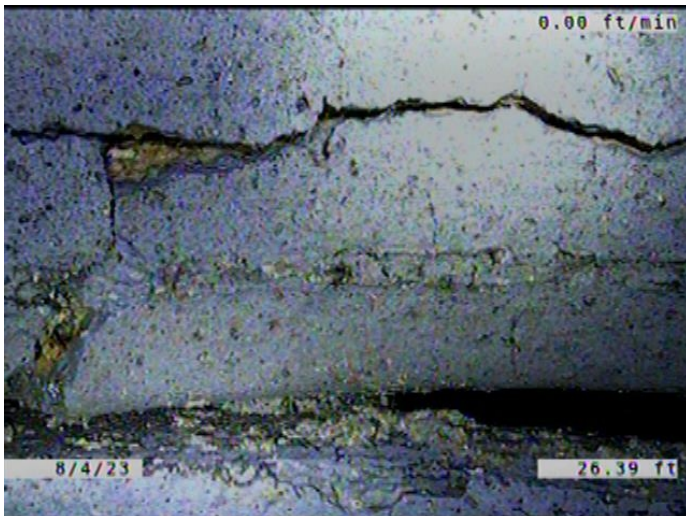
Code: **B**
Description: **Broken**

Distance (ft): **26.4**
Structural Grade: **4**
O&M Grade: **0**
Clock Start/From: **7**
Clock To: **5**
1st Value:
2nd Value:
Value Percent:
Continuous Index: **S04**
Within 8" of Joint: **YES**
Remarks: **At joints**

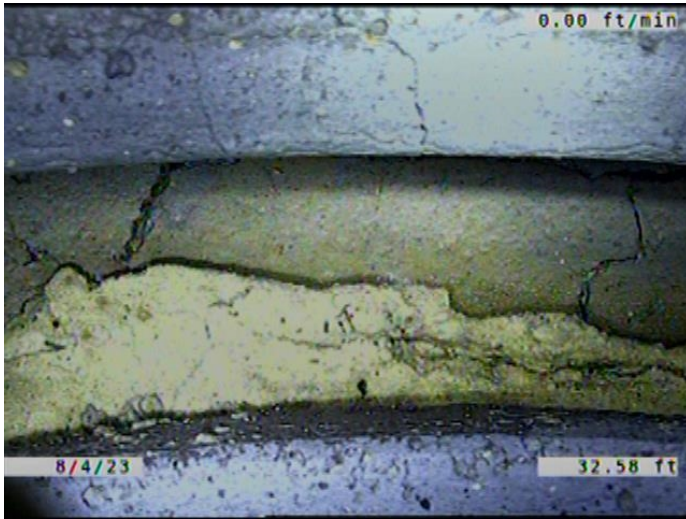
Code: **JAL**
Description: **Joint Angular Large**

Distance (ft): **32.6**
Structural Grade: **4**
O&M Grade: **0**
Clock Start/From:
Clock To:
1st Value:
2nd Value:
Value Percent:
Continuous Index:
Within 8" of Joint: **NO**
Remarks:

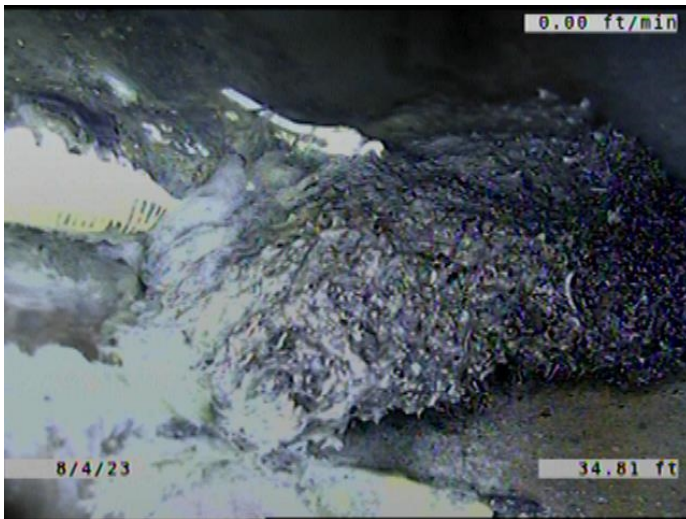
Code: **OBZ**
Description: **Obstruction Other**

Distance (ft): **34.8**
Structural Grade: **0**
O&M Grade: **2**
Clock Start/From: **4**
Clock To: **7**
1st Value:
2nd Value:
Value Percent: **5.000**
Continuous Index:
Within 8" of Joint: **NO**
Remarks: **ROOTS THAT HAVE BEEN CUT. LOOKS LIKE PLASTIC CLOTHES PINS.**

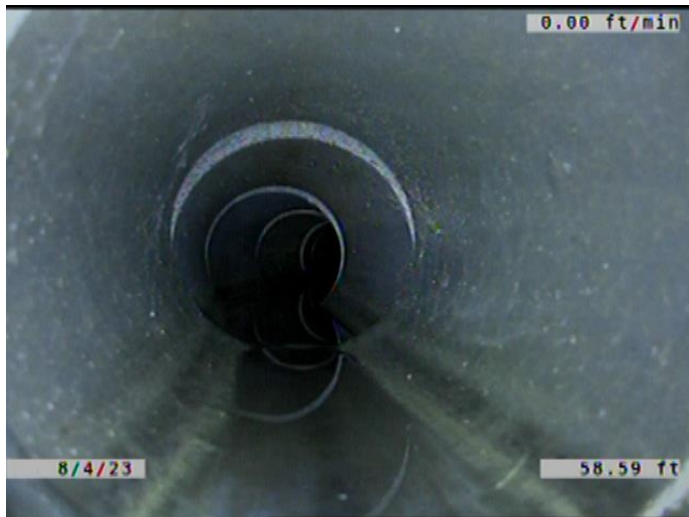
Code: **TF**
Description: **Tap Factory**

Distance (ft): **54.2**
Structural Grade: **0**
O&M Grade: **0**
Clock Start/From: **2**
Clock To:
1st Value: **6.000**
2nd Value:
Value Percent:
Continuous Index:
Within 8" of Joint: **YES**
Remarks: **75% PLUGGED WITH DIRT.**

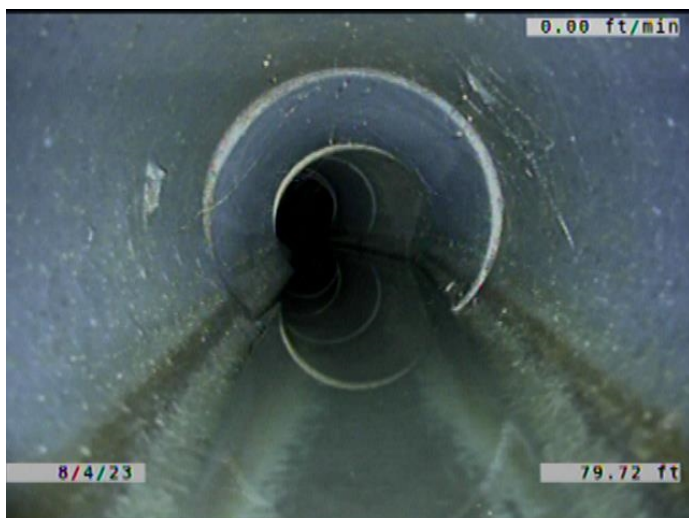
Code: **TF**
Description: **Tap Factory**

Distance (ft): **78.9**
Structural Grade: **0**
O&M Grade: **0**
Clock Start/From: **10**
Clock To:
1st Value: **6.000**
2nd Value:
Value Percent:
Continuous Index:
Within 8" of Joint: **YES**
Remarks: **SERVICE ANGLED. SOIL AND VOID VISIBLE.**

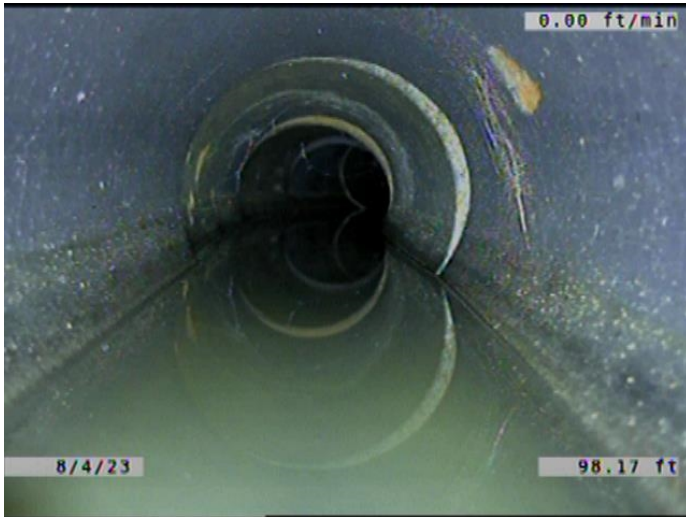
Code: **TBI**
Description: **Tap Break-in Intruding**

Distance (ft): **97.4**
Structural Grade: **0**
O&M Grade: **2**
Clock Start/From: **10**
Clock To:
1st Value: **6.000**
2nd Value: **2.000**
Value Percent:
Continuous Index:
Within 8" of Joint: **YES**
Remarks: **SERVICE BROKEN.**

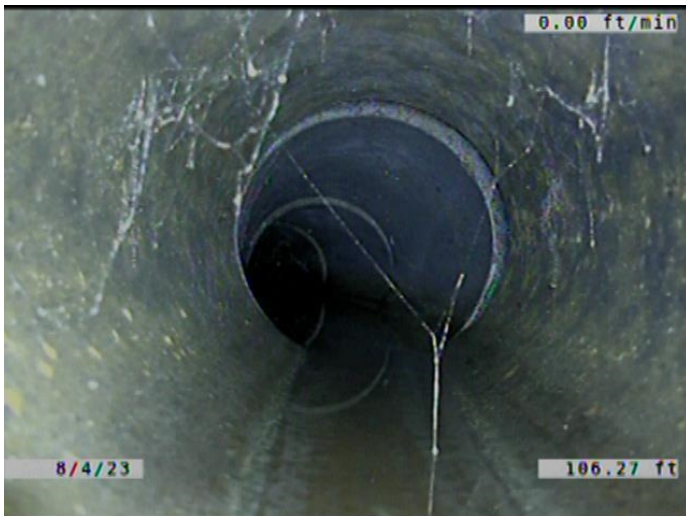
Code:	TFD
Description:	Tap Factory Defective
Distance (ft):	105.7
Structural Grade:	0
O&M Grade:	3
Clock Start/From:	2
Clock To:	
1st Value:	6.000
2nd Value:	
Value Percent:	
Continuous Index:	
Within 8" of Joint:	YES
Remarks:	TAP BROKEN. SERVICE BROKEN. SOIL VISIBLE.

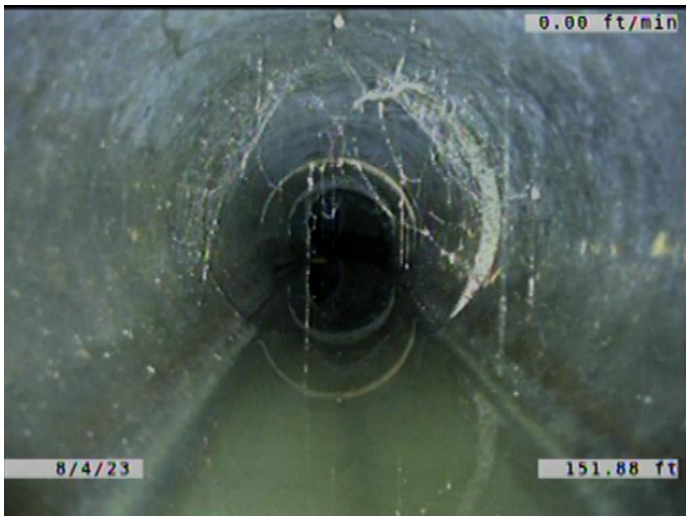
Code: **TFD**
Description: **Tap Factory Defective**

Distance (ft): **142.6**
Structural Grade: **0**
O&M Grade: **3**
Clock Start/From: **2**
Clock To:
1st Value: **6.000**
2nd Value:
Value Percent:
Continuous Index:
Within 8" of Joint: **YES**
Remarks: **100% PLUGGED WITH ROOTS.**

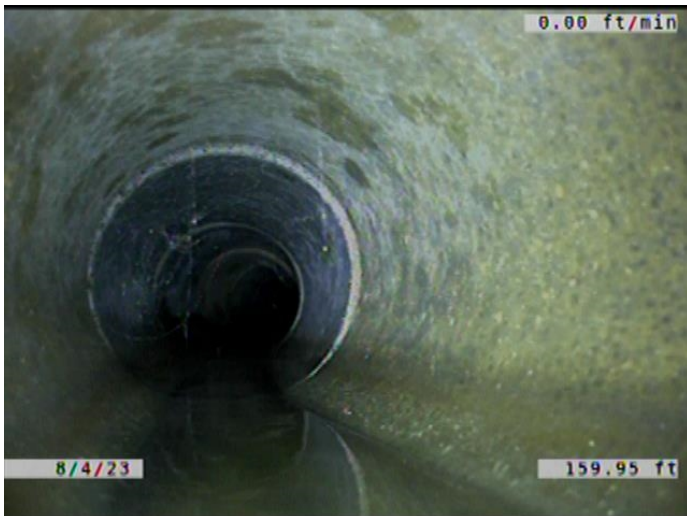
Code:	TFD
Description:	Tap Factory Defective
Distance (ft):	159.2
Structural Grade:	0
O&M Grade:	3
Clock Start/From:	10
Clock To:	
1st Value:	6.000
2nd Value:	
Value Percent:	
Continuous Index:	
Within 8" of Joint:	YES
Remarks:	TAP BROKEN. SERVICE ANGLED. SOIL VISIBLE.

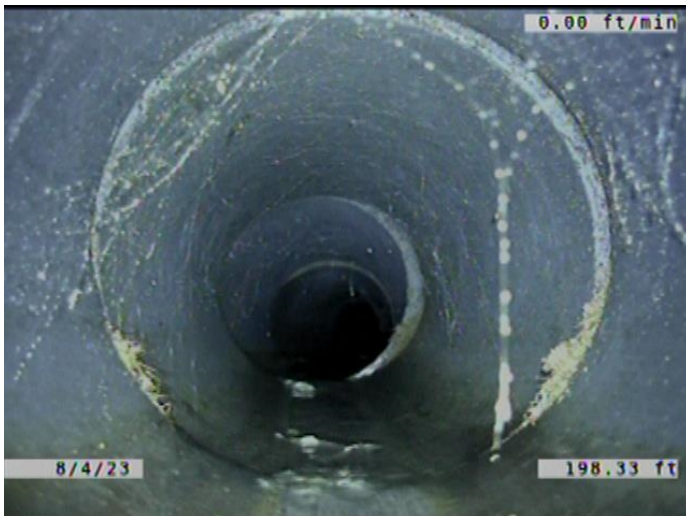
Code:	TFD
Description:	Tap Factory Defective
Distance (ft):	196.5
Structural Grade:	0
O&M Grade:	3
Clock Start/From:	2
Clock To:	
1st Value:	6.000
2nd Value:	
Value Percent:	
Continuous Index:	
Within 8" of Joint:	YES
Remarks:	TAP BROKEN. SERVICE OFFSET. SOIL VISIBLE.

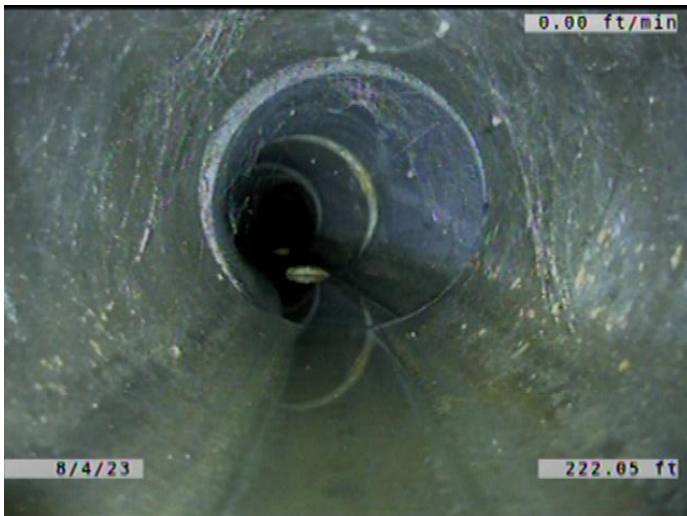
Code:	TFD
Description:	Tap Factory Defective
Distance (ft):	219.3
Structural Grade:	0
O&M Grade:	3
Clock Start/From:	10
Clock To:	
1st Value:	6.000
2nd Value:	
Value Percent:	
Continuous Index:	
Within 8" of Joint:	YES
Remarks:	TAP BROKEN. ROOTS GROWING FROM THE SERVICE TO MAIN CONN

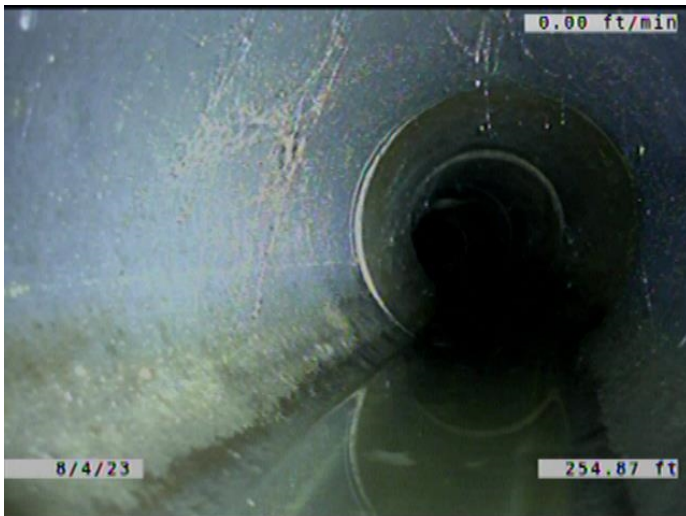
Code:	TFD
Description:	Tap Factory Defective
Distance (ft):	254.0
Structural Grade:	0
O&M Grade:	3
Clock Start/From:	10
Clock To:	
1st Value:	6.000
2nd Value:	
Value Percent:	
Continuous Index:	
Within 8" of Joint:	YES
Remarks:	TAP BROKEN. SERVICE OFFSET. SOIL VISIBLE.

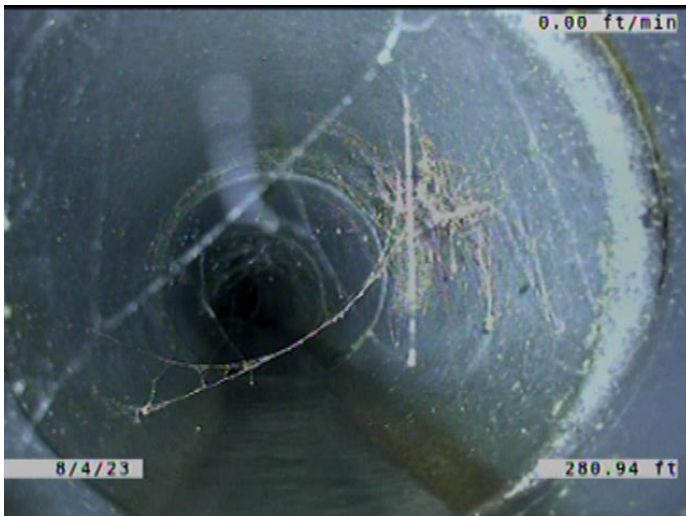
Code: **TFD**
Description: **Tap Factory Defective**

Distance (ft): **276.9**
Structural Grade: **0**
O&M Grade: **3**
Clock Start/From: **2**
Clock To:
1st Value: **6.000**
2nd Value:
Value Percent:
Continuous Index:
Within 8" of Joint: **YES**
Remarks: **TAP BROKEN. ACTIVITY**
