Profile/Photo Observation Report

Date:	08/04/2023	Weather:		Coding:	PACP 7.0
Pipe Length (ft):	414.0	Owner:	City of Hobart	Pre Clean:	Heavy Cleaning
P.O.#:	YES502259	Surveyor:	S. Bucklin	PSR:	P-804-010-011
Customer:	City of Hobart	Clean Date:	11/15/2022	Shape:	C

Street:	East Cleveland Avenue	Flow Control:	Not Controlled
City:	Hobart, IN	Year Renewed:	
Location:	Local rural streets with light traffic, t	Tape/Media #:	
Purpose:	Routine Assessment	Dia/Height:	8"
Use:	Sanitary Sewage Pipe	Material:	VCP
Drain Area:		Lining:	None
Category:	NA		
Comment:			
Location Details:		Direction of Survey:	Downstream
US MH:	M-804-010	DS MH:	M-804-011
		Total Length Surveyed (ft):	106.0

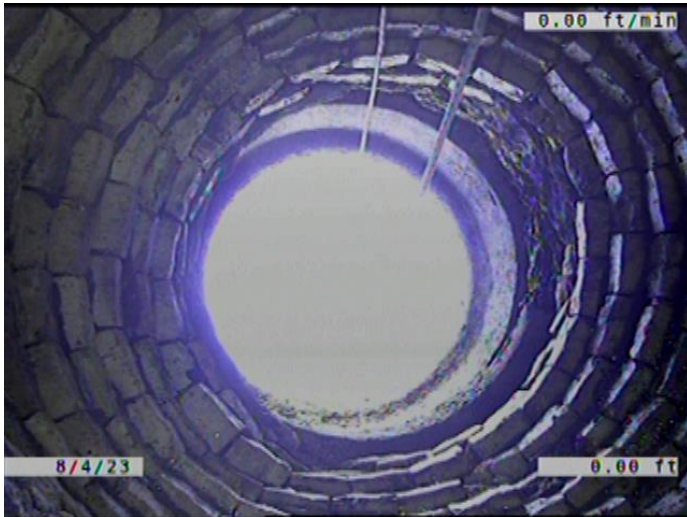
Code: **AMH**
Description: **Manhole**

Distance (ft): **.0**
Structural Grade: **0**
O&M Grade: **0**
Clock Start/From:
Clock To:
1st Value:
2nd Value:
Value Percent:
Continuous Index:
Within 8" of Joint: **NO**
Remarks: **M-804-010**

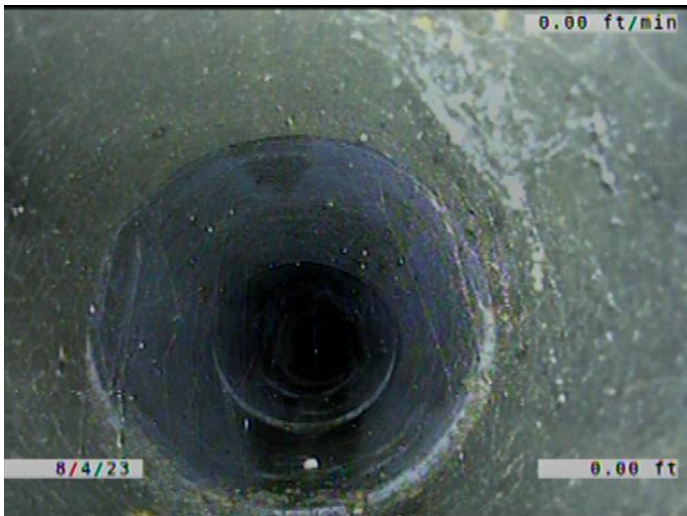
Code: **MWL**
Description: **Miscellaneous Water Level**

Distance (ft): **.0**
Structural Grade: **0**
O&M Grade: **0**
Clock Start/From:
Clock To:
1st Value:
2nd Value:
Value Percent: **5.000**
Continuous Index:
Within 8" of Joint: **NO**
Remarks:

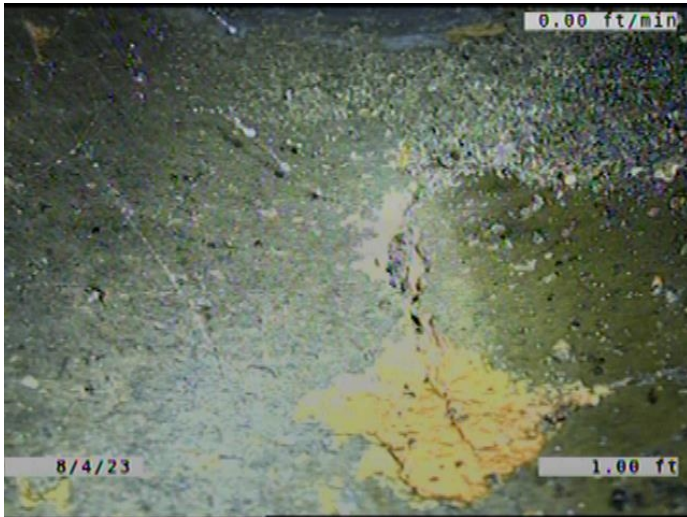
Code: **B**
 Description: **Broken**

Distance (ft): **1.0**
 Structural Grade: **4**
 O&M Grade: **0**
 Clock Start/From: **4**
 Clock To: **8**
 1st Value:
 2nd Value:
 Value Percent:
 Continuous Index:
 Within 8" of Joint: **YES**
 Remarks:

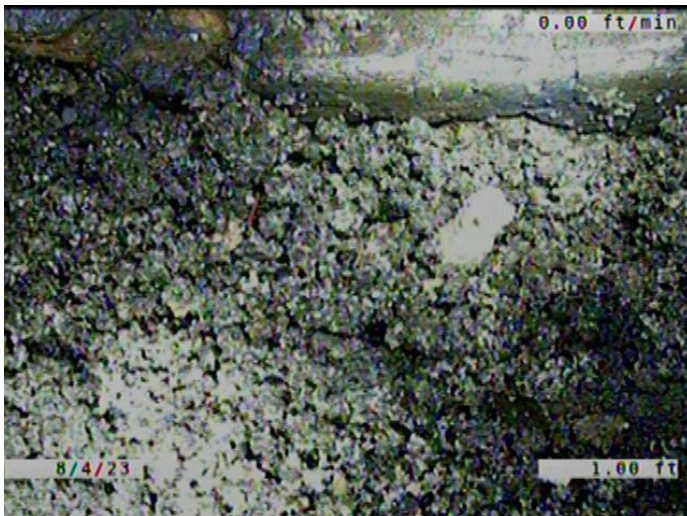
Code: **DSF**
 Description: **Deposits Settled Fine**

Distance (ft): **1.0**
 Structural Grade: **0**
 O&M Grade: **2**
 Clock Start/From: **5**
 Clock To: **7**
 1st Value:
 2nd Value:
 Value Percent: **5.000**
 Continuous Index: **S01**
 Within 8" of Joint: **YES**
 Remarks:

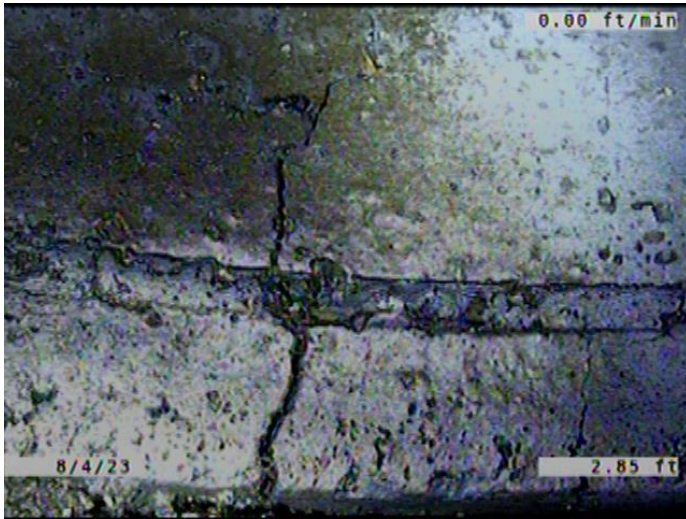
Code: **CM**
Description: **Crack Multiple**

Distance (ft): **2.8**
Structural Grade: **3**
O&M Grade: **0**
Clock Start/From: **5**
Clock To: **6**
1st Value:
2nd Value:
Value Percent:
Continuous Index:
Within 8" of Joint: **YES**
Remarks:

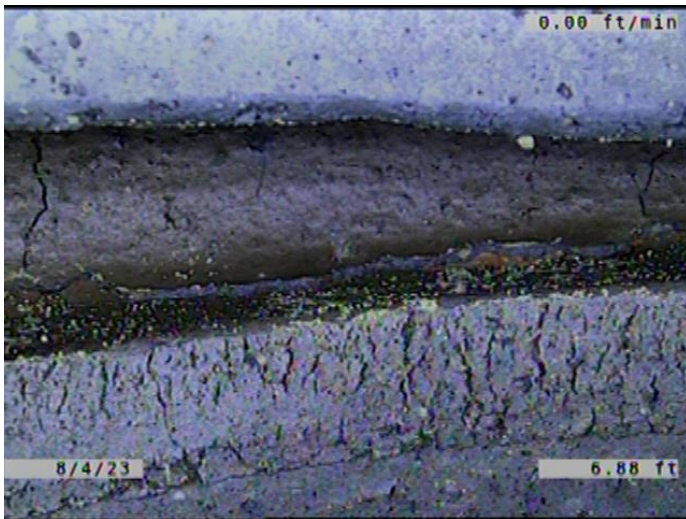
Code: **FM**
Description: **Fracture Multiple**

Distance (ft): **6.9**
Structural Grade: **4**
O&M Grade: **0**
Clock Start/From: **12**
Clock To: **12**
1st Value:
2nd Value:
Value Percent:
Continuous Index: **S02**
Within 8" of Joint: **YES**
Remarks:

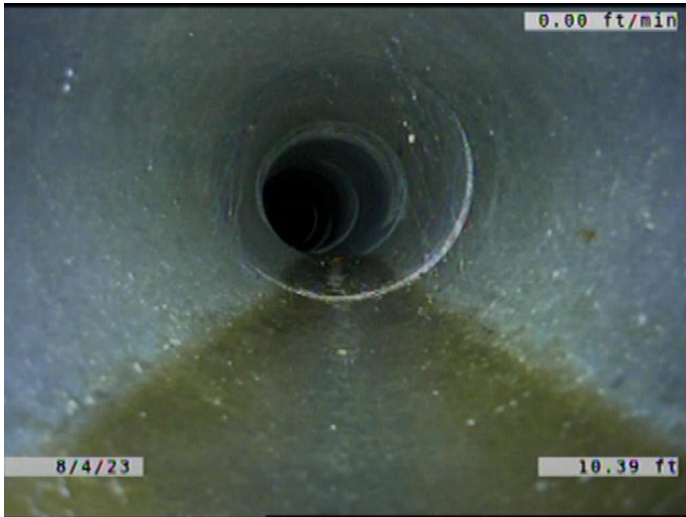
Code: **MWLS**
Description: **Miscellaneous Water Level Sag**

Distance (ft): **10.4**
Structural Grade: **2**
O&M Grade: **0**
Clock Start/From:
Clock To:
1st Value:
2nd Value:
Value Percent: **5.000**
Continuous Index:
Within 8" of Joint: **NO**
Remarks:

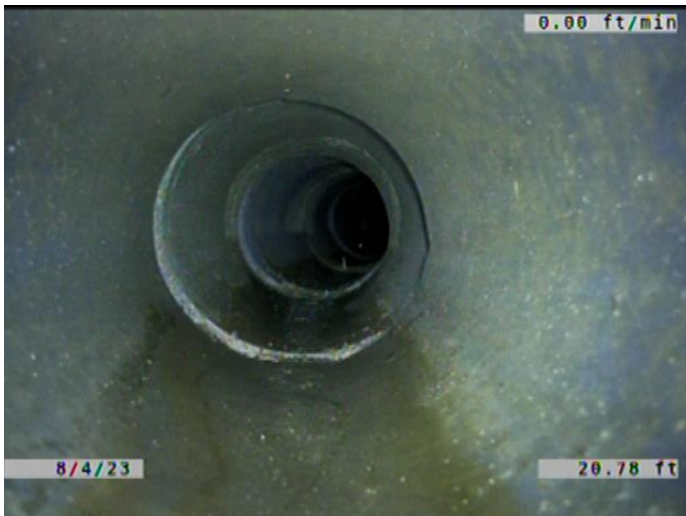
Code: **LL**
Description: **Line Left**

Distance (ft): **20.8**
Structural Grade: **0**
O&M Grade: **1**
Clock Start/From:
Clock To:
1st Value:
2nd Value:
Value Percent: **5.000**
Continuous Index:
Within 8" of Joint: **NO**
Remarks:

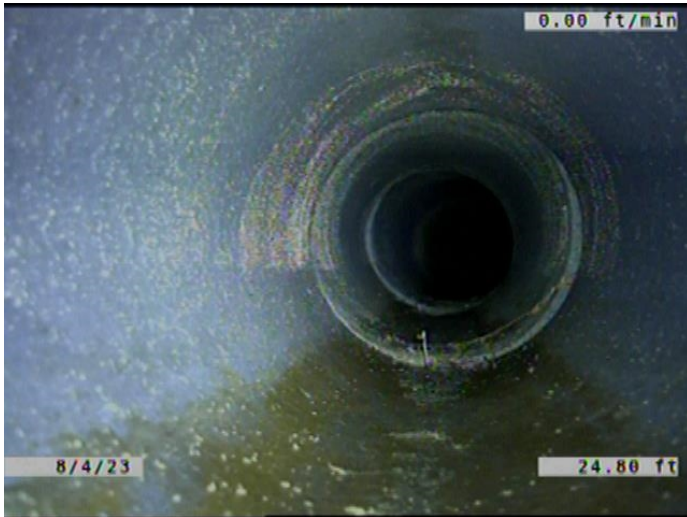
Code: **LR**
Description: **Line Right**

Distance (ft): **24.8**
Structural Grade: **0**
O&M Grade: **1**
Clock Start/From:
Clock To:
1st Value:
2nd Value:
Value Percent: **10.000**
Continuous Index:
Within 8" of Joint: **NO**
Remarks:

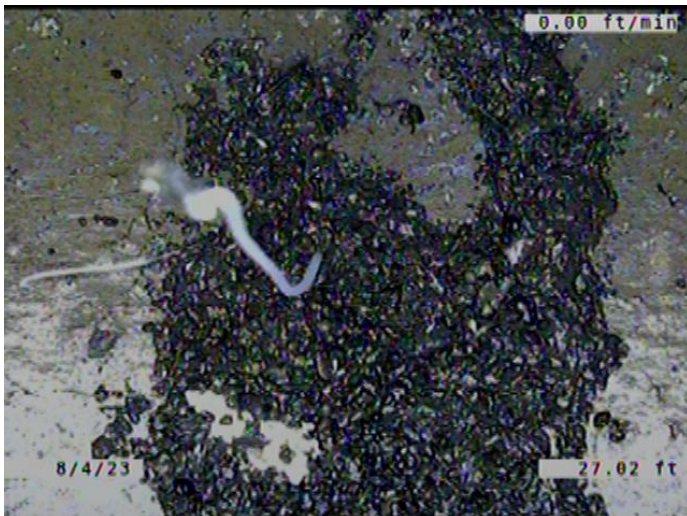
Code: **RFB**
Description: **Roots Fine Barrel**

Distance (ft): **27.0**
Structural Grade: **0**
O&M Grade: **2**
Clock Start/From: **6**
Clock To:
1st Value:
2nd Value:
Value Percent:
Continuous Index:
Within 8" of Joint: **NO**
Remarks:

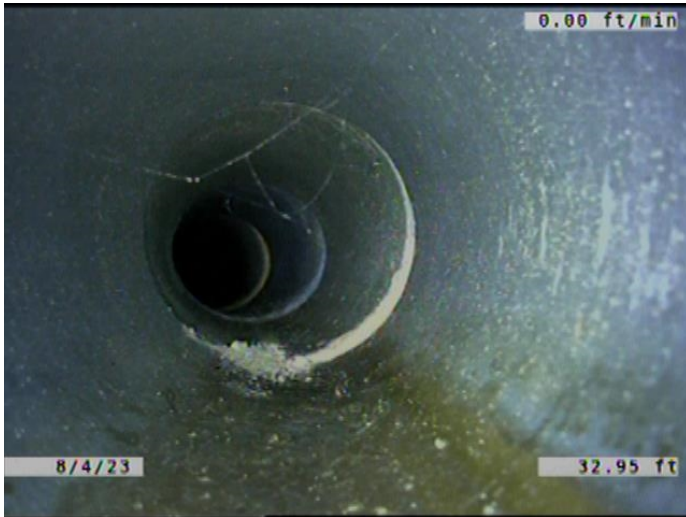
Code: **LL**
Description: **Line Left**

Distance (ft): **32.9**
Structural Grade: **0**
O&M Grade: **1**
Clock Start/From:
Clock To:
1st Value:
2nd Value:
Value Percent: **10.000**
Continuous Index:
Within 8" of Joint: **NO**
Remarks:

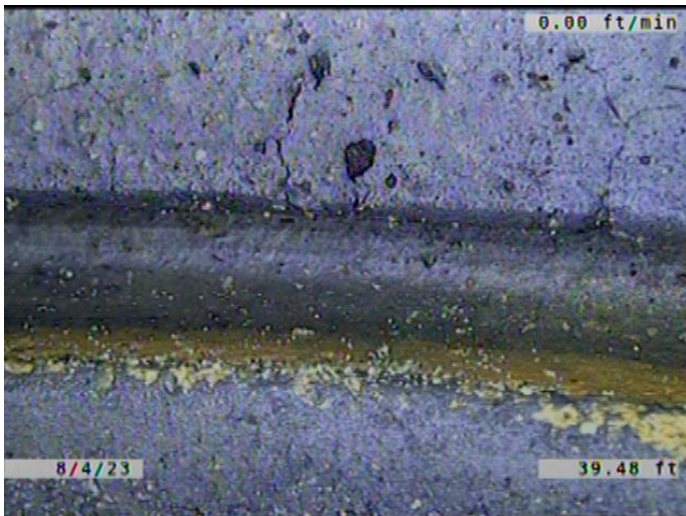
Code: **JAM**
Description: **Joint Angular Medium**

Distance (ft): **39.5**
Structural Grade: **3**
O&M Grade: **0**
Clock Start/From:
Clock To:
1st Value:
2nd Value:
Value Percent:
Continuous Index:
Within 8" of Joint: **NO**
Remarks:

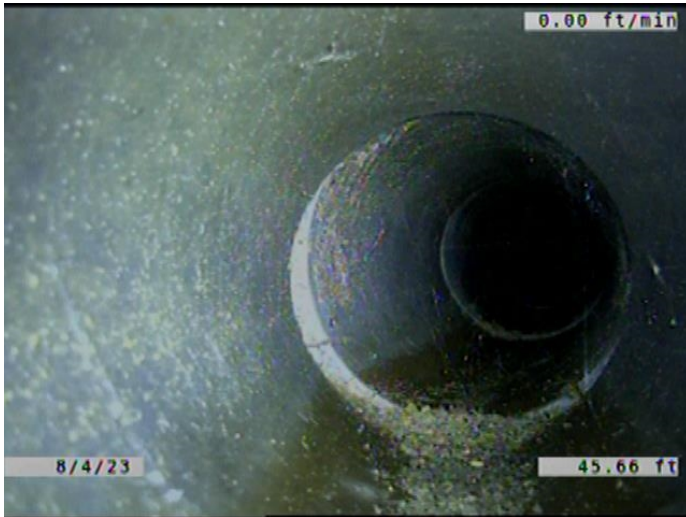
Code: **LR**
Description: **Line Right**

Distance (ft): **45.7**
Structural Grade: **0**
O&M Grade: **1**
Clock Start/From:
Clock To:
1st Value:
2nd Value:
Value Percent: **10.000**
Continuous Index:
Within 8" of Joint: **NO**
Remarks:

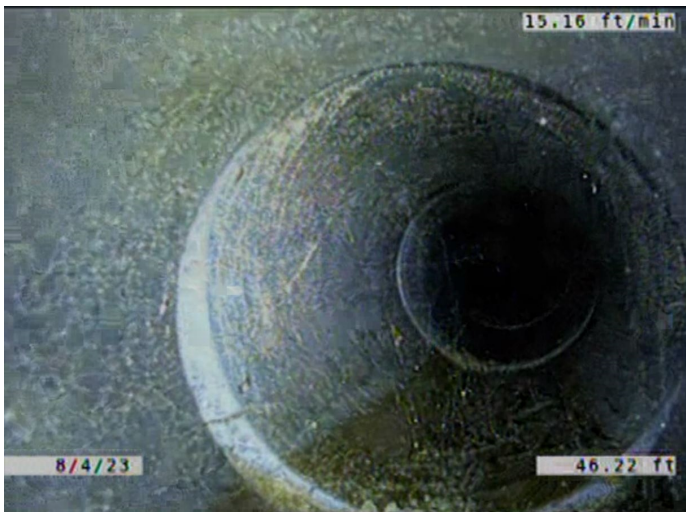
Code: **FM**
Description: **Fracture Multiple**

Distance (ft): **46.2**
Structural Grade: **4**
O&M Grade: **0**
Clock Start/From: **12**
Clock To: **12**
1st Value:
2nd Value:
Value Percent:
Continuous Index: **F02**
Within 8" of Joint: **YES**
Remarks:

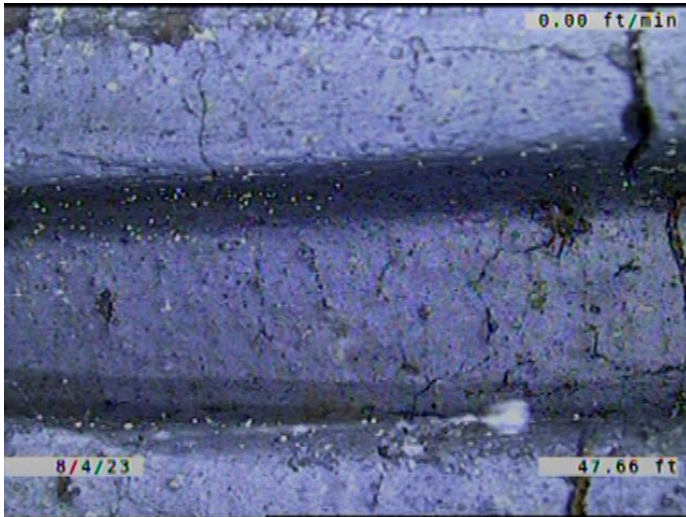
Code: **JAL**
Description: **Joint Angular Large**

Distance (ft): **47.7**
Structural Grade: **4**
O&M Grade: **0**
Clock Start/From:
Clock To:
1st Value:
2nd Value:
Value Percent:
Continuous Index:
Within 8" of Joint: **NO**
Remarks:

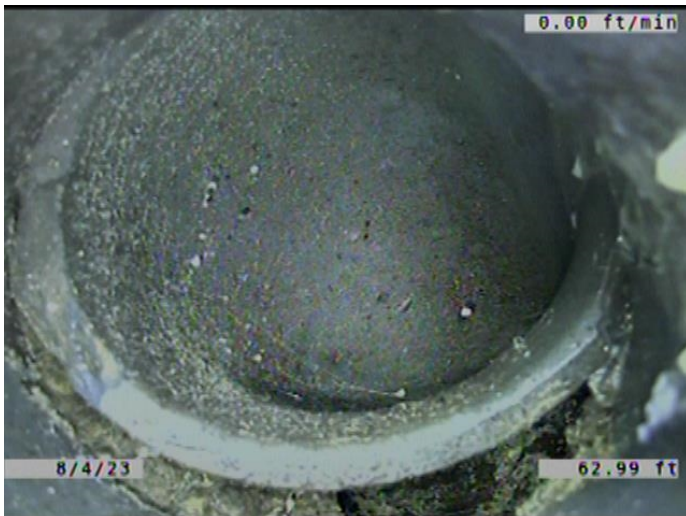
Code: **TFD**
Description: **Tap Factory Defective**

Distance (ft): **63.0**
Structural Grade: **0**
O&M Grade: **3**
Clock Start/From: **2**
Clock To:
1st Value: **6.000**
2nd Value:
Value Percent:
Continuous Index:
Within 8" of Joint: **YES**
Remarks: **TAP BROKEN. SERVICE BROKEN.,
SERVICE OFFSET. SOIL AND VOID VIS**

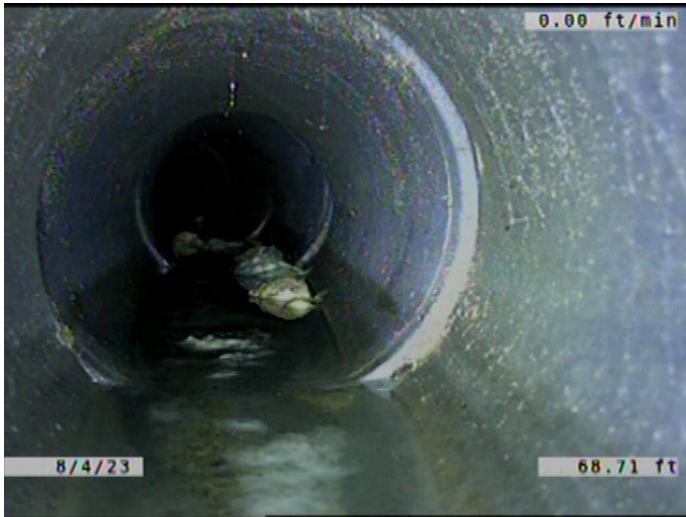
Code: **LL**
 Description: **Line Left**

Distance (ft): **68.7**
 Structural Grade: **0**
 O&M Grade: **1**
 Clock Start/From:
 Clock To:
 1st Value:
 2nd Value:
 Value Percent: **5.000**
 Continuous Index:
 Within 8" of Joint: **NO**
 Remarks:

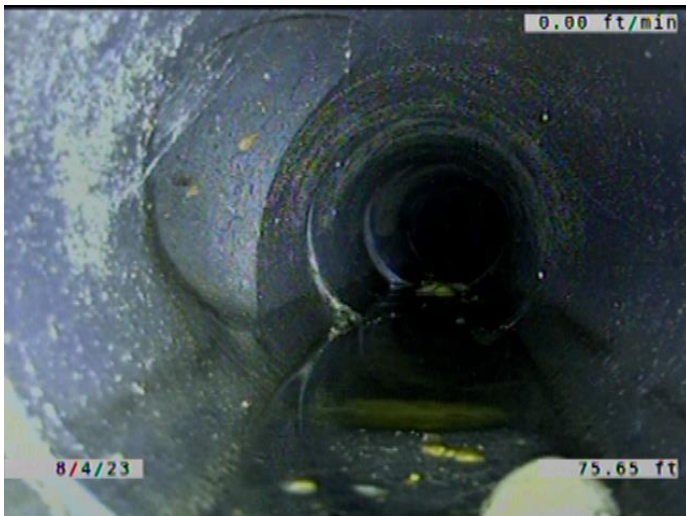
Code: **LR**
 Description: **Line Right**

Distance (ft): **75.6**
 Structural Grade: **0**
 O&M Grade: **1**
 Clock Start/From:
 Clock To:
 1st Value:
 2nd Value:
 Value Percent: **5.000**
 Continuous Index:
 Within 8" of Joint: **NO**
 Remarks:

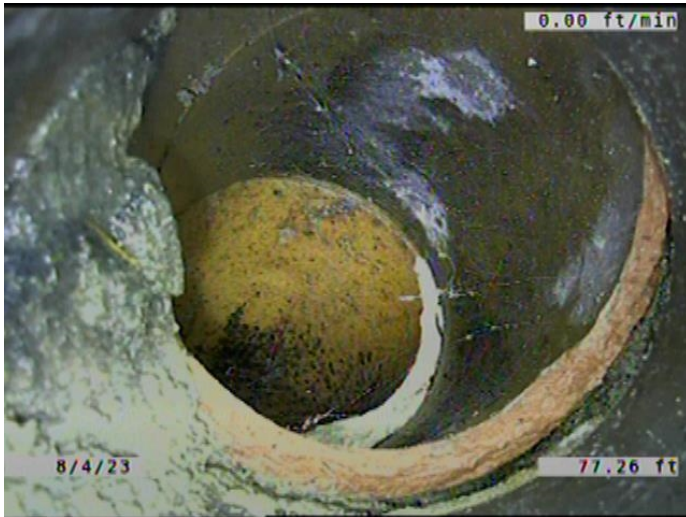
Code:	TFD
Description:	Tap Factory Defective
Distance (ft):	77.3
Structural Grade:	0
O&M Grade:	3
Clock Start/From:	10
Clock To:	
1st Value:	6.000
2nd Value:	
Value Percent:	
Continuous Index:	
Within 8" of Joint:	YES
Remarks:	TAP BROKEN. SERVICE BROKEN AND OFFSET. SOIL VISIBLE.

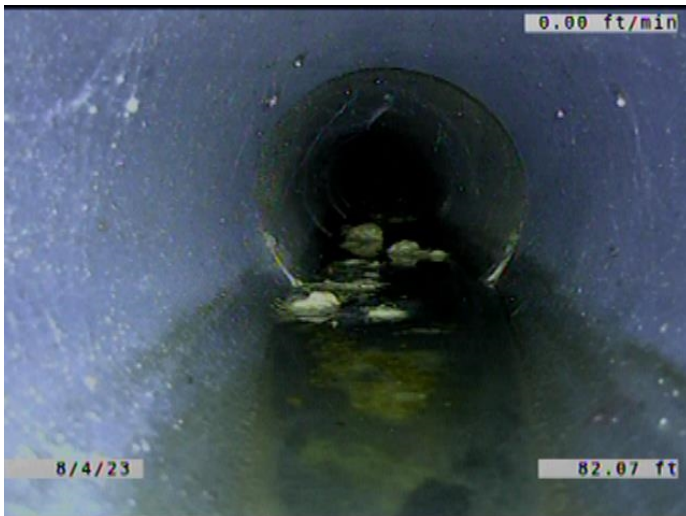
Code:	MWLS
Description:	Miscellaneous Water Level Sag
Distance (ft):	82.1
Structural Grade:	2
O&M Grade:	0
Clock Start/From:	
Clock To:	
1st Value:	
2nd Value:	
Value Percent:	10.000
Continuous Index:	S03
Within 8" of Joint:	NO
Remarks:

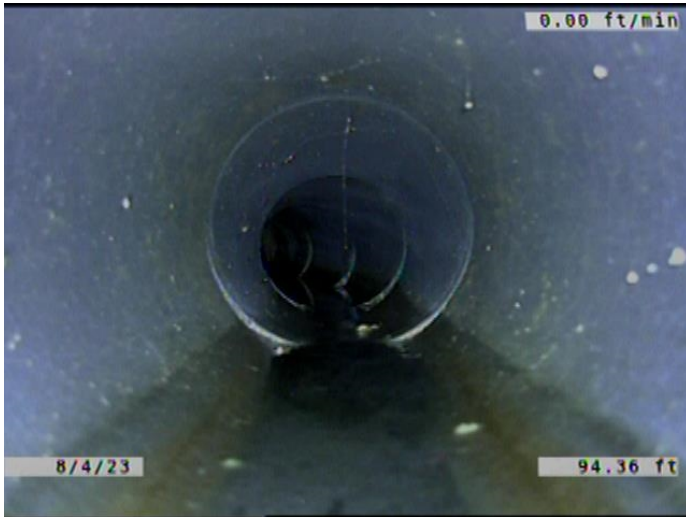
Code: **MWLS**
Description: **Miscellaneous Water Level Sag**

Distance (ft): **94.4**
Structural Grade: **2**
O&M Grade: **0**
Clock Start/From:
Clock To:
1st Value:
2nd Value:
Value Percent: **10.000**
Continuous Index: **F03**
Within 8" of Joint: **NO**
Remarks:

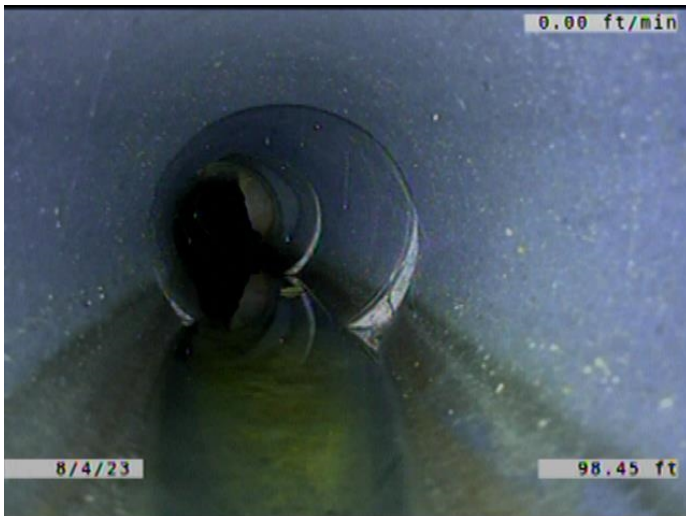
Code: **MWLS**
Description: **Miscellaneous Water Level Sag**

Distance (ft): **98.5**
Structural Grade: **2**
O&M Grade: **0**
Clock Start/From:
Clock To:
1st Value:
2nd Value:
Value Percent: **10.000**
Continuous Index: **S04**
Within 8" of Joint: **NO**
Remarks:

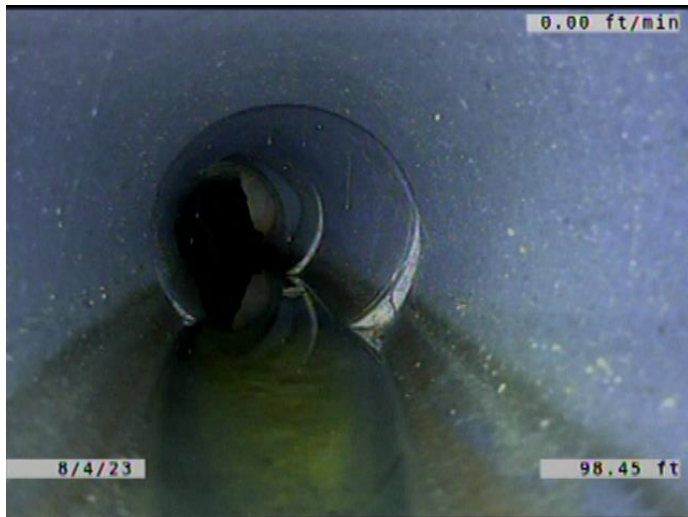
Code: **LL**
Description: **Line Left**

Distance (ft): **98.5**
Structural Grade: **0**
O&M Grade: **1**
Clock Start/From:
Clock To:
1st Value:
2nd Value:
Value Percent: **10.000**
Continuous Index:
Within 8" of Joint: **NO**
Remarks:

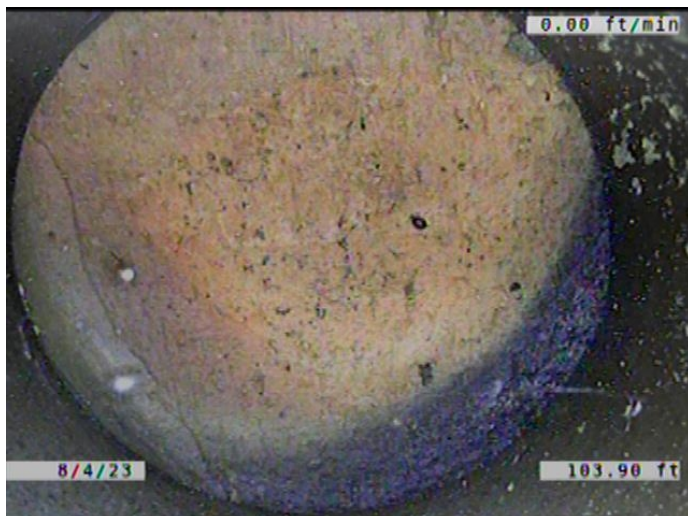
Code: **TFC**
Description: **Tap Factory Capped**

Distance (ft): **103.9**
Structural Grade: **0**
O&M Grade: **0**
Clock Start/From: **2**
Clock To:
1st Value: **6.000**
2nd Value:
Value Percent:
Continuous Index:
Within 8" of Joint: **YES**
Remarks:

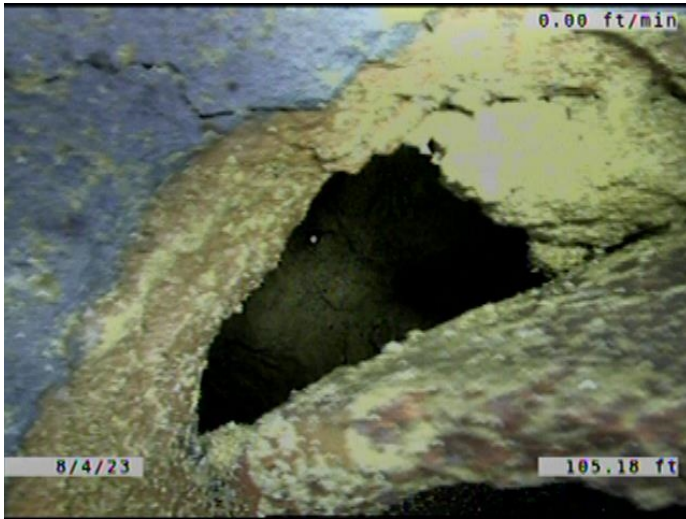
Code: **BVV**
Description: **Broken Void Visible**

Distance (ft): **105.2**
Structural Grade: **5**
O&M Grade: **0**
Clock Start/From: **12**
Clock To: **4**
1st Value:
2nd Value:
Value Percent:
Continuous Index:
Within 8" of Joint: **YES**
Remarks:

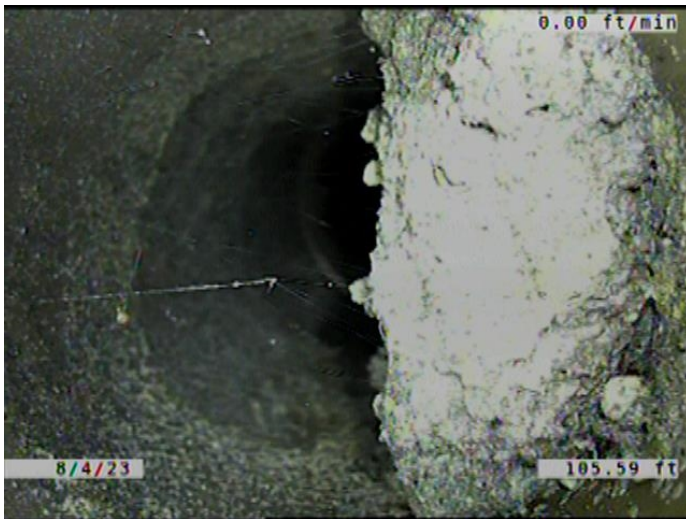
Code: **TBI**
Description: **Tap Break-in Intruding**

Distance (ft): **105.6**
Structural Grade: **0**
O&M Grade: **2**
Clock Start/From: **3**
Clock To:
1st Value: **6.000**
2nd Value: **3.000**
Value Percent:
Continuous Index:
Within 8" of Joint: **YES**
Remarks: **SERVICE BROKEN. MAIN BROKEN. VOID AND SOIL VISIBLE. AROUND T**

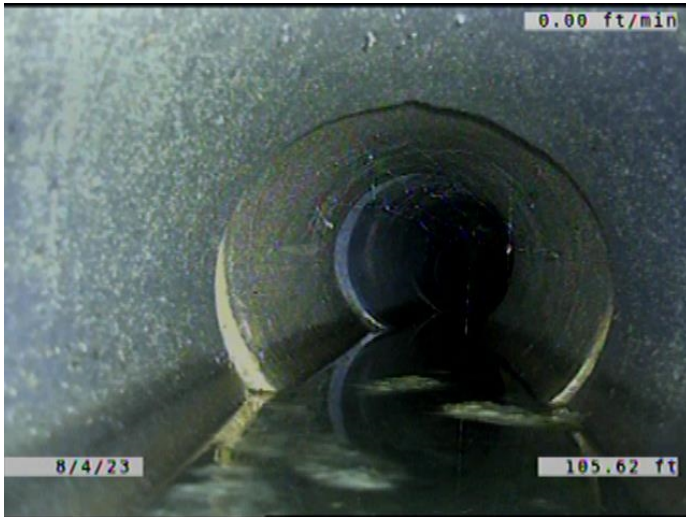
Code: **DSF**
Description: **Deposits Settled Fine**

Distance (ft): **105.6**
Structural Grade: **0**
O&M Grade: **2**
Clock Start/From: **5**
Clock To: **7**
1st Value:
2nd Value:
Value Percent: **5.000**
Continuous Index: **F01**
Within 8" of Joint: **YES**
Remarks:

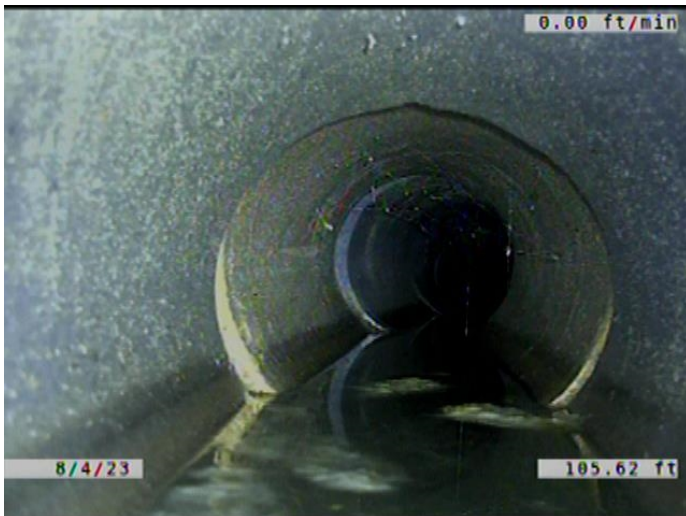
Code: **MWLS**
Description: **Miscellaneous Water Level Sag**

Distance (ft): **105.6**
Structural Grade: **2**
O&M Grade: **0**
Clock Start/From:
Clock To:
1st Value:
2nd Value:
Value Percent: **10.000**
Continuous Index: **F04**
Within 8" of Joint: **NO**
Remarks:

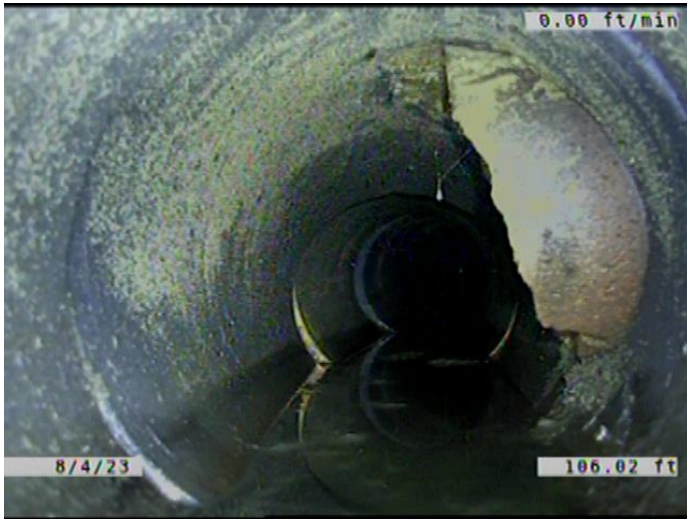
Code:	MSA
Description:	Miscellaneous Survey Abandoned
Distance (ft):	106.0
Structural Grade:	0
O&M Grade:	0
Clock Start/From:	
Clock To:	
1st Value:	
2nd Value:	
Value Percent:	
Continuous Index:	
Within 8" of Joint:	NO
Remarks:	CAMERA CANT MAKE IT PAST PROTRUDING TAP.
