## Profile/Photo Observation Report

Street:	<b>E CLEVELAND AVE</b>	Flow Control:	<b>Not Controlled</b>
City:	<b>Hobart, IN</b>	Year Renewed:	
Location:	<b>Other</b>	Tape/Media #:	
Purpose:	<b>Not Known</b>	Dia/Height:	<b>8"</b>
Use:	<b>Sanitary</b>	Material:	<b>VCP</b>
Drain Area:	<b>NA</b>	Lining:	
Category:	<b>NA</b>		
Comment:

Location Details:		Direction of Survey:	<b>Upstream</b>
US MH:	<b>M-804-010</b>	DS MH:	<b>M-805-061</b>
		Total Length Surveyed (ft):	<b>18.8</b>

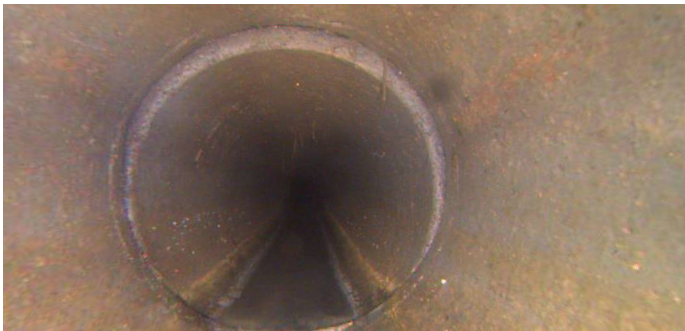
Code: **AMH**  
Description: **Manhole**

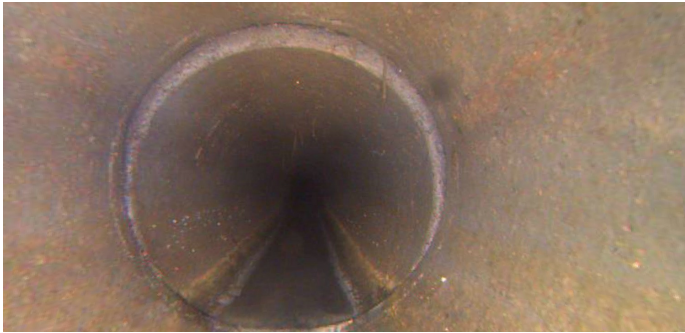
Code:	<b>MWL</b>
Description:	<b>Water Level</b>

Distance (ft):	<b>.0</b>
Structural Grade:	<b>0</b>
O&M Grade:	<b>0</b>
Clock Start/From:	
Clock To:	
1st Value:	
2nd Value:	
Value Percent:	<b>5.000</b>
Continuous Index:	
Within 8" of Joint:	<b>NO</b>
Remarks:

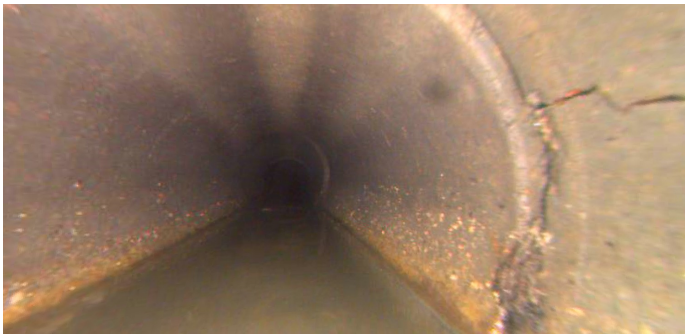
Code:	<b>FL</b>
Description:	<b>Fracture Longitudinal</b>

Distance (ft):	<b>7.3</b>
Structural Grade:	<b>3</b>
O&M Grade:	<b>0</b>
Clock Start/From:	<b>2</b>
Clock To:	
1st Value:	
2nd Value:	
Value Percent:	
Continuous Index:	
Within 8" of Joint:	<b>YES</b>
Remarks:

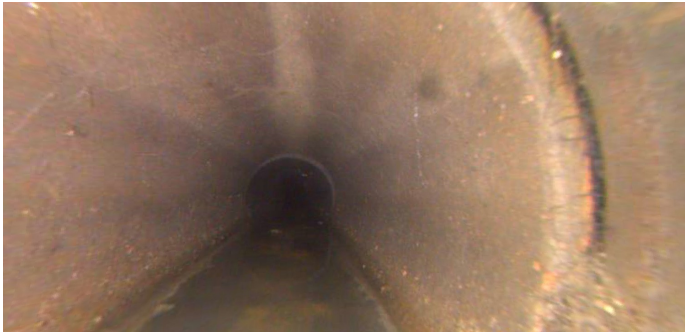
Code: **RFJ**  
Description: **Roots Fine Joint**

Distance (ft): **9.4**  
Structural Grade: **0**  
O&M Grade: **1**  
Clock Start/From: **2**  
Clock To: **3**  
1st Value:  
2nd Value:  
Value Percent:  
Continuous Index:  
Within 8" of Joint: **YES**  
Remarks:

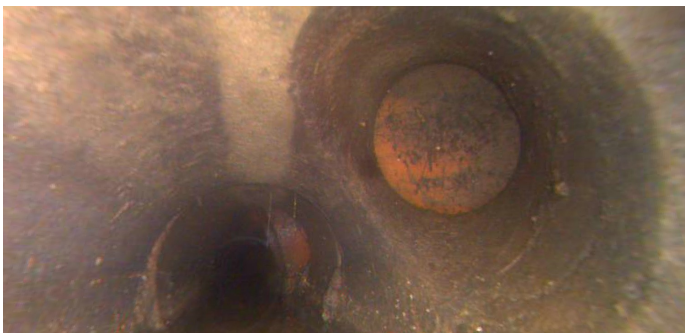
Code: **TFC**  
Description: **Tap Factory Capped**

Distance (ft): **14.5**  
Structural Grade: **0**  
O&M Grade: **0**  
Clock Start/From: **2**  
Clock To:  
1st Value: **4.000**  
2nd Value:  
Value Percent:  
Continuous Index:  
Within 8" of Joint:  
Remarks:

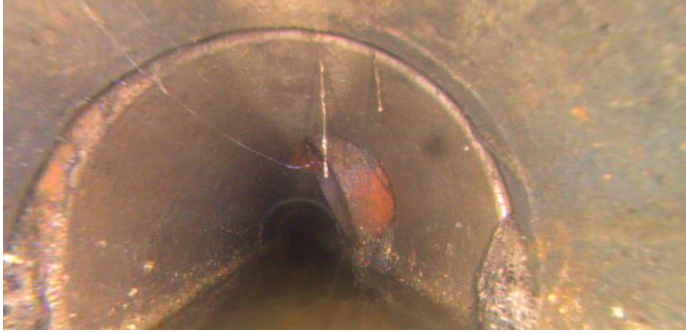
Code: **RFJ**  
Description: **Roots Fine Joint**

Distance (ft): **15.2**  
Structural Grade: **0**  
O&M Grade: **1**  
Clock Start/From: **7**  
Clock To: **5**  
1st Value:  
2nd Value:  
Value Percent:  
Continuous Index:  
Within 8" of Joint: **YES**  
Remarks:

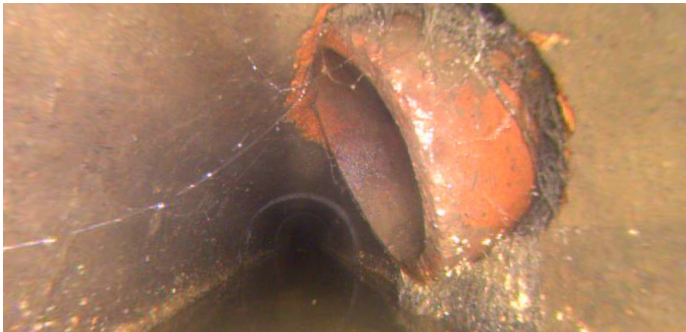
Code: **TBI**  
Description: **Tap Break-in Intruding**

Distance (ft): **16.0**  
Structural Grade: **0**  
O&M Grade: **2**  
Clock Start/From: **2**  
Clock To:  
1st Value: **4.000**  
2nd Value: **2.000**  
Value Percent:  
Continuous Index:  
Within 8" of Joint:  
Remarks: **rfc**

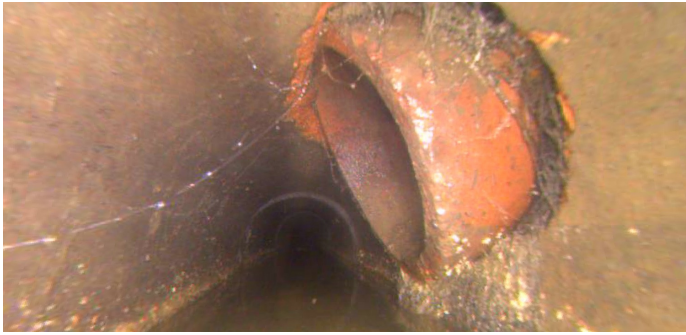
Code: **RFB**  
Description: **Roots Fine Barrel**

Distance (ft): **16.0**  
Structural Grade: **0**  
O&M Grade: **2**  
Clock Start/From: **12**  
Clock To: **4**  
1st Value:  
2nd Value:  
Value Percent:  
Continuous Index:  
Within 8" of Joint: **NO**  
Remarks:

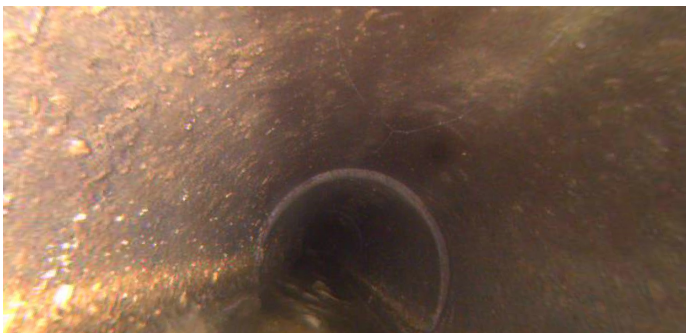
Code: **MSA**  
Description: **Abandoned Survey**

Distance (ft): **18.8**  
Structural Grade: **0**  
O&M Grade: **0**  
Clock Start/From:  
Clock To:  
1st Value:  
2nd Value:  
Value Percent:  
Continuous Index:  
Within 8" of Joint: **NO**  
Remarks: **tbi**
