## Profile/Photo Observation Report

Date:	<b>04/22/2018</b>	Weather:		Coding:	<b>PACP 6.0</b>
Pipe Length (ft):	<b>215.4</b>	Owner:	<b>NA</b>	Pre Clean:	<b>Not Known</b>
P.O.#:		Surveyor:	<b>Nikola</b>	PSR:	<b>P-804-012-011</b>
Customer:		Clean Date:	<b>01/01/1900</b>	Shape:	<b>C</b>

Street:	<b>E CLEVELAND AVE</b>	Flow Control:	<b>Not Controlled</b>
City:	<b>Hobart, IN</b>	Year Renewed:	
Location:	<b>Other</b>	Tape/Media #:	
Purpose:	<b>Not Known</b>	Dia/Height:	<b>8"</b>
Use:	<b>Sanitary</b>	Material:	<b>VCP</b>
Drain Area:	<b>NA</b>	Lining:	
Category:	<b>NA</b>		
Comment:

Location Details:		Direction of Survey:	<b>Upstream</b>
US MH:	<b>M-804-011</b>	DS MH:	<b>M-804-012</b>
		Total Length Surveyed (ft):	<b>47.3</b>

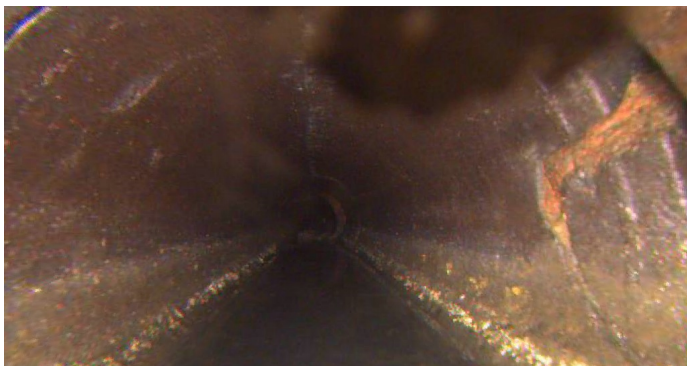
Code: **AMH**  
Description: **Manhole**

Distance (ft): **.0**  
Structural Grade: **0**  
O&M Grade: **0**  
Clock Start/From:  
Clock To:  
1st Value:  
2nd Value:  
Value Percent:  
Continuous Index:  
Within 8" of Joint: **NO**  
Remarks: **M-804-012**

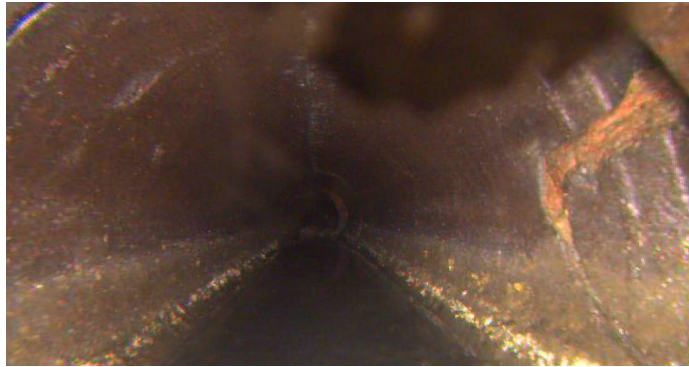
Code:	<b>MWL</b>
Description:	<b>Water Level</b>
Distance (ft):	<b>.0</b>
Structural Grade:	<b>0</b>
O&M Grade:	<b>0</b>
Clock Start/From:	
Clock To:	
1st Value:	
2nd Value:	
Value Percent:	<b>10.000</b>
Continuous Index:	
Within 8" of Joint:	<b>NO</b>
Remarks:

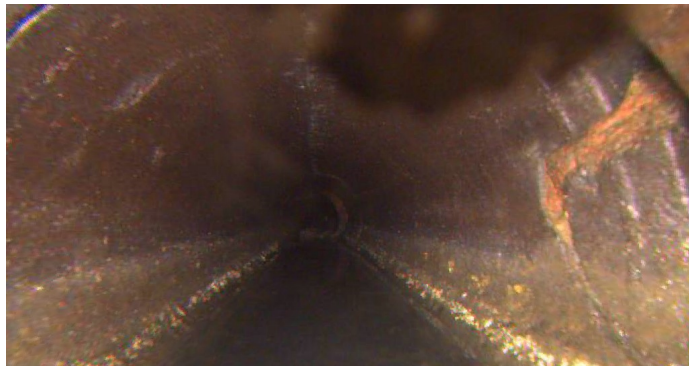
Code:	<b>CS</b>
Description:	<b>Crack Spiral</b>
Distance (ft):	<b>.0</b>
Structural Grade:	<b>2</b>
O&M Grade:	<b>0</b>
Clock Start/From:	<b>2</b>
Clock To:	<b>5</b>
1st Value:	
2nd Value:	
Value Percent:	
Continuous Index:	
Within 8" of Joint:	<b>YES</b>
Remarks:

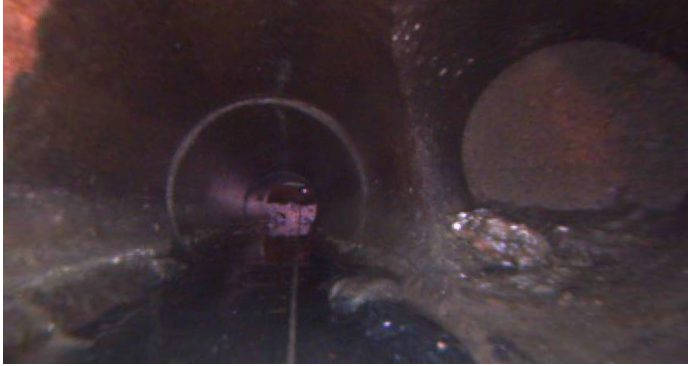
Code: **TFC**  
Description: **Tap Factory Capped**

Distance (ft): **4.5**  
Structural Grade: **0**  
O&M Grade: **0**  
Clock Start/From: **8**  
Clock To:  
1st Value: **4.000**  
2nd Value:  
Value Percent:  
Continuous Index:  
Within 8" of Joint:  
Remarks:

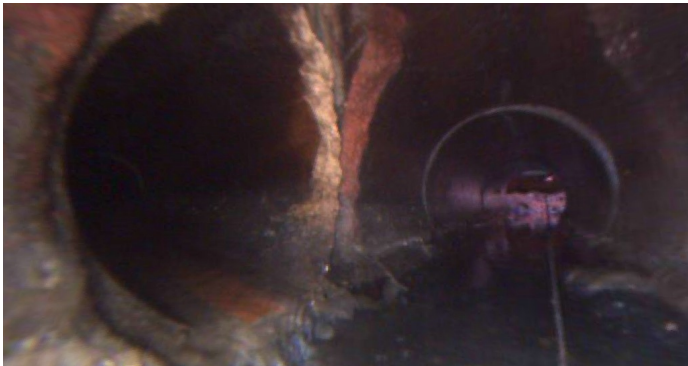
Code: **TB**  
Description: **Tap Break-in**

Distance (ft): **4.7**  
Structural Grade: **0**  
O&M Grade: **0**  
Clock Start/From: **4**  
Clock To:  
1st Value: **4.000**  
2nd Value:  
Value Percent:  
Continuous Index:  
Within 8" of Joint:  
Remarks:

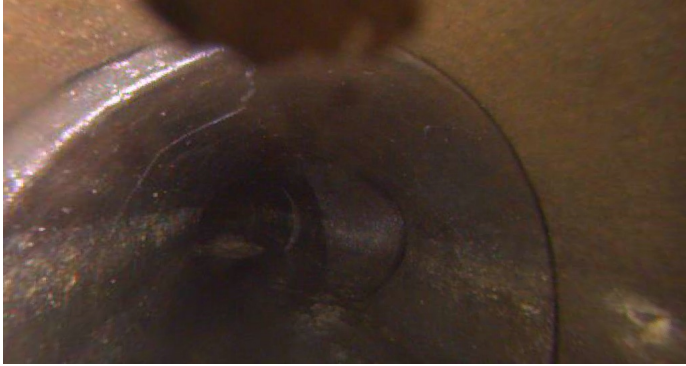
Code: **CS**  
Description: **Crack Spiral**

Distance (ft): **27.3**  
Structural Grade: **2**  
O&M Grade: **0**  
Clock Start/From: **7**  
Clock To: **12**  
1st Value:  
2nd Value:  
Value Percent:  
Continuous Index:  
Within 8" of Joint: **YES**  
Remarks:

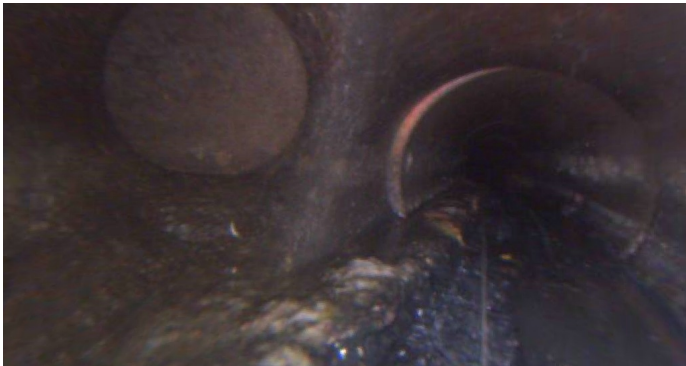
Code: **TFC**  
Description: **Tap Factory Capped**

Distance (ft): **28.7**  
Structural Grade: **0**  
O&M Grade: **0**  
Clock Start/From: **3**  
Clock To:  
1st Value: **4.000**  
2nd Value:  
Value Percent:  
Continuous Index:  
Within 8" of Joint:  
Remarks:

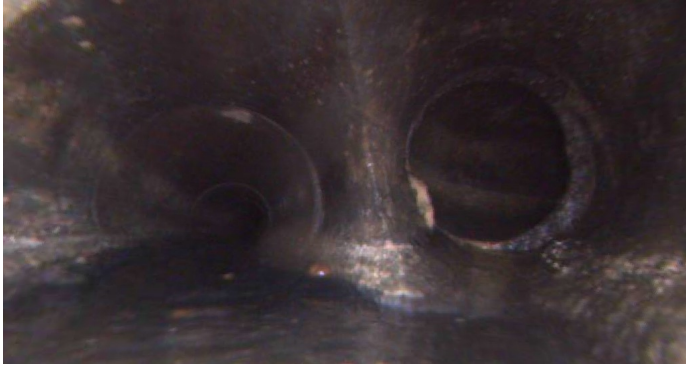
Code: **TF**  
Description: **Tap Factory**

Distance (ft): **45.3**  
Structural Grade: **0**  
O&M Grade: **0**  
Clock Start/From: **8**  
Clock To:  
1st Value: **4.000**  
2nd Value:  
Value Percent:  
Continuous Index:  
Within 8" of Joint:  
Remarks:

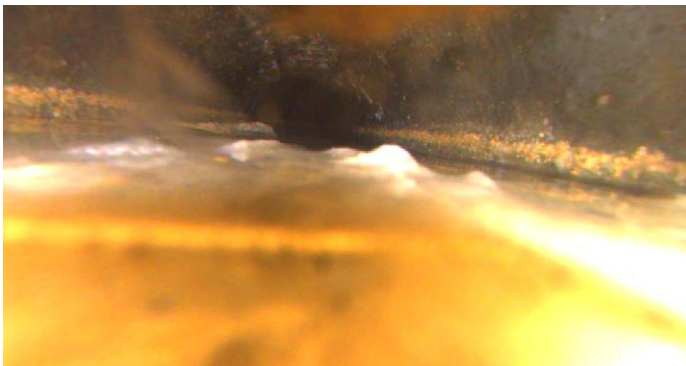
Code: **MWL**  
Description: **Water Level**

Distance (ft): **45.9**  
Structural Grade: **0**  
O&M Grade: **0**  
Clock Start/From:  
Clock To:  
1st Value:  
2nd Value:  
Value Percent: **40.000**  
Continuous Index:  
Within 8" of Joint: **NO**  
Remarks:

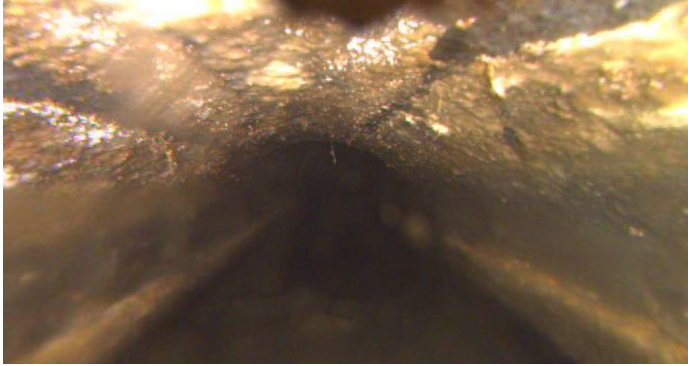
Code:	<b>MSA</b>
Description:	<b>Abandoned Survey</b>
Distance (ft):	<b>47.3</b>
Structural Grade:	<b>0</b>
O&M Grade:	<b>0</b>
Clock Start/From:	
Clock To:	
1st Value:	
2nd Value:	
Value Percent:	
Continuous Index:	
Within 8" of Joint:	<b>NO</b>
Remarks:	<b>Debris</b>
