Profile/Photo Observation Report

Street:	E Cleveland Ave.	Flow Control:	Not Controlled
City:	Hobart, IN	Year Renewed:	
Location:	Other	Tape/Media #:	
Purpose:	Not Known	Dia/Height:	8"
Use:	Sanitary	Material:	VCP
Drain Area:	NA	Lining:	
Category:	NA		
Comment:

Location Details:		Direction of Survey:	Upstream
US MH:	M-804-011	DS MH:	M-804-012
		Total Length Surveyed (ft):	47.3

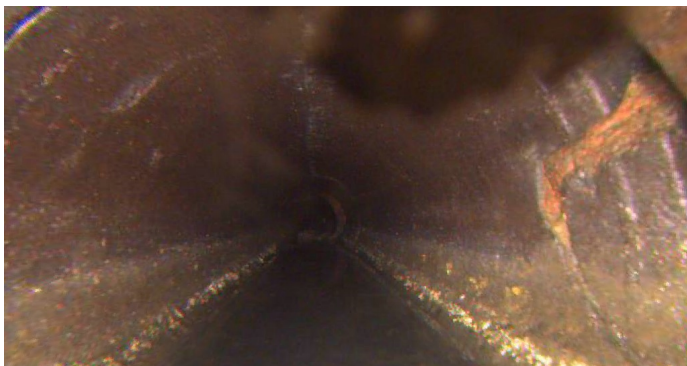
Code: **AMH**
Description: **Manhole**

Distance (ft): **.0**
Structural Grade: **0**
O&M Grade: **0**
Clock Start/From:
Clock To:
1st Value:
2nd Value:
Value Percent:
Continuous Index:
Within 8" of Joint: **NO**
Remarks: **M-804-012**

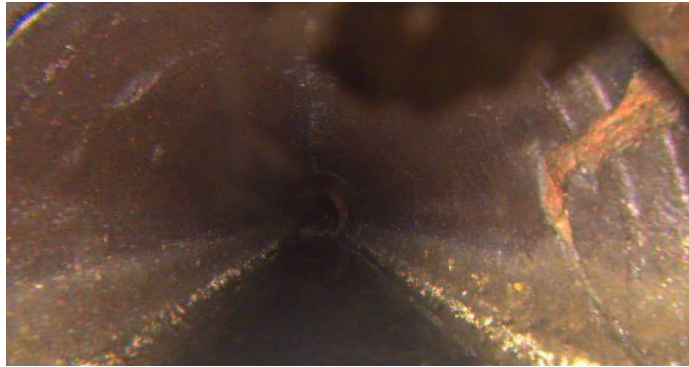
Code:	MWL
Description:	Water Level
Distance (ft):	.0
Structural Grade:	0
O&M Grade:	0
Clock Start/From:	
Clock To:	
1st Value:	
2nd Value:	
Value Percent:	10.000
Continuous Index:	
Within 8" of Joint:	NO
Remarks:

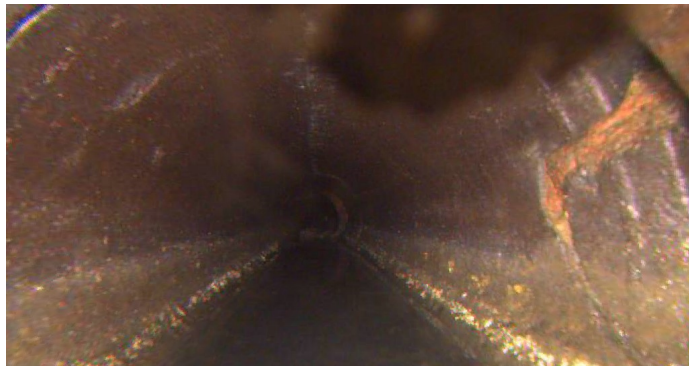
Code:	CS
Description:	Crack Spiral
Distance (ft):	.0
Structural Grade:	2
O&M Grade:	0
Clock Start/From:	2
Clock To:	5
1st Value:	
2nd Value:	
Value Percent:	
Continuous Index:	
Within 8" of Joint:	YES
Remarks:

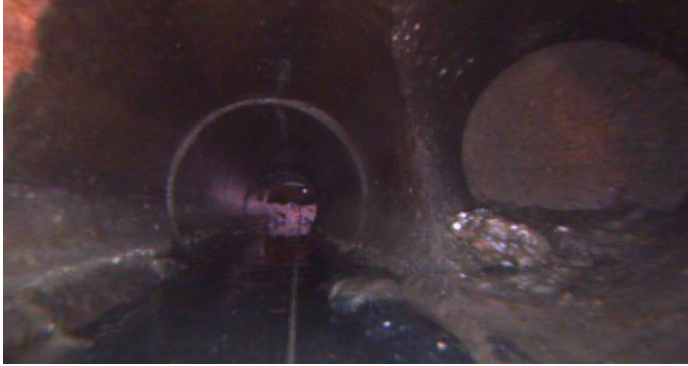
Code: **TFC**
Description: **Tap Factory Capped**

Distance (ft): **4.5**
Structural Grade: **0**
O&M Grade: **0**
Clock Start/From: **8**
Clock To:
1st Value: **4.000**
2nd Value:
Value Percent:
Continuous Index:
Within 8" of Joint:
Remarks:

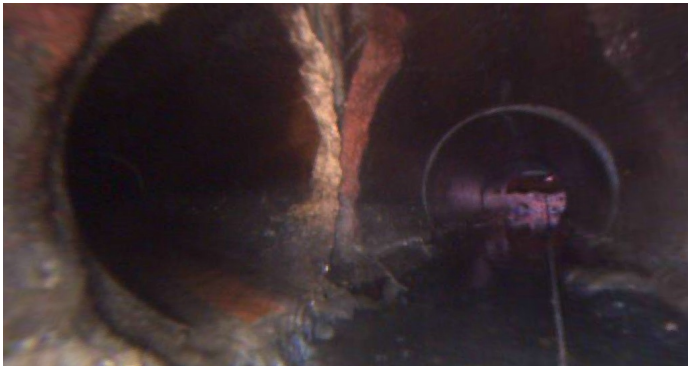
Code: **TB**
Description: **Tap Break-in**

Distance (ft): **4.7**
Structural Grade: **0**
O&M Grade: **0**
Clock Start/From: **4**
Clock To:
1st Value: **4.000**
2nd Value:
Value Percent:
Continuous Index:
Within 8" of Joint:
Remarks:

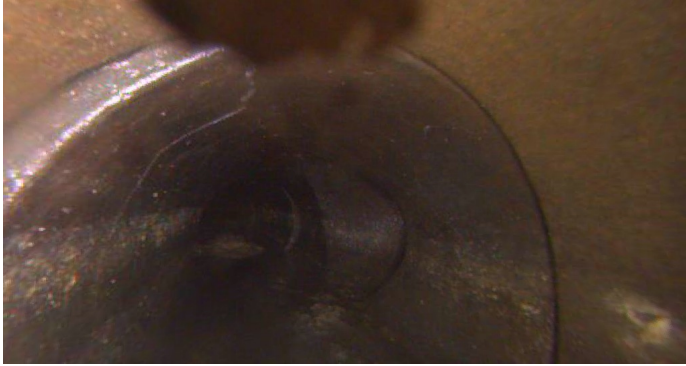
Code: **CS**
Description: **Crack Spiral**

Distance (ft): **27.3**
Structural Grade: **2**
O&M Grade: **0**
Clock Start/From: **7**
Clock To: **12**
1st Value:
2nd Value:
Value Percent:
Continuous Index:
Within 8" of Joint: **YES**
Remarks:

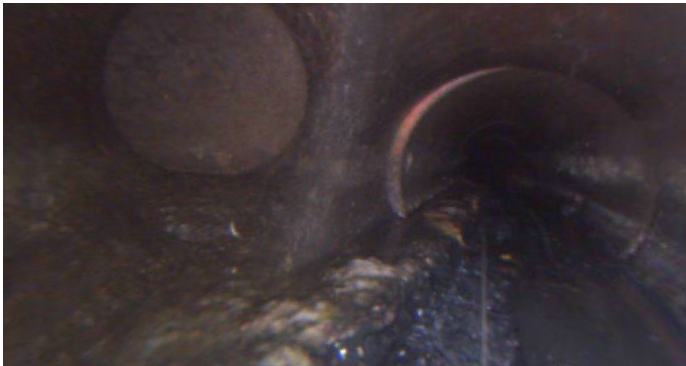
Code: **TFC**
Description: **Tap Factory Capped**

Distance (ft): **28.7**
Structural Grade: **0**
O&M Grade: **0**
Clock Start/From: **3**
Clock To:
1st Value: **4.000**
2nd Value:
Value Percent:
Continuous Index:
Within 8" of Joint:
Remarks:

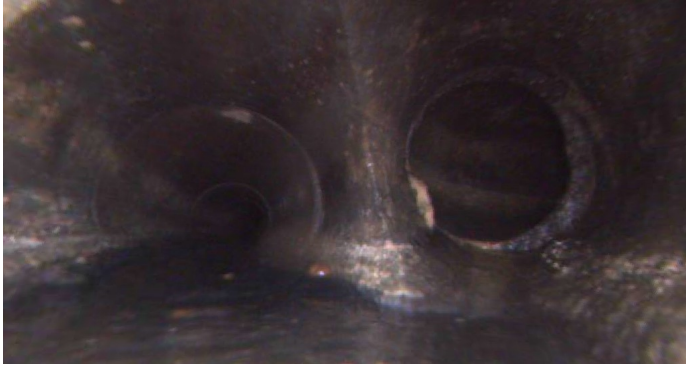
Code: **TF**
Description: **Tap Factory**

Distance (ft): **45.3**
Structural Grade: **0**
O&M Grade: **0**
Clock Start/From: **8**
Clock To:
1st Value: **4.000**
2nd Value:
Value Percent:
Continuous Index:
Within 8" of Joint:
Remarks:

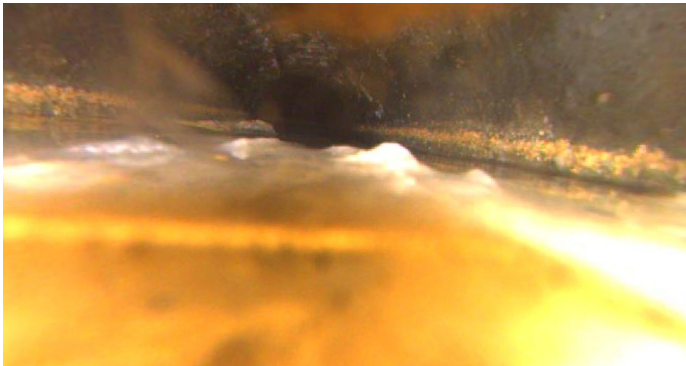
Code: **MWL**
Description: **Water Level**

Distance (ft): **45.9**
Structural Grade: **0**
O&M Grade: **0**
Clock Start/From:
Clock To:
1st Value:
2nd Value:
Value Percent: **40.000**
Continuous Index:
Within 8" of Joint: **NO**
Remarks:

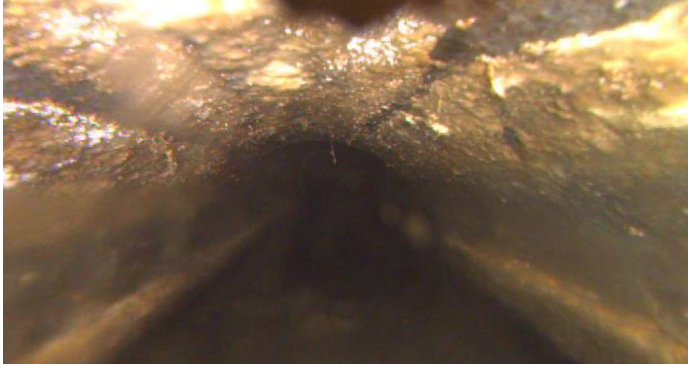
Code:	MSA
Description:	Abandoned Survey
Distance (ft):	47.3
Structural Grade:	0
O&M Grade:	0
Clock Start/From:	
Clock To:	
1st Value:	
2nd Value:	
Value Percent:	
Continuous Index:	
Within 8" of Joint:	NO
Remarks:	Debris
