Profile/Photo Observation Report

Date:	10/17/2021	Weather:		Coding:	PACP 6.0
Pipe Length (ft):		Owner:	Hobart, IN	Pre Clean:	Not Known
P.O.#:	845_1	Surveyor:	M. Pielacha	PSR:	P-804-0SL-012
Customer:	Hobart, IN	Clean Date:		Shape:	C

Street:	East Cleveland Avenue	Flow Control:	
City:	Hobart, IN	Year Renewed:	
Location:	Light Highway	Tape/Media #:	845
Purpose:	Routine Assessment	Dia/Height:	6"
Use:	Sanitary	Material:	VCP
Drain Area:		Lining:	
Category:	NA		
Comment:

Location Details:		Direction of Survey:	Upstream
US MH:	M-804-12	DS MH:	M-804-12
		Total Length Surveyed (ft):	14.4

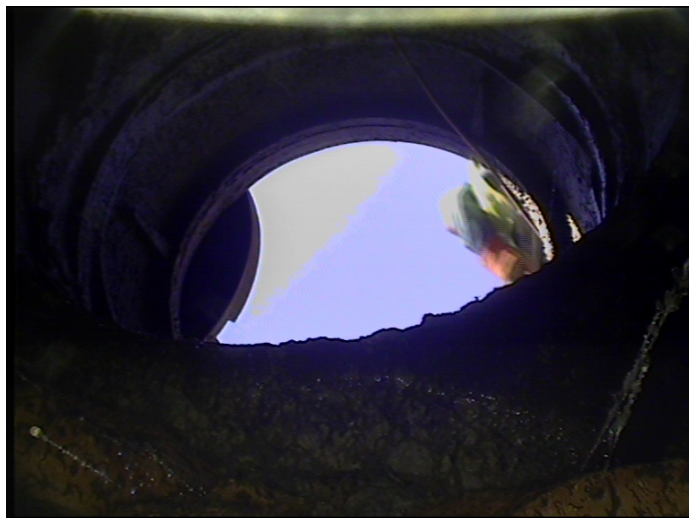
Code: **AMH**
Description: **Manhole**

Distance (ft): **.0**
Structural Grade: **0**
O&M Grade: **0**
Clock Start/From:
Clock To:
1st Value:
2nd Value:
Value Percent:
Continuous Index:
Within 8" of Joint: **NO**
Remarks: **M-804-12**

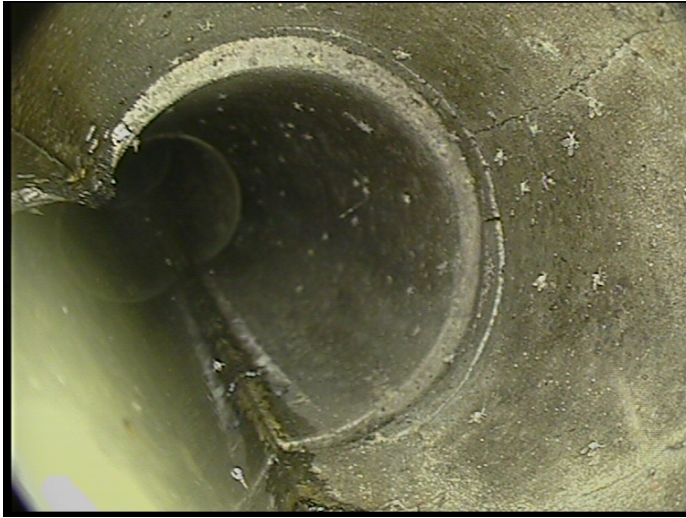
Code: **MWL**
Description: **Water Level**

Distance (ft): **.0**
Structural Grade: **0**
O&M Grade: **0**
Clock Start/From:
Clock To:
1st Value:
2nd Value:
Value Percent: **10.000**
Continuous Index:
Within 8" of Joint: **NO**
Remarks:

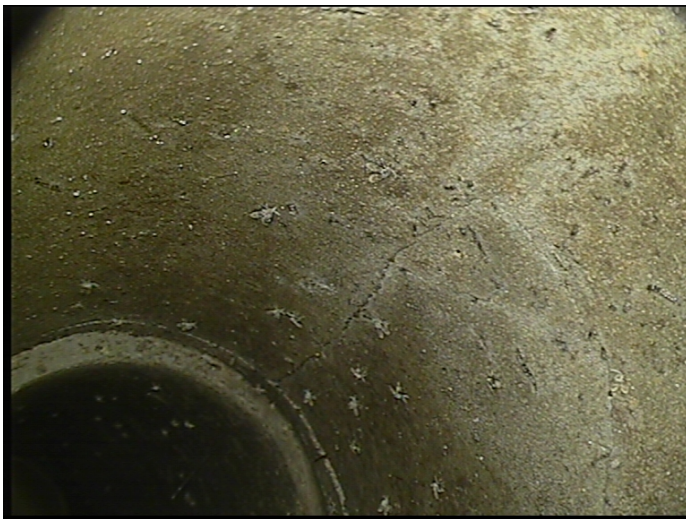
Code: **CL**
Description: **Crack Longitudinal**

Distance (ft): **1.0**
Structural Grade: **2**
O&M Grade: **0**
Clock Start/From: **12**
Clock To:
1st Value:
2nd Value:
Value Percent:
Continuous Index:
Within 8" of Joint: **YES**
Remarks:

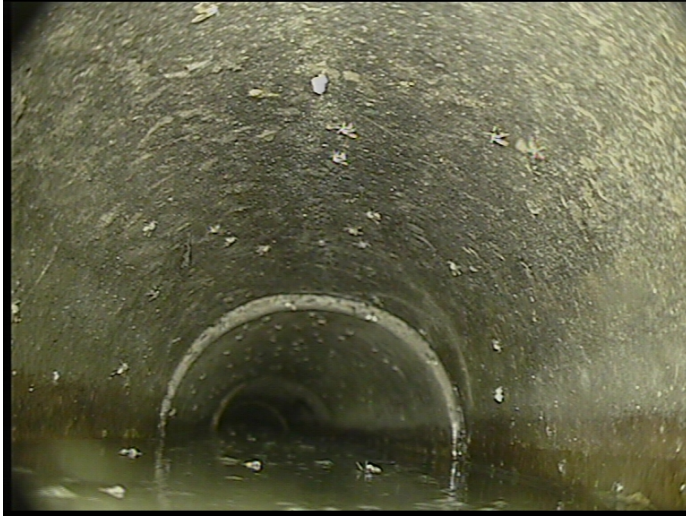
Code:	MWL
Description:	Water Level
Distance (ft):	8.4
Structural Grade:	0
O&M Grade:	0
Clock Start/From:	
Clock To:	
1st Value:	
2nd Value:	
Value Percent:	45.000
Continuous Index:	
Within 8" of Joint:	NO
Remarks:

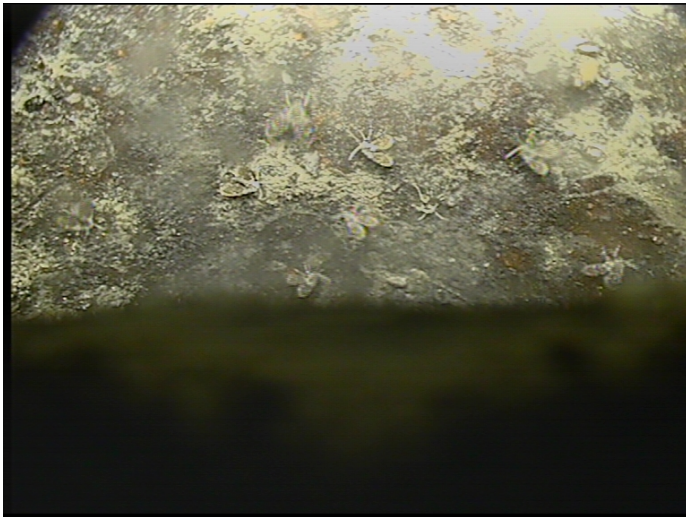
Code:	DSF
Description:	Deposits Settled Fine
Distance (ft):	14.4
Structural Grade:	0
O&M Grade:	3
Clock Start/From:	4
Clock To:	8
1st Value:	
2nd Value:	
Value Percent:	20.000
Continuous Index:	
Within 8" of Joint:	NO
Remarks:

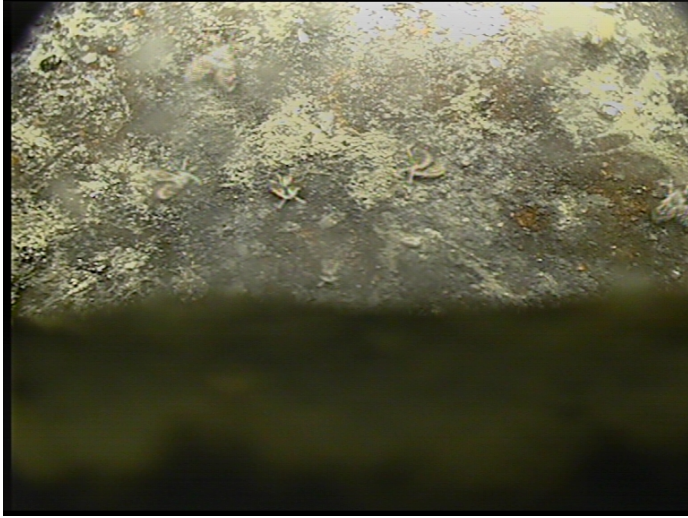
Code:	MSA
Description:	Abandoned Survey
Distance (ft):	14.4
Structural Grade:	0
O&M Grade:	0
Clock Start/From:	
Clock To:	
1st Value:	
2nd Value:	
Value Percent:	
Continuous Index:	
Within 8" of Joint:	NO
Remarks:	sediment/under water debris
