Profile/Photo Observation Report

Street:	N KELLY ST & E HOME AVE	Flow Control:	Not Controlled
City:	Hobart, IN	Year Renewed:	
Location:	Other	Tape/Media #:	
Purpose:	Not Known	Dia/Height:	12"
Use:	Sanitary	Material:	VCP
Drain Area:	NA	Lining:	
Category:	NA		
Comment:

Location Details:		Direction of Survey:	Downstream
US MH:	M-804-013	DS MH:	M-804-024
		Total Length Surveyed (ft):	28.5

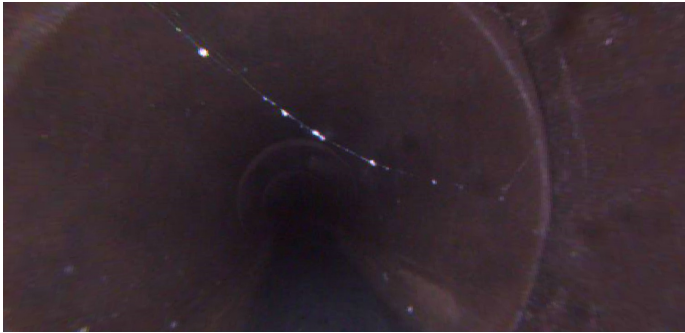
Code:	MWL
Description:	Water Level

Distance (ft):	.0
Structural Grade:	0
O&M Grade:	0
Clock Start/From:	
Clock To:	
1st Value:	
2nd Value:	
Value Percent:	5.000
Continuous Index:	
Within 8" of Joint:	NO
Remarks:

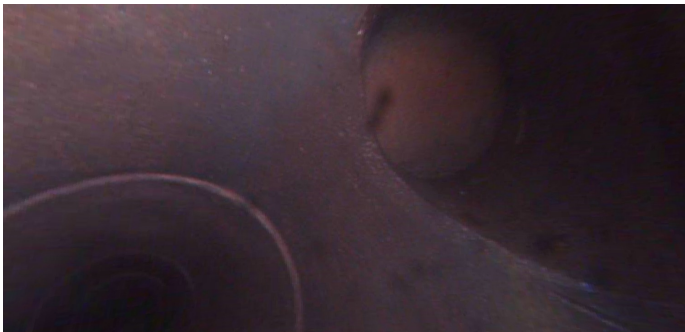
Code:	TFC
Description:	Tap Factory Capped

Distance (ft):	26.0
Structural Grade:	0
O&M Grade:	0
Clock Start/From:	1
Clock To:	
1st Value:	4.000
2nd Value:	
Value Percent:	
Continuous Index:	
Within 8" of Joint:	YES
Remarks:

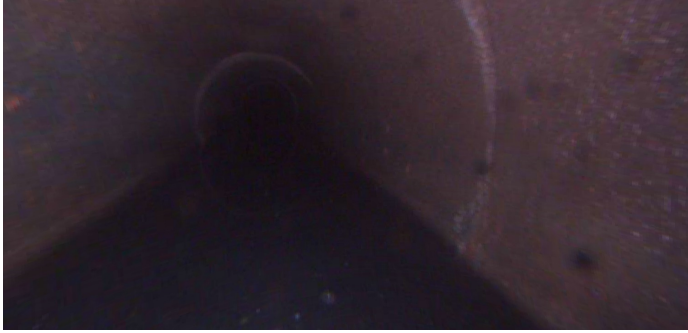
Code:	MSA
Description:	Abandoned Survey
Distance (ft):	28.5
Structural Grade:	0
O&M Grade:	0
Clock Start/From:	
Clock To:	
1st Value:	
2nd Value:	
Value Percent:	
Continuous Index:	
Within 8" of Joint:	NO
Remarks:	no blockage
