Profile/Photo Observation Report

Date:	10/18/2021	Weather:		Coding:	PACP 7.0
Pipe Length (ft):	363.8	Owner:	City of Hobart	Pre Clean:	Heavy Cleaning
P.O.#:	YES502259	Surveyor:	S. Bucklin	PSR:	P-804-024-013
Customer:	City of Hobart	Clean Date:	10/16/2021	Shape:	C

Street:	North Kelly Street	Flow Control:	Not Controlled
City:	Hobart, IN	Year Renewed:	
Location:	Local rural streets with light traffic, t	Tape/Media #:	
Purpose:	Routine Assessment	Dia/Height:	12"
Use:	Sanitary Sewage Pipe	Material:	VCP
Drain Area:		Lining:	
Category:	NA		
Comment:			
Location Details:		Direction of Survey:	Downstream
US MH:	M-804-013	DS MH:	M-804-024
		Total Length Surveyed (ft):	363.8

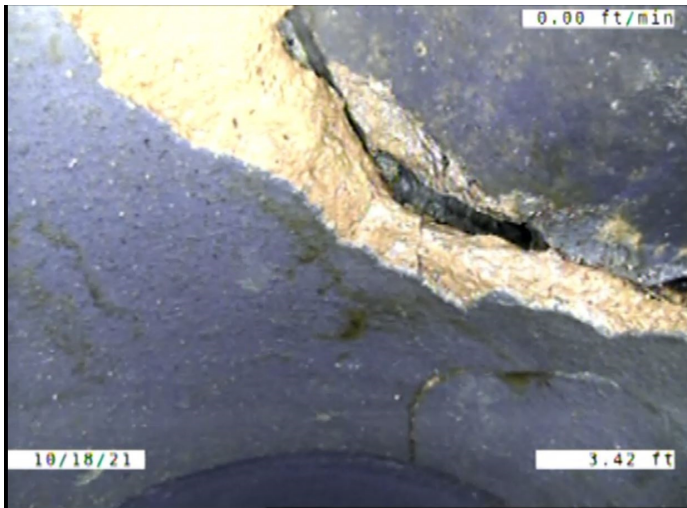
Code: **FC**
 Description: **Fracture Circumferential**

Distance (ft): **3.4**
 Structural Grade: **2**
 O&M Grade: **0**
 Clock Start/From: **2**
 Clock To: **3**
 1st Value:
 2nd Value:
 Value Percent:
 Continuous Index:
 Within 8" of Joint: **YES**
 Remarks:

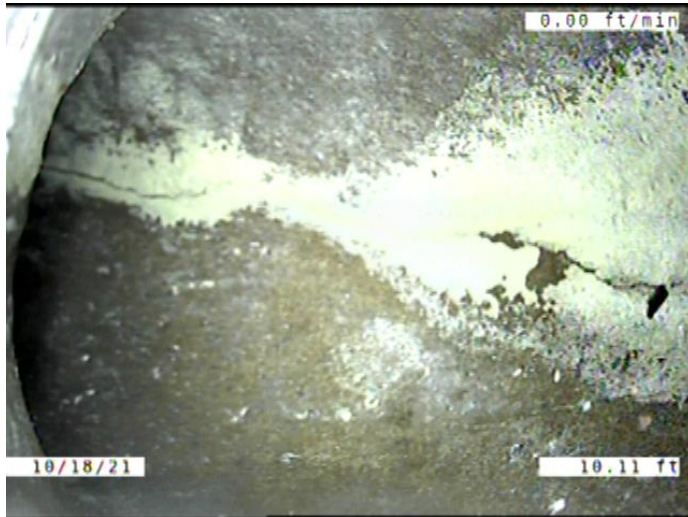
Code: **TBI**
 Description: **Tap Break-in Intruding**

Distance (ft): **10.1**
 Structural Grade: **0**
 O&M Grade: **2**
 Clock Start/From: **12**
 Clock To:
 1st Value: **4.000**
 2nd Value: **3.000**
 Value Percent:
 Continuous Index:
 Within 8" of Joint: **YES**
 Remarks: **Section of lateral missing**

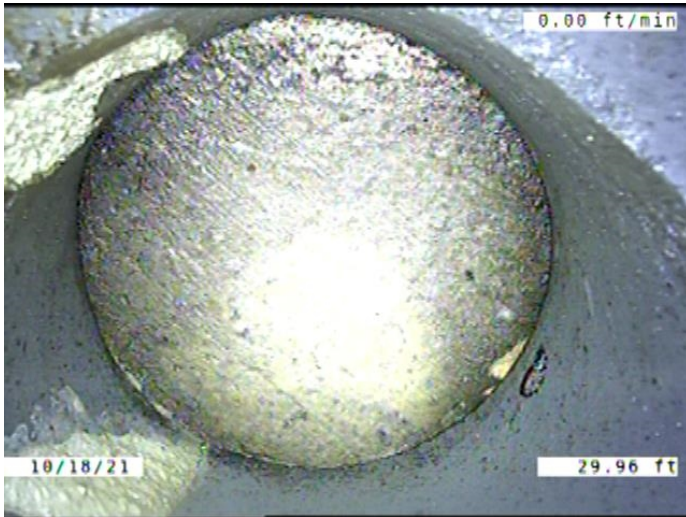
Code: **TFC**
 Description: **Tap Factory Capped**

Distance (ft): **30.0**
 Structural Grade: **0**
 O&M Grade: **0**
 Clock Start/From: **11**
 Clock To:
 1st Value: **4.000**
 2nd Value:
 Value Percent:
 Continuous Index:
 Within 8" of Joint: **YES**
 Remarks: **ENCRUSTATION IN THE TAP**

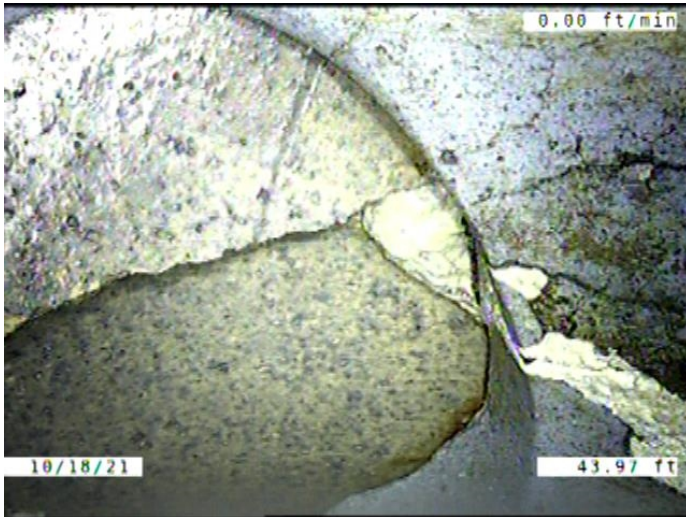
Code: **CM**
 Description: **Crack Multiple**

Distance (ft): **44.0**
 Structural Grade: **3**
 O&M Grade: **0**
 Clock Start/From: **11**
 Clock To: **3**
 1st Value:
 2nd Value:
 Value Percent:
 Continuous Index:
 Within 8" of Joint: **YES**
 Remarks:

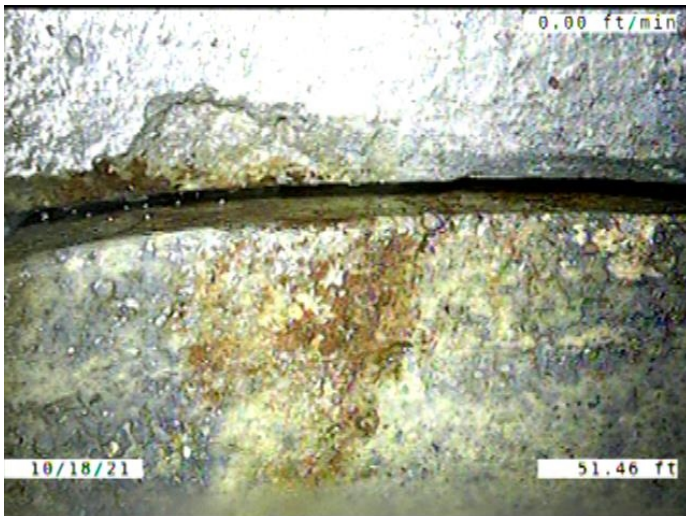
Code: **ISJ**
Description: **Infiltration Stain Joint**

Distance (ft): **51.5**
Structural Grade: **0**
O&M Grade: **1**
Clock Start/From: **8**
Clock To: **10**
1st Value:
2nd Value:
Value Percent:
Continuous Index:
Within 8" of Joint: **YES**
Remarks:

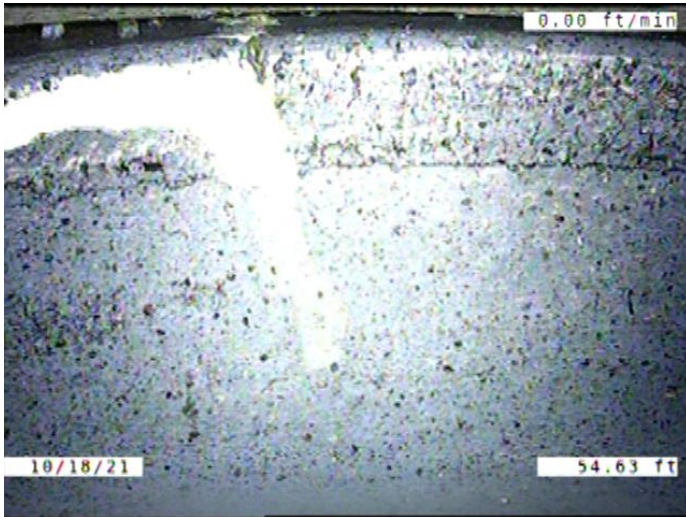
Code: **CL**
 Description: **Crack Longitudinal**

Distance (ft): **54.6**
 Structural Grade: **2**
 O&M Grade: **0**
 Clock Start/From: **12**
 Clock To:
 1st Value:
 2nd Value:
 Value Percent:
 Continuous Index:
 Within 8" of Joint: **YES**
 Remarks:

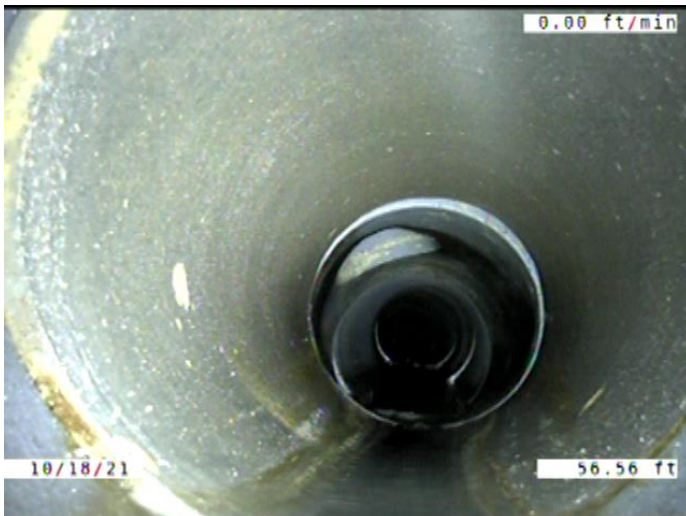
Code: **MWLS**
 Description: **Miscellaneous Water Level Sag**

Distance (ft): **56.6**
 Structural Grade: **2**
 O&M Grade: **0**
 Clock Start/From:
 Clock To:
 1st Value:
 2nd Value:
 Value Percent: **15.000**
 Continuous Index: **F01**
 Within 8" of Joint: **NO**
 Remarks:

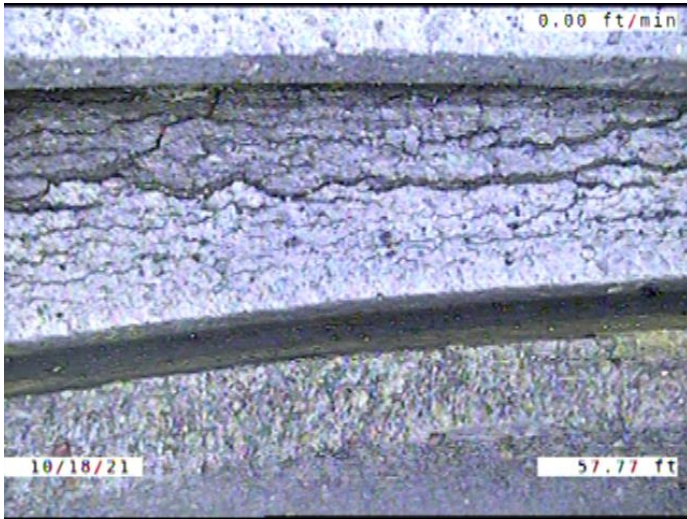
Code: **JAL**
 Description: **Joint Angular Large**

Distance (ft): **57.8**
 Structural Grade: **4**
 O&M Grade: **0**
 Clock Start/From:
 Clock To:
 1st Value:
 2nd Value:
 Value Percent:
 Continuous Index:
 Within 8" of Joint: **NO**
 Remarks:

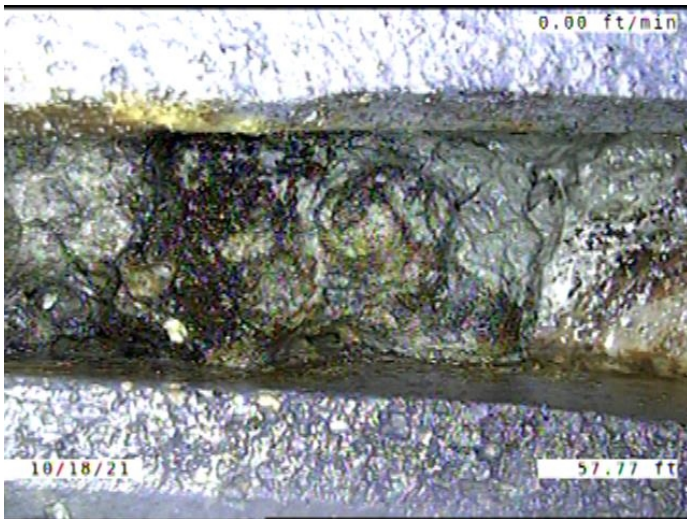
Code: **DAE**
 Description: **Deposits Attached Encrustation**

Distance (ft): **57.8**
 Structural Grade: **0**
 O&M Grade: **2**
 Clock Start/From: **7**
 Clock To: **10**
 1st Value:
 2nd Value:
 Value Percent: **5.000**
 Continuous Index:
 Within 8" of Joint: **YES**
 Remarks:

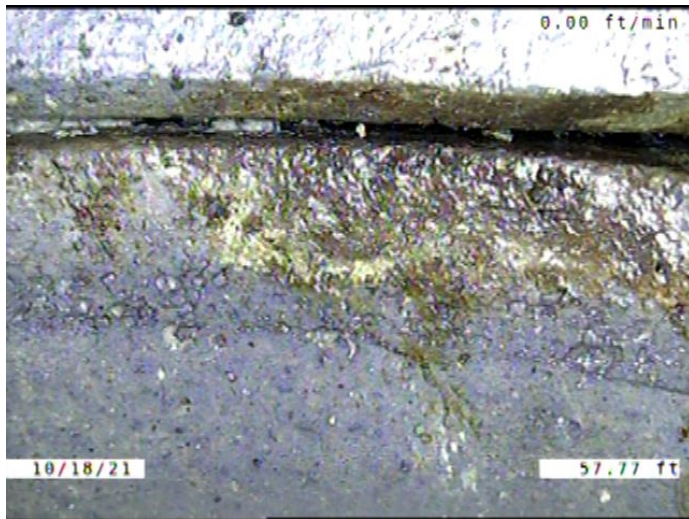
Code: **ISJ**
 Description: **Infiltration Stain Joint**

Distance (ft): **57.8**
 Structural Grade: **0**
 O&M Grade: **1**
 Clock Start/From: **3**
 Clock To: **5**
 1st Value:
 2nd Value:
 Value Percent:
 Continuous Index:
 Within 8" of Joint: **YES**
 Remarks:

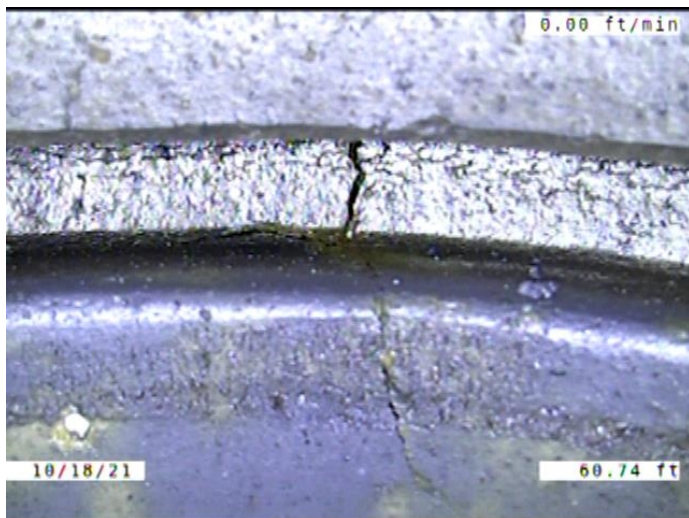
Code: **FM**
 Description: **Fracture Multiple**

Distance (ft): **60.7**
 Structural Grade: **4**
 O&M Grade: **0**
 Clock Start/From: **9**
 Clock To: **3**
 1st Value:
 2nd Value:
 Value Percent:
 Continuous Index:
 Within 8" of Joint: **YES**
 Remarks:

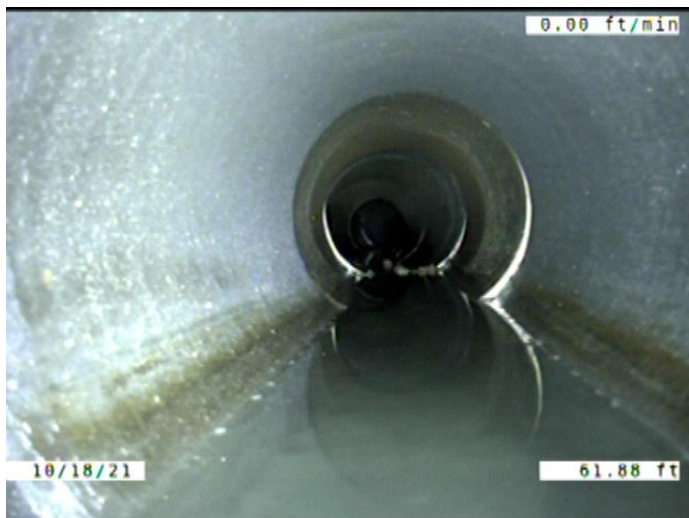
Code: **MWLS**
 Description: **Miscellaneous Water Level Sag**

Distance (ft): **61.9**
 Structural Grade: **2**
 O&M Grade: **0**
 Clock Start/From:
 Clock To:
 1st Value:
 2nd Value:
 Value Percent: **5.000**
 Continuous Index:
 Within 8" of Joint: **NO**
 Remarks:

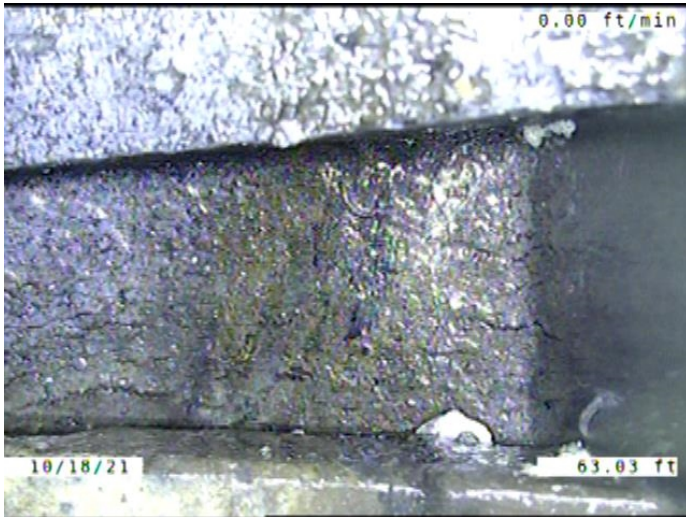
Code: **JAL**
 Description: **Joint Angular Large**

Distance (ft): **63.0**
 Structural Grade: **4**
 O&M Grade: **0**
 Clock Start/From:
 Clock To:
 1st Value:
 2nd Value:
 Value Percent:
 Continuous Index:
 Within 8" of Joint: **NO**
 Remarks:

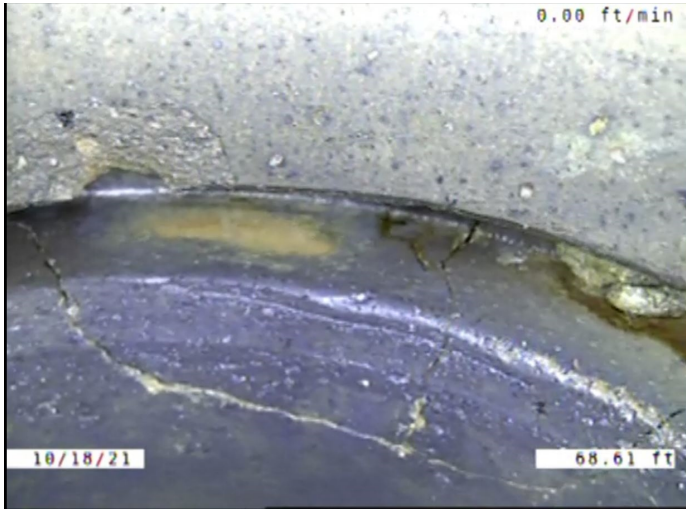
Code: **SSS**
 Description: **Surface Damage Surface Spalling**

Distance (ft): **68.6**
 Structural Grade: **2**
 O&M Grade: **0**
 Clock Start/From: **3**
 Clock To:
 1st Value:
 2nd Value:
 Value Percent:
 Continuous Index:
 Within 8" of Joint: **YES**
 Remarks:

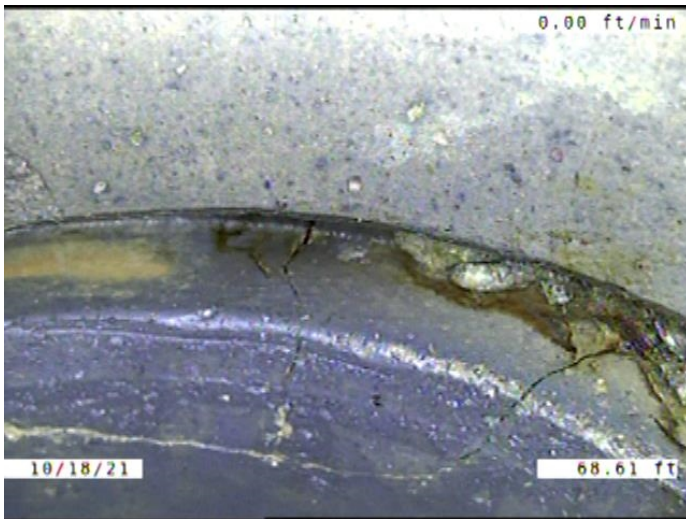
Code: **ISJ**
 Description: **Infiltration Stain Joint**

Distance (ft): **68.6**
 Structural Grade: **0**
 O&M Grade: **1**
 Clock Start/From: **2**
 Clock To: **4**
 1st Value:
 2nd Value:
 Value Percent:
 Continuous Index:
 Within 8" of Joint: **YES**
 Remarks:

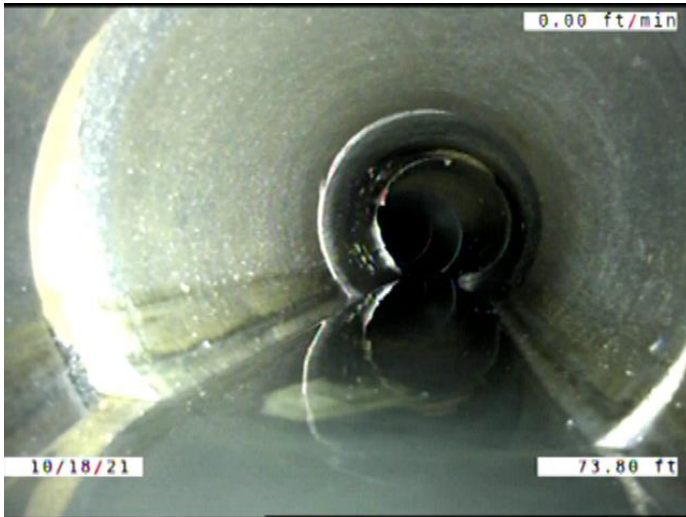
Code: **MWLS**
 Description: **Miscellaneous Water Level Sag**

Distance (ft): **73.8**
 Structural Grade: **2**
 O&M Grade: **0**
 Clock Start/From:
 Clock To:
 1st Value:
 2nd Value:
 Value Percent: **5.000**
 Continuous Index:
 Within 8" of Joint: **NO**
 Remarks:

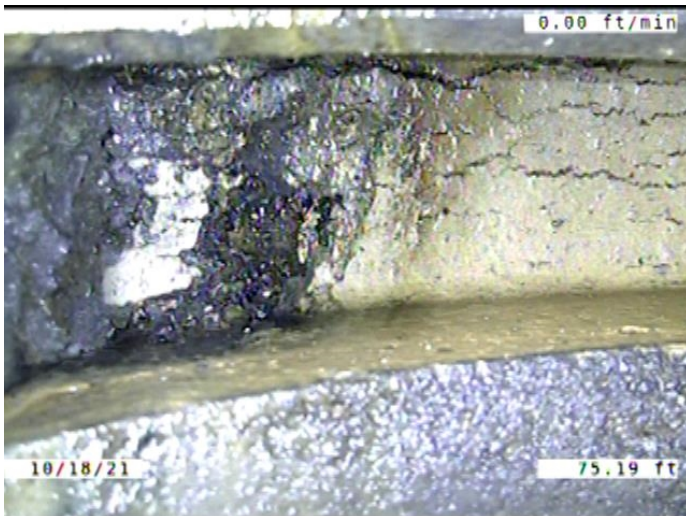
Code: **JAL**
 Description: **Joint Angular Large**

Distance (ft): **75.2**
 Structural Grade: **4**
 O&M Grade: **0**
 Clock Start/From:
 Clock To:
 1st Value:
 2nd Value:
 Value Percent:
 Continuous Index:
 Within 8" of Joint: **NO**
 Remarks:

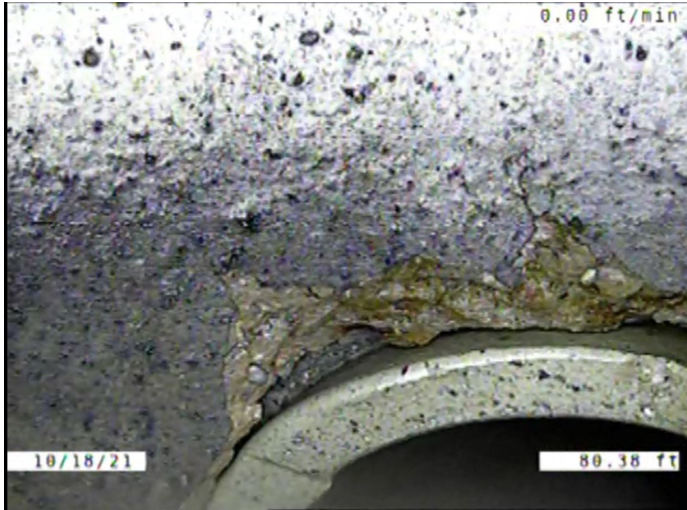
Code: **SSS**
Description: **Surface Damage Surface Spalling**

Distance (ft): **80.4**
Structural Grade: **2**
O&M Grade: **0**
Clock Start/From: **11**
Clock To: **2**
1st Value:
2nd Value:
Value Percent:
Continuous Index:
Within 8" of Joint: **NO**
Remarks:

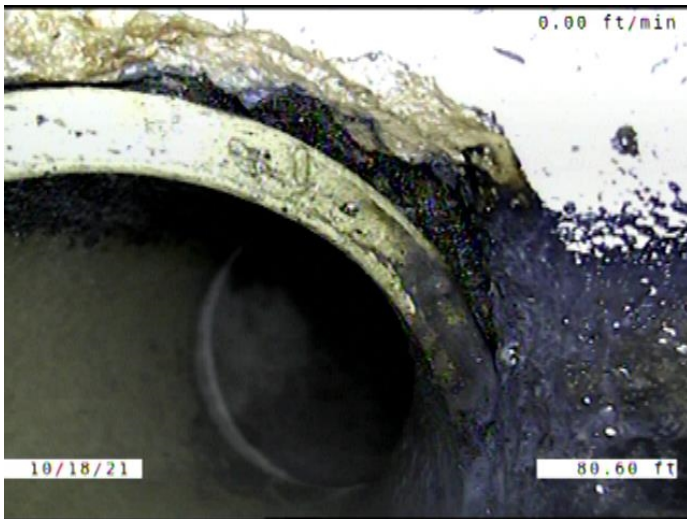
Code: **FM**
Description: **Fracture Multiple**

Distance (ft): **80.6**
Structural Grade: **4**
O&M Grade: **0**
Clock Start/From: **11**
Clock To: **2**
1st Value:
2nd Value:
Value Percent:
Continuous Index:
Within 8" of Joint: **YES**
Remarks:

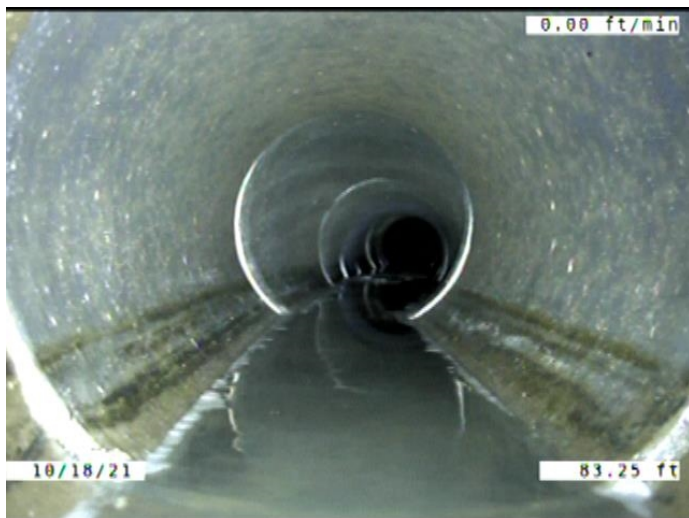
Code: **MWLS**
 Description: **Miscellaneous Water Level Sag**

Distance (ft): **83.3**
 Structural Grade: **2**
 O&M Grade: **0**
 Clock Start/From:
 Clock To:
 1st Value:
 2nd Value:
 Value Percent: **10.000**
 Continuous Index: **S02**
 Within 8" of Joint: **NO**
 Remarks:

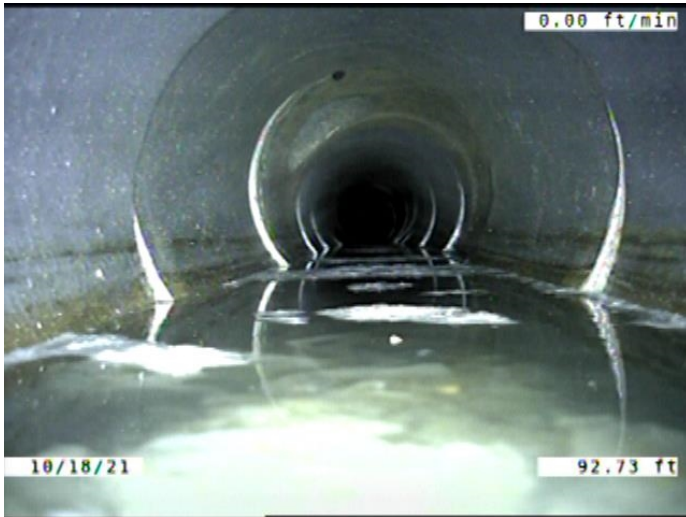
Code: **DSF**
Description: **Deposits Settled Fine**

Distance (ft): **92.7**
Structural Grade: **0**
O&M Grade: **2**
Clock Start/From: **5**
Clock To: **7**
1st Value:
2nd Value:
Value Percent: **5.000**
Continuous Index: **S03**
Within 8" of Joint: **YES**
Remarks:

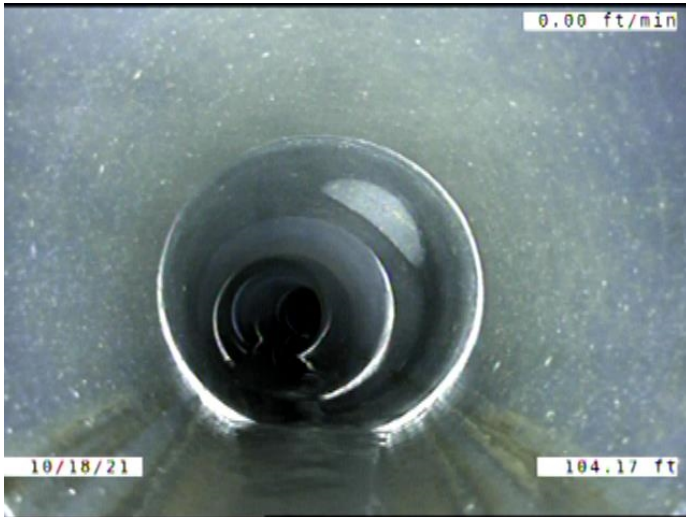
Code: **MWLS**
Description: **Miscellaneous Water Level Sag**

Distance (ft): **104.2**
Structural Grade: **2**
O&M Grade: **0**
Clock Start/From:
Clock To:
1st Value:
2nd Value:
Value Percent: **10.000**
Continuous Index: **F02**
Within 8" of Joint: **NO**
Remarks:

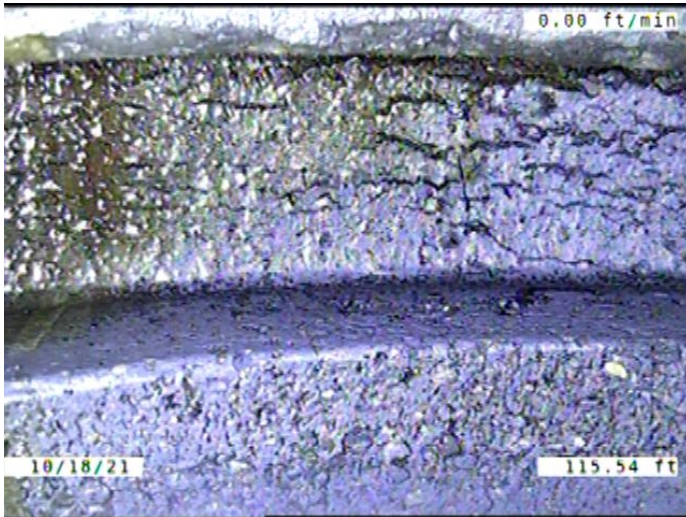
Code: **JAM**
 Description: **Joint Angular Medium**

Distance (ft): **115.5**
 Structural Grade: **3**
 O&M Grade: **0**
 Clock Start/From:
 Clock To:
 1st Value:
 2nd Value:
 Value Percent:
 Continuous Index:
 Within 8" of Joint: **NO**
 Remarks:

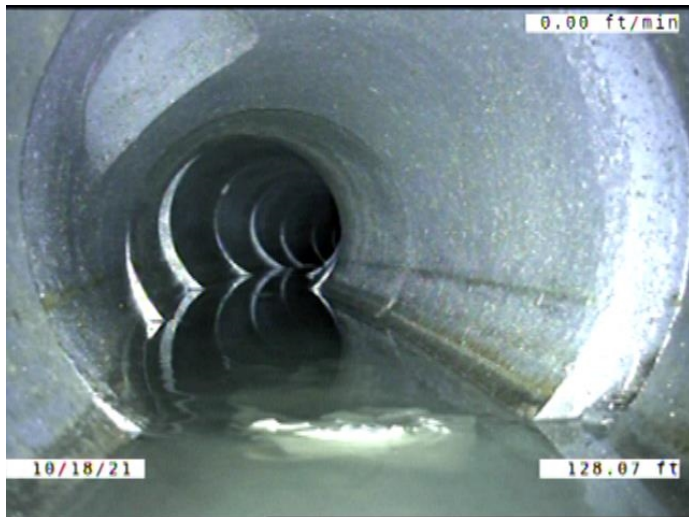
Code: **LL**
 Description: **Line Left**

Distance (ft): **128.1**
 Structural Grade: **0**
 O&M Grade: **1**
 Clock Start/From:
 Clock To:
 1st Value:
 2nd Value:
 Value Percent: **5.000**
 Continuous Index:
 Within 8" of Joint: **NO**
 Remarks:

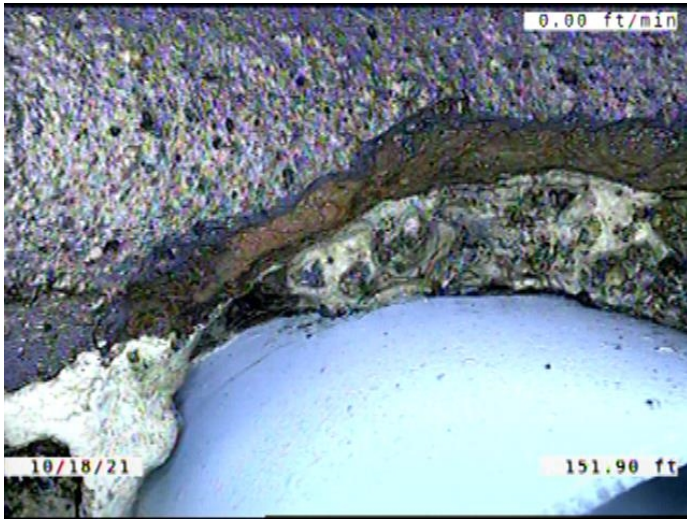
Code: **SSS**
 Description: **Surface Damage Surface Spalling**

Distance (ft): **151.9**
 Structural Grade: **2**
 O&M Grade: **0**
 Clock Start/From: **10**
 Clock To: **1**
 1st Value:
 2nd Value:
 Value Percent:
 Continuous Index:
 Within 8" of Joint: **YES**
 Remarks:

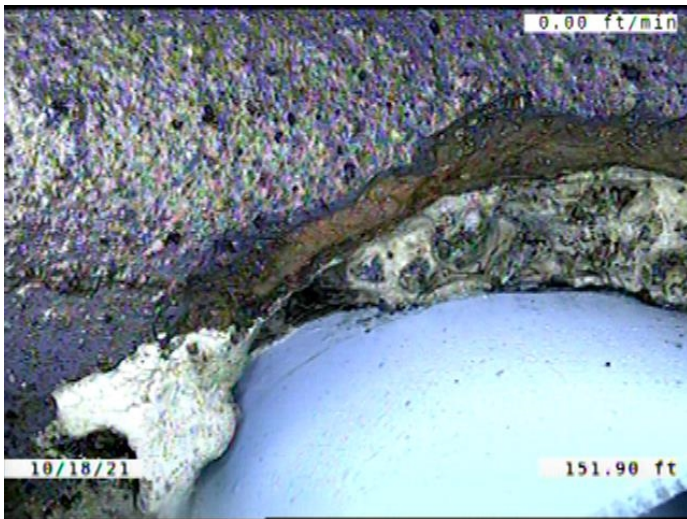
Code: **DAE**
 Description: **Deposits Attached Encrustation**

Distance (ft): **151.9**
 Structural Grade: **0**
 O&M Grade: **2**
 Clock Start/From: **7**
 Clock To: **1**
 1st Value:
 2nd Value:
 Value Percent: **5.000**
 Continuous Index:
 Within 8" of Joint: **YES**
 Remarks:

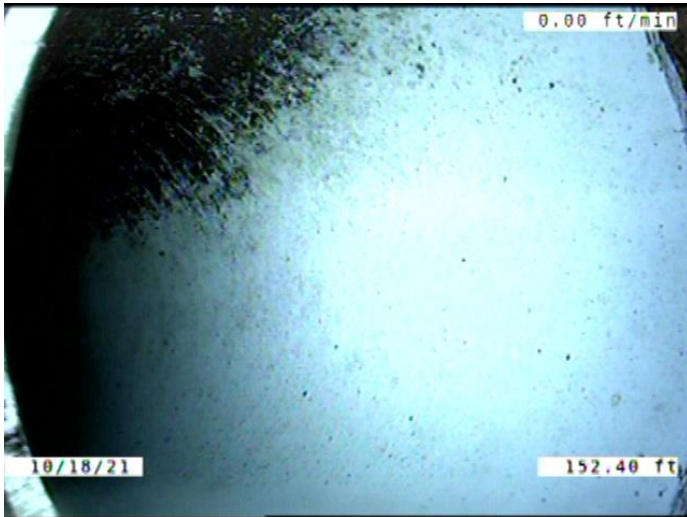
Code: **TBI**
 Description: **Tap Break-in Intruding**

Distance (ft): **152.4**
 Structural Grade: **0**
 O&M Grade: **2**
 Clock Start/From: **11**
 Clock To:
 1st Value: **4.000**
 2nd Value: **4.000**
 Value Percent:
 Continuous Index:
 Within 8" of Joint: **YES**
 Remarks: **CONSTANTLY DRIPPING WATER**

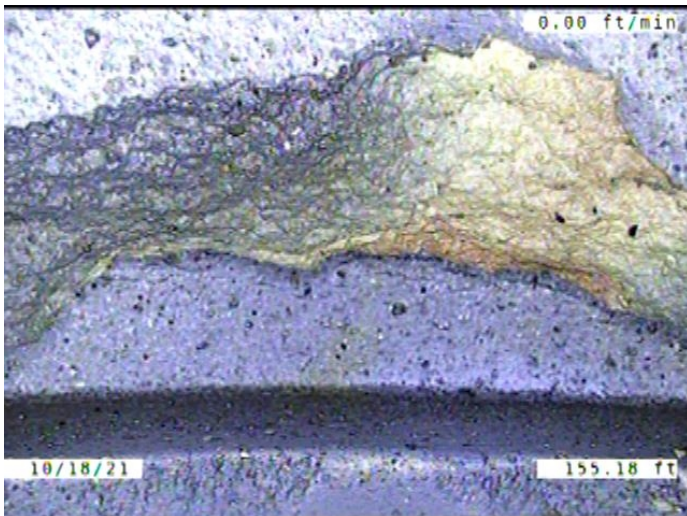
Code: **SMW**
 Description: **Surface Damage Missing Wall**

Distance (ft): **155.2**
 Structural Grade: **5**
 O&M Grade: **0**
 Clock Start/From: **10**
 Clock To: **12**
 1st Value:
 2nd Value:
 Value Percent:
 Continuous Index:
 Within 8" of Joint: **YES**
 Remarks: **INSIDE OF THE JOINT**

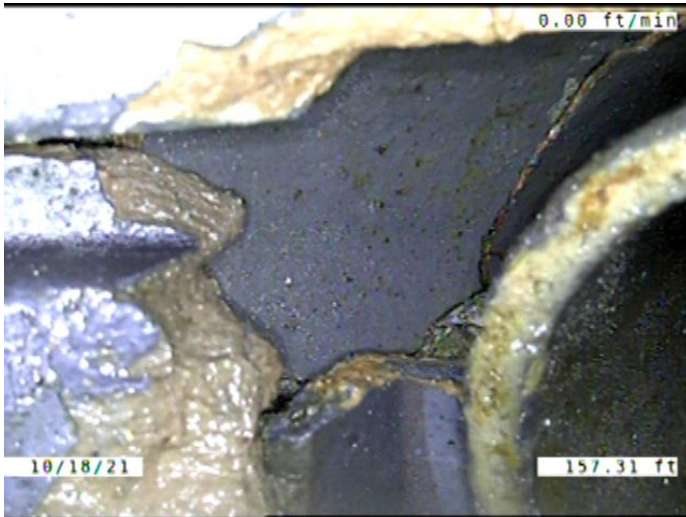
Code: **SSS**
 Description: **Surface Damage Surface Spalling**

Distance (ft): **157.3**
 Structural Grade: **2**
 O&M Grade: **0**
 Clock Start/From: **12**
 Clock To: **3**
 1st Value:
 2nd Value:
 Value Percent:
 Continuous Index:
 Within 8" of Joint: **YES**
 Remarks:

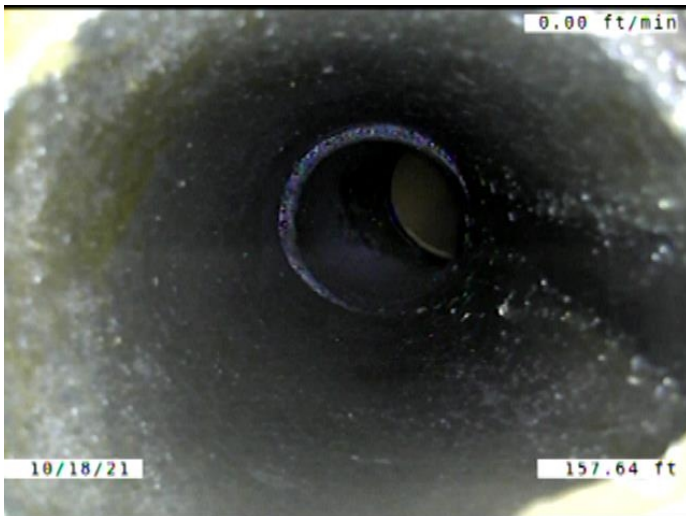
Code: **TBD**
 Description: **Tap Break-in/Hammer Defective**

Distance (ft): **157.6**
 Structural Grade: **0**
 O&M Grade: **3**
 Clock Start/From: **2**
 Clock To:
 1st Value: **4.000**
 2nd Value:
 Value Percent:
 Continuous Index:
 Within 8" of Joint: **YES**
 Remarks: **Defective**

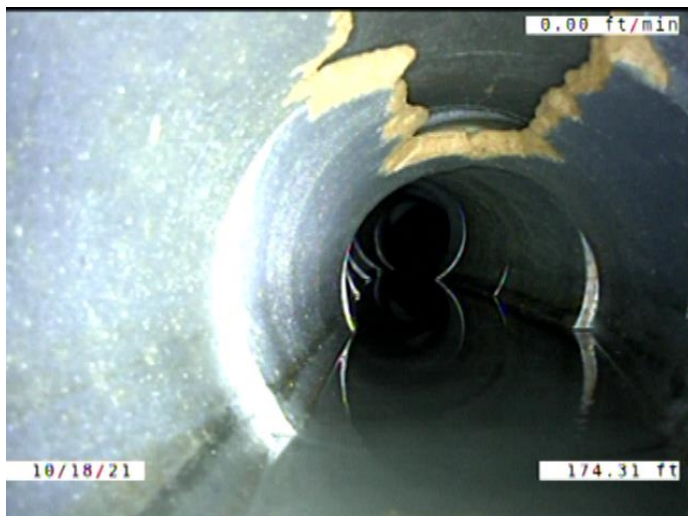
Code: **MWLS**
Description: **Miscellaneous Water Level Sag**

Distance (ft): **174.3**
Structural Grade: **2**
O&M Grade: **0**
Clock Start/From:
Clock To:
1st Value:
2nd Value:
Value Percent: **10.000**
Continuous Index: **S06**
Within 8" of Joint: **NO**
Remarks:

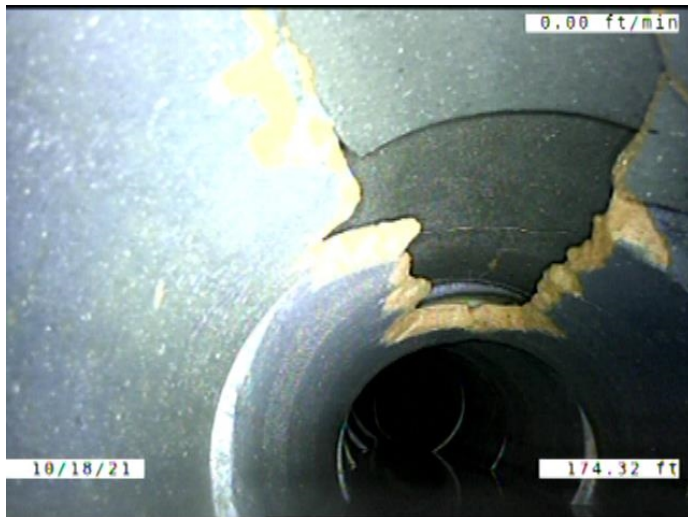
Code: **H**
Description: **Hole**

Distance (ft): **174.3**
Structural Grade: **5**
O&M Grade: **0**
Clock Start/From: **10**
Clock To: **4**
1st Value:
2nd Value:
Value Percent:
Continuous Index: **S07**
Within 8" of Joint: **YES**
Remarks:

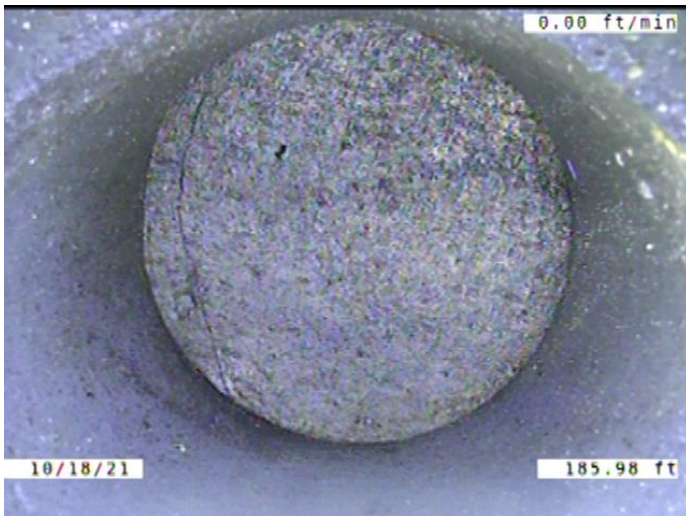
Code: **TFC**
Description: **Tap Factory Capped**

Distance (ft): **186.0**
Structural Grade: **0**
O&M Grade: **0**
Clock Start/From: **1**
Clock To:
1st Value: **4.000**
2nd Value:
Value Percent:
Continuous Index:
Within 8" of Joint: **YES**
Remarks: **CAP CRACKED**

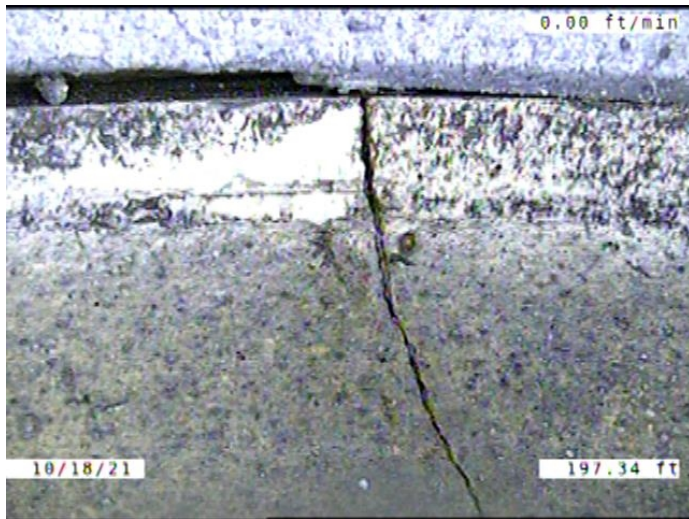
Code: **FM**
 Description: **Fracture Multiple**

Distance (ft): **197.3**
 Structural Grade: **4**
 O&M Grade: **0**
 Clock Start/From: **8**
 Clock To: **1**
 1st Value:
 2nd Value:
 Value Percent:
 Continuous Index:
 Within 8" of Joint: **YES**
 Remarks:

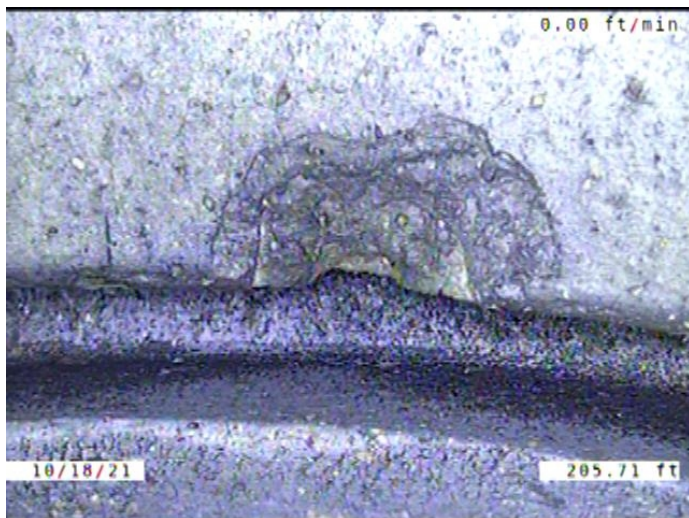
Code: **SZ**
 Description: **Surface Damage Other**

Distance (ft): **205.7**
 Structural Grade: **0**
 O&M Grade: **0**
 Clock Start/From: **2**
 Clock To:
 1st Value:
 2nd Value:
 Value Percent:
 Continuous Index:
 Within 8" of Joint: **YES**
 Remarks: **A PIECE CHIPPED AWAY FROM THE JOINT**

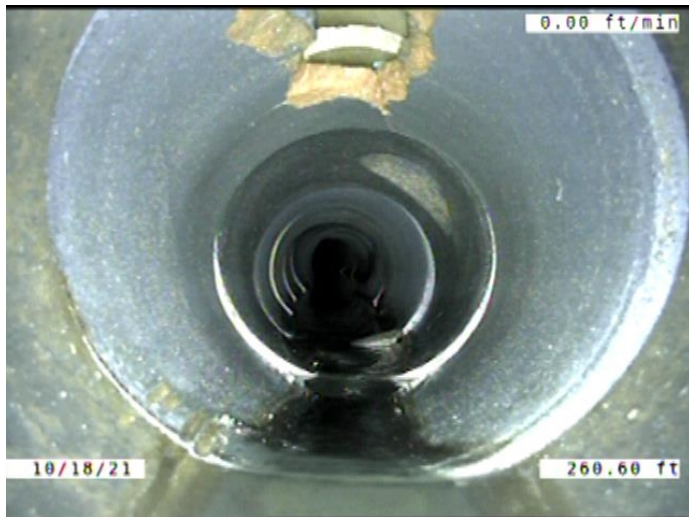
Code: **MWLS**
 Description: **Miscellaneous Water Level Sag**

Distance (ft): **260.6**
 Structural Grade: **2**
 O&M Grade: **0**
 Clock Start/From:
 Clock To:
 1st Value:
 2nd Value:
 Value Percent: **15.000**
 Continuous Index: **F08**
 Within 8" of Joint: **NO**
 Remarks:

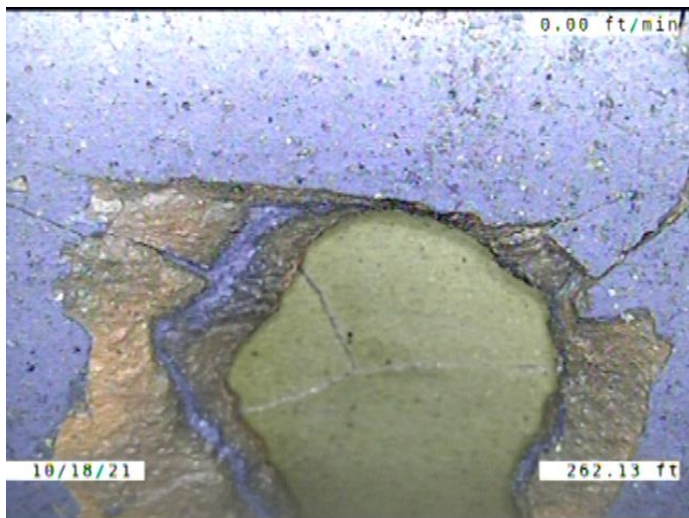
Code: **B**
 Description: **Broken**

Distance (ft): **262.1**
 Structural Grade: **4**
 O&M Grade: **0**
 Clock Start/From: **11**
 Clock To: **1**
 1st Value:
 2nd Value:
 Value Percent:
 Continuous Index:
 Within 8" of Joint: **YES**
 Remarks:

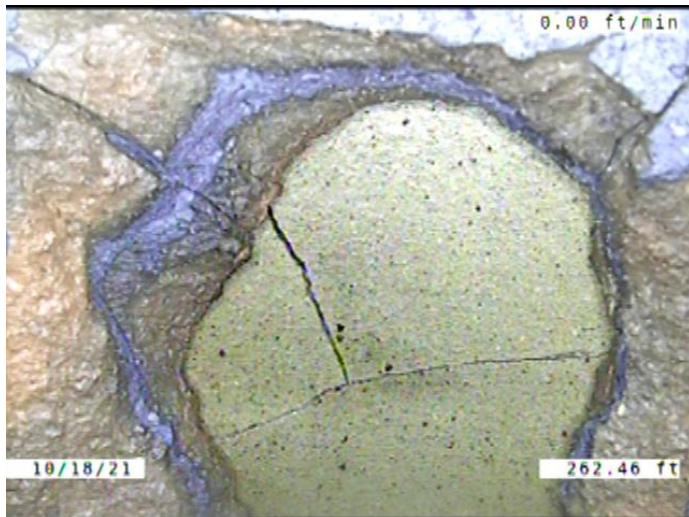
Code: **RPPD**
 Description: **Point Repair Patch Patch Defective**

Distance (ft): **262.5**
 Structural Grade: **4**
 O&M Grade: **0**
 Clock Start/From: **12**
 Clock To:
 1st Value:
 2nd Value:
 Value Percent:
 Continuous Index:
 Within 8" of Joint: **YES**
 Remarks: **REPAIR PIECES BROKEN**

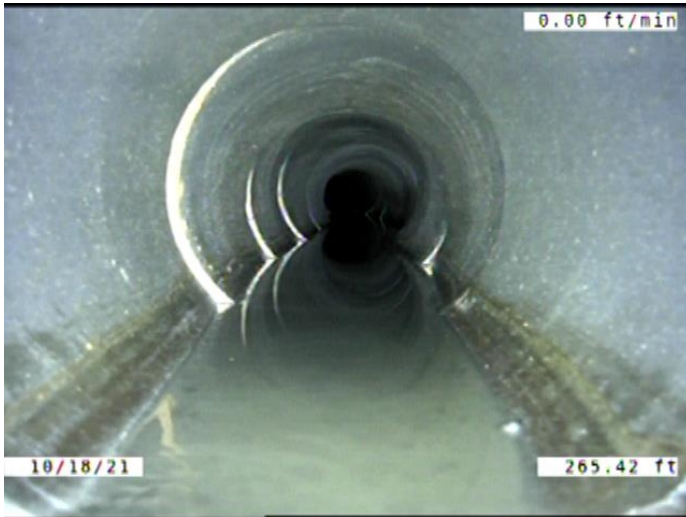
Code: **MWLS**
 Description: **Miscellaneous Water Level Sag**

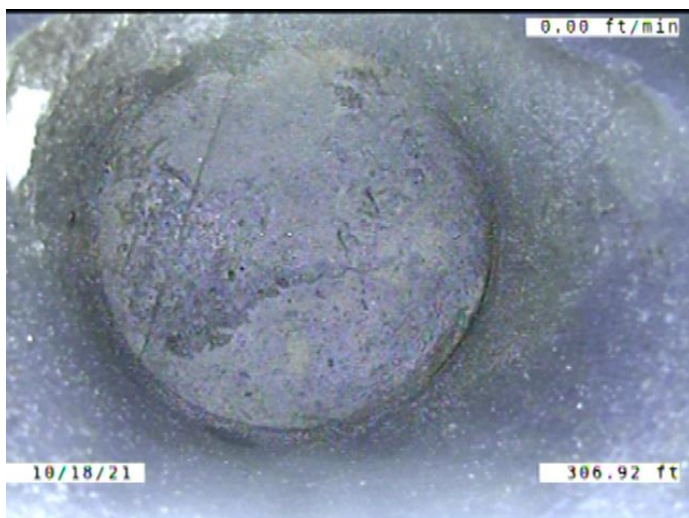
Code: **TFC**
 Description: **Tap Factory Capped**

Distance (ft): **306.9**
 Structural Grade: **0**
 O&M Grade: **0**
 Clock Start/From: **11**
 Clock To:
 1st Value: **4.000**
 2nd Value:
 Value Percent:
 Continuous Index:
 Within 8" of Joint: **YES**
 Remarks: **CAP CRACKED**

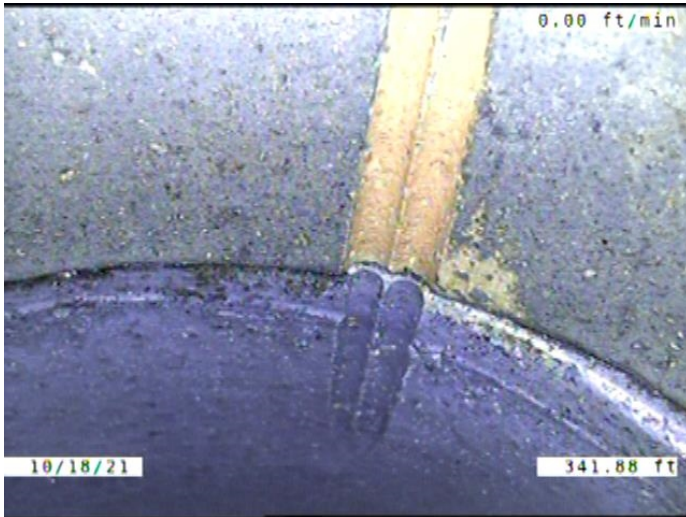
Code: **SZ**
Description: **Surface Damage Other**

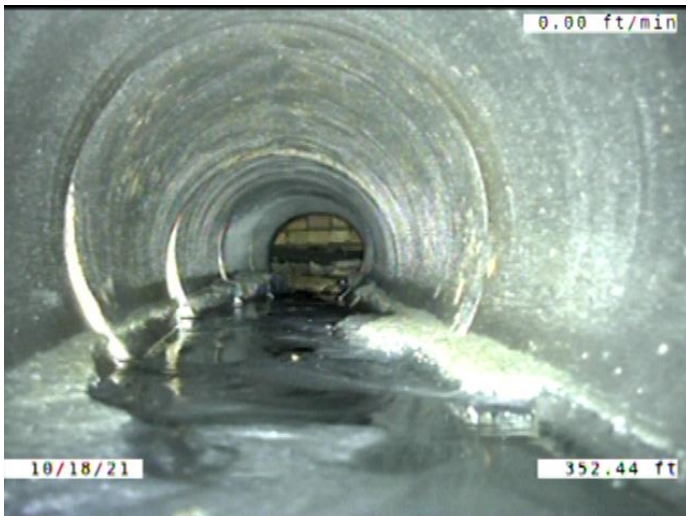
Code: **DSF**
Description: **Deposits Settled Fine**

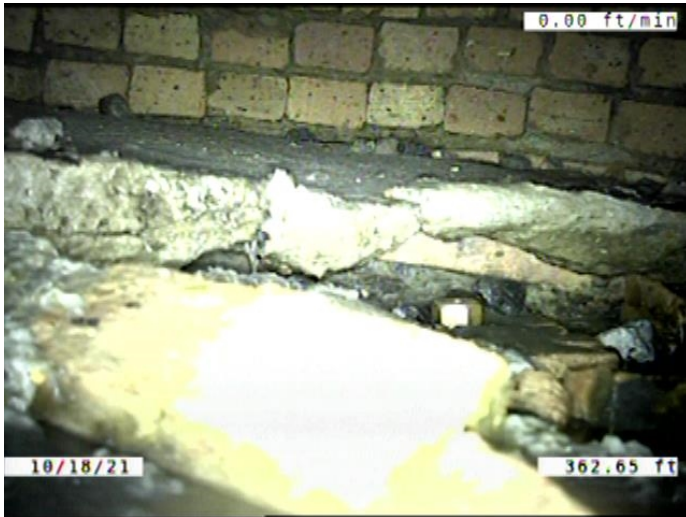
Code: **JAL**
 Description: **Joint Angular Large**
