Profile/Photo Observation Report

| Pipe Length (ft): | 363.8 | Owner: | City of Hobart | Pre Clean: | Heavy Cleaning |

| Street: | North Kelly Street | Flow Control: | Not Controlled |
| US MH: | M-804-013 | DS MH: | M-804-024 |

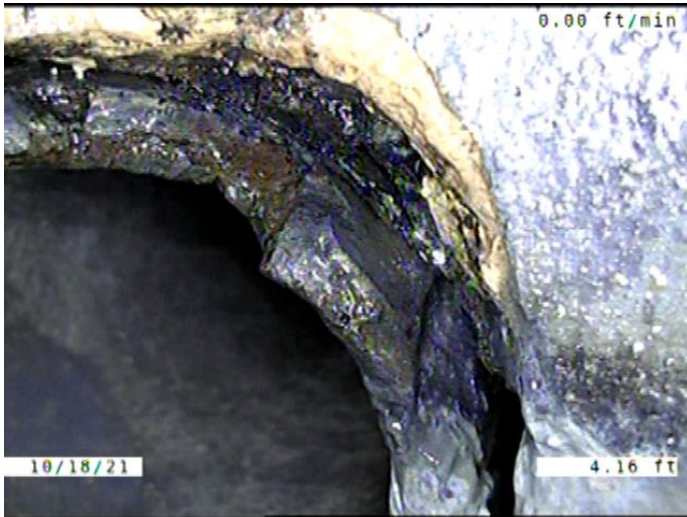
Code: **FC**
 Description: **Fracture Circumferential**

Distance (ft): **3.4**
 Structural Grade: **2**
 O&M Grade: **0**
 Clock Start/From: **2**
 Clock To: **3**
 1st Value:
 2nd Value:
 Value Percent:
 Continuous Index:
 Within 8" of Joint: **YES**
 Remarks:

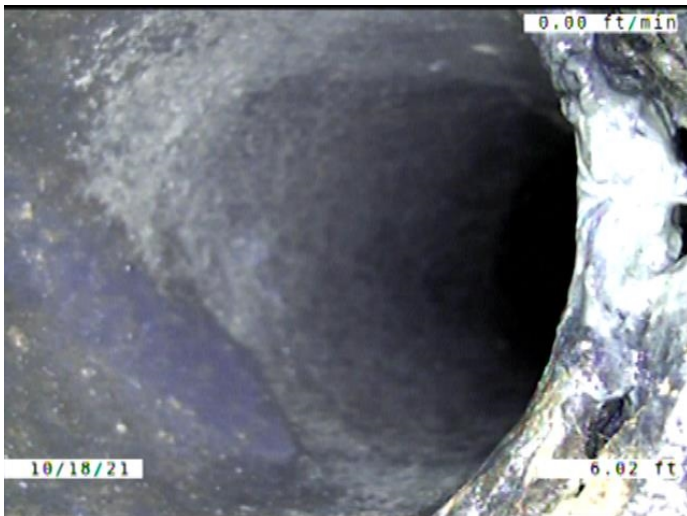
| Description: | Surface Damage Surface Spalling |
| Within 8" of Joint: | YES |

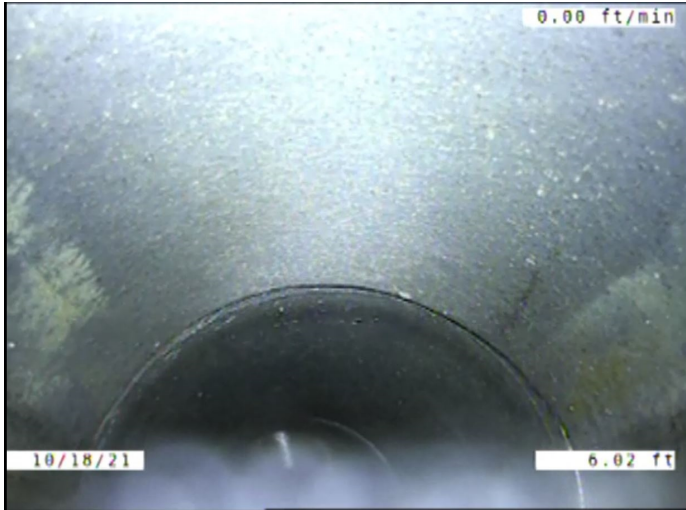
| Description: | Tap Break-in Activity |
| Remarks: | CONSTANTLY RUNNING WATER |

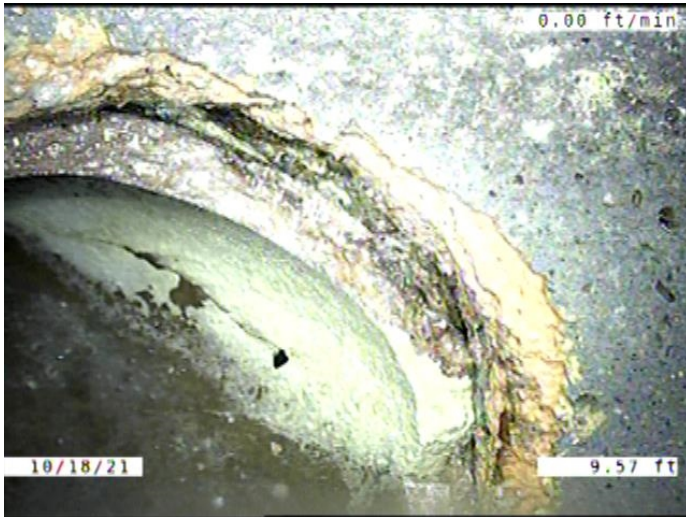
Code: **CL**
 Description: **Crack Longitudinal**

Distance (ft): **6.0**
 Structural Grade: **2**
 O&M Grade: **0**
 Clock Start/From: **2**
 Clock To:
 1st Value:
 2nd Value:
 Value Percent:
 Continuous Index:
 Within 8" of Joint: **YES**
 Remarks:

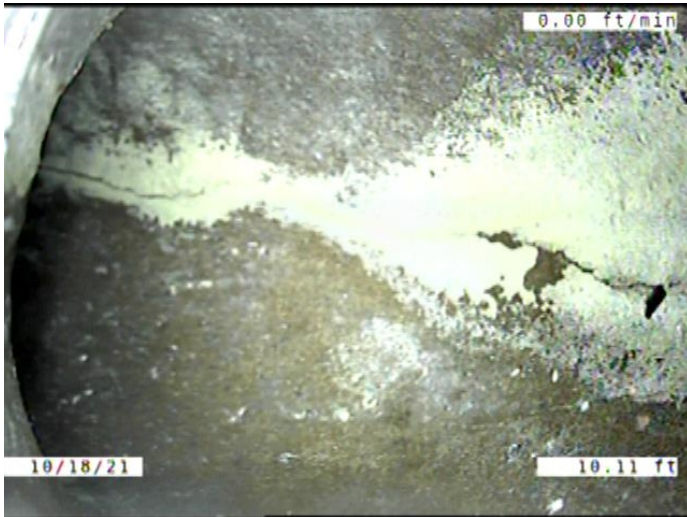
Code: **SSS**
 Description: **Surface Damage Surface Spalling**

Distance (ft): **9.6**
 Structural Grade: **2**
 O&M Grade: **0**
 Clock Start/From: **10**
 Clock To: **2**
 1st Value:
 2nd Value:
 Value Percent:
 Continuous Index:
 Within 8" of Joint: **YES**
 Remarks:

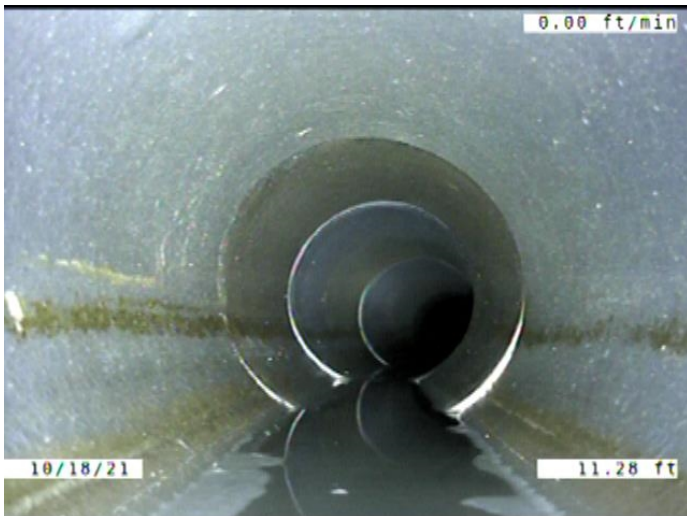
Code: **TBI**
 Description: **Tap Break-in Intruding**

Distance (ft): **10.1**
 Structural Grade: **0**
 O&M Grade: **2**
 Clock Start/From: **12**
 Clock To:
 1st Value: **4.000**
 2nd Value: **3.000**
 Value Percent:
 Continuous Index:
 Within 8" of Joint: **YES**
 Remarks: **Section of lateral missing**

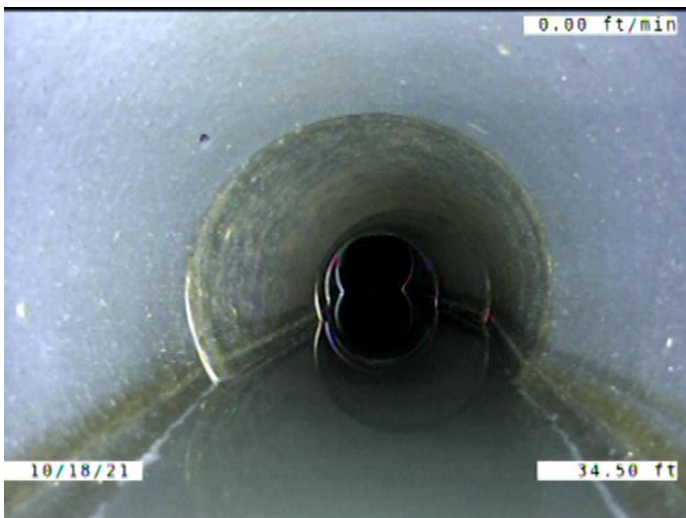
Code: **TFC**
 Description: **Tap Factory Capped**

Distance (ft): **30.0**
 Structural Grade: **0**
 O&M Grade: **0**
 Clock Start/From: **11**
 Clock To:
 1st Value: **4.000**
 2nd Value:
 Value Percent:
 Continuous Index:
 Within 8" of Joint: **YES**
 Remarks: **ENCRUSTATION IN THE TAP**

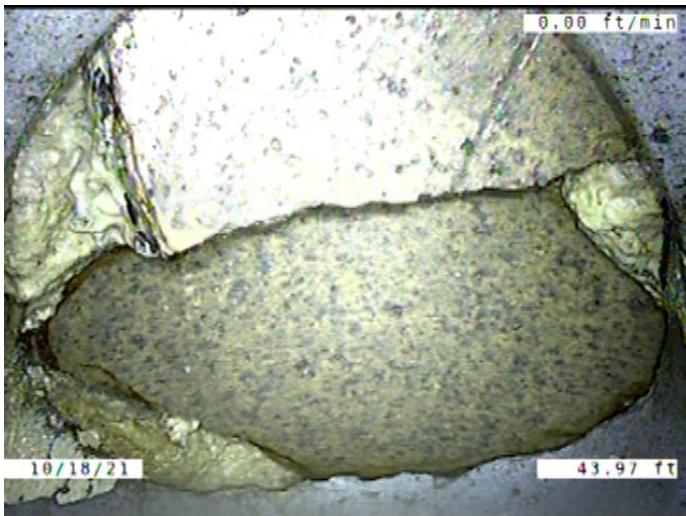
Code: **CM**
 Description: **Crack Multiple**

Distance (ft): **44.0**
 Structural Grade: **3**
 O&M Grade: **0**
 Clock Start/From: **11**
 Clock To: **3**
 1st Value:
 2nd Value:
 Value Percent:
 Continuous Index:
 Within 8" of Joint: **YES**
 Remarks:

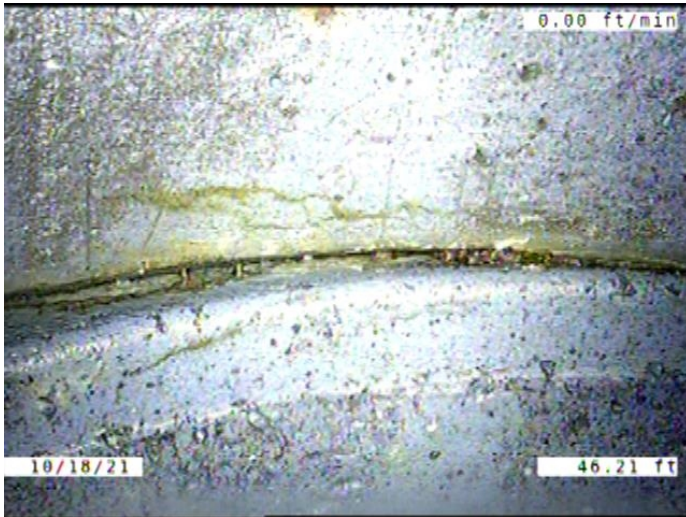
Code: **TFD**
 Description: **Tap Factory Defective**

Distance (ft): **44.0**
 Structural Grade: **0**
 O&M Grade: **3**
 Clock Start/From: **12**
 Clock To:
 1st Value: **4.000**
 2nd Value:
 Value Percent:
 Continuous Index:
 Within 8" of Joint: **YES**
 Remarks: **CAP BROKEN AND ENCUSTATION
 AROUND THE CAP**

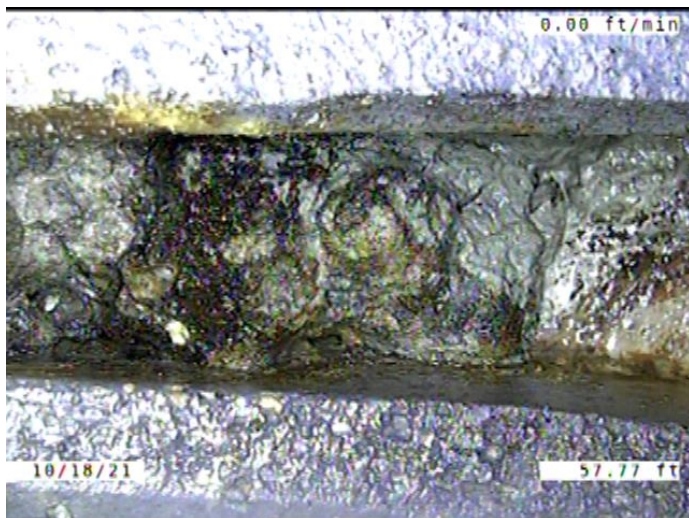
Code: **JAL**
 Description: **Joint Angular Large**

Distance (ft): **57.8**
 Structural Grade: **4**
 O&M Grade: **0**
 Clock Start/From:
 Clock To:
 1st Value:
 2nd Value:
 Value Percent:
 Continuous Index:
 Within 8" of Joint: **NO**
 Remarks:

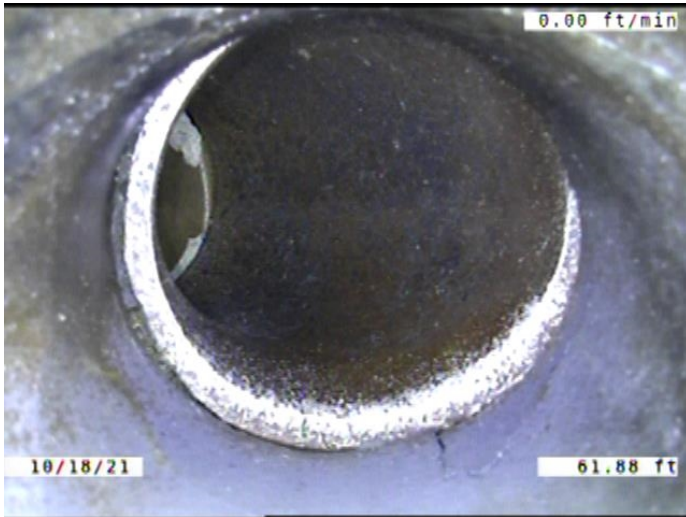
Code: **FM**
 Description: **Fracture Multiple**

Distance (ft): **60.7**
 Structural Grade: **4**
 O&M Grade: **0**
 Clock Start/From: **9**
 Clock To: **3**
 1st Value:
 2nd Value:
 Value Percent:
 Continuous Index:
 Within 8" of Joint: **YES**
 Remarks:

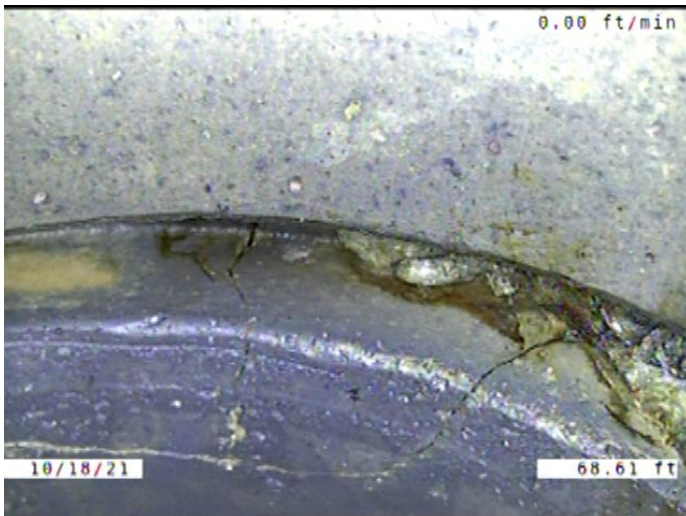
Code: **JAL**
 Description: **Joint Angular Large**

Distance (ft): **63.0**
 Structural Grade: **4**
 O&M Grade: **0**
 Clock Start/From:
 Clock To:
 1st Value:
 2nd Value:
 Value Percent:
 Continuous Index:
 Within 8" of Joint: **NO**
 Remarks:

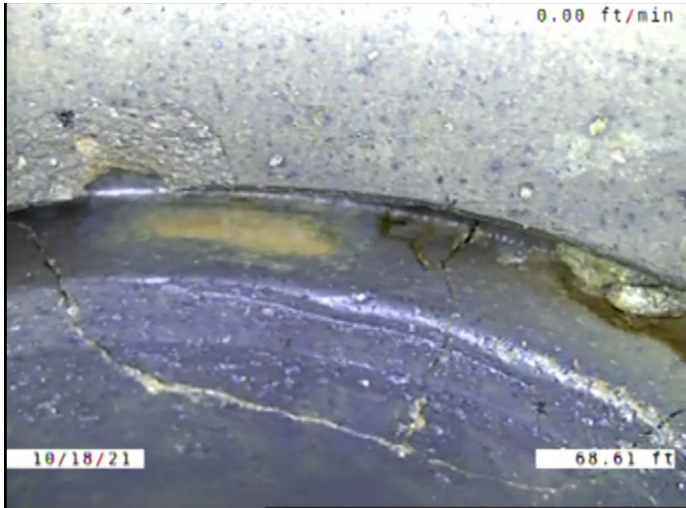
Code: **FM**
 Description: **Fracture Multiple**

Distance (ft): **68.6**
 Structural Grade: **4**
 O&M Grade: **0**
 Clock Start/From: **12**
 Clock To: **4**
 1st Value:
 2nd Value:
 Value Percent:
 Continuous Index:
 Within 8" of Joint: **YES**
 Remarks:

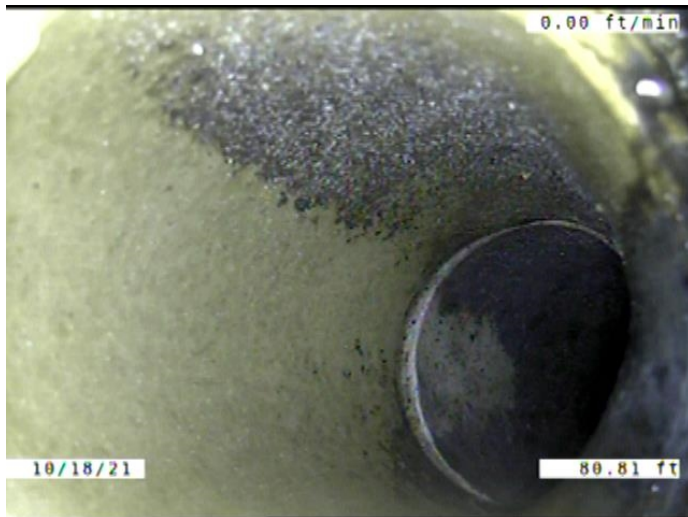
Code: **FM**
Description: **Fracture Multiple**

Distance (ft): **80.6**
Structural Grade: **4**
O&M Grade: **0**
Clock Start/From: **11**
Clock To: **2**
1st Value:
2nd Value:
Value Percent:
Continuous Index:
Within 8" of Joint: **YES**
Remarks:

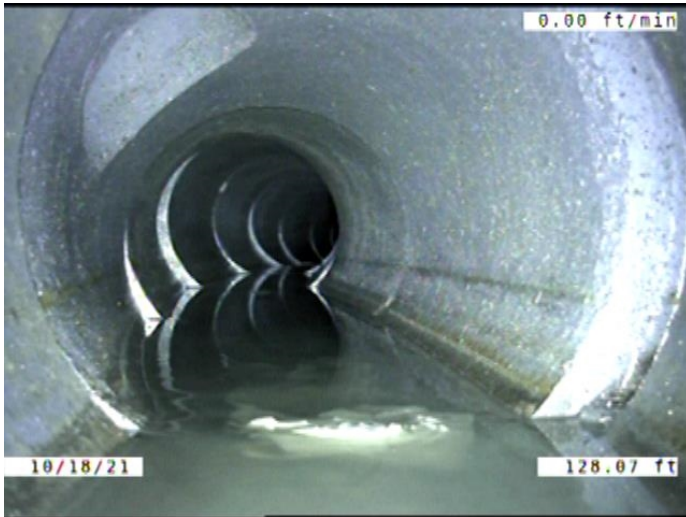
Code: **JAL**
Description: **Joint Angular Large**

Distance (ft): **128.1**
Structural Grade: **4**
O&M Grade: **0**
Clock Start/From:
Clock To:
1st Value:
2nd Value:
Value Percent:
Continuous Index: **S05**
Within 8" of Joint: **NO**
Remarks:

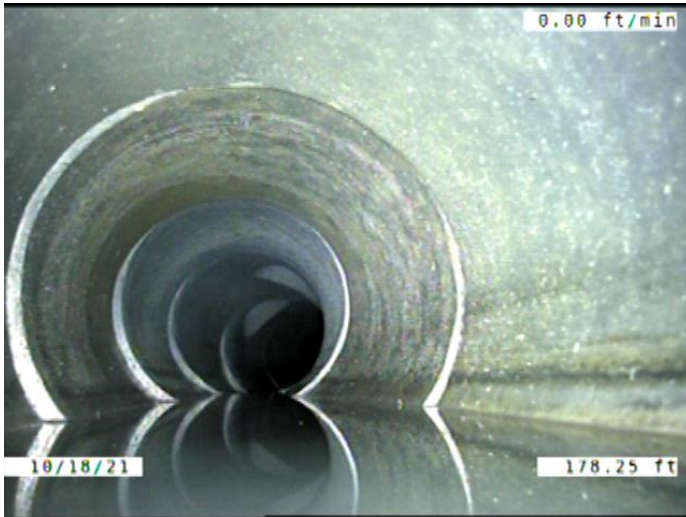
Code: **RPPD**
Description: **Point Repair Patch Patch Defective**

Distance (ft): **174.9**
Structural Grade: **4**
O&M Grade: **0**
Clock Start/From: **11**
Clock To: **1**
1st Value:
2nd Value:
Value Percent:
Continuous Index:
Within 8" of Joint: **YES**
Remarks: **REPAIRED PIECES CRACKED AND FRACTURED**

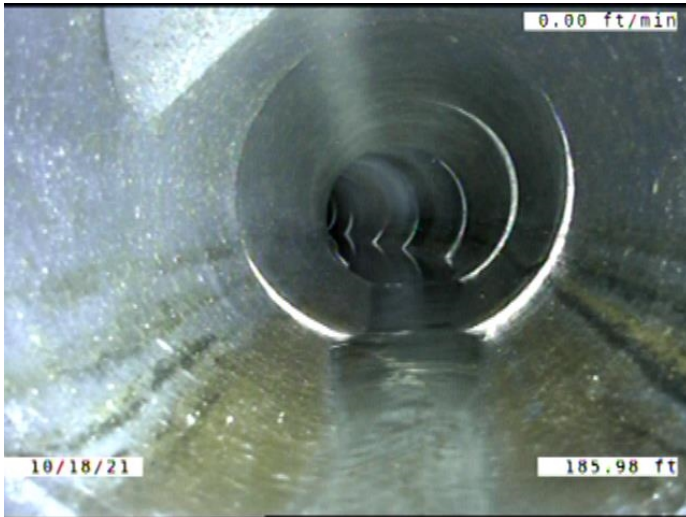
Code: **TFC**
 Description: **Tap Factory Capped**

Distance (ft): **186.0**
 Structural Grade: **0**
 O&M Grade: **0**
 Clock Start/From: **1**
 Clock To:
 1st Value: **4.000**
 2nd Value:
 Value Percent:
 Continuous Index:
 Within 8" of Joint: **YES**
 Remarks: **CAP CRACKED**

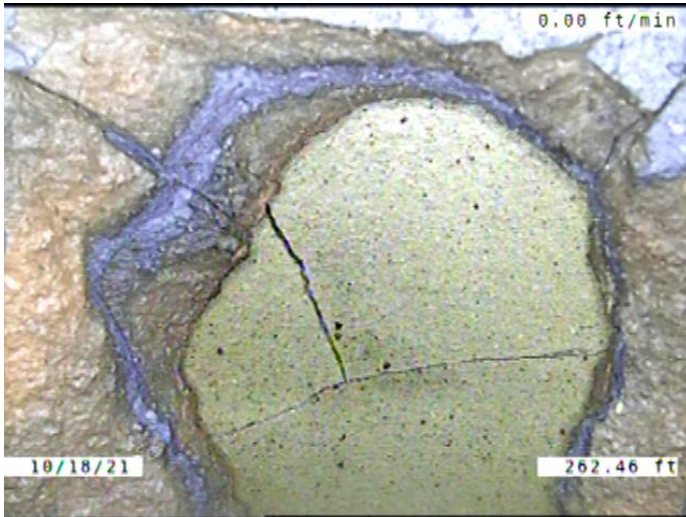
Code: **B**
 Description: **Broken**
