Profile/Photo Observation Report

Date:	04/20/2018	Weather:		Coding:	PACP 6.0
Pipe Length (ft):	383.3	Owner:	NA	Pre Clean:	Not Known
P.O.#:		Surveyor:	Byrd Fitzgerald	PSR:	P-804-013-014
Customer:		Clean Date:	01/01/1900	Shape:	C

Street:	E HOME AVE	Flow Control:	Not Controlled
City:	Hobart, IN	Year Renewed:	
Location:	Other	Tape/Media #:	
Purpose:	Not Known	Dia/Height:	12"
Use:	Sanitary	Material:	VCP
Drain Area:	NA	Lining:	
Category:	NA		
Comment:			
Location Details:		Direction of Survey:	Upstream
US MH:	M-804-014	DS MH:	M-804-013
		Total Length Surveyed (ft):	250.0

M-804-014

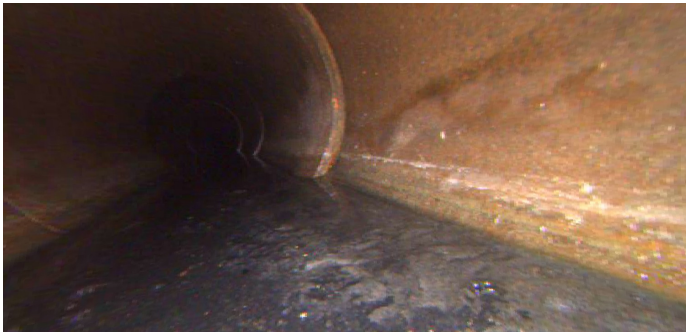
Code: **AMH**
Description: **Manhole**

Distance (ft): **.0**
Structural Grade: **0**
O&M Grade: **0**
Clock Start/From:
Clock To:
1st Value:
2nd Value:
Value Percent:
Continuous Index:
Within 8" of Joint: **NO**
Remarks: **M-804-013**

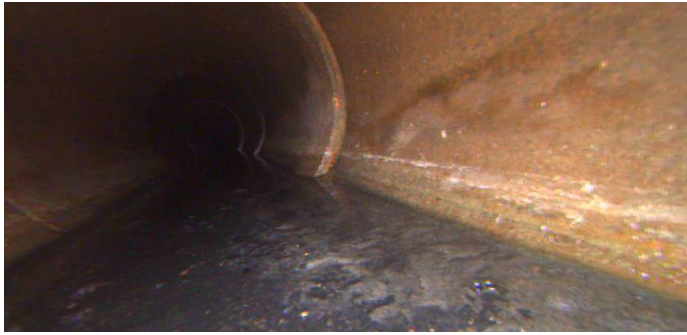
Code: **MWL**
Description: **Water Level**

Distance (ft): **.0**
Structural Grade: **0**
O&M Grade: **0**
Clock Start/From:
Clock To:
1st Value:
2nd Value:
Value Percent: **5.000**
Continuous Index:
Within 8" of Joint: **NO**
Remarks:

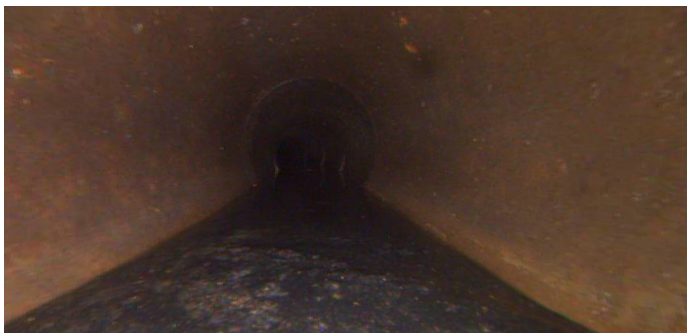
Code: **DSZ**
Description: **Deposits Settled Other**

Distance (ft): **7.9**
Structural Grade: **0**
O&M Grade: **2**
Clock Start/From: **6**
Clock To:
1st Value:
2nd Value:
Value Percent: **5.000**
Continuous Index: **S01**
Within 8" of Joint: **NO**
Remarks: **sediments/debris**

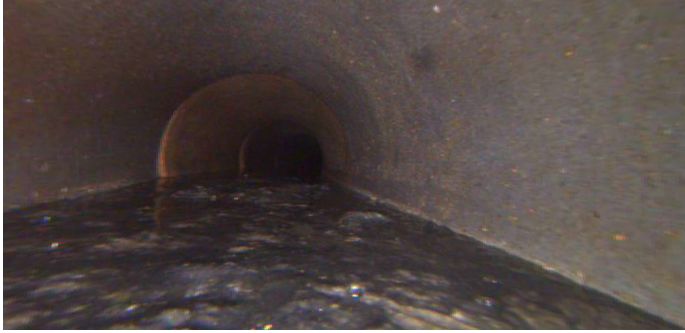
Code: **MWL**
Description: **Water Level**

Distance (ft): **16.6**
Structural Grade: **0**
O&M Grade: **0**
Clock Start/From:
Clock To:
1st Value:
2nd Value:
Value Percent: **25.000**
Continuous Index:
Within 8" of Joint: **NO**
Remarks:

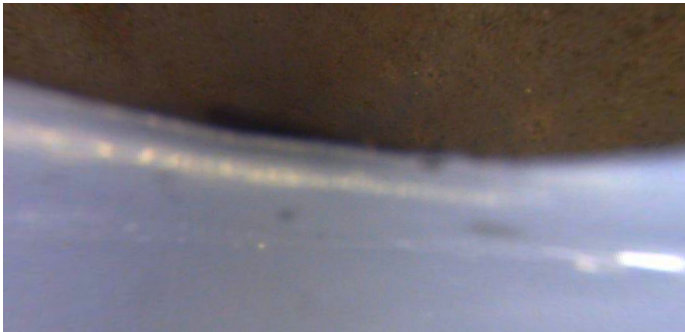
Code: **MCU**
Description: **Camera Underwater**

Distance (ft): **48.1**
Structural Grade: **0**
O&M Grade: **4**
Clock Start/From:
Clock To:
1st Value:
2nd Value:
Value Percent:
Continuous Index:
Within 8" of Joint: **NO**
Remarks: **partially**

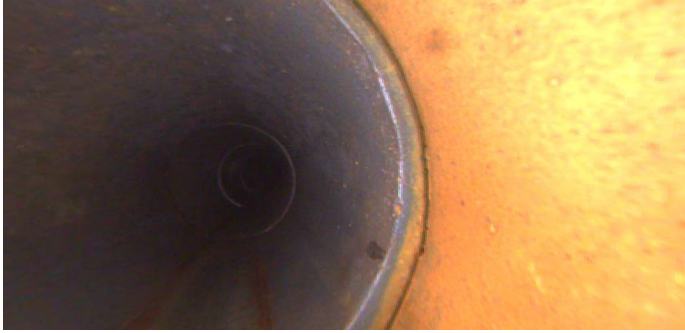
Code: **DSZ**
Description: **Deposits Settled Other**

Distance (ft): **53.6**
Structural Grade: **0**
O&M Grade: **2**
Clock Start/From: **6**
Clock To:
1st Value:
2nd Value:
Value Percent: **5.000**
Continuous Index: **F01**
Within 8" of Joint: **NO**
Remarks: **sediments/debris**

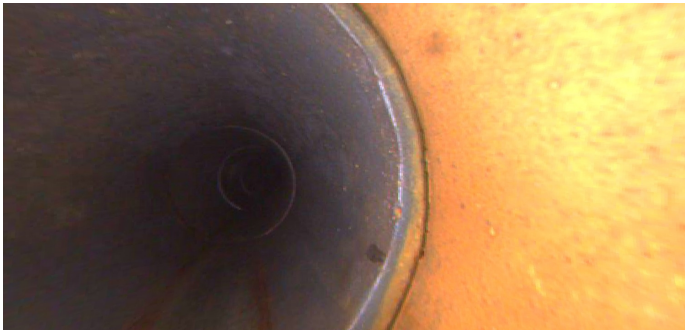
Code: **MWL**
Description: **Water Level**

Distance (ft): **53.6**
Structural Grade: **0**
O&M Grade: **0**
Clock Start/From:
Clock To:
1st Value:
2nd Value:
Value Percent: **5.000**
Continuous Index:
Within 8" of Joint: **NO**
Remarks:

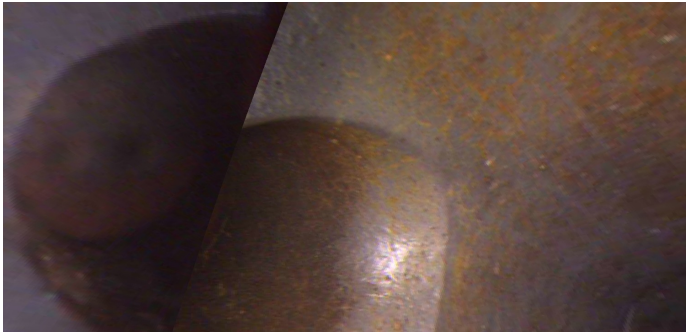
Code: **TFC**
Description: **Tap Factory Capped**

Distance (ft): **58.4**
Structural Grade: **0**
O&M Grade: **0**
Clock Start/From: **10**
Clock To:
1st Value: **4.000**
2nd Value:
Value Percent:
Continuous Index:
Within 8" of Joint: **YES**
Remarks:

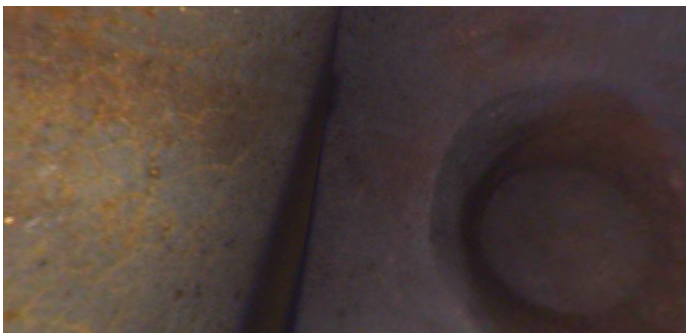
Code: **TFC**
Description: **Tap Factory Capped**

Distance (ft): **62.1**
Structural Grade: **0**
O&M Grade: **0**
Clock Start/From: **2**
Clock To:
1st Value: **4.000**
2nd Value:
Value Percent:
Continuous Index:
Within 8" of Joint: **YES**
Remarks:

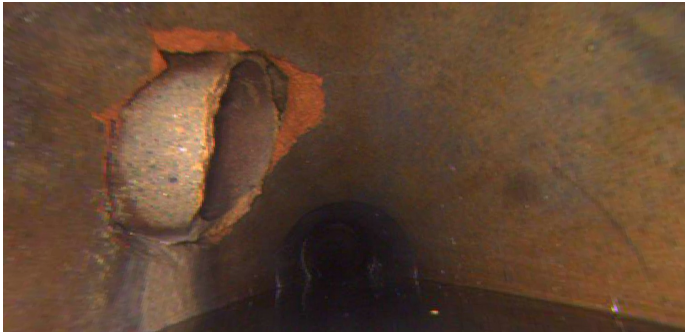
Code: **TBI**
Description: **Tap Break-in Intruding**

Distance (ft): **71.2**
Structural Grade: **0**
O&M Grade: **2**
Clock Start/From: **10**
Clock To:
1st Value: **4.000**
2nd Value: **1.000**
Value Percent:
Continuous Index:
Within 8" of Joint:
Remarks:

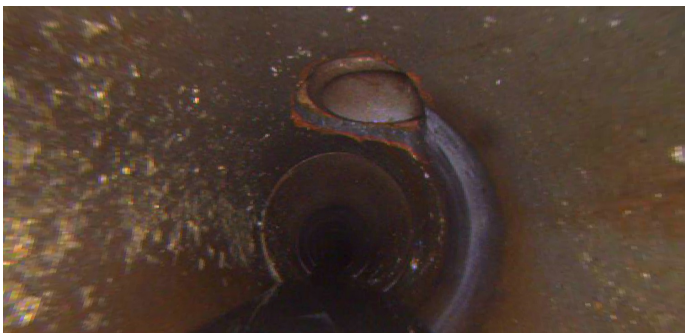
Code: **TB**
Description: **Tap Break-in**

Distance (ft): **75.6**
Structural Grade: **0**
O&M Grade: **0**
Clock Start/From: **12**
Clock To:
1st Value: **4.000**
2nd Value:
Value Percent:
Continuous Index:
Within 8" of Joint:
Remarks:

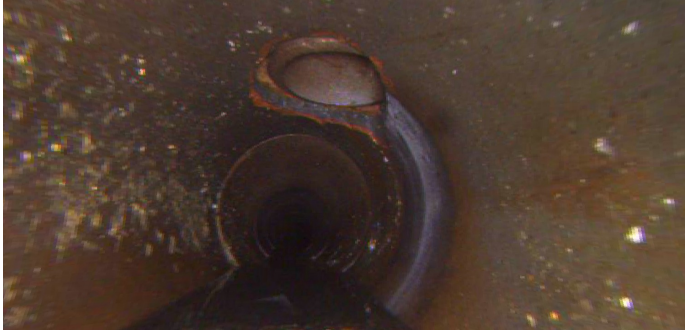
Code: **DAGS**
Description: **Deposits Attached Grease**

Distance (ft): **75.6**
Structural Grade: **0**
O&M Grade: **2**
Clock Start/From: **2**
Clock To: **5**
1st Value:
2nd Value:
Value Percent: **5.000**
Continuous Index:
Within 8" of Joint: **NO**
Remarks:

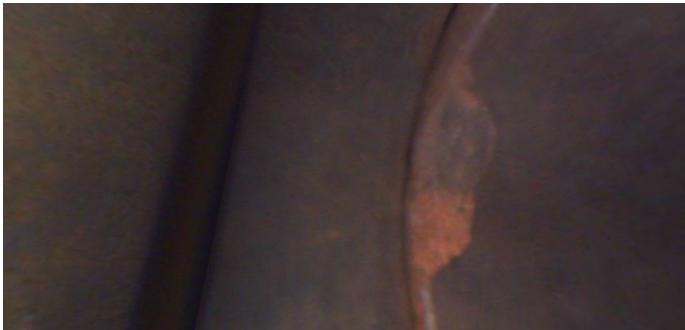
Code: **MGO**
Description: **General Observation**

Distance (ft): **81.7**
Structural Grade: **0**
O&M Grade: **0**
Clock Start/From:
Clock To:
1st Value:
2nd Value:
Value Percent:
Continuous Index:
Within 8" of Joint: **NO**
Remarks: **chip at joint**

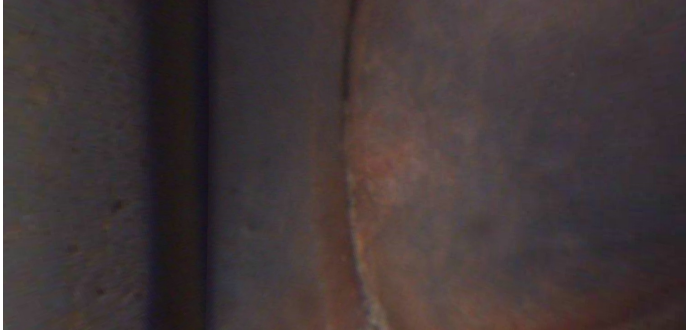
Code: **MGO**
Description: **General Observation**

Distance (ft): **89.7**
Structural Grade: **0**
O&M Grade: **0**
Clock Start/From:
Clock To:
1st Value:
2nd Value:
Value Percent:
Continuous Index:
Within 8" of Joint: **NO**
Remarks: **chip at joint**

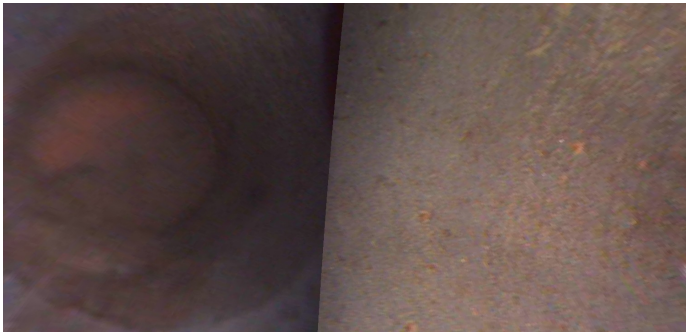
Code: **TFC**
Description: **Tap Factory Capped**

Distance (ft): **105.0**
Structural Grade: **0**
O&M Grade: **0**
Clock Start/From: **10**
Clock To:
1st Value: **4.000**
2nd Value:
Value Percent:
Continuous Index:
Within 8" of Joint: **YES**
Remarks:

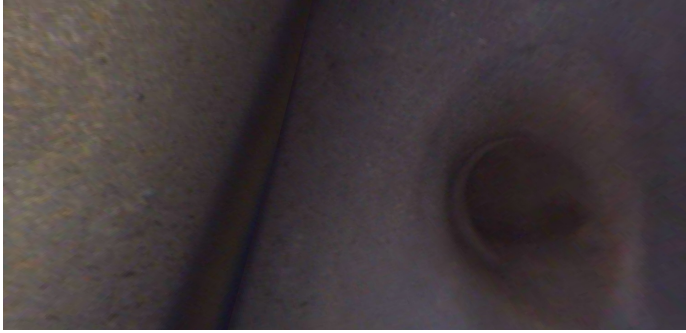
Code: **TF**
Description: **Tap Factory**

Distance (ft): **108.0**
Structural Grade: **0**
O&M Grade: **0**
Clock Start/From: **2**
Clock To:
1st Value: **4.000**
2nd Value:
Value Percent:
Continuous Index:
Within 8" of Joint: **YES**
Remarks:

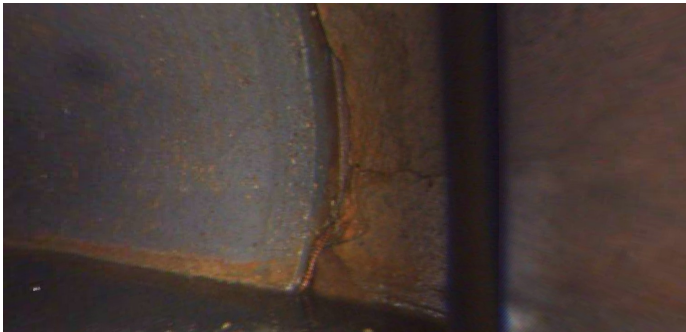
Code: **CL**
Description: **Crack Longitudinal**

Distance (ft): **117.3**
Structural Grade: **2**
O&M Grade: **0**
Clock Start/From: **4**
Clock To:
1st Value:
2nd Value:
Value Percent:
Continuous Index:
Within 8" of Joint: **YES**
Remarks:

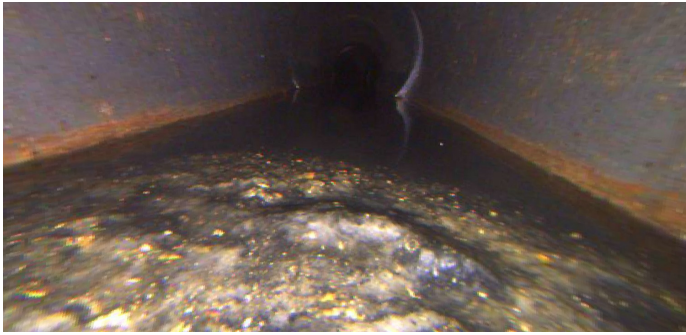
Code: **DSZ**
Description: **Deposits Settled Other**

Distance (ft): **117.3**
Structural Grade: **0**
O&M Grade: **3**
Clock Start/From: **6**
Clock To:
1st Value:
2nd Value:
Value Percent: **15.000**
Continuous Index:
Within 8" of Joint: **NO**
Remarks: **debris/sediments**

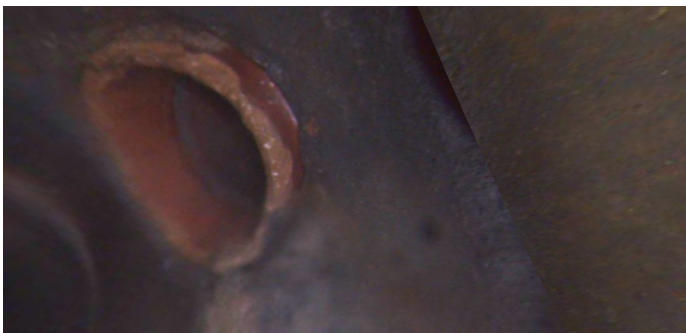
Code: **TB**
Description: **Tap Break-in**

Distance (ft): **125.1**
Structural Grade: **0**
O&M Grade: **0**
Clock Start/From: **10**
Clock To:
1st Value: **4.000**
2nd Value:
Value Percent:
Continuous Index:
Within 8" of Joint: **YES**
Remarks:

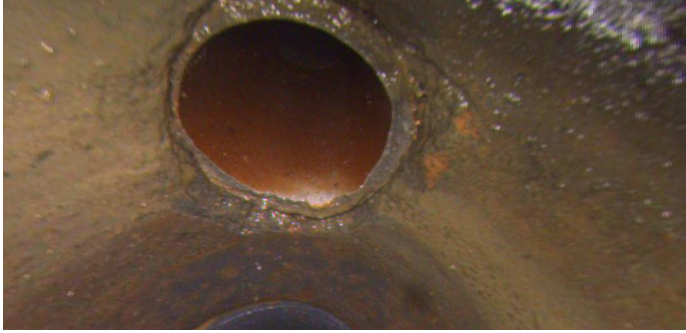
Code: **TB**
Description: **Tap Break-in**

Distance (ft): **130.6**
Structural Grade: **0**
O&M Grade: **0**
Clock Start/From: **12**
Clock To:
1st Value: **4.000**
2nd Value:
Value Percent:
Continuous Index:
Within 8" of Joint:
Remarks:

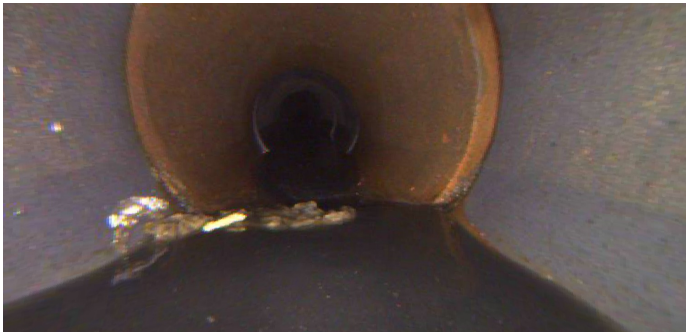
Code: **LD**
Description: **Alignment Down**

Distance (ft): **135.2**
Structural Grade: **0**
O&M Grade: **1**
Clock Start/From:
Clock To:
1st Value:
2nd Value:
Value Percent: **5.000**
Continuous Index:
Within 8" of Joint: **NO**
Remarks:

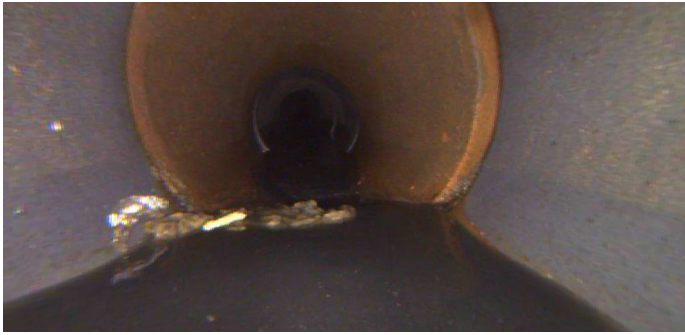
Code: **DSZ**
Description: **Deposits Settled Other**

Distance (ft): **135.2**
Structural Grade: **0**
O&M Grade: **2**
Clock Start/From: **6**
Clock To:
1st Value:
2nd Value:
Value Percent: **5.000**
Continuous Index: **S02**
Within 8" of Joint: **NO**
Remarks: **debris**

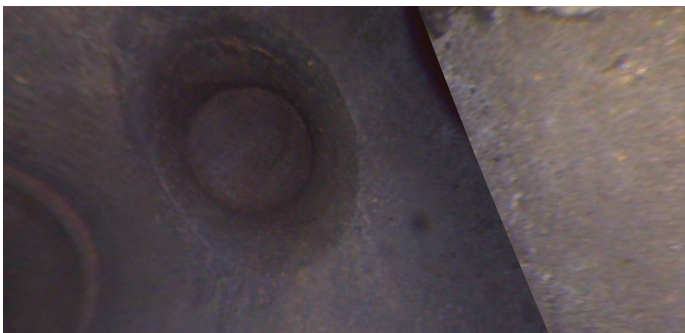
Code: **TFC**
Description: **Tap Factory Capped**

Distance (ft): **159.9**
Structural Grade: **0**
O&M Grade: **0**
Clock Start/From: **10**
Clock To:
1st Value: **4.000**
2nd Value:
Value Percent:
Continuous Index:
Within 8" of Joint: **YES**
Remarks:

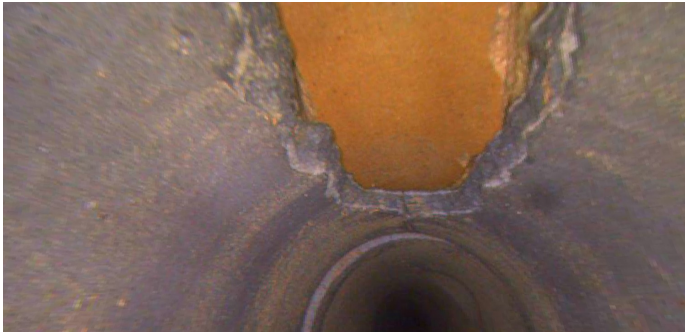
Code: **RPP**
Description: **Repair Patch**

Distance (ft): **159.9**
Structural Grade: **0**
O&M Grade: **0**
Clock Start/From: **12**
Clock To:
1st Value:
2nd Value:
Value Percent:
Continuous Index:
Within 8" of Joint: **NO**
Remarks: **break patched/former accesspoint?**

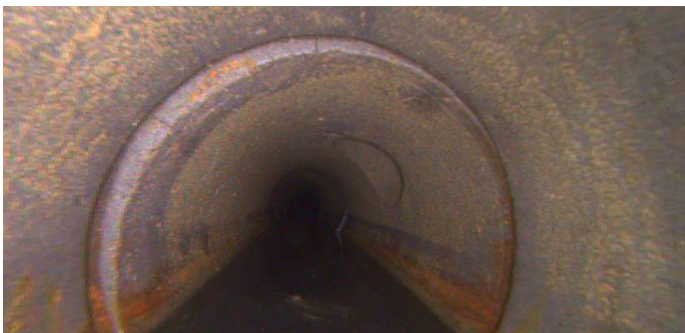
Code: **CM**
Description: **Crack Multiple**

Distance (ft): **160.7**
Structural Grade: **3**
O&M Grade: **0**
Clock Start/From: **7**
Clock To: **12**
1st Value:
2nd Value:
Value Percent:
Continuous Index:
Within 8" of Joint: **YES**
Remarks:

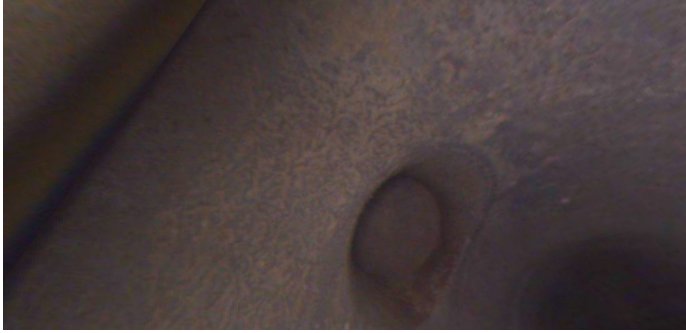
Code: **TFC**
Description: **Tap Factory Capped**

Distance (ft): **163.3**
Structural Grade: **0**
O&M Grade: **0**
Clock Start/From: **2**
Clock To:
1st Value: **4.000**
2nd Value:
Value Percent:
Continuous Index:
Within 8" of Joint: **YES**
Remarks:

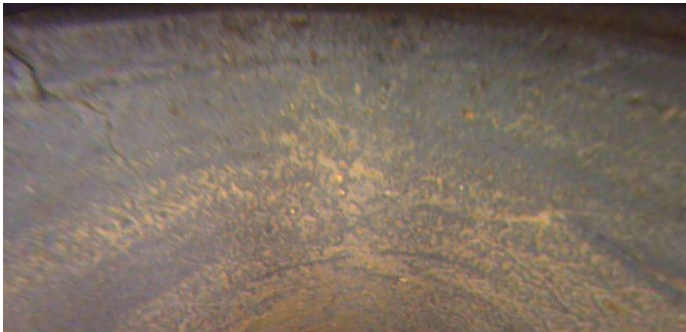
Code: **CM**
Description: **Crack Multiple**

Distance (ft): **172.5**
Structural Grade: **3**
O&M Grade: **0**
Clock Start/From: **9**
Clock To: **4**
1st Value:
2nd Value:
Value Percent:
Continuous Index: **S03**
Within 8" of Joint: **YES**
Remarks: **wandering**

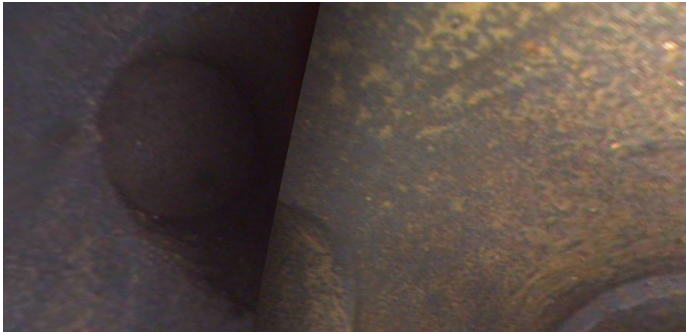
Code: **TFC**
Description: **Tap Factory Capped**

Distance (ft): **206.1**
Structural Grade: **0**
O&M Grade: **0**
Clock Start/From: **10**
Clock To:
1st Value: **4.000**
2nd Value:
Value Percent:
Continuous Index:
Within 8" of Joint: **YES**
Remarks:

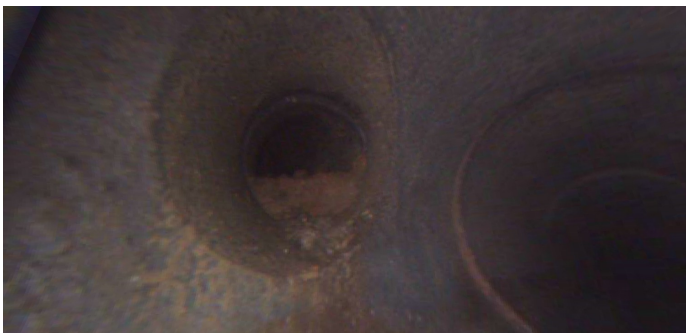
Code: **TFD**
Description: **Tap Factory Defective**

Distance (ft): **208.6**
Structural Grade: **0**
O&M Grade: **2**
Clock Start/From: **2**
Clock To:
1st Value: **4.000**
2nd Value:
Value Percent:
Continuous Index:
Within 8" of Joint: **YES**
Remarks: **partially blocked**

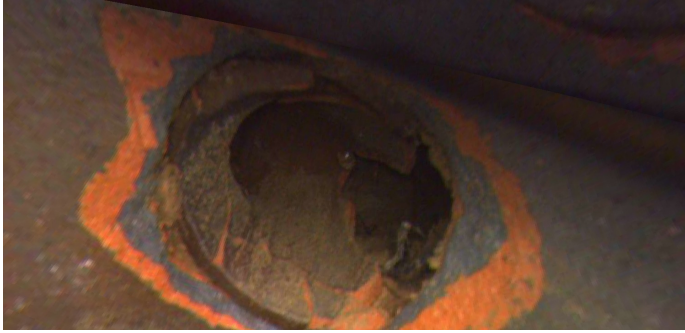
Code: **TBD**
Description: **Tap Break-in Defective**

Distance (ft): **210.4**
Structural Grade: **0**
O&M Grade: **3**
Clock Start/From: **1**
Clock To:
1st Value: **4.000**
2nd Value:
Value Percent:
Continuous Index:
Within 8" of Joint:
Remarks: **tap broken**

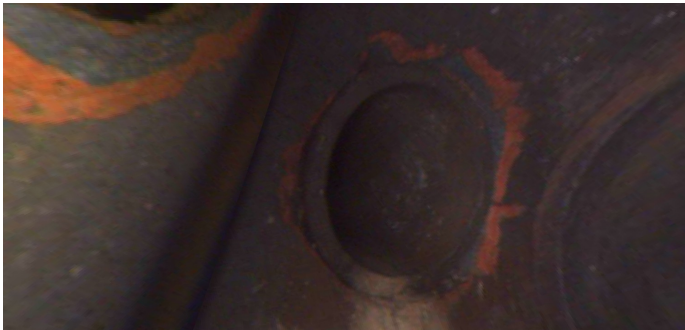
Code: **TB**
Description: **Tap Break-in**

Distance (ft): **210.4**
Structural Grade: **0**
O&M Grade: **0**
Clock Start/From: **2**
Clock To:
1st Value: **4.000**
2nd Value:
Value Percent:
Continuous Index:
Within 8" of Joint: **YES**
Remarks:

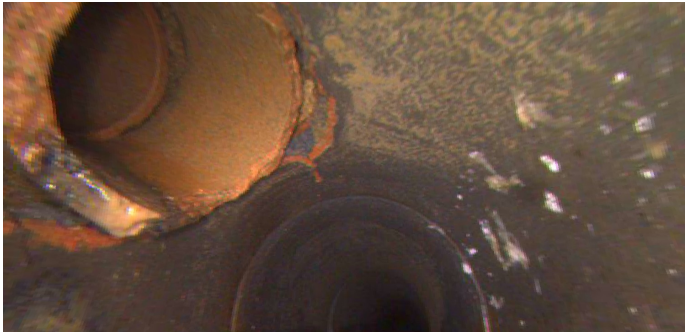
Code: **TB**
Description: **Tap Break-in**

Distance (ft): **212.2**
Structural Grade: **0**
O&M Grade: **0**
Clock Start/From: **11**
Clock To:
1st Value: **4.000**
2nd Value:
Value Percent:
Continuous Index:
Within 8" of Joint:
Remarks:

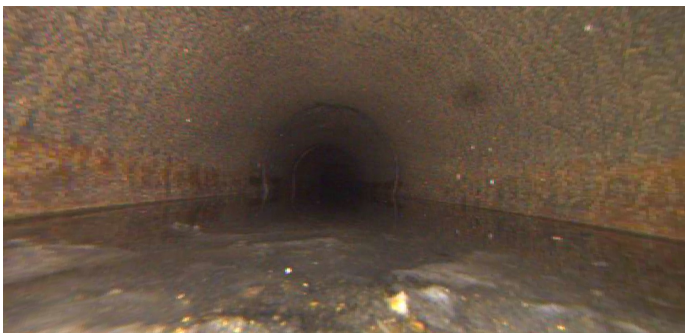
Code: **MWL**
Description: **Water Level**

Distance (ft): **221.4**
Structural Grade: **0**
O&M Grade: **0**
Clock Start/From:
Clock To:
1st Value:
2nd Value:
Value Percent: **25.000**
Continuous Index:
Within 8" of Joint: **NO**
Remarks:

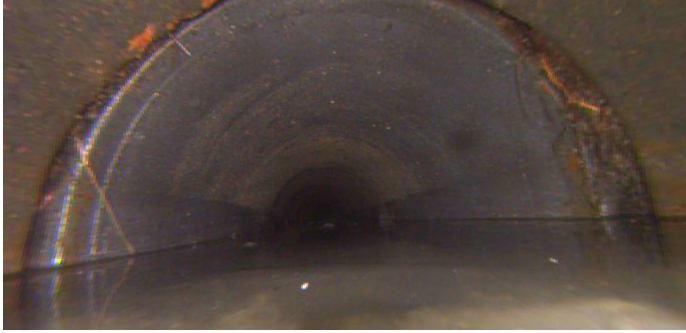
Code: **MWL**
Description: **Water Level**

Distance (ft): **243.0**
Structural Grade: **0**
O&M Grade: **0**
Clock Start/From:
Clock To:
1st Value:
2nd Value:
Value Percent: **50.000**
Continuous Index:
Within 8" of Joint: **NO**
Remarks:

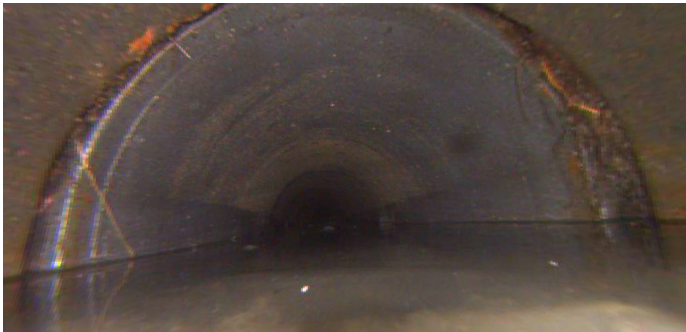
Code: **RFJ**
Description: **Roots Fine Joint**

Distance (ft): **243.0**
Structural Grade: **0**
O&M Grade: **1**
Clock Start/From: **9**
Clock To: **3**
1st Value:
2nd Value:
Value Percent:
Continuous Index:
Within 8" of Joint: **YES**
Remarks:

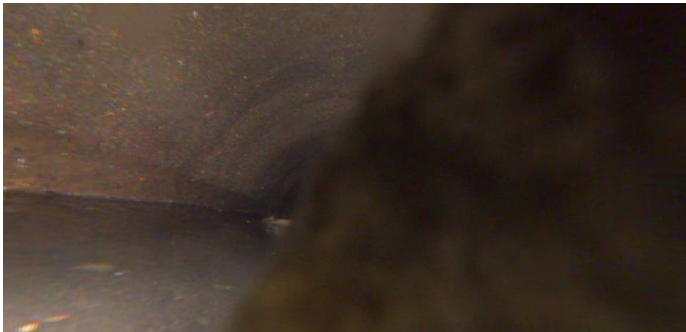
Code: **MSA**
Description: **Abandoned Survey**

Distance (ft): **250.0**
Structural Grade: **0**
O&M Grade: **0**
Clock Start/From:
Clock To:
1st Value:
2nd Value:
Value Percent:
Continuous Index:
Within 8" of Joint: **NO**
Remarks: **no blockage**

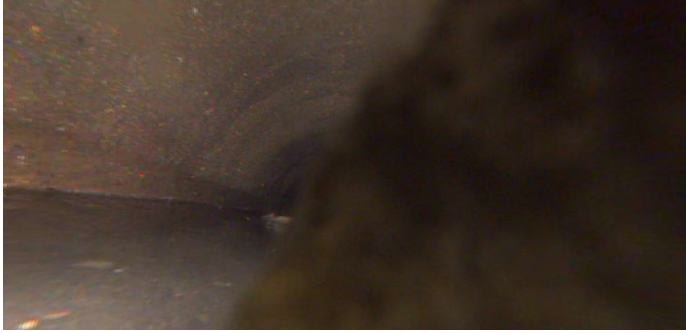
Code: **CM**
Description: **Crack Multiple**

Distance (ft): **250.0**
Structural Grade: **3**
O&M Grade: **0**
Clock Start/From: **9**
Clock To: **4**
1st Value:
2nd Value:
Value Percent:
Continuous Index: **F03**
Within 8" of Joint: **YES**
Remarks: **wandering**

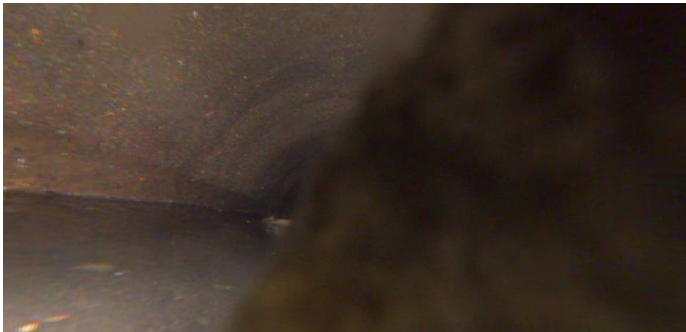
Code: **DSZ**
Description: **Deposits Settled Other**

Distance (ft): **250.0**
Structural Grade: **0**
O&M Grade: **2**
Clock Start/From: **6**
Clock To:
1st Value:
2nd Value:
Value Percent: **5.000**
Continuous Index: **F02**
Within 8" of Joint: **NO**
Remarks: **debris**
