Profile/Photo Observation Report

Date:	04/20/2018	Weather:		Coding:	PACP 6.0
Pipe Length (ft):	383.3	Owner:	NA	Pre Clean:	Not Known
P.O.#:		Surveyor:	Byrd Fitzgerald	PSR:	P-804-013-014
Customer:		Clean Date:	01/01/1900	Shape:	C

Street:	E Home Ave	Flow Control:	Not Controlled
City:	Hobart, IN	Year Renewed:	
Location:	Other	Tape/Media #:	
Purpose:	Not Known	Dia/Height:	12"
Use:	Sanitary	Material:	VCP
Drain Area:	NA	Lining:	
Category:	NA		
Comment:			
Location Details:		Direction of Survey:	Upstream
US MH:	M-804-014	DS MH:	M-804-013
		Total Length Surveyed (ft):	250.0

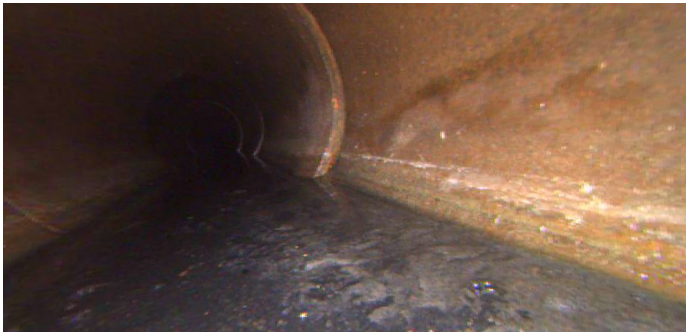
Code: **AMH**
Description: **Manhole**

Distance (ft): **.0**
Structural Grade: **0**
O&M Grade: **0**
Clock Start/From:
Clock To:
1st Value:
2nd Value:
Value Percent:
Continuous Index:
Within 8" of Joint: **NO**
Remarks: **M-804-013**

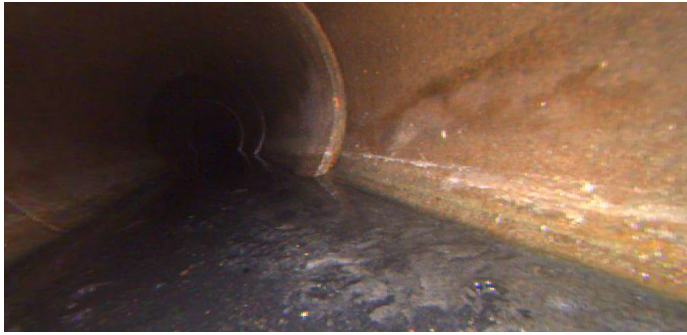
Code: **MWL**
Description: **Water Level**

Distance (ft): **.0**
Structural Grade: **0**
O&M Grade: **0**
Clock Start/From:
Clock To:
1st Value:
2nd Value:
Value Percent: **5.000**
Continuous Index:
Within 8" of Joint: **NO**
Remarks:

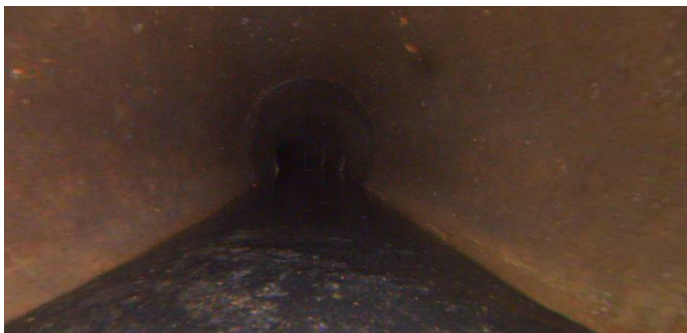
Code: **DSZ**
Description: **Deposits Settled Other**

Distance (ft): **7.9**
Structural Grade: **0**
O&M Grade: **2**
Clock Start/From: **6**
Clock To:
1st Value:
2nd Value:
Value Percent: **5.000**
Continuous Index: **S01**
Within 8" of Joint: **NO**
Remarks: **sediments/debris**

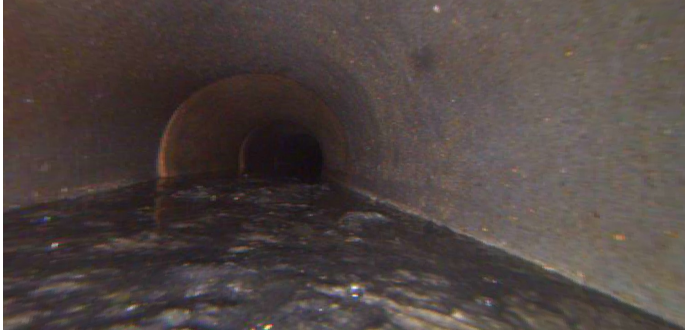
Code: **MWL**
Description: **Water Level**

Distance (ft): **16.6**
Structural Grade: **0**
O&M Grade: **0**
Clock Start/From:
Clock To:
1st Value:
2nd Value:
Value Percent: **25.000**
Continuous Index:
Within 8" of Joint: **NO**
Remarks:

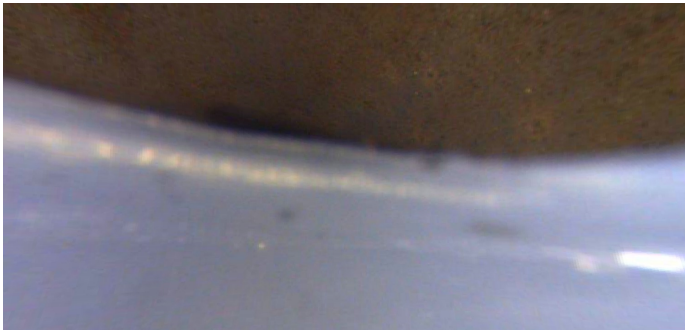
Code: **MCU**
Description: **Camera Underwater**

Distance (ft): **48.1**
Structural Grade: **0**
O&M Grade: **4**
Clock Start/From:
Clock To:
1st Value:
2nd Value:
Value Percent:
Continuous Index:
Within 8" of Joint: **NO**
Remarks: **partially**

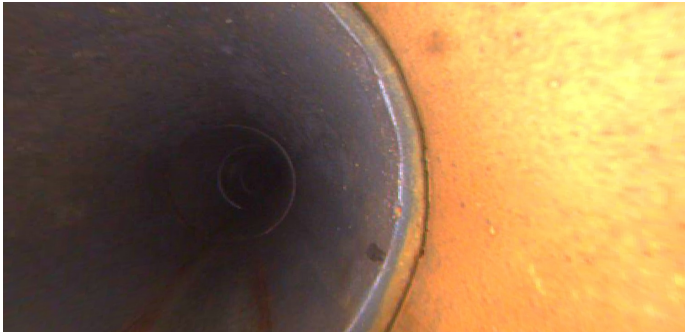
Code: **DSZ**
Description: **Deposits Settled Other**

Distance (ft): **53.6**
Structural Grade: **0**
O&M Grade: **2**
Clock Start/From: **6**
Clock To:
1st Value:
2nd Value:
Value Percent: **5.000**
Continuous Index: **F01**
Within 8" of Joint: **NO**
Remarks: **sediments/debris**

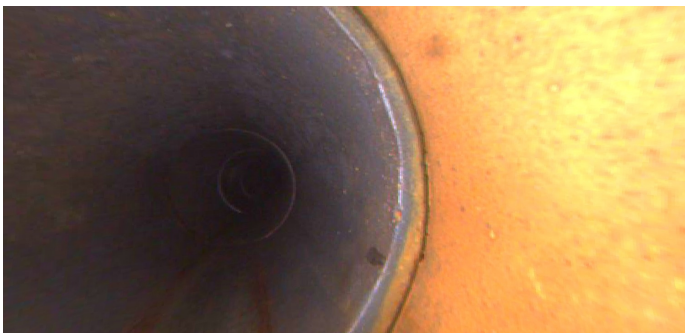
Code: **MWL**
Description: **Water Level**

Distance (ft): **53.6**
Structural Grade: **0**
O&M Grade: **0**
Clock Start/From:
Clock To:
1st Value:
2nd Value:
Value Percent: **5.000**
Continuous Index:
Within 8" of Joint: **NO**
Remarks:

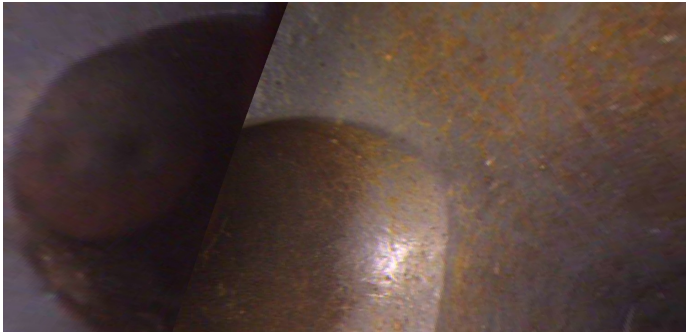
Code: **TFC**
Description: **Tap Factory Capped**

Distance (ft): **58.4**
Structural Grade: **0**
O&M Grade: **0**
Clock Start/From: **10**
Clock To:
1st Value: **4.000**
2nd Value:
Value Percent:
Continuous Index:
Within 8" of Joint: **YES**
Remarks:

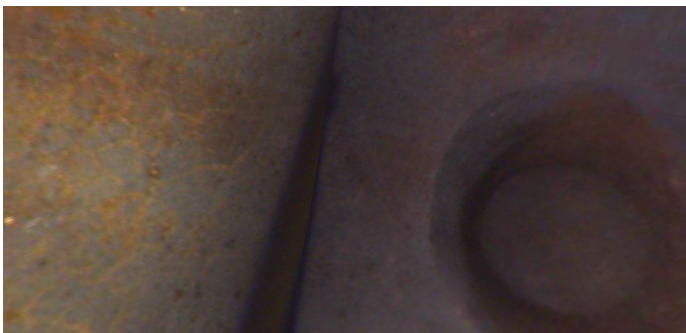
Code: **TFC**
Description: **Tap Factory Capped**

Distance (ft): **62.1**
Structural Grade: **0**
O&M Grade: **0**
Clock Start/From: **2**
Clock To:
1st Value: **4.000**
2nd Value:
Value Percent:
Continuous Index:
Within 8" of Joint: **YES**
Remarks:

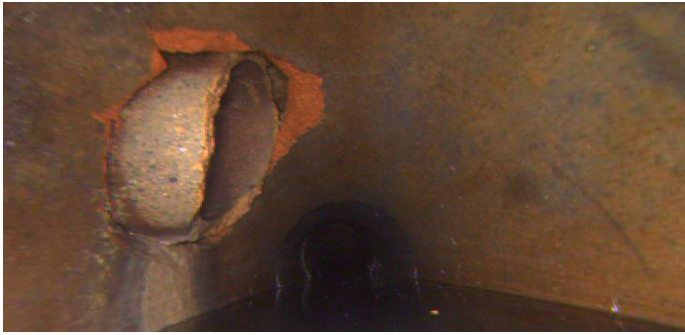
Code: **TBI**
Description: **Tap Break-in Intruding**

Distance (ft): **71.2**
Structural Grade: **0**
O&M Grade: **2**
Clock Start/From: **10**
Clock To:
1st Value: **4.000**
2nd Value: **1.000**
Value Percent:
Continuous Index:
Within 8" of Joint:
Remarks:

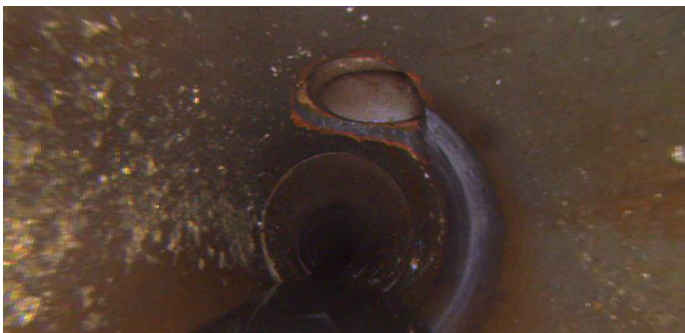
Code: **TB**
Description: **Tap Break-in**

Distance (ft): **75.6**
Structural Grade: **0**
O&M Grade: **0**
Clock Start/From: **12**
Clock To:
1st Value: **4.000**
2nd Value:
Value Percent:
Continuous Index:
Within 8" of Joint:
Remarks:

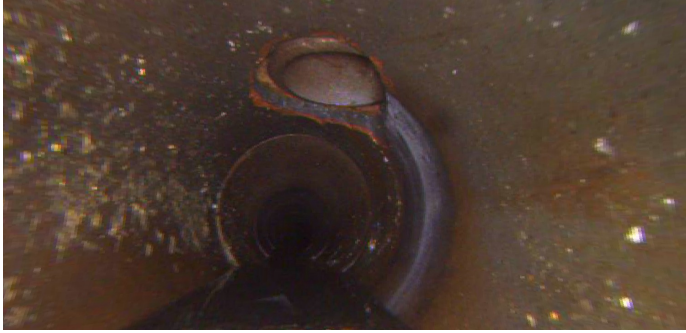
Code: **DAGS**
Description: **Deposits Attached Grease**

Distance (ft): **75.6**
Structural Grade: **0**
O&M Grade: **2**
Clock Start/From: **2**
Clock To: **5**
1st Value:
2nd Value:
Value Percent: **5.000**
Continuous Index:
Within 8" of Joint: **NO**
Remarks:

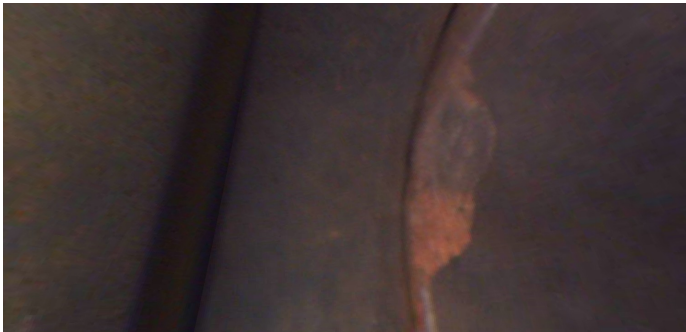
Code: **MGO**
Description: **General Observation**

Distance (ft): **81.7**
Structural Grade: **0**
O&M Grade: **0**
Clock Start/From:
Clock To:
1st Value:
2nd Value:
Value Percent:
Continuous Index:
Within 8" of Joint: **NO**
Remarks: **chip at joint**

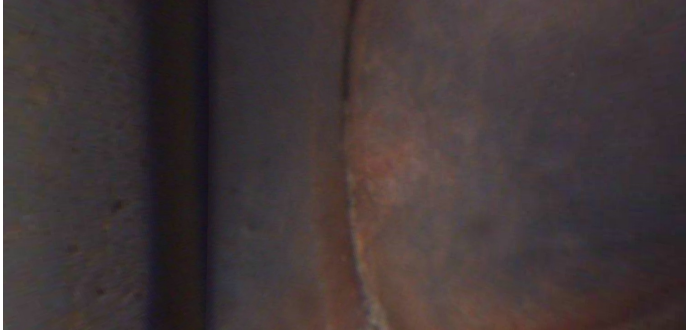
Code: **MGO**
Description: **General Observation**

Distance (ft): **89.7**
Structural Grade: **0**
O&M Grade: **0**
Clock Start/From:
Clock To:
1st Value:
2nd Value:
Value Percent:
Continuous Index:
Within 8" of Joint: **NO**
Remarks: **chip at joint**

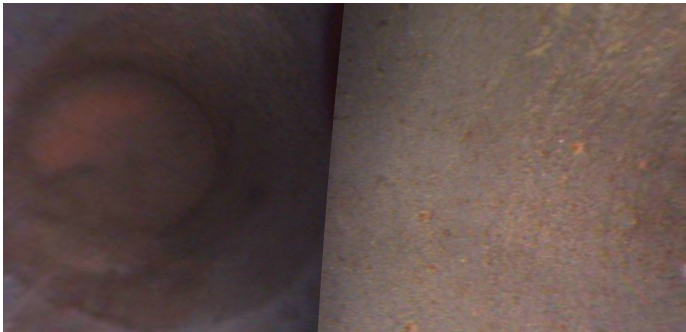
Code: **TFC**
Description: **Tap Factory Capped**

Distance (ft): **105.0**
Structural Grade: **0**
O&M Grade: **0**
Clock Start/From: **10**
Clock To:
1st Value: **4.000**
2nd Value:
Value Percent:
Continuous Index:
Within 8" of Joint: **YES**
Remarks:

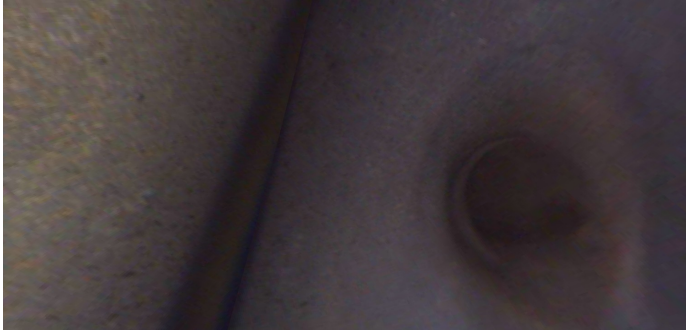
Code: **TF**
Description: **Tap Factory**

Distance (ft): **108.0**
Structural Grade: **0**
O&M Grade: **0**
Clock Start/From: **2**
Clock To:
1st Value: **4.000**
2nd Value:
Value Percent:
Continuous Index:
Within 8" of Joint: **YES**
Remarks:

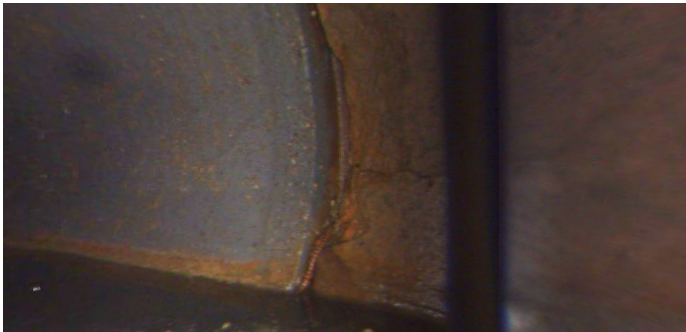
Code: **CL**
Description: **Crack Longitudinal**

Distance (ft): **117.3**
Structural Grade: **2**
O&M Grade: **0**
Clock Start/From: **4**
Clock To:
1st Value:
2nd Value:
Value Percent:
Continuous Index:
Within 8" of Joint: **YES**
Remarks:

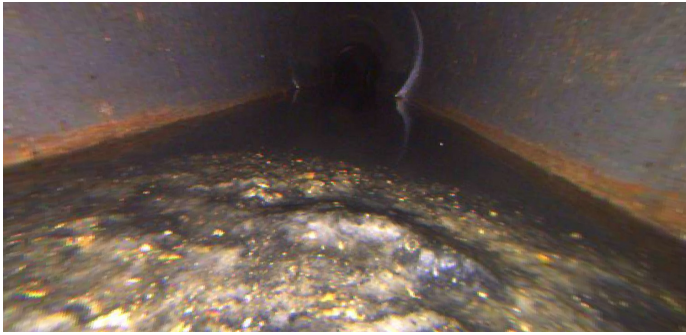
Code: **DSZ**
Description: **Deposits Settled Other**

Distance (ft): **117.3**
Structural Grade: **0**
O&M Grade: **3**
Clock Start/From: **6**
Clock To:
1st Value:
2nd Value:
Value Percent: **15.000**
Continuous Index:
Within 8" of Joint: **NO**
Remarks: **debris/sediments**

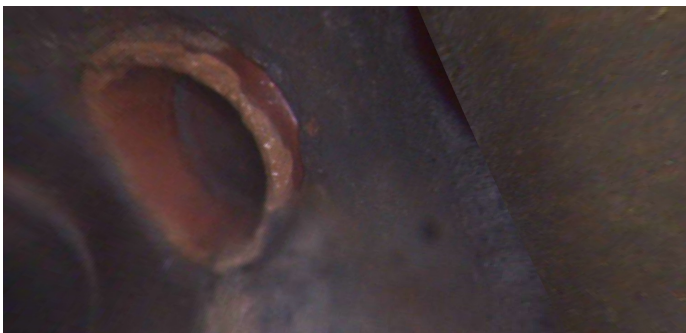
Code: **TB**
Description: **Tap Break-in**

Distance (ft): **125.1**
Structural Grade: **0**
O&M Grade: **0**
Clock Start/From: **10**
Clock To:
1st Value: **4.000**
2nd Value:
Value Percent:
Continuous Index:
Within 8" of Joint: **YES**
Remarks:

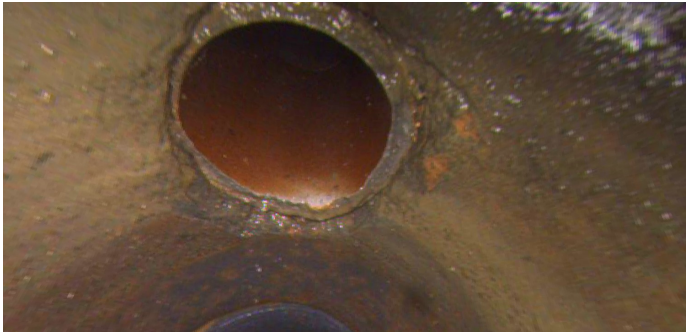
Code: **TB**
Description: **Tap Break-in**

Distance (ft): **130.6**
Structural Grade: **0**
O&M Grade: **0**
Clock Start/From: **12**
Clock To:
1st Value: **4.000**
2nd Value:
Value Percent:
Continuous Index:
Within 8" of Joint:
Remarks:

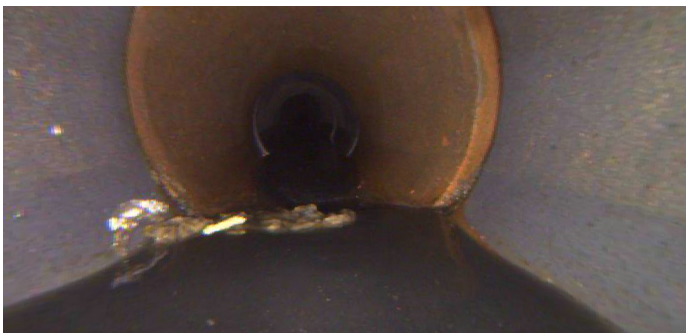
Code: **LD**
Description: **Alignment Down**

Distance (ft): **135.2**
Structural Grade: **0**
O&M Grade: **1**
Clock Start/From:
Clock To:
1st Value:
2nd Value:
Value Percent: **5.000**
Continuous Index:
Within 8" of Joint: **NO**
Remarks:

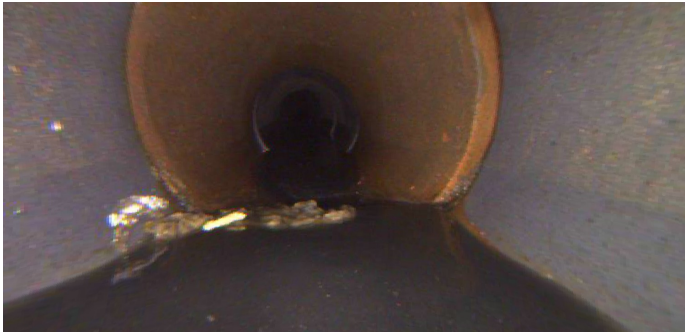
Code: **DSZ**
Description: **Deposits Settled Other**

Distance (ft): **135.2**
Structural Grade: **0**
O&M Grade: **2**
Clock Start/From: **6**
Clock To:
1st Value:
2nd Value:
Value Percent: **5.000**
Continuous Index: **S02**
Within 8" of Joint: **NO**
Remarks: **debris**

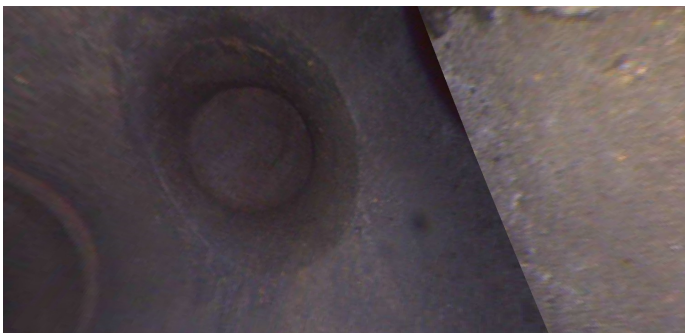
Code: **TFC**
Description: **Tap Factory Capped**

Distance (ft): **159.9**
Structural Grade: **0**
O&M Grade: **0**
Clock Start/From: **10**
Clock To:
1st Value: **4.000**
2nd Value:
Value Percent:
Continuous Index:
Within 8" of Joint: **YES**
Remarks:

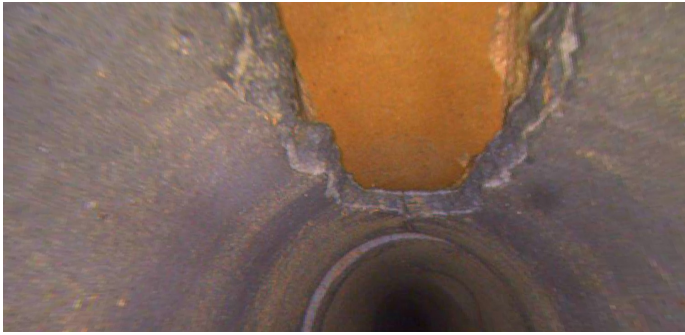
Code: **RPP**
Description: **Repair Patch**

Distance (ft): **159.9**
Structural Grade: **0**
O&M Grade: **0**
Clock Start/From: **12**
Clock To:
1st Value:
2nd Value:
Value Percent:
Continuous Index:
Within 8" of Joint: **NO**
Remarks: **break patched/former accesspoint?**

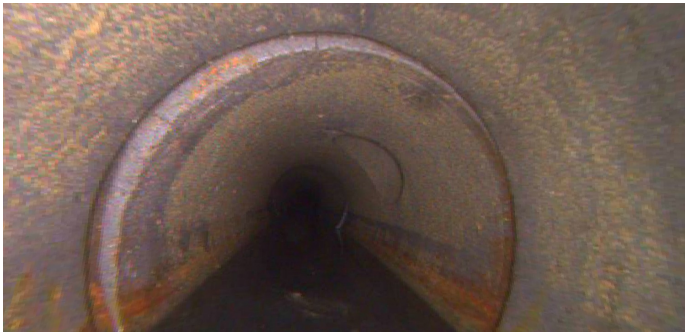
Code: **CM**
Description: **Crack Multiple**

Distance (ft): **160.7**
Structural Grade: **3**
O&M Grade: **0**
Clock Start/From: **7**
Clock To: **12**
1st Value:
2nd Value:
Value Percent:
Continuous Index:
Within 8" of Joint: **YES**
Remarks:

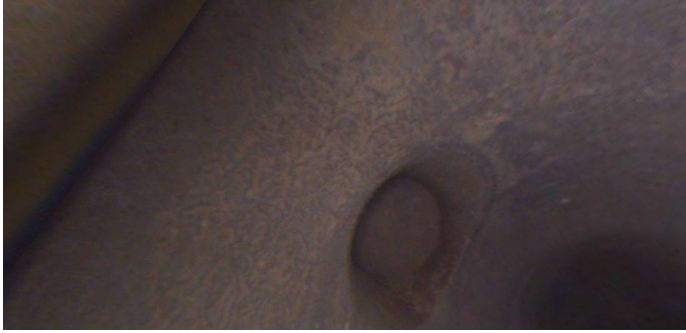
Code: **TFC**
Description: **Tap Factory Capped**

Distance (ft): **163.3**
Structural Grade: **0**
O&M Grade: **0**
Clock Start/From: **2**
Clock To:
1st Value: **4.000**
2nd Value:
Value Percent:
Continuous Index:
Within 8" of Joint: **YES**
Remarks:

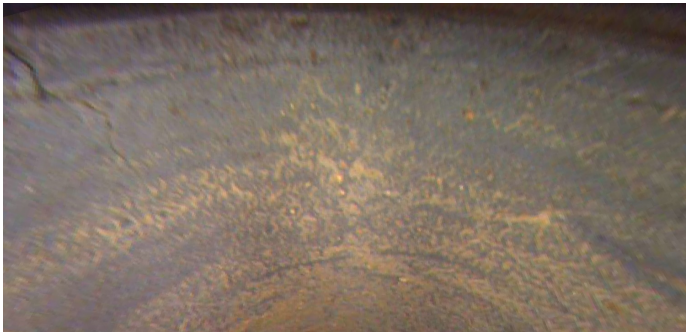
Code: **CM**
Description: **Crack Multiple**

Distance (ft): **172.5**
Structural Grade: **3**
O&M Grade: **0**
Clock Start/From: **9**
Clock To: **4**
1st Value:
2nd Value:
Value Percent:
Continuous Index: **S03**
Within 8" of Joint: **YES**
Remarks: **wandering**

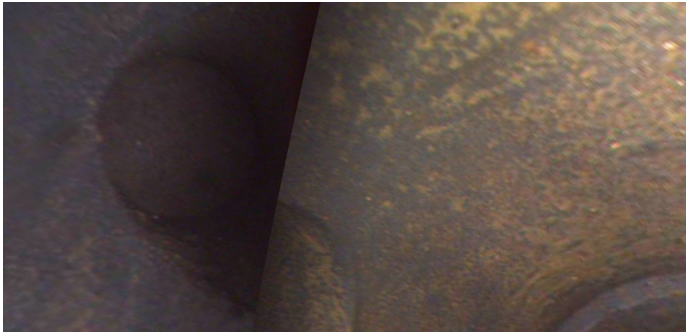
Code: **TFC**
Description: **Tap Factory Capped**

Distance (ft): **206.1**
Structural Grade: **0**
O&M Grade: **0**
Clock Start/From: **10**
Clock To:
1st Value: **4.000**
2nd Value:
Value Percent:
Continuous Index:
Within 8" of Joint: **YES**
Remarks:

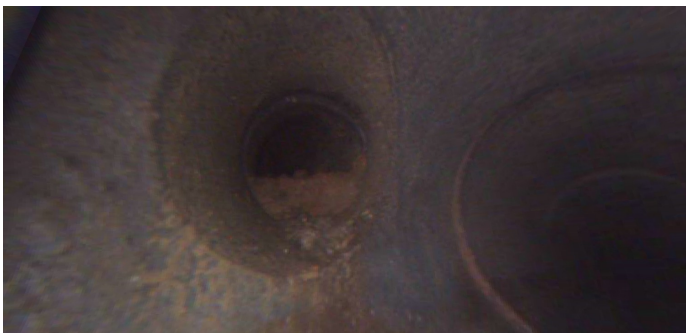
Code: **TFD**
Description: **Tap Factory Defective**

Distance (ft): **208.6**
Structural Grade: **0**
O&M Grade: **2**
Clock Start/From: **2**
Clock To:
1st Value: **4.000**
2nd Value:
Value Percent:
Continuous Index:
Within 8" of Joint: **YES**
Remarks: **partially blocked**

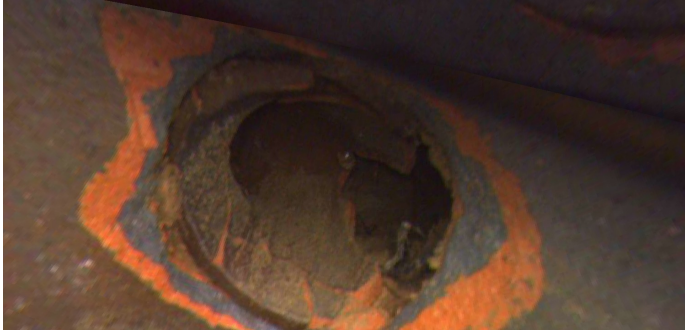
Code: **TBD**
Description: **Tap Break-in Defective**

Distance (ft): **210.4**
Structural Grade: **0**
O&M Grade: **3**
Clock Start/From: **1**
Clock To:
1st Value: **4.000**
2nd Value:
Value Percent:
Continuous Index:
Within 8" of Joint:
Remarks: **tap broken**

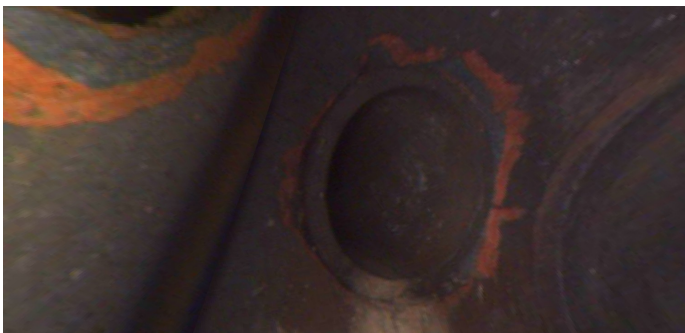
Code: **TB**
Description: **Tap Break-in**

Distance (ft): **210.4**
Structural Grade: **0**
O&M Grade: **0**
Clock Start/From: **2**
Clock To:
1st Value: **4.000**
2nd Value:
Value Percent:
Continuous Index:
Within 8" of Joint: **YES**
Remarks:

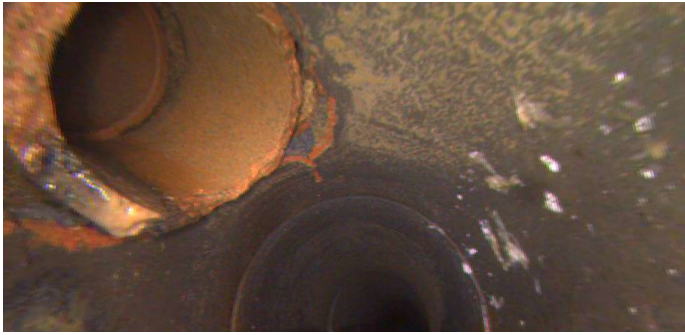
Code: **TB**
Description: **Tap Break-in**

Distance (ft): **212.2**
Structural Grade: **0**
O&M Grade: **0**
Clock Start/From: **11**
Clock To:
1st Value: **4.000**
2nd Value:
Value Percent:
Continuous Index:
Within 8" of Joint:
Remarks:

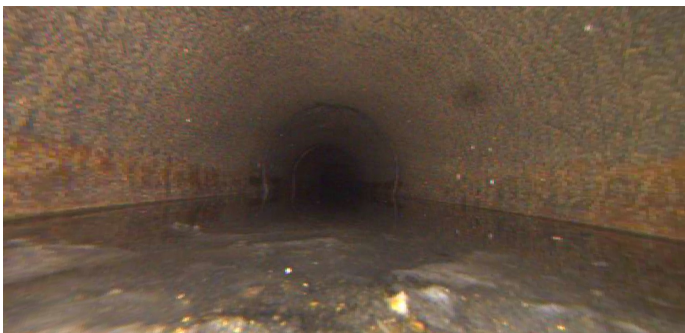
Code: **MWL**
Description: **Water Level**

Distance (ft): **221.4**
Structural Grade: **0**
O&M Grade: **0**
Clock Start/From:
Clock To:
1st Value:
2nd Value:
Value Percent: **25.000**
Continuous Index:
Within 8" of Joint: **NO**
Remarks:

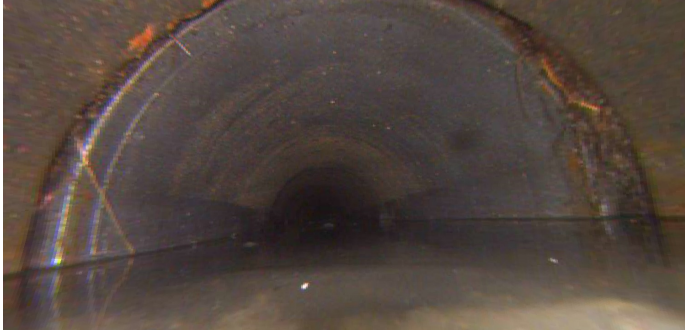
Code: **MWL**
Description: **Water Level**

Distance (ft): **243.0**
Structural Grade: **0**
O&M Grade: **0**
Clock Start/From:
Clock To:
1st Value:
2nd Value:
Value Percent: **50.000**
Continuous Index:
Within 8" of Joint: **NO**
Remarks:

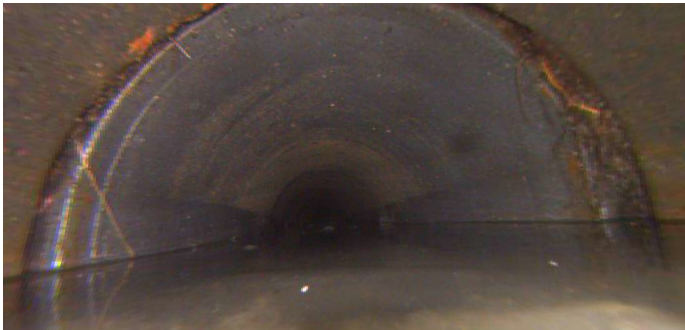
Code: **RFJ**
Description: **Roots Fine Joint**

Distance (ft): **243.0**
Structural Grade: **0**
O&M Grade: **1**
Clock Start/From: **9**
Clock To: **3**
1st Value:
2nd Value:
Value Percent:
Continuous Index:
Within 8" of Joint: **YES**
Remarks:

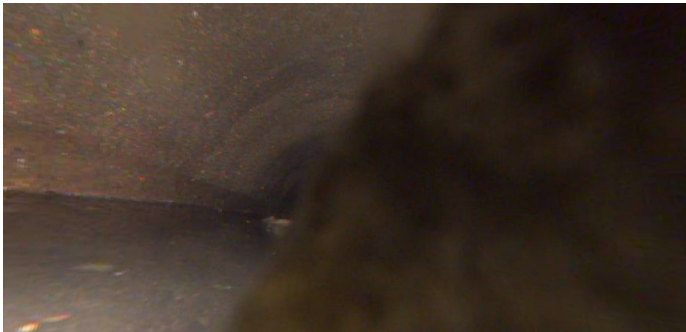
Code: **MSA**
Description: **Abandoned Survey**

Distance (ft): **250.0**
Structural Grade: **0**
O&M Grade: **0**
Clock Start/From:
Clock To:
1st Value:
2nd Value:
Value Percent:
Continuous Index:
Within 8" of Joint: **NO**
Remarks: **no blockage**

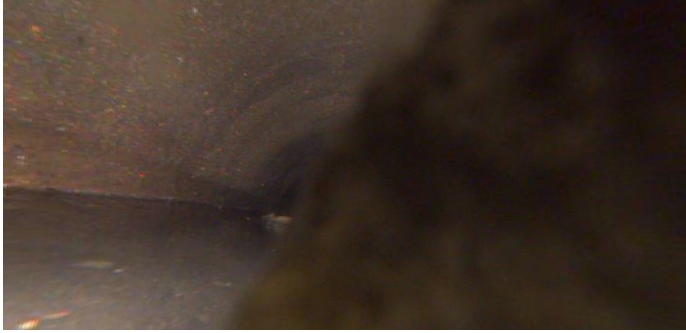
Code: **CM**
Description: **Crack Multiple**

Distance (ft): **250.0**
Structural Grade: **3**
O&M Grade: **0**
Clock Start/From: **9**
Clock To: **4**
1st Value:
2nd Value:
Value Percent:
Continuous Index: **F03**
Within 8" of Joint: **YES**
Remarks: **wandering**

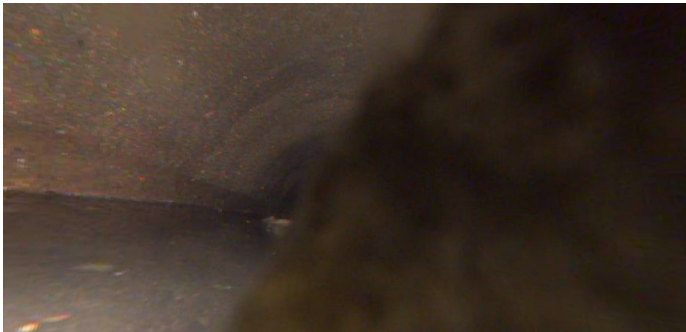
Code: **DSZ**
Description: **Deposits Settled Other**

Distance (ft): **250.0**
Structural Grade: **0**
O&M Grade: **2**
Clock Start/From: **6**
Clock To:
1st Value:
2nd Value:
Value Percent: **5.000**
Continuous Index: **F02**
Within 8" of Joint: **NO**
Remarks: **debris**
