Profile/Photo Observation Report

Street:	E HOME AVE	Flow Control:	Not Controlled
City:	Hobart, IN	Year Renewed:	
Location:	Other	Tape/Media #:	
Purpose:	Not Known	Dia/Height:	12"
Use:	Sanitary	Material:	VCP
Drain Area:	NA	Lining:	
Category:	NA		
Comment:

Location Details:		Direction of Survey:	Downstream
US MH:	M-804-014	DS MH:	M-804-013
		Total Length Surveyed (ft):	22.0

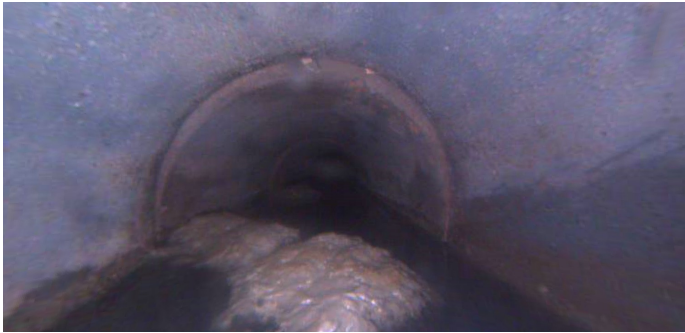
Code:	MWL
Description:	Water Level

Distance (ft):	.0
Structural Grade:	0
O&M Grade:	0
Clock Start/From:	
Clock To:	
1st Value:	
2nd Value:	
Value Percent:	20.000
Continuous Index:	
Within 8" of Joint:	NO
Remarks:

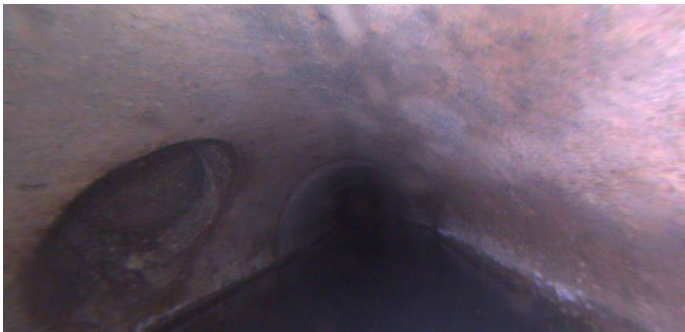
Code:	TFC
Description:	Tap Factory Capped

Distance (ft):	5.4
Structural Grade:	0
O&M Grade:	0
Clock Start/From:	10
Clock To:	
1st Value:	4.000
2nd Value:	
Value Percent:	
Continuous Index:	
Within 8" of Joint:	
Remarks:
