Profile/Photo Observation Report

Date:	10/10/2021	Weather:		Coding:	PACP 7.0
Pipe Length (ft):	378.6	Owner:	City of Hobart	Pre Clean:	Heavy Cleaning
P.O.#:	YES502259	Surveyor:	S. Bucklin	PSR:	P-804-013-014
Customer:	City of Hobart	Clean Date:	10/09/2021	Shape:	C

Street:	East Home Avenue	Flow Control:	Not Controlled
City:	Hobart, IN	Year Renewed:	
Location:	Local rural streets with light traffic, t	Tape/Media #:	
Purpose:	Routine Assessment	Dia/Height:	12"
Use:	Sanitary Sewage Pipe	Material:	VCP
Drain Area:		Lining:	
Category:	NA		
Comment:			
Location Details:		Direction of Survey:	Upstream
US MH:	M-804-014	DS MH:	M-804-013
		Total Length Surveyed (ft):	378.6

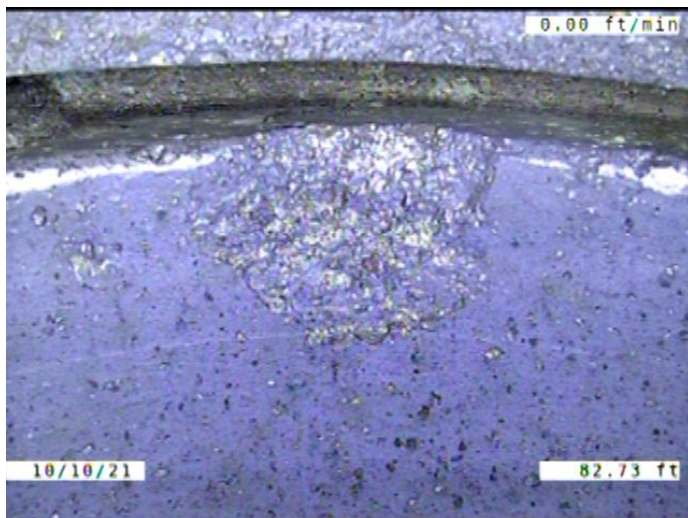
Code: **SZ**
 Description: **Surface Damage Other**

Distance (ft): **82.7**
 Structural Grade: **0**
 O&M Grade: **0**
 Clock Start/From: **1**
 Clock To:
 1st Value:
 2nd Value:
 Value Percent:
 Continuous Index:
 Within 8" of Joint: **YES**
 Remarks: **A PIECE CHIPPED AWAY FROM THE JOINT**

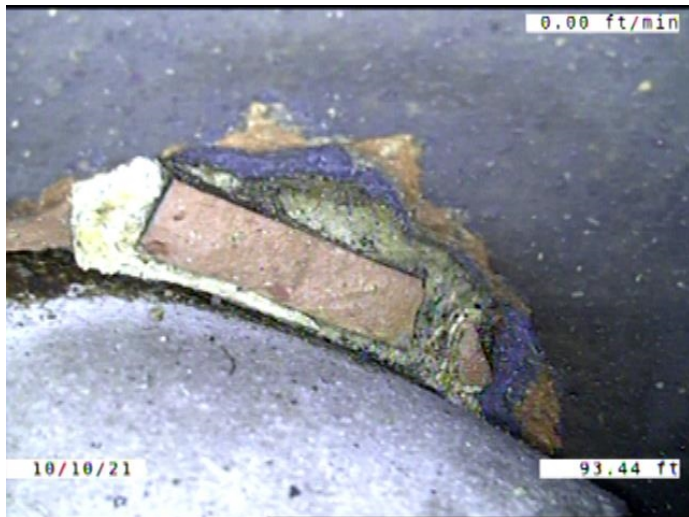
Code: **B**
 Description: **Broken**

Distance (ft): **93.4**
 Structural Grade: **4**
 O&M Grade: **0**
 Clock Start/From: **12**
 Clock To: **1**
 1st Value:
 2nd Value:
 Value Percent:
 Continuous Index:
 Within 8" of Joint: **YES**
 Remarks:

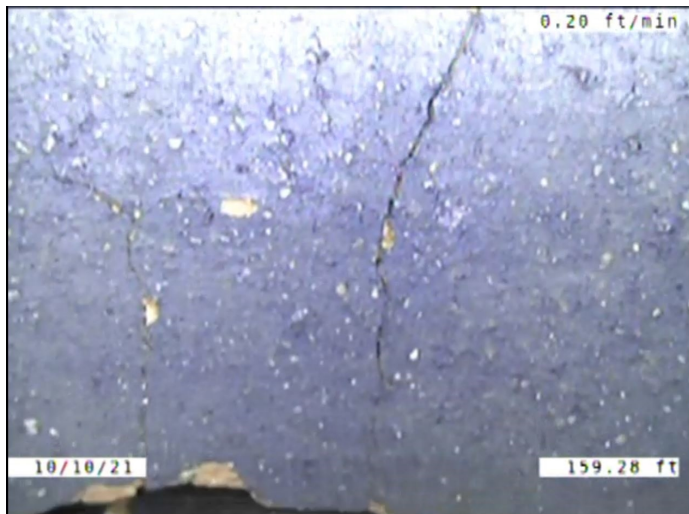
Code: **CM**
Description: **Crack Multiple**

Distance (ft): **159.3**
Structural Grade: **3**
O&M Grade: **0**
Clock Start/From: **10**
Clock To: **12**
1st Value:
2nd Value:
Value Percent:
Continuous Index:
Within 8" of Joint: **NO**
Remarks:

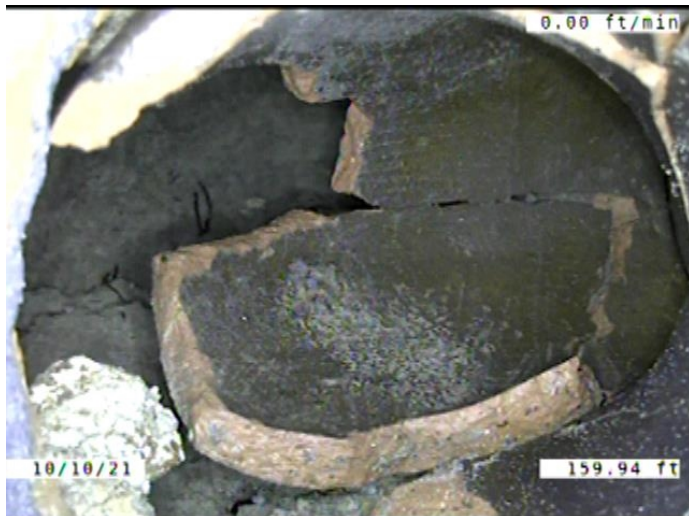
Code: **TBD**
 Description: **Tap Break-in/Hammer Defective**

Distance (ft): **159.9**
 Structural Grade: **0**
 O&M Grade: **3**
 Clock Start/From: **1**
 Clock To:
 1st Value: **4.000**
 2nd Value:
 Value Percent:
 Continuous Index:
 Within 8" of Joint: **YES**
 Remarks: **Defective**

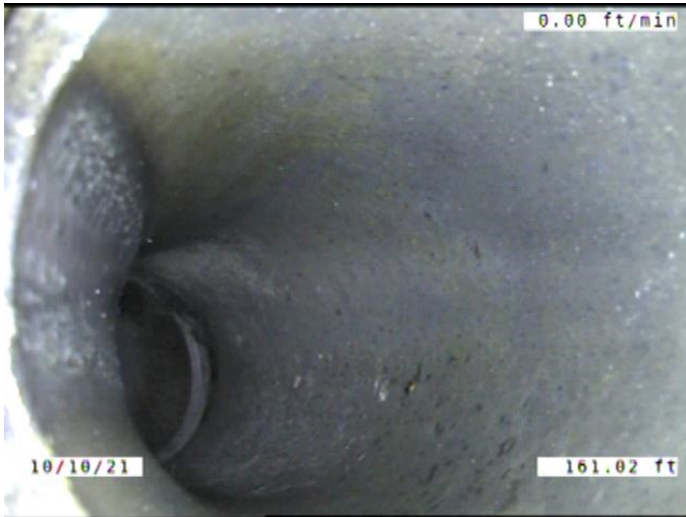
Code: **TBD**
Description: **Tap Break-in/Hammer Defective**

Distance (ft): **161.0**
Structural Grade: **0**
O&M Grade: **3**
Clock Start/From: **11**
Clock To:
1st Value: **4.000**
2nd Value:
Value Percent:
Continuous Index:
Within 8" of Joint: **YES**
Remarks: **Defective**

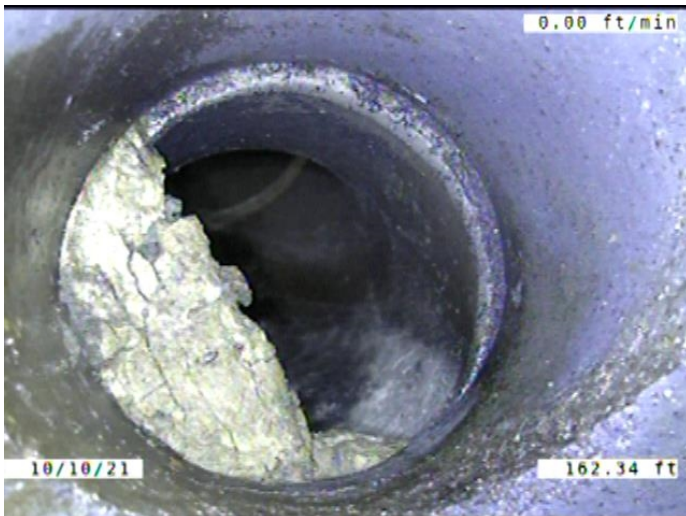
Code: **TFD**
Description: **Tap Factory Defective**

Distance (ft): **162.3**
Structural Grade: **0**
O&M Grade: **3**
Clock Start/From: **10**
Clock To:
1st Value: **4.000**
2nd Value:
Value Percent:
Continuous Index:
Within 8" of Joint: **YES**
Remarks: **LOOKS TO BE 40" PLUGGED**

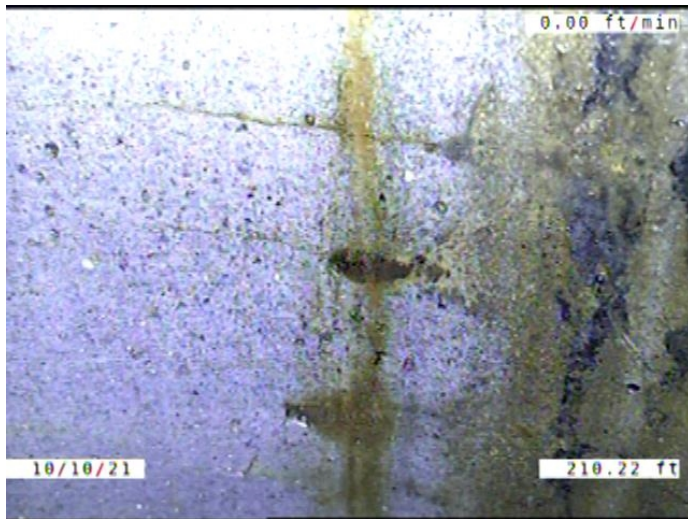
Code: **CM**
Description: **Crack Multiple**

Distance (ft): **210.2**
Structural Grade: **3**
O&M Grade: **0**
Clock Start/From: **8**
Clock To: **4**
1st Value:
2nd Value:
Value Percent:
Continuous Index:
Within 8" of Joint: **YES**
Remarks:
