Profile/Photo Observation Report

Date:	10/10/2021	Weather:		Coding:	PACP 7.0
Pipe Length (ft):	378.6	Owner:	City of Hobart	Pre Clean:	Heavy Cleaning
P.O.#:	YES502259	Surveyor:	S. Bucklin	PSR:	P-804-013-014
Customer:	City of Hobart	Clean Date:	10/09/2021	Shape:	C

Street:	East Home Avenue	Flow Control:	Not Controlled
City:	Hobart, IN	Year Renewed:	
Location:	Local rural streets with light traffic, t	Tape/Media #:	
Purpose:	Routine Assessment	Dia/Height:	12"
Use:	Sanitary Sewage Pipe	Material:	VCP
Drain Area:		Lining:	
Category:	NA		
Comment:			
Location Details:		Direction of Survey:	Upstream
US MH:	M-804-014	DS MH:	M-804-013
		Total Length Surveyed (ft):	378.6

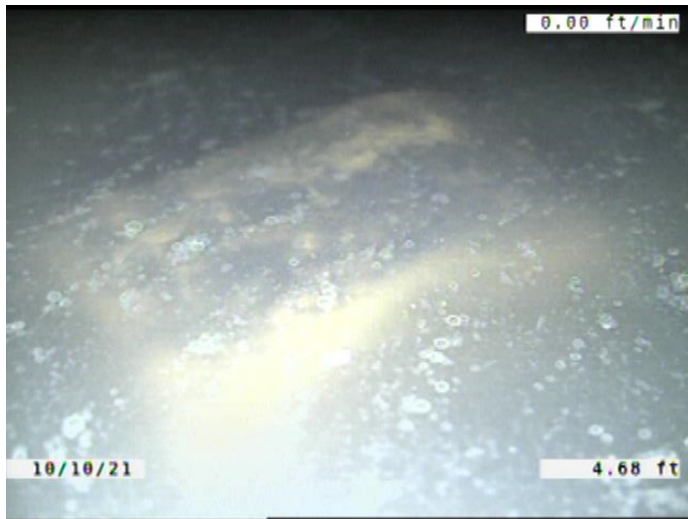
Code: **OBB**
 Description: **Obstruction Brick or Masonry**

Distance (ft): **4.7**
 Structural Grade: **0**
 O&M Grade: **2**
 Clock Start/From: **6**
 Clock To:
 1st Value:
 2nd Value:
 Value Percent: **5.000**
 Continuous Index:
 Within 8" of Joint: **YES**
 Remarks:

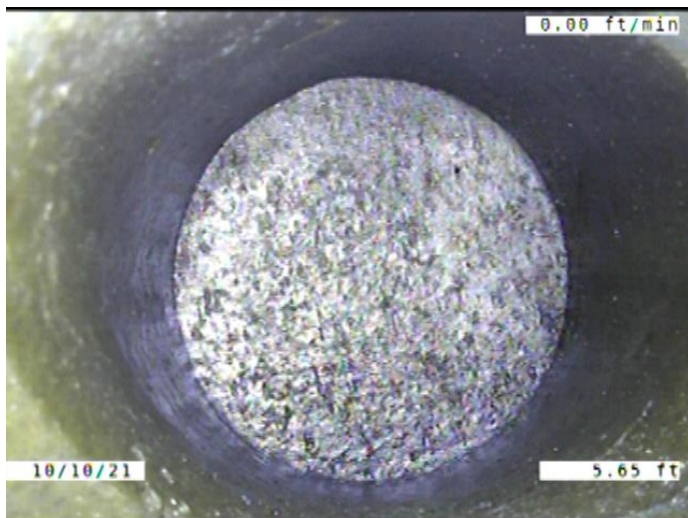
Code: **TFC**
 Description: **Tap Factory Capped**

Distance (ft): **5.6**
 Structural Grade: **0**
 O&M Grade: **0**
 Clock Start/From: **10**
 Clock To:
 1st Value: **4.000**
 2nd Value:
 Value Percent:
 Continuous Index:
 Within 8" of Joint: **YES**
 Remarks:

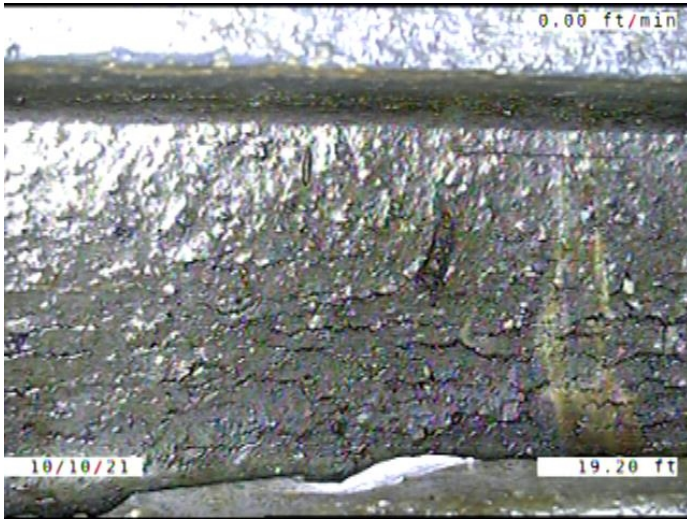
Code: **JSM**
 Description: **Joint Separated Medium**

Distance (ft): **19.2**
 Structural Grade: **3**
 O&M Grade: **0**
 Clock Start/From:
 Clock To:
 1st Value:
 2nd Value:
 Value Percent:
 Continuous Index:
 Within 8" of Joint: **NO**
 Remarks:

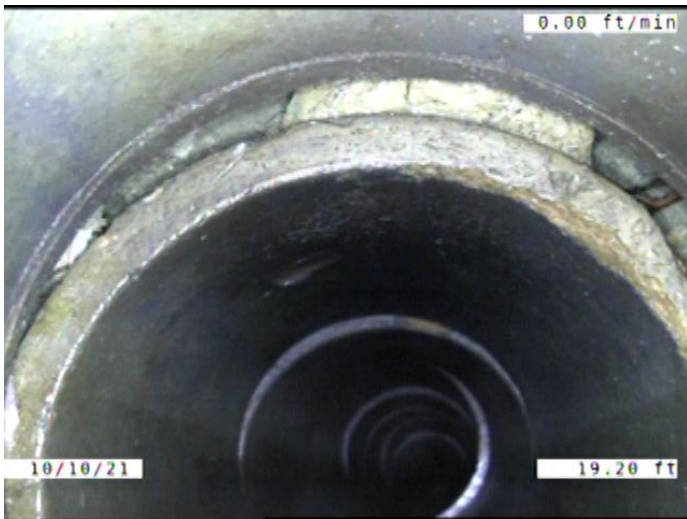
Code: **JOLD**
 Description: **Joint Offset Large Defective**

Distance (ft): **19.2**
 Structural Grade: **4**
 O&M Grade: **0**
 Clock Start/From:
 Clock To:
 1st Value:
 2nd Value:
 Value Percent:
 Continuous Index:
 Within 8" of Joint: **NO**
 Remarks:

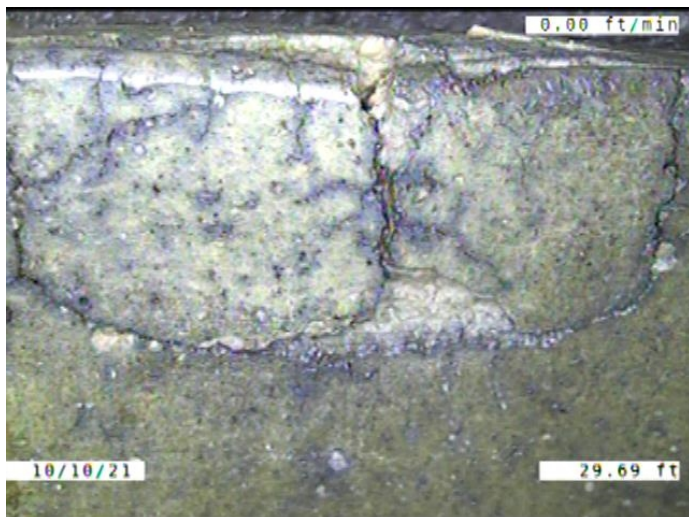
Code: **B**
 Description: **Broken**

Distance (ft): **29.7**
 Structural Grade: **4**
 O&M Grade: **0**
 Clock Start/From: **9**
 Clock To: **10**
 1st Value:
 2nd Value:
 Value Percent:
 Continuous Index:
 Within 8" of Joint: **YES**
 Remarks:

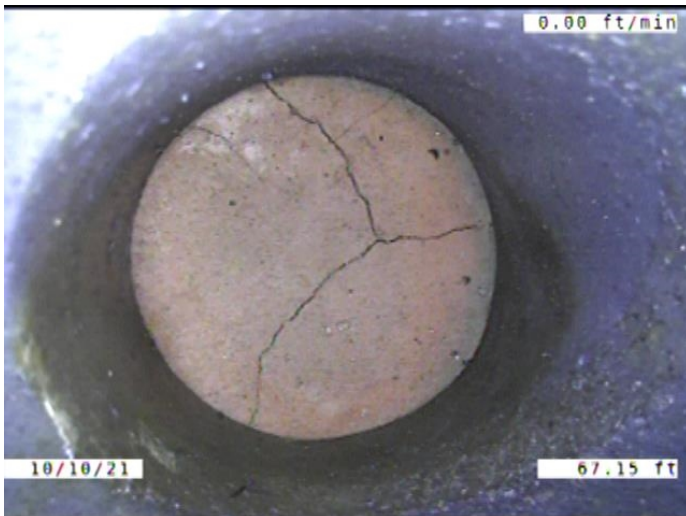
Code: **TFC**
 Description: **Tap Factory Capped**

Distance (ft): **67.2**
 Structural Grade: **0**
 O&M Grade: **0**
 Clock Start/From: **10**
 Clock To:
 1st Value: **4.000**
 2nd Value:
 Value Percent:
 Continuous Index:
 Within 8" of Joint: **YES**
 Remarks: **CAP BROKEN**

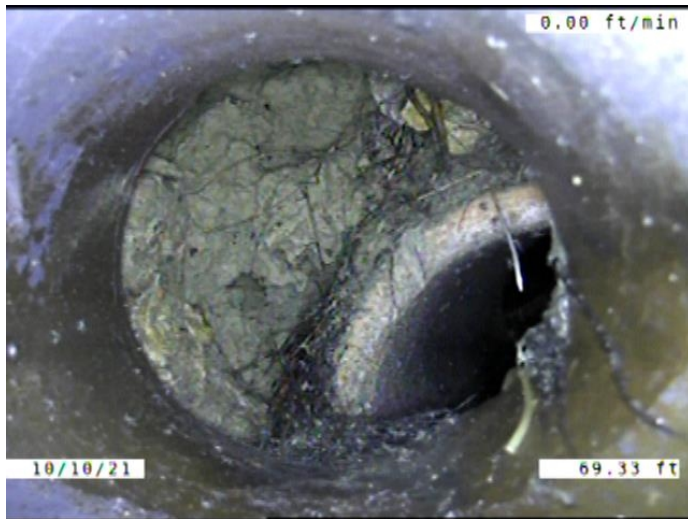
Code:	TFD
Description:	Tap Factory Defective
Distance (ft):	69.3
Structural Grade:	0
O&M Grade:	3
Clock Start/From:	2
Clock To:	
1st Value:	4.000
2nd Value:	
Value Percent:	
Continuous Index:	
Within 8" of Joint:	YES
Remarks:	LARGE OFFSET AT THE FIRST JOINT BACK. SOIL VISIBLE

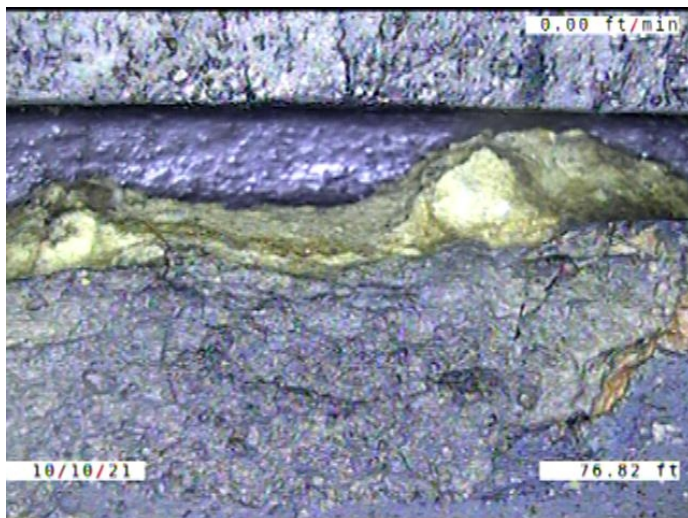
Code:	SZ
Description:	Surface Damage Other
Distance (ft):	76.8
Structural Grade:	0
O&M Grade:	0
Clock Start/From:	9
Clock To:	11
1st Value:	
2nd Value:	
Value Percent:	
Continuous Index:	
Within 8" of Joint:	YES
Remarks:	A PIECE CHIPPED AWAY FROM THE JOINT

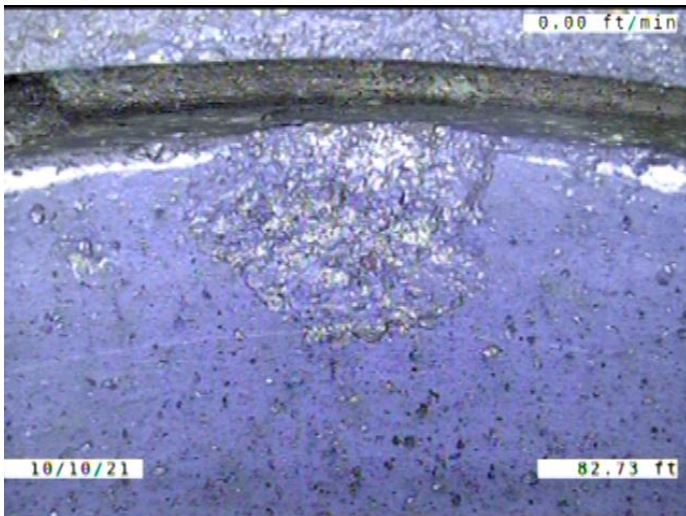
Code: **SZ**
 Description: **Surface Damage Other**

Distance (ft): **82.7**
 Structural Grade: **0**
 O&M Grade: **0**
 Clock Start/From: **1**
 Clock To:
 1st Value:
 2nd Value:
 Value Percent:
 Continuous Index:
 Within 8" of Joint: **YES**
 Remarks: **A PIECE CHIPPED AWAY FROM THE JOINT**

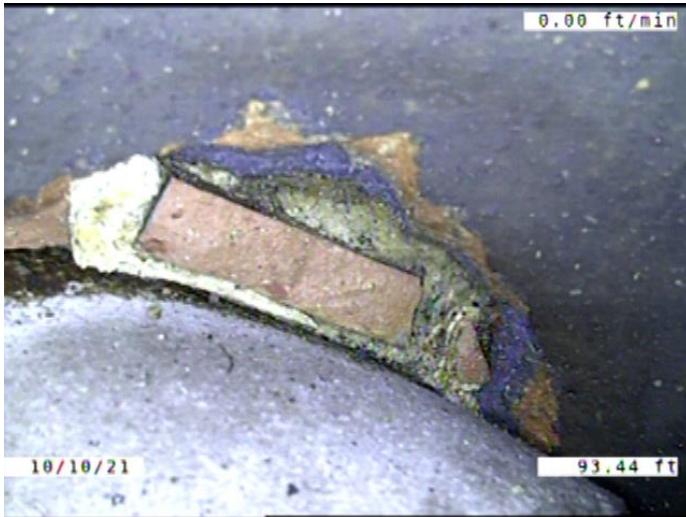
Code: **B**
 Description: **Broken**

Distance (ft): **93.4**
 Structural Grade: **4**
 O&M Grade: **0**
 Clock Start/From: **12**
 Clock To: **1**
 1st Value:
 2nd Value:
 Value Percent:
 Continuous Index:
 Within 8" of Joint: **YES**
 Remarks:

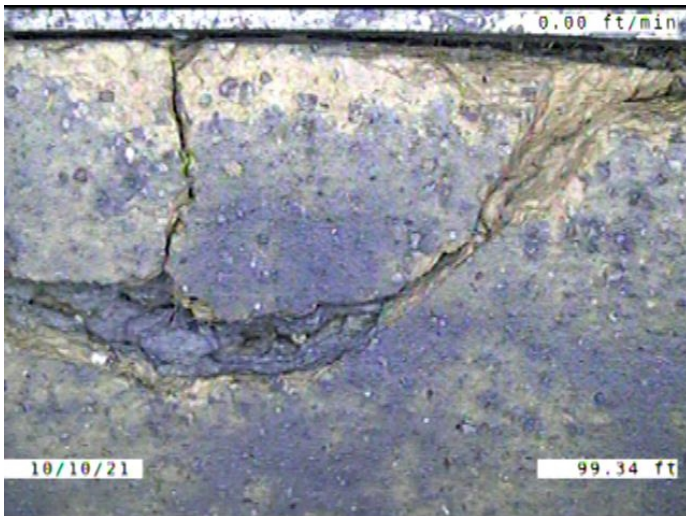
Code: **BSV**
 Description: **Broken Soil Visible**

Distance (ft): **99.3**
 Structural Grade: **5**
 O&M Grade: **0**
 Clock Start/From: **11**
 Clock To: **1**
 1st Value:
 2nd Value:
 Value Percent:
 Continuous Index:
 Within 8" of Joint: **YES**
 Remarks:

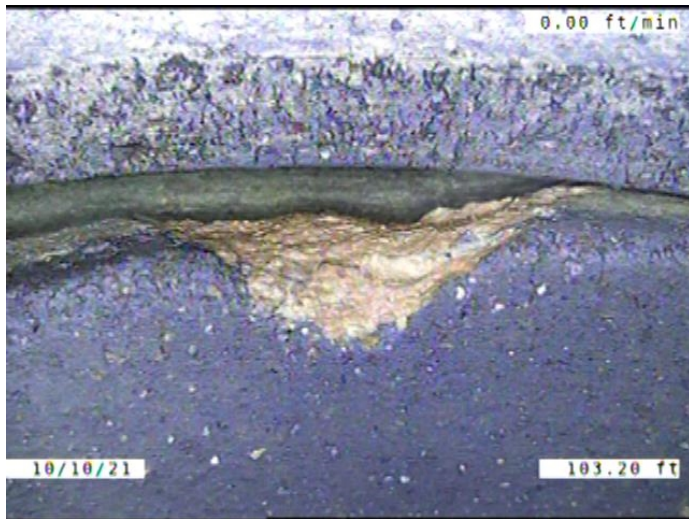
Code:	SZ
Description:	Surface Damage Other
Distance (ft):	103.2
Structural Grade:	0
O&M Grade:	0
Clock Start/From:	1
Clock To:	
1st Value:	
2nd Value:	
Value Percent:	
Continuous Index:	
Within 8" of Joint:	YES
Remarks:	A PIECE CHIPPED AWAY FROM THE JOINT

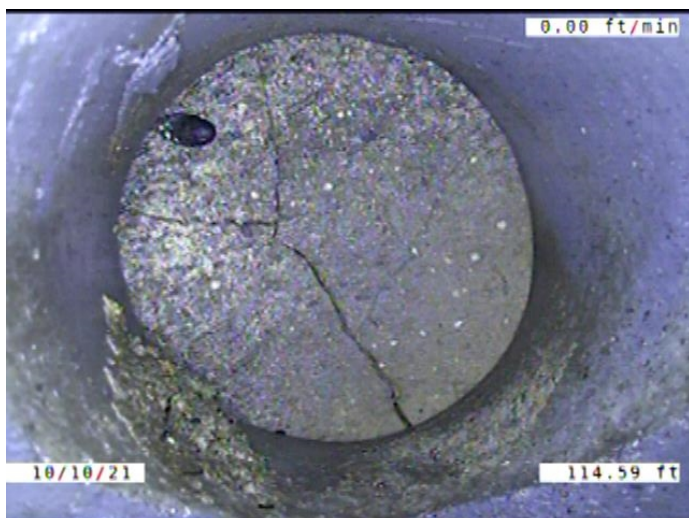
Code: **TFC**
 Description: **Tap Factory Capped**

Distance (ft): **114.6**
 Structural Grade: **0**
 O&M Grade: **0**
 Clock Start/From: **10**
 Clock To:
 1st Value: **4.000**
 2nd Value:
 Value Percent:
 Continuous Index:
 Within 8" of Joint: **YES**
 Remarks: **CAP BROKEN**

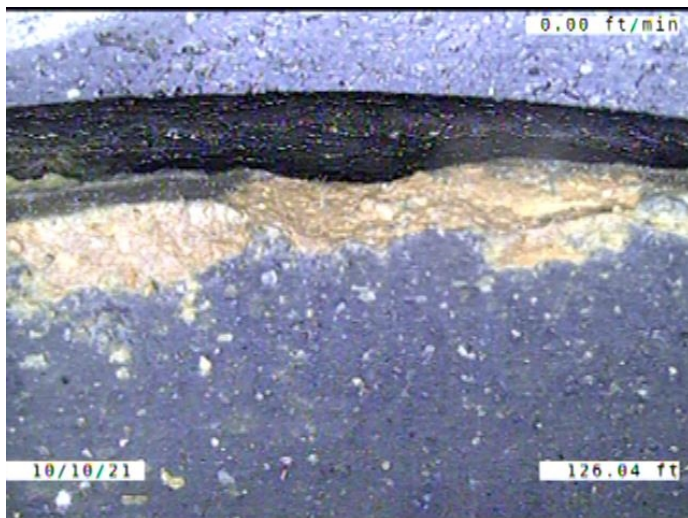
Code: **SZ**
 Description: **Surface Damage Other**

Distance (ft): **126.0**
 Structural Grade: **0**
 O&M Grade: **0**
 Clock Start/From: **12**
 Clock To: **1**
 1st Value:
 2nd Value:
 Value Percent:
 Continuous Index:
 Within 8" of Joint: **YES**
 Remarks: **A FEW PIECES CHIPPED AWAY FROM THE JOINT**

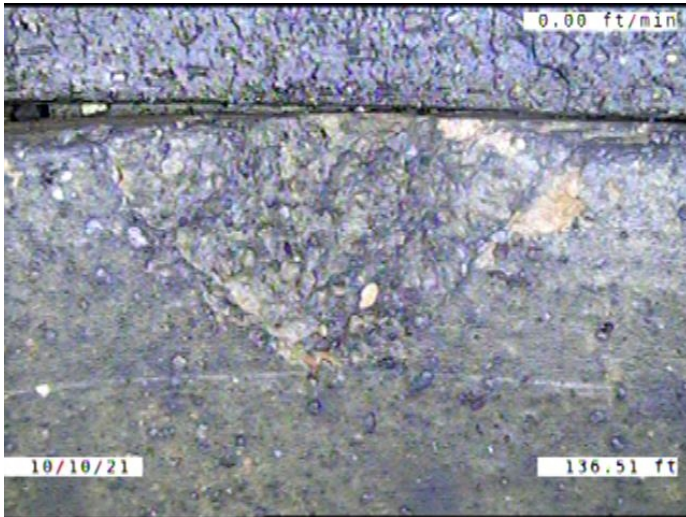
Code: **SZ**
 Description: **Surface Damage Other**

Distance (ft): **136.5**
 Structural Grade: **0**
 O&M Grade: **0**
 Clock Start/From: **11**
 Clock To: **2**
 1st Value:
 2nd Value:
 Value Percent:
 Continuous Index:
 Within 8" of Joint: **YES**
 Remarks: **A FEW PIECES CHIPPED AWAY FROM TRE JOINT**

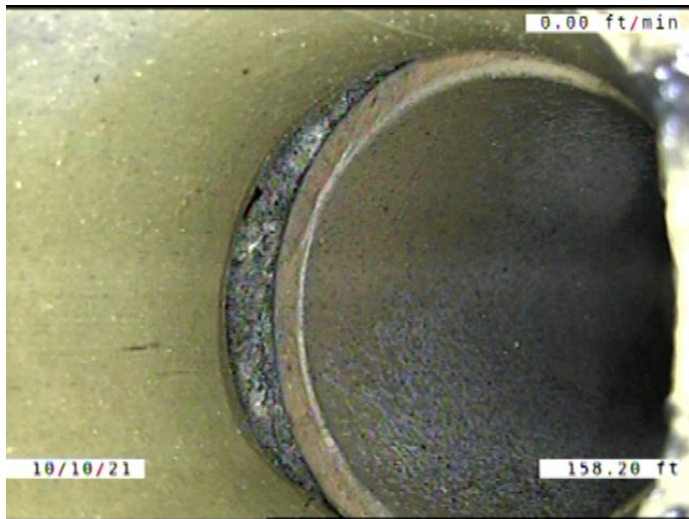
Code:	TBI
Description:	Tap Break-in Intruding
Distance (ft):	158.2
Structural Grade:	0
O&M Grade:	2
Clock Start/From:	1
Clock To:	
1st Value:	4.000
2nd Value:	1.000
Value Percent:	
Continuous Index:	
Within 8" of Joint:	YES
Remarks:	CONSTANTLY RUNNING WATER

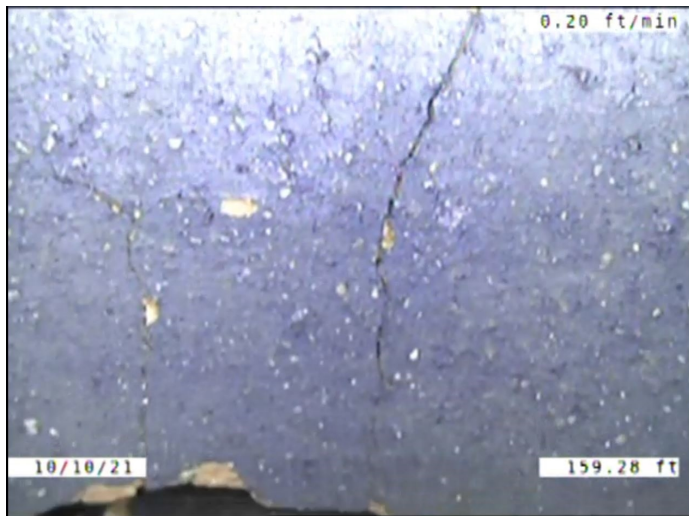
Code:	CM
Description:	Crack Multiple
Distance (ft):	159.3
Structural Grade:	3
O&M Grade:	0
Clock Start/From:	10
Clock To:	12
1st Value:	
2nd Value:	
Value Percent:	
Continuous Index:	
Within 8" of Joint:	NO
Remarks:

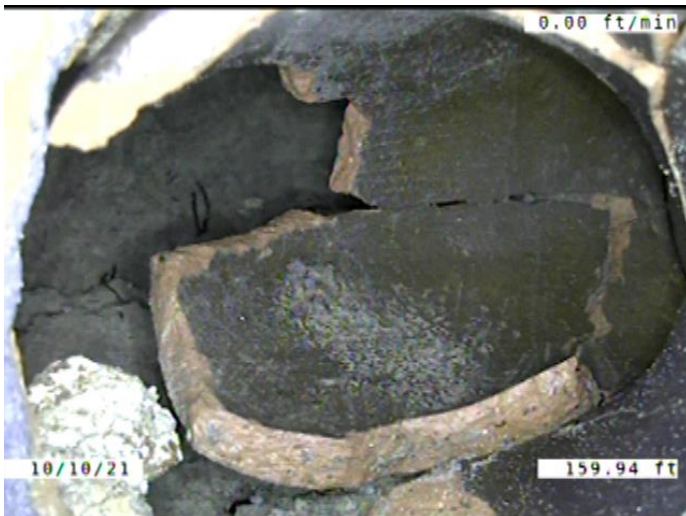
Code: **TBD**
 Description: **Tap Break-in/Hammer Defective**

Distance (ft): **159.9**
 Structural Grade: **0**
 O&M Grade: **3**
 Clock Start/From: **1**
 Clock To:
 1st Value: **4.000**
 2nd Value:
 Value Percent:
 Continuous Index:
 Within 8" of Joint: **YES**
 Remarks: **Defective**

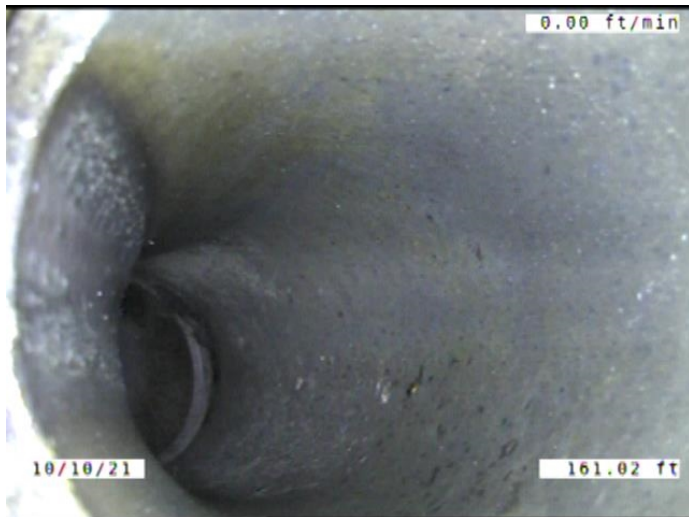
Code: **TBD**
 Description: **Tap Break-in/Hammer Defective**

Distance (ft): **161.0**
 Structural Grade: **0**
 O&M Grade: **3**
 Clock Start/From: **11**
 Clock To:
 1st Value: **4.000**
 2nd Value:
 Value Percent:
 Continuous Index:
 Within 8" of Joint: **YES**
 Remarks: **Defective**

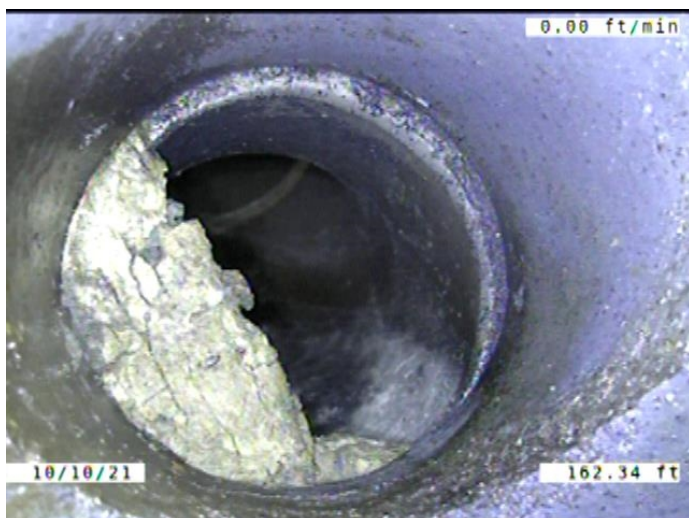
Code: **TFD**
 Description: **Tap Factory Defective**

Distance (ft): **162.3**
 Structural Grade: **0**
 O&M Grade: **3**
 Clock Start/From: **10**
 Clock To:
 1st Value: **4.000**
 2nd Value:
 Value Percent:
 Continuous Index:
 Within 8" of Joint: **YES**
 Remarks: **LOOKS TO BE 40" PLUGGED**

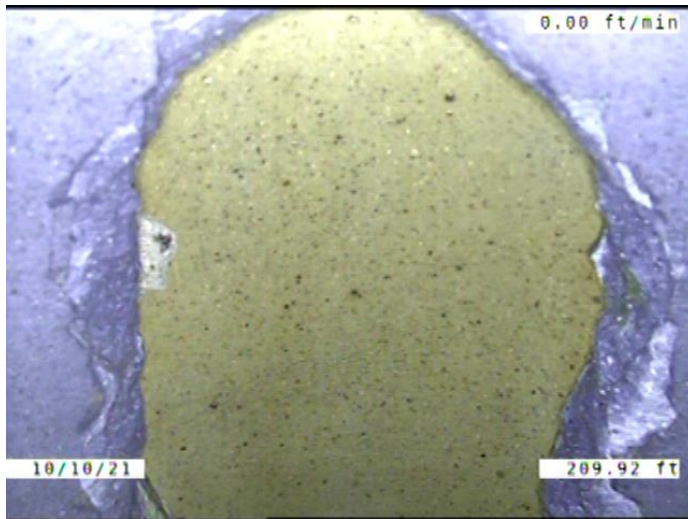
Code: **H**
 Description: **Hole**

Distance (ft): **209.9**
 Structural Grade: **5**
 O&M Grade: **0**
 Clock Start/From: **11**
 Clock To: **1**
 1st Value:
 2nd Value:
 Value Percent:
 Continuous Index:
 Within 8" of Joint: **YES**
 Remarks:

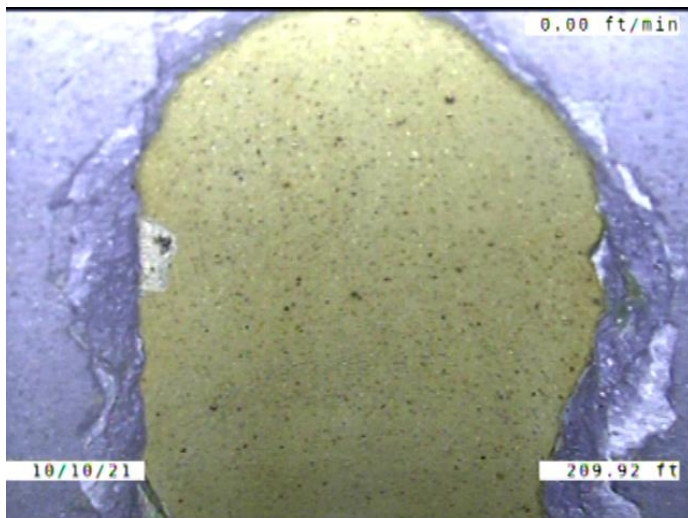
Code: **RPP**
 Description: **Point Repair Patch**

Distance (ft): **209.9**
 Structural Grade: **0**
 O&M Grade: **0**
 Clock Start/From: **11**
 Clock To: **1**
 1st Value:
 2nd Value:
 Value Percent:
 Continuous Index:
 Within 8" of Joint: **YES**
 Remarks: **HOLE LOOKS TO BE REPAIRED WITH ANOTHER PIECE OF VCP**

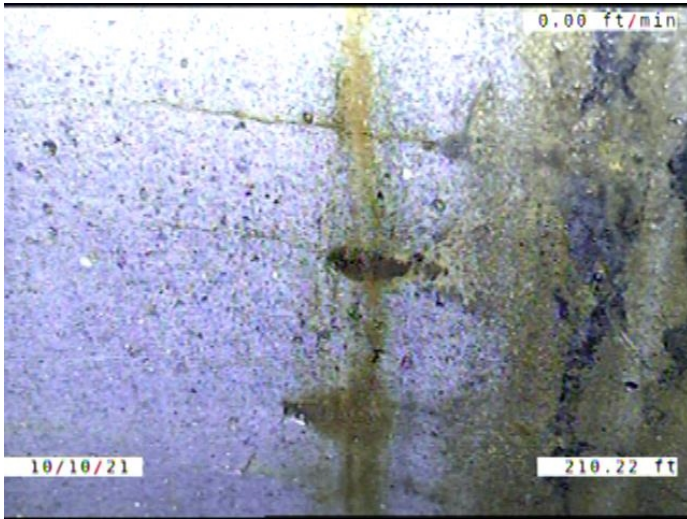
Code: **CM**
Description: **Crack Multiple**

Distance (ft): **210.2**
Structural Grade: **3**
O&M Grade: **0**
Clock Start/From: **8**
Clock To: **4**
1st Value:
2nd Value:
Value Percent:
Continuous Index:
Within 8" of Joint: **YES**
Remarks:

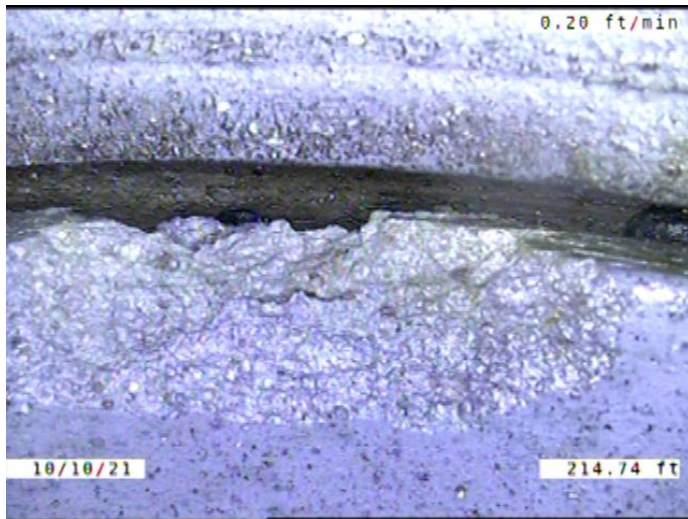
Code: **SZ**
 Description: **Surface Damage Other**

Distance (ft): **214.7**
 Structural Grade: **0**
 O&M Grade: **0**
 Clock Start/From: **2**
 Clock To: **3**
 1st Value:
 2nd Value:
 Value Percent:
 Continuous Index:
 Within 8" of Joint: **YES**
 Remarks: **A PIECE CHIPPED AWAY FROM THE JOINT**

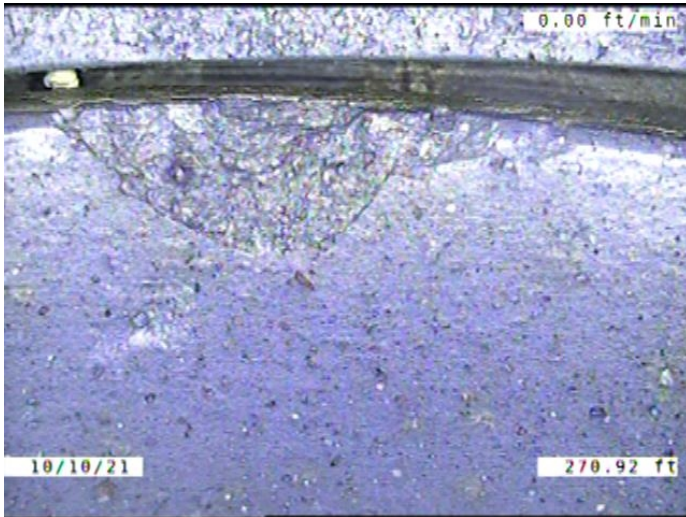
Code:	SZ
Description:	Surface Damage Other
Distance (ft):	270.9
Structural Grade:	0
O&M Grade:	0
Clock Start/From:	1
Clock To:	2
1st Value:	
2nd Value:	
Value Percent:	
Continuous Index:	
Within 8" of Joint:	YES
Remarks:	A FEW PIECES CHIPPED AWAY FROM THE JOINT

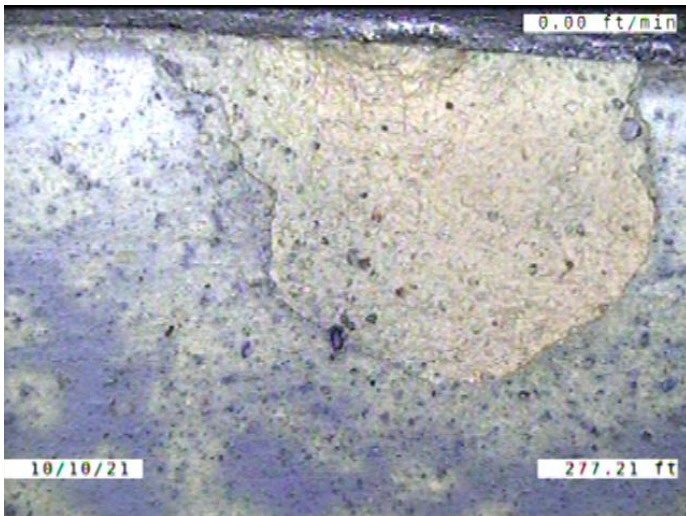
Code:	SZ
Description:	Surface Damage Other
Distance (ft):	277.2
Structural Grade:	0
O&M Grade:	0
Clock Start/From:	12
Clock To:	
1st Value:	
2nd Value:	
Value Percent:	
Continuous Index:	
Within 8" of Joint:	YES
Remarks:	A PIECE CHIPPED AWAY FROM THE JOINT

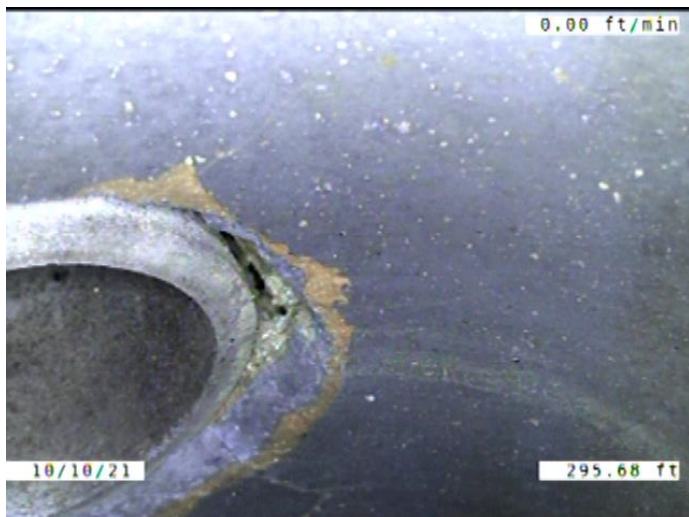
Code: **FM**
 Description: **Fracture Multiple**

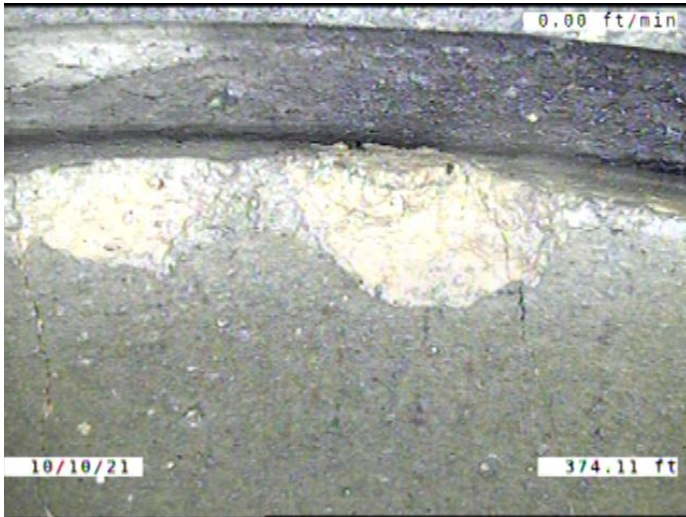
Code:	SZ
Description:	Surface Damage Other
Distance (ft):	374.1
Structural Grade:	0
O&M Grade:	0
Clock Start/From:	12
Clock To:	1
1st Value:	
2nd Value:	
Value Percent:	
Continuous Index:	
Within 8" of Joint:	YES
Remarks:	A FEW PIECES CHIPPED AWAY FROM THE JOINT

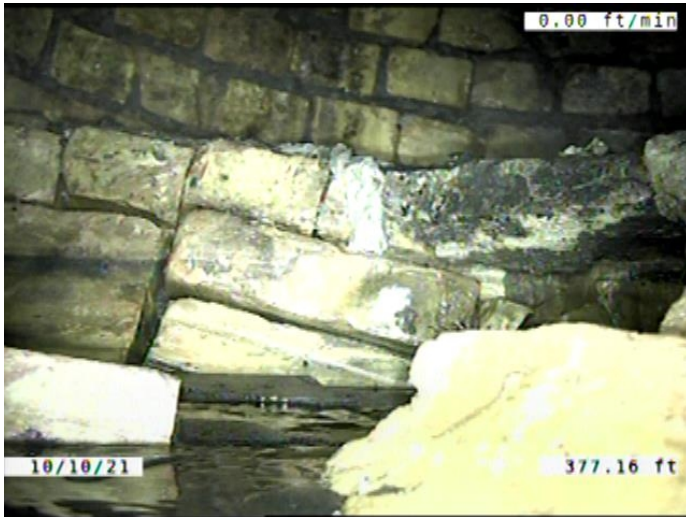
Code: **JOMD**
 Description: **Joint Offset Medium Defective**
