## Profile/Photo Observation Report

Street:	<b>E HOME AVE &amp; N ILLINOIS ST</b>	Flow Control:	<b>Not Controlled</b>
City:	<b>Hobart, IN</b>	Year Renewed:	
Location:	<b>Other</b>	Tape/Media #:	
Purpose:	<b>Not Known</b>	Dia/Height:	<b>12"</b>
Use:	<b>Sanitary</b>	Material:	<b>VCP</b>
Drain Area:	<b>NA</b>	Lining:	
Category:	<b>NA</b>		
Comment:

Location Details:		Direction of Survey:	<b>Downstream</b>
US MH:	<b>M-804-015</b>	DS MH:	<b>M-804-014</b>
		Total Length Surveyed (ft):	<b>6.2</b>

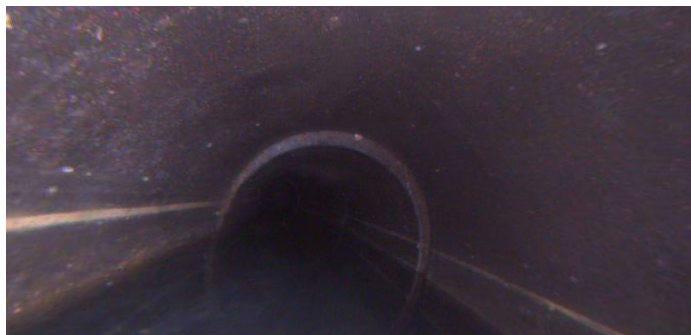
Code: **AMH**  
 Description: **Manhole**

Distance (ft): **.0**  
 Structural Grade: **0**  
 O&M Grade: **0**  
 Clock Start/From:  
 Clock To:  
 1st Value:  
 2nd Value:  
 Value Percent:  
 Continuous Index:  
 Within 8" of Joint: **NO**  
 Remarks: **M-804-015**

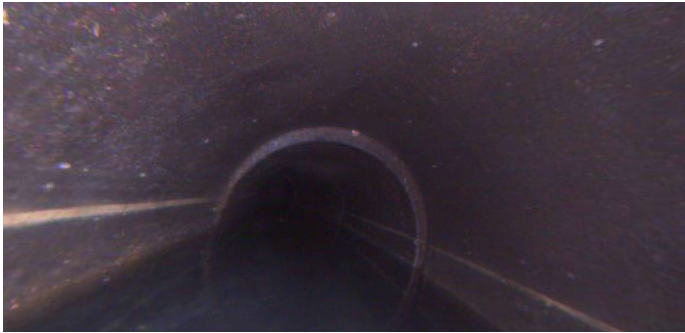
Code:	<b>MWL</b>
Description:	<b>Water Level</b>

Distance (ft):	<b>.0</b>
Structural Grade:	<b>0</b>
O&M Grade:	<b>0</b>
Clock Start/From:	
Clock To:	
1st Value:	
2nd Value:	
Value Percent:	<b>30.000</b>
Continuous Index:	
Within 8" of Joint:	<b>NO</b>
Remarks:

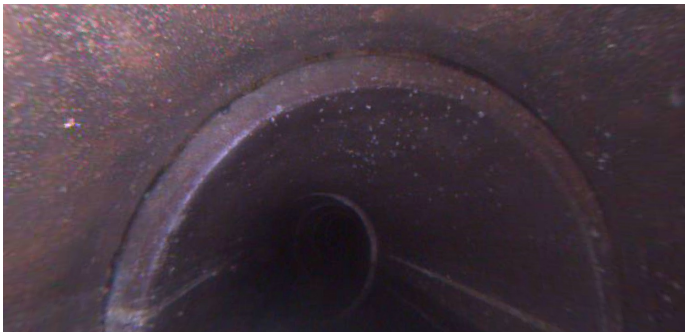
Code:	<b>MSA</b>
Description:	<b>Abandoned Survey</b>

Distance (ft):	<b>6.2</b>
Structural Grade:	<b>0</b>
O&M Grade:	<b>0</b>
Clock Start/From:	
Clock To:	
1st Value:	
2nd Value:	
Value Percent:	
Continuous Index:	
Within 8" of Joint:	<b>NO</b>
Remarks:	<b>unknown</b>
