## Profile/Photo Observation Report

Street:	<b>E Home Ave</b>	Flow Control:	<b>Not Controlled</b>
City:	<b>Hobart, IN</b>	Year Renewed:	
Location:	<b>Other</b>	Tape/Media #:	
Purpose:	<b>Not Known</b>	Dia/Height:	<b>12"</b>
Use:	<b>Sanitary</b>	Material:	<b>VCP</b>
Drain Area:	<b>NA</b>	Lining:	
Category:	<b>NA</b>		
Comment:

Location Details:		Direction of Survey:	<b>Downstream</b>
US MH:	<b>M-804-015</b>	DS MH:	<b>M-804-014</b>
		Total Length Surveyed (ft):	<b>6.2</b>

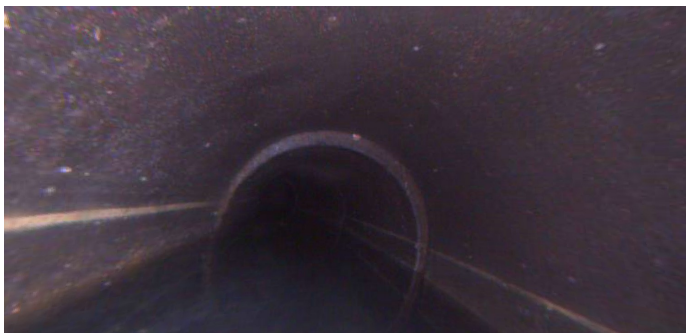
Code: **AMH**  
Description: **Manhole**

Distance (ft): **.0**  
Structural Grade: **0**  
O&M Grade: **0**  
Clock Start/From:  
Clock To:  
1st Value:  
2nd Value:  
Value Percent:  
Continuous Index:  
Within 8" of Joint: **NO**  
Remarks: **M-804-015**

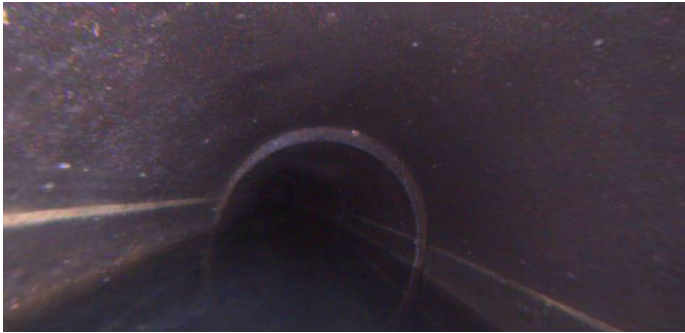
Code:	<b>MWL</b>
Description:	<b>Water Level</b>

Distance (ft):	<b>.0</b>
Structural Grade:	<b>0</b>
O&M Grade:	<b>0</b>
Clock Start/From:	
Clock To:	
1st Value:	
2nd Value:	
Value Percent:	<b>30.000</b>
Continuous Index:	
Within 8" of Joint:	<b>NO</b>
Remarks:

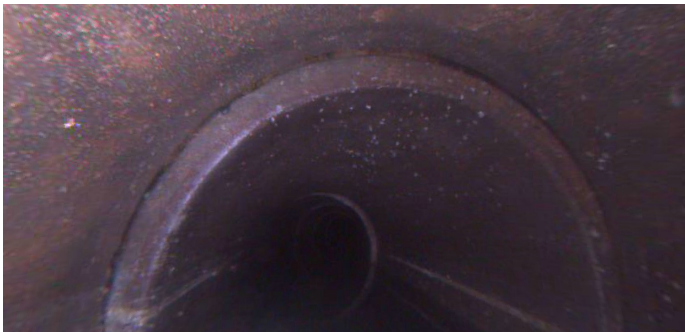
Code:	<b>MSA</b>
Description:	<b>Abandoned Survey</b>

Distance (ft):	<b>6.2</b>
Structural Grade:	<b>0</b>
O&M Grade:	<b>0</b>
Clock Start/From:	
Clock To:	
1st Value:	
2nd Value:	
Value Percent:	
Continuous Index:	
Within 8" of Joint:	<b>NO</b>
Remarks:	<b>unknown</b>
