## Profile/Photo Observation Report

Date:	<b>10/11/2021</b>	Weather:		Coding:	<b>PACP 7.0</b>
Pipe Length (ft):	<b>111.1</b>	Owner:	<b>City of Hobart</b>	Pre Clean:	<b>Heavy Cleaning</b>
P.O.#:	<b>YES502259</b>	Surveyor:	<b>S. Bucklin</b>	PSR:	<b>P-804-014-015</b>
Customer:	<b>City of Hobart</b>	Clean Date:	<b>10/09/2021</b>	Shape:	<b>C</b>

Street:	<b>East Home Avenue</b>	Flow Control:	<b>Not Controlled</b>
City:	<b>Hobart, IN</b>	Year Renewed:	
Location:	<b>Local rural streets with light traffic, t</b>	Tape/Media #:	
Purpose:	<b>Routine Assessment</b>	Dia/Height:	<b>12"</b>
Use:	<b>Sanitary Sewage Pipe</b>	Material:	<b>VCP</b>
Drain Area:		Lining:	
Category:	<b>NA</b>		
Comment:			
Location Details:		Direction of Survey:	<b>Upstream</b>
US MH:	<b>M-804-015</b>	DS MH:	<b>M-804-014</b>
		Total Length Surveyed (ft):	<b>111.1</b>

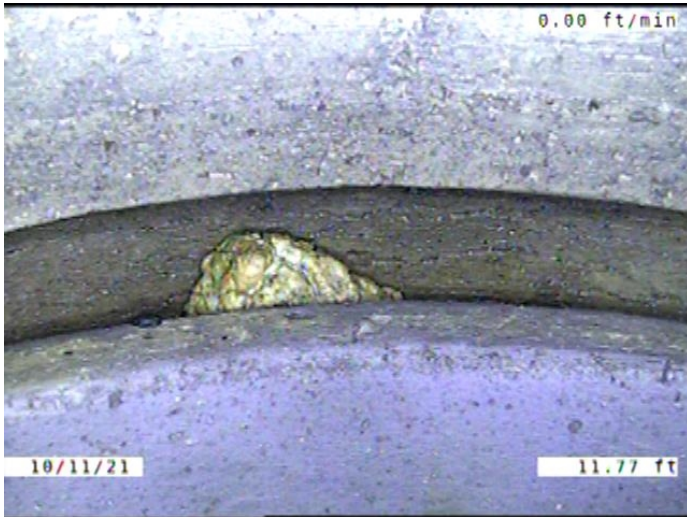
Code: **JAM**  
Description: **Joint Angular Medium**

Distance (ft): **11.8**  
Structural Grade: **3**  
O&M Grade: **0**  
Clock Start/From:  
Clock To:  
1st Value:  
2nd Value:  
Value Percent:  
Continuous Index:  
Within 8" of Joint: **NO**  
Remarks:

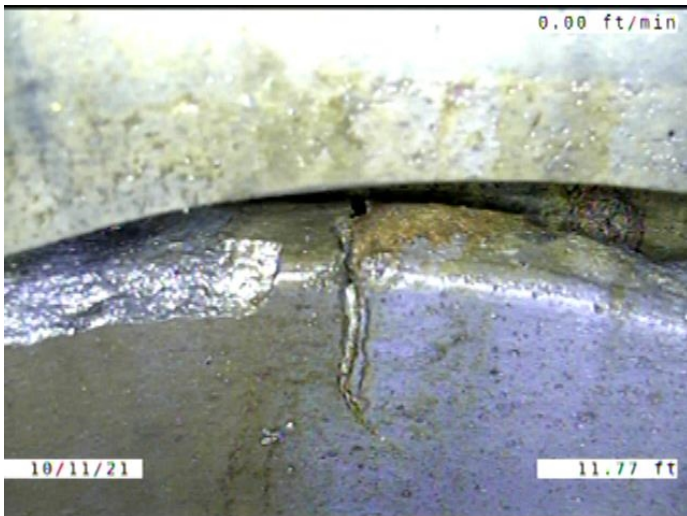
Code: **FL**  
Description: **Fracture Longitudinal**

Distance (ft): **11.8**  
Structural Grade: **3**  
O&M Grade: **0**  
Clock Start/From: **9**  
Clock To:  
1st Value:  
2nd Value:  
Value Percent:  
Continuous Index:  
Within 8" of Joint: **YES**  
Remarks:

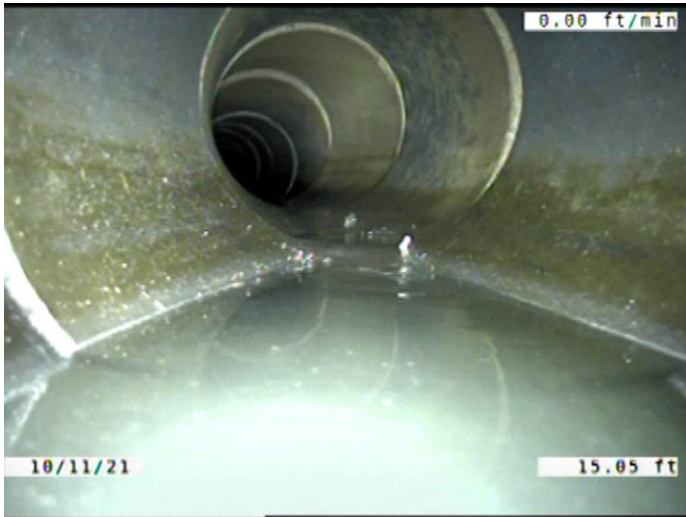
Code: **MWLS**  
 Description: **Miscellaneous Water Level Sag**

Distance (ft): **15.1**  
 Structural Grade: **2**  
 O&M Grade: **0**  
 Clock Start/From:  
 Clock To:  
 1st Value:  
 2nd Value:  
 Value Percent: **5.000**  
 Continuous Index:  
 Within 8" of Joint: **NO**  
 Remarks:

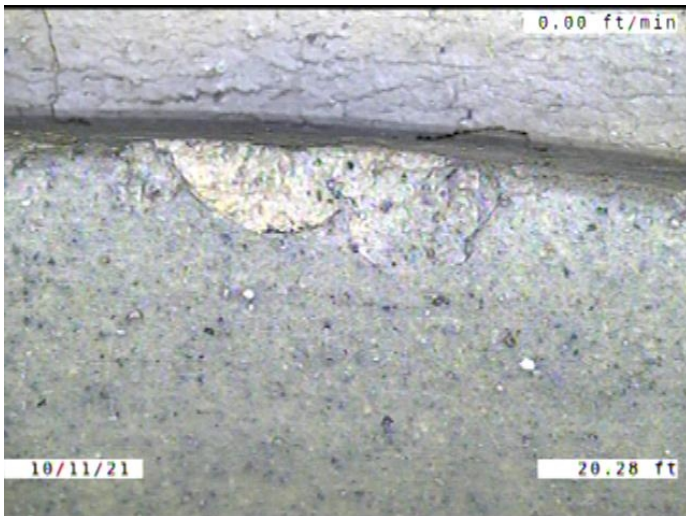
Code: **SSS**  
 Description: **Surface Damage Surface Spalling**

Distance (ft): **20.3**  
 Structural Grade: **2**  
 O&M Grade: **0**  
 Clock Start/From: **2**  
 Clock To:  
 1st Value:  
 2nd Value:  
 Value Percent:  
 Continuous Index:  
 Within 8" of Joint: **YES**  
 Remarks:

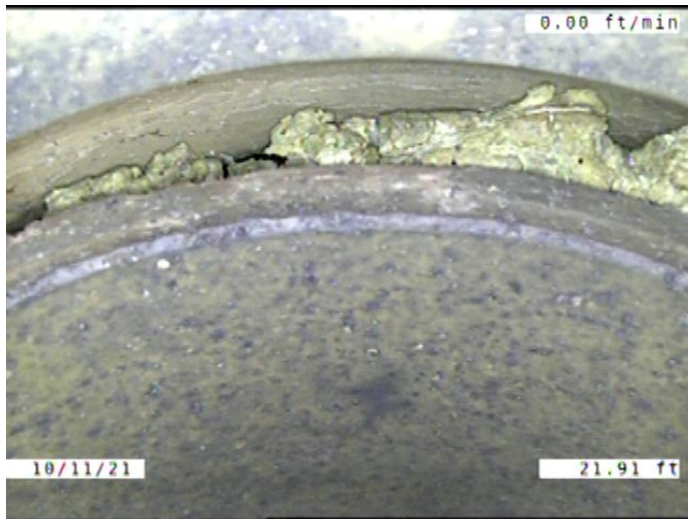
Code: **JOMD**  
 Description: **Joint Offset Medium Defective**

Distance (ft): **21.9**  
 Structural Grade: **3**  
 O&M Grade: **0**  
 Clock Start/From:  
 Clock To:  
 1st Value:  
 2nd Value:  
 Value Percent:  
 Continuous Index:  
 Within 8" of Joint: **NO**  
 Remarks:

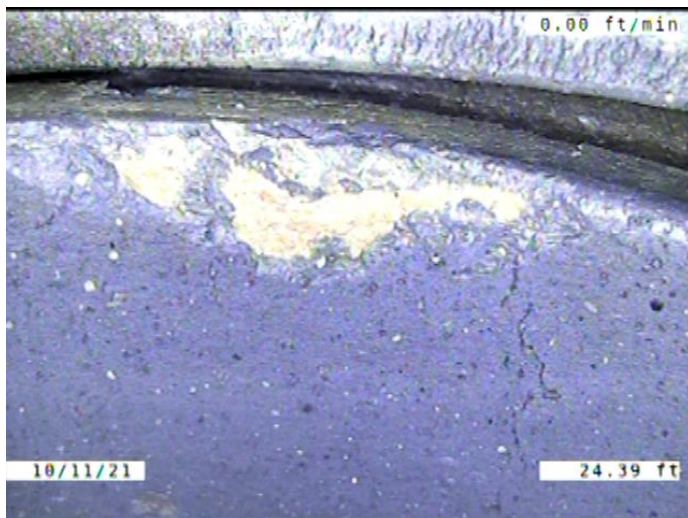
Code: **SSS**  
 Description: **Surface Damage Surface Spalling**

Distance (ft): **24.4**  
 Structural Grade: **2**  
 O&M Grade: **0**  
 Clock Start/From: **1**  
 Clock To: **2**  
 1st Value:  
 2nd Value:  
 Value Percent:  
 Continuous Index:  
 Within 8" of Joint: **YES**  
 Remarks:

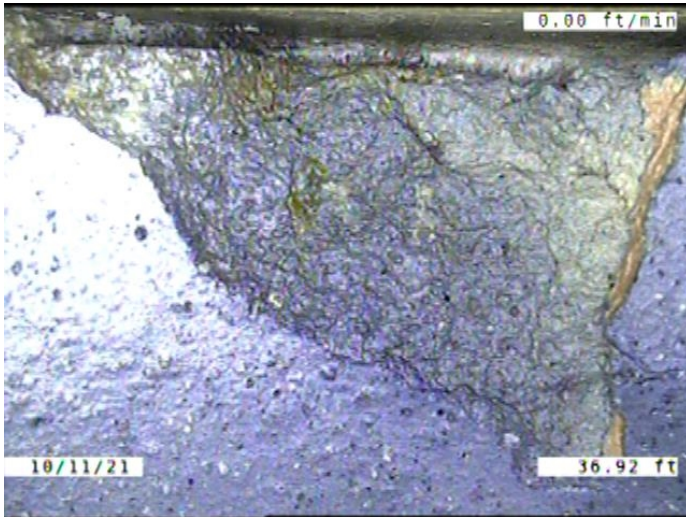
Code: **SSS**  
 Description: **Surface Damage Surface Spalling**

Distance (ft): **36.9**  
 Structural Grade: **2**  
 O&M Grade: **0**  
 Clock Start/From: **9**  
 Clock To: **10**  
 1st Value:  
 2nd Value:  
 Value Percent:  
 Continuous Index:  
 Within 8" of Joint: **YES**  
 Remarks:

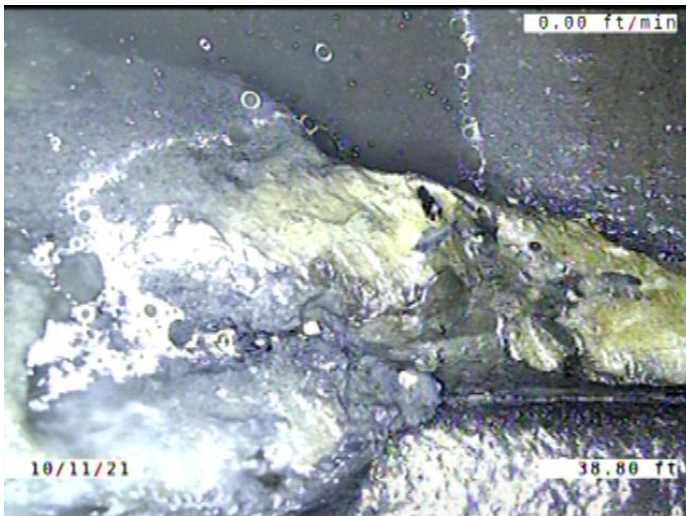
Code: **DAE**  
 Description: **Deposits Attached Encrustation**

Distance (ft): **38.8**  
 Structural Grade: **0**  
 O&M Grade: **2**  
 Clock Start/From: **4**  
 Clock To: **8**  
 1st Value:  
 2nd Value:  
 Value Percent: **5.000**  
 Continuous Index:  
 Within 8" of Joint: **YES**  
 Remarks:

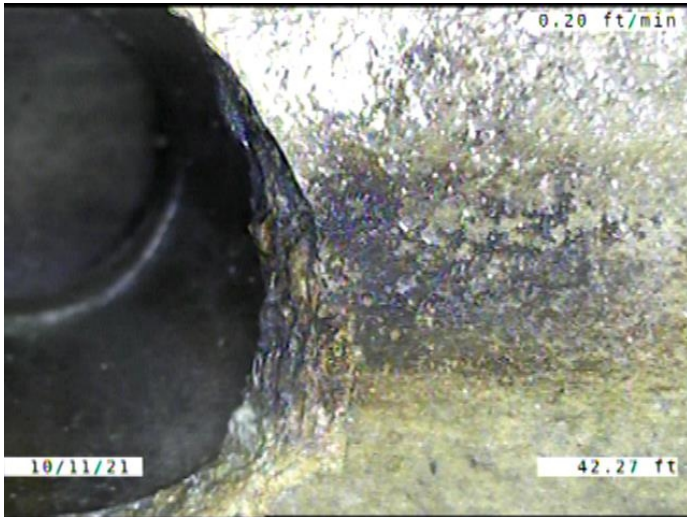
Code: **SSS**  
 Description: **Surface Damage Surface Spalling**

Distance (ft): **42.3**  
 Structural Grade: **2**  
 O&M Grade: **0**  
 Clock Start/From: **11**  
 Clock To: **1**  
 1st Value:  
 2nd Value:  
 Value Percent:  
 Continuous Index:  
 Within 8" of Joint: **YES**  
 Remarks:

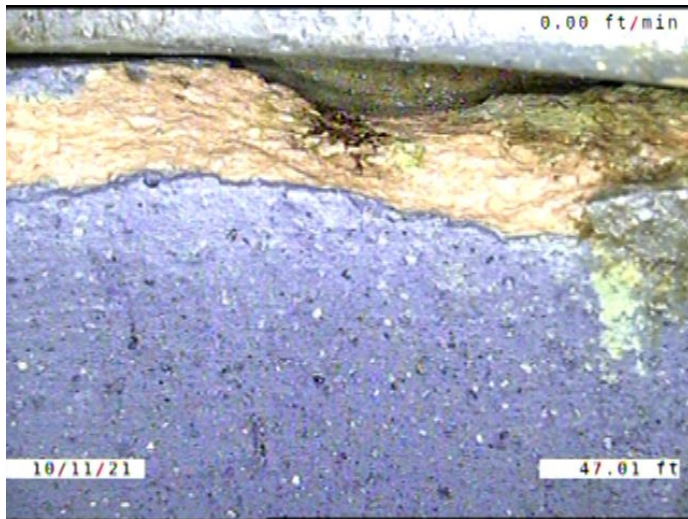
Code:	<b>SZ</b>
Description:	<b>Surface Damage Other</b>
Distance (ft):	<b>47.0</b>
Structural Grade:	<b>0</b>
O&M Grade:	<b>0</b>
Clock Start/From:	<b>3</b>
Clock To:	<b>4</b>
1st Value:	
2nd Value:	
Value Percent:	
Continuous Index:	
Within 8" of Joint:	<b>YES</b>
Remarks:	<b>A PIECE CHIPPED AWAY FROM THE JOINT</b>

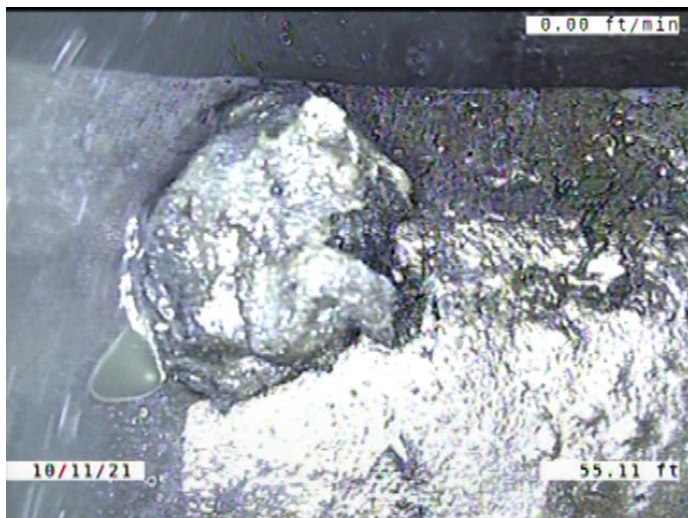
Code:	<b>DAE</b>
Description:	<b>Deposits Attached Encrustation</b>
Distance (ft):	<b>55.1</b>
Structural Grade:	<b>0</b>
O&M Grade:	<b>2</b>
Clock Start/From:	<b>5</b>
Clock To:	
1st Value:	
2nd Value:	
Value Percent:	<b>5.000</b>
Continuous Index:	
Within 8" of Joint:	<b>YES</b>
Remarks:

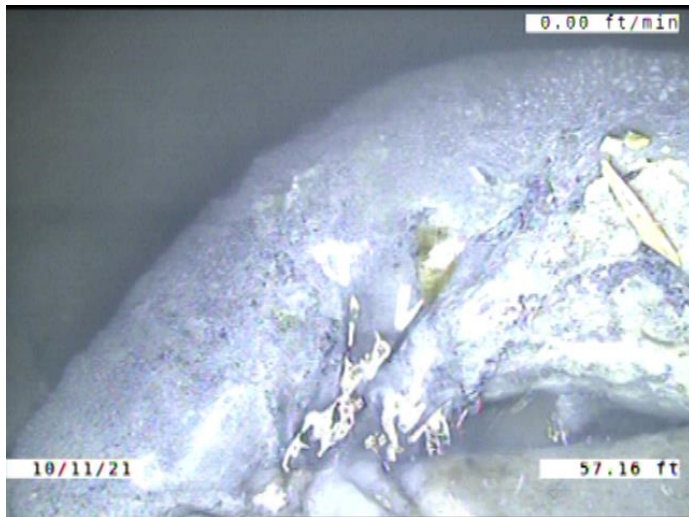
Code:	<b>DAE</b>
Description:	<b>Deposits Attached Encrustation</b>
Distance (ft):	<b>57.2</b>
Structural Grade:	<b>0</b>
O&M Grade:	<b>2</b>
Clock Start/From:	<b>4</b>
Clock To:	<b>8</b>
1st Value:	
2nd Value:	
Value Percent:	<b>5.000</b>
Continuous Index:	
Within 8" of Joint:	<b>YES</b>
Remarks:

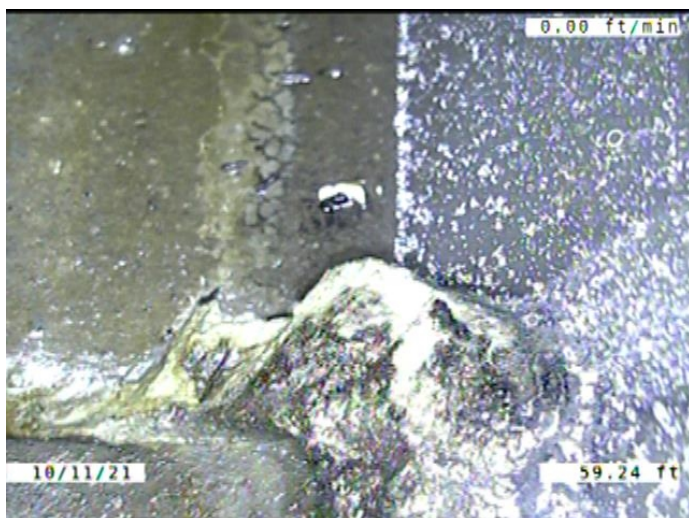
Code:	<b>DAE</b>
Description:	<b>Deposits Attached Encrustation</b>
Distance (ft):	<b>59.2</b>
Structural Grade:	<b>0</b>
O&M Grade:	<b>2</b>
Clock Start/From:	<b>4</b>
Clock To:	<b>8</b>
1st Value:	
2nd Value:	
Value Percent:	<b>5.000</b>
Continuous Index:	
Within 8" of Joint:	<b>YES</b>
Remarks:

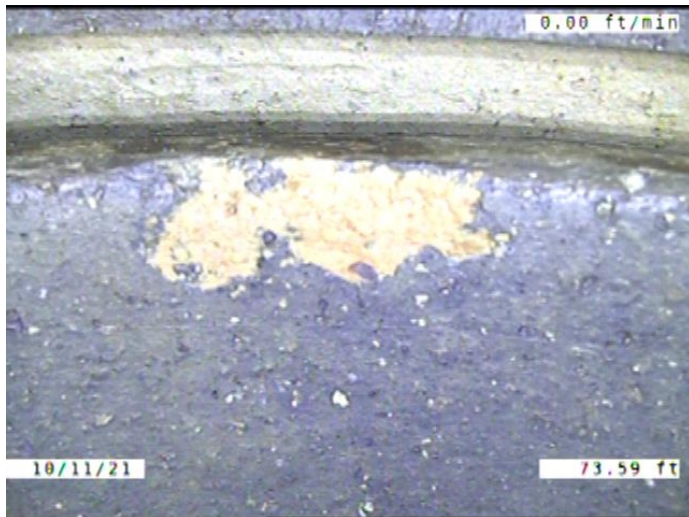
Code: **SSS**  
 Description: **Surface Damage Surface Spalling**

Distance (ft): **73.6**  
 Structural Grade: **2**  
 O&M Grade: **0**  
 Clock Start/From: **1**  
 Clock To:  
 1st Value:  
 2nd Value:  
 Value Percent:  
 Continuous Index:  
 Within 8" of Joint: **YES**  
 Remarks:

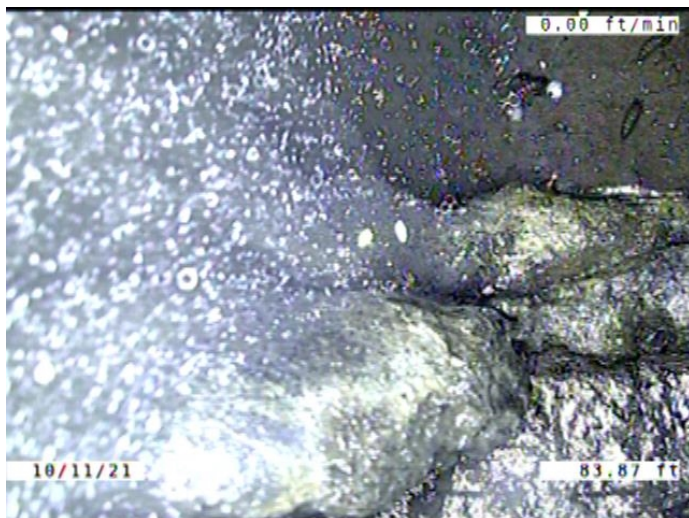
Code: **DAE**  
 Description: **Deposits Attached Encrustation**

Distance (ft): **83.9**  
 Structural Grade: **0**  
 O&M Grade: **2**  
 Clock Start/From: **4**  
 Clock To: **5**  
 1st Value:  
 2nd Value:  
 Value Percent: **5.000**  
 Continuous Index:  
 Within 8" of Joint: **YES**  
 Remarks:

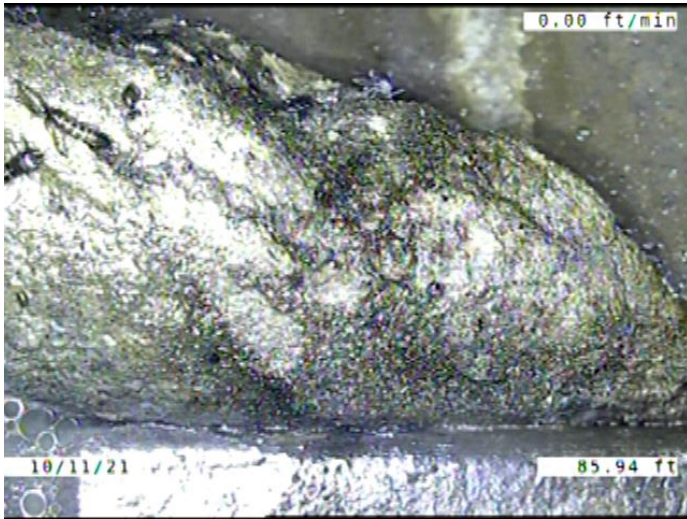
Code: **DAE**  
 Description: **Deposits Attached Encrustation**

Distance (ft): **85.9**  
 Structural Grade: **0**  
 O&M Grade: **2**  
 Clock Start/From: **4**  
 Clock To: **8**  
 1st Value:  
 2nd Value:  
 Value Percent: **5.000**  
 Continuous Index:  
 Within 8" of Joint: **YES**  
 Remarks:

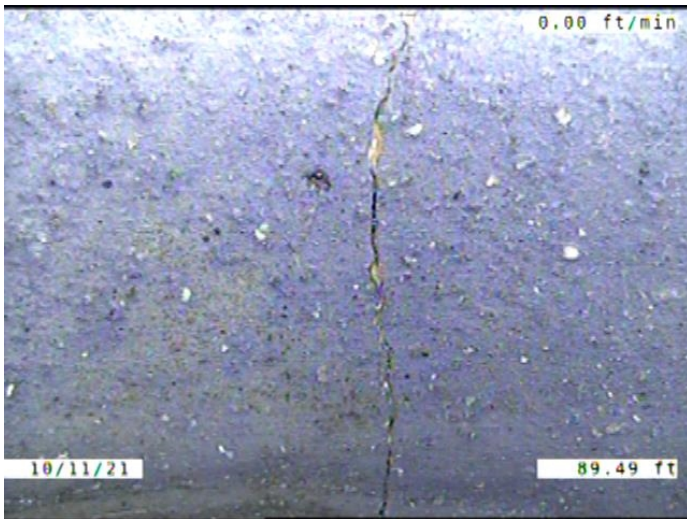
Code: **FM**  
 Description: **Fracture Multiple**

Distance (ft): **89.5**  
 Structural Grade: **4**  
 O&M Grade: **0**  
 Clock Start/From: **11**  
 Clock To: **2**  
 1st Value:  
 2nd Value:  
 Value Percent:  
 Continuous Index:  
 Within 8" of Joint: **YES**  
 Remarks:

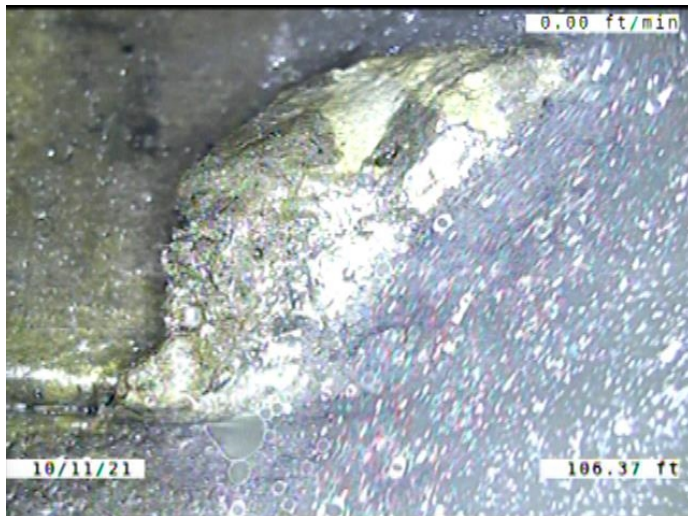
Code: **DAE**  
 Description: **Deposits Attached Encrustation**

Distance (ft): **106.4**  
 Structural Grade: **0**  
 O&M Grade: **2**  
 Clock Start/From: **7**  
 Clock To: **8**  
 1st Value:  
 2nd Value:  
 Value Percent: **5.000**  
 Continuous Index:  
 Within 8" of Joint: **YES**  
 Remarks:

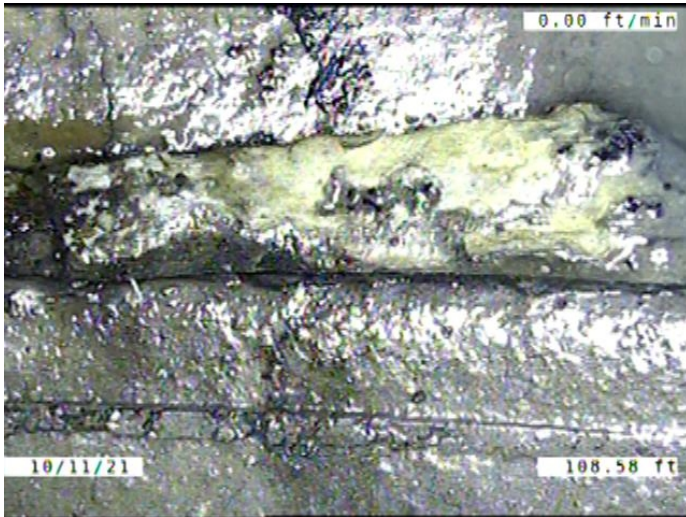
Code: **DAE**  
 Description: **Deposits Attached Encrustation**

Distance (ft): **108.6**  
 Structural Grade: **0**  
 O&M Grade: **2**  
 Clock Start/From: **3**  
 Clock To: **9**  
 1st Value:  
 2nd Value:  
 Value Percent: **5.000**  
 Continuous Index:  
 Within 8" of Joint: **YES**  
 Remarks:
