Profile/Photo Observation Report

Street:	E HOME AVE	Flow Control:	Not Controlled
City:	Hobart, IN	Year Renewed:	
Location:	Other	Tape/Media #:	
Purpose:	Not Known	Dia/Height:	12"
Use:	Sanitary	Material:	PVC
Drain Area:	NA	Lining:	
Category:	NA		
Comment:

Location Details:		Direction of Survey:	Downstream
US MH:	M-804-016	DS MH:	M-804-015
		Total Length Surveyed (ft):	17.8

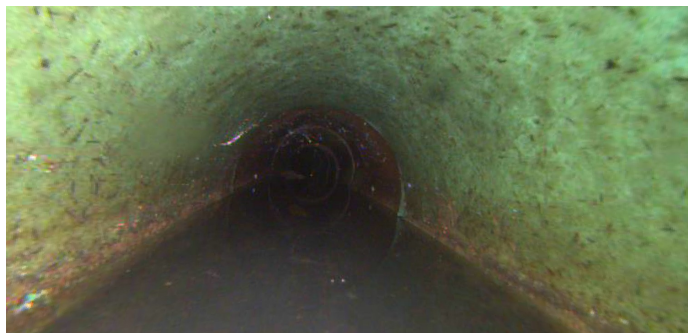
Code: **AMH**
 Description: **Manhole**
 Distance (ft): **.0**
 Structural Grade: **0**
 O&M Grade: **0**
 Clock Start/From:
 Clock To:
 1st Value:
 2nd Value:
 Value Percent:
 Continuous Index:
 Within 8" of Joint: **NO**
 Remarks: **M-804-016**

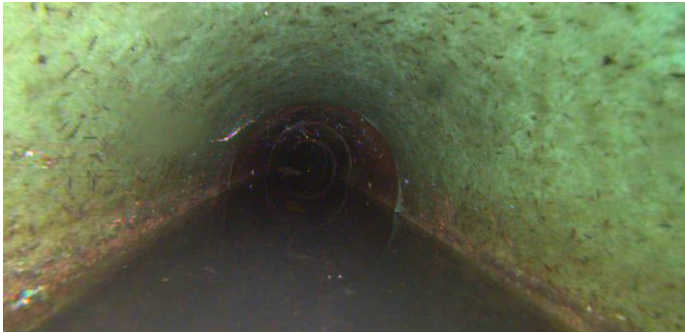
Code:	MWL
Description:	Water Level

Distance (ft):	.0
Structural Grade:	0
O&M Grade:	0
Clock Start/From:	
Clock To:	
1st Value:	
2nd Value:	
Value Percent:	30.000
Continuous Index:	
Within 8" of Joint:	NO
Remarks:

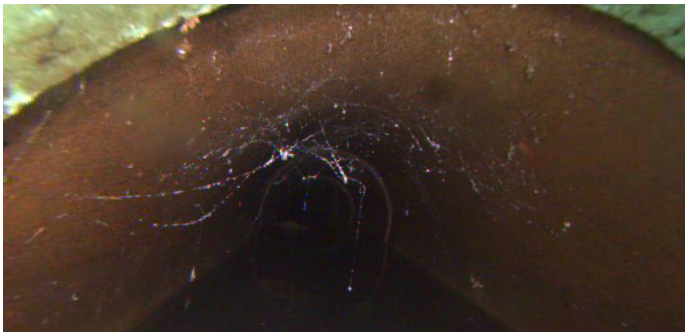
Code:	MMC
Description:	Material Change

Distance (ft):	2.6
Structural Grade:	0
O&M Grade:	0
Clock Start/From:	
Clock To:	
1st Value:	
2nd Value:	
Value Percent:	
Continuous Index:	
Within 8" of Joint:	NO
Remarks:	vcp

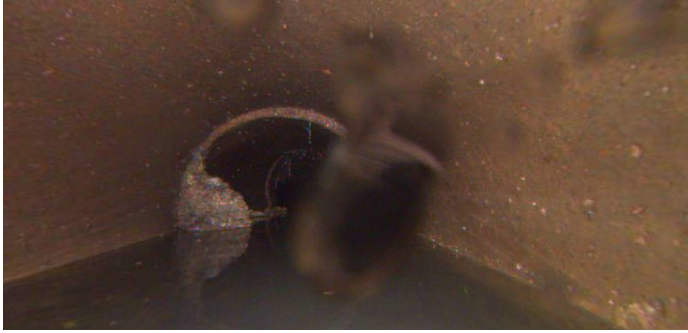
Code:	MSA
Description:	Abandoned Survey
Distance (ft):	17.8
Structural Grade:	0
O&M Grade:	0
Clock Start/From:	
Clock To:	
1st Value:	
2nd Value:	
Value Percent:	
Continuous Index:	
Within 8" of Joint:	NO
Remarks:	debris under water
