## Profile/Photo Observation Report

Date:	<b>04/21/2018</b>	Weather:		Coding:	<b>PACP 6.0</b>
Pipe Length (ft):	<b>42.6</b>	Owner:	<b>NA</b>	Pre Clean:	<b>Not Known</b>
P.O.#:		Surveyor:	<b>Jen Costello</b>	PSR:	<b>P-804-015-016</b>
Customer:		Clean Date:	<b>01/01/1900</b>	Shape:	<b>C</b>

Street:	<b>E Home Ave</b>	Flow Control:	<b>Not Controlled</b>
City:	<b>Hobart, IN</b>	Year Renewed:	
Location:	<b>Other</b>	Tape/Media #:	
Purpose:	<b>Not Known</b>	Dia/Height:	<b>12"</b>
Use:	<b>Sanitary</b>	Material:	<b>PVC</b>
Drain Area:	<b>NA</b>	Lining:	
Category:	<b>NA</b>		
Comment:

Location Details:		Direction of Survey:	<b>Downstream</b>
US MH:	<b>M-804-016</b>	DS MH:	<b>M-804-015</b>
		Total Length Surveyed (ft):	<b>17.8</b>

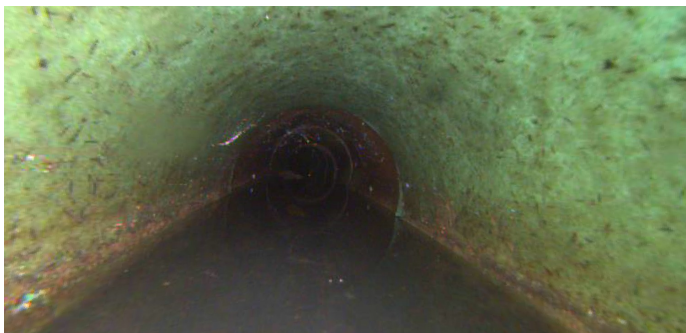
Code: **AMH**  
Description: **Manhole**

Distance (ft): **.0**  
Structural Grade: **0**  
O&M Grade: **0**  
Clock Start/From:  
Clock To:  
1st Value:  
2nd Value:  
Value Percent:  
Continuous Index:  
Within 8" of Joint: **NO**  
Remarks: **M-804-016**

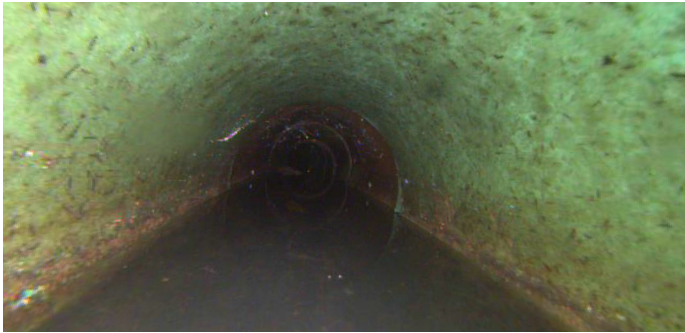
Code:	<b>MWL</b>
Description:	<b>Water Level</b>

Distance (ft):	<b>.0</b>
Structural Grade:	<b>0</b>
O&M Grade:	<b>0</b>
Clock Start/From:	
Clock To:	
1st Value:	
2nd Value:	
Value Percent:	<b>30.000</b>
Continuous Index:	
Within 8" of Joint:	<b>NO</b>
Remarks:

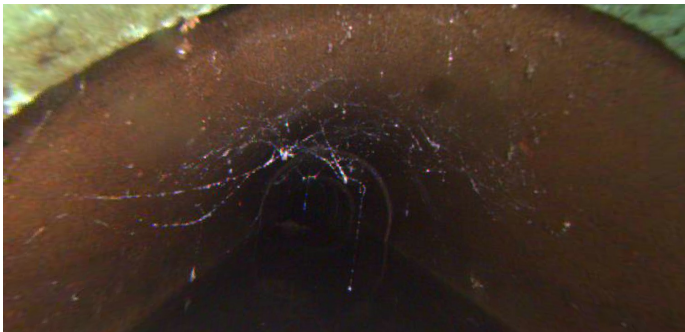
Code:	<b>MMC</b>
Description:	<b>Material Change</b>

Distance (ft):	<b>2.6</b>
Structural Grade:	<b>0</b>
O&M Grade:	<b>0</b>
Clock Start/From:	
Clock To:	
1st Value:	
2nd Value:	
Value Percent:	
Continuous Index:	
Within 8" of Joint:	<b>NO</b>
Remarks:	<b>vcp</b>

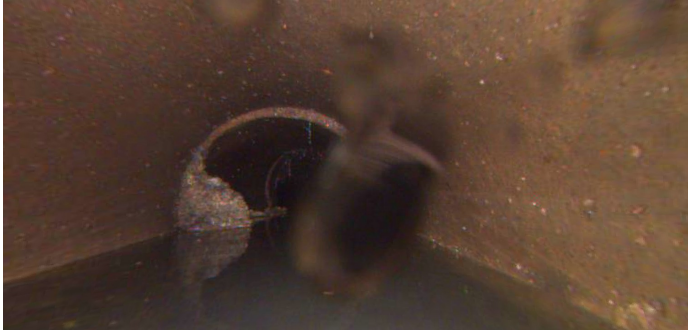
Code:	<b>MSA</b>
Description:	<b>Abandoned Survey</b>
Distance (ft):	<b>17.8</b>
Structural Grade:	<b>0</b>
O&M Grade:	<b>0</b>
Clock Start/From:	
Clock To:	
1st Value:	
2nd Value:	
Value Percent:	
Continuous Index:	
Within 8" of Joint:	<b>NO</b>
Remarks:	<b>debris under water</b>
