Profile/Photo Observation Report

Street:	E HOME AVE	Flow Control:	Not Controlled
City:	Hobart, IN	Year Renewed:	
Location:	Other	Tape/Media #:	
Purpose:	Not Known	Dia/Height:	12"
Use:	Sanitary	Material:	VCP
Drain Area:	NA	Lining:	
Category:	NA		
Comment:

Location Details:		Direction of Survey:	Upstream
US MH:	M-804-016	DS MH:	M-804-015
		Total Length Surveyed (ft):	19.7

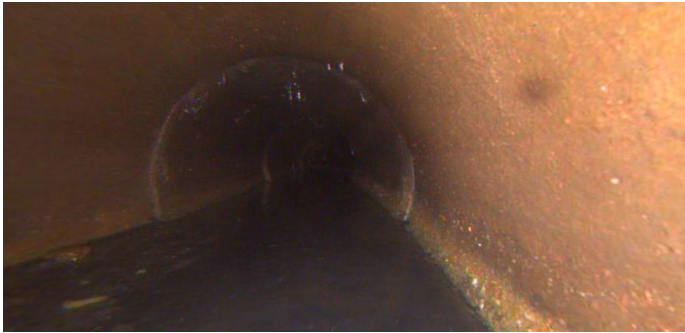
Code:	MWL
Description:	Water Level

Distance (ft):	.0
Structural Grade:	0
O&M Grade:	0
Clock Start/From:	
Clock To:	
1st Value:	
2nd Value:	
Value Percent:	20.000
Continuous Index:	
Within 8" of Joint:	NO
Remarks:

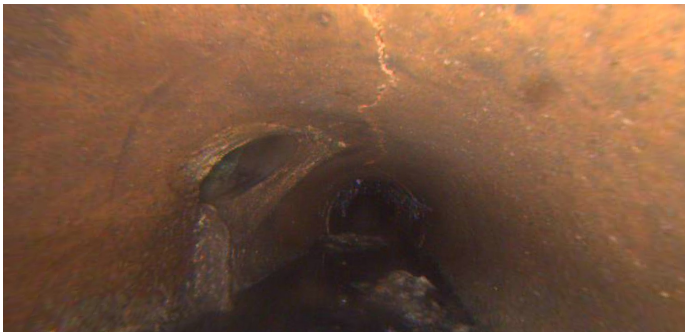
Code:	FL
Description:	Fracture Longitudinal

Distance (ft):	6.4
Structural Grade:	3
O&M Grade:	0
Clock Start/From:	12
Clock To:	
1st Value:	
2nd Value:	
Value Percent:	
Continuous Index:	
Within 8" of Joint:	YES
Remarks:

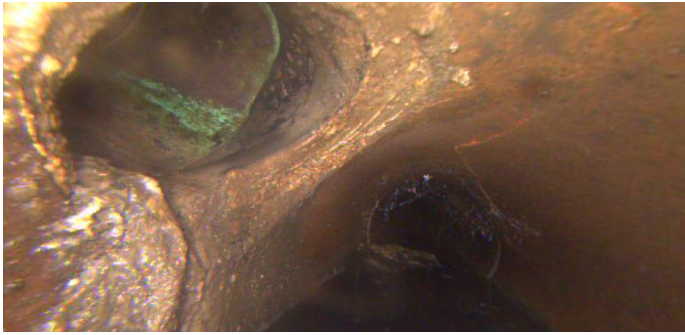
Code: **TB**
Description: **Tap Break-in**

Distance (ft): **7.1**
Structural Grade: **0**
O&M Grade: **0**
Clock Start/From: **10**
Clock To:
1st Value: **4.000**
2nd Value:
Value Percent:
Continuous Index:
Within 8" of Joint:
Remarks:

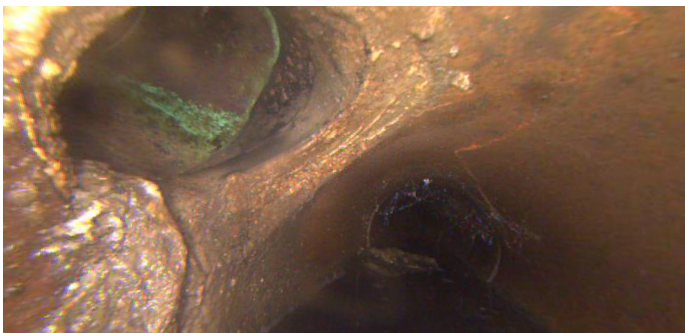
Code: **DAE**
Description: **Deposits Attached Encrustation**

Distance (ft): **7.1**
Structural Grade: **0**
O&M Grade: **2**
Clock Start/From: **8**
Clock To: **9**
1st Value:
2nd Value:
Value Percent: **5.000**
Continuous Index:
Within 8" of Joint: **NO**
Remarks:

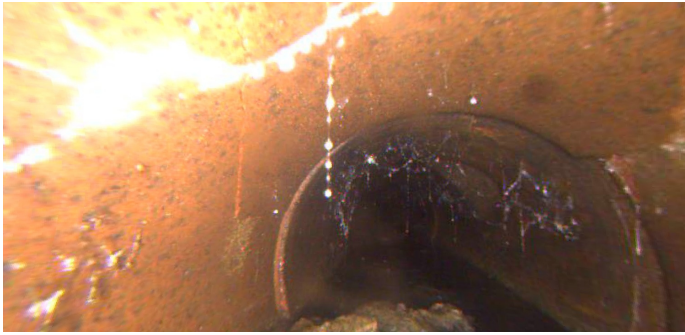
Code: **FM**
Description: **Fracture Multiple**

Distance (ft): **8.7**
Structural Grade: **4**
O&M Grade: **0**
Clock Start/From: **9**
Clock To: **3**
1st Value:
2nd Value:
Value Percent:
Continuous Index:
Within 8" of Joint: **YES**
Remarks:

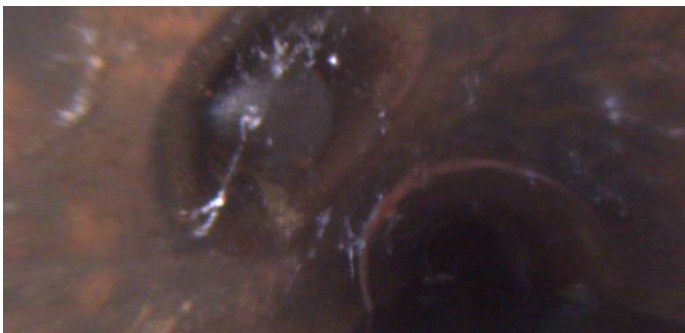
Code: **TFC**
Description: **Tap Factory Capped**

Distance (ft): **11.1**
Structural Grade: **0**
O&M Grade: **0**
Clock Start/From: **2**
Clock To:
1st Value: **4.000**
2nd Value:
Value Percent:
Continuous Index:
Within 8" of Joint:
Remarks:

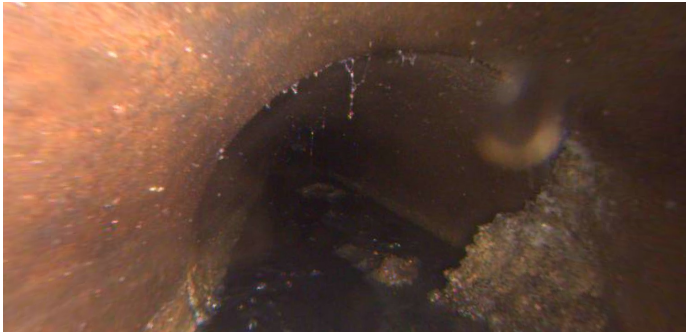
Code: **DAZ**
Description: **Deposits Attached Other**

Distance (ft): **16.1**
Structural Grade: **0**
O&M Grade: **2**
Clock Start/From: **2**
Clock To: **4**
1st Value:
2nd Value:
Value Percent: **10.000**
Continuous Index:
Within 8" of Joint: **YES**
Remarks:

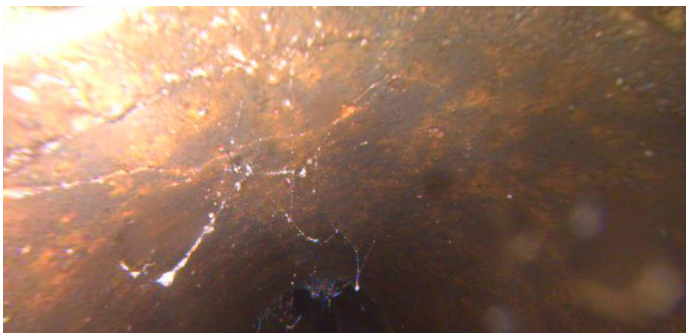
Code: **FM**
Description: **Fracture Multiple**

Distance (ft): **18.7**
Structural Grade: **4**
O&M Grade: **0**
Clock Start/From: **10**
Clock To: **12**
1st Value:
2nd Value:
Value Percent:
Continuous Index:
Within 8" of Joint: **YES**
Remarks:

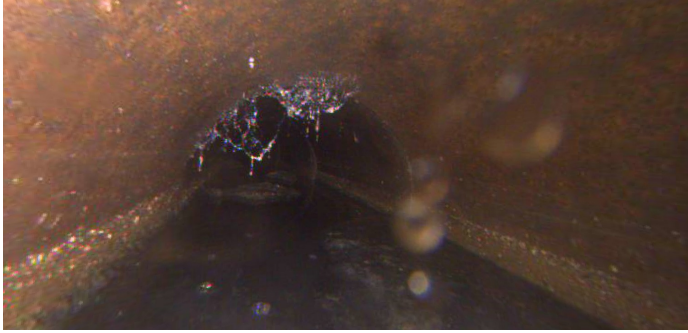
Code:	MSA
Description:	Abandoned Survey
Distance (ft):	19.7
Structural Grade:	0
O&M Grade:	0
Clock Start/From:	
Clock To:	
1st Value:	
2nd Value:	
Value Percent:	
Continuous Index:	
Within 8" of Joint:	NO
Remarks:	DEBRIS UNDER WATER
