Profile/Photo Observation Report

Street:	E Home Ave	Flow Control:	Not Controlled
City:	Hobart, IN	Year Renewed:	
Location:	Other	Tape/Media #:	
Purpose:	Not Known	Dia/Height:	12"
Use:	Sanitary	Material:	VCP
Drain Area:	NA	Lining:	
Category:	NA		
Comment:

Location Details:		Direction of Survey:	Upstream
US MH:	M-804-016	DS MH:	M-804-015
		Total Length Surveyed (ft):	19.7

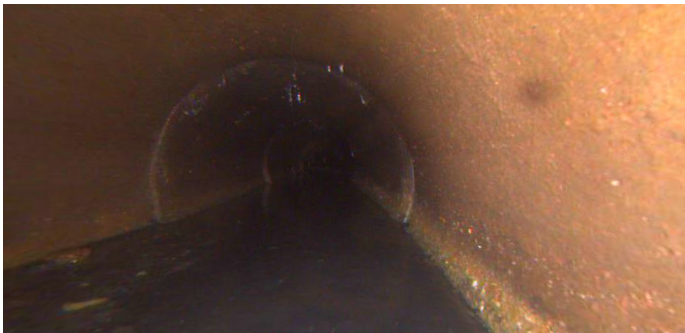
Code: **AMH**
Description: **Manhole**

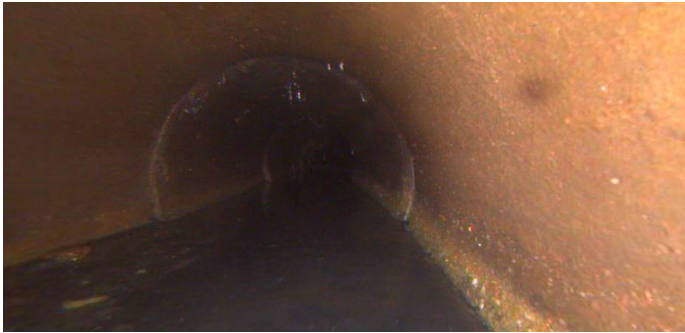
Code:	MWL
Description:	Water Level

Distance (ft):	.0
Structural Grade:	0
O&M Grade:	0
Clock Start/From:	
Clock To:	
1st Value:	
2nd Value:	
Value Percent:	20.000
Continuous Index:	
Within 8" of Joint:	NO
Remarks:

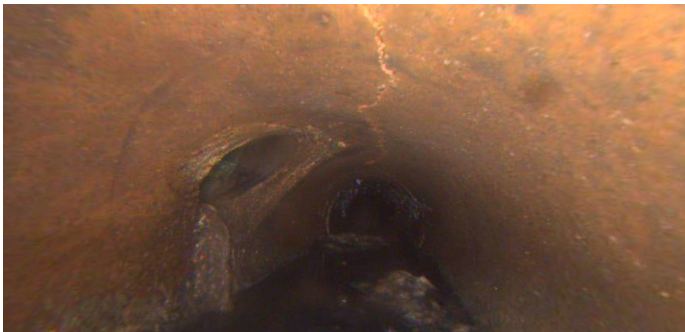
Code:	FL
Description:	Fracture Longitudinal

Distance (ft):	6.4
Structural Grade:	3
O&M Grade:	0
Clock Start/From:	12
Clock To:	
1st Value:	
2nd Value:	
Value Percent:	
Continuous Index:	
Within 8" of Joint:	YES
Remarks:

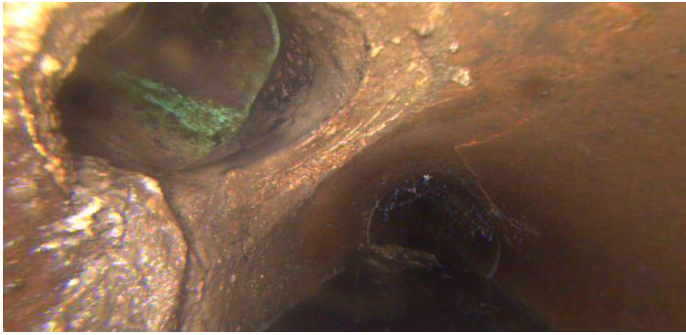
Code: **TB**
Description: **Tap Break-in**

Distance (ft): **7.1**
Structural Grade: **0**
O&M Grade: **0**
Clock Start/From: **10**
Clock To:
1st Value: **4.000**
2nd Value:
Value Percent:
Continuous Index:
Within 8" of Joint:
Remarks:

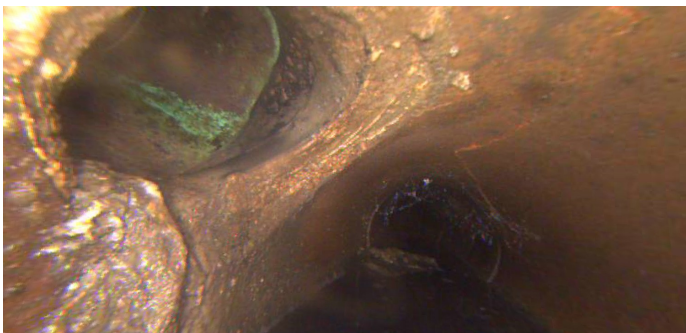
Code: **DAE**
Description: **Deposits Attached Encrustation**

Distance (ft): **7.1**
Structural Grade: **0**
O&M Grade: **2**
Clock Start/From: **8**
Clock To: **9**
1st Value:
2nd Value:
Value Percent: **5.000**
Continuous Index:
Within 8" of Joint: **NO**
Remarks:

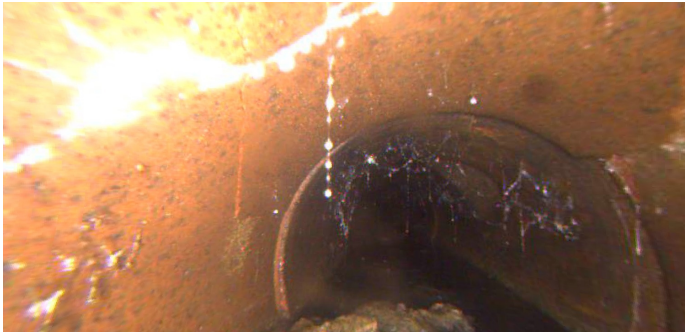
Code: **FM**
Description: **Fracture Multiple**

Distance (ft): **8.7**
Structural Grade: **4**
O&M Grade: **0**
Clock Start/From: **9**
Clock To: **3**
1st Value:
2nd Value:
Value Percent:
Continuous Index:
Within 8" of Joint: **YES**
Remarks:

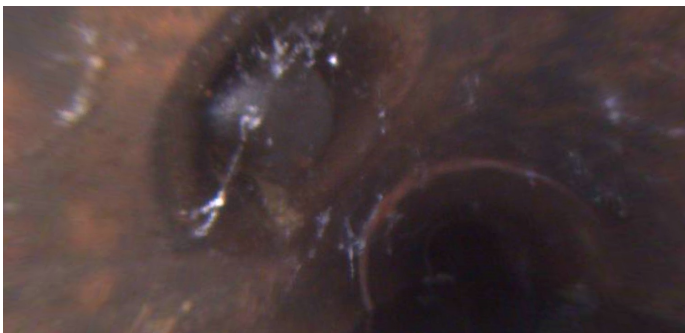
Code: **TFC**
Description: **Tap Factory Capped**

Distance (ft): **11.1**
Structural Grade: **0**
O&M Grade: **0**
Clock Start/From: **2**
Clock To:
1st Value: **4.000**
2nd Value:
Value Percent:
Continuous Index:
Within 8" of Joint:
Remarks:

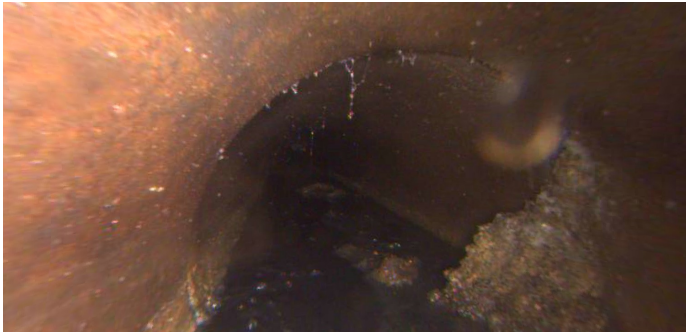
Code: **DAZ**
Description: **Deposits Attached Other**

Distance (ft): **16.1**
Structural Grade: **0**
O&M Grade: **2**
Clock Start/From: **2**
Clock To: **4**
1st Value:
2nd Value:
Value Percent: **10.000**
Continuous Index:
Within 8" of Joint: **YES**
Remarks:

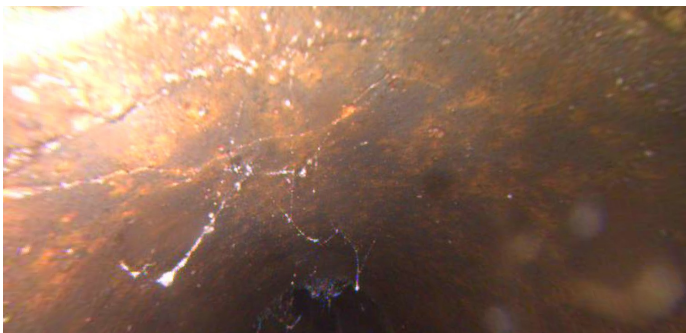
Code: **FM**
Description: **Fracture Multiple**

Distance (ft): **18.7**
Structural Grade: **4**
O&M Grade: **0**
Clock Start/From: **10**
Clock To: **12**
1st Value:
2nd Value:
Value Percent:
Continuous Index:
Within 8" of Joint: **YES**
Remarks:

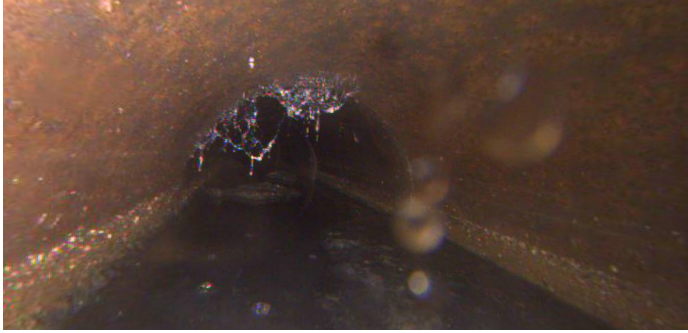
Code:	MSA
Description:	Abandoned Survey
Distance (ft):	19.7
Structural Grade:	0
O&M Grade:	0
Clock Start/From:	
Clock To:	
1st Value:	
2nd Value:	
Value Percent:	
Continuous Index:	
Within 8" of Joint:	NO
Remarks:	DEBRIS UNDER WATER
