Date:	10/11/2021	Weather:		Coding:	PACP 7.0
Pipe Length (ft)	38.3	Owner:	City of Hobart	Pre Clean:	Heavy Cleaning
P.O.#:	YES502259	Surveyor:	S. Bucklin	PSR:	P-804-015-016
Customer:	City of Hobart	Clean Date:	10/09/2021	Shape:	С
Street:	East Home Avenu	e	Flow Control:	Not Controlled	d
City:	Hobart, IN		Year Renewed:		
Location:	Local rural streets	with light traffic,	t Tape/Media #:		
Purpose:	Routine Assessme	ent	Dia/Height:	12"	
Use:	Sanitary Sewage F	Pipe	Material:	VCP	
Drain Area:			Lining:		
Category:	NA				
Comment:					
Location Details	:		Direction of Surve	ey: Upstream	
US MH:	M-804-016	DS MH:	M-804-015	Total Length Surveyed (ft	:): <b>38.3</b>
0&M Index:	2.22	O&M Quick:	3227	O&M Rating:	20.00
Structural Index:	3.50	Structural Qu	ick: 4131		7.00
Overall Index:	2.45	Overall Quick	44.20		27.00

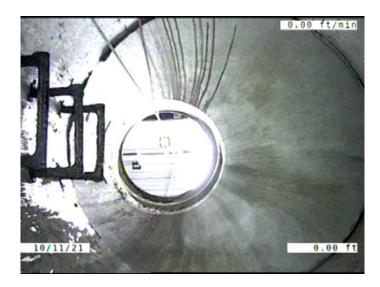
Code: Description:	AMH Manhole
Distance (ft):	.0
Structural Grade:	0
O&M Grade:	0
Clock Start/From:	
Clock To:	
1st Value:	
2nd Value:	
Value Percent:	
Continuous Index:	
Within 8" of Joint:	NO
Remarks:	M-804-015

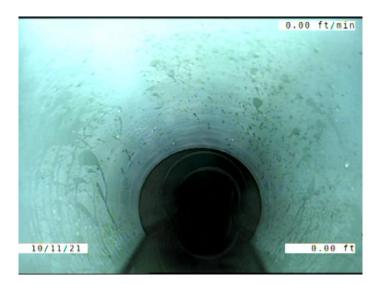
Code:	MWL
Description:	Miscellaneous Water Level
	-
Distance (ft):	.0
Structural Grade:	0
O&M Grade:	0
Clock Start/From:	
Clock To:	
1st Value:	
2nd Value:	
Value Percent:	5.000
Continuous Index:	
Within 8" of Joint:	NO
Remarks:

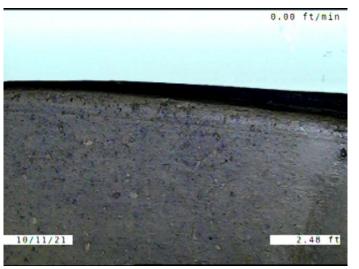
Code: Description:	MMC Miscellaneous Material Change
Distance (ft): Structural Grade: O&M Grade: Clock Start/From: Clock To: 1st Value: 2nd Value: Value Percent: Continuous Index: Within 8" of Joint: Demarks:	2.5 0 0
Remarks:	ΡVC ΤΟ VCP

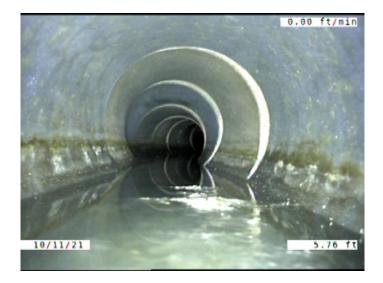
Code: Description:	DSF Deposits Settled Fine
Distance (ft):	5.8
Structural Grade:	0
O&M Grade:	2
Clock Start/From:	5
Clock To:	7
1st Value:	
2nd Value:	
Value Percent:	5.000
Continuous Index:	S01
Within 8" of Joint:	YES
Remarks:

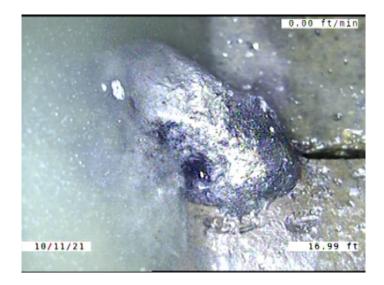
Code: Description:	DAE Deposits Attached Encrustation
Distance (ft): Structural Grade: O&M Grade: Clock Start/From: Clock To:	17.0 0 2 4
1st Value: 2nd Value: Value Percent: Continuous Index: Within 8" of Joint: Remarks:	5.000 YES

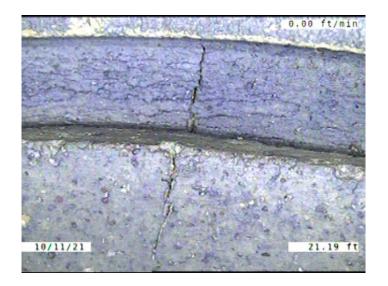
Code: Description:	FL Fracture Longitudinal
Distance (ft):	21.2
Structural Grade:	3
O&M Grade:	0
Clock Start/From:	2
Clock To:	
1st Value:	
2nd Value:	
Value Percent:	
Continuous Index:	
Within 8" of Joint:	YES
Remarks:

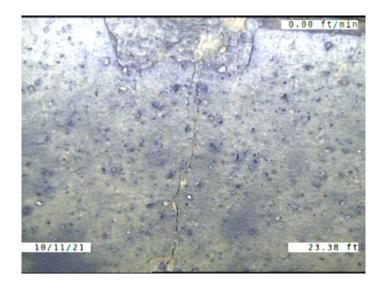
Code: Description:	FM Fracture Multiple
Distance (ft): Structural Grade: O&M Grade: Clock Start/From: Clock To: 1st Value: 2nd Value: Value Percent: Continuous Index: Within 8" of Joint:	23.4 4 0 11 3 \$02 YES
Remarks:

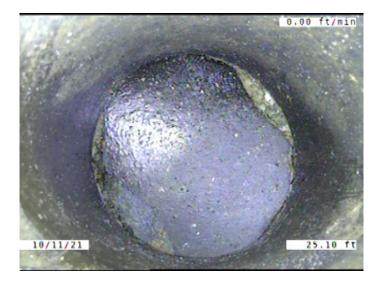
Code:	TFD
Description:	Tap Factory Defective
	25.4
Distance (ft):	25.1
Structural Grade:	0
O&M Grade:	3
Clock Start/From:	11
Clock To:	
1st Value:	4.000
2nd Value:	
Value Percent:	
Continuous Index:	
Within 8" of Joint:	YES
Remarks:	LOOKS TO BE CAPPED

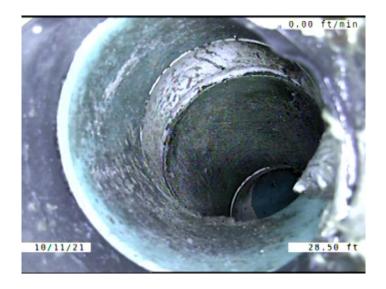
Code: Description:	TFD Tap Factory Defective
Distance (ft): Structural Grade: O&M Grade: Clock Start/From: Clock To: 1st Value: 2nd Value:	28.5 0 3 2 4.000
Value Percent: Continuous Index: Within 8" of Joint: Remarks:	YES Defective

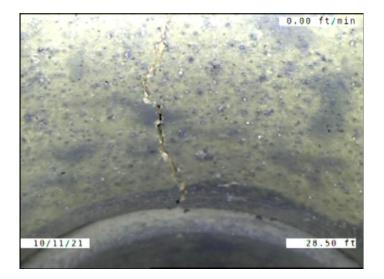
Code:	FM
Description:	Fracture Multiple
<b>D</b> (1)	
Distance (ft):	28.5
Structural Grade:	4
O&M Grade:	0
Clock Start/From:	11
Clock To:	3
1st Value:	
2nd Value:	
Value Percent:	
Continuous Index:	F02
Within 8" of Joint:	YES
Remarks:

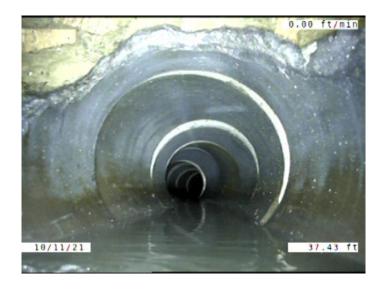
Code:	DSF
Description:	Deposits Settled Fine
Distance (ft): Structural Grade: O&M Grade: Clock Start/From: Clock To: 1st Value: 2nd Value: Value Percent: Continuous Index: Within 8" of Joint: Remarks:	37.4 0 2 5 7 5.000 F01 YES

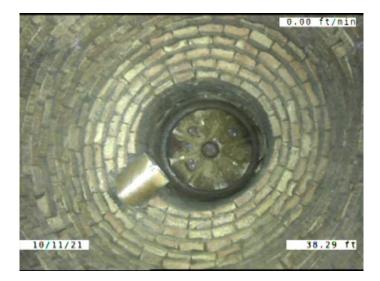
Code:	AMH
Description:	Manhole
Distance (ft):	38.3
Structural Grade:	0
O&M Grade:	0
Clock Start/From: Clock To: 1st Value: 2nd Value: Value Percent: Continuous Index:	
Within 8" of Joint:	NO
Remarks:	M-804-016
