Profile/Photo Observation Report

Street:	E HOME AVE	Flow Control:	Not Controlled
City:	Hobart, IN	Year Renewed:	
Location:	Other	Tape/Media #:	
Purpose:	Not Known	Dia/Height:	8"
Use:	Sanitary	Material:	VCP
Drain Area:	NA	Lining:	
Category:	NA		
Comment:

Location Details:		Direction of Survey:	Upstream
US MH:	M-804-020	DS MH:	M-804-015
		Total Length Surveyed (ft):	41.4

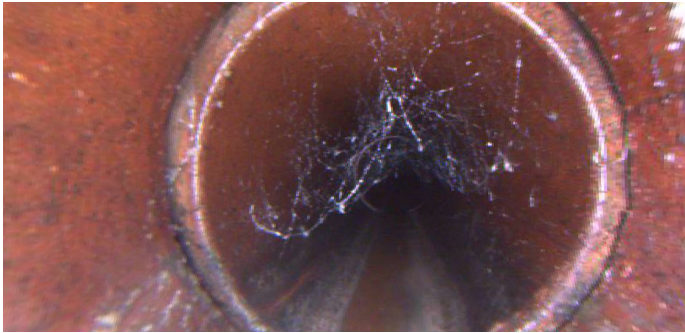
Code:	MWL
Description:	Water Level

Distance (ft):	.0
Structural Grade:	0
O&M Grade:	0
Clock Start/From:	
Clock To:	
1st Value:	
2nd Value:	
Value Percent:	5.000
Continuous Index:	
Within 8" of Joint:	NO
Remarks:

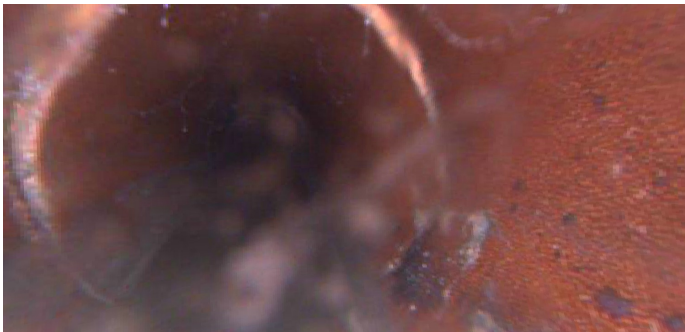
Code:	CL
Description:	Crack Longitudinal

Distance (ft):	17.2
Structural Grade:	2
O&M Grade:	0
Clock Start/From:	4
Clock To:	
1st Value:	
2nd Value:	
Value Percent:	
Continuous Index:	
Within 8" of Joint:	YES
Remarks:

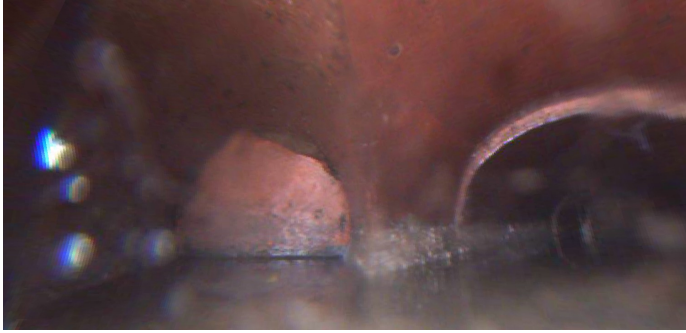
Code: **TFC**
Description: **Tap Factory Capped**

Distance (ft): **27.0**
Structural Grade: **0**
O&M Grade: **0**
Clock Start/From: **9**
Clock To:
1st Value: **4.000**
2nd Value:
Value Percent:
Continuous Index:
Within 8" of Joint: **YES**
Remarks:

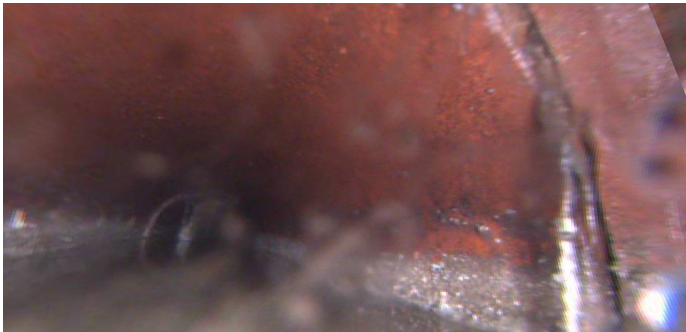
Code: **RFJ**
Description: **Roots Fine Joint**

Distance (ft): **27.8**
Structural Grade: **0**
O&M Grade: **1**
Clock Start/From: **3**
Clock To:
1st Value:
2nd Value:
Value Percent:
Continuous Index:
Within 8" of Joint: **YES**
Remarks:

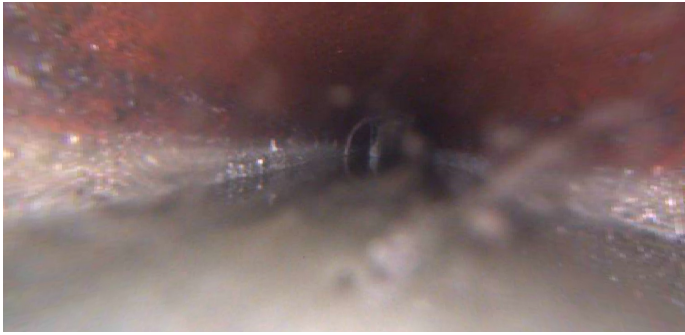
Code: **MWL**
Description: **Water Level**

Distance (ft): **27.8**
Structural Grade: **0**
O&M Grade: **0**
Clock Start/From:
Clock To:
1st Value:
2nd Value:
Value Percent: **50.000**
Continuous Index:
Within 8" of Joint: **NO**
Remarks:

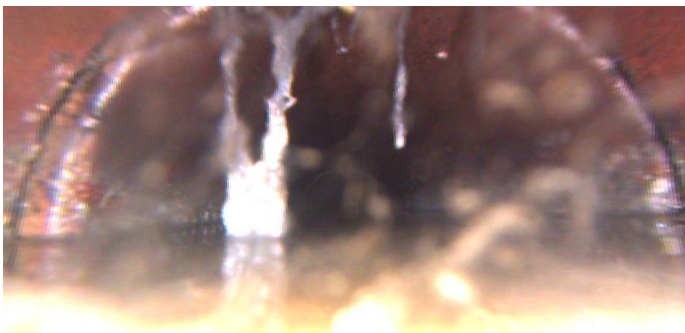
Code: **RFJ**
Description: **Roots Fine Joint**

Distance (ft): **29.6**
Structural Grade: **0**
O&M Grade: **1**
Clock Start/From: **11**
Clock To: **12**
1st Value:
2nd Value:
Value Percent:
Continuous Index:
Within 8" of Joint: **YES**
Remarks:

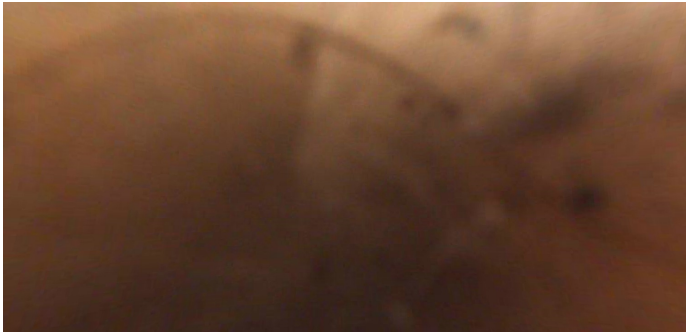
Code: **MCU**
Description: **Camera Underwater**

Distance (ft): **37.6**
Structural Grade: **0**
O&M Grade: **4**
Clock Start/From:
Clock To:
1st Value:
2nd Value:
Value Percent:
Continuous Index: **S01**
Within 8" of Joint: **NO**
Remarks:
