Profile/Photo Observation Report

Street:	E Hickey St. Alley	Flow Control:	Not Controlled
City:	Hobart, IN	Year Renewed:	
Location:	Other	Tape/Media #:	
Purpose:	Not Known	Dia/Height:	8"
Use:	Sanitary	Material:	VCP
Drain Area:	NA	Lining:	
Category:	NA		
Comment:

Location Details:		Direction of Survey:	Upstream
US MH:	M-804-020	DS MH:	M-804-015
		Total Length Surveyed (ft):	41.4

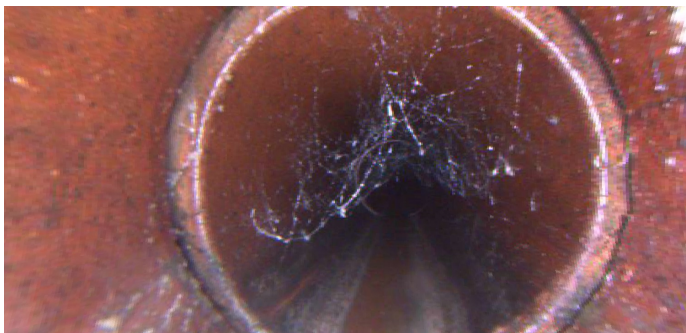
Code: **AMH**
Description: **Manhole**

Distance (ft): **.0**
Structural Grade: **0**
O&M Grade: **0**
Clock Start/From:
Clock To:
1st Value:
2nd Value:
Value Percent:
Continuous Index:
Within 8" of Joint: **NO**
Remarks: **M-804-015**

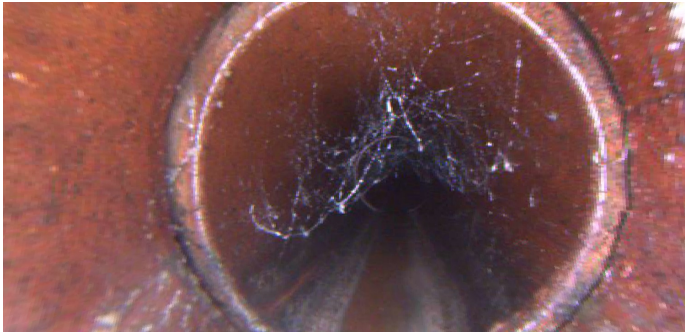
Code:	MWL
Description:	Water Level

Distance (ft):	.0
Structural Grade:	0
O&M Grade:	0
Clock Start/From:	
Clock To:	
1st Value:	
2nd Value:	
Value Percent:	5.000
Continuous Index:	
Within 8" of Joint:	NO
Remarks:

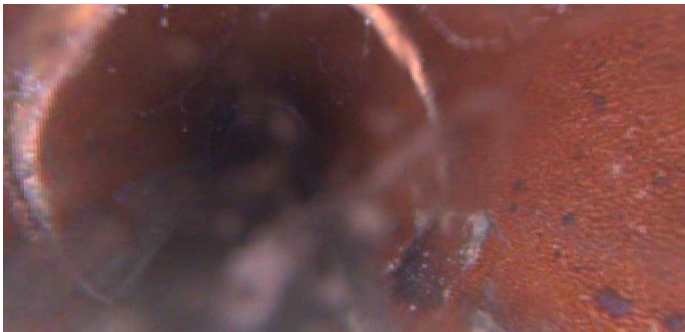
Code:	CL
Description:	Crack Longitudinal

Distance (ft):	17.2
Structural Grade:	2
O&M Grade:	0
Clock Start/From:	4
Clock To:	
1st Value:	
2nd Value:	
Value Percent:	
Continuous Index:	
Within 8" of Joint:	YES
Remarks:

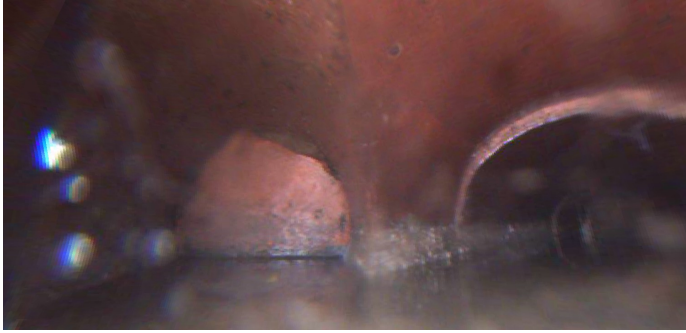
Code: **TFC**
Description: **Tap Factory Capped**

Distance (ft): **27.0**
Structural Grade: **0**
O&M Grade: **0**
Clock Start/From: **9**
Clock To:
1st Value: **4.000**
2nd Value:
Value Percent:
Continuous Index:
Within 8" of Joint: **YES**
Remarks:

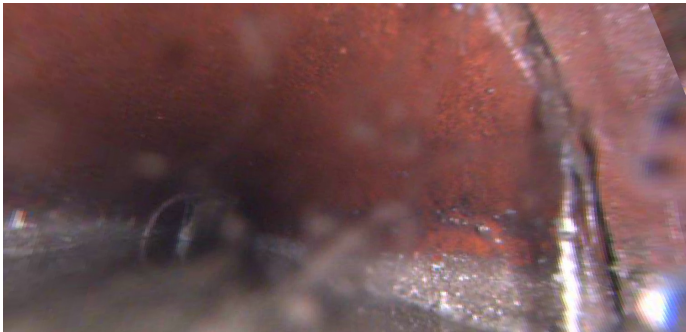
Code: **RFJ**
Description: **Roots Fine Joint**

Distance (ft): **27.8**
Structural Grade: **0**
O&M Grade: **1**
Clock Start/From: **3**
Clock To:
1st Value:
2nd Value:
Value Percent:
Continuous Index:
Within 8" of Joint: **YES**
Remarks:

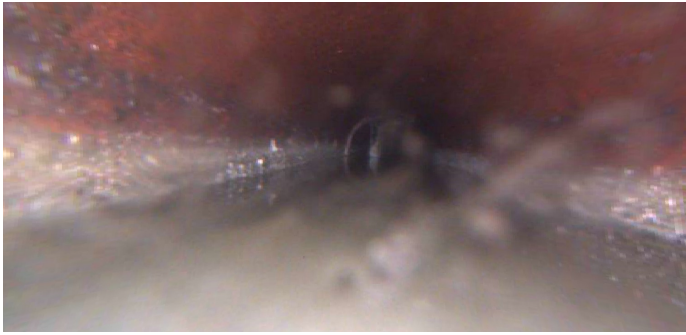
Code: **MWL**
Description: **Water Level**

Distance (ft): **27.8**
Structural Grade: **0**
O&M Grade: **0**
Clock Start/From:
Clock To:
1st Value:
2nd Value:
Value Percent: **50.000**
Continuous Index:
Within 8" of Joint: **NO**
Remarks:

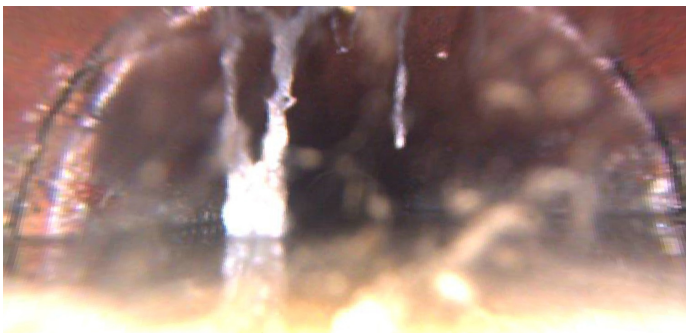
Code: **RFJ**
Description: **Roots Fine Joint**

Distance (ft): **29.6**
Structural Grade: **0**
O&M Grade: **1**
Clock Start/From: **11**
Clock To: **12**
1st Value:
2nd Value:
Value Percent:
Continuous Index:
Within 8" of Joint: **YES**
Remarks:

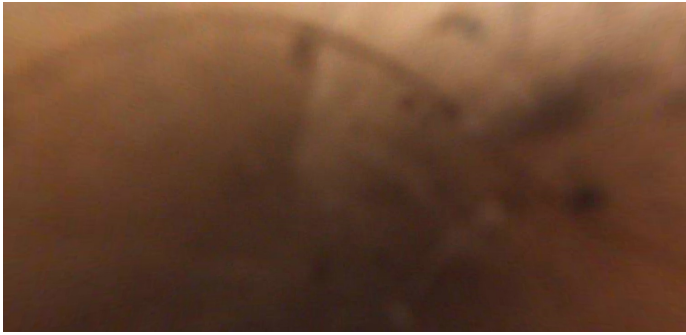
Code: **MCU**
Description: **Camera Underwater**

Distance (ft): **37.6**
Structural Grade: **0**
O&M Grade: **4**
Clock Start/From:
Clock To:
1st Value:
2nd Value:
Value Percent:
Continuous Index: **S01**
Within 8" of Joint: **NO**
Remarks:
