Profile/Photo Observation Report

Date:	10/23/2021	Weather:		Coding:	PACP 7.0
Pipe Length (ft):	351.0	Owner:	City of Hobart	Pre Clean:	Heavy Cleaning
P.O.#:	YES502259	Surveyor:	S. Bucklin	PSR:	P-804-020-015
Customer:	City of Hobart	Clean Date:	09/15/2021	Shape:	C

Street:	North Illinois Street	Flow Control:	Not Controlled
City:	Hobart, IN	Year Renewed:	
Location:	Alley	Tape/Media #:	
Purpose:	Routine Assessment	Dia/Height:	8"
Use:	Sanitary Sewage Pipe	Material:	VCP
Drain Area:		Lining:	None
Category:	NA		
Comment:			
Location Details:		Direction of Survey:	Upstream
US MH:	M-804-020	DS MH:	M-804-015
		Total Length Surveyed (ft):	237.3

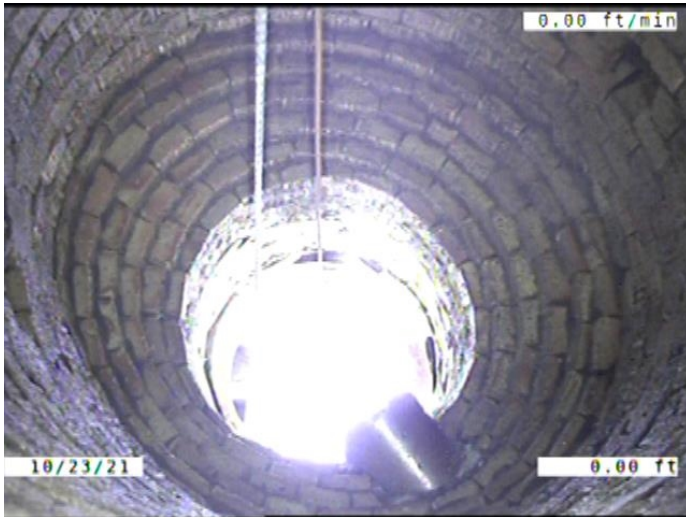
Code: **AMH**
Description: **Manhole**

Distance (ft): **.0**
Structural Grade: **0**
O&M Grade: **0**
Clock Start/From:
Clock To:
1st Value:
2nd Value:
Value Percent:
Continuous Index:
Within 8" of Joint: **NO**
Remarks: **M-804-015**

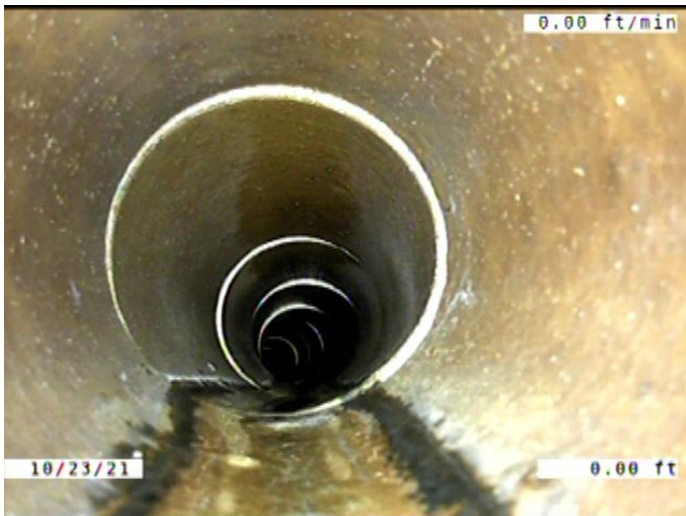
Code: **MWL**
Description: **Miscellaneous Water Level**

Distance (ft): **.0**
Structural Grade: **0**
O&M Grade: **0**
Clock Start/From:
Clock To:
1st Value:
2nd Value:
Value Percent: **5.000**
Continuous Index:
Within 8" of Joint: **NO**
Remarks:

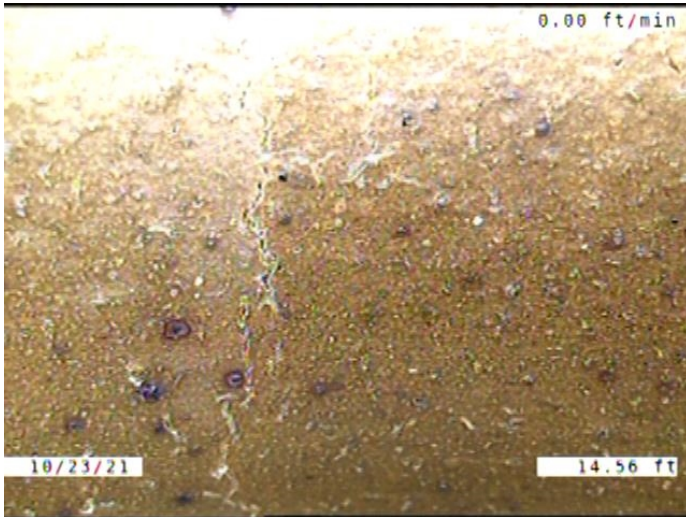
Code: **CL**
Description: **Crack Longitudinal**

Distance (ft): **14.6**
Structural Grade: **2**
O&M Grade: **0**
Clock Start/From: **11**
Clock To:
1st Value:
2nd Value:
Value Percent:
Continuous Index:
Within 8" of Joint: **YES**
Remarks:

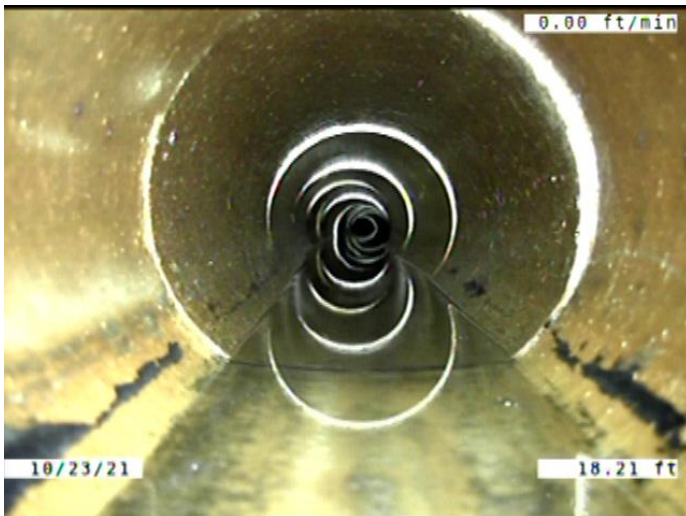
Code: **MWLS**
Description: **Miscellaneous Water Level Sag**

Distance (ft): **18.2**
Structural Grade: **3**
O&M Grade: **0**
Clock Start/From:
Clock To:
1st Value:
2nd Value:
Value Percent: **40.000**
Continuous Index: **S01**
Within 8" of Joint: **NO**
Remarks:

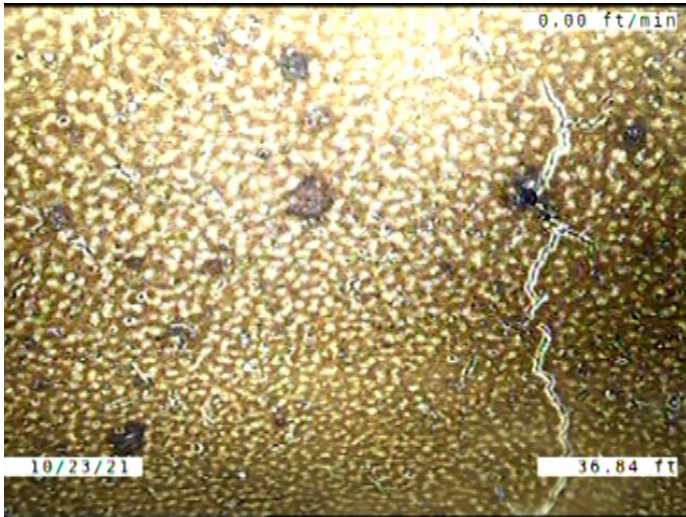
Code: **CL**
Description: **Crack Longitudinal**

Distance (ft): **36.8**
Structural Grade: **2**
O&M Grade: **0**
Clock Start/From: **1**
Clock To:
1st Value:
2nd Value:
Value Percent:
Continuous Index:
Within 8" of Joint: **YES**
Remarks:

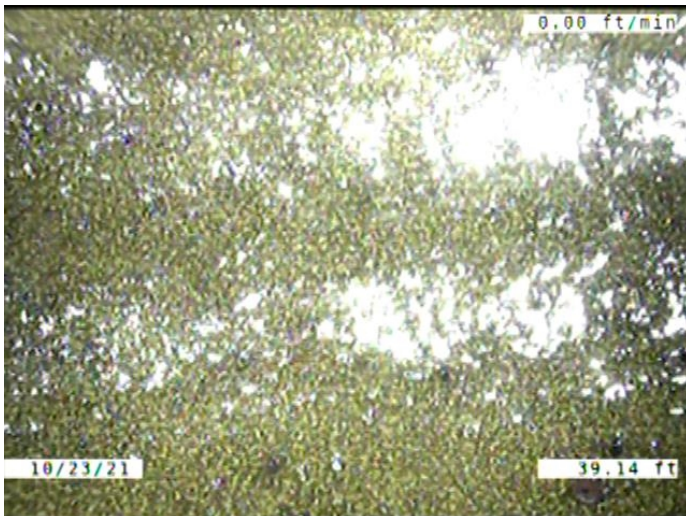
Code: **MCU**
Description: **Miscellaneous Camera Underwater**

Distance (ft): **39.1**
Structural Grade: **0**
O&M Grade: **4**
Clock Start/From:
Clock To:
1st Value:
2nd Value:
Value Percent:
Continuous Index:
Within 8" of Joint: **NO**
Remarks: **Out at 40.5**

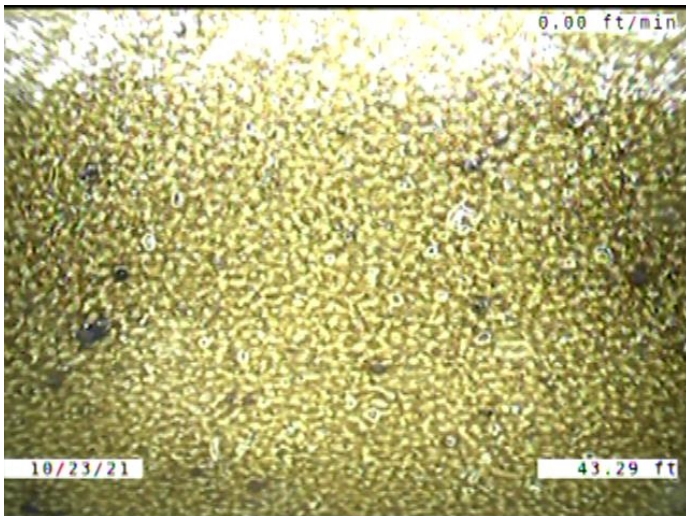
Code: **MCU**
 Description: **Miscellaneous Camera Underwater**

Distance (ft): **43.3**
 Structural Grade: **0**
 O&M Grade: **4**
 Clock Start/From:
 Clock To:
 1st Value:
 2nd Value:
 Value Percent:
 Continuous Index:
 Within 8" of Joint: **NO**
 Remarks: **Out at 44.6**

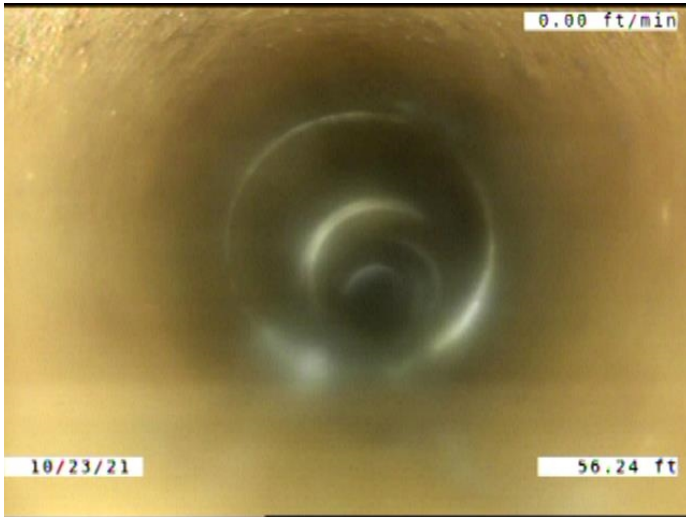
Code: **MWLS**
Description: **Miscellaneous Water Level Sag**

Distance (ft): **56.2**
Structural Grade: **3**
O&M Grade: **0**
Clock Start/From:
Clock To:
1st Value:
2nd Value:
Value Percent: **40.000**
Continuous Index: **F01**
Within 8" of Joint: **NO**
Remarks:

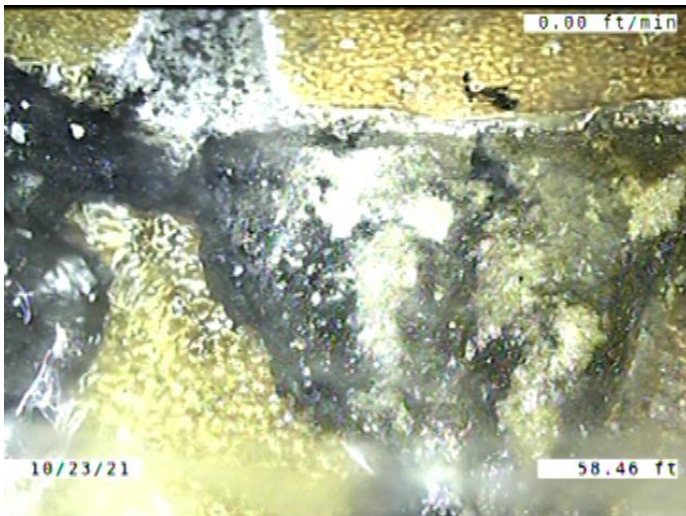
Code: **DAE**
Description: **Deposits Attached Encrustation**

Distance (ft): **58.5**
Structural Grade: **0**
O&M Grade: **2**
Clock Start/From: **4**
Clock To: **7**
1st Value:
2nd Value:
Value Percent: **5.000**
Continuous Index:
Within 8" of Joint: **YES**
Remarks:

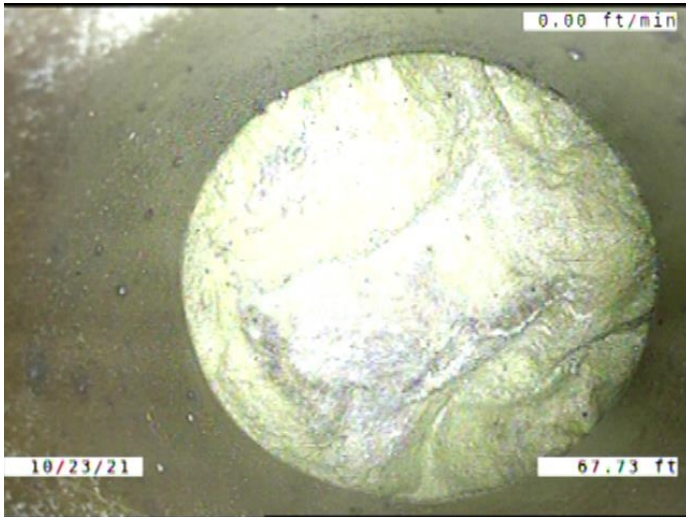
Code: **TFC**
 Description: **Tap Factory Capped**

Distance (ft): **67.7**
 Structural Grade: **0**
 O&M Grade: **0**
 Clock Start/From: **1**
 Clock To:
 1st Value: **4.000**
 2nd Value:
 Value Percent:
 Continuous Index:
 Within 8" of Joint: **YES**
 Remarks:

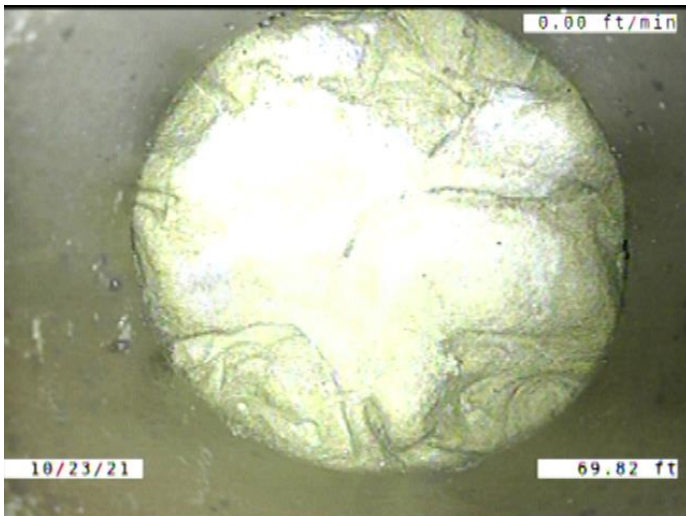
Code: **TFC**
 Description: **Tap Factory Capped**

Distance (ft): **69.8**
 Structural Grade: **0**
 O&M Grade: **0**
 Clock Start/From: **10**
 Clock To:
 1st Value: **4.000**
 2nd Value:
 Value Percent:
 Continuous Index:
 Within 8" of Joint: **YES**
 Remarks:

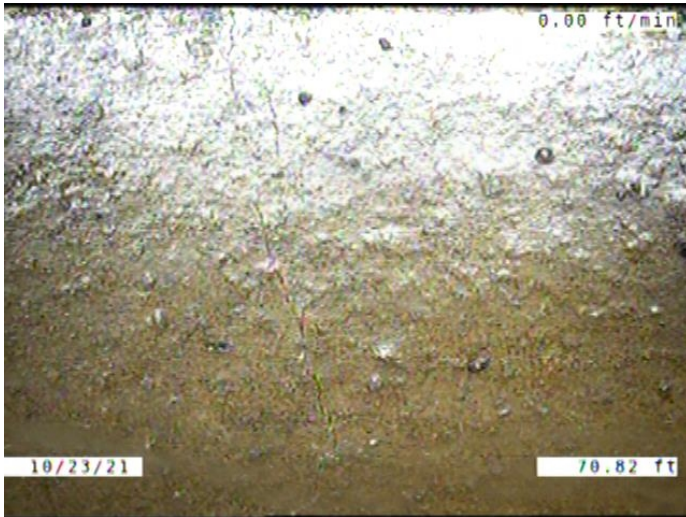
Code: **CL**
Description: **Crack Longitudinal**

Distance (ft): **70.8**
Structural Grade: **2**
O&M Grade: **0**
Clock Start/From: **11**
Clock To:
1st Value:
2nd Value:
Value Percent:
Continuous Index:
Within 8" of Joint: **YES**
Remarks:

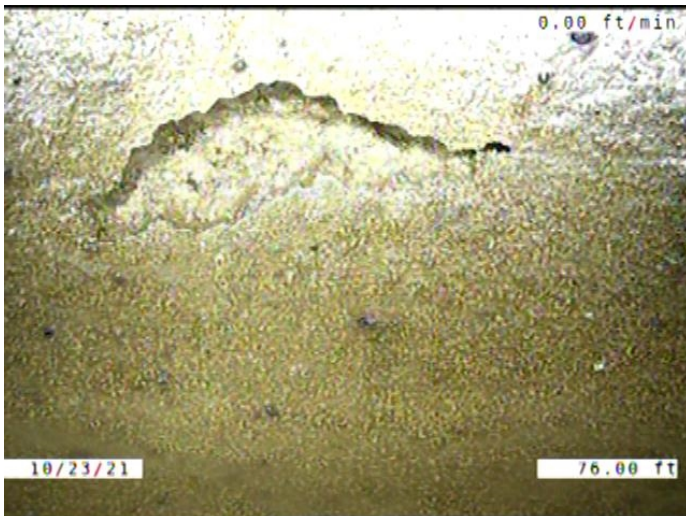
Code: **SSS**
Description: **Surface Damage Surface Spalling**

Distance (ft): **76.0**
Structural Grade: **2**
O&M Grade: **0**
Clock Start/From: **10**
Clock To:
1st Value:
2nd Value:
Value Percent:
Continuous Index:
Within 8" of Joint: **NO**
Remarks:

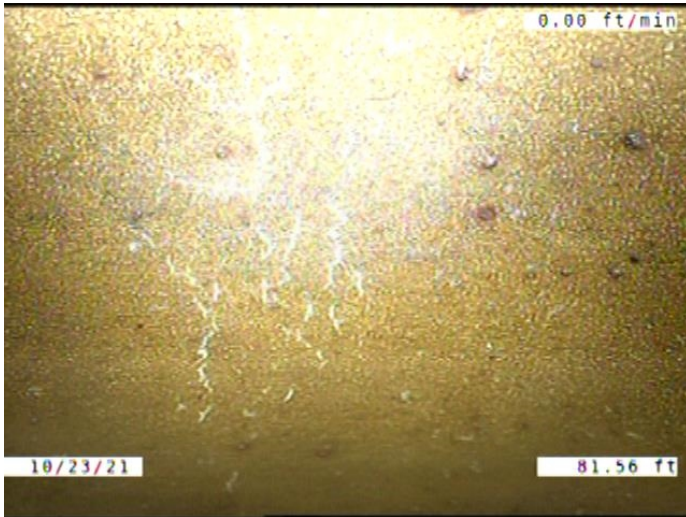
Code: **CM**
Description: **Crack Multiple**

Distance (ft): **81.6**
Structural Grade: **3**
O&M Grade: **0**
Clock Start/From: **11**
Clock To: **3**
1st Value:
2nd Value:
Value Percent:
Continuous Index:
Within 8" of Joint: **YES**
Remarks:

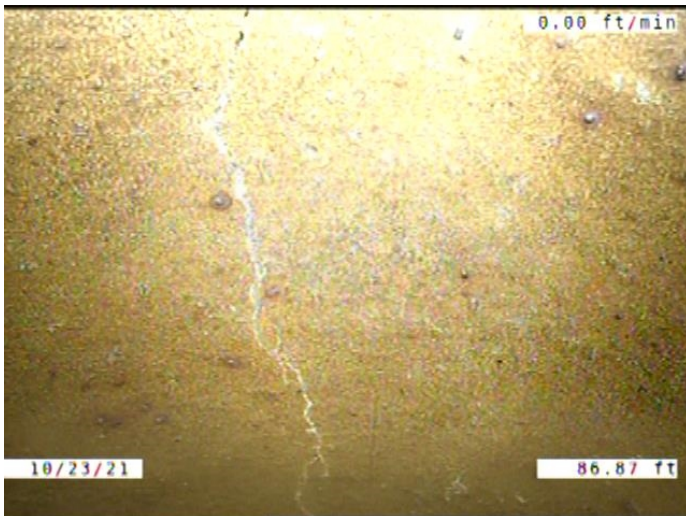
Code: **CL**
Description: **Crack Longitudinal**

Distance (ft): **86.9**
Structural Grade: **2**
O&M Grade: **0**
Clock Start/From: **12**
Clock To:
1st Value:
2nd Value:
Value Percent:
Continuous Index:
Within 8" of Joint: **YES**
Remarks:

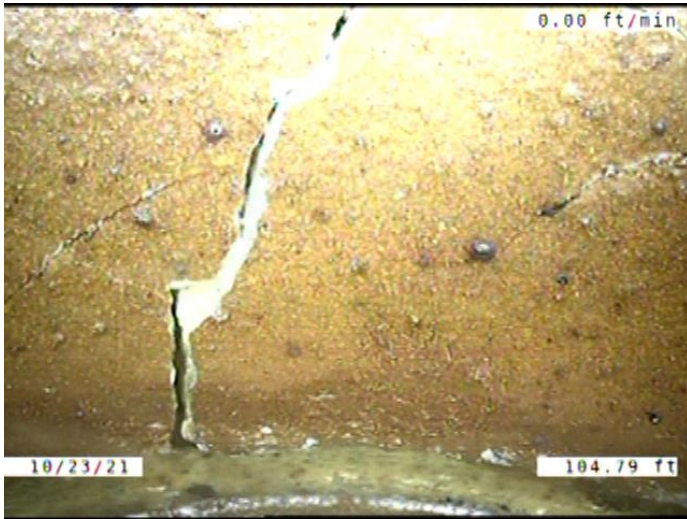
Code: **B**
Description: **Broken**

Distance (ft): **104.8**
Structural Grade: **4**
O&M Grade: **0**
Clock Start/From: **2**
Clock To: **5**
1st Value:
2nd Value:
Value Percent:
Continuous Index:
Within 8" of Joint: **YES**
Remarks:

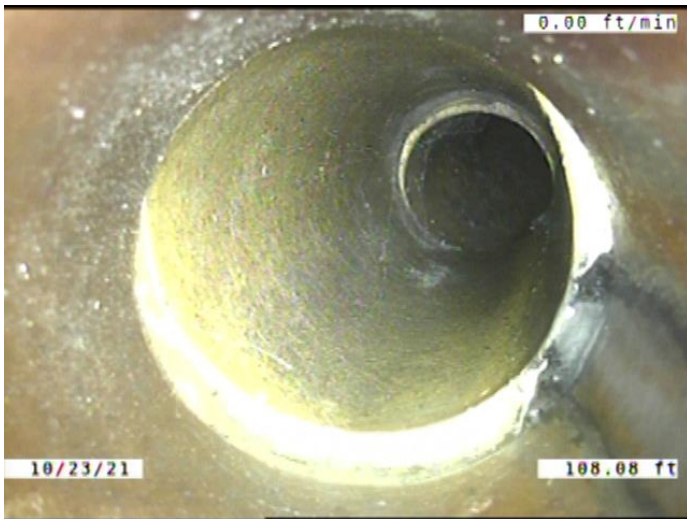
Code: **TF**
Description: **Tap Factory**

Distance (ft): **108.1**
Structural Grade: **0**
O&M Grade: **0**
Clock Start/From: **1**
Clock To:
1st Value: **4.000**
2nd Value:
Value Percent:
Continuous Index:
Within 8" of Joint: **YES**
Remarks:

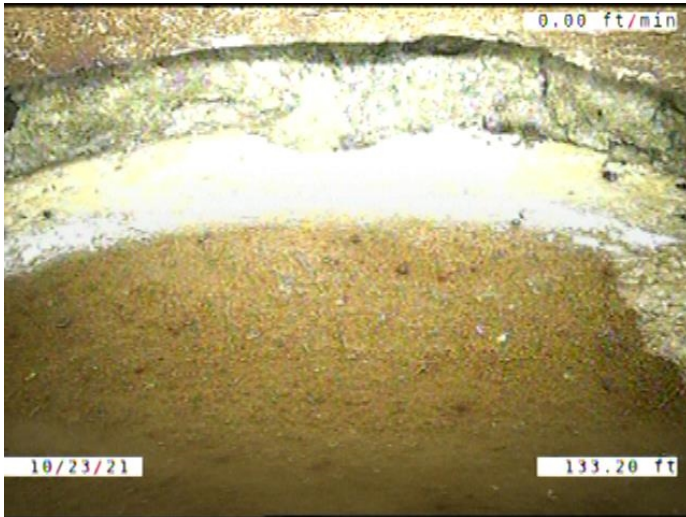
Code: **JOM**
 Description: **Joint Offset Medium**

Distance (ft): **133.2**
 Structural Grade: **3**
 O&M Grade: **0**
 Clock Start/From:
 Clock To:
 1st Value:
 2nd Value:
 Value Percent:
 Continuous Index:
 Within 8" of Joint: **NO**
 Remarks:

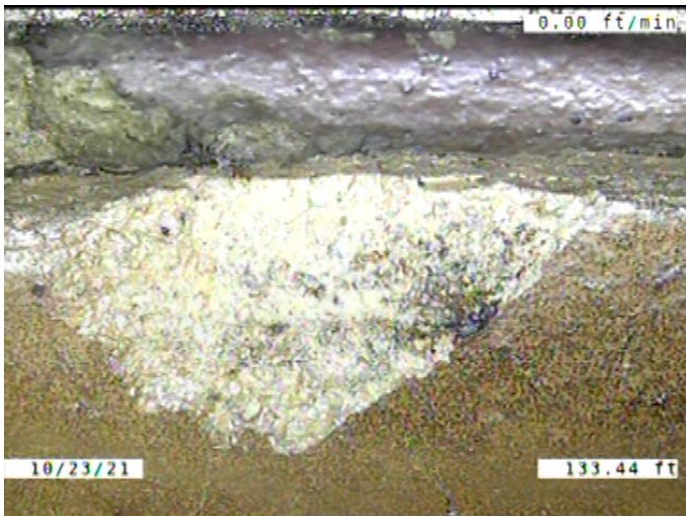
Code: **SZ**
 Description: **Surface Damage Other**

Distance (ft): **133.4**
 Structural Grade: **0**
 O&M Grade: **0**
 Clock Start/From: **1**
 Clock To:
 1st Value:
 2nd Value:
 Value Percent:
 Continuous Index:
 Within 8" of Joint: **YES**
 Remarks: **A PIECE CHIPPED AWAY FROM THE JOINT**

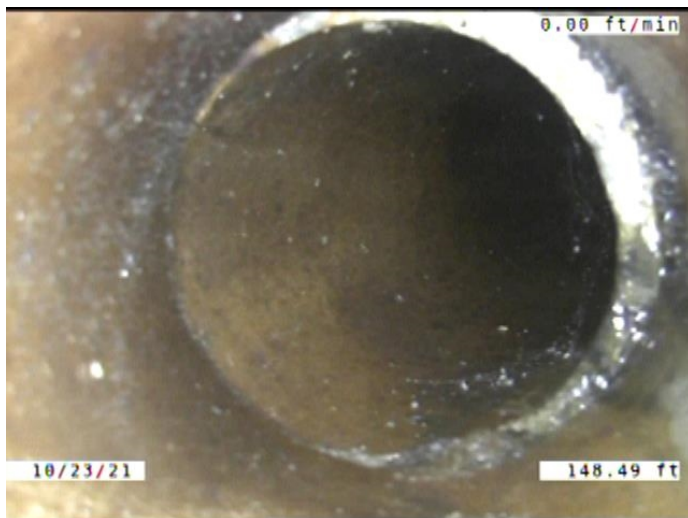
Code: **TF**
Description: **Tap Factory**

Distance (ft): **148.5**
Structural Grade: **0**
O&M Grade: **0**
Clock Start/From: **2**
Clock To:
1st Value: **4.000**
2nd Value:
Value Percent:
Continuous Index:
Within 8" of Joint: **YES**
Remarks:

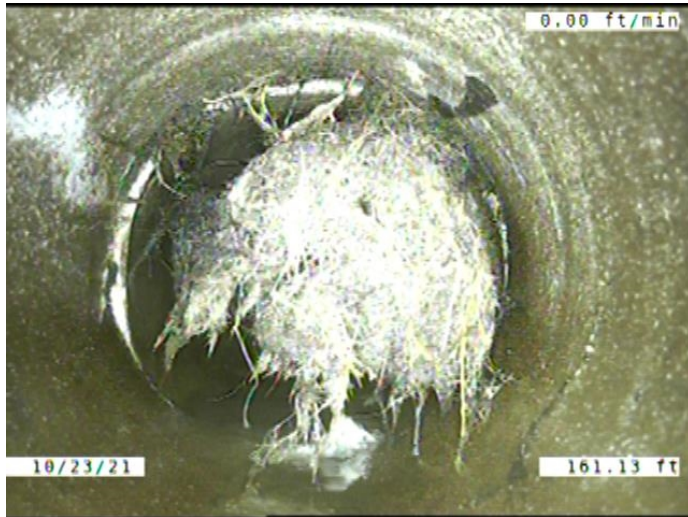
Code: **RBJ**
 Description: **Roots Ball Joint**

Distance (ft): **161.1**
 Structural Grade: **0**
 O&M Grade: **4**
 Clock Start/From: **8**
 Clock To: **5**
 1st Value:
 2nd Value:
 Value Percent: **80.000**
 Continuous Index:
 Within 8" of Joint: **YES**
 Remarks:

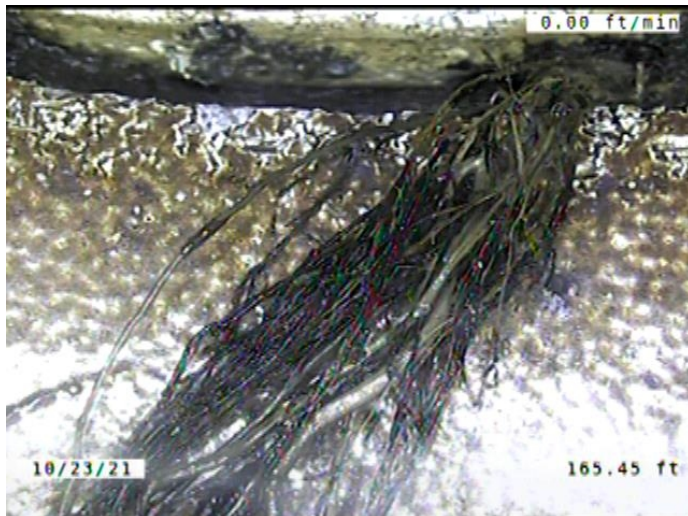
Code: **RMJ**
 Description: **Roots Medium Joint**

Distance (ft): **165.4**
 Structural Grade: **0**
 O&M Grade: **3**
 Clock Start/From: **8**
 Clock To: **4**
 1st Value:
 2nd Value:
 Value Percent: **15.000**
 Continuous Index: **S03**
 Within 8" of Joint: **YES**
 Remarks:

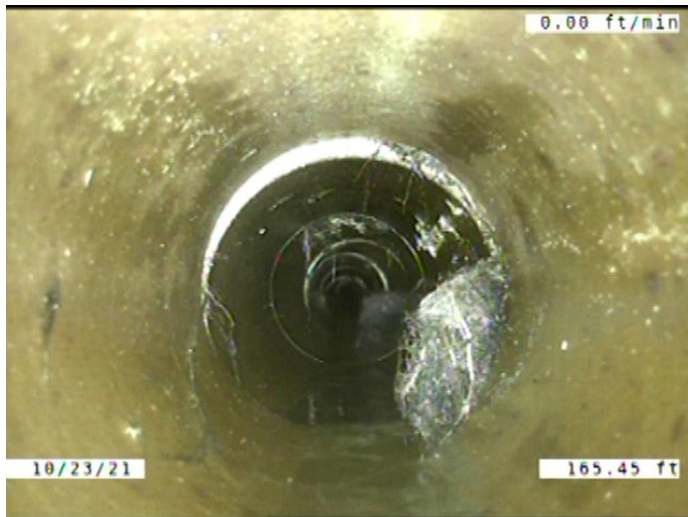
Code: **RFJ**
Description: **Roots Fine Joint**

Distance (ft): **165.4**
Structural Grade: **0**
O&M Grade: **1**
Clock Start/From: **8**
Clock To: **4**
1st Value:
2nd Value:
Value Percent:
Continuous Index: **F02**
Within 8" of Joint: **YES**
Remarks:

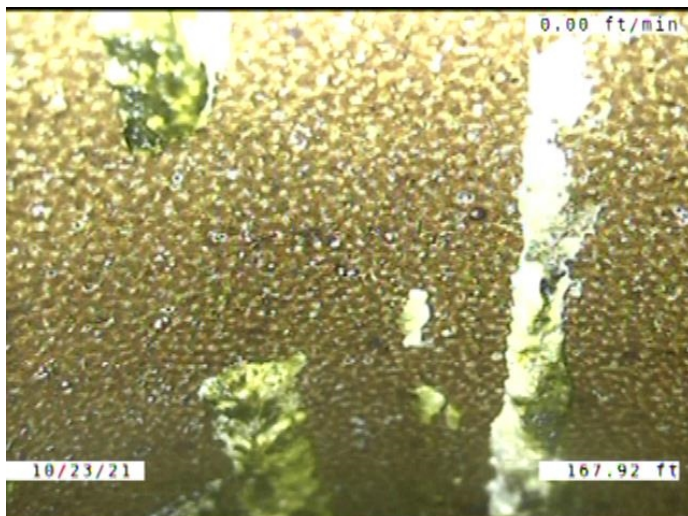
Code: **DAGS**
Description: **Deposits Attached Grease**

Distance (ft): **167.9**
Structural Grade: **0**
O&M Grade: **2**
Clock Start/From: **11**
Clock To: **3**
1st Value:
2nd Value:
Value Percent: **5.000**
Continuous Index: **S05**
Within 8" of Joint: **YES**
Remarks:

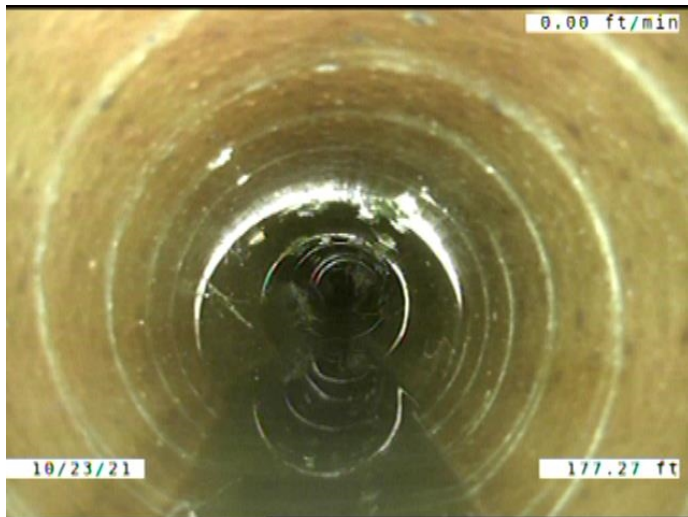
Code: **MWLS**
 Description: **Miscellaneous Water Level Sag**

Distance (ft): **177.3**
 Structural Grade: **2**
 O&M Grade: **0**
 Clock Start/From:
 Clock To:
 1st Value:
 2nd Value:
 Value Percent: **5.000**
 Continuous Index: **S04**
 Within 8" of Joint: **NO**
 Remarks:

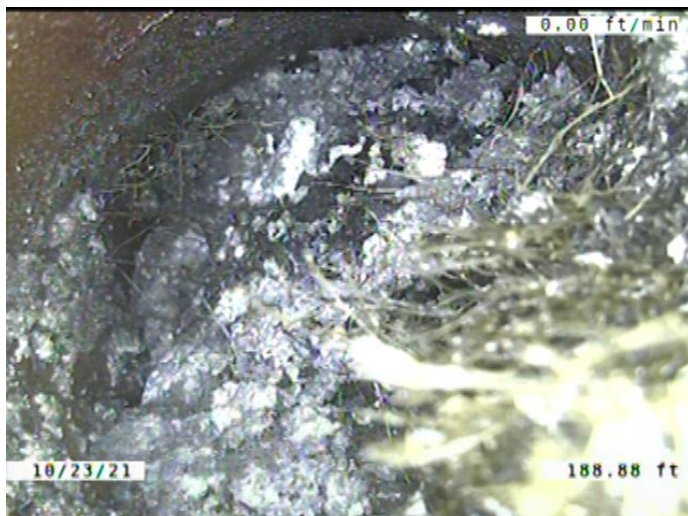
Code: **TFD**
 Description: **Tap Factory Defective**

Distance (ft): **188.9**
 Structural Grade: **0**
 O&M Grade: **3**
 Clock Start/From: **1**
 Clock To:
 1st Value: **4.000**
 2nd Value:
 Value Percent:
 Continuous Index:
 Within 8" of Joint: **YES**
 Remarks: **100% FULL OF ROOTS**

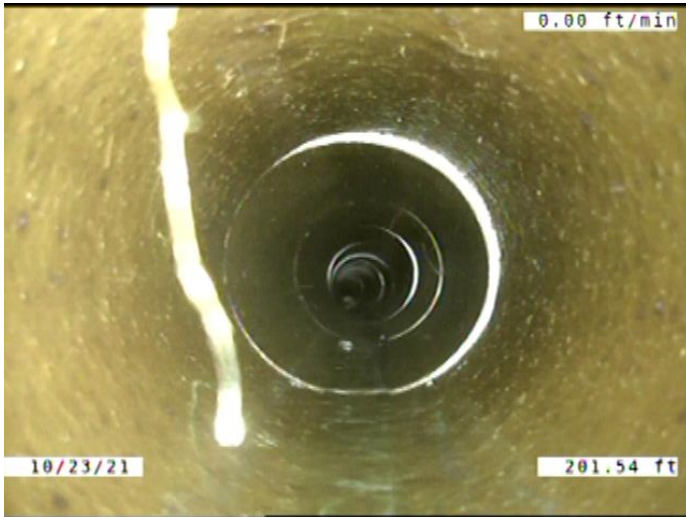
Code: **MWLS**
Description: **Miscellaneous Water Level Sag**

Distance (ft): **201.5**
Structural Grade: **2**
O&M Grade: **0**
Clock Start/From:
Clock To:
1st Value:
2nd Value:
Value Percent: **5.000**
Continuous Index: **F04**
Within 8" of Joint: **NO**
Remarks:

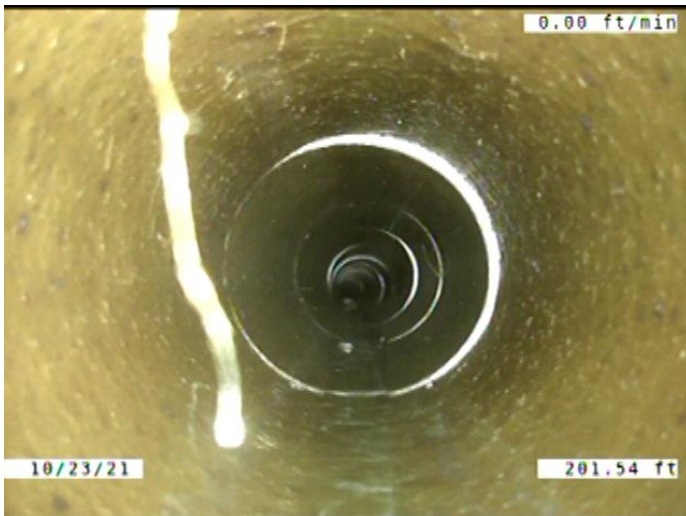
Code: **DAGS**
Description: **Deposits Attached Grease**

Distance (ft): **201.5**
Structural Grade: **0**
O&M Grade: **2**
Clock Start/From: **11**
Clock To: **3**
1st Value:
2nd Value:
Value Percent: **5.000**
Continuous Index: **F05**
Within 8" of Joint: **YES**
Remarks:

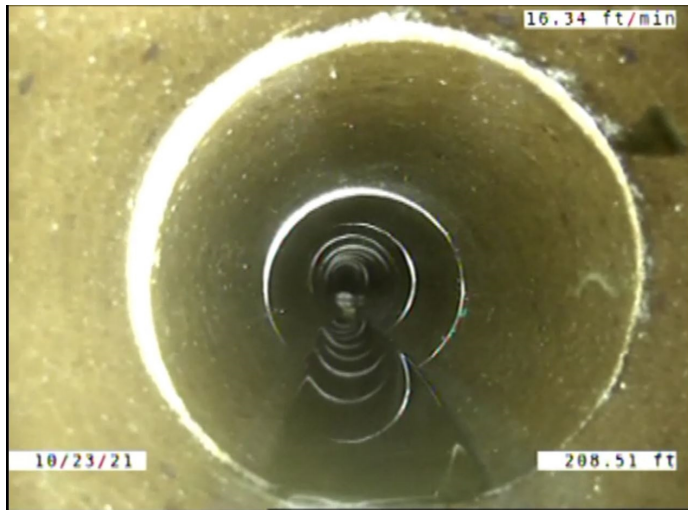
Code: **CM**
Description: **Crack Multiple**

Distance (ft): **208.5**
Structural Grade: **3**
O&M Grade: **0**
Clock Start/From: **7**
Clock To: **5**
1st Value:
2nd Value:
Value Percent:
Continuous Index: **F07**
Within 8" of Joint: **YES**
Remarks: **Wandering**

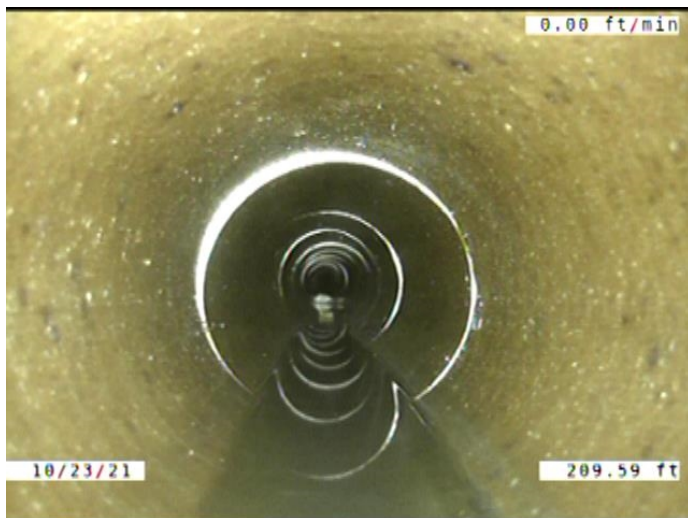
Code: **MWLS**
Description: **Miscellaneous Water Level Sag**

Distance (ft): **209.6**
Structural Grade: **2**
O&M Grade: **0**
Clock Start/From:
Clock To:
1st Value:
2nd Value:
Value Percent: **5.000**
Continuous Index: **S06**
Within 8" of Joint: **NO**
Remarks:

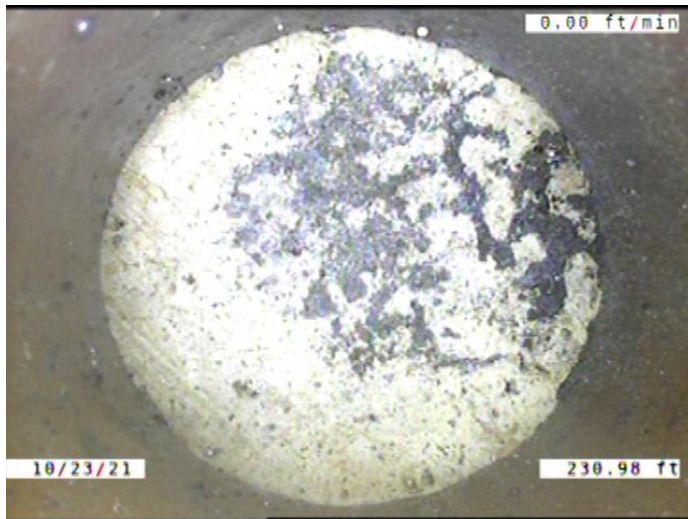
Code: **TFC**
 Description: **Tap Factory Capped**

Distance (ft): **231.0**
 Structural Grade: **0**
 O&M Grade: **0**
 Clock Start/From: **10**
 Clock To:
 1st Value: **4.000**
 2nd Value:
 Value Percent:
 Continuous Index:
 Within 8" of Joint: **YES**
 Remarks:

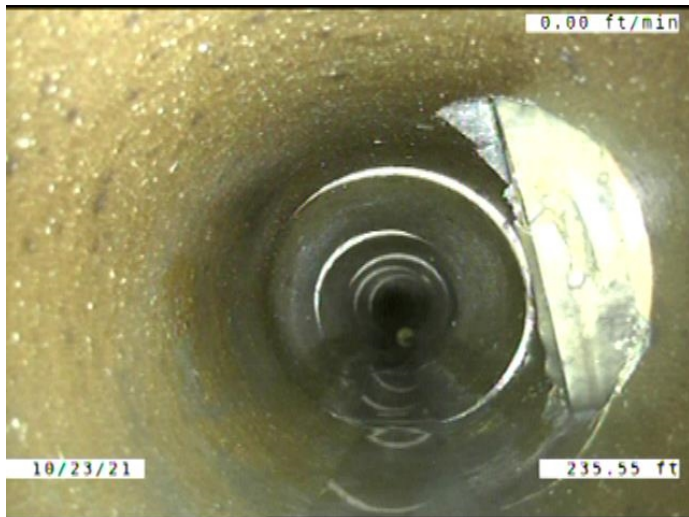
Code: **MWLS**
Description: **Miscellaneous Water Level Sag**

Distance (ft): **235.5**
Structural Grade: **2**
O&M Grade: **0**
Clock Start/From:
Clock To:
1st Value:
2nd Value:
Value Percent: **5.000**
Continuous Index: **F06**
Within 8" of Joint: **NO**
Remarks:

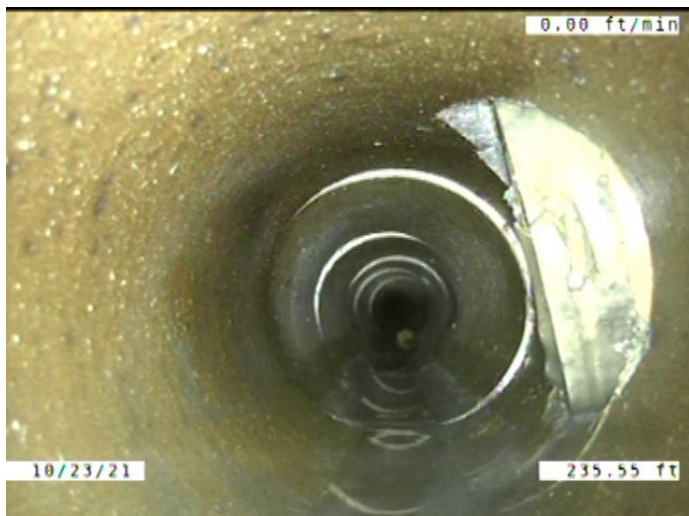
Code: **RMJ**
Description: **Roots Medium Joint**

Distance (ft): **235.6**
Structural Grade: **0**
O&M Grade: **3**
Clock Start/From: **8**
Clock To: **4**
1st Value:
2nd Value:
Value Percent: **15.000**
Continuous Index: **F03**
Within 8" of Joint: **YES**
Remarks:

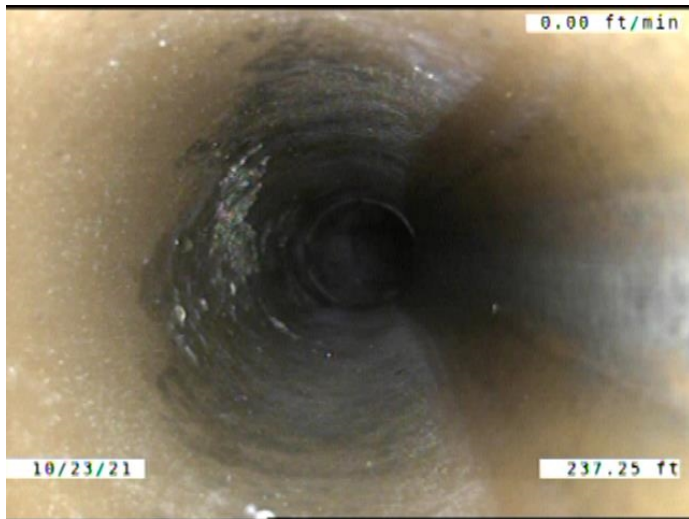
Code: **TBI**
 Description: **Tap Break-in Intruding**

Distance (ft): **237.3**
 Structural Grade: **0**
 O&M Grade: **2**
 Clock Start/From: **2**
 Clock To:
 1st Value: **4.000**
 2nd Value: **2.000**
 Value Percent:
 Continuous Index:
 Within 8" of Joint: **YES**
 Remarks:

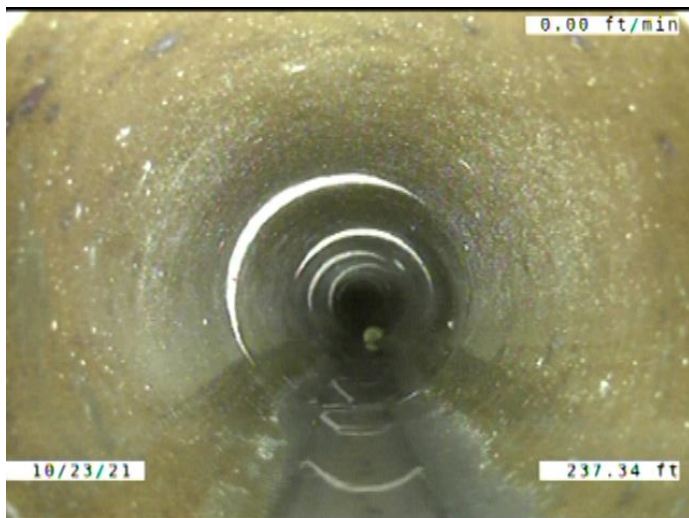
Code: **MSA**
 Description: **Miscellaneous Survey Abandoned**

Distance (ft): **237.3**
 Structural Grade: **0**
 O&M Grade: **0**
 Clock Start/From:
 Clock To:
 1st Value:
 2nd Value:
 Value Percent:
 Continuous Index:
 Within 8" of Joint: **NO**
 Remarks: **CAMERA CANT MAKE IT PAST PROTRUDING TAP. MADE IT TO THE**
