Profile/Photo Observation Report

Date:	10/23/2021	Weather:		Coding:	PACP 7.0
Pipe Length (ft):	351.0	Owner:	City of Hobart	Pre Clean:	Heavy Cleaning
P.O.#:	YES502259	Surveyor:	S. Bucklin	PSR:	P-804-020-015
Customer:	City of Hobart	Clean Date:	09/15/2021	Shape:	C

Street:	North Illinois Street	Flow Control:	Not Controlled
City:	Hobart, IN	Year Renewed:	
Location:	Alley	Tape/Media #:	
Purpose:	Routine Assessment	Dia/Height:	8"
Use:	Sanitary Sewage Pipe	Material:	VCP
Drain Area:		Lining:	None
Category:	NA		
Comment:			
Location Details:		Direction of Survey:	Upstream
US MH:	M-804-020	DS MH:	M-804-015
		Total Length Surveyed (ft):	237.3

O&M Index:	2.46	O&M Quick:	433B	O&M Rating:	96.00
Structural Index:	2.72	Structural Quick:	5242	Structural Rating:	136.00
Overall Index:	2.61	Overall Quick:	5245	Overall Rating:	232.00

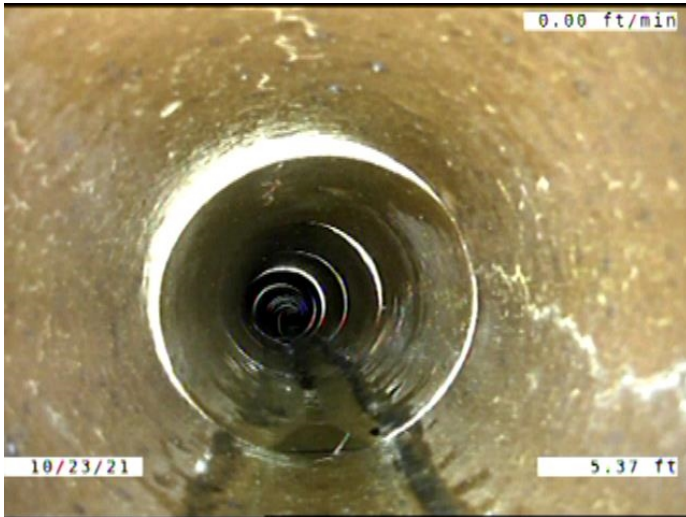
Code: **CM**
Description: **Crack Multiple**

Distance (ft): **5.4**
Structural Grade: **3**
O&M Grade: **0**
Clock Start/From: **10**
Clock To: **3**
1st Value:
2nd Value:
Value Percent:
Continuous Index:
Within 8" of Joint: **YES**
Remarks:

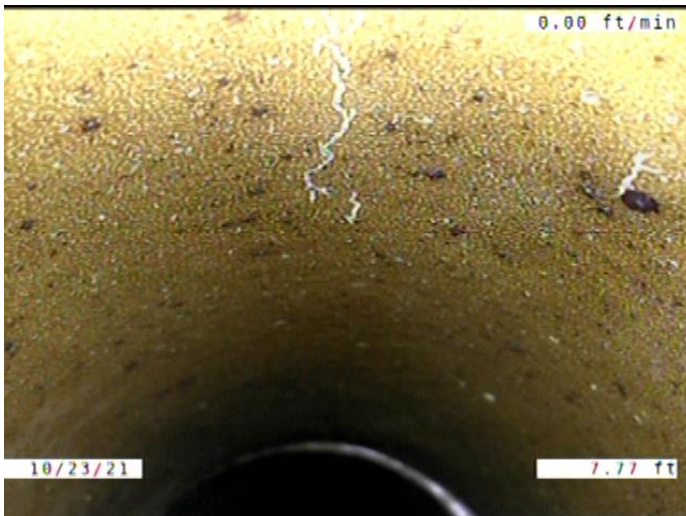
Code: **CL**
Description: **Crack Longitudinal**

Distance (ft): **7.8**
Structural Grade: **2**
O&M Grade: **0**
Clock Start/From: **11**
Clock To:
1st Value:
2nd Value:
Value Percent:
Continuous Index:
Within 8" of Joint: **YES**
Remarks:

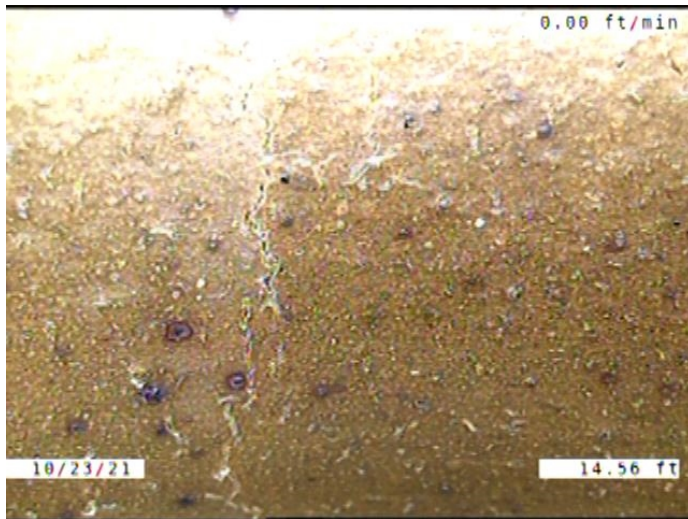
Code: **CL**
 Description: **Crack Longitudinal**

Distance (ft): **14.6**
 Structural Grade: **2**
 O&M Grade: **0**
 Clock Start/From: **11**
 Clock To:
 1st Value:
 2nd Value:
 Value Percent:
 Continuous Index:
 Within 8" of Joint: **YES**
 Remarks:

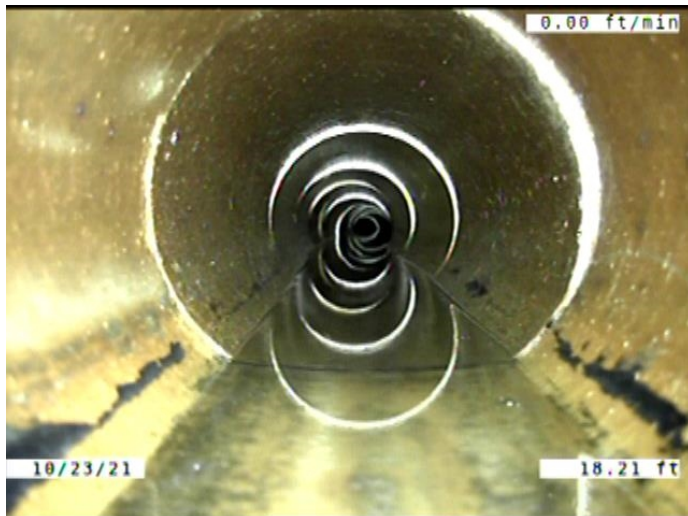
Code: **MWLS**
 Description: **Miscellaneous Water Level Sag**

Distance (ft): **18.2**
 Structural Grade: **3**
 O&M Grade: **0**
 Clock Start/From:
 Clock To:
 1st Value:
 2nd Value:
 Value Percent: **40.000**
 Continuous Index: **S01**
 Within 8" of Joint: **NO**
 Remarks:

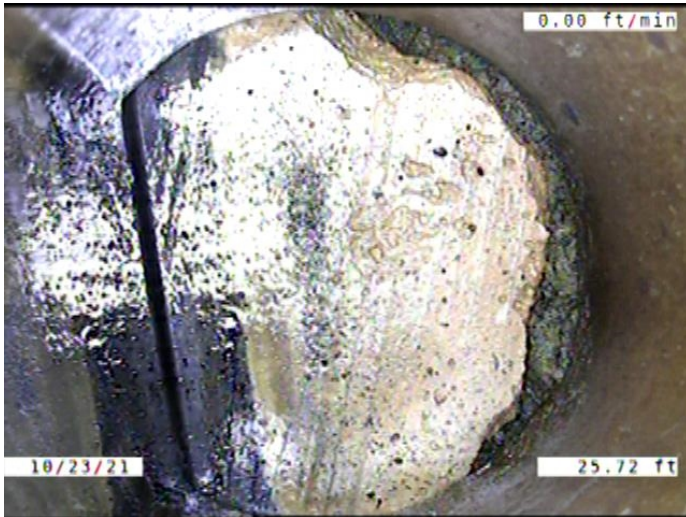
Code: **TFD**
 Description: **Tap Factory Defective**

Distance (ft): **25.7**
 Structural Grade: **0**
 O&M Grade: **3**
 Clock Start/From: **9**
 Clock To:
 1st Value: **4.000**
 2nd Value:
 Value Percent:
 Continuous Index:
 Within 8" of Joint: **YES**
 Remarks: **CAP BROKEN. SOIL VISIBLE**

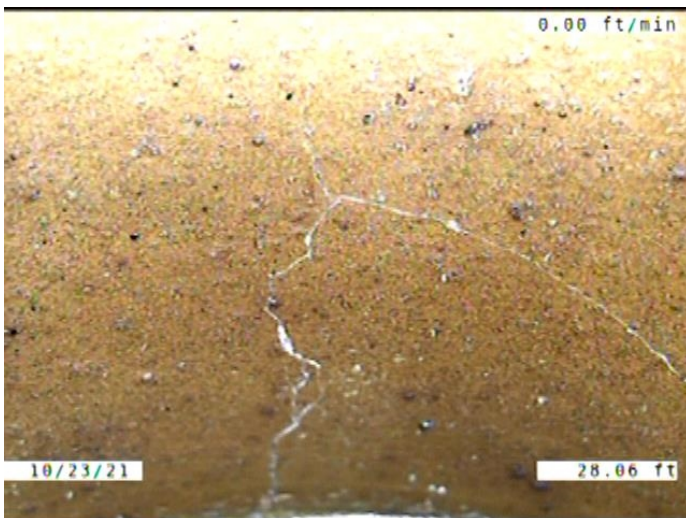
Code: **CM**
 Description: **Crack Multiple**

Distance (ft): **28.1**
 Structural Grade: **3**
 O&M Grade: **0**
 Clock Start/From: **12**
 Clock To: **2**
 1st Value:
 2nd Value:
 Value Percent:
 Continuous Index:
 Within 8" of Joint: **YES**
 Remarks:

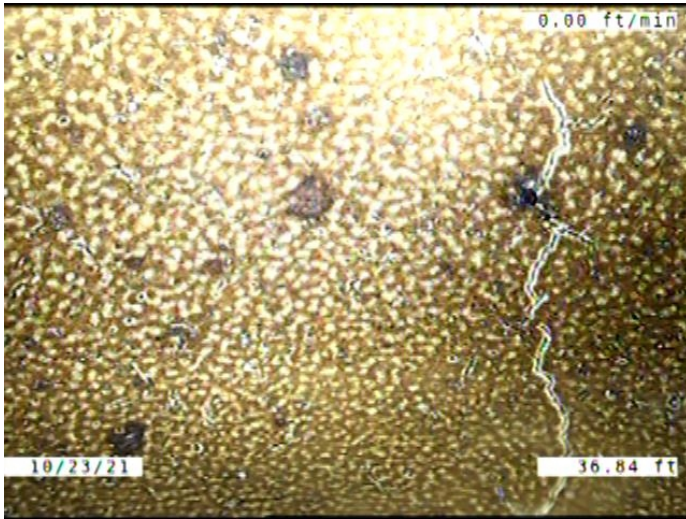
Code: **CL**
 Description: **Crack Longitudinal**

Distance (ft): **36.8**
 Structural Grade: **2**
 O&M Grade: **0**
 Clock Start/From: **1**
 Clock To:
 1st Value:
 2nd Value:
 Value Percent:
 Continuous Index:
 Within 8" of Joint: **YES**
 Remarks:

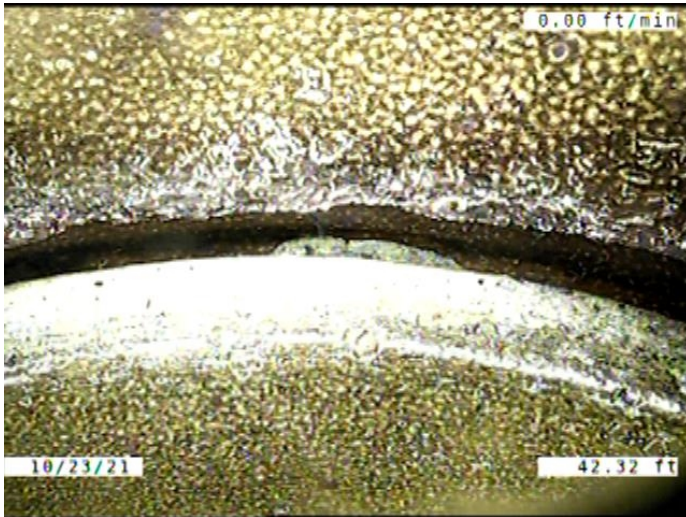
Code: **JOM**
 Description: **Joint Offset Medium**

Distance (ft): **42.3**
 Structural Grade: **3**
 O&M Grade: **0**
 Clock Start/From:
 Clock To:
 1st Value:
 2nd Value:
 Value Percent:
 Continuous Index:
 Within 8" of Joint: **NO**
 Remarks:

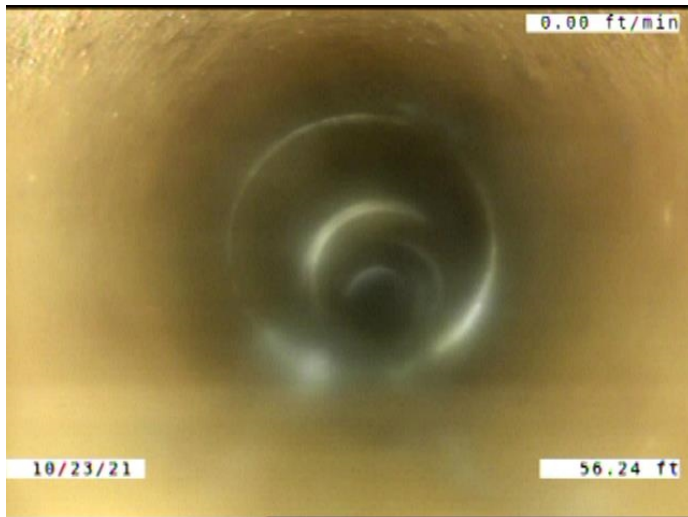
Code: **MWLS**
 Description: **Miscellaneous Water Level Sag**

Distance (ft): **56.2**
 Structural Grade: **3**
 O&M Grade: **0**
 Clock Start/From:
 Clock To:
 1st Value:
 2nd Value:
 Value Percent: **40.000**
 Continuous Index: **F01**
 Within 8" of Joint: **NO**
 Remarks:

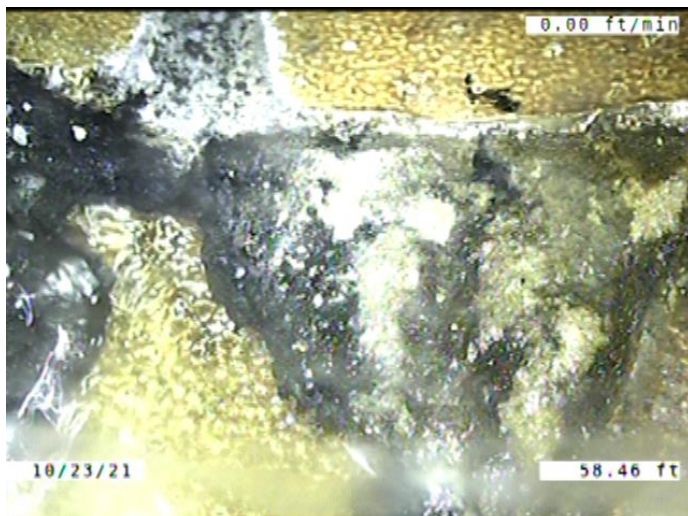
Code: **DAE**
 Description: **Deposits Attached Encrustation**

Distance (ft): **58.5**
 Structural Grade: **0**
 O&M Grade: **2**
 Clock Start/From: **4**
 Clock To: **7**
 1st Value:
 2nd Value:
 Value Percent: **5.000**
 Continuous Index:
 Within 8" of Joint: **YES**
 Remarks:

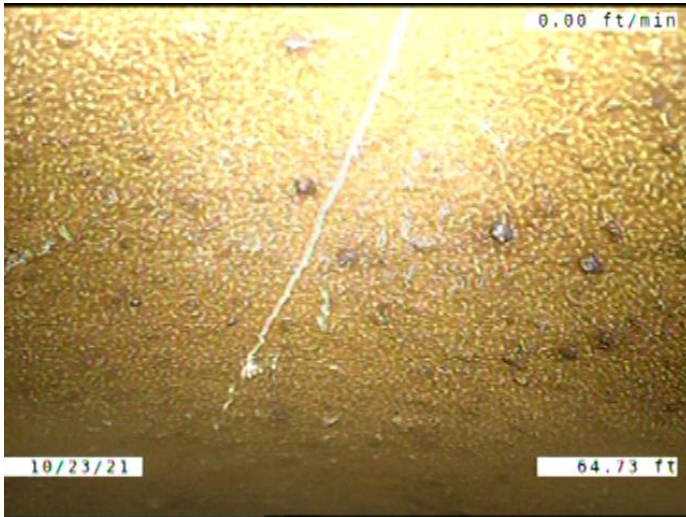
Code: **CM**
 Description: **Crack Multiple**

Distance (ft): **64.7**
 Structural Grade: **3**
 O&M Grade: **0**
 Clock Start/From: **12**
 Clock To: **12**
 1st Value:
 2nd Value:
 Value Percent:
 Continuous Index:
 Within 8" of Joint: **YES**
 Remarks:

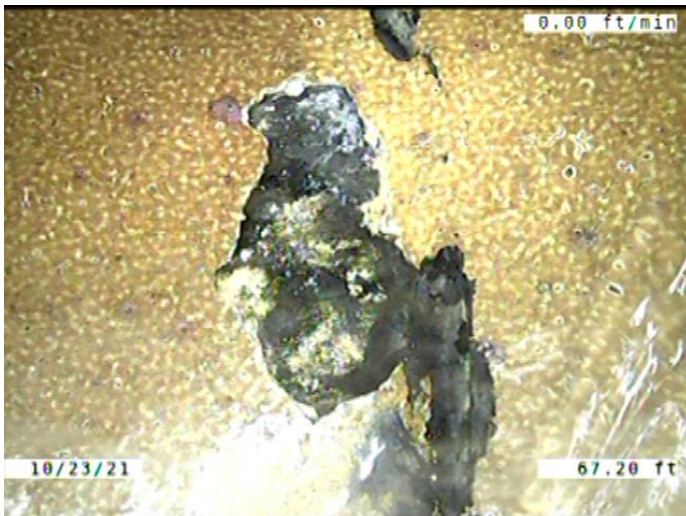
Code: **HSV**
 Description: **Hole Soil Visible**

Distance (ft): **67.2**
 Structural Grade: **5**
 O&M Grade: **0**
 Clock Start/From: **6**
 Clock To:
 1st Value:
 2nd Value:
 Value Percent:
 Continuous Index:
 Within 8" of Joint: **YES**
 Remarks:

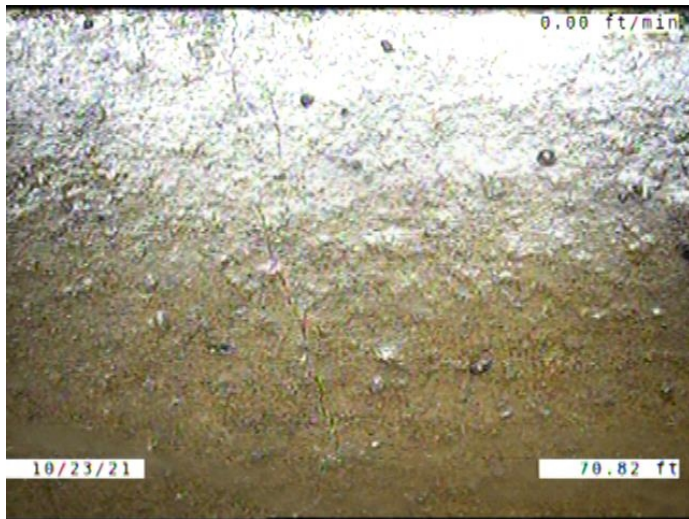
Code: **CL**
 Description: **Crack Longitudinal**

Distance (ft): **70.8**
 Structural Grade: **2**
 O&M Grade: **0**
 Clock Start/From: **11**
 Clock To:
 1st Value:
 2nd Value:
 Value Percent:
 Continuous Index:
 Within 8" of Joint: **YES**
 Remarks:

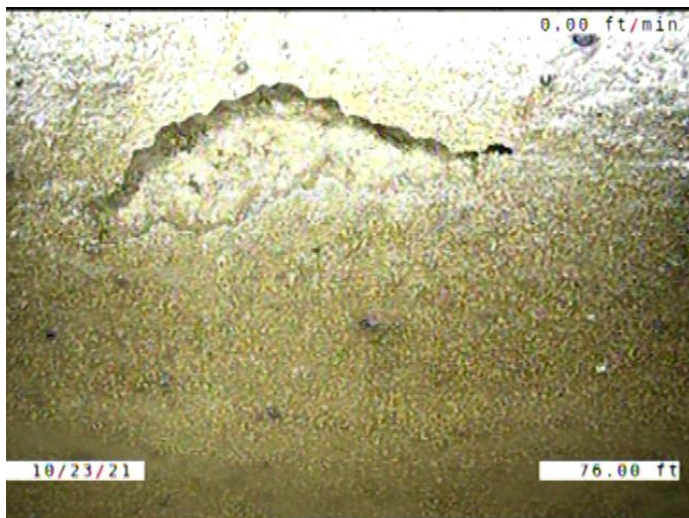
Code: **SSS**
 Description: **Surface Damage Surface Spalling**

Distance (ft): **76.0**
 Structural Grade: **2**
 O&M Grade: **0**
 Clock Start/From: **10**
 Clock To:
 1st Value:
 2nd Value:
 Value Percent:
 Continuous Index:
 Within 8" of Joint: **NO**
 Remarks:

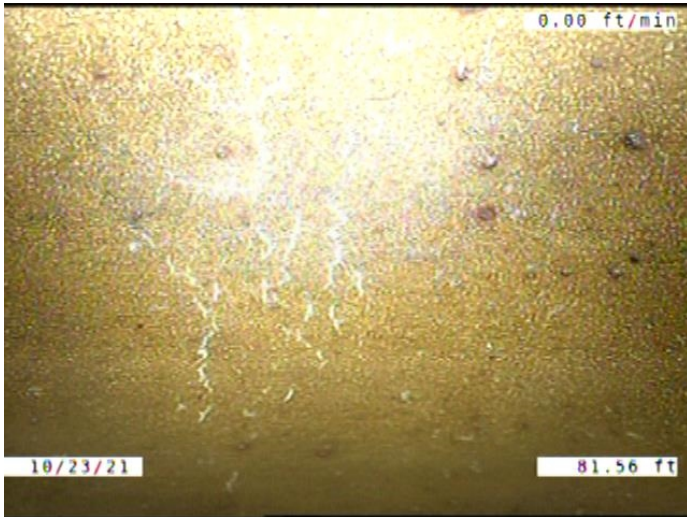
Code: **CM**
Description: **Crack Multiple**

Distance (ft): **81.6**
Structural Grade: **3**
O&M Grade: **0**
Clock Start/From: **11**
Clock To: **3**
1st Value:
2nd Value:
Value Percent:
Continuous Index:
Within 8" of Joint: **YES**
Remarks:

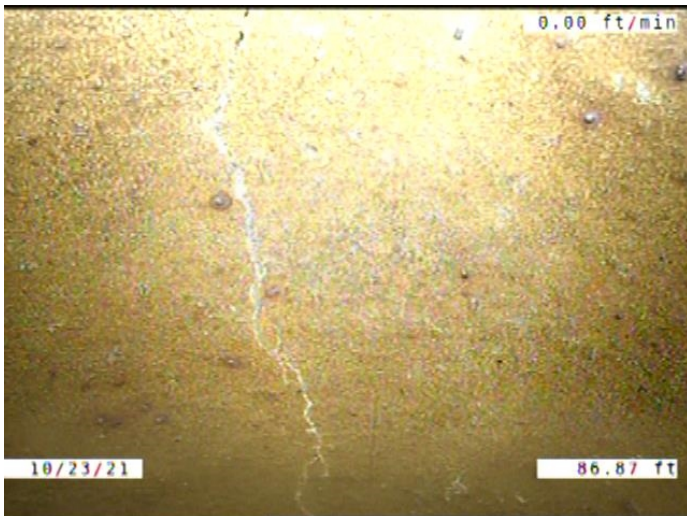
Code: **CL**
Description: **Crack Longitudinal**

Distance (ft): **86.9**
Structural Grade: **2**
O&M Grade: **0**
Clock Start/From: **12**
Clock To:
1st Value:
2nd Value:
Value Percent:
Continuous Index:
Within 8" of Joint: **YES**
Remarks:

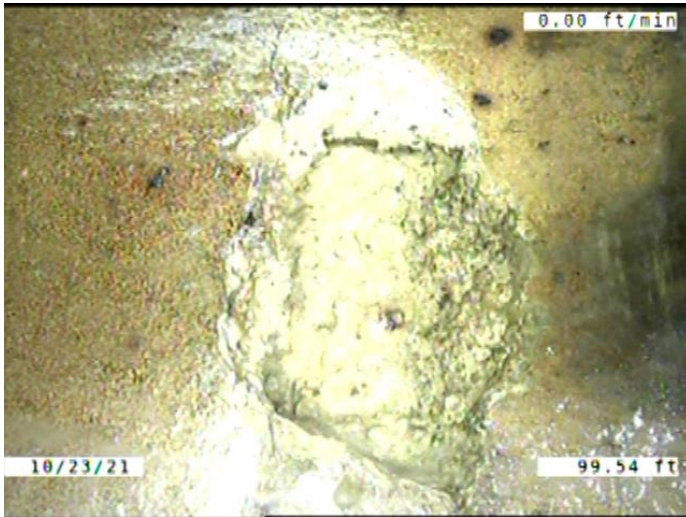
Code: **HSV**
 Description: **Hole Soil Visible**

Distance (ft): **99.5**
 Structural Grade: **5**
 O&M Grade: **0**
 Clock Start/From: **7**
 Clock To:
 1st Value:
 2nd Value:
 Value Percent:
 Continuous Index:
 Within 8" of Joint: **YES**
 Remarks:

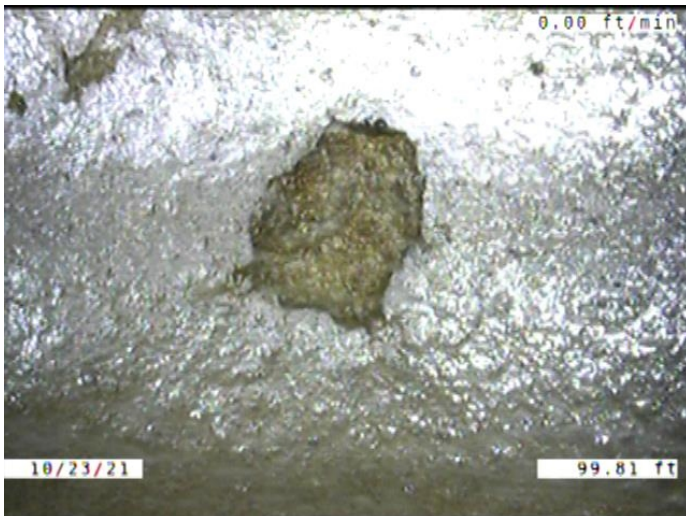
Code: **SSS**
 Description: **Surface Damage Surface Spalling**

Distance (ft): **99.8**
 Structural Grade: **2**
 O&M Grade: **0**
 Clock Start/From: **10**
 Clock To: **11**
 1st Value:
 2nd Value:
 Value Percent:
 Continuous Index:
 Within 8" of Joint: **YES**
 Remarks:

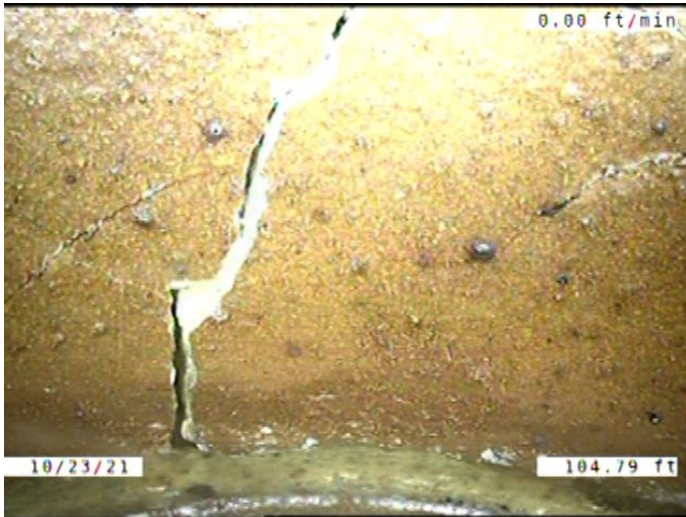
Code: **B**
 Description: **Broken**

Distance (ft): **104.8**
 Structural Grade: **4**
 O&M Grade: **0**
 Clock Start/From: **2**
 Clock To: **5**
 1st Value:
 2nd Value:
 Value Percent:
 Continuous Index:
 Within 8" of Joint: **YES**
 Remarks:

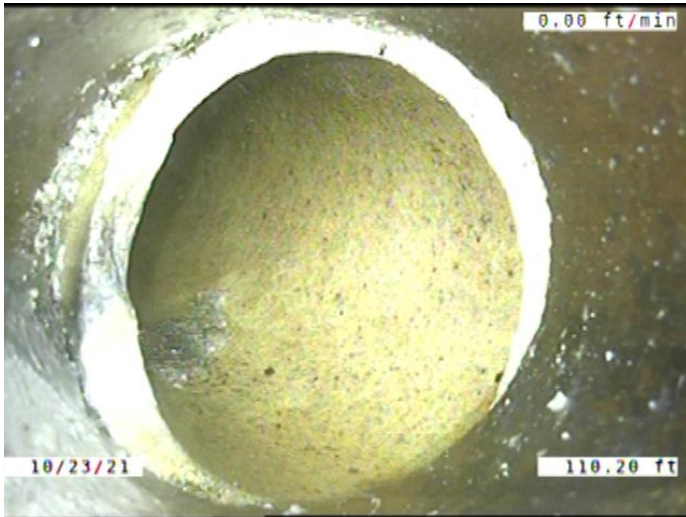
Code:	TF
Description:	Tap Factory
Distance (ft):	110.2
Structural Grade:	0
O&M Grade:	0
Clock Start/From:	10
Clock To:	
1st Value:	4.000
2nd Value:	
Value Percent:	
Continuous Index:	
Within 8" of Joint:	YES
Remarks:	CONSTANTLY RUNNING WATER

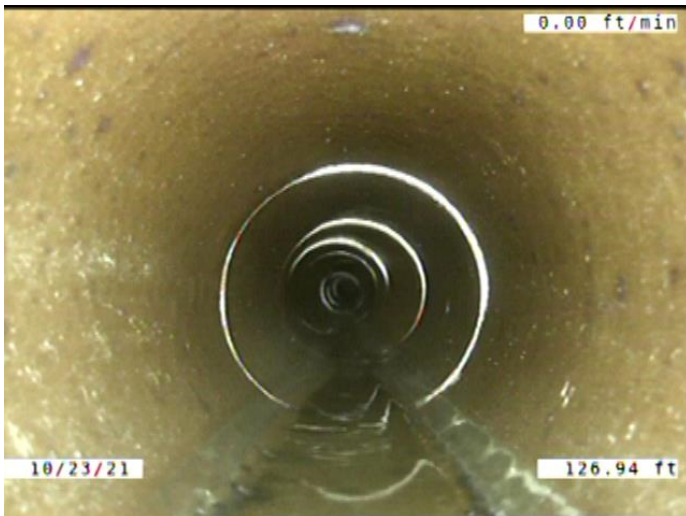
Code:	MWLS
Description:	Miscellaneous Water Level Sag
Distance (ft):	126.9
Structural Grade:	2
O&M Grade:	0
Clock Start/From:	
Clock To:	
1st Value:	
2nd Value:	
Value Percent:	5.000
Continuous Index:	
Within 8" of Joint:	NO
Remarks:

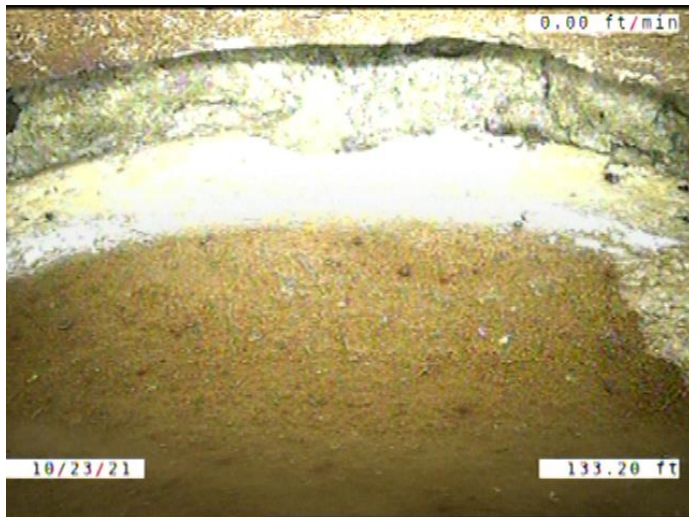
Code: **JOM**
 Description: **Joint Offset Medium**

Distance (ft): **133.2**
 Structural Grade: **3**
 O&M Grade: **0**
 Clock Start/From:
 Clock To:
 1st Value:
 2nd Value:
 Value Percent:
 Continuous Index:
 Within 8" of Joint: **NO**
 Remarks:

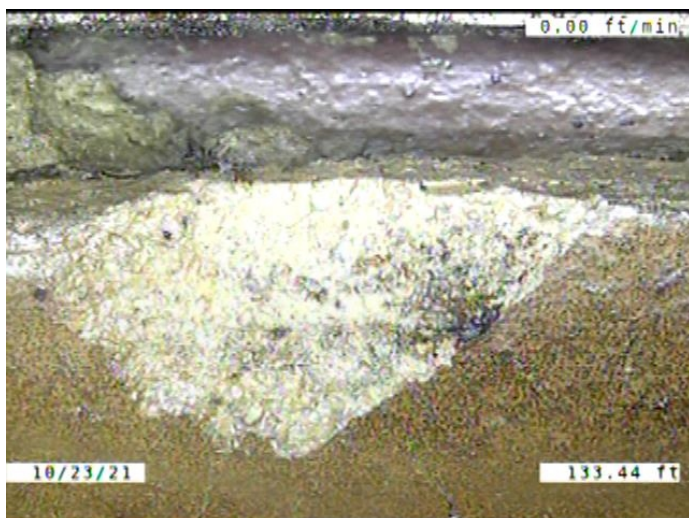
Code: **SZ**
 Description: **Surface Damage Other**

Distance (ft): **133.4**
 Structural Grade: **0**
 O&M Grade: **0**
 Clock Start/From: **1**
 Clock To:
 1st Value:
 2nd Value:
 Value Percent:
 Continuous Index:
 Within 8" of Joint: **YES**
 Remarks: **A PIECE CHIPPED AWAY FROM THE JOINT**

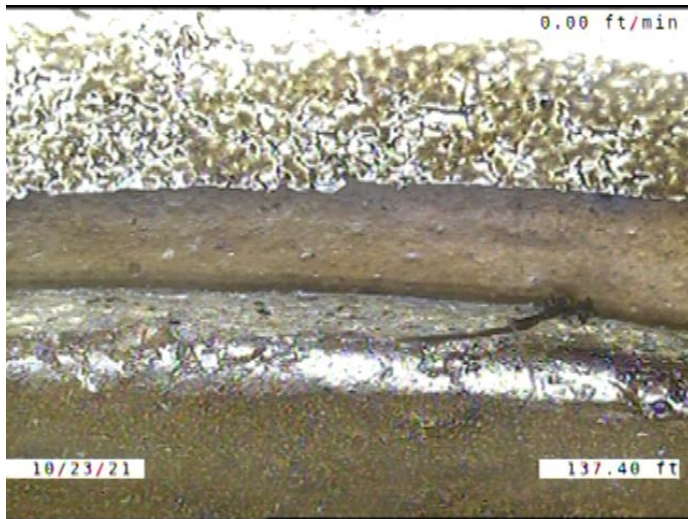
Code: **RFJ**
 Description: **Roots Fine Joint**

Distance (ft): **137.4**
 Structural Grade: **0**
 O&M Grade: **1**
 Clock Start/From: **8**
 Clock To: **4**
 1st Value:
 2nd Value:
 Value Percent:
 Continuous Index: **S02**
 Within 8" of Joint: **YES**
 Remarks:

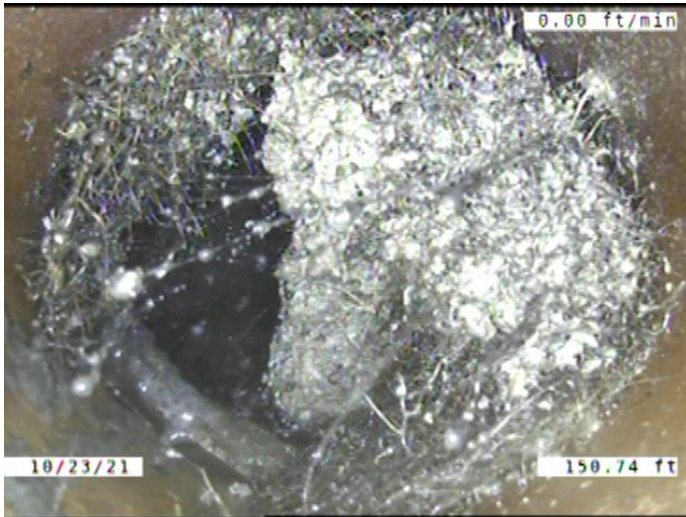
Code: **TFD**
 Description: **Tap Factory Defective**

Distance (ft): **150.7**
 Structural Grade: **0**
 O&M Grade: **3**
 Clock Start/From: **11**
 Clock To:
 1st Value: **4.000**
 2nd Value:
 Value Percent:
 Continuous Index:
 Within 8" of Joint: **YES**
 Remarks: **85% PLUGGED WITH ROOTS.
 CONSTANTLY DRIPPING WATER**

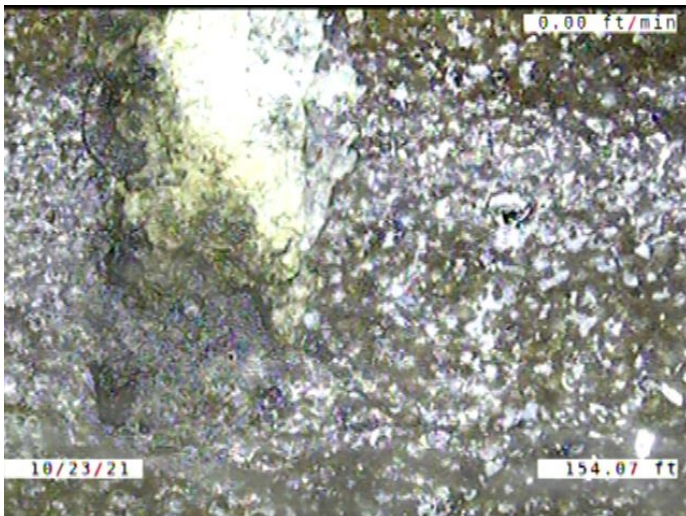
Code: **CM**
 Description: **Crack Multiple**

Distance (ft): **154.1**
 Structural Grade: **3**
 O&M Grade: **0**
 Clock Start/From: **7**
 Clock To: **5**
 1st Value:
 2nd Value:
 Value Percent:
 Continuous Index: **S07**
 Within 8" of Joint: **YES**
 Remarks: **Wandering**

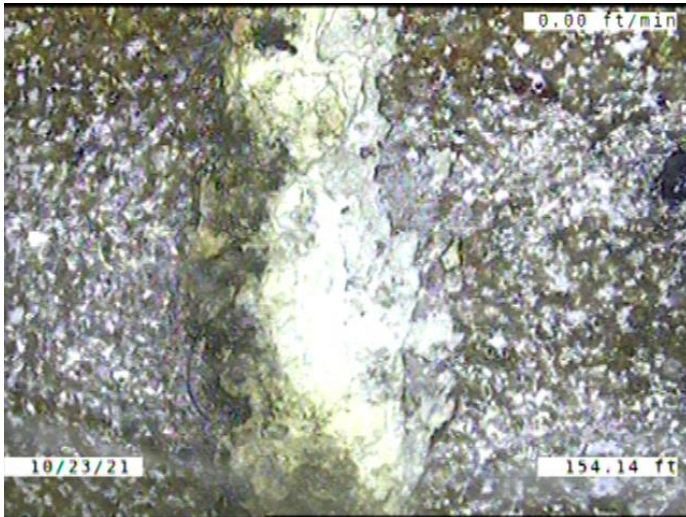
Code: **DAE**
 Description: **Deposits Attached Encrustation**

Distance (ft): **154.1**
 Structural Grade: **0**
 O&M Grade: **2**
 Clock Start/From: **8**
 Clock To: **9**
 1st Value:
 2nd Value:
 Value Percent: **5.000**
 Continuous Index:
 Within 8" of Joint: **NO**
 Remarks:

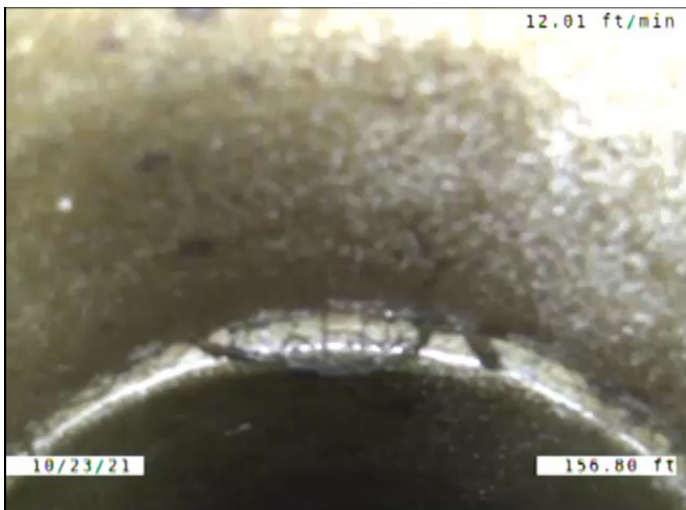
Code: **B**
 Description: **Broken**

Distance (ft): **156.8**
 Structural Grade: **4**
 O&M Grade: **0**
 Clock Start/From: **12**
 Clock To:
 1st Value:
 2nd Value:
 Value Percent:
 Continuous Index:
 Within 8" of Joint: **YES**
 Remarks:

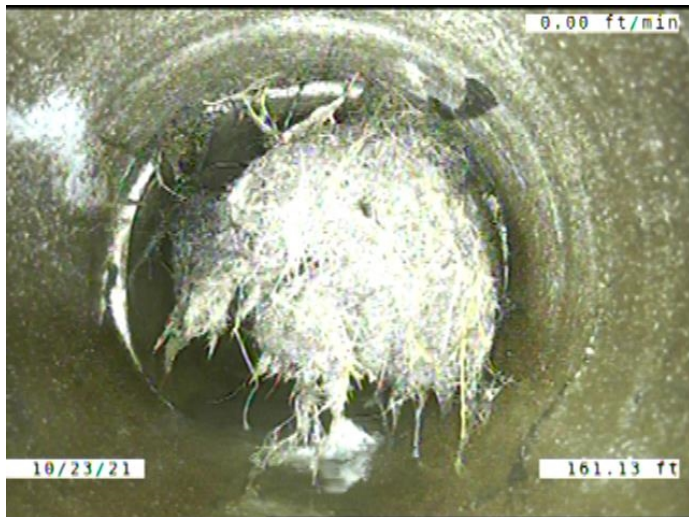
Code: **RBJ**
 Description: **Roots Ball Joint**

Distance (ft): **161.1**
 Structural Grade: **0**
 O&M Grade: **4**
 Clock Start/From: **8**
 Clock To: **5**
 1st Value:
 2nd Value:
 Value Percent: **80.000**
 Continuous Index:
 Within 8" of Joint: **YES**
 Remarks:

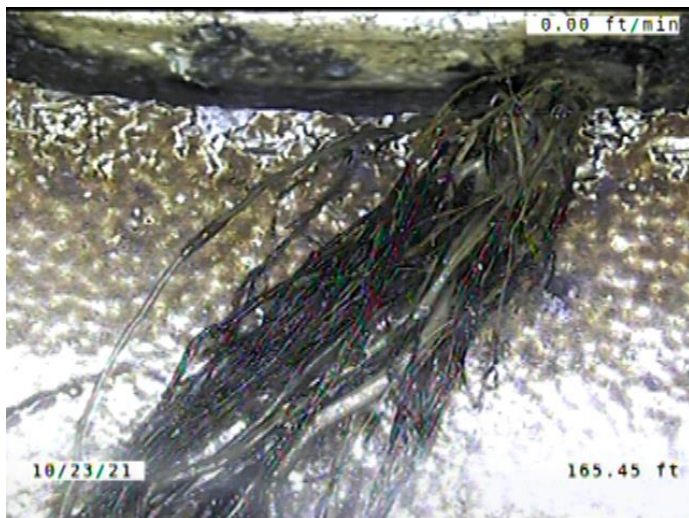
Code: **RMJ**
 Description: **Roots Medium Joint**

Distance (ft): **165.4**
 Structural Grade: **0**
 O&M Grade: **3**
 Clock Start/From: **8**
 Clock To: **4**
 1st Value:
 2nd Value:
 Value Percent: **15.000**
 Continuous Index: **S03**
 Within 8" of Joint: **YES**
 Remarks:

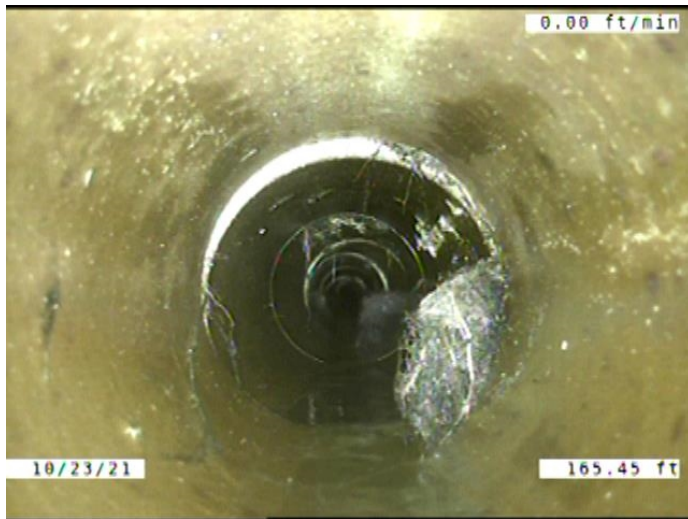
Code: **RFJ**
 Description: **Roots Fine Joint**

Distance (ft): **165.4**
 Structural Grade: **0**
 O&M Grade: **1**
 Clock Start/From: **8**
 Clock To: **4**
 1st Value:
 2nd Value:
 Value Percent:
 Continuous Index: **F02**
 Within 8" of Joint: **YES**
 Remarks:

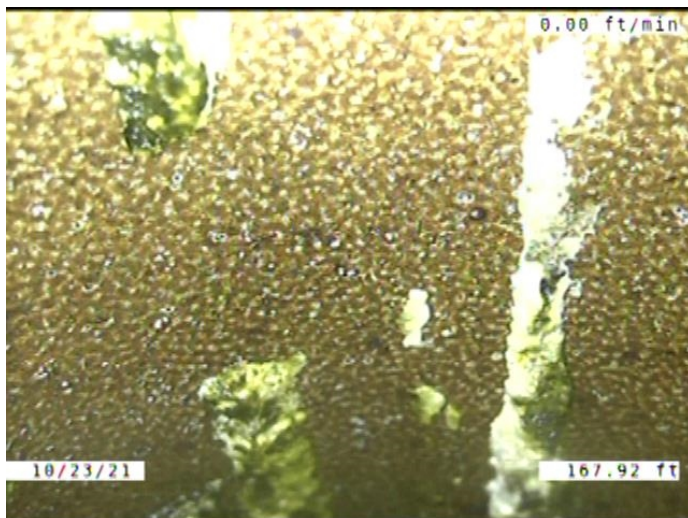
Code: **DAGS**
 Description: **Deposits Attached Grease**

Distance (ft): **167.9**
 Structural Grade: **0**
 O&M Grade: **2**
 Clock Start/From: **11**
 Clock To: **3**
 1st Value:
 2nd Value:
 Value Percent: **5.000**
 Continuous Index: **S05**
 Within 8" of Joint: **YES**
 Remarks:

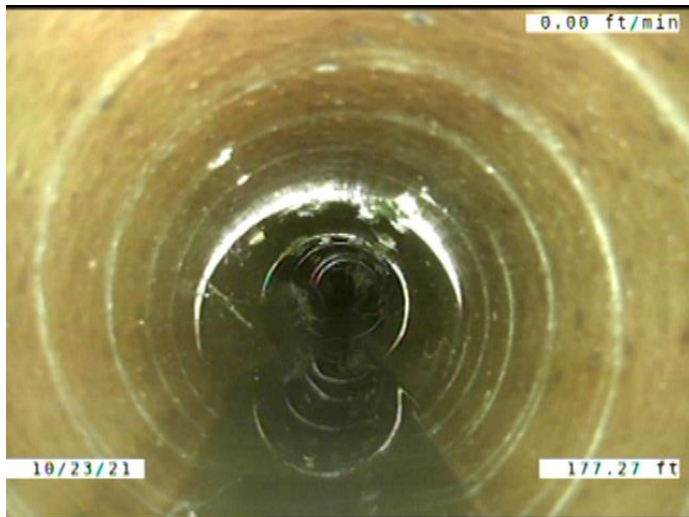
Code: **MWLS**
 Description: **Miscellaneous Water Level Sag**

Distance (ft): **177.3**
 Structural Grade: **2**
 O&M Grade: **0**
 Clock Start/From:
 Clock To:
 1st Value:
 2nd Value:
 Value Percent: **5.000**
 Continuous Index: **S04**
 Within 8" of Joint: **NO**
 Remarks:

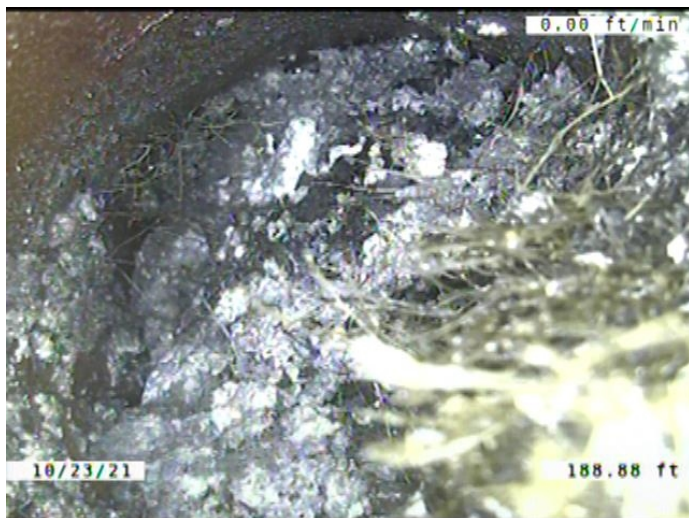
Code: **TFD**
 Description: **Tap Factory Defective**

Distance (ft): **188.9**
 Structural Grade: **0**
 O&M Grade: **3**
 Clock Start/From: **1**
 Clock To:
 1st Value: **4.000**
 2nd Value:
 Value Percent:
 Continuous Index:
 Within 8" of Joint: **YES**
 Remarks: **100% FULL OF ROOTS**

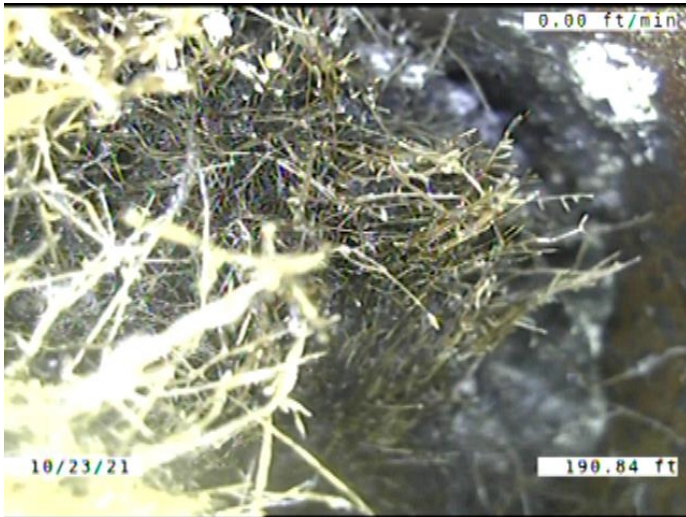
Code: **TFD**
 Description: **Tap Factory Defective**

Distance (ft): **190.8**
 Structural Grade: **0**
 O&M Grade: **3**
 Clock Start/From: **10**
 Clock To:
 1st Value: **4.000**
 2nd Value:
 Value Percent:
 Continuous Index:
 Within 8" of Joint: **YES**
 Remarks: **100% FULL OF ROOTS**

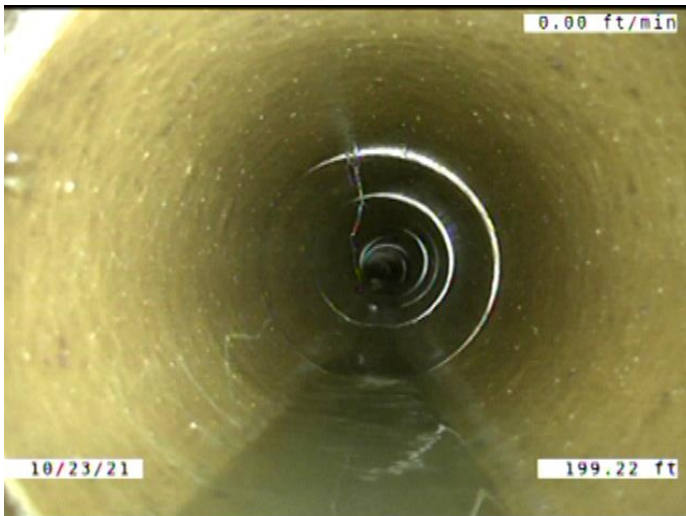
Code: **MWLS**
 Description: **Miscellaneous Water Level Sag**

Distance (ft): **199.2**
 Structural Grade: **2**
 O&M Grade: **0**
 Clock Start/From:
 Clock To:
 1st Value:
 2nd Value:
 Value Percent: **5.000**
 Continuous Index:
 Within 8" of Joint: **NO**
 Remarks:

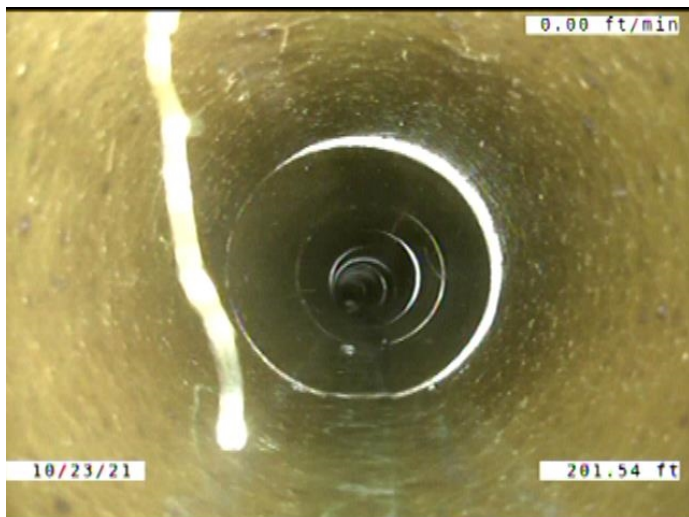
Code: **MWLS**
 Description: **Miscellaneous Water Level Sag**

Distance (ft): **201.5**
 Structural Grade: **2**
 O&M Grade: **0**
 Clock Start/From:
 Clock To:
 1st Value:
 2nd Value:
 Value Percent: **5.000**
 Continuous Index: **F04**
 Within 8" of Joint: **NO**
 Remarks:

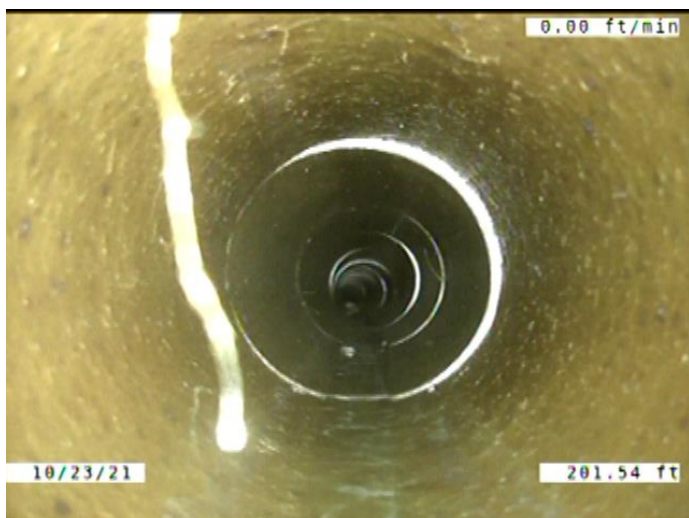
Code: **DAGS**
 Description: **Deposits Attached Grease**

Distance (ft): **201.5**
 Structural Grade: **0**
 O&M Grade: **2**
 Clock Start/From: **11**
 Clock To: **3**
 1st Value:
 2nd Value:
 Value Percent: **5.000**
 Continuous Index: **F05**
 Within 8" of Joint: **YES**
 Remarks:

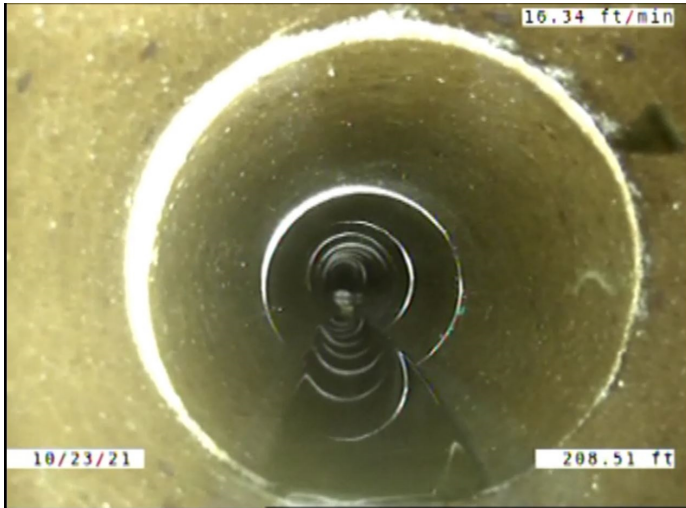
Code: **CM**
Description: **Crack Multiple**

Distance (ft): **208.5**
Structural Grade: **3**
O&M Grade: **0**
Clock Start/From: **7**
Clock To: **5**
1st Value:
2nd Value:
Value Percent:
Continuous Index: **F07**
Within 8" of Joint: **YES**
Remarks: **Wandering**

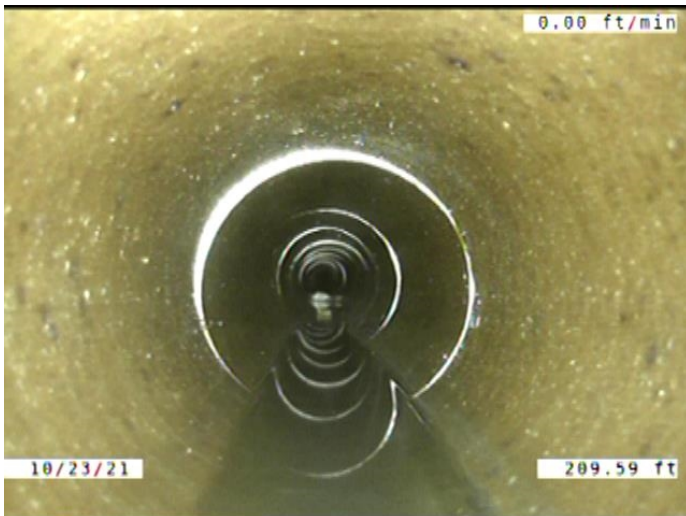
Code: **MWLS**
Description: **Miscellaneous Water Level Sag**

Distance (ft): **209.6**
Structural Grade: **2**
O&M Grade: **0**
Clock Start/From:
Clock To:
1st Value:
2nd Value:
Value Percent: **5.000**
Continuous Index: **S06**
Within 8" of Joint: **NO**
Remarks:

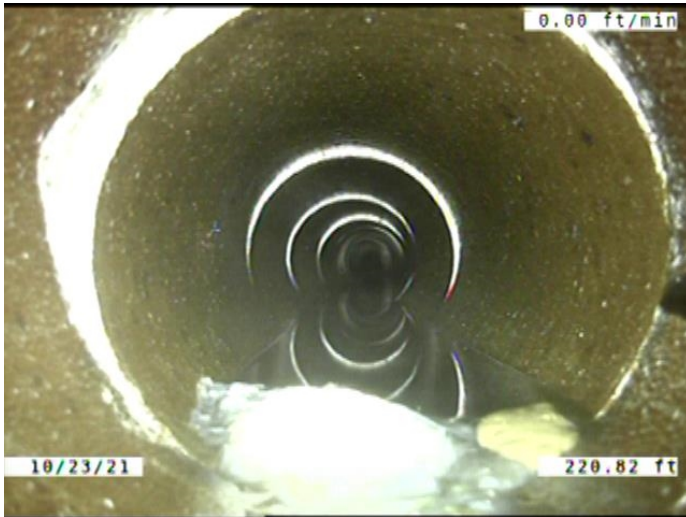
Code: **DSF**
 Description: **Deposits Settled Fine**

Distance (ft): **220.8**
 Structural Grade: **0**
 O&M Grade: **2**
 Clock Start/From: **5**
 Clock To: **7**
 1st Value:
 2nd Value:
 Value Percent: **5.000**
 Continuous Index:
 Within 8" of Joint: **YES**
 Remarks:

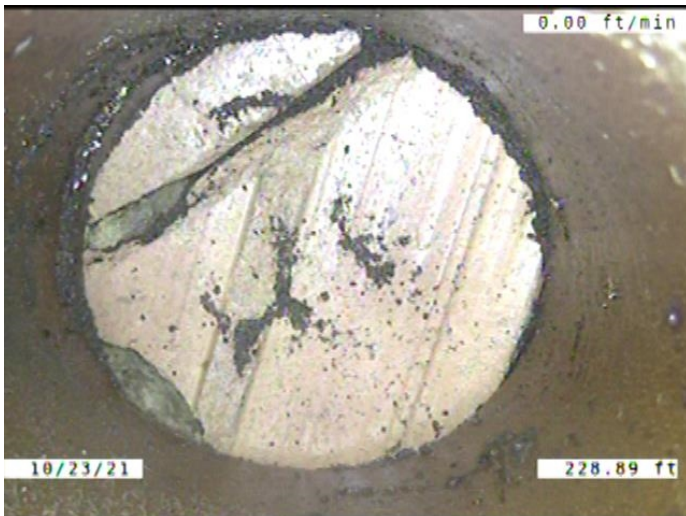
Code: **TFC**
 Description: **Tap Factory Capped**

Distance (ft): **228.9**
 Structural Grade: **0**
 O&M Grade: **0**
 Clock Start/From: **2**
 Clock To:
 1st Value: **4.000**
 2nd Value:
 Value Percent:
 Continuous Index:
 Within 8" of Joint: **YES**
 Remarks: **CAP BROKEN**

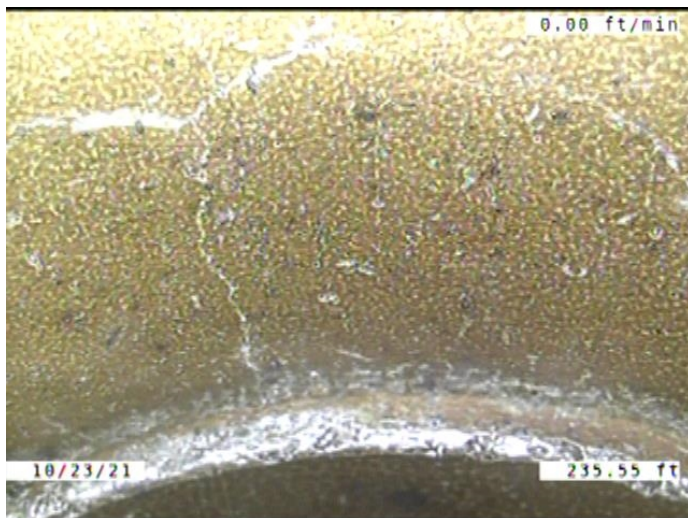
Code: **CM**
 Description: **Crack Multiple**

Distance (ft): **235.5**
 Structural Grade: **3**
 O&M Grade: **0**
 Clock Start/From: **10**
 Clock To: **3**
 1st Value:
 2nd Value:
 Value Percent:
 Continuous Index:
 Within 8" of Joint: **YES**
 Remarks:

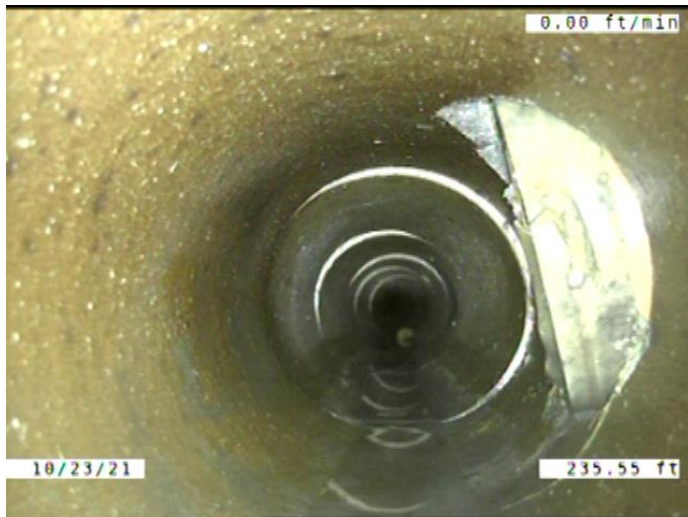
Code: **MWLS**
 Description: **Miscellaneous Water Level Sag**

Distance (ft): **235.5**
 Structural Grade: **2**
 O&M Grade: **0**
 Clock Start/From:
 Clock To:
 1st Value:
 2nd Value:
 Value Percent: **5.000**
 Continuous Index: **F06**
 Within 8" of Joint: **NO**
 Remarks:

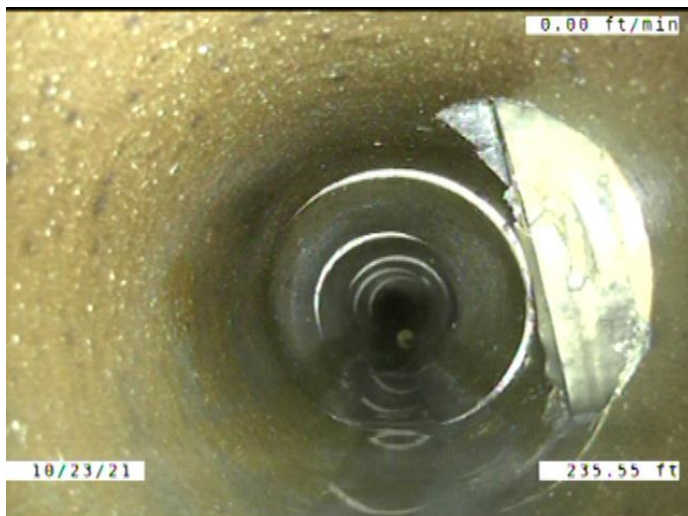
Code: **RMJ**
 Description: **Roots Medium Joint**

Distance (ft): **235.6**
 Structural Grade: **0**
 O&M Grade: **3**
 Clock Start/From: **8**
 Clock To: **4**
 1st Value:
 2nd Value:
 Value Percent: **15.000**
 Continuous Index: **F03**
 Within 8" of Joint: **YES**
 Remarks:

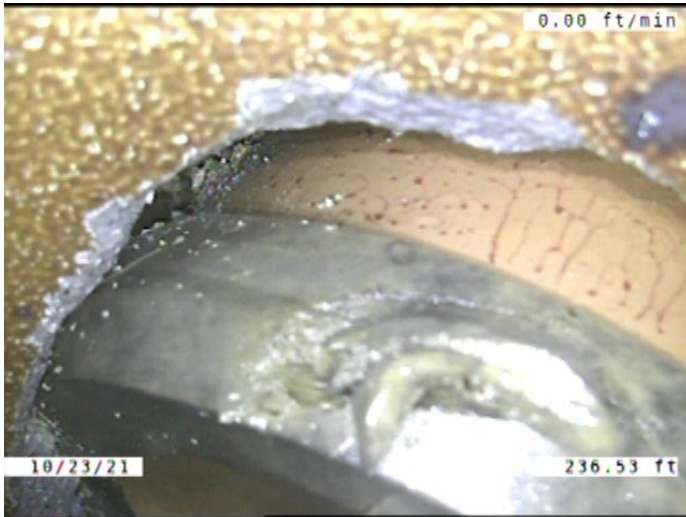
Code: **SSS**
 Description: **Surface Damage Surface Spalling**

Distance (ft): **236.5**
 Structural Grade: **2**
 O&M Grade: **0**
 Clock Start/From: **12**
 Clock To: **4**
 1st Value:
 2nd Value:
 Value Percent:
 Continuous Index:
 Within 8" of Joint: **YES**
 Remarks:

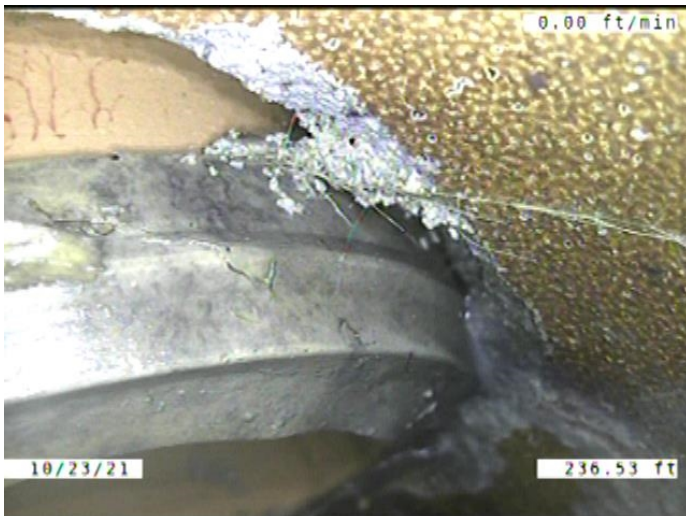
Code: **RFB**
 Description: **Roots Fine Barrel**

Distance (ft): **236.5**
 Structural Grade: **0**
 O&M Grade: **2**
 Clock Start/From: **3**
 Clock To:
 1st Value:
 2nd Value:
 Value Percent:
 Continuous Index:
 Within 8" of Joint: **NO**
 Remarks:

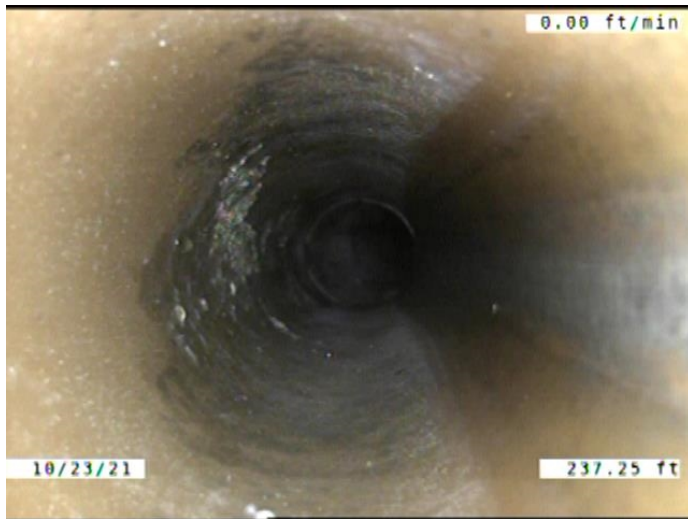
Code: **TBI**
 Description: **Tap Break-in Intruding**

Distance (ft): **237.3**
 Structural Grade: **0**
 O&M Grade: **2**
 Clock Start/From: **2**
 Clock To:
 1st Value: **4.000**
 2nd Value: **2.000**
 Value Percent:
 Continuous Index:
 Within 8" of Joint: **YES**
 Remarks:

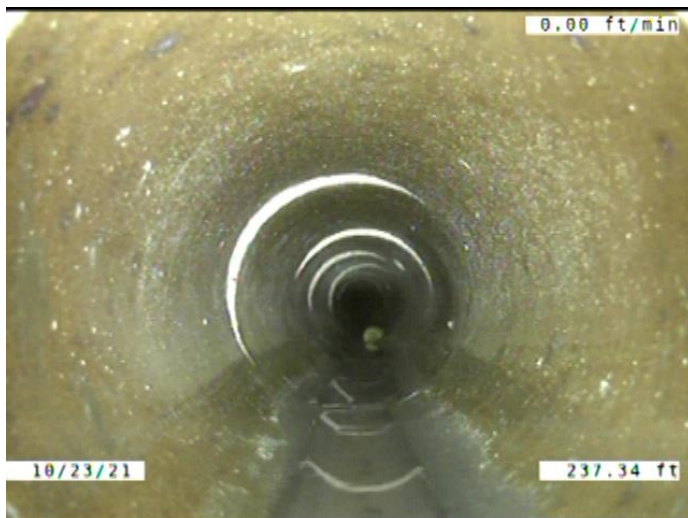
Code: **MSA**
 Description: **Miscellaneous Survey Abandoned**

Distance (ft): **237.3**
 Structural Grade: **0**
 O&M Grade: **0**
 Clock Start/From:
 Clock To:
 1st Value:
 2nd Value:
 Value Percent:
 Continuous Index:
 Within 8" of Joint: **NO**
 Remarks: **CAMERA CANT MAKE IT PAST PROTRUDING TAP. MADE IT TO THE**
