Profile/Photo Observation Report

Date:	10/23/2021	Weather:		Coding:	PACP 7.0
Pipe Length (ft):	351.0	Owner:	City of Hobart	Pre Clean:	Heavy Cleaning
P.O.#:	YES502259	Surveyor:	S. Bucklin	PSR:	P-804-020-015
Customer:	City of Hobart	Clean Date:	09/15/2021	Shape:	C

Street:	North Illinois Street	Flow Control:	Not Controlled
City:	Hobart, IN	Year Renewed:	
Location:	Alley	Tape/Media #:	
Purpose:	Routine Assessment	Dia/Height:	8"
Use:	Sanitary Sewage Pipe	Material:	VCP
Drain Area:		Lining:	None
Category:	NA		
Comment:			
Location Details:		Direction of Survey:	Downstream
US MH:	M-804-020	DS MH:	M-804-015
		Total Length Surveyed (ft):	109.4

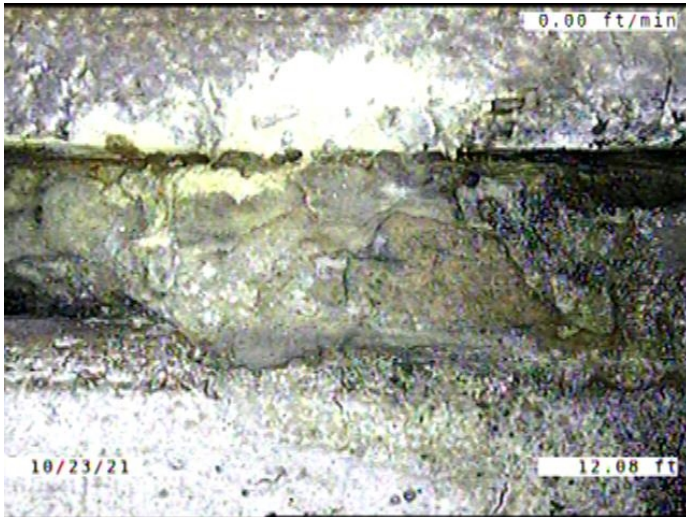
Code: **DAE**
Description: **Deposits Attached Encrustation**

Distance (ft): **12.1**
Structural Grade: **0**
O&M Grade: **2**
Clock Start/From: **7**
Clock To: **8**
1st Value:
2nd Value:
Value Percent: **5.000**
Continuous Index:
Within 8" of Joint: **YES**
Remarks:

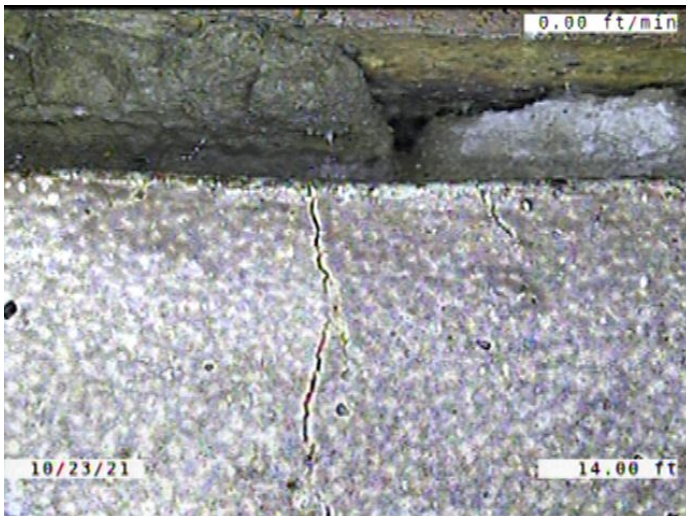
Code: **CL**
Description: **Crack Longitudinal**

Distance (ft): **14.0**
Structural Grade: **2**
O&M Grade: **0**
Clock Start/From: **2**
Clock To:
1st Value:
2nd Value:
Value Percent:
Continuous Index:
Within 8" of Joint: **YES**
Remarks:

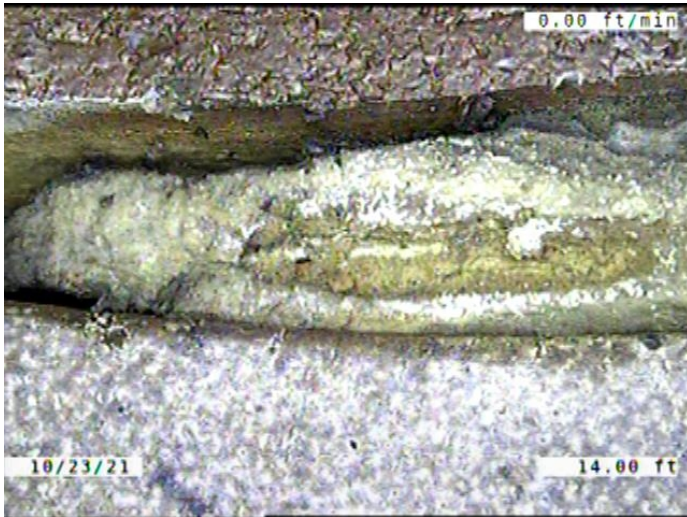
Code: **DAE**
 Description: **Deposits Attached Encrustation**

Distance (ft): **14.0**
 Structural Grade: **0**
 O&M Grade: **2**
 Clock Start/From: **3**
 Clock To: **9**
 1st Value:
 2nd Value:
 Value Percent: **5.000**
 Continuous Index:
 Within 8" of Joint: **YES**
 Remarks:

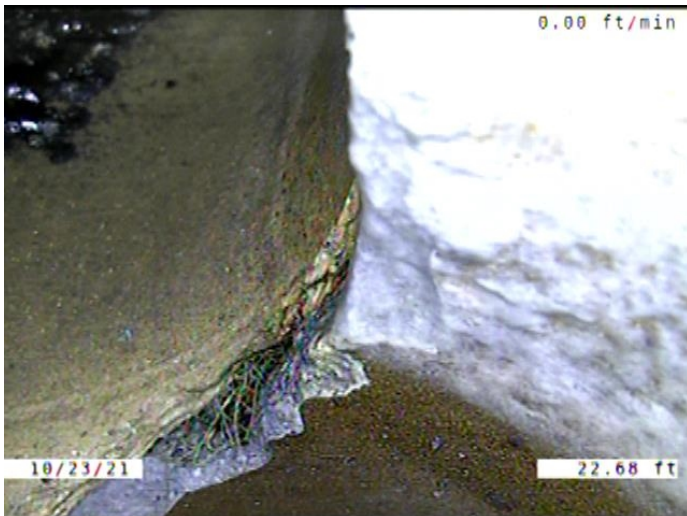
Code: **SSS**
 Description: **Surface Damage Surface Spalling**

Distance (ft): **22.7**
 Structural Grade: **2**
 O&M Grade: **0**
 Clock Start/From: **12**
 Clock To: **3**
 1st Value:
 2nd Value:
 Value Percent:
 Continuous Index:
 Within 8" of Joint: **YES**
 Remarks:

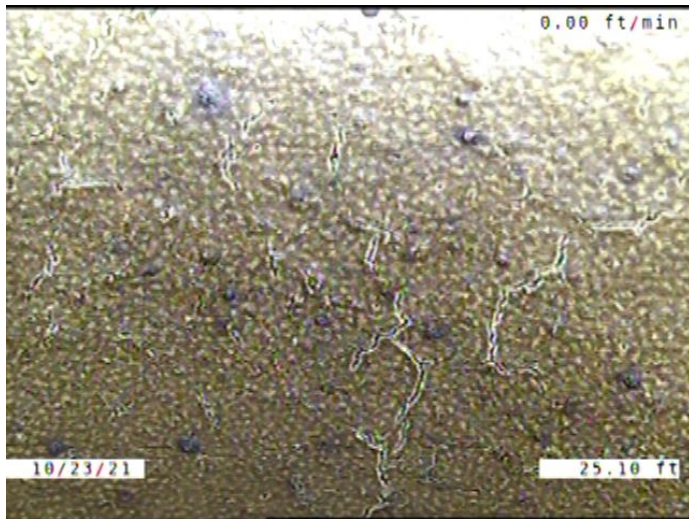
Code: **CM**
 Description: **Crack Multiple**

Distance (ft): **25.1**
 Structural Grade: **3**
 O&M Grade: **0**
 Clock Start/From: **1**
 Clock To: **2**
 1st Value:
 2nd Value:
 Value Percent:
 Continuous Index:
 Within 8" of Joint: **YES**
 Remarks:

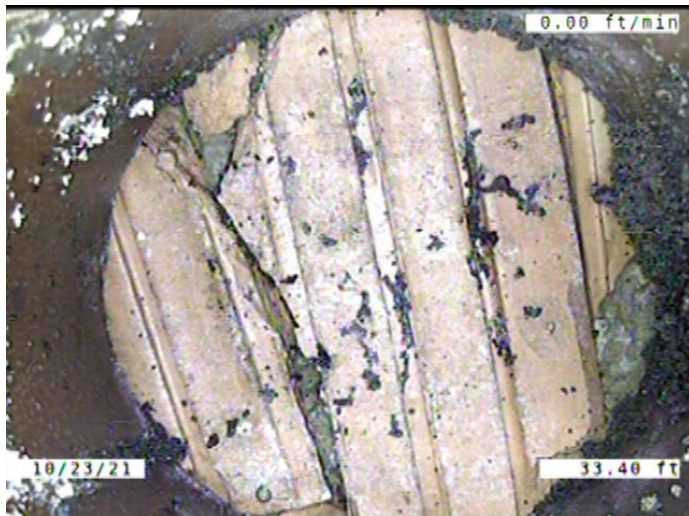
Code: **TFD**
 Description: **Tap Factory Defective**

Distance (ft): **33.4**
 Structural Grade: **0**
 O&M Grade: **3**
 Clock Start/From: **2**
 Clock To:
 1st Value: **4.000**
 2nd Value:
 Value Percent:
 Continuous Index:
 Within 8" of Joint: **YES**
 Remarks: **CAP BROKEN. SOIL VISIBLE**

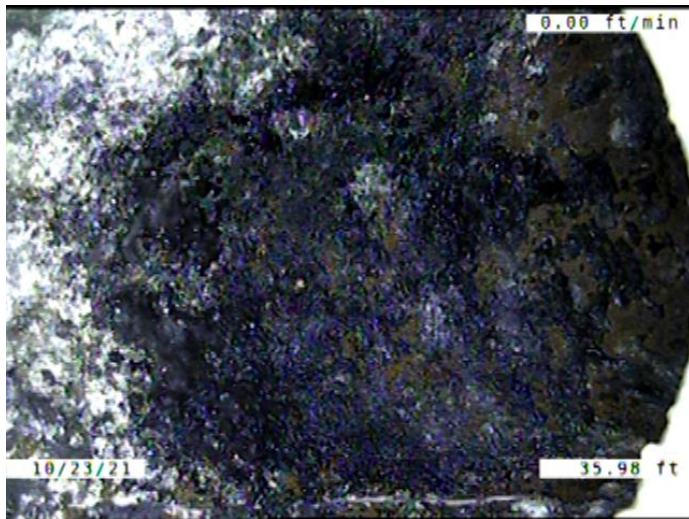
Code: **TF**
 Description: **Tap Factory**

Distance (ft): **36.0**
 Structural Grade: **0**
 O&M Grade: **0**
 Clock Start/From: **12**
 Clock To:
 1st Value: **4.000**
 2nd Value:
 Value Percent:
 Continuous Index:
 Within 8" of Joint: **YES**
 Remarks: **LOOKS TO COME IN FROM THE RIGHT (WEST)**

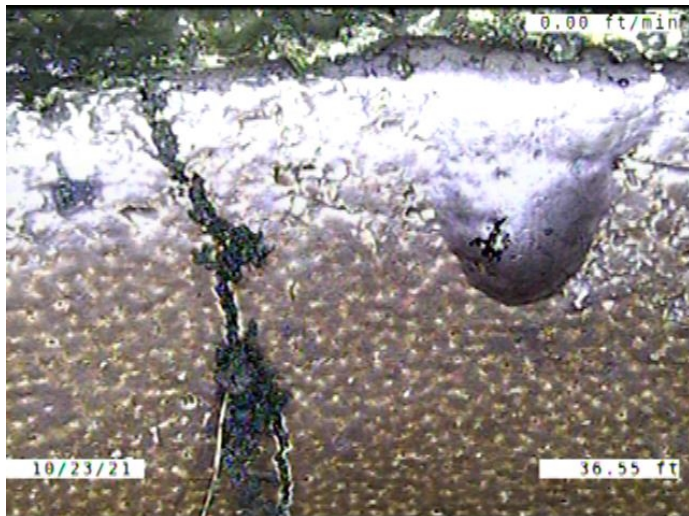
Code: **FL**
 Description: **Fracture Longitudinal**

Distance (ft): **36.5**
 Structural Grade: **3**
 O&M Grade: **0**
 Clock Start/From: **12**
 Clock To:
 1st Value:
 2nd Value:
 Value Percent:
 Continuous Index:
 Within 8" of Joint: **YES**
 Remarks:

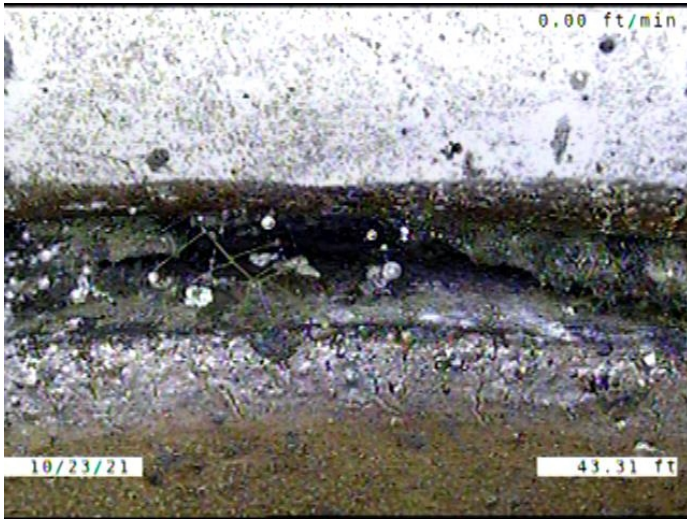
Code: **RFJ**
 Description: **Roots Fine Joint**

Distance (ft): **43.3**
 Structural Grade: **0**
 O&M Grade: **1**
 Clock Start/From: **12**
 Clock To: **5**
 1st Value:
 2nd Value:
 Value Percent:
 Continuous Index:
 Within 8" of Joint: **YES**
 Remarks:

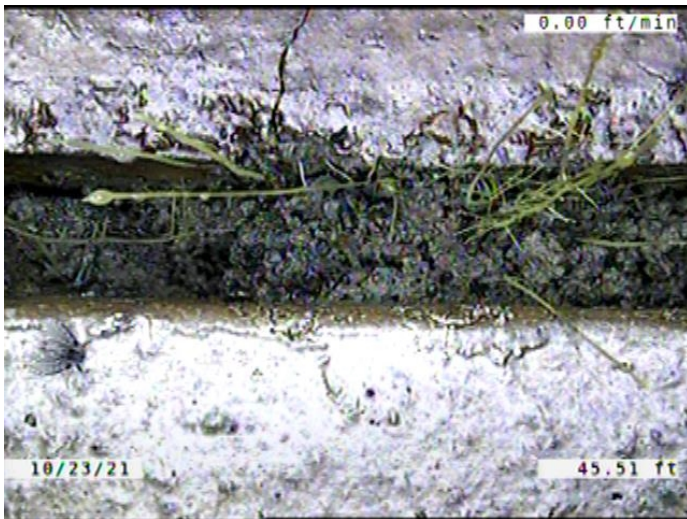
Code: **RFJ**
 Description: **Roots Fine Joint**

Distance (ft): **45.5**
 Structural Grade: **0**
 O&M Grade: **1**
 Clock Start/From: **3**
 Clock To: **5**
 1st Value:
 2nd Value:
 Value Percent:
 Continuous Index:
 Within 8" of Joint: **YES**
 Remarks:

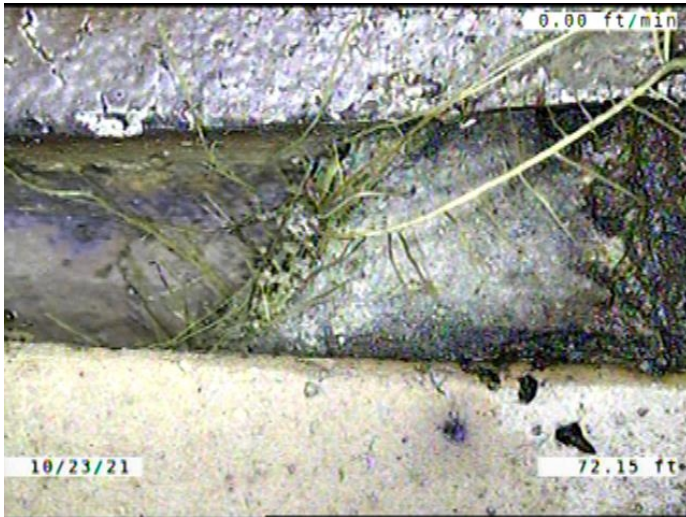
Code: **RFJ**
 Description: **Roots Fine Joint**

Distance (ft): **72.2**
 Structural Grade: **0**
 O&M Grade: **1**
 Clock Start/From: **8**
 Clock To: **9**
 1st Value:
 2nd Value:
 Value Percent:
 Continuous Index:
 Within 8" of Joint: **YES**
 Remarks:

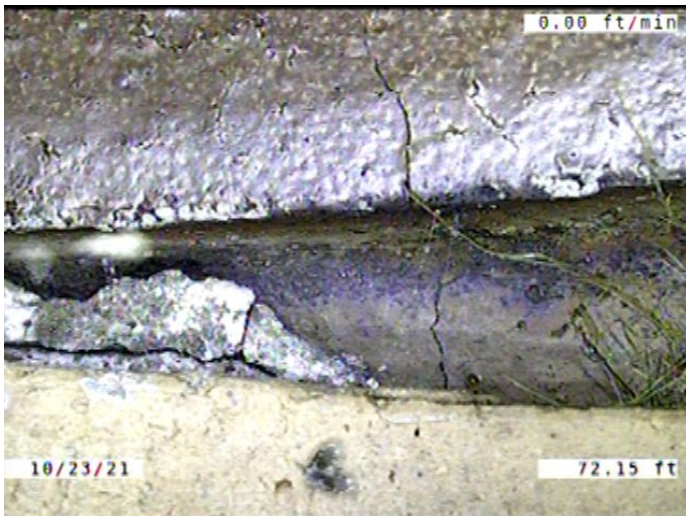
Code: **CL**
 Description: **Crack Longitudinal**

Distance (ft): **72.2**
 Structural Grade: **2**
 O&M Grade: **0**
 Clock Start/From: **10**
 Clock To:
 1st Value:
 2nd Value:
 Value Percent:
 Continuous Index:
 Within 8" of Joint: **YES**
 Remarks:

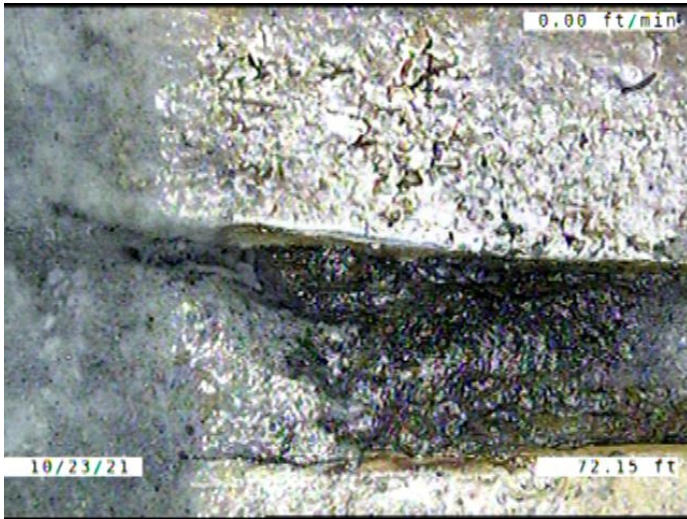
Code: **DAE**
 Description: **Deposits Attached Encrustation**

Distance (ft): **72.2**
 Structural Grade: **0**
 O&M Grade: **2**
 Clock Start/From: **3**
 Clock To: **9**
 1st Value:
 2nd Value:
 Value Percent: **5.000**
 Continuous Index:
 Within 8" of Joint: **YES**
 Remarks:

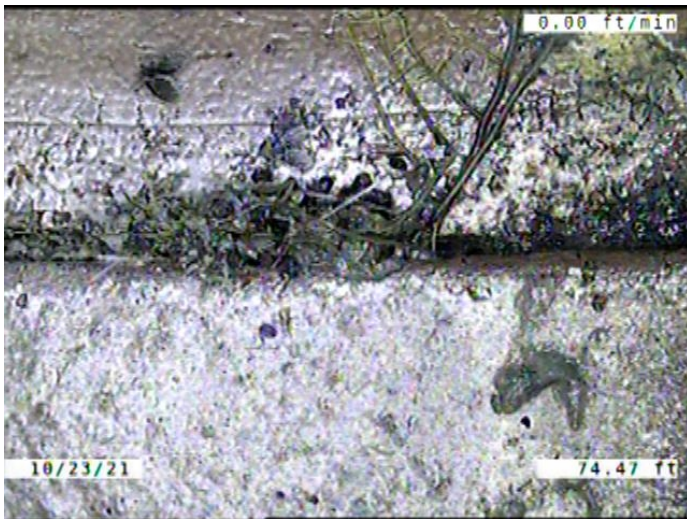
Code: **RFJ**
 Description: **Roots Fine Joint**

Distance (ft): **74.5**
 Structural Grade: **0**
 O&M Grade: **1**
 Clock Start/From: **8**
 Clock To: **11**
 1st Value:
 2nd Value:
 Value Percent:
 Continuous Index: **S01**
 Within 8" of Joint: **YES**
 Remarks:

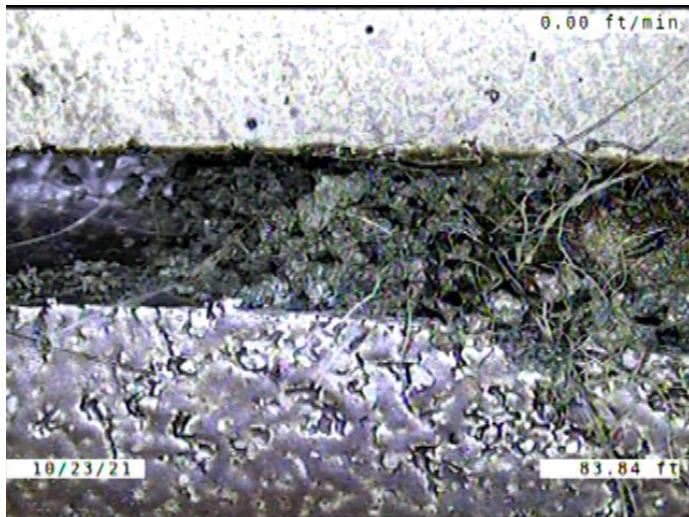
Code: **RFJ**
 Description: **Roots Fine Joint**

Distance (ft): **83.8**
 Structural Grade: **0**
 O&M Grade: **1**
 Clock Start/From: **2**
 Clock To: **4**
 1st Value:
 2nd Value:
 Value Percent:
 Continuous Index:
 Within 8" of Joint: **YES**
 Remarks:

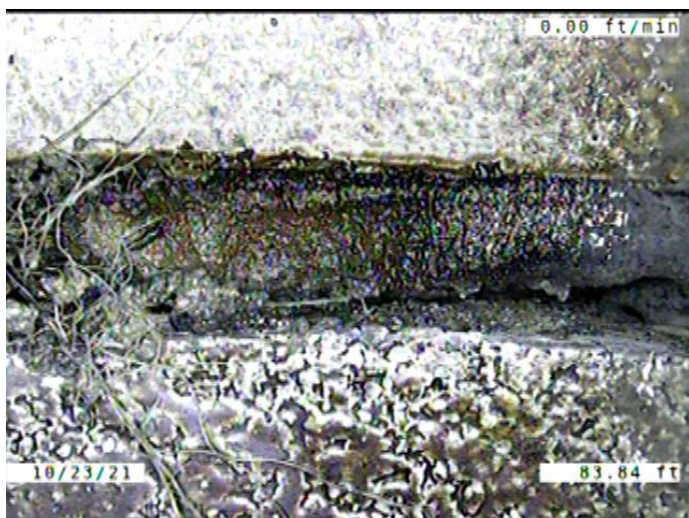
Code: **DAE**
 Description: **Deposits Attached Encrustation**

Distance (ft): **83.8**
 Structural Grade: **0**
 O&M Grade: **2**
 Clock Start/From: **5**
 Clock To: **9**
 1st Value:
 2nd Value:
 Value Percent: **5.000**
 Continuous Index:
 Within 8" of Joint: **YES**
 Remarks:

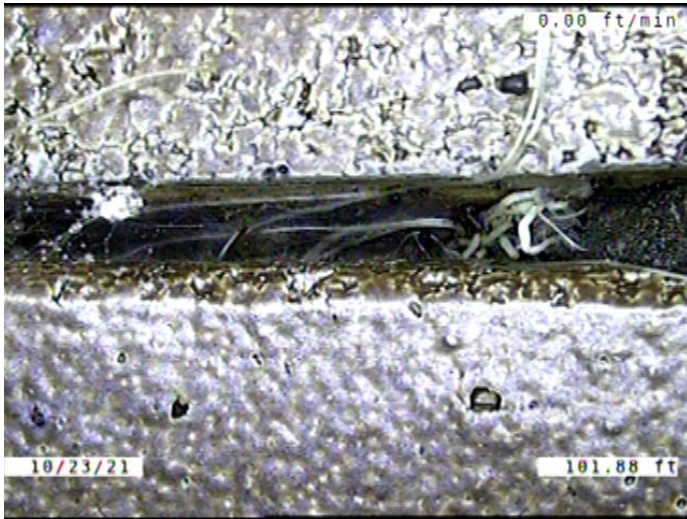
Code: **RFJ**
 Description: **Roots Fine Joint**

Distance (ft): **101.9**
 Structural Grade: **0**
 O&M Grade: **1**
 Clock Start/From: **8**
 Clock To: **4**
 1st Value:
 2nd Value:
 Value Percent:
 Continuous Index:
 Within 8" of Joint: **YES**
 Remarks:

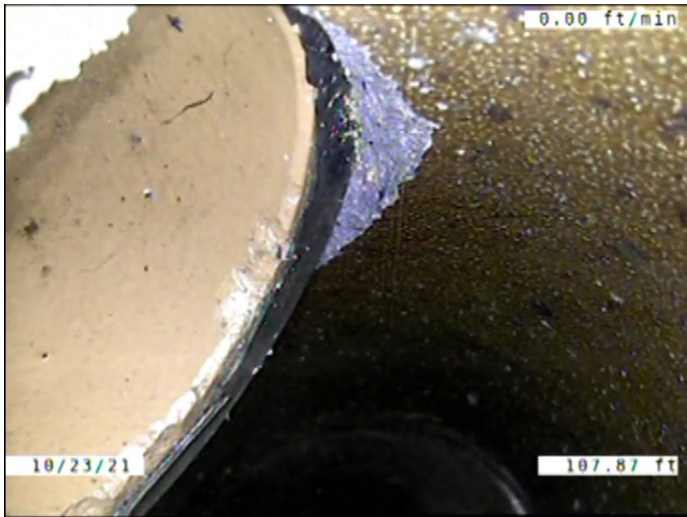
Code: **SSS**
 Description: **Surface Damage Surface Spalling**

Distance (ft): **107.9**
 Structural Grade: **2**
 O&M Grade: **0**
 Clock Start/From: **8**
 Clock To: **11**
 1st Value:
 2nd Value:
 Value Percent:
 Continuous Index:
 Within 8" of Joint: **NO**
 Remarks:

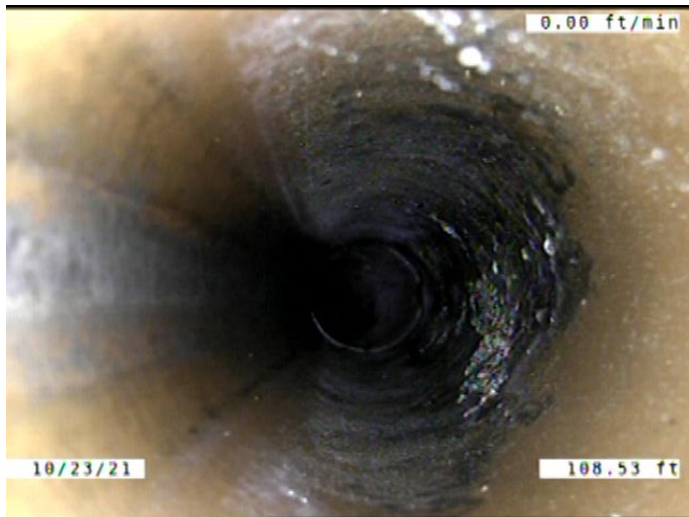
Code: **TBI**
 Description: **Tap Break-in Intruding**

Distance (ft): **108.5**
 Structural Grade: **0**
 O&M Grade: **2**
 Clock Start/From: **9**
 Clock To:
 1st Value: **6.000**
 2nd Value: **2.000**
 Value Percent:
 Continuous Index:
 Within 8" of Joint: **YES**
 Remarks:

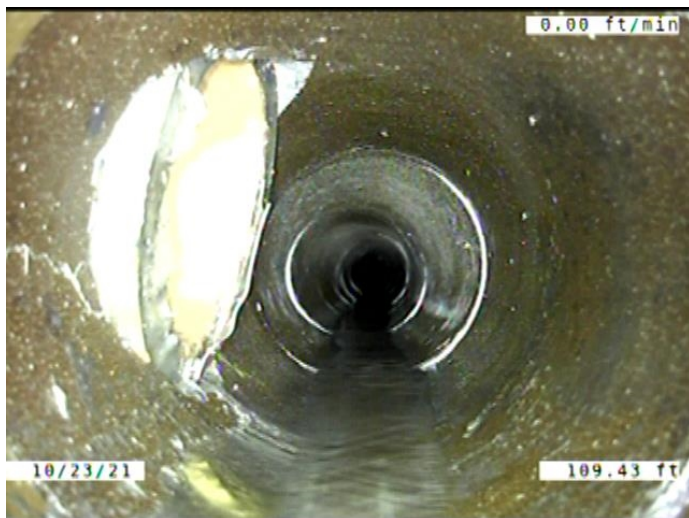
Code: **RFJ**
 Description: **Roots Fine Joint**

Distance (ft): **109.4**
 Structural Grade: **0**
 O&M Grade: **1**
 Clock Start/From: **8**
 Clock To: **11**
 1st Value:
 2nd Value:
 Value Percent:
 Continuous Index: **F01**
 Within 8" of Joint: **YES**
 Remarks:
