# Profile/Photo Observation Report

Date:	<b>10/23/2021</b>	Weather:		Coding:	<b>PACP 7.0</b>
Pipe Length (ft):	<b>351.0</b>	Owner:	<b>City of Hobart</b>	Pre Clean:	<b>Heavy Cleaning</b>
P.O.#:	<b>YES502259</b>	Surveyor:	<b>S. Bucklin</b>	PSR:	<b>P-804-020-015</b>
Customer:	<b>City of Hobart</b>	Clean Date:	<b>09/15/2021</b>	Shape:	<b>C</b>

Street:	<b>North Illinois Street</b>	Flow Control:	<b>Not Controlled</b>
City:	<b>Hobart, IN</b>	Year Renewed:	
Location:	<b>Alley</b>	Tape/Media #:	
Purpose:	<b>Routine Assessment</b>	Dia/Height:	<b>8"</b>
Use:	<b>Sanitary Sewage Pipe</b>	Material:	<b>VCP</b>
Drain Area:		Lining:	<b>None</b>
Category:	<b>NA</b>		
Comment:			
Location Details:		Direction of Survey:	<b>Downstream</b>
US MH:	<b>M-804-020</b>	DS MH:	<b>M-804-015</b>
		Total Length Surveyed (ft):	<b>109.4</b>

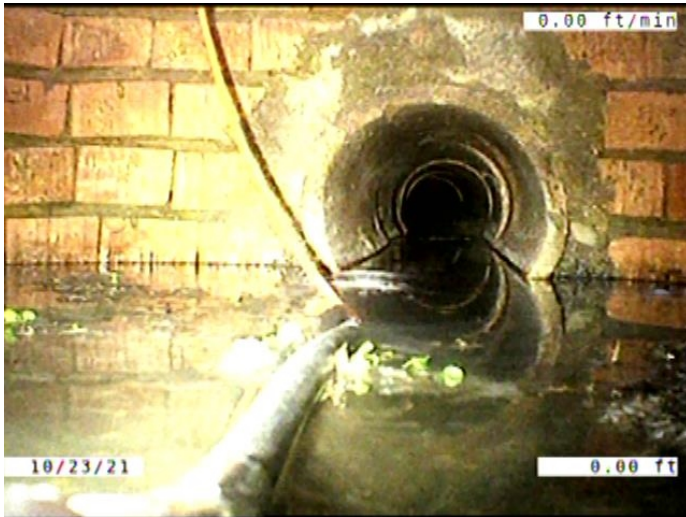
Code: **AMH**  
 Description: **Manhole**

Distance (ft): **.0**  
 Structural Grade: **0**  
 O&M Grade: **0**  
 Clock Start/From:  
 Clock To:  
 1st Value:  
 2nd Value:  
 Value Percent:  
 Continuous Index:  
 Within 8" of Joint: **NO**  
 Remarks: **M-804-020**

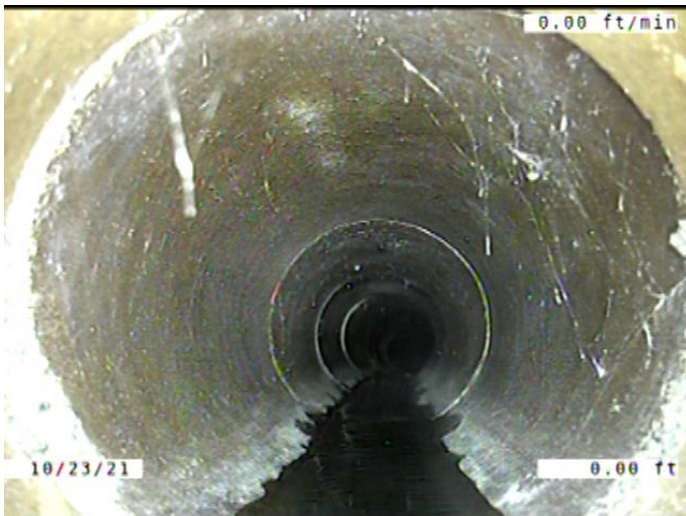
Code: **MWL**  
 Description: **Miscellaneous Water Level**

Distance (ft): **.0**  
 Structural Grade: **0**  
 O&M Grade: **0**  
 Clock Start/From:  
 Clock To:  
 1st Value:  
 2nd Value:  
 Value Percent: **5.000**  
 Continuous Index:  
 Within 8" of Joint: **NO**  
 Remarks:

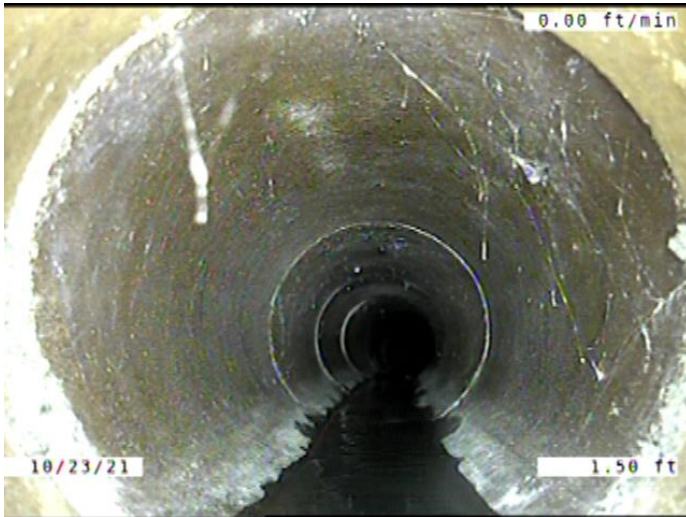
Code: **MGO**  
 Description: **Miscellaneous General Observation**

Distance (ft): **1.5**  
 Structural Grade: **0**  
 O&M Grade: **0**  
 Clock Start/From:  
 Clock To:  
 1st Value:  
 2nd Value:  
 Value Percent:  
 Continuous Index:  
 Within 8" of Joint: **NO**  
 Remarks: **DROP INTO THE MANHOLE. HAD TO START IN THE PIPE.**

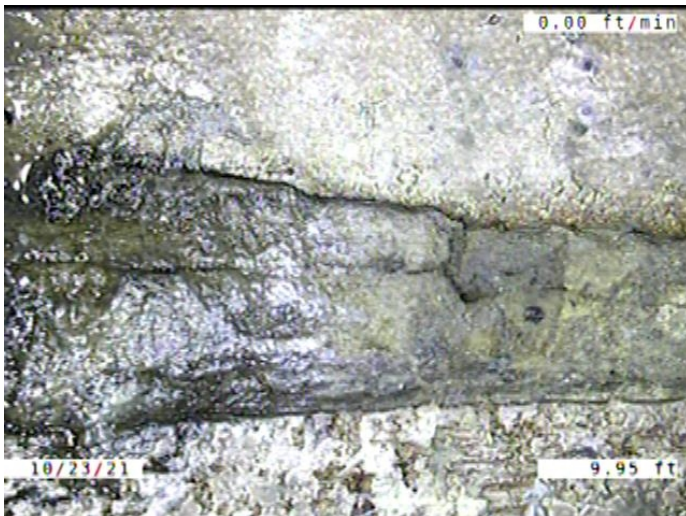
Code: **DAE**  
 Description: **Deposits Attached Encrustation**

Distance (ft): **9.9**  
 Structural Grade: **0**  
 O&M Grade: **2**  
 Clock Start/From: **2**  
 Clock To: **9**  
 1st Value:  
 2nd Value:  
 Value Percent: **5.000**  
 Continuous Index:  
 Within 8" of Joint: **YES**  
 Remarks:

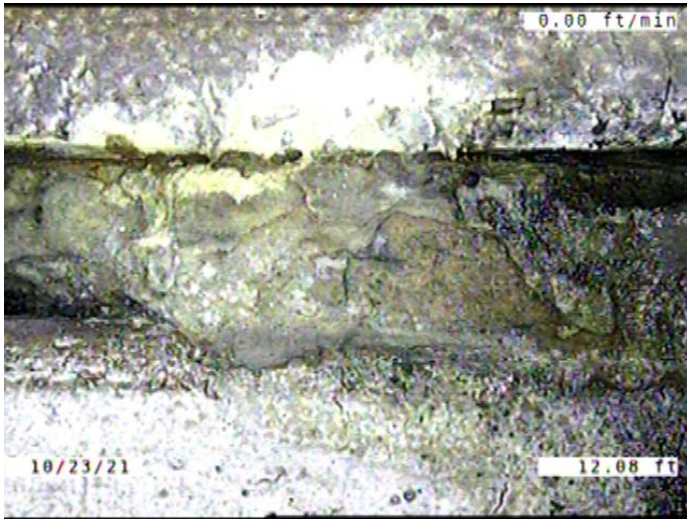
Code: **DAE**  
 Description: **Deposits Attached Encrustation**

Distance (ft): **12.1**  
 Structural Grade: **0**  
 O&M Grade: **2**  
 Clock Start/From: **7**  
 Clock To: **8**  
 1st Value:  
 2nd Value:  
 Value Percent: **5.000**  
 Continuous Index:  
 Within 8" of Joint: **YES**  
 Remarks:

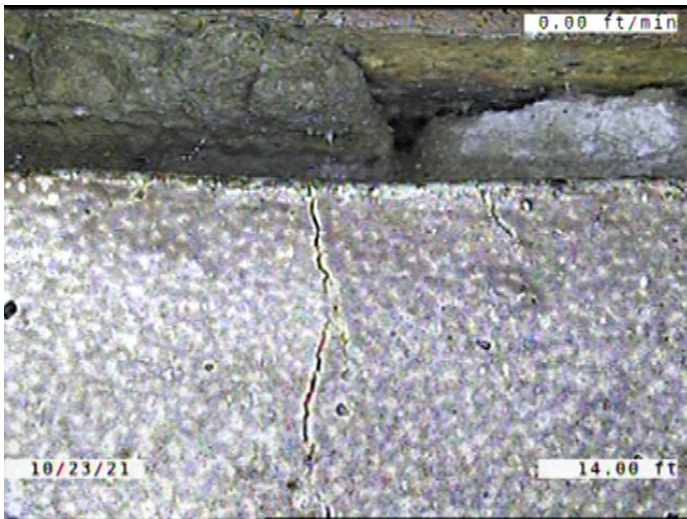
Code: **CL**  
 Description: **Crack Longitudinal**

Distance (ft): **14.0**  
 Structural Grade: **2**  
 O&M Grade: **0**  
 Clock Start/From: **2**  
 Clock To:  
 1st Value:  
 2nd Value:  
 Value Percent:  
 Continuous Index:  
 Within 8" of Joint: **YES**  
 Remarks:

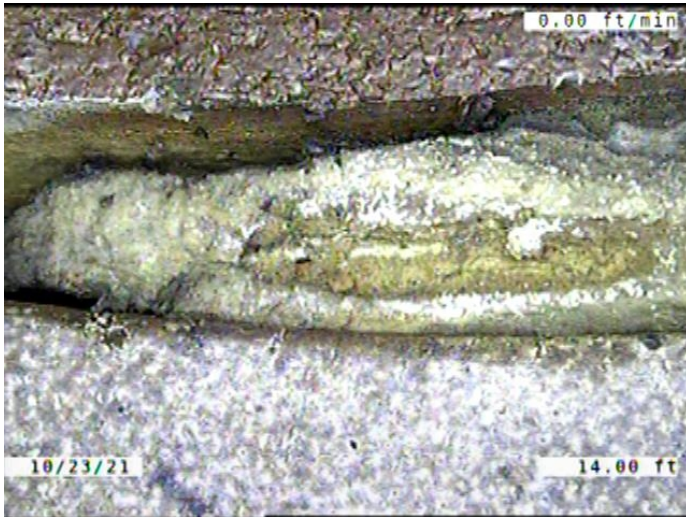
Code: **DAE**  
 Description: **Deposits Attached Encrustation**

Distance (ft): **14.0**  
 Structural Grade: **0**  
 O&M Grade: **2**  
 Clock Start/From: **3**  
 Clock To: **9**  
 1st Value:  
 2nd Value:  
 Value Percent: **5.000**  
 Continuous Index:  
 Within 8" of Joint: **YES**  
 Remarks:

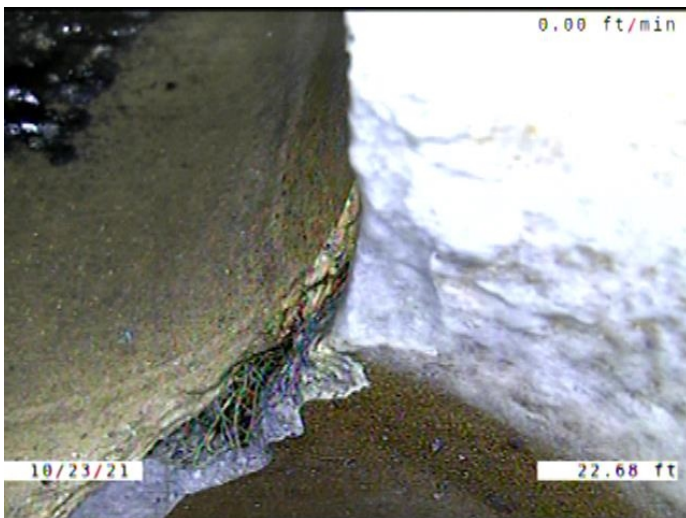
Code: **SSS**  
 Description: **Surface Damage Surface Spalling**

Distance (ft): **22.7**  
 Structural Grade: **2**  
 O&M Grade: **0**  
 Clock Start/From: **12**  
 Clock To: **3**  
 1st Value:  
 2nd Value:  
 Value Percent:  
 Continuous Index:  
 Within 8" of Joint: **YES**  
 Remarks:

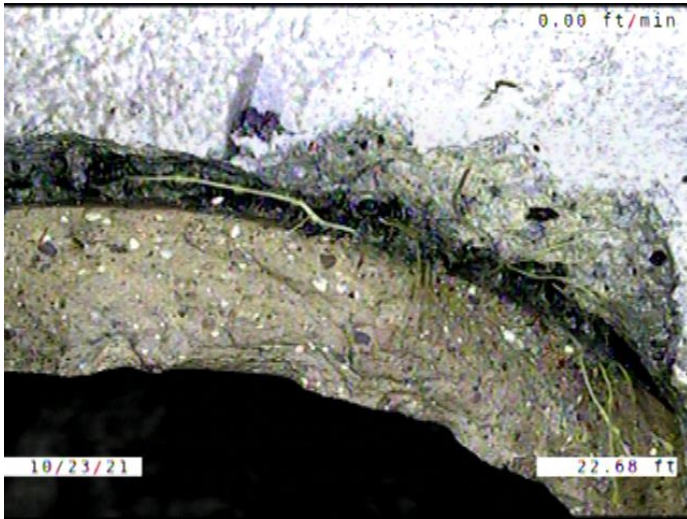
Code: **RFC**  
 Description: **Roots Fine Connection**

Distance (ft): **22.7**  
 Structural Grade: **0**  
 O&M Grade: **1**  
 Clock Start/From: **12**  
 Clock To: **3**  
 1st Value:  
 2nd Value:  
 Value Percent:  
 Continuous Index:  
 Within 8" of Joint: **NO**  
 Remarks:

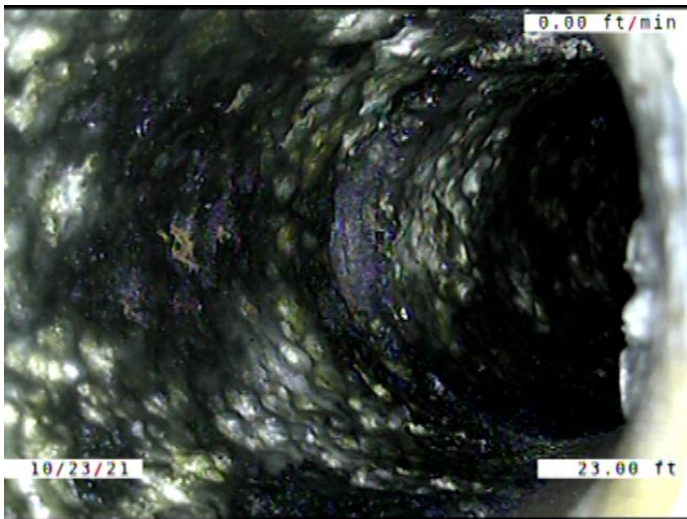
Code: **TB**  
 Description: **Tap Break-in/Hammer**

Distance (ft): **23.0**  
 Structural Grade: **0**  
 O&M Grade: **0**  
 Clock Start/From: **2**  
 Clock To:  
 1st Value: **6.000**  
 2nd Value:  
 Value Percent:  
 Continuous Index:  
 Within 8" of Joint: **YES**  
 Remarks:

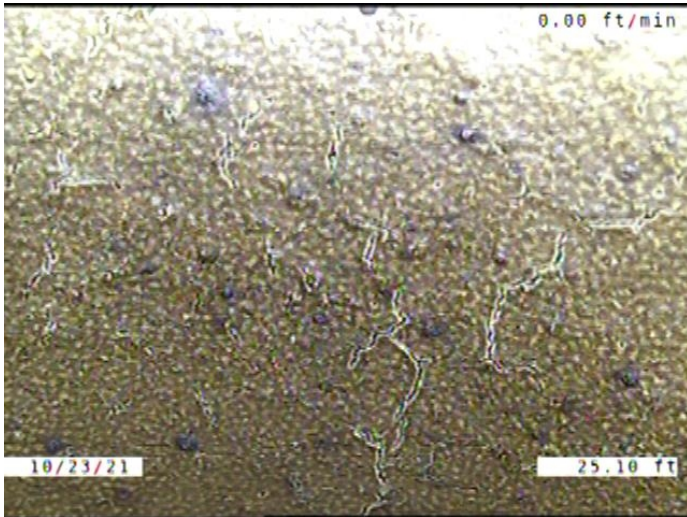
Code: **CM**  
 Description: **Crack Multiple**

Distance (ft): **25.1**  
 Structural Grade: **3**  
 O&M Grade: **0**  
 Clock Start/From: **1**  
 Clock To: **2**  
 1st Value:  
 2nd Value:  
 Value Percent:  
 Continuous Index:  
 Within 8" of Joint: **YES**  
 Remarks:

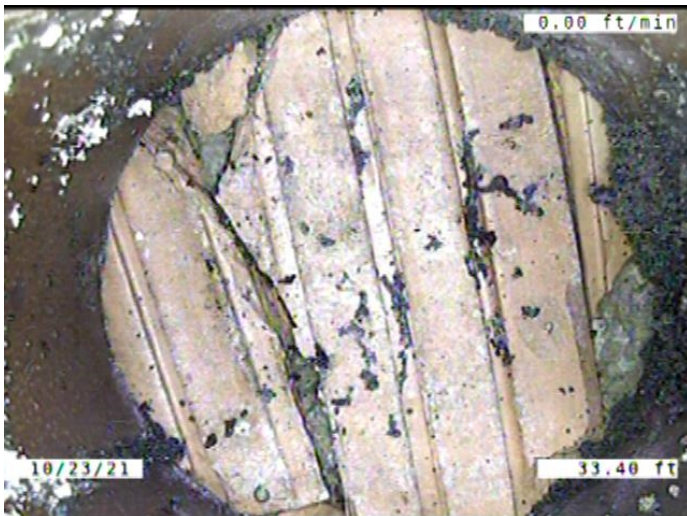
Code: **TFD**  
 Description: **Tap Factory Defective**

Distance (ft): **33.4**  
 Structural Grade: **0**  
 O&M Grade: **3**  
 Clock Start/From: **2**  
 Clock To:  
 1st Value: **4.000**  
 2nd Value:  
 Value Percent:  
 Continuous Index:  
 Within 8" of Joint: **YES**  
 Remarks: **CAP BROKEN. SOIL VISIBLE**

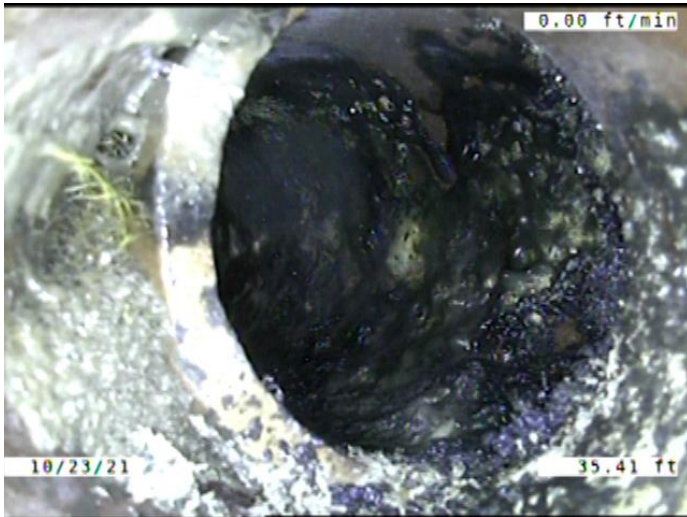
Code: **TFD**  
 Description: **Tap Factory Defective**

Distance (ft): **35.4**  
 Structural Grade: **0**  
 O&M Grade: **3**  
 Clock Start/From: **11**  
 Clock To:  
 1st Value: **4.000**  
 2nd Value:  
 Value Percent:  
 Continuous Index:  
 Within 8" of Joint: **YES**  
 Remarks: **LARGE OFFSET. ROOTS GROWING IN THE JOINT**

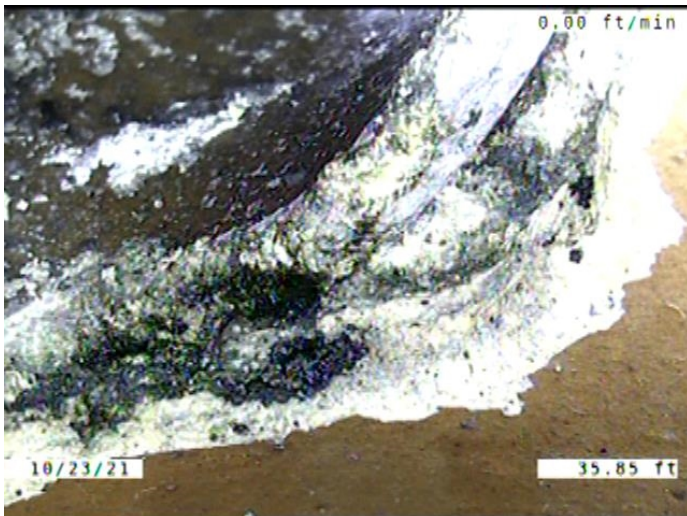
Code: **SSS**  
 Description: **Surface Damage Surface Spalling**

Distance (ft): **35.8**  
 Structural Grade: **2**  
 O&M Grade: **0**  
 Clock Start/From: **11**  
 Clock To: **1**  
 1st Value:  
 2nd Value:  
 Value Percent:  
 Continuous Index:  
 Within 8" of Joint: **YES**  
 Remarks:

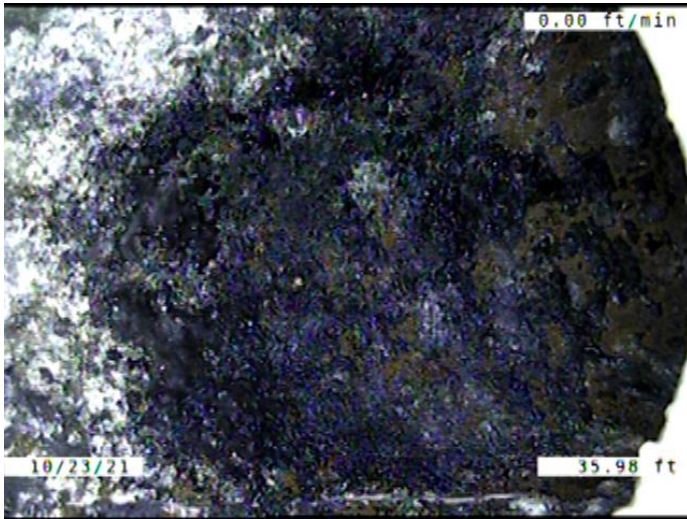
Code: **TF**  
 Description: **Tap Factory**

Distance (ft): **36.0**  
 Structural Grade: **0**  
 O&M Grade: **0**  
 Clock Start/From: **12**  
 Clock To:  
 1st Value: **4.000**  
 2nd Value:  
 Value Percent:  
 Continuous Index:  
 Within 8" of Joint: **YES**  
 Remarks: **LOOKS TO COME IN FROM THE RIGHT (WEST)**

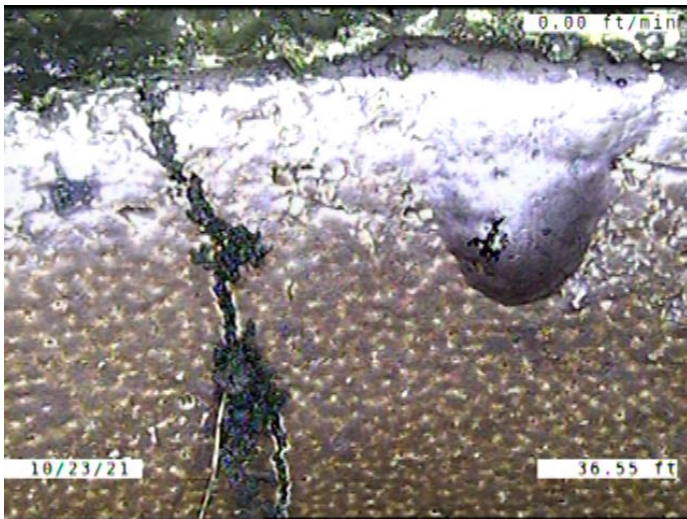
Code: **FL**  
 Description: **Fracture Longitudinal**

Distance (ft): **36.5**  
 Structural Grade: **3**  
 O&M Grade: **0**  
 Clock Start/From: **12**  
 Clock To:  
 1st Value:  
 2nd Value:  
 Value Percent:  
 Continuous Index:  
 Within 8" of Joint: **YES**  
 Remarks:

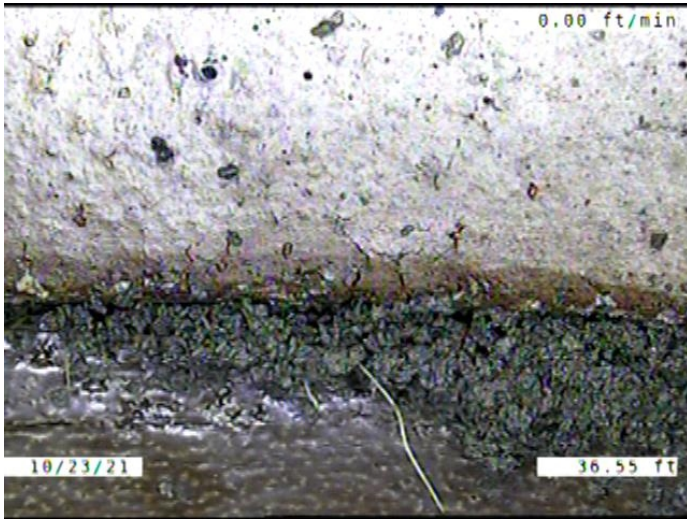
Code: **RFJ**  
 Description: **Roots Fine Joint**

Distance (ft): **36.5**  
 Structural Grade: **0**  
 O&M Grade: **1**  
 Clock Start/From: **8**  
 Clock To: **4**  
 1st Value:  
 2nd Value:  
 Value Percent:  
 Continuous Index:  
 Within 8" of Joint: **YES**  
 Remarks:

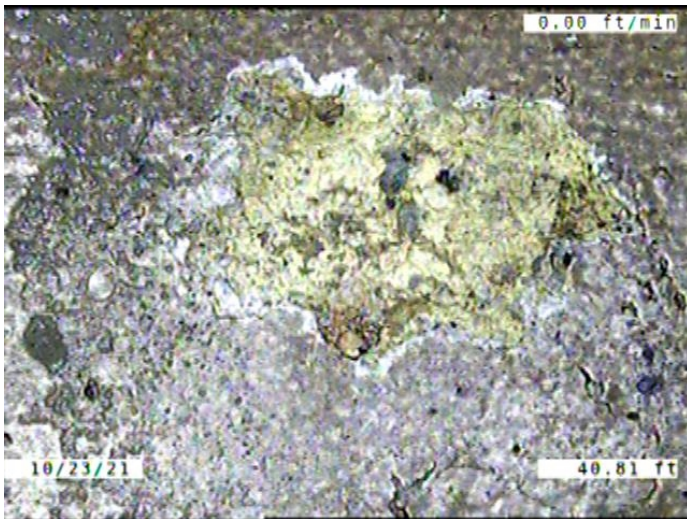
Code: **SSS**  
 Description: **Surface Damage Surface Spalling**

Distance (ft): **40.8**  
 Structural Grade: **2**  
 O&M Grade: **0**  
 Clock Start/From: **4**  
 Clock To:  
 1st Value:  
 2nd Value:  
 Value Percent:  
 Continuous Index:  
 Within 8" of Joint: **YES**  
 Remarks:

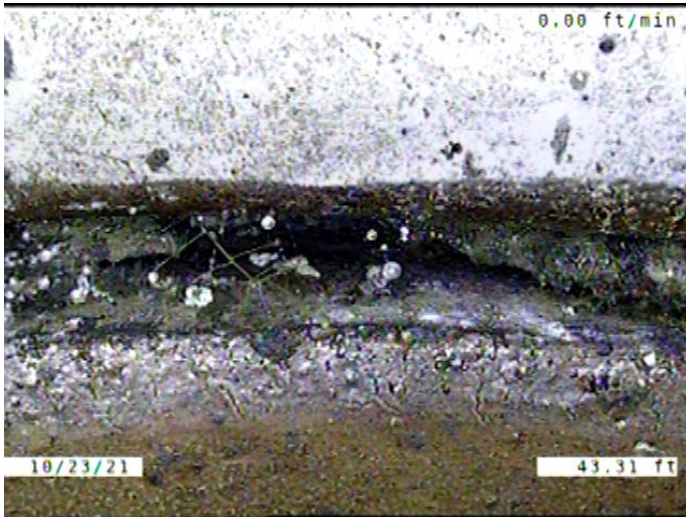
Code: **RFJ**  
 Description: **Roots Fine Joint**

Distance (ft): **43.3**  
 Structural Grade: **0**  
 O&M Grade: **1**  
 Clock Start/From: **12**  
 Clock To: **5**  
 1st Value:  
 2nd Value:  
 Value Percent:  
 Continuous Index:  
 Within 8" of Joint: **YES**  
 Remarks:

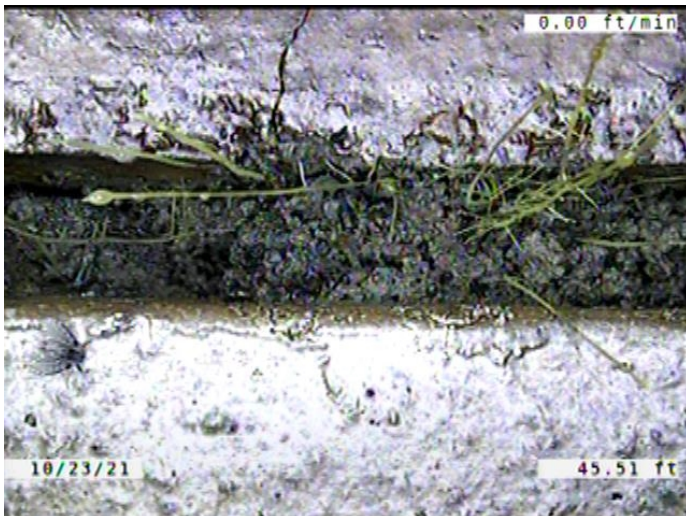
Code: **RFJ**  
 Description: **Roots Fine Joint**

Distance (ft): **45.5**  
 Structural Grade: **0**  
 O&M Grade: **1**  
 Clock Start/From: **3**  
 Clock To: **5**  
 1st Value:  
 2nd Value:  
 Value Percent:  
 Continuous Index:  
 Within 8" of Joint: **YES**  
 Remarks:

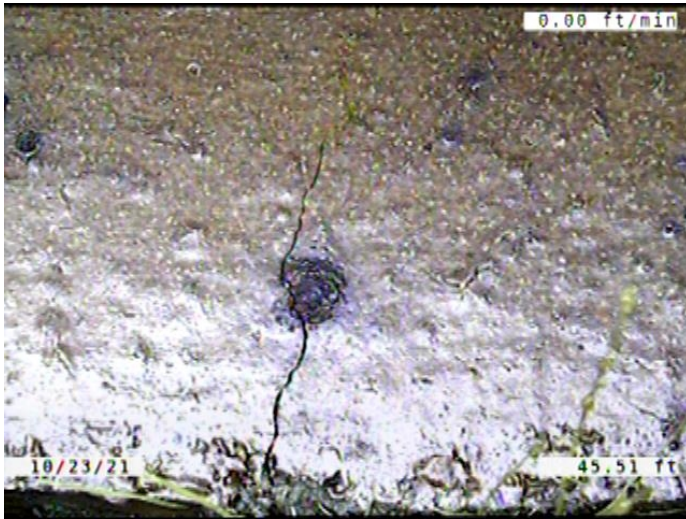
Code: **CL**  
 Description: **Crack Longitudinal**

Distance (ft): **45.5**  
 Structural Grade: **2**  
 O&M Grade: **0**  
 Clock Start/From: **4**  
 Clock To:  
 1st Value:  
 2nd Value:  
 Value Percent:  
 Continuous Index:  
 Within 8" of Joint: **YES**  
 Remarks:

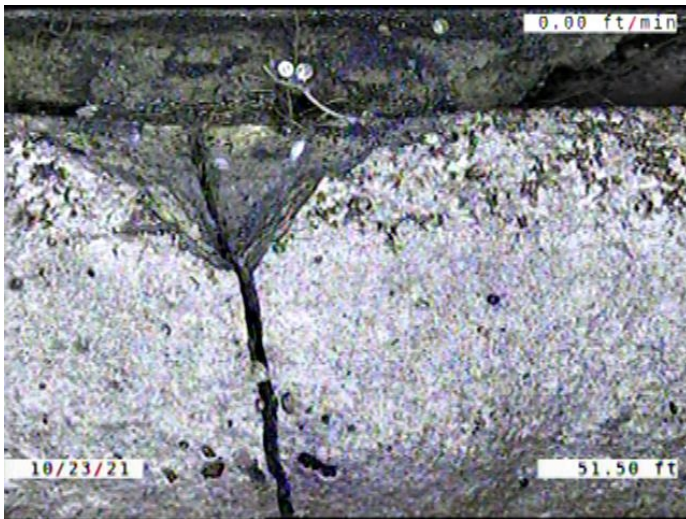
Code: **FM**  
 Description: **Fracture Multiple**

Distance (ft): **51.5**  
 Structural Grade: **4**  
 O&M Grade: **0**  
 Clock Start/From: **12**  
 Clock To: **2**  
 1st Value:  
 2nd Value:  
 Value Percent:  
 Continuous Index:  
 Within 8" of Joint: **YES**  
 Remarks:

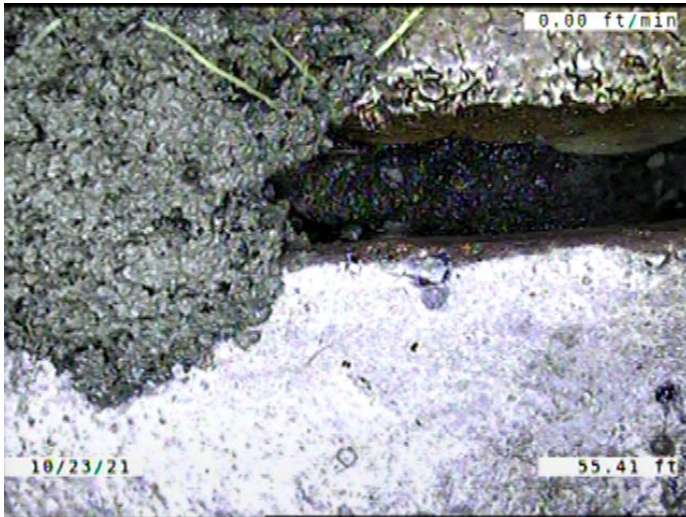
Code: **RFJ**  
 Description: **Roots Fine Joint**

Distance (ft): **55.4**  
 Structural Grade: **0**  
 O&M Grade: **1**  
 Clock Start/From: **7**  
 Clock To: **10**  
 1st Value:  
 2nd Value:  
 Value Percent:  
 Continuous Index:  
 Within 8" of Joint: **YES**  
 Remarks:

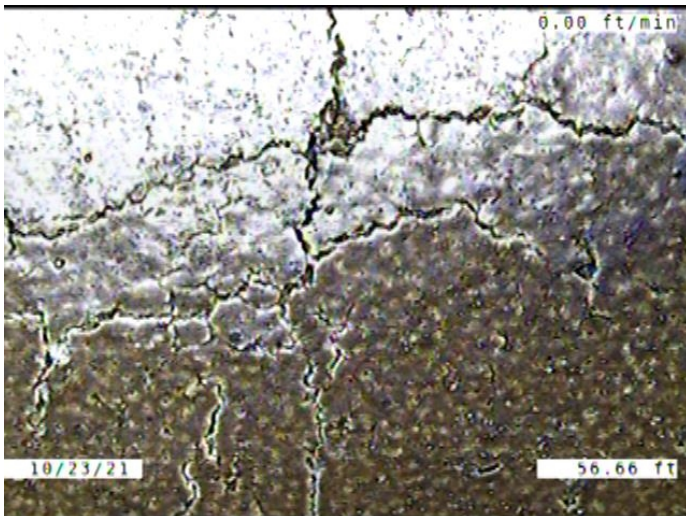
Code: **FM**  
 Description: **Fracture Multiple**

Distance (ft): **56.7**  
 Structural Grade: **4**  
 O&M Grade: **0**  
 Clock Start/From: **9**  
 Clock To: **10**  
 1st Value:  
 2nd Value:  
 Value Percent:  
 Continuous Index:  
 Within 8" of Joint: **YES**  
 Remarks:

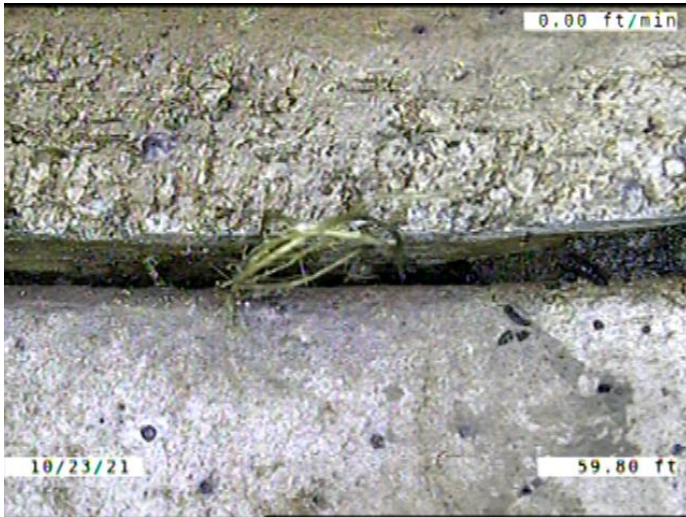
Code: **RFJ**  
 Description: **Roots Fine Joint**

Distance (ft): **59.8**  
 Structural Grade: **0**  
 O&M Grade: **1**  
 Clock Start/From: **8**  
 Clock To: **9**  
 1st Value:  
 2nd Value:  
 Value Percent:  
 Continuous Index:  
 Within 8" of Joint: **YES**  
 Remarks:

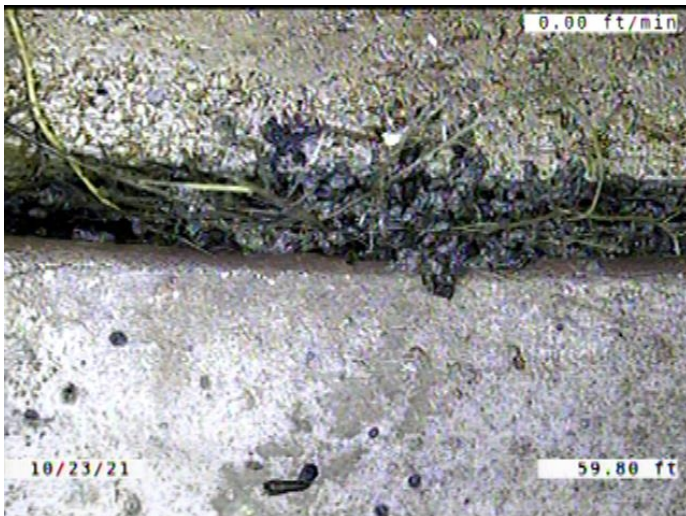
Code: **RFJ**  
 Description: **Roots Fine Joint**

Distance (ft): **59.8**  
 Structural Grade: **0**  
 O&M Grade: **1**  
 Clock Start/From: **3**  
 Clock To: **5**  
 1st Value:  
 2nd Value:  
 Value Percent:  
 Continuous Index:  
 Within 8" of Joint: **YES**  
 Remarks:

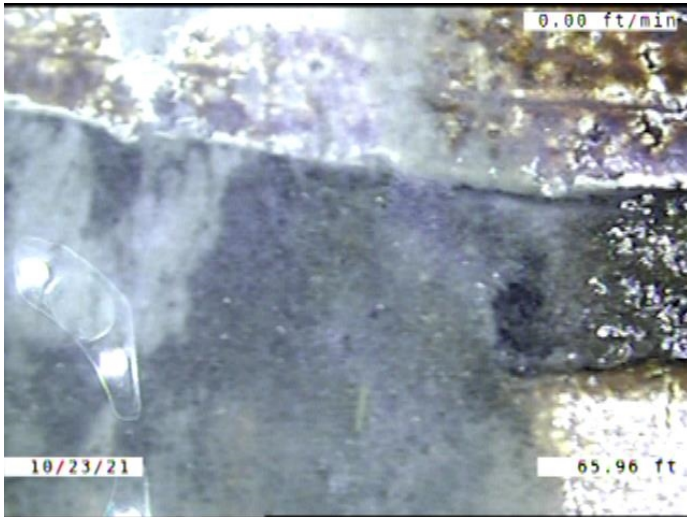
Code: **DAE**  
 Description: **Deposits Attached Encrustation**

Distance (ft): **66.0**  
 Structural Grade: **0**  
 O&M Grade: **2**  
 Clock Start/From: **4**  
 Clock To: **8**  
 1st Value:  
 2nd Value:  
 Value Percent: **5.000**  
 Continuous Index:  
 Within 8" of Joint: **YES**  
 Remarks:

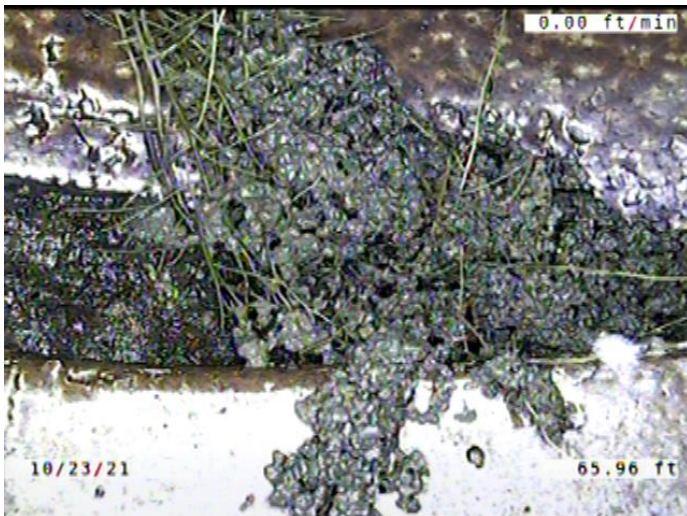
Code: **RFJ**  
 Description: **Roots Fine Joint**

Distance (ft): **66.0**  
 Structural Grade: **0**  
 O&M Grade: **1**  
 Clock Start/From: **12**  
 Clock To: **4**  
 1st Value:  
 2nd Value:  
 Value Percent:  
 Continuous Index:  
 Within 8" of Joint: **YES**  
 Remarks:

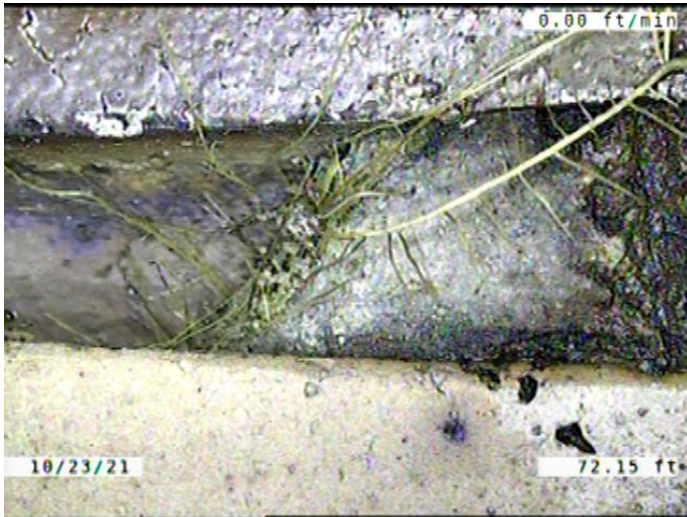
Code: **RFJ**  
 Description: **Roots Fine Joint**

Distance (ft): **72.2**  
 Structural Grade: **0**  
 O&M Grade: **1**  
 Clock Start/From: **8**  
 Clock To: **9**  
 1st Value:  
 2nd Value:  
 Value Percent:  
 Continuous Index:  
 Within 8" of Joint: **YES**  
 Remarks:

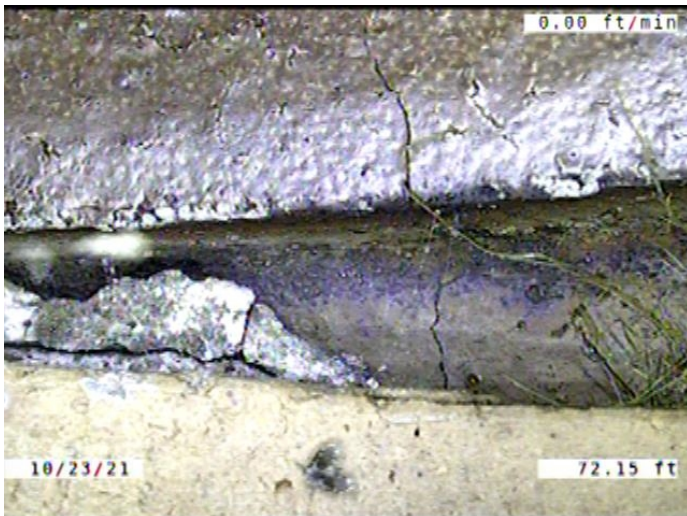
Code: **CL**  
 Description: **Crack Longitudinal**

Distance (ft): **72.2**  
 Structural Grade: **2**  
 O&M Grade: **0**  
 Clock Start/From: **10**  
 Clock To:  
 1st Value:  
 2nd Value:  
 Value Percent:  
 Continuous Index:  
 Within 8" of Joint: **YES**  
 Remarks:

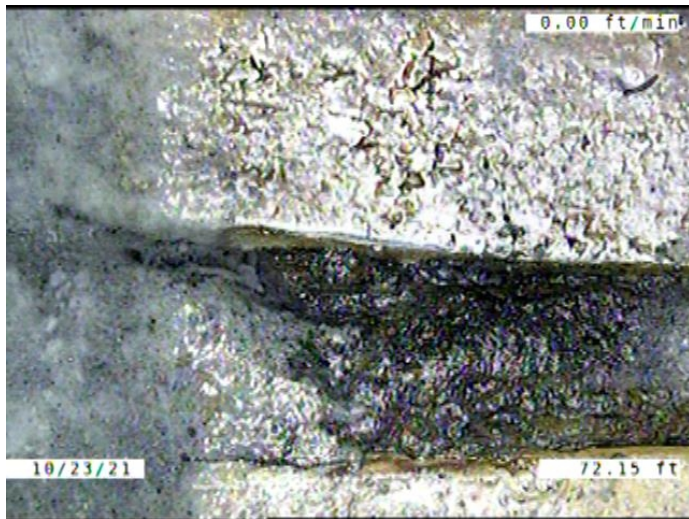
Code: **DAE**  
 Description: **Deposits Attached Encrustation**

Distance (ft): **72.2**  
 Structural Grade: **0**  
 O&M Grade: **2**  
 Clock Start/From: **3**  
 Clock To: **9**  
 1st Value:  
 2nd Value:  
 Value Percent: **5.000**  
 Continuous Index:  
 Within 8" of Joint: **YES**  
 Remarks:

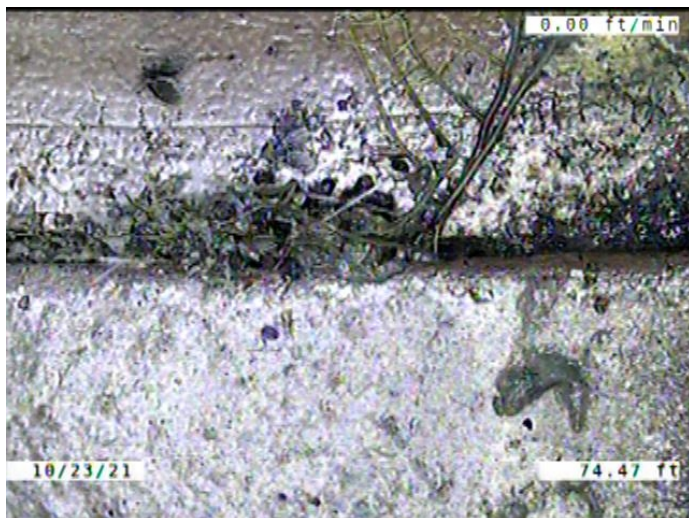
Code: **RFJ**  
 Description: **Roots Fine Joint**

Distance (ft): **74.5**  
 Structural Grade: **0**  
 O&M Grade: **1**  
 Clock Start/From: **8**  
 Clock To: **11**  
 1st Value:  
 2nd Value:  
 Value Percent:  
 Continuous Index: **S01**  
 Within 8" of Joint: **YES**  
 Remarks:

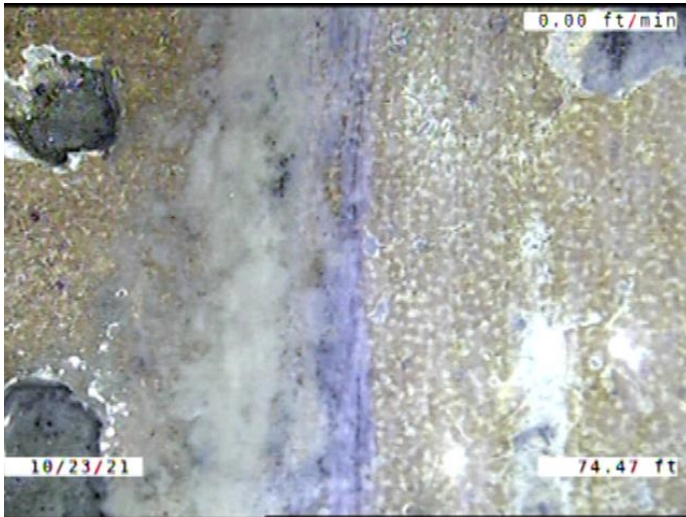
Code: **HSV**  
 Description: **Hole Soil Visible**

Distance (ft): **74.5**  
 Structural Grade: **5**  
 O&M Grade: **0**  
 Clock Start/From: **6**  
 Clock To: **8**  
 1st Value:  
 2nd Value:  
 Value Percent:  
 Continuous Index:  
 Within 8" of Joint: **YES**  
 Remarks: **(3) HOLES**

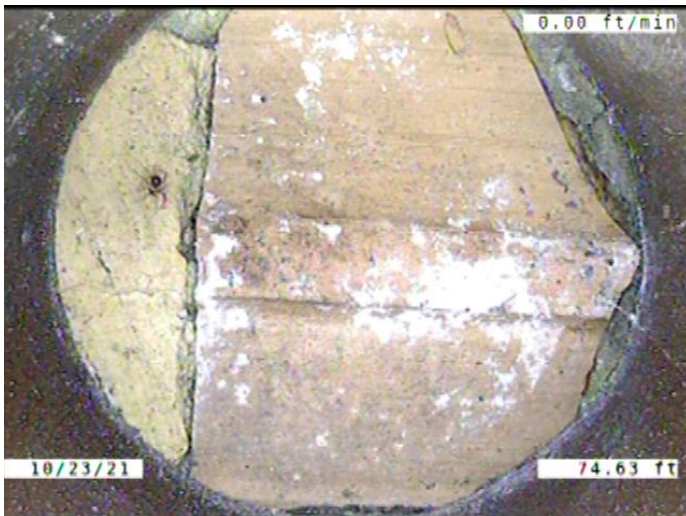
Code: **TFD**  
 Description: **Tap Factory Defective**

Distance (ft): **74.6**  
 Structural Grade: **0**  
 O&M Grade: **3**  
 Clock Start/From: **2**  
 Clock To:  
 1st Value: **4.000**  
 2nd Value:  
 Value Percent:  
 Continuous Index:  
 Within 8" of Joint: **YES**  
 Remarks: **CAP BROKEN**

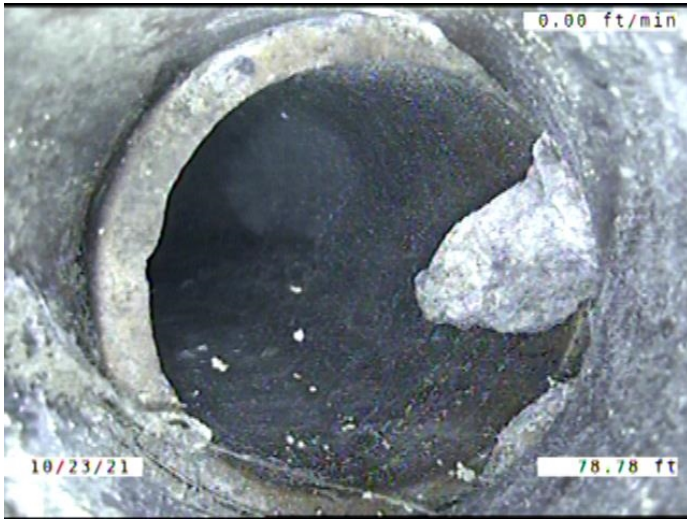
Code: **TF**  
 Description: **Tap Factory**

Distance (ft): **78.8**  
 Structural Grade: **0**  
 O&M Grade: **0**  
 Clock Start/From: **11**  
 Clock To:  
 1st Value: **4.000**  
 2nd Value:  
 Value Percent:  
 Continuous Index:  
 Within 8" of Joint: **YES**  
 Remarks:

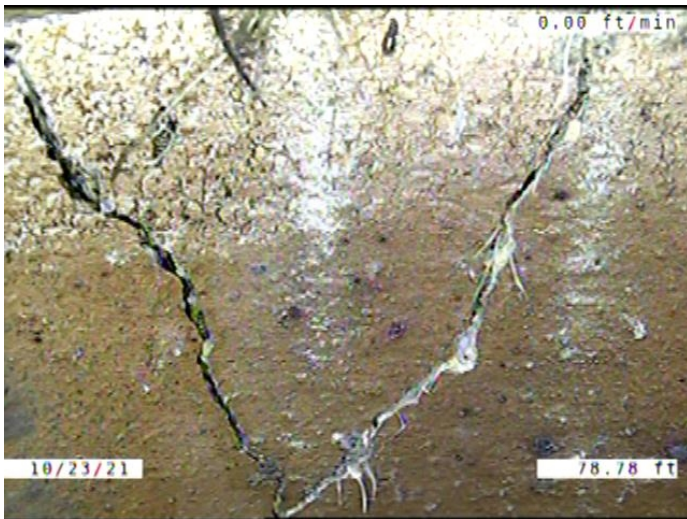
Code: **CM**  
 Description: **Crack Multiple**

Distance (ft): **78.8**  
 Structural Grade: **3**  
 O&M Grade: **0**  
 Clock Start/From: **12**  
 Clock To: **12**  
 1st Value:  
 2nd Value:  
 Value Percent:  
 Continuous Index:  
 Within 8" of Joint: **YES**  
 Remarks:

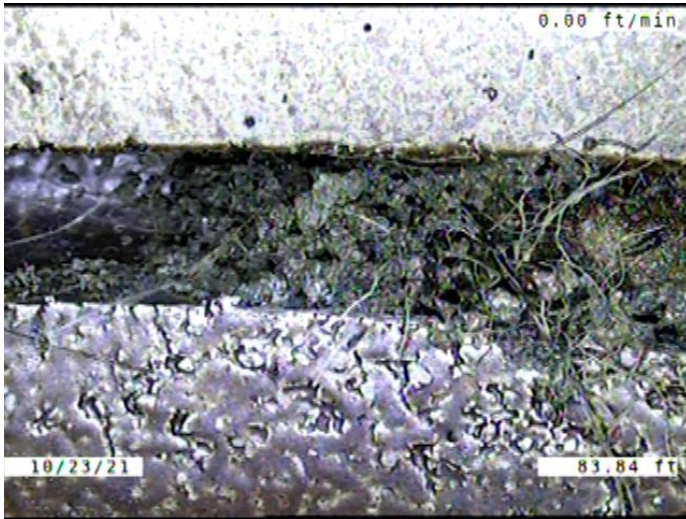
Code: **RFJ**  
 Description: **Roots Fine Joint**

Distance (ft): **83.8**  
 Structural Grade: **0**  
 O&M Grade: **1**  
 Clock Start/From: **2**  
 Clock To: **4**  
 1st Value:  
 2nd Value:  
 Value Percent:  
 Continuous Index:  
 Within 8" of Joint: **YES**  
 Remarks:

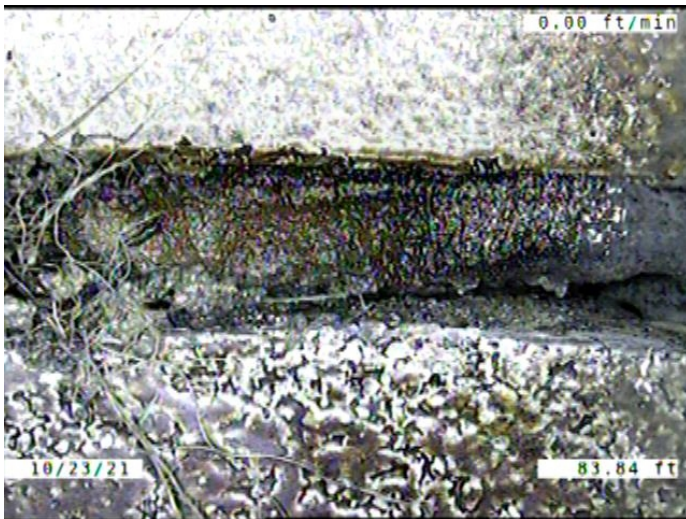
Code: **DAE**  
 Description: **Deposits Attached Encrustation**

Distance (ft): **83.8**  
 Structural Grade: **0**  
 O&M Grade: **2**  
 Clock Start/From: **5**  
 Clock To: **9**  
 1st Value:  
 2nd Value:  
 Value Percent: **5.000**  
 Continuous Index:  
 Within 8" of Joint: **YES**  
 Remarks:

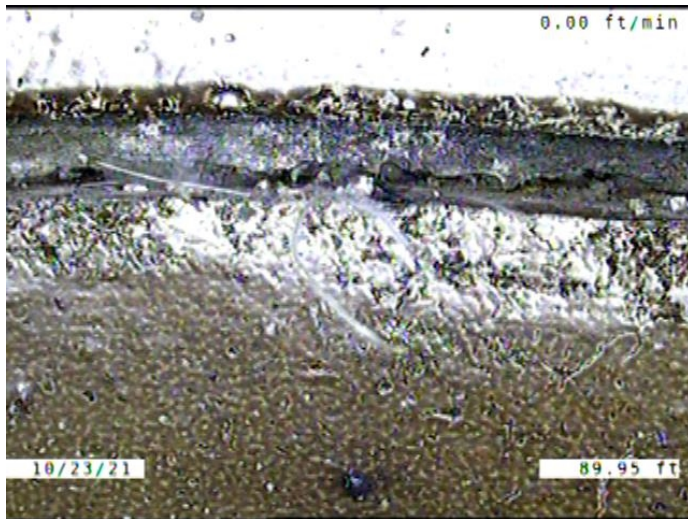
Code: **RFJ**  
 Description: **Roots Fine Joint**

Distance (ft): **90.0**  
 Structural Grade: **0**  
 O&M Grade: **1**  
 Clock Start/From: **1**  
 Clock To: **2**  
 1st Value:  
 2nd Value:  
 Value Percent:  
 Continuous Index:  
 Within 8" of Joint: **YES**  
 Remarks:

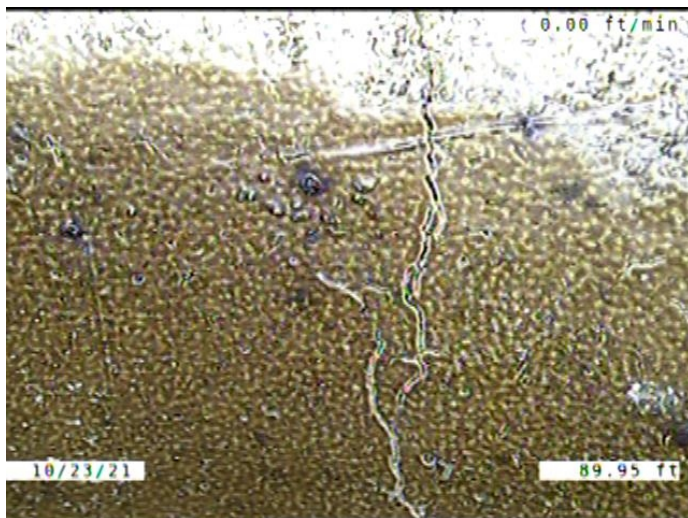
Code: **CM**  
 Description: **Crack Multiple**

Distance (ft): **90.0**  
 Structural Grade: **3**  
 O&M Grade: **0**  
 Clock Start/From: **2**  
 Clock To: **3**  
 1st Value:  
 2nd Value:  
 Value Percent:  
 Continuous Index:  
 Within 8" of Joint: **YES**  
 Remarks:

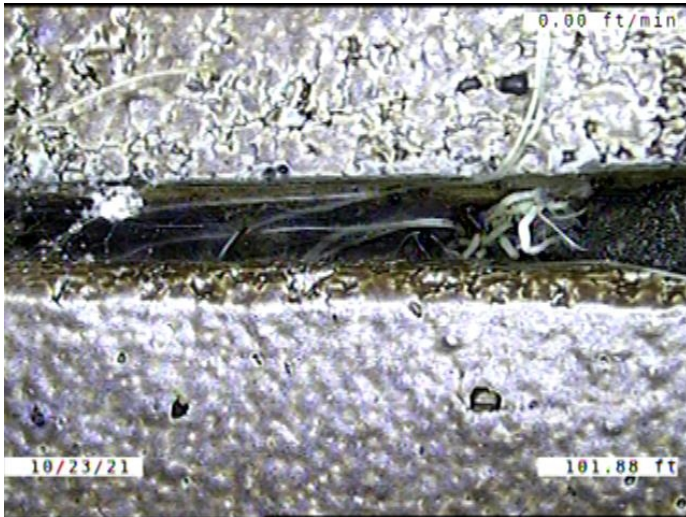
Code: **RFJ**  
 Description: **Roots Fine Joint**

Distance (ft): **101.9**  
 Structural Grade: **0**  
 O&M Grade: **1**  
 Clock Start/From: **8**  
 Clock To: **4**  
 1st Value:  
 2nd Value:  
 Value Percent:  
 Continuous Index:  
 Within 8" of Joint: **YES**  
 Remarks:

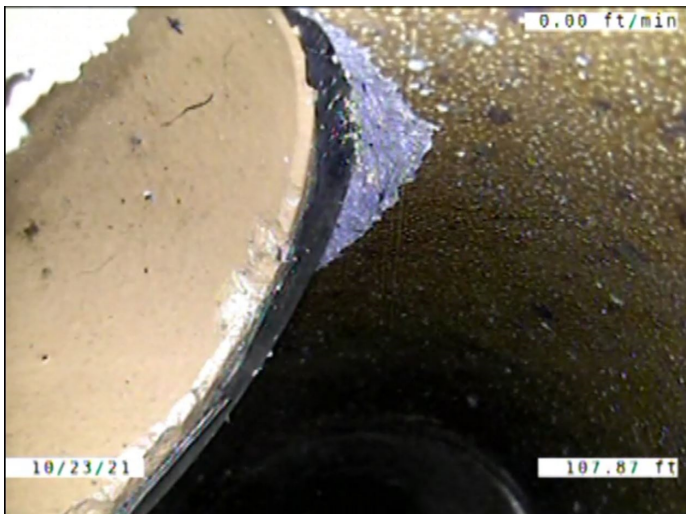
Code: **SSS**  
 Description: **Surface Damage Surface Spalling**

Distance (ft): **107.9**  
 Structural Grade: **2**  
 O&M Grade: **0**  
 Clock Start/From: **8**  
 Clock To: **11**  
 1st Value:  
 2nd Value:  
 Value Percent:  
 Continuous Index:  
 Within 8" of Joint: **NO**  
 Remarks:

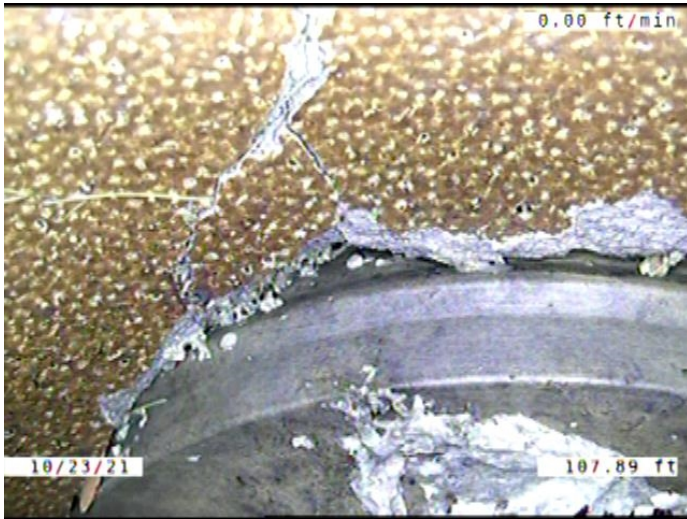
Code: **B**  
Description: **Broken**

Distance (ft): **107.9**  
Structural Grade: **4**  
O&M Grade: **0**  
Clock Start/From: **10**  
Clock To:  
1st Value:  
2nd Value:  
Value Percent:  
Continuous Index:  
Within 8" of Joint: **YES**  
Remarks:

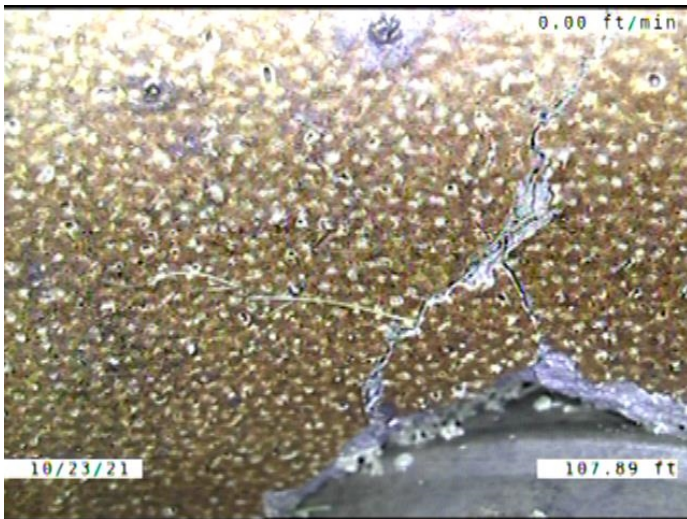
Code: **RFB**  
Description: **Roots Fine Barrel**

Distance (ft): **107.9**  
Structural Grade: **0**  
O&M Grade: **2**  
Clock Start/From: **8**  
Clock To:  
1st Value:  
2nd Value:  
Value Percent:  
Continuous Index:  
Within 8" of Joint: **NO**  
Remarks:

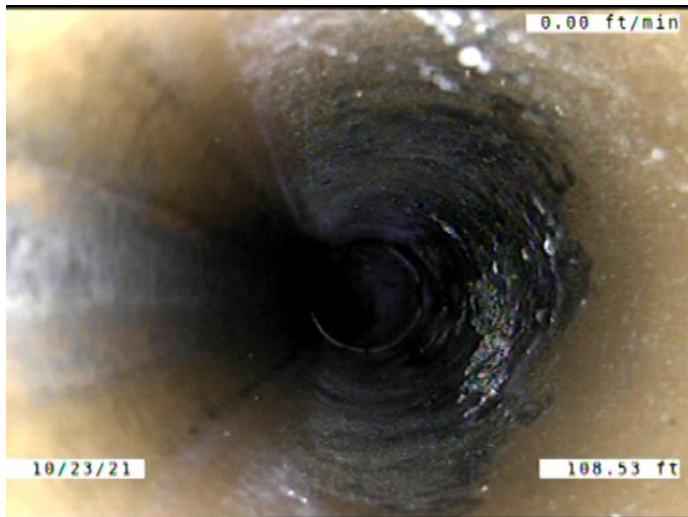
Code: **TBI**  
 Description: **Tap Break-in Intruding**

Distance (ft): **108.5**  
 Structural Grade: **0**  
 O&M Grade: **2**  
 Clock Start/From: **9**  
 Clock To:  
 1st Value: **6.000**  
 2nd Value: **2.000**  
 Value Percent:  
 Continuous Index:  
 Within 8" of Joint: **YES**  
 Remarks:

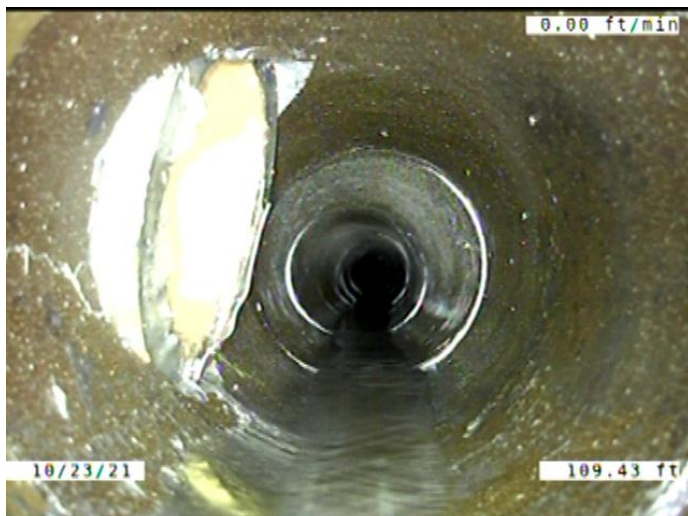
Code: **RFJ**  
 Description: **Roots Fine Joint**

Distance (ft): **109.4**  
 Structural Grade: **0**  
 O&M Grade: **1**  
 Clock Start/From: **8**  
 Clock To: **11**  
 1st Value:  
 2nd Value:  
 Value Percent:  
 Continuous Index: **F01**  
 Within 8" of Joint: **YES**  
 Remarks:

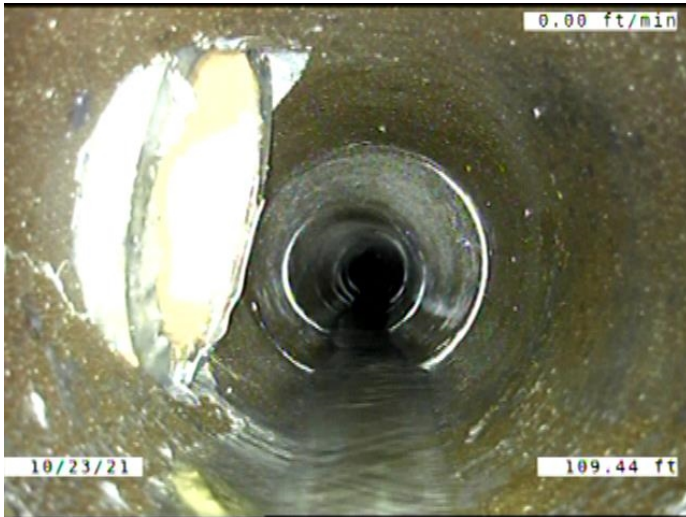
Code:	MSA
Description:	Miscellaneous Survey Abandoned
Distance (ft):	109.4
Structural Grade:	0
O&M Grade:	0
Clock Start/From:	
Clock To:	
1st Value:	
2nd Value:	
Value Percent:	
Continuous Index:	
Within 8" of Joint:	NO
Remarks:	CAMERA CANT MAKE IT PAST PROTRUDING TAP
