Profile/Photo Observation Report

Date:	10/22/2021	Weather:		Coding:	PACP 7.0
Pipe Length (ft):	294.0	Owner:	City of Hobart	Pre Clean:	Heavy Cleaning
P.O.#:	YES502259	Surveyor:	S. Bucklin	PSR:	P-804-021-020
Customer:	City of Hobart	Clean Date:	09/15/2021	Shape:	C

Street:	North Illinois Street	Flow Control:	Not Controlled
City:	Hobart, IN	Year Renewed:	
Location:	Alley	Tape/Media #:	
Purpose:	Routine Assessment	Dia/Height:	8"
Use:	Sanitary Sewage Pipe	Material:	VCP
Drain Area:		Lining:	None
Category:	NA		
Comment:			
Location Details:		Direction of Survey:	Upstream
US MH:	M-804-021	DS MH:	M-804-020
		Total Length Surveyed (ft):	238.4

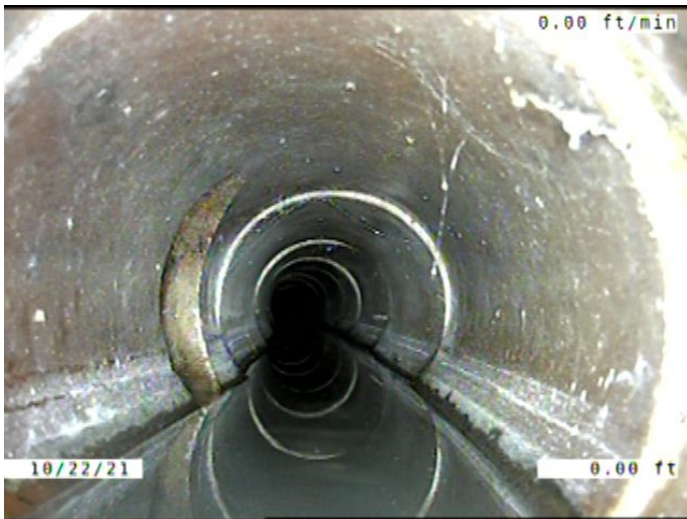
Code: **MWL**
 Description: **Miscellaneous Water Level**

Distance (ft): **.0**
 Structural Grade: **0**
 O&M Grade: **0**
 Clock Start/From:
 Clock To:
 1st Value:
 2nd Value:
 Value Percent: **5.000**
 Continuous Index:
 Within 8" of Joint: **NO**
 Remarks:

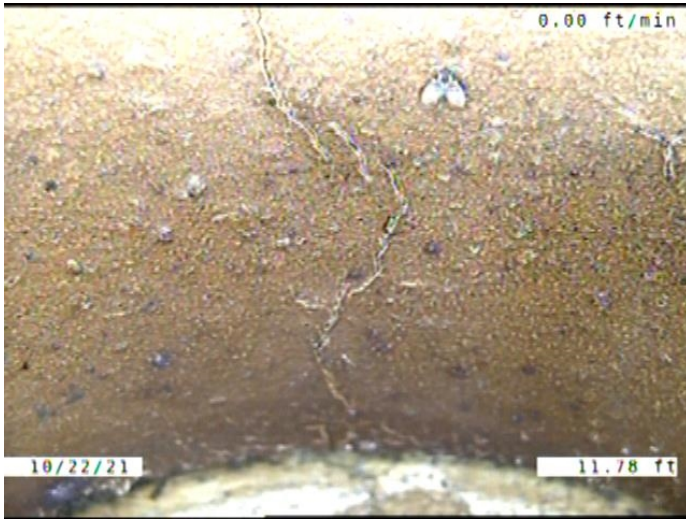
Code: **CM**
Description: **Crack Multiple**

Distance (ft): **11.8**
Structural Grade: **3**
O&M Grade: **0**
Clock Start/From: **11**
Clock To: **1**
1st Value:
2nd Value:
Value Percent:
Continuous Index:
Within 8" of Joint: **YES**
Remarks:

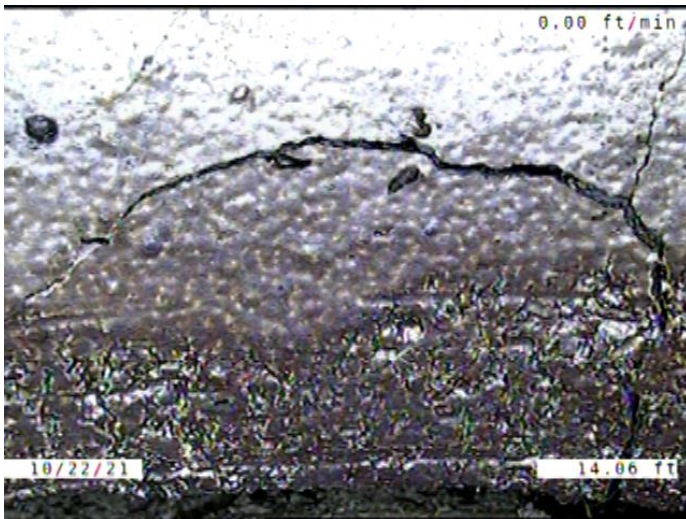
Code: **B**
Description: **Broken**

Distance (ft): **14.1**
Structural Grade: **4**
O&M Grade: **0**
Clock Start/From: **8**
Clock To: **10**
1st Value:
2nd Value:
Value Percent:
Continuous Index:
Within 8" of Joint: **YES**
Remarks:

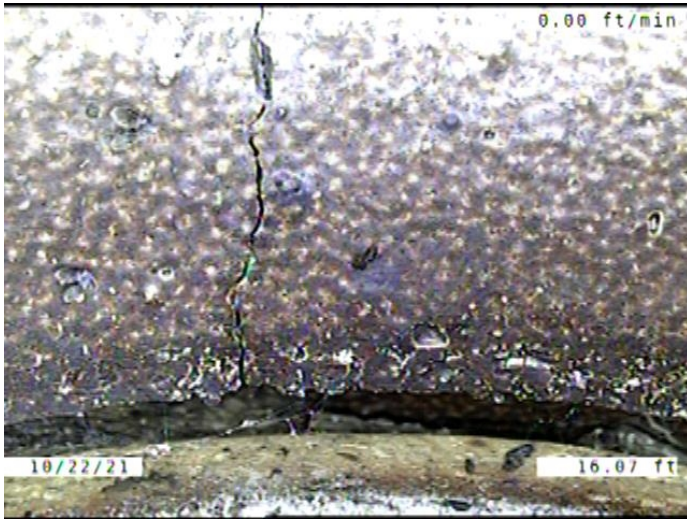
Code: **FM**
Description: **Fracture Multiple**

Distance (ft): **16.1**
Structural Grade: **4**
O&M Grade: **0**
Clock Start/From: **7**
Clock To: **9**
1st Value:
2nd Value:
Value Percent:
Continuous Index:
Within 8" of Joint: **YES**
Remarks:

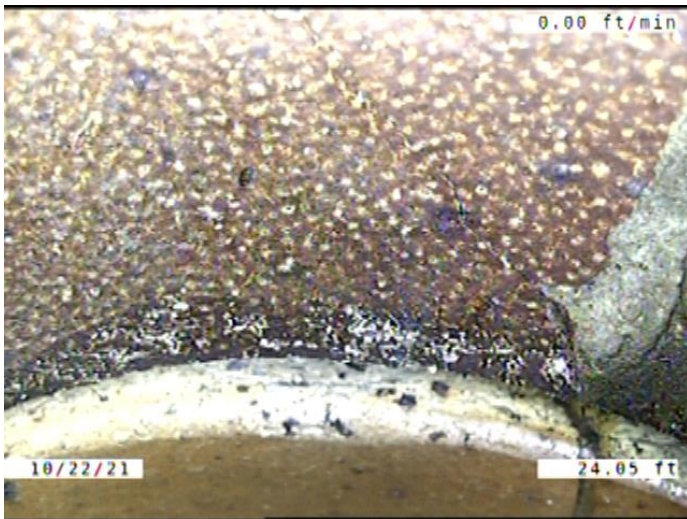
Code: **CM**
Description: **Crack Multiple**

Distance (ft): **24.1**
Structural Grade: **3**
O&M Grade: **0**
Clock Start/From: **11**
Clock To: **3**
1st Value:
2nd Value:
Value Percent:
Continuous Index:
Within 8" of Joint: **YES**
Remarks:

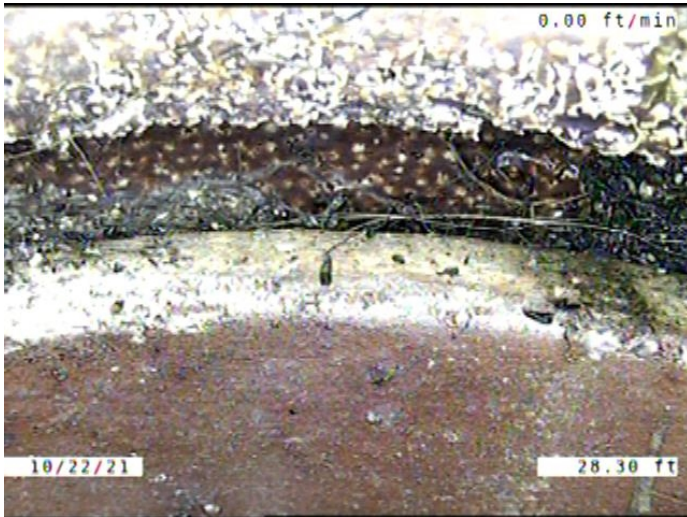
Code: **RFJ**
 Description: **Roots Fine Joint**

Distance (ft): **28.3**
 Structural Grade: **0**
 O&M Grade: **1**
 Clock Start/From: **7**
 Clock To: **5**
 1st Value:
 2nd Value:
 Value Percent:
 Continuous Index: **S01**
 Within 8" of Joint: **YES**
 Remarks:

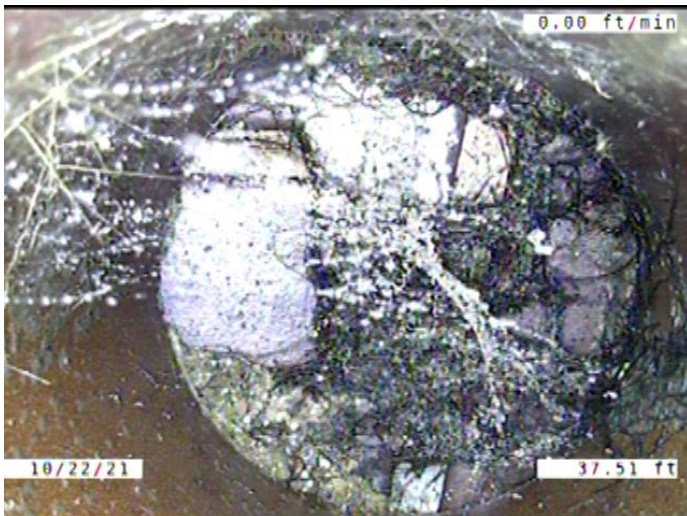
Code: **TFC**
 Description: **Tap Factory Capped**

Distance (ft): **37.5**
 Structural Grade: **0**
 O&M Grade: **0**
 Clock Start/From: **3**
 Clock To:
 1st Value: **4.000**
 2nd Value:
 Value Percent:
 Continuous Index:
 Within 8" of Joint: **YES**
 Remarks:

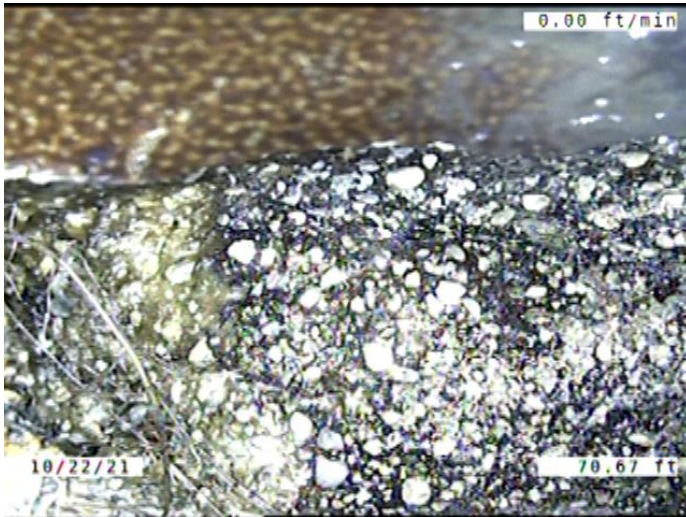
Code: **DAE**
 Description: **Deposits Attached Encrustation**

Distance (ft): **70.7**
 Structural Grade: **0**
 O&M Grade: **2**
 Clock Start/From: **4**
 Clock To: **8**
 1st Value:
 2nd Value:
 Value Percent: **5.000**
 Continuous Index:
 Within 8" of Joint: **YES**
 Remarks:

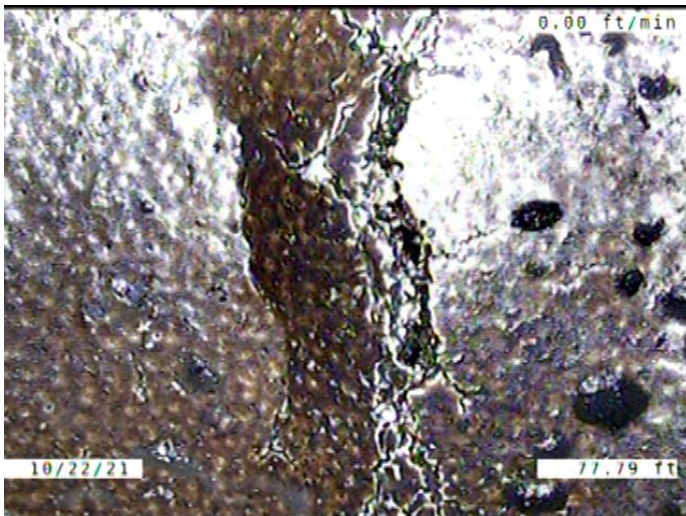
Code: **FM**
 Description: **Fracture Multiple**

Distance (ft): **77.8**
 Structural Grade: **4**
 O&M Grade: **0**
 Clock Start/From: **2**
 Clock To: **3**
 1st Value:
 2nd Value:
 Value Percent:
 Continuous Index:
 Within 8" of Joint: **YES**
 Remarks:

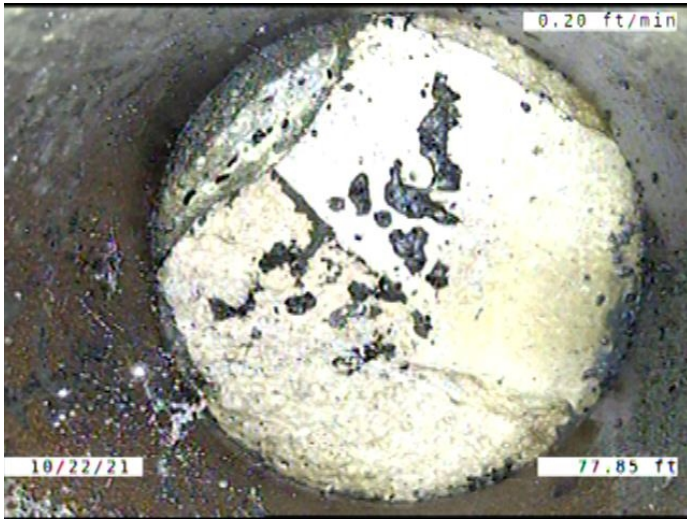
Code: **TFC**
Description: **Tap Factory Capped**

Distance (ft): **77.8**
Structural Grade: **0**
O&M Grade: **0**
Clock Start/From: **2**
Clock To:
1st Value: **4.000**
2nd Value:
Value Percent:
Continuous Index:
Within 8" of Joint: **YES**
Remarks: **ENCUSRUSTATION AROUND THE CAP**

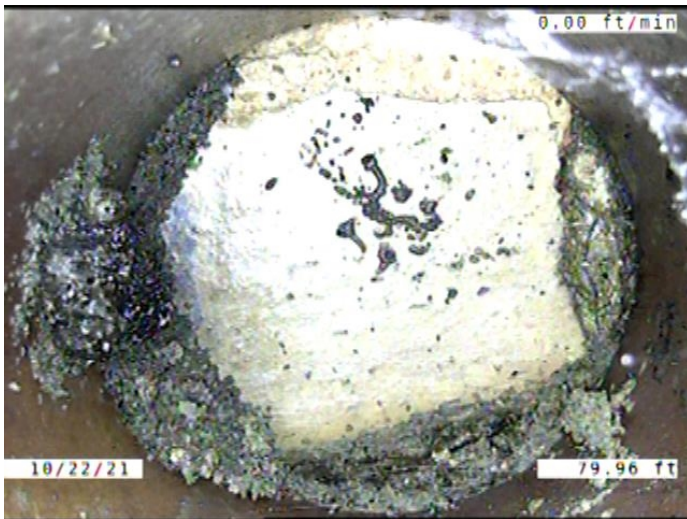
Code: **TFC**
Description: **Tap Factory Capped**

Distance (ft): **80.0**
Structural Grade: **0**
O&M Grade: **0**
Clock Start/From: **10**
Clock To:
1st Value: **4.000**
2nd Value:
Value Percent:
Continuous Index:
Within 8" of Joint: **YES**
Remarks: **ENCUSTATION AROND THE CAP**

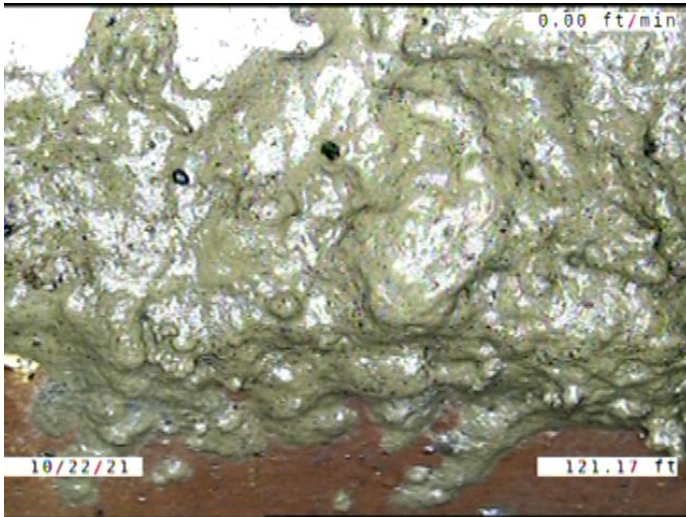
Code: **DAE**
 Description: **Deposits Attached Encrustation**

Distance (ft): **121.2**
 Structural Grade: **0**
 O&M Grade: **2**
 Clock Start/From: **7**
 Clock To: **5**
 1st Value:
 2nd Value:
 Value Percent: **5.000**
 Continuous Index: **S02**
 Within 8" of Joint: **YES**
 Remarks:

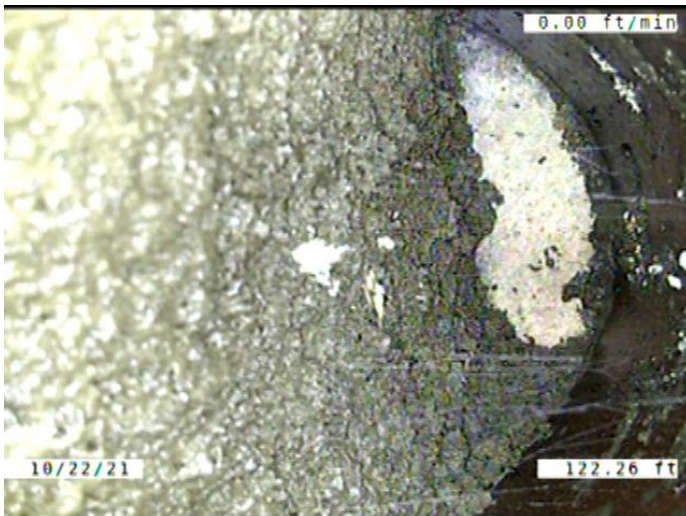
Code: **TFC**
 Description: **Tap Factory Capped**

Distance (ft): **122.3**
 Structural Grade: **0**
 O&M Grade: **0**
 Clock Start/From: **10**
 Clock To:
 1st Value: **4.000**
 2nd Value:
 Value Percent:
 Continuous Index:
 Within 8" of Joint: **YES**
 Remarks:

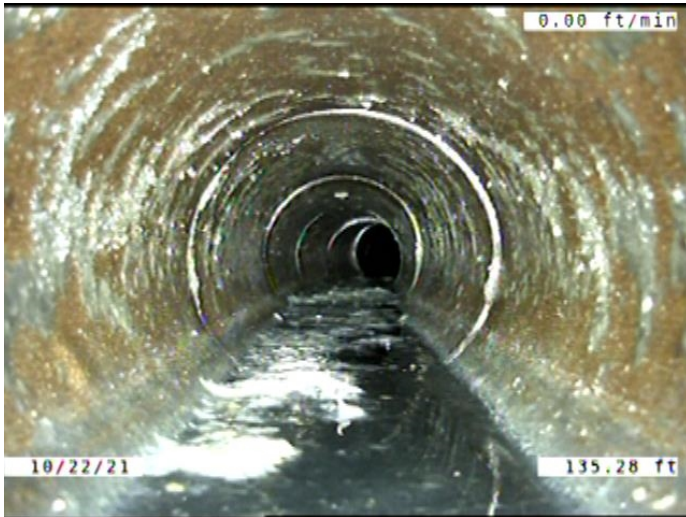
Code: **DAGS**
 Description: **Deposits Attached Grease**

Distance (ft): **135.3**
 Structural Grade: **0**
 O&M Grade: **2**
 Clock Start/From: **11**
 Clock To: **1**
 1st Value:
 2nd Value:
 Value Percent: **5.000**
 Continuous Index: **F03**
 Within 8" of Joint: **YES**
 Remarks:

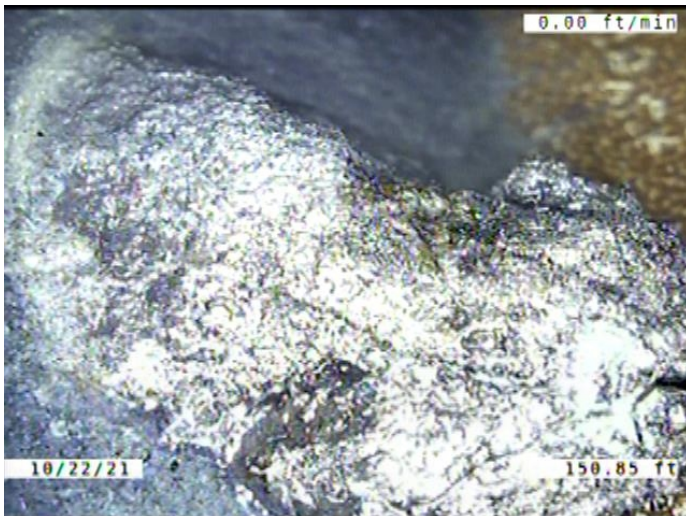
Code: **DAE**
 Description: **Deposits Attached Encrustation**

Distance (ft): **150.8**
 Structural Grade: **0**
 O&M Grade: **2**
 Clock Start/From: **4**
 Clock To: **7**
 1st Value:
 2nd Value:
 Value Percent: **5.000**
 Continuous Index:
 Within 8" of Joint: **YES**
 Remarks:

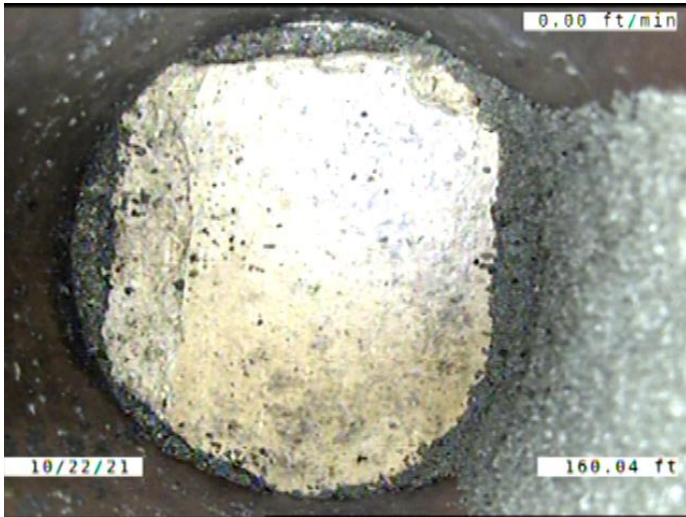
Code: **TFC**
Description: **Tap Factory Capped**

Distance (ft): **160.0**
Structural Grade: **0**
O&M Grade: **0**
Clock Start/From: **3**
Clock To:
1st Value: **4.000**
2nd Value:
Value Percent:
Continuous Index:
Within 8" of Joint: **YES**
Remarks:

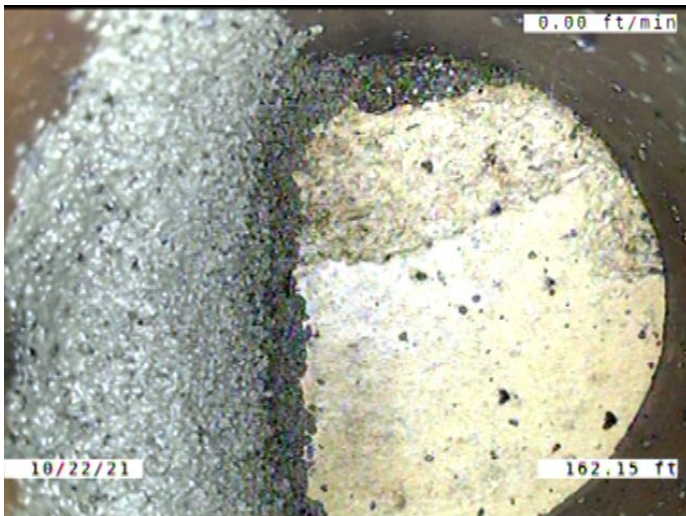
Code: **TFC**
Description: **Tap Factory Capped**

Distance (ft): **162.1**
Structural Grade: **0**
O&M Grade: **0**
Clock Start/From: **9**
Clock To:
1st Value: **4.000**
2nd Value:
Value Percent:
Continuous Index:
Within 8" of Joint: **YES**
Remarks:

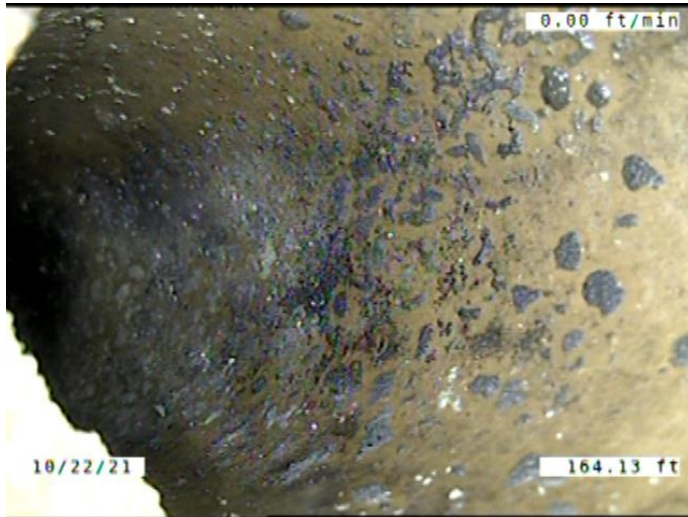
Code: **TBI**
 Description: **Tap Break-in Intruding**

Distance (ft): **164.1**
 Structural Grade: **0**
 O&M Grade: **2**
 Clock Start/From: **11**
 Clock To:
 1st Value: **4.000**
 2nd Value: **2.000**
 Value Percent:
 Continuous Index:
 Within 8" of Joint: **YES**
 Remarks:

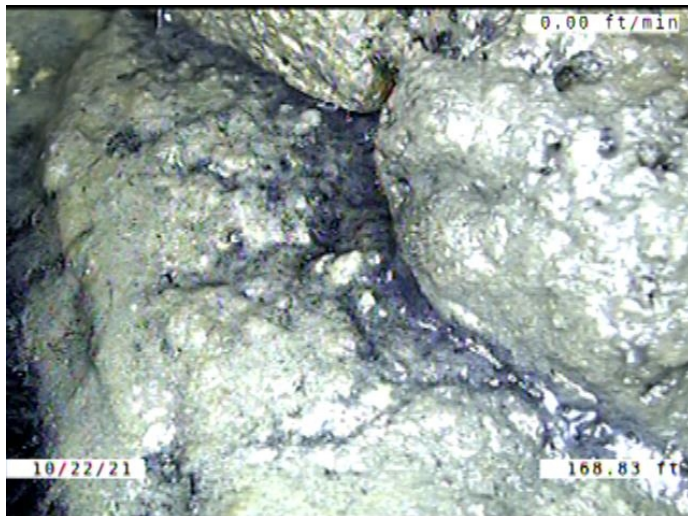
Code: **DAE**
 Description: **Deposits Attached Encrustation**

Distance (ft): **168.8**
 Structural Grade: **0**
 O&M Grade: **2**
 Clock Start/From: **5**
 Clock To: **7**
 1st Value:
 2nd Value:
 Value Percent: **5.000**
 Continuous Index:
 Within 8" of Joint: **YES**
 Remarks:

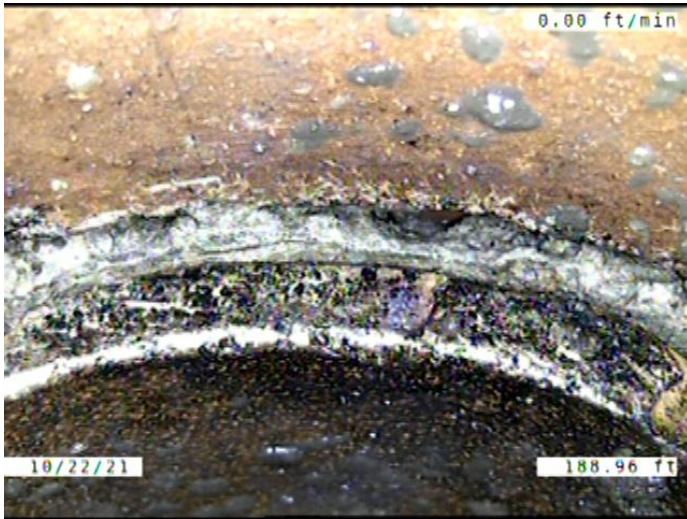
Code: **JOM**
Description: **Joint Offset Medium**

Distance (ft): **189.0**
Structural Grade: **3**
O&M Grade: **0**
Clock Start/From:
Clock To:
1st Value:
2nd Value:
Value Percent:
Continuous Index:
Within 8" of Joint: **NO**
Remarks:

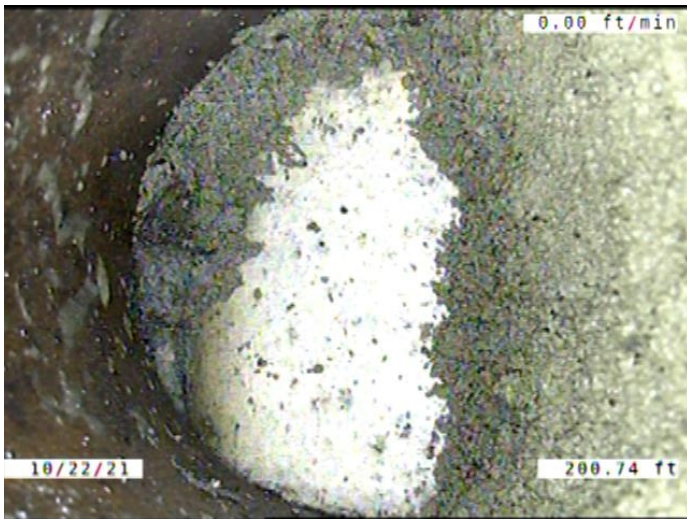
Code: **TFC**
Description: **Tap Factory Capped**

Distance (ft): **200.7**
Structural Grade: **0**
O&M Grade: **0**
Clock Start/From: **3**
Clock To:
1st Value: **4.000**
2nd Value:
Value Percent:
Continuous Index:
Within 8" of Joint: **YES**
Remarks:

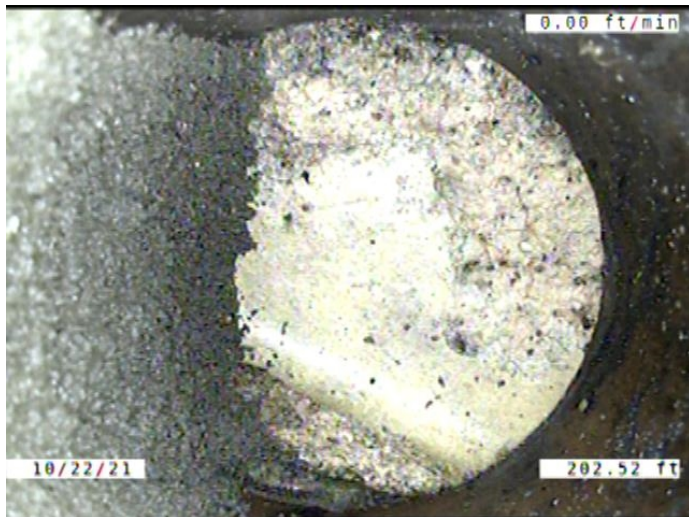
Code: **TFC**
 Description: **Tap Factory Capped**

Distance (ft): **202.5**
 Structural Grade: **0**
 O&M Grade: **0**
 Clock Start/From: **9**
 Clock To:
 1st Value: **4.000**
 2nd Value:
 Value Percent:
 Continuous Index:
 Within 8" of Joint: **YES**
 Remarks:

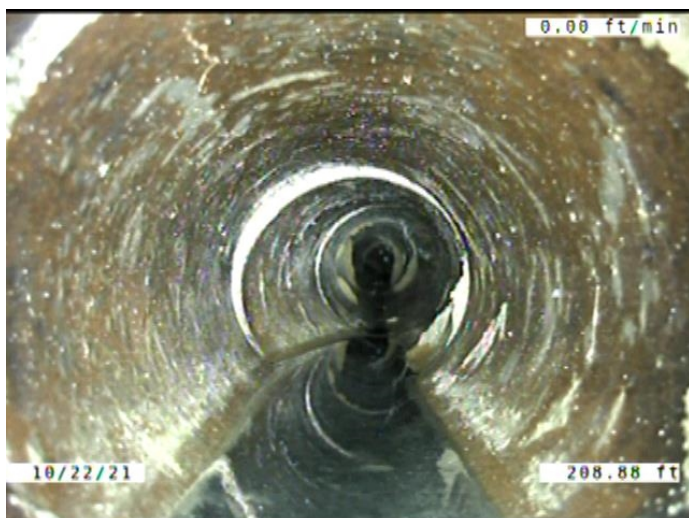
Code: **MWLS**
 Description: **Miscellaneous Water Level Sag**

Distance (ft): **208.9**
 Structural Grade: **2**
 O&M Grade: **0**
 Clock Start/From:
 Clock To:
 1st Value:
 2nd Value:
 Value Percent: **5.000**
 Continuous Index: **S05**
 Within 8" of Joint: **NO**
 Remarks:

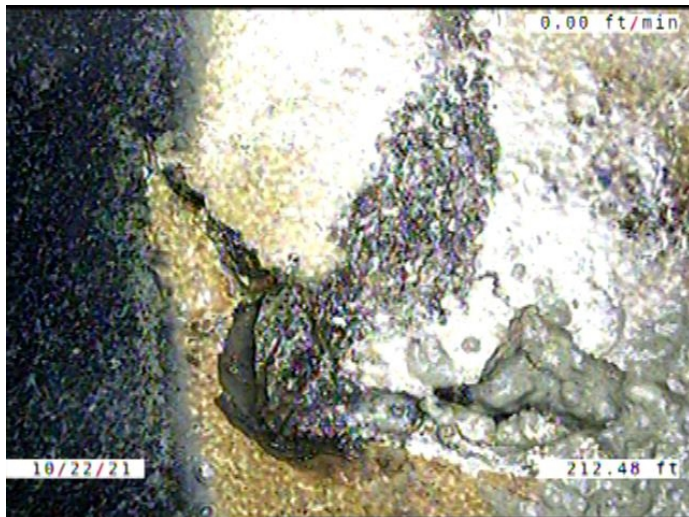
Code: **B**
 Description: **Broken**

Distance (ft): **212.5**
 Structural Grade: **4**
 O&M Grade: **0**
 Clock Start/From: **3**
 Clock To: **5**
 1st Value:
 2nd Value:
 Value Percent:
 Continuous Index:
 Within 8" of Joint: **YES**
 Remarks:

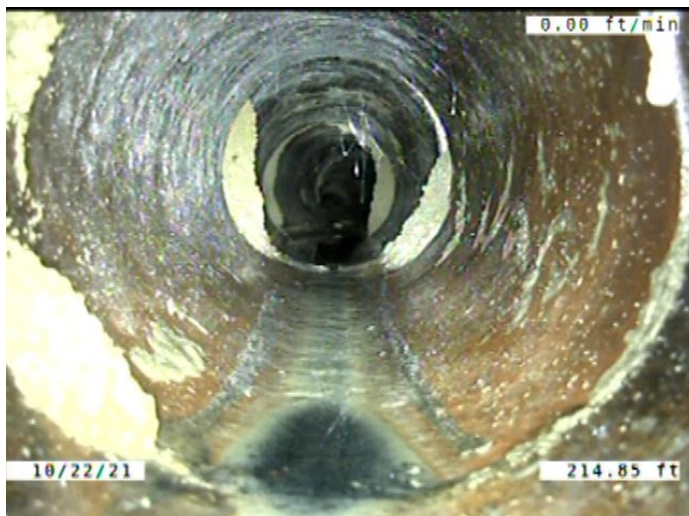
Code: **MWLS**
 Description: **Miscellaneous Water Level Sag**

Distance (ft): **214.8**
 Structural Grade: **2**
 O&M Grade: **0**
 Clock Start/From:
 Clock To:
 1st Value:
 2nd Value:
 Value Percent: **5.000**
 Continuous Index: **F05**
 Within 8" of Joint: **NO**
 Remarks:

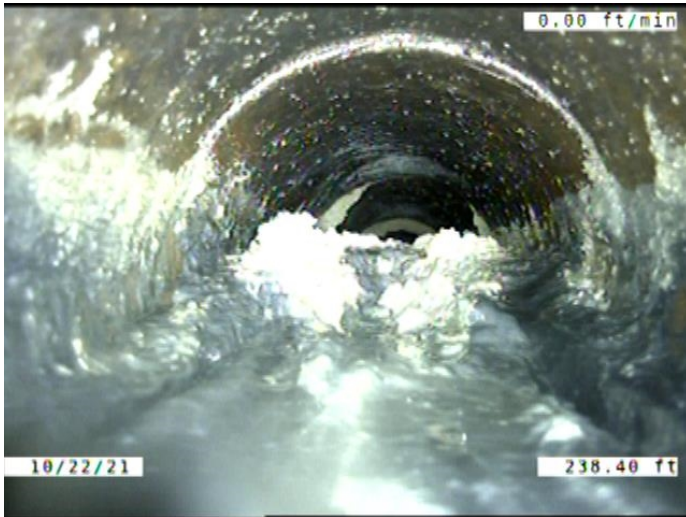
Code:	DAE
Description:	Deposits Attached Encrustation
Distance (ft):	238.4
Structural Grade:	0
O&M Grade:	2
Clock Start/From:	7
Clock To:	5
1st Value:	
2nd Value:	
Value Percent:	5.000
Continuous Index:	F02
Within 8" of Joint:	YES
Remarks:

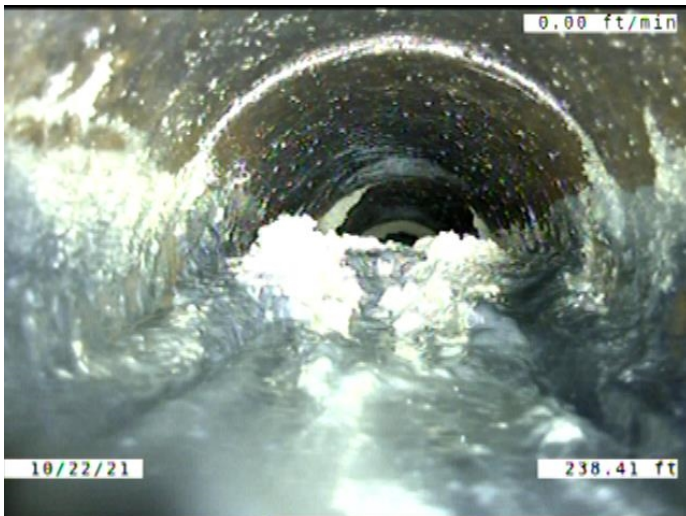
Code:	MSA
Description:	Miscellaneous Survey Abandoned
Distance (ft):	238.4
Structural Grade:	0
O&M Grade:	0
Clock Start/From:	
Clock To:	
1st Value:	
2nd Value:	
Value Percent:	
Continuous Index:	
Within 8" of Joint:	NO
Remarks:	CAMERA CANT MAKE IT PAST DEBRIS
