# Profile/Photo Observation Report

Date:	10/22/2021	Weather:		Coding:	PACP 7.0
Pipe Length (ft):	294.0	Owner:	City of Hobart	Pre Clean:	Heavy Cleaning
P.O.#:	YES502259	Surveyor:	S. Bucklin	PSR:	P-804-021-020
Customer:	City of Hobart	Clean Date:	09/15/2021	Shape:	C

Street:	North Illinois Street	Flow Control:	Not Controlled
City:	Hobart, IN	Year Renewed:	
Location:	Alley	Tape/Media #:	
Purpose:	Routine Assessment	Dia/Height:	8"
Use:	Sanitary Sewage Pipe	Material:	VCP
Drain Area:		Lining:	None
Category:	NA		
Comment:			
Location Details:		Direction of Survey:	Upstream
US MH:	M-804-021	DS MH:	M-804-020
		Total Length Surveyed (ft):	238.4

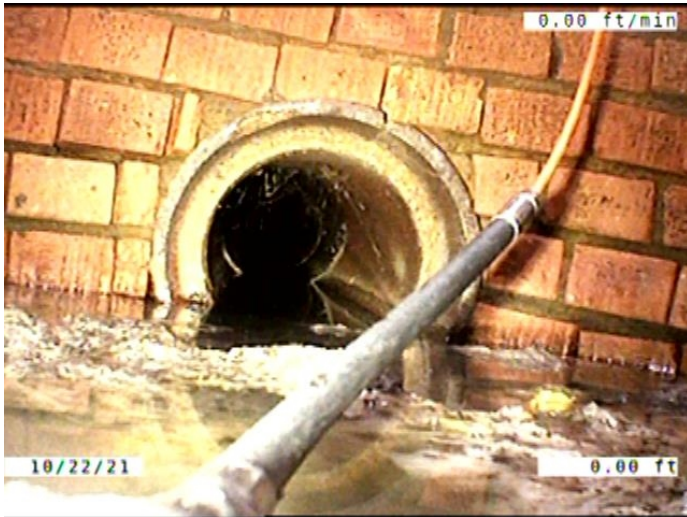
Code: **AMH**  
 Description: **Manhole**

Distance (ft): **.0**  
 Structural Grade: **0**  
 O&M Grade: **0**  
 Clock Start/From:  
 Clock To:  
 1st Value:  
 2nd Value:  
 Value Percent:  
 Continuous Index:  
 Within 8" of Joint: **NO**  
 Remarks: **M-804-020**

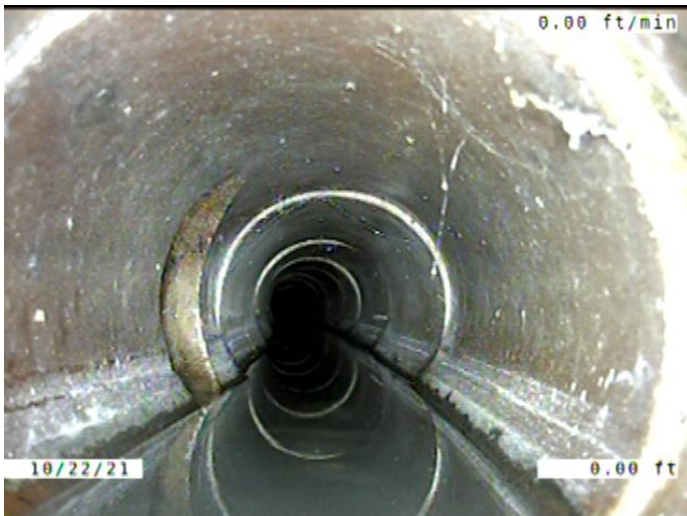
Code: **MWL**  
 Description: **Miscellaneous Water Level**

Distance (ft): **.0**  
 Structural Grade: **0**  
 O&M Grade: **0**  
 Clock Start/From:  
 Clock To:  
 1st Value:  
 2nd Value:  
 Value Percent: **5.000**  
 Continuous Index:  
 Within 8" of Joint: **NO**  
 Remarks:

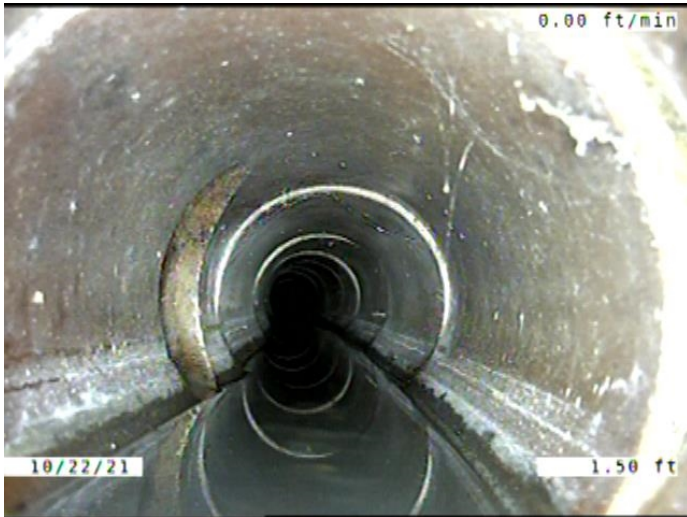
Code: **MGO**  
 Description: **Miscellaneous General Observation**

Distance (ft): **1.5**  
 Structural Grade: **0**  
 O&M Grade: **0**  
 Clock Start/From:  
 Clock To:  
 1st Value:  
 2nd Value:  
 Value Percent:  
 Continuous Index:  
 Within 8" of Joint: **NO**  
 Remarks: **DROP INTO THE MANHOLE. HAD TO START IN THE PIPE.**

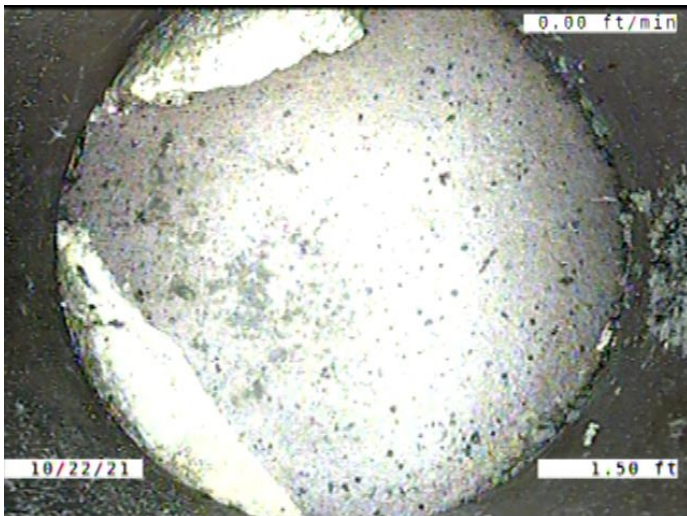
Code: **TFC**  
 Description: **Tap Factory Capped**

Distance (ft): **1.5**  
 Structural Grade: **0**  
 O&M Grade: **0**  
 Clock Start/From: **2**  
 Clock To:  
 1st Value: **4.000**  
 2nd Value:  
 Value Percent:  
 Continuous Index:  
 Within 8" of Joint: **YES**  
 Remarks: **ENCUSTATION AROUND THE CAP**

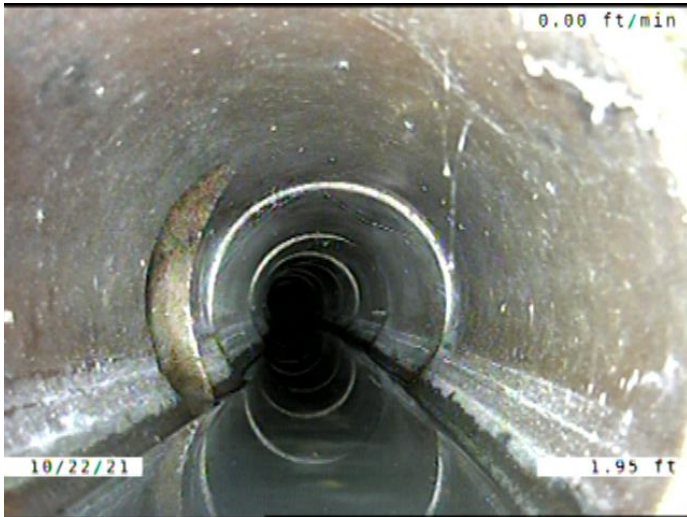
Code: **DSF**  
 Description: **Deposits Settled Fine**

Distance (ft): **2.0**  
 Structural Grade: **0**  
 O&M Grade: **2**  
 Clock Start/From: **5**  
 Clock To: **7**  
 1st Value:  
 2nd Value:  
 Value Percent: **5.000**  
 Continuous Index: **S04**  
 Within 8" of Joint: **YES**  
 Remarks:

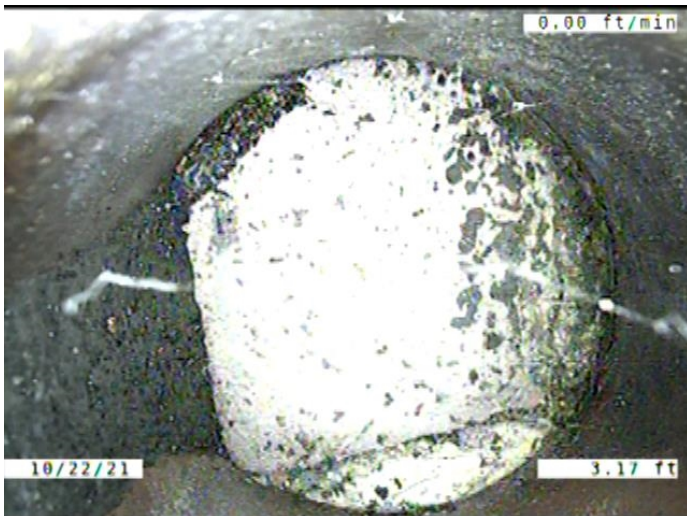
Code: **TFC**  
 Description: **Tap Factory Capped**

Distance (ft): **3.2**  
 Structural Grade: **0**  
 O&M Grade: **0**  
 Clock Start/From: **9**  
 Clock To:  
 1st Value: **4.000**  
 2nd Value:  
 Value Percent:  
 Continuous Index:  
 Within 8" of Joint: **YES**  
 Remarks: **ENCRUSTATION AROUND THE CAP**

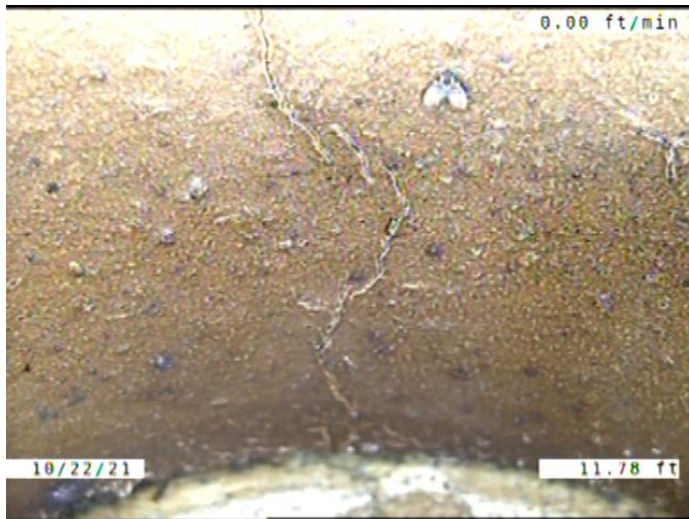
Code: **CM**  
 Description: **Crack Multiple**

Distance (ft): **11.8**  
 Structural Grade: **3**  
 O&M Grade: **0**  
 Clock Start/From: **11**  
 Clock To: **1**  
 1st Value:  
 2nd Value:  
 Value Percent:  
 Continuous Index:  
 Within 8" of Joint: **YES**  
 Remarks:

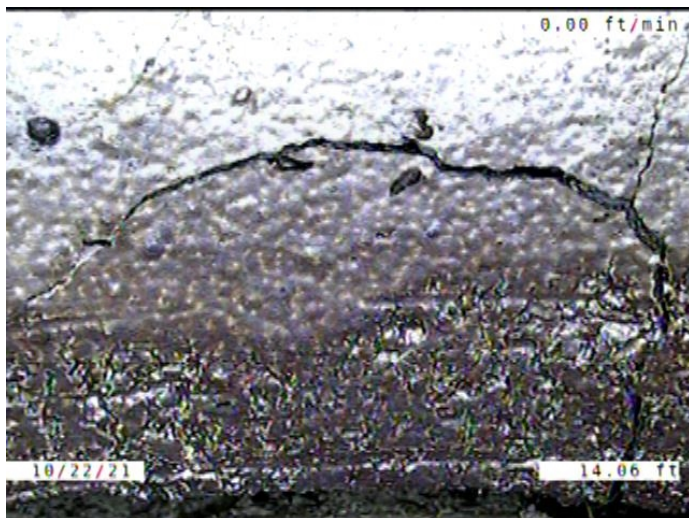
Code: **B**  
 Description: **Broken**

Distance (ft): **14.1**  
 Structural Grade: **4**  
 O&M Grade: **0**  
 Clock Start/From: **8**  
 Clock To: **10**  
 1st Value:  
 2nd Value:  
 Value Percent:  
 Continuous Index:  
 Within 8" of Joint: **YES**  
 Remarks:

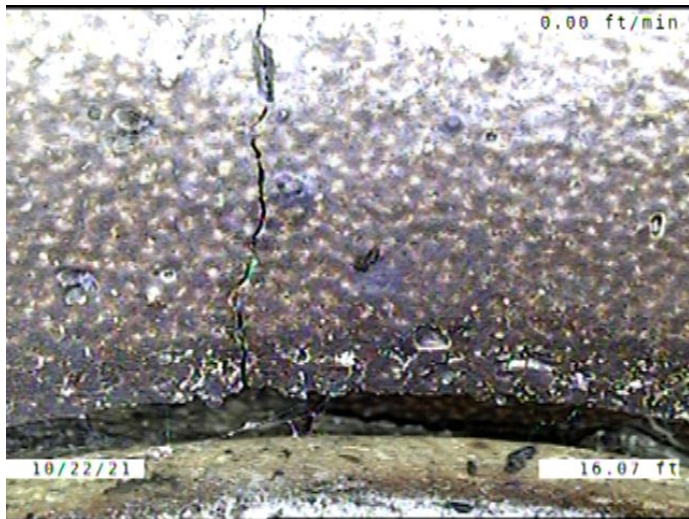
Code: **FM**  
 Description: **Fracture Multiple**

Distance (ft): **16.1**  
 Structural Grade: **4**  
 O&M Grade: **0**  
 Clock Start/From: **7**  
 Clock To: **9**  
 1st Value:  
 2nd Value:  
 Value Percent:  
 Continuous Index:  
 Within 8" of Joint: **YES**  
 Remarks:

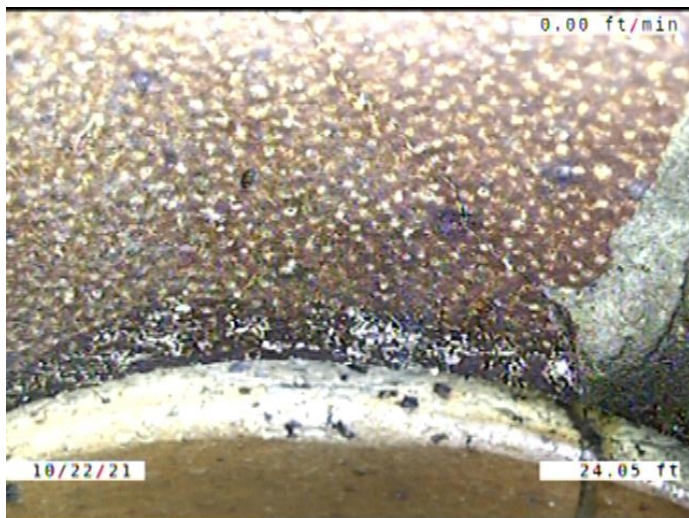
Code: **CM**  
 Description: **Crack Multiple**

Distance (ft): **24.1**  
 Structural Grade: **3**  
 O&M Grade: **0**  
 Clock Start/From: **11**  
 Clock To: **3**  
 1st Value:  
 2nd Value:  
 Value Percent:  
 Continuous Index:  
 Within 8" of Joint: **YES**  
 Remarks:

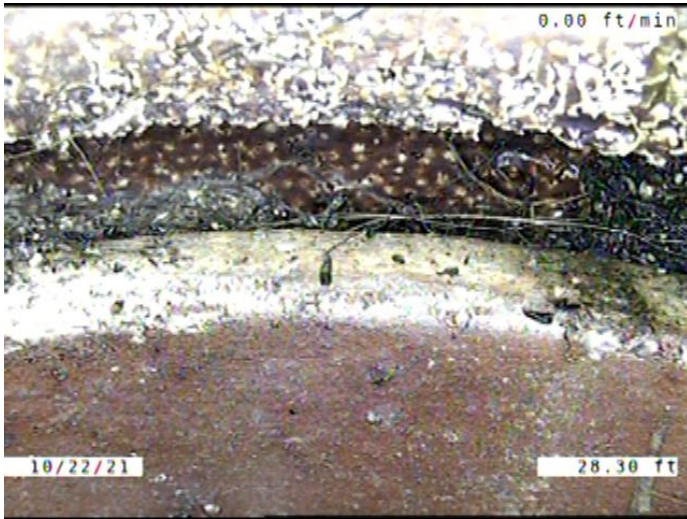
Code: **RFJ**  
 Description: **Roots Fine Joint**

Distance (ft): **28.3**  
 Structural Grade: **0**  
 O&M Grade: **1**  
 Clock Start/From: **7**  
 Clock To: **5**  
 1st Value:  
 2nd Value:  
 Value Percent:  
 Continuous Index: **S01**  
 Within 8" of Joint: **YES**  
 Remarks:

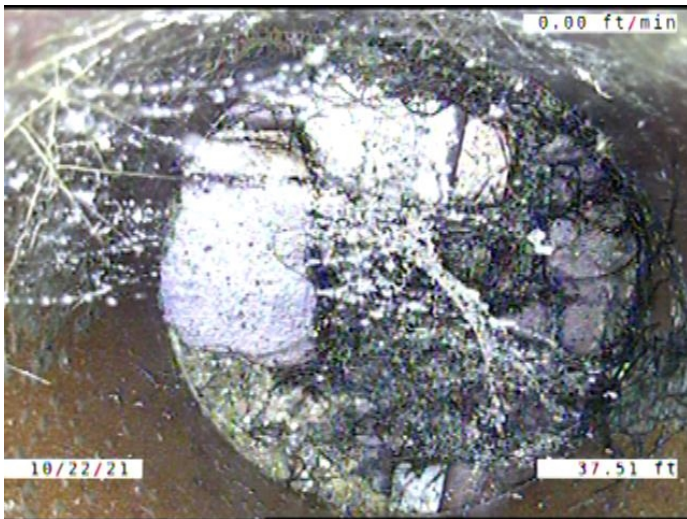
Code: **TFC**  
 Description: **Tap Factory Capped**

Distance (ft): **37.5**  
 Structural Grade: **0**  
 O&M Grade: **0**  
 Clock Start/From: **3**  
 Clock To:  
 1st Value: **4.000**  
 2nd Value:  
 Value Percent:  
 Continuous Index:  
 Within 8" of Joint: **YES**  
 Remarks:

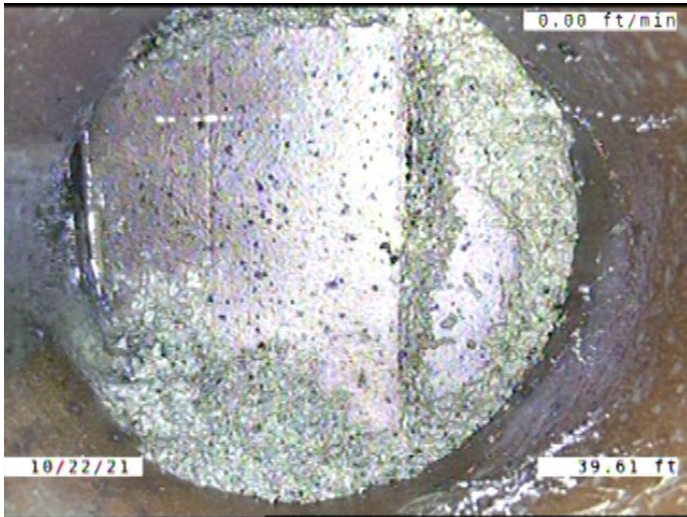
Code: **TFC**  
 Description: **Tap Factory Capped**

Distance (ft): **39.6**  
 Structural Grade: **0**  
 O&M Grade: **0**  
 Clock Start/From: **10**  
 Clock To:  
 1st Value: **4.000**  
 2nd Value:  
 Value Percent:  
 Continuous Index:  
 Within 8" of Joint: **YES**  
 Remarks:

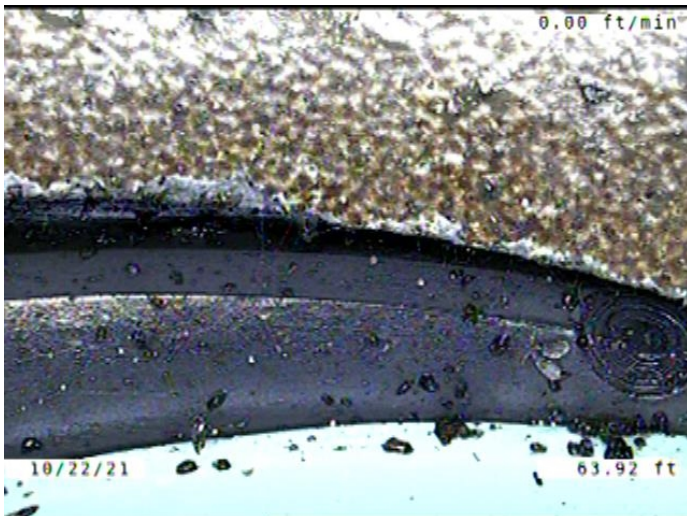
Code: **MMC**  
 Description: **Miscellaneous Material Change**

Distance (ft): **63.9**  
 Structural Grade: **0**  
 O&M Grade: **0**  
 Clock Start/From:  
 Clock To:  
 1st Value:  
 2nd Value:  
 Value Percent:  
 Continuous Index:  
 Within 8" of Joint: **NO**  
 Remarks: **VCP TO PVC**

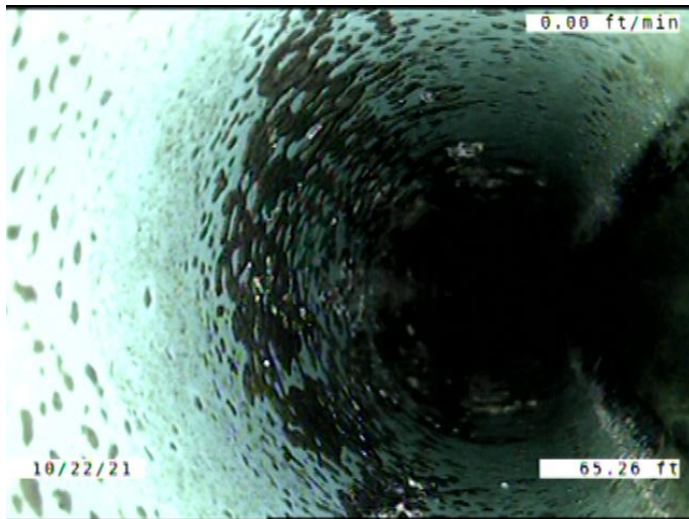
Code: **TS**  
 Description: **Tap Saddle**

Distance (ft): **65.3**  
 Structural Grade: **0**  
 O&M Grade: **0**  
 Clock Start/From: **3**  
 Clock To:  
 1st Value: **4.000**  
 2nd Value:  
 Value Percent:  
 Continuous Index:  
 Within 8" of Joint: **YES**  
 Remarks:

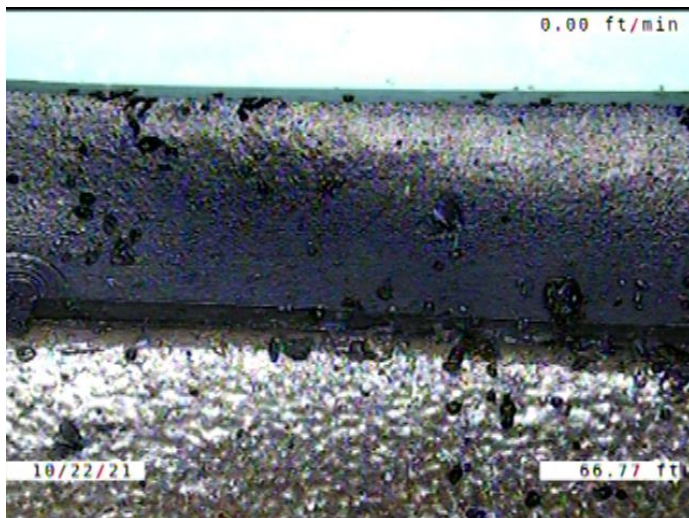
Code: **MMC**  
 Description: **Miscellaneous Material Change**

Distance (ft): **66.8**  
 Structural Grade: **0**  
 O&M Grade: **0**  
 Clock Start/From:  
 Clock To:  
 1st Value:  
 2nd Value:  
 Value Percent:  
 Continuous Index:  
 Within 8" of Joint: **NO**  
 Remarks: **PVC TO VCP**

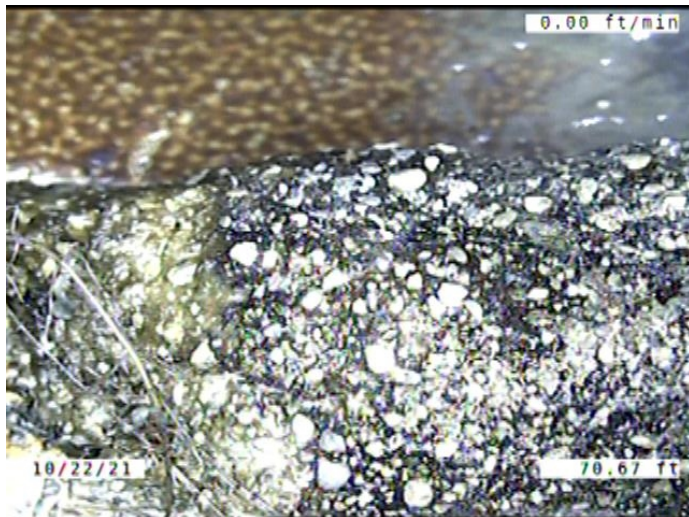
Code: **DAE**  
 Description: **Deposits Attached Encrustation**

Distance (ft): **70.7**  
 Structural Grade: **0**  
 O&M Grade: **2**  
 Clock Start/From: **4**  
 Clock To: **8**  
 1st Value:  
 2nd Value:  
 Value Percent: **5.000**  
 Continuous Index:  
 Within 8" of Joint: **YES**  
 Remarks:

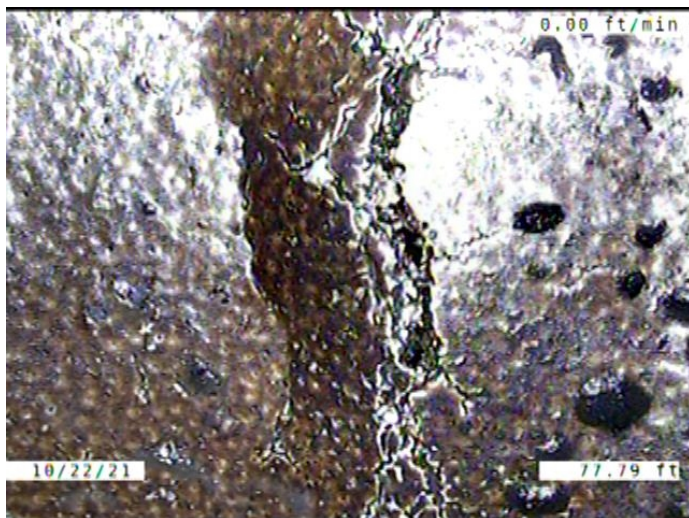
Code: **FM**  
 Description: **Fracture Multiple**

Distance (ft): **77.8**  
 Structural Grade: **4**  
 O&M Grade: **0**  
 Clock Start/From: **2**  
 Clock To: **3**  
 1st Value:  
 2nd Value:  
 Value Percent:  
 Continuous Index:  
 Within 8" of Joint: **YES**  
 Remarks:

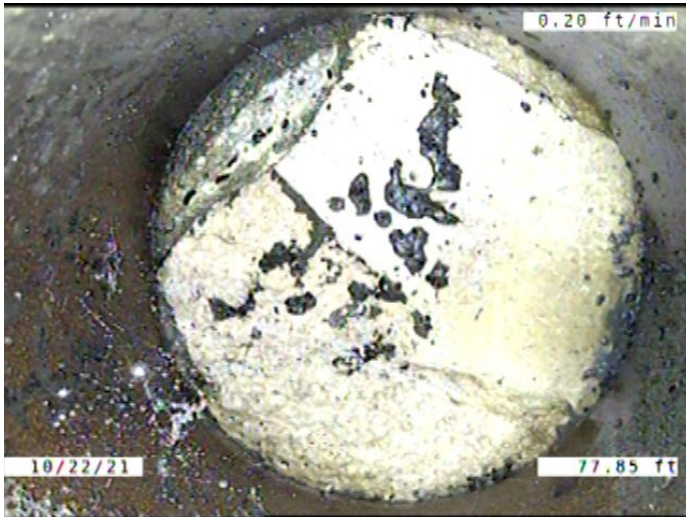
Code: **TFC**  
Description: **Tap Factory Capped**

Distance (ft): **77.8**  
Structural Grade: **0**  
O&M Grade: **0**  
Clock Start/From: **2**  
Clock To:  
1st Value: **4.000**  
2nd Value:  
Value Percent:  
Continuous Index:  
Within 8" of Joint: **YES**  
Remarks: **ENCUSRUSTATION AROUND THE CAP**

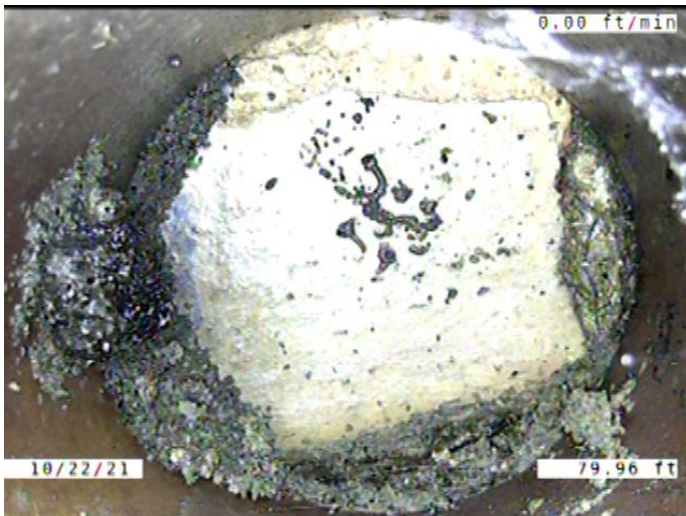
Code: **TFC**  
Description: **Tap Factory Capped**

Distance (ft): **80.0**  
Structural Grade: **0**  
O&M Grade: **0**  
Clock Start/From: **10**  
Clock To:  
1st Value: **4.000**  
2nd Value:  
Value Percent:  
Continuous Index:  
Within 8" of Joint: **YES**  
Remarks: **ENCUSTATION AROUND THE CAP**

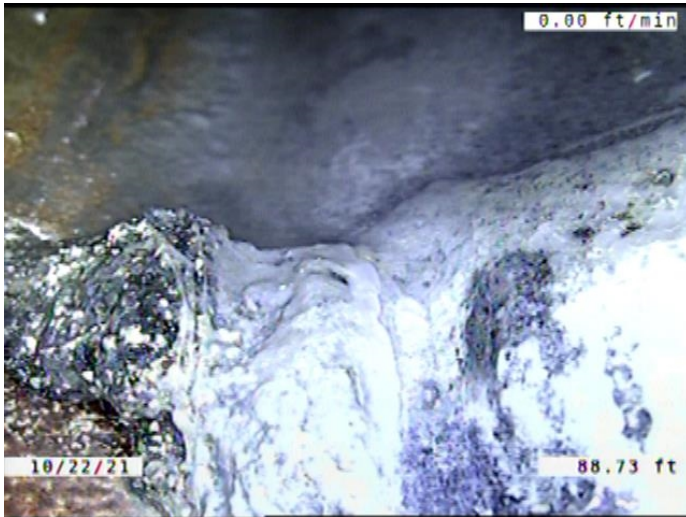
Code: **DAE**  
 Description: **Deposits Attached Encrustation**

Distance (ft): **88.7**  
 Structural Grade: **0**  
 O&M Grade: **2**  
 Clock Start/From: **4**  
 Clock To: **8**  
 1st Value:  
 2nd Value:  
 Value Percent: **5.000**  
 Continuous Index:  
 Within 8" of Joint: **YES**  
 Remarks:

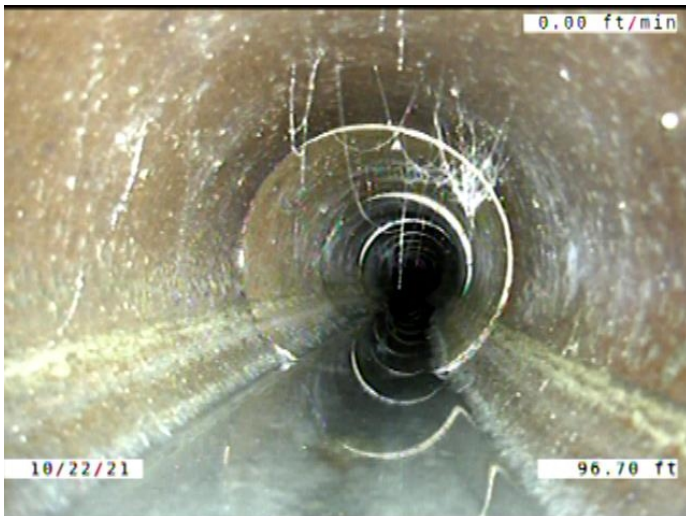
Code: **RFJ**  
 Description: **Roots Fine Joint**

Distance (ft): **96.7**  
 Structural Grade: **0**  
 O&M Grade: **1**  
 Clock Start/From: **7**  
 Clock To: **5**  
 1st Value:  
 2nd Value:  
 Value Percent:  
 Continuous Index: **F01**  
 Within 8" of Joint: **YES**  
 Remarks:

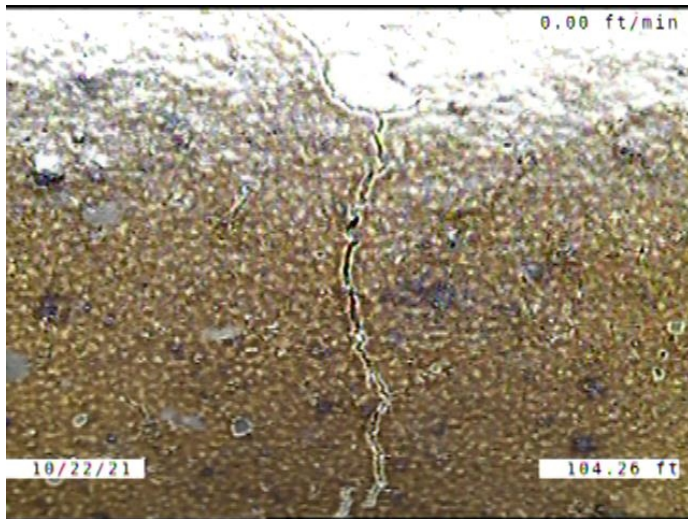
Code: **CM**  
 Description: **Crack Multiple**

Distance (ft): **104.3**  
 Structural Grade: **3**  
 O&M Grade: **0**  
 Clock Start/From: **1**  
 Clock To: **2**  
 1st Value:  
 2nd Value:  
 Value Percent:  
 Continuous Index:  
 Within 8" of Joint: **NO**  
 Remarks:

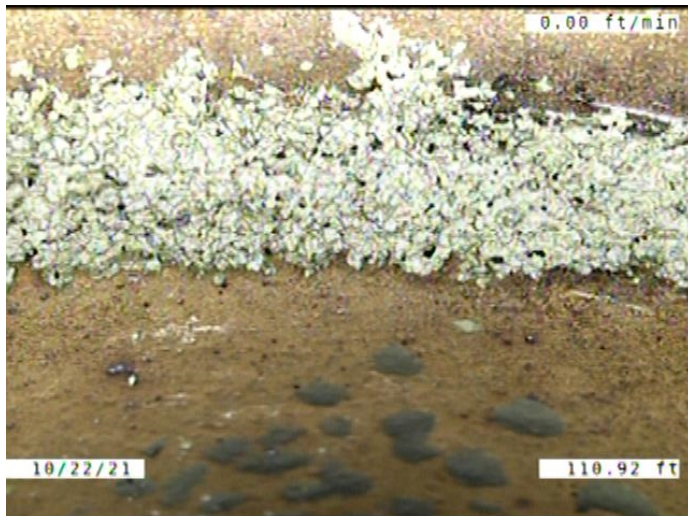
Code: **DAZ**  
 Description: **Deposits Attached Other**

Distance (ft): **110.9**  
 Structural Grade: **0**  
 O&M Grade: **2**  
 Clock Start/From: **8**  
 Clock To: **4**  
 1st Value:  
 2nd Value:  
 Value Percent: **5.000**  
 Continuous Index:  
 Within 8" of Joint: **YES**  
 Remarks: **MUD**

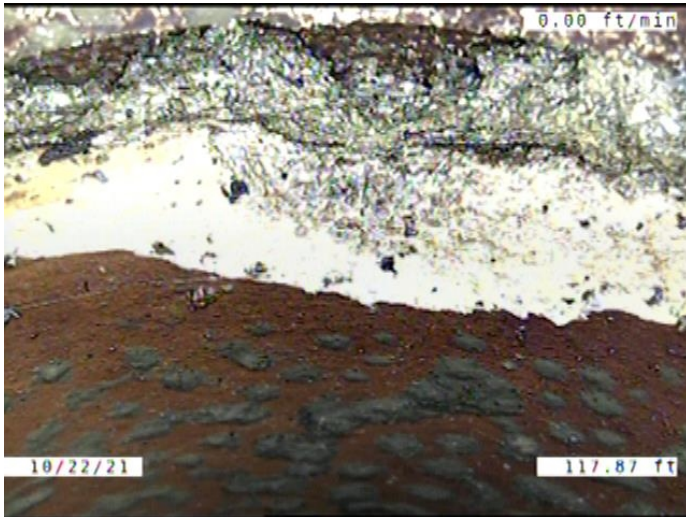
Code: **JOMD**  
 Description: **Joint Offset Medium Defective**

Distance (ft): **117.9**  
 Structural Grade: **3**  
 O&M Grade: **0**  
 Clock Start/From:  
 Clock To:  
 1st Value:  
 2nd Value:  
 Value Percent:  
 Continuous Index:  
 Within 8" of Joint: **NO**  
 Remarks:

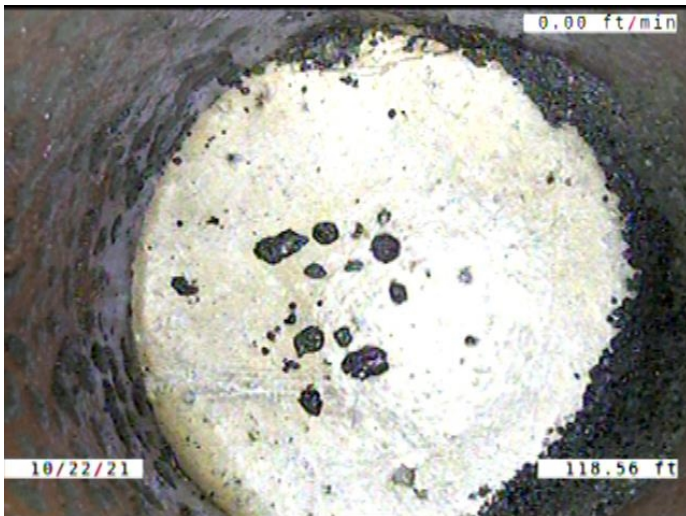
Code: **TFC**  
 Description: **Tap Factory Capped**

Distance (ft): **118.6**  
 Structural Grade: **0**  
 O&M Grade: **0**  
 Clock Start/From: **3**  
 Clock To:  
 1st Value: **4.000**  
 2nd Value:  
 Value Percent:  
 Continuous Index:  
 Within 8" of Joint: **YES**  
 Remarks:

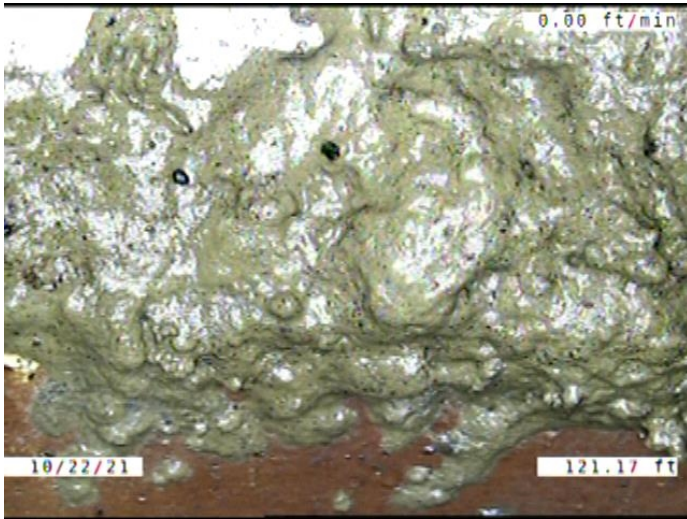
Code: **DAE**  
Description: **Deposits Attached Encrustation**

Distance (ft): **121.2**  
Structural Grade: **0**  
O&M Grade: **2**  
Clock Start/From: **7**  
Clock To: **5**  
1st Value:  
2nd Value:  
Value Percent: **5.000**  
Continuous Index: **S02**  
Within 8" of Joint: **YES**  
Remarks:

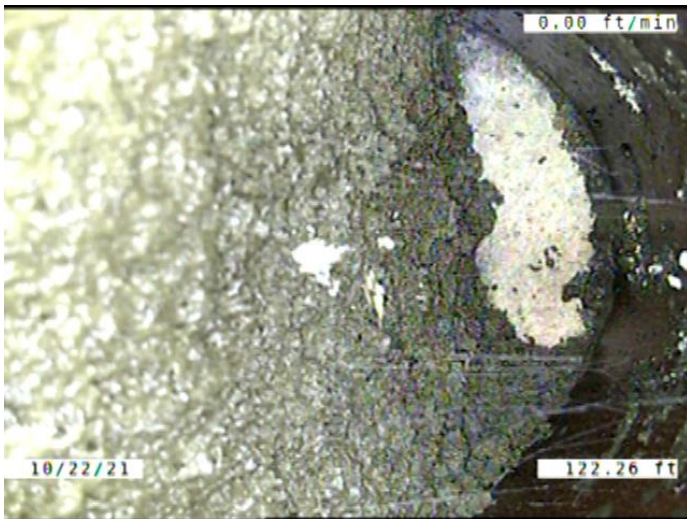
Code: **TFC**  
Description: **Tap Factory Capped**

Distance (ft): **122.3**  
Structural Grade: **0**  
O&M Grade: **0**  
Clock Start/From: **10**  
Clock To:  
1st Value: **4.000**  
2nd Value:  
Value Percent:  
Continuous Index:  
Within 8" of Joint: **YES**  
Remarks:

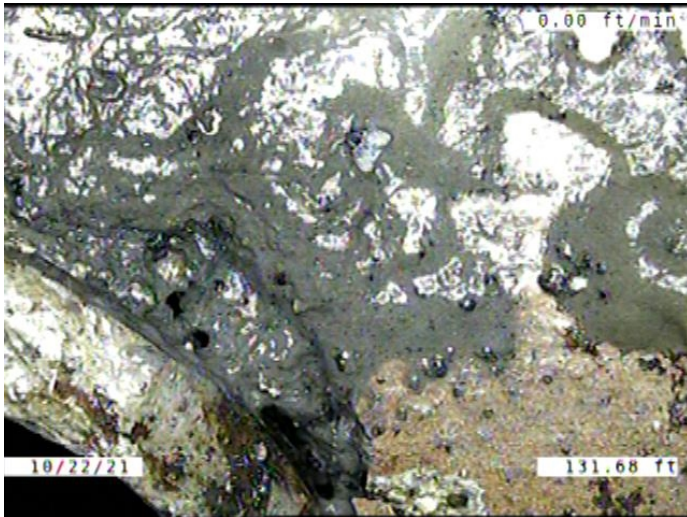
Code: **B**  
 Description: **Broken**

Distance (ft): **131.7**  
 Structural Grade: **4**  
 O&M Grade: **0**  
 Clock Start/From: **2**  
 Clock To:  
 1st Value:  
 2nd Value:  
 Value Percent:  
 Continuous Index:  
 Within 8" of Joint: **YES**  
 Remarks:

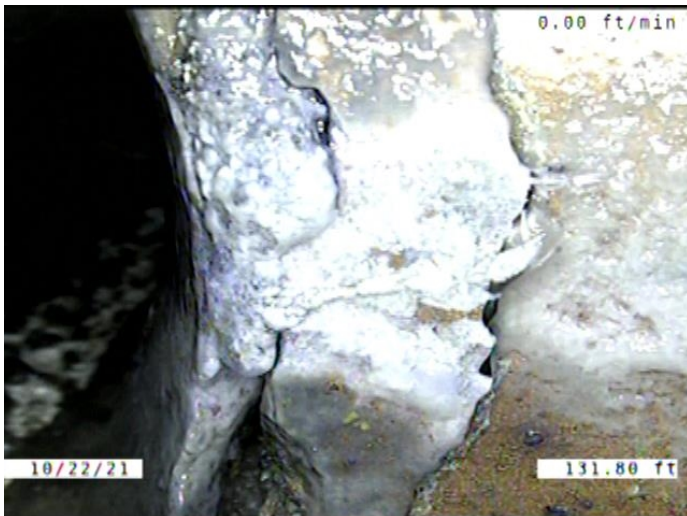
Code: **IRC**  
 Description: **Infiltration Runner Connection**

Distance (ft): **131.8**  
 Structural Grade: **0**  
 O&M Grade: **4**  
 Clock Start/From: **2**  
 Clock To:  
 1st Value:  
 2nd Value:  
 Value Percent:  
 Continuous Index:  
 Within 8" of Joint: **YES**  
 Remarks:

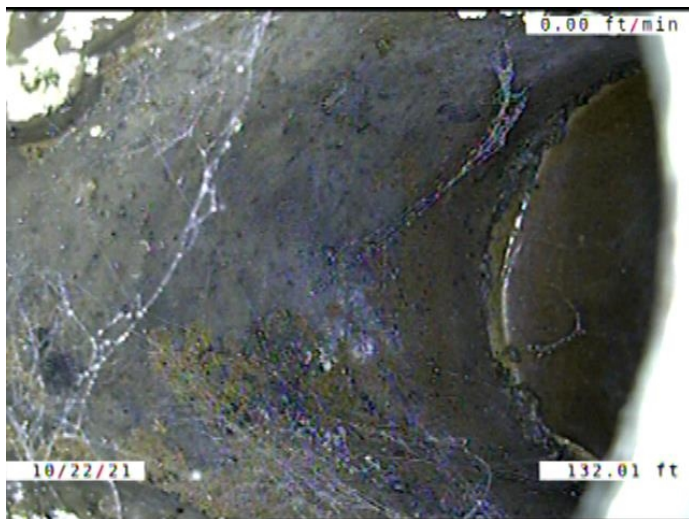
Code: **TBI**  
 Description: **Tap Break-in Intruding**

Distance (ft): **132.0**  
 Structural Grade: **0**  
 O&M Grade: **2**  
 Clock Start/From: **1**  
 Clock To:  
 1st Value: **4.000**  
 2nd Value: **1.000**  
 Value Percent:  
 Continuous Index:  
 Within 8" of Joint: **YES**  
 Remarks:

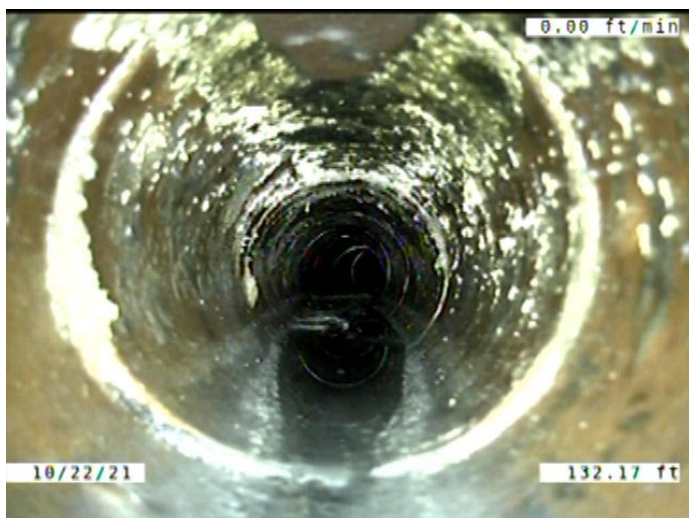
Code: **DAGS**  
 Description: **Deposits Attached Grease**

Distance (ft): **132.2**  
 Structural Grade: **0**  
 O&M Grade: **2**  
 Clock Start/From: **11**  
 Clock To: **1**  
 1st Value:  
 2nd Value:  
 Value Percent: **5.000**  
 Continuous Index: **S03**  
 Within 8" of Joint: **YES**  
 Remarks:

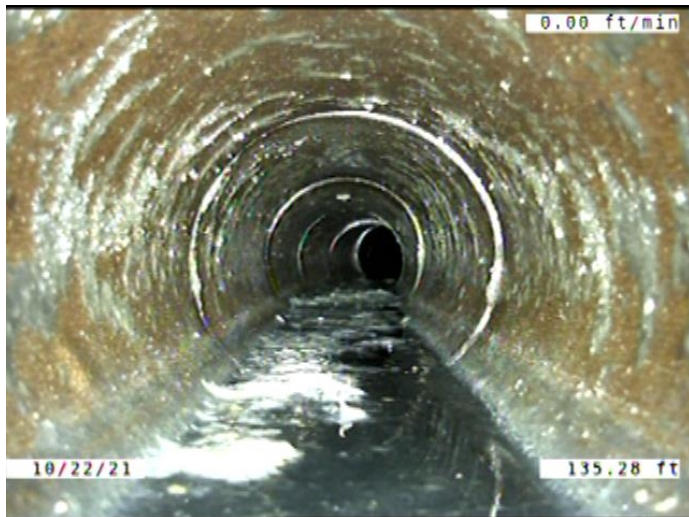
Code: **DAGS**  
 Description: **Deposits Attached Grease**

Distance (ft): **135.3**  
 Structural Grade: **0**  
 O&M Grade: **2**  
 Clock Start/From: **11**  
 Clock To: **1**  
 1st Value:  
 2nd Value:  
 Value Percent: **5.000**  
 Continuous Index: **F03**  
 Within 8" of Joint: **YES**  
 Remarks:

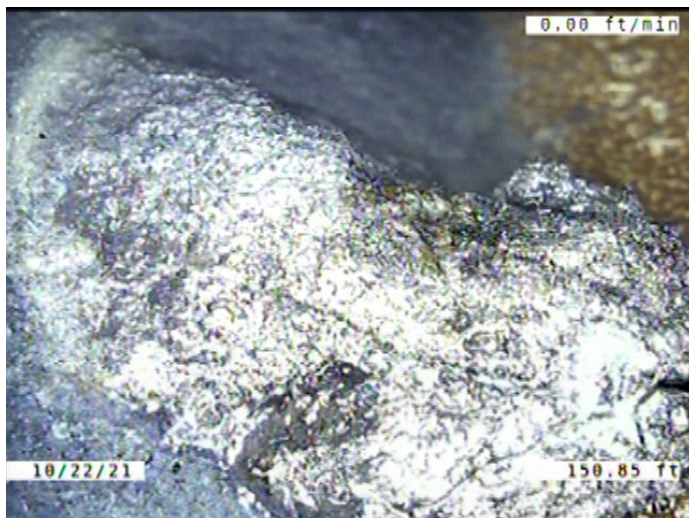
Code: **DAE**  
 Description: **Deposits Attached Encrustation**

Distance (ft): **150.8**  
 Structural Grade: **0**  
 O&M Grade: **2**  
 Clock Start/From: **4**  
 Clock To: **7**  
 1st Value:  
 2nd Value:  
 Value Percent: **5.000**  
 Continuous Index:  
 Within 8" of Joint: **YES**  
 Remarks:

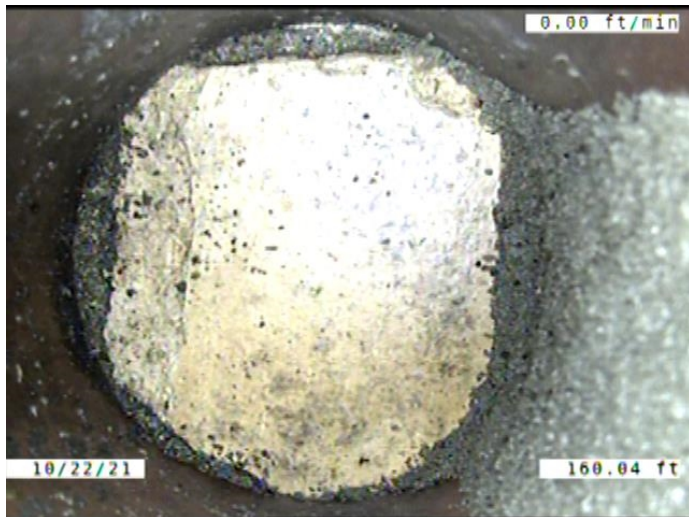
Code: **TFC**  
 Description: **Tap Factory Capped**

Distance (ft): **160.0**  
 Structural Grade: **0**  
 O&M Grade: **0**  
 Clock Start/From: **3**  
 Clock To:  
 1st Value: **4.000**  
 2nd Value:  
 Value Percent:  
 Continuous Index:  
 Within 8" of Joint: **YES**  
 Remarks:

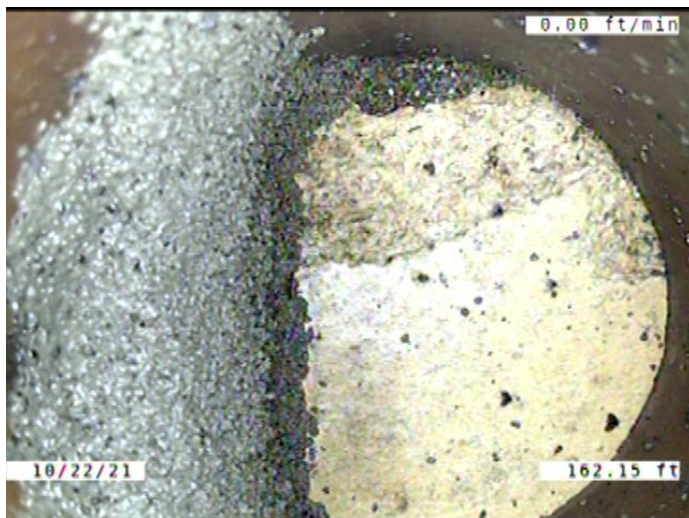
Code: **TFC**  
 Description: **Tap Factory Capped**

Distance (ft): **162.1**  
 Structural Grade: **0**  
 O&M Grade: **0**  
 Clock Start/From: **9**  
 Clock To:  
 1st Value: **4.000**  
 2nd Value:  
 Value Percent:  
 Continuous Index:  
 Within 8" of Joint: **YES**  
 Remarks:

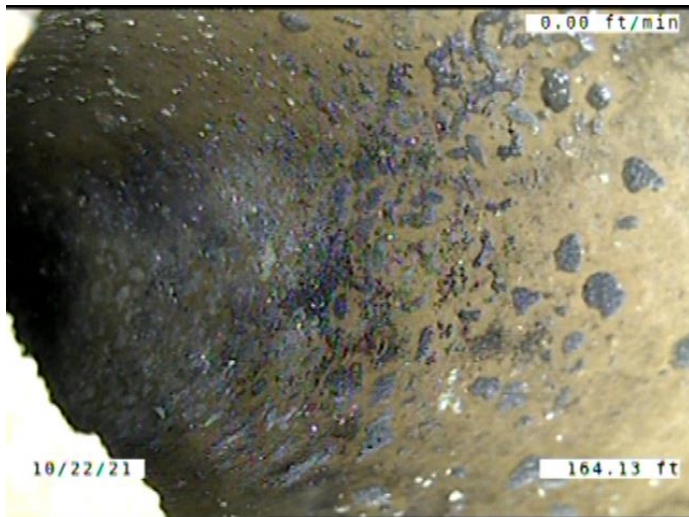
Code: **TBI**  
 Description: **Tap Break-in Intruding**

Distance (ft): **164.1**  
 Structural Grade: **0**  
 O&M Grade: **2**  
 Clock Start/From: **11**  
 Clock To:  
 1st Value: **4.000**  
 2nd Value: **2.000**  
 Value Percent:  
 Continuous Index:  
 Within 8" of Joint: **YES**  
 Remarks:

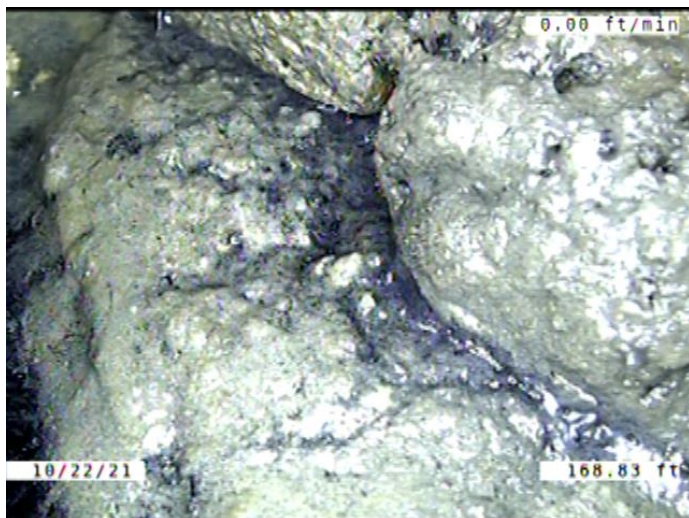
Code: **DAE**  
 Description: **Deposits Attached Encrustation**

Distance (ft): **168.8**  
 Structural Grade: **0**  
 O&M Grade: **2**  
 Clock Start/From: **5**  
 Clock To: **7**  
 1st Value:  
 2nd Value:  
 Value Percent: **5.000**  
 Continuous Index:  
 Within 8" of Joint: **YES**  
 Remarks:

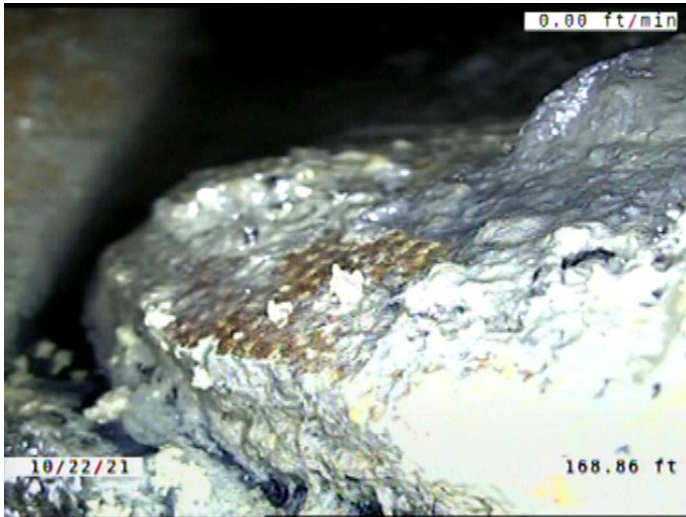
Code: **OBM**  
 Description: **Obstruction Pipe Material in Invert**

Distance (ft): **168.9**  
 Structural Grade: **0**  
 O&M Grade: **2**  
 Clock Start/From: **5**  
 Clock To: **7**  
 1st Value:  
 2nd Value:  
 Value Percent: **5.000**  
 Continuous Index:  
 Within 8" of Joint: **YES**  
 Remarks:

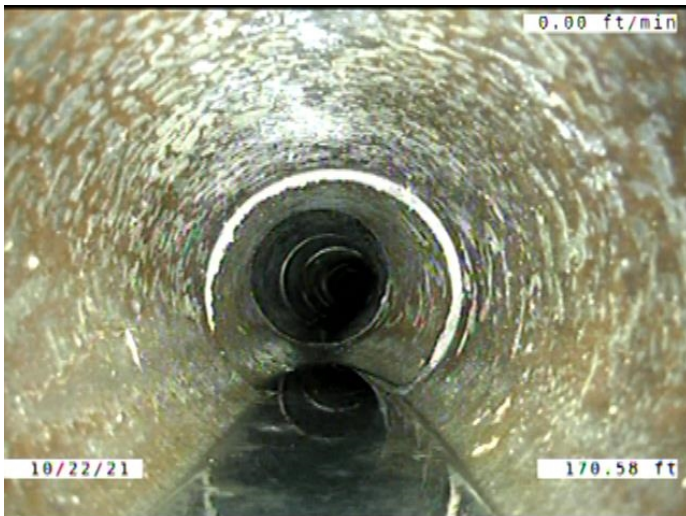
Code: **MWLS**  
 Description: **Miscellaneous Water Level Sag**

Distance (ft): **170.6**  
 Structural Grade: **2**  
 O&M Grade: **0**  
 Clock Start/From:  
 Clock To:  
 1st Value:  
 2nd Value:  
 Value Percent: **5.000**  
 Continuous Index:  
 Within 8" of Joint: **NO**  
 Remarks:

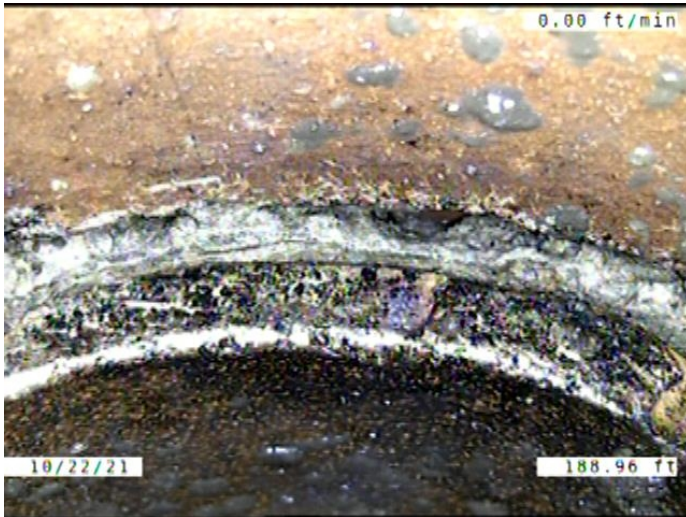
Code: **JOM**  
 Description: **Joint Offset Medium**

Distance (ft): **189.0**  
 Structural Grade: **3**  
 O&M Grade: **0**  
 Clock Start/From:  
 Clock To:  
 1st Value:  
 2nd Value:  
 Value Percent:  
 Continuous Index:  
 Within 8" of Joint: **NO**  
 Remarks:

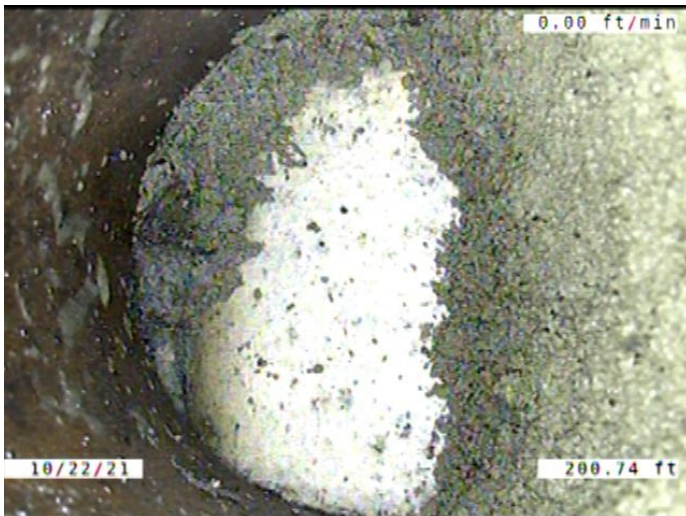
Code: **TFC**  
 Description: **Tap Factory Capped**

Distance (ft): **200.7**  
 Structural Grade: **0**  
 O&M Grade: **0**  
 Clock Start/From: **3**  
 Clock To:  
 1st Value: **4.000**  
 2nd Value:  
 Value Percent:  
 Continuous Index:  
 Within 8" of Joint: **YES**  
 Remarks:

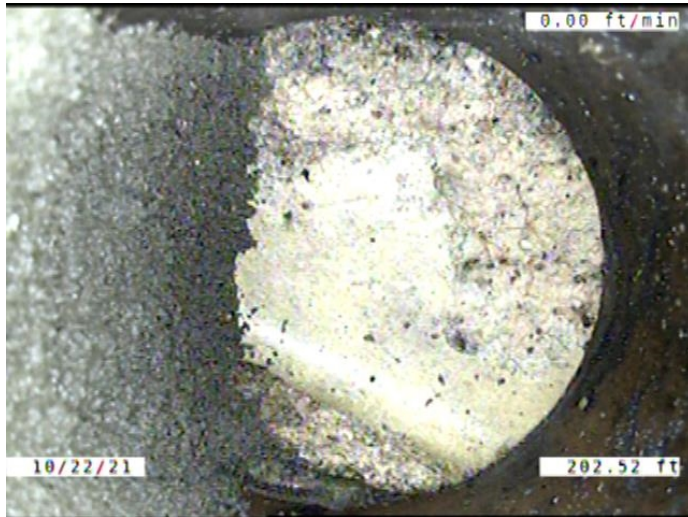
Code: **TFC**  
 Description: **Tap Factory Capped**

Distance (ft): **202.5**  
 Structural Grade: **0**  
 O&M Grade: **0**  
 Clock Start/From: **9**  
 Clock To:  
 1st Value: **4.000**  
 2nd Value:  
 Value Percent:  
 Continuous Index:  
 Within 8" of Joint: **YES**  
 Remarks:

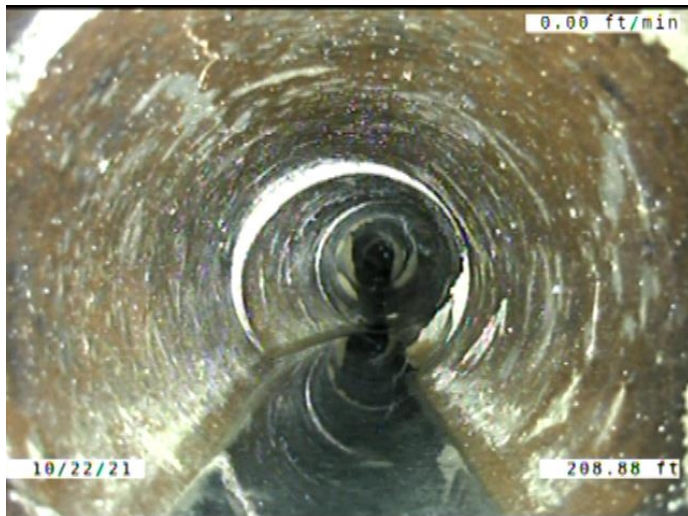
Code: **MWLS**  
 Description: **Miscellaneous Water Level Sag**

Distance (ft): **208.9**  
 Structural Grade: **2**  
 O&M Grade: **0**  
 Clock Start/From:  
 Clock To:  
 1st Value:  
 2nd Value:  
 Value Percent: **5.000**  
 Continuous Index: **S05**  
 Within 8" of Joint: **NO**  
 Remarks:

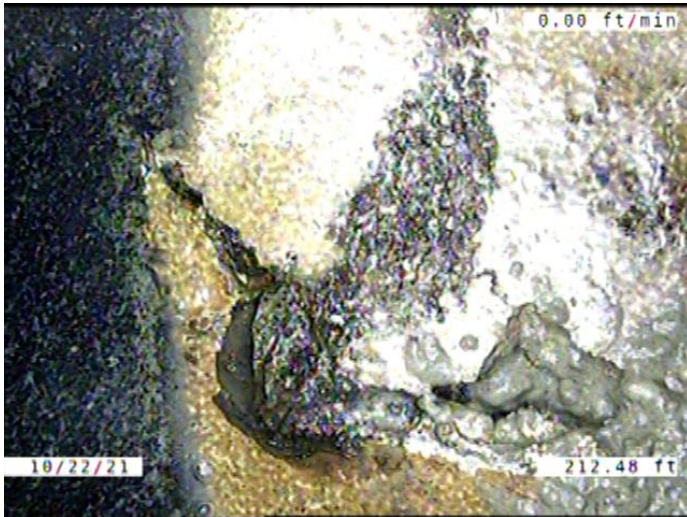
Code: **B**  
 Description: **Broken**

Distance (ft): **212.5**  
 Structural Grade: **4**  
 O&M Grade: **0**  
 Clock Start/From: **3**  
 Clock To: **5**  
 1st Value:  
 2nd Value:  
 Value Percent:  
 Continuous Index:  
 Within 8" of Joint: **YES**  
 Remarks:

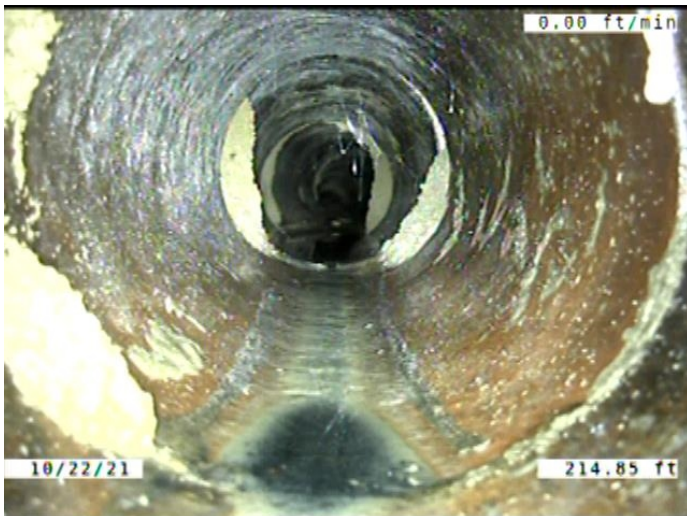
Code: **MWLS**  
 Description: **Miscellaneous Water Level Sag**

Distance (ft): **214.8**  
 Structural Grade: **2**  
 O&M Grade: **0**  
 Clock Start/From:  
 Clock To:  
 1st Value:  
 2nd Value:  
 Value Percent: **5.000**  
 Continuous Index: **F05**  
 Within 8" of Joint: **NO**  
 Remarks:

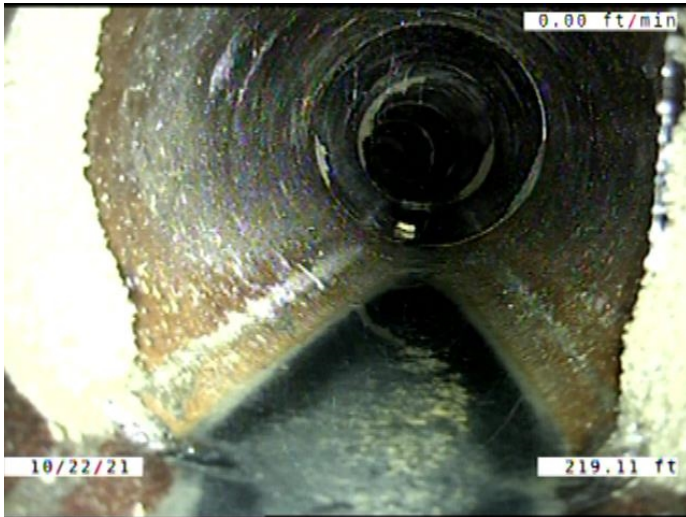
Code: **MWLS**  
 Description: **Miscellaneous Water Level Sag**

Distance (ft): **219.1**  
 Structural Grade: **2**  
 O&M Grade: **0**  
 Clock Start/From:  
 Clock To:  
 1st Value:  
 2nd Value:  
 Value Percent: **5.000**  
 Continuous Index:  
 Within 8" of Joint: **NO**  
 Remarks:

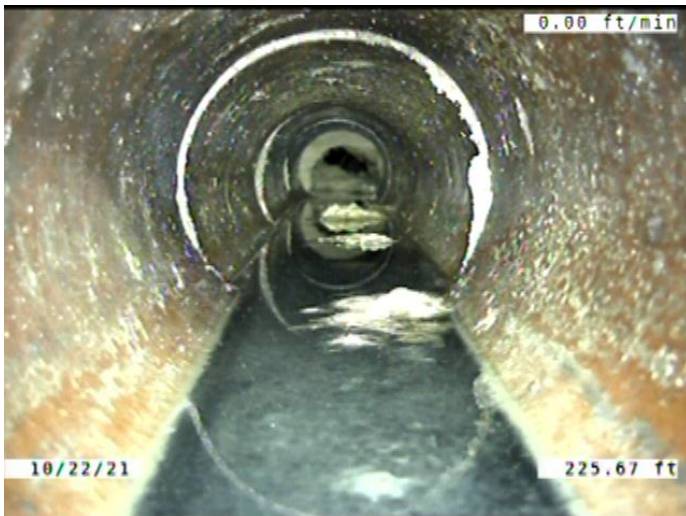
Code: **MWLS**  
 Description: **Miscellaneous Water Level Sag**

Distance (ft): **225.7**  
 Structural Grade: **2**  
 O&M Grade: **0**  
 Clock Start/From:  
 Clock To:  
 1st Value:  
 2nd Value:  
 Value Percent: **5.000**  
 Continuous Index: **S06**  
 Within 8" of Joint: **NO**  
 Remarks:

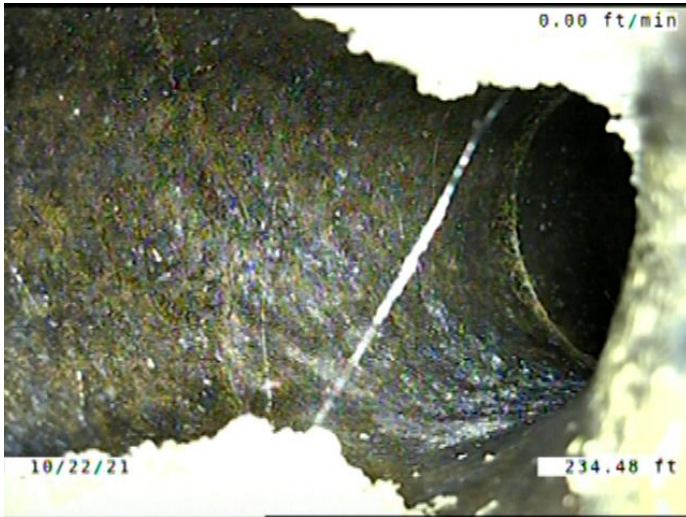
Code: **TBI**  
 Description: **Tap Break-in Intruding**

Distance (ft): **234.5**  
 Structural Grade: **0**  
 O&M Grade: **2**  
 Clock Start/From: **1**  
 Clock To:  
 1st Value: **4.000**  
 2nd Value: **2.000**  
 Value Percent:  
 Continuous Index:  
 Within 8" of Joint: **YES**  
 Remarks:

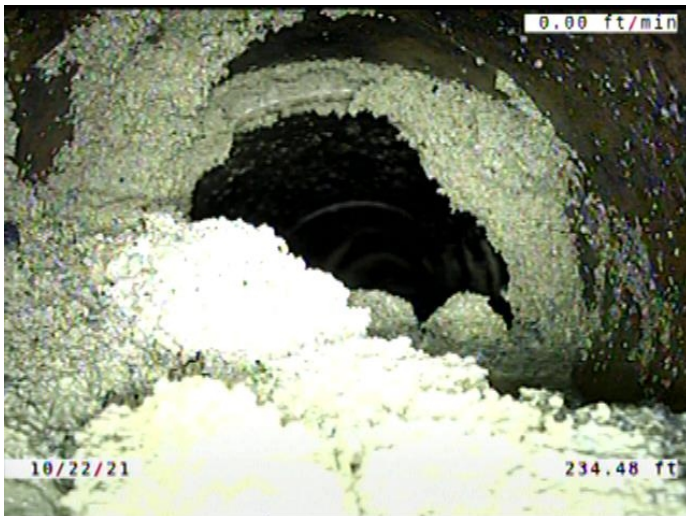
Code: **MWLS**  
 Description: **Miscellaneous Water Level Sag**

Distance (ft): **234.5**  
 Structural Grade: **2**  
 O&M Grade: **0**  
 Clock Start/From:  
 Clock To:  
 1st Value:  
 2nd Value:  
 Value Percent: **5.000**  
 Continuous Index: **F06**  
 Within 8" of Joint: **NO**  
 Remarks:

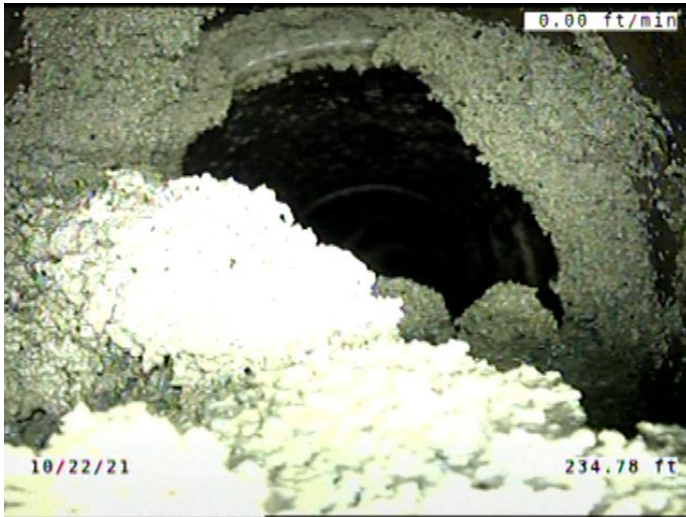
Code: **DSF**  
 Description: **Deposits Settled Fine**

Distance (ft): **234.8**  
 Structural Grade: **0**  
 O&M Grade: **5**  
 Clock Start/From: **12**  
 Clock To: **12**  
 1st Value:  
 2nd Value:  
 Value Percent: **55.000**  
 Continuous Index:  
 Within 8" of Joint: **YES**  
 Remarks:

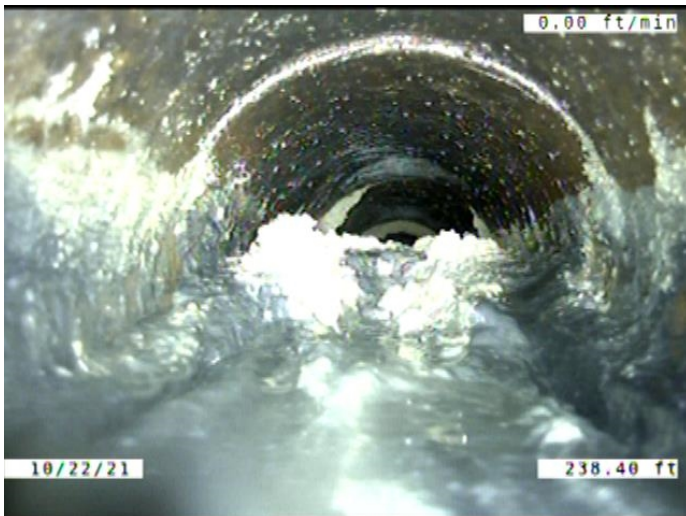
Code: **DSF**  
 Description: **Deposits Settled Fine**

Distance (ft): **238.4**  
 Structural Grade: **0**  
 O&M Grade: **2**  
 Clock Start/From: **5**  
 Clock To: **7**  
 1st Value:  
 2nd Value:  
 Value Percent: **5.000**  
 Continuous Index: **F04**  
 Within 8" of Joint: **YES**  
 Remarks:
