# Profile/Photo Observation Report

Date:	10/22/2021	Weather:		Coding:	PACP 7.0
Pipe Length (ft):	294.0	Owner:	City of Hobart	Pre Clean:	Heavy Cleaning
P.O.#:	YES502259	Surveyor:	S. Bucklin	PSR:	P-804-021-020
Customer:	City of Hobart	Clean Date:	09/15/2021	Shape:	C

Street:	North Illinois Street	Flow Control:	Not Controlled
City:	Hobart, IN	Year Renewed:	
Location:	Alley	Tape/Media #:	
Purpose:	Routine Assessment	Dia/Height:	8"
Use:	Sanitary Sewage Pipe	Material:	VCP
Drain Area:		Lining:	None
Category:	NA		
Comment:			
Location Details:		Direction of Survey:	Upstream
US MH:	M-804-021	DS MH:	M-804-020
		Total Length Surveyed (ft):	238.4

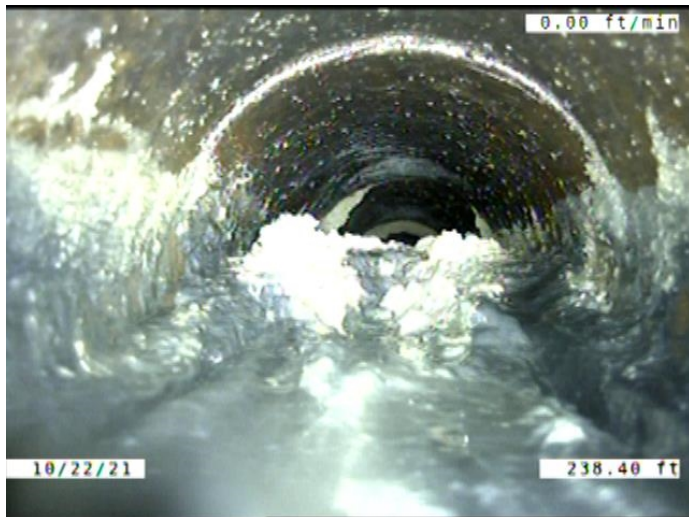
Code: **DAE**  
 Description: **Deposits Attached Encrustation**

Distance (ft): **238.4**  
 Structural Grade: **0**  
 O&M Grade: **2**  
 Clock Start/From: **7**  
 Clock To: **5**  
 1st Value:  
 2nd Value:  
 Value Percent: **5.000**  
 Continuous Index: **F02**  
 Within 8" of Joint: **YES**  
 Remarks:

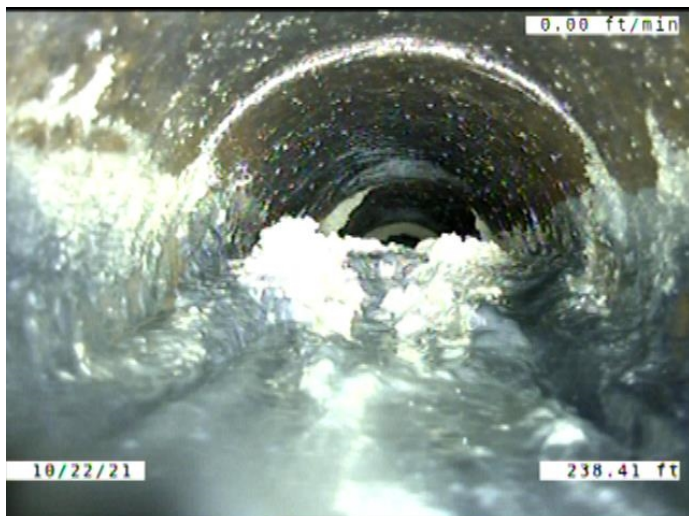
Code: **MSA**  
 Description: **Miscellaneous Survey Abandoned**

Distance (ft): **238.4**  
 Structural Grade: **0**  
 O&M Grade: **0**  
 Clock Start/From:  
 Clock To:  
 1st Value:  
 2nd Value:  
 Value Percent:  
 Continuous Index:  
 Within 8" of Joint: **NO**  
 Remarks: **CAMERA CANT MAKE IT PAST DEBRIS**
