## Profile/Photo Observation Report

Date:	<b>10/23/2021</b>	Weather:		Coding:	<b>PACP 7.0</b>
Pipe Length (ft):	<b>294.0</b>	Owner:	<b>City of Hobart</b>	Pre Clean:	<b>Heavy Cleaning</b>
P.O.#:	<b>YES502259</b>	Surveyor:	<b>S. Bucklin</b>	PSR:	<b>P-804-021-020</b>
Customer:	<b>City of Hobart</b>	Clean Date:	<b>09/15/2021</b>	Shape:	<b>C</b>

Street:	<b>North Illinois Street</b>	Flow Control:	<b>Not Controlled</b>
City:	<b>Hobart, IN</b>	Year Renewed:	
Location:	<b>Alley</b>	Tape/Media #:	
Purpose:	<b>Routine Assessment</b>	Dia/Height:	<b>8"</b>
Use:	<b>Sanitary Sewage Pipe</b>	Material:	<b>VCP</b>
Drain Area:		Lining:	<b>None</b>
Category:	<b>NA</b>		
Comment:

Location Details:		Direction of Survey:	<b>Downstream</b>
US MH:	<b>M-804-021</b>	DS MH:	<b>M-804-020</b>
		Total Length Surveyed (ft):	<b>82.8</b>

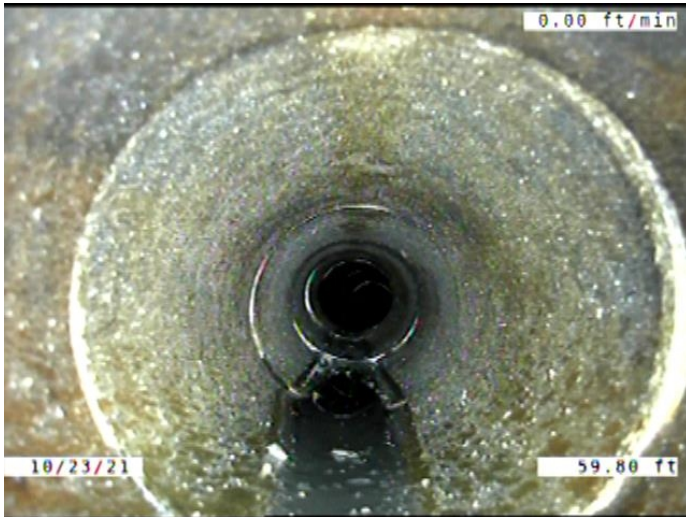
Code: **BSV**  
Description: **Broken Soil Visible**

Distance (ft): **59.8**  
Structural Grade: **5**  
O&M Grade: **0**  
Clock Start/From: **12**  
Clock To: **12**  
1st Value:  
2nd Value:  
Value Percent:  
Continuous Index: **F04**  
Within 8" of Joint: **YES**  
Remarks:

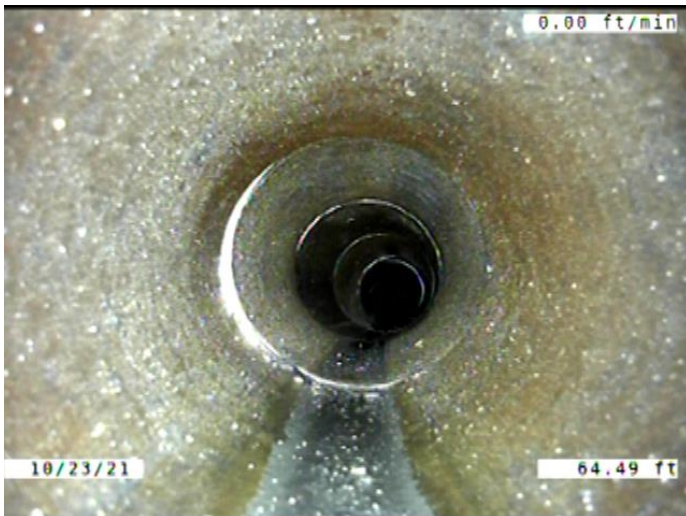
Code: **MWLS**  
Description: **Miscellaneous Water Level Sag**

Distance (ft): **64.5**  
Structural Grade: **2**  
O&M Grade: **0**  
Clock Start/From:  
Clock To:  
1st Value:  
2nd Value:  
Value Percent: **10.000**  
Continuous Index: **F02**  
Within 8" of Joint: **NO**  
Remarks:

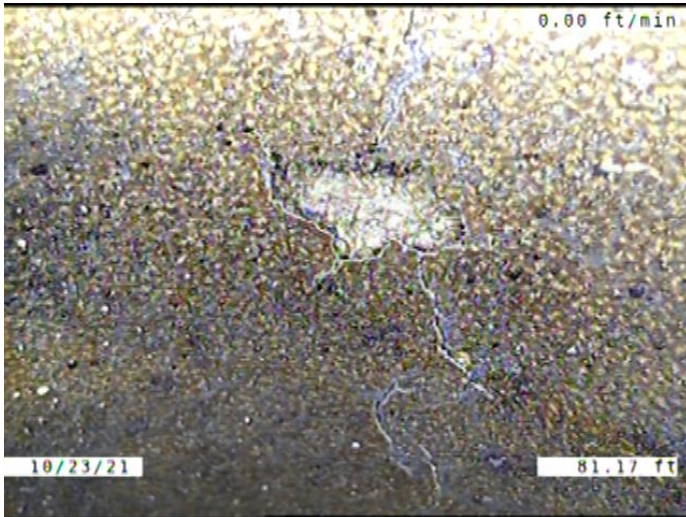
Code:	<b>SSS</b>
Description:	<b>Surface Damage Surface Spalling</b>
Distance (ft):	<b>81.2</b>
Structural Grade:	<b>2</b>
O&M Grade:	<b>0</b>
Clock Start/From:	<b>1</b>
Clock To:	
1st Value:	
2nd Value:	
Value Percent:	
Continuous Index:	
Within 8" of Joint:	<b>YES</b>
Remarks:

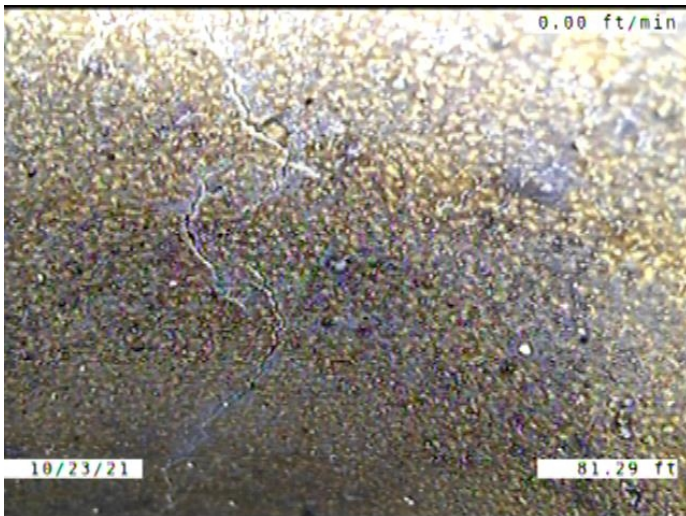
Code:	<b>CS</b>
Description:	<b>Crack Spiral</b>
Distance (ft):	<b>81.3</b>
Structural Grade:	<b>2</b>
O&M Grade:	<b>0</b>
Clock Start/From:	<b>1</b>
Clock To:	<b>2</b>
1st Value:	
2nd Value:	
Value Percent:	
Continuous Index:	
Within 8" of Joint:	<b>YES</b>
Remarks:

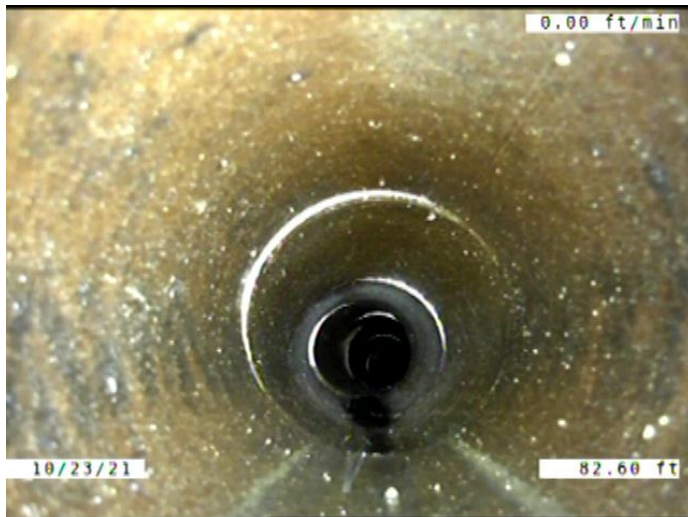
Code: **DSF**  
 Description: **Deposits Settled Fine**

Distance (ft): **82.6**  
 Structural Grade: **0**  
 O&M Grade: **2**  
 Clock Start/From: **5**  
 Clock To: **7**  
 1st Value:  
 2nd Value:  
 Value Percent: **5.000**  
 Continuous Index: **F03**  
 Within 8" of Joint: **YES**  
 Remarks:

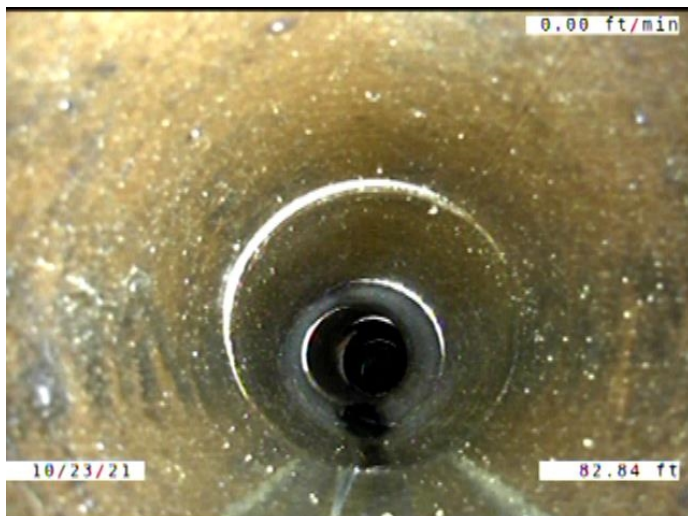
Code: **MSA**  
 Description: **Miscellaneous Survey Abandoned**

Distance (ft): **82.8**  
 Structural Grade: **0**  
 O&M Grade: **0**  
 Clock Start/From:  
 Clock To:  
 1st Value:  
 2nd Value:  
 Value Percent:  
 Continuous Index:  
 Within 8" of Joint: **NO**  
 Remarks: **MADE IT TO THE POINT OF OVERLAP.  
 REVERSAL COMPLETE.**
