## Profile/Photo Observation Report

Date:	<b>10/23/2021</b>	Weather:		Coding:	<b>PACP 7.0</b>
Pipe Length (ft):	<b>294.0</b>	Owner:	<b>City of Hobart</b>	Pre Clean:	<b>Heavy Cleaning</b>
P.O.#:	<b>YES502259</b>	Surveyor:	<b>S. Bucklin</b>	PSR:	<b>P-804-021-020</b>
Customer:	<b>City of Hobart</b>	Clean Date:	<b>09/15/2021</b>	Shape:	<b>C</b>

Street:	<b>North Illinois Street</b>	Flow Control:	<b>Not Controlled</b>
City:	<b>Hobart, IN</b>	Year Renewed:	
Location:	<b>Alley</b>	Tape/Media #:	
Purpose:	<b>Routine Assessment</b>	Dia/Height:	<b>8"</b>
Use:	<b>Sanitary Sewage Pipe</b>	Material:	<b>VCP</b>
Drain Area:		Lining:	<b>None</b>
Category:	<b>NA</b>		
Comment:

Location Details:		Direction of Survey:	<b>Downstream</b>
US MH:	<b>M-804-021</b>	DS MH:	<b>M-804-020</b>
		Total Length Surveyed (ft):	<b>82.8</b>

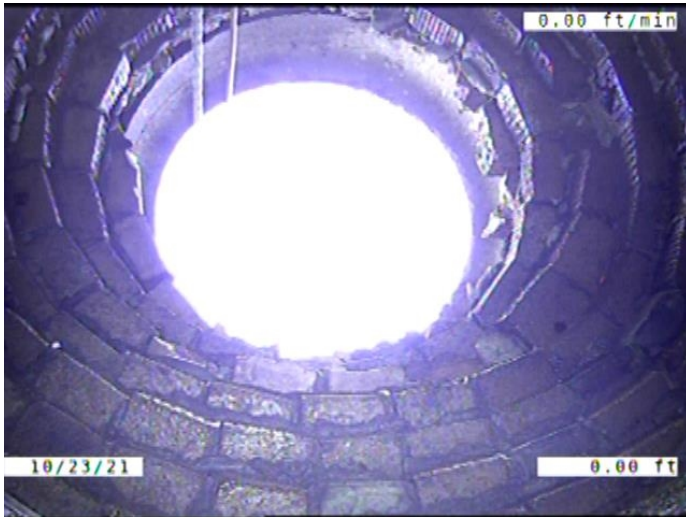
Code: **AMH**  
 Description: **Manhole**

Distance (ft): **.0**  
 Structural Grade: **0**  
 O&M Grade: **0**  
 Clock Start/From:  
 Clock To:  
 1st Value:  
 2nd Value:  
 Value Percent:  
 Continuous Index:  
 Within 8" of Joint: **NO**  
 Remarks: **M-804-021**

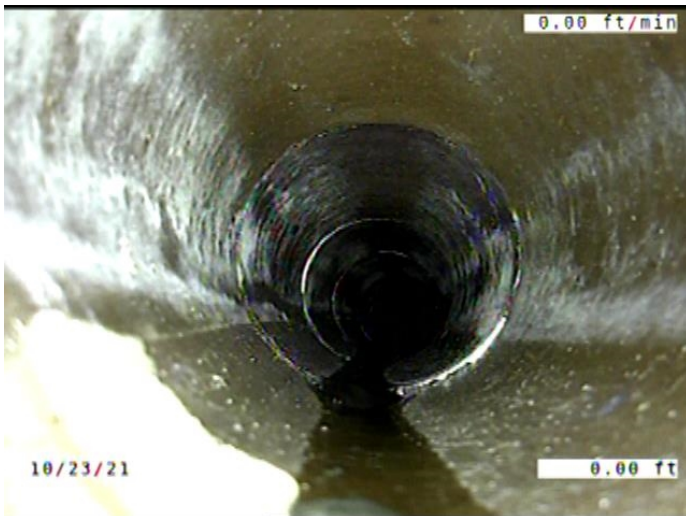
Code: **MWL**  
 Description: **Miscellaneous Water Level**

Distance (ft): **.0**  
 Structural Grade: **0**  
 O&M Grade: **0**  
 Clock Start/From:  
 Clock To:  
 1st Value:  
 2nd Value:  
 Value Percent: **5.000**  
 Continuous Index:  
 Within 8" of Joint: **NO**  
 Remarks:

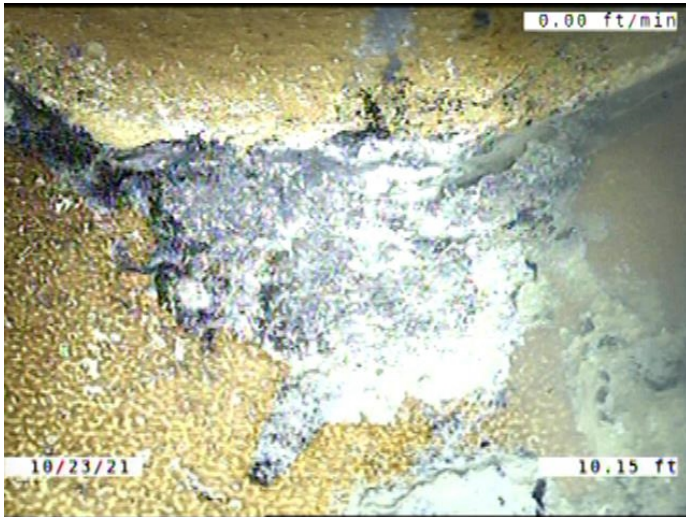
Code: **DAE**  
 Description: **Deposits Attached Encrustation**

Distance (ft): **10.2**  
 Structural Grade: **0**  
 O&M Grade: **2**  
 Clock Start/From: **3**  
 Clock To: **9**  
 1st Value:  
 2nd Value:  
 Value Percent: **5.000**  
 Continuous Index: **S01**  
 Within 8" of Joint: **YES**  
 Remarks:

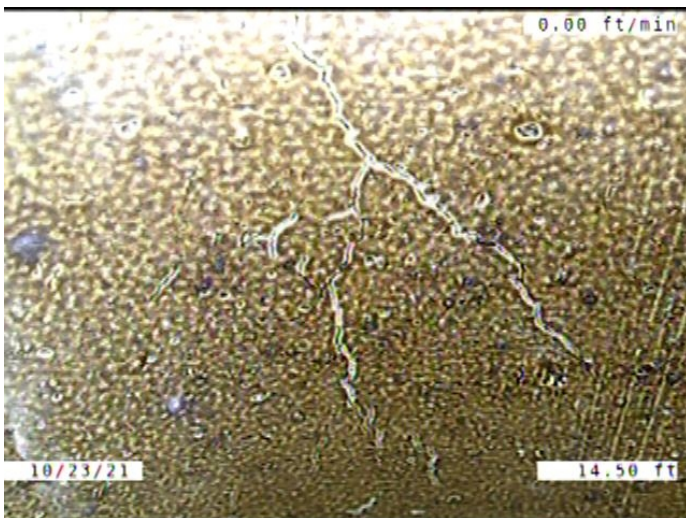
Code: **CM**  
 Description: **Crack Multiple**

Distance (ft): **14.5**  
 Structural Grade: **3**  
 O&M Grade: **0**  
 Clock Start/From: **10**  
 Clock To: **11**  
 1st Value:  
 2nd Value:  
 Value Percent:  
 Continuous Index:  
 Within 8" of Joint: **YES**  
 Remarks:

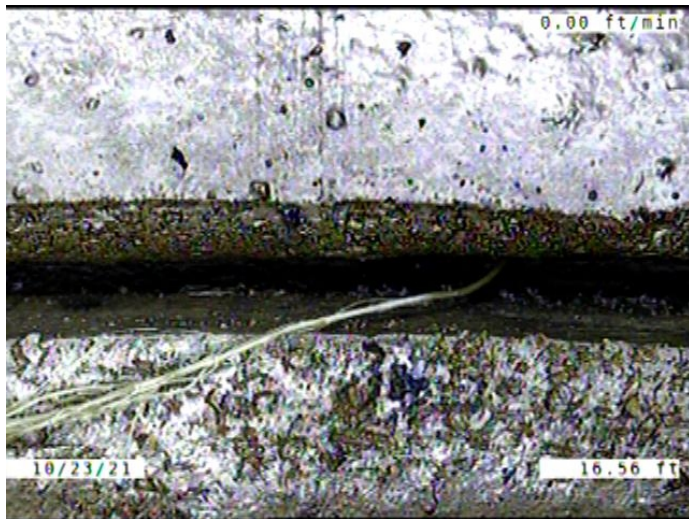
Code: **RFJ**  
 Description: **Roots Fine Joint**

Distance (ft): **16.6**  
 Structural Grade: **0**  
 O&M Grade: **1**  
 Clock Start/From: **9**  
 Clock To: **11**  
 1st Value:  
 2nd Value:  
 Value Percent:  
 Continuous Index:  
 Within 8" of Joint: **YES**  
 Remarks:

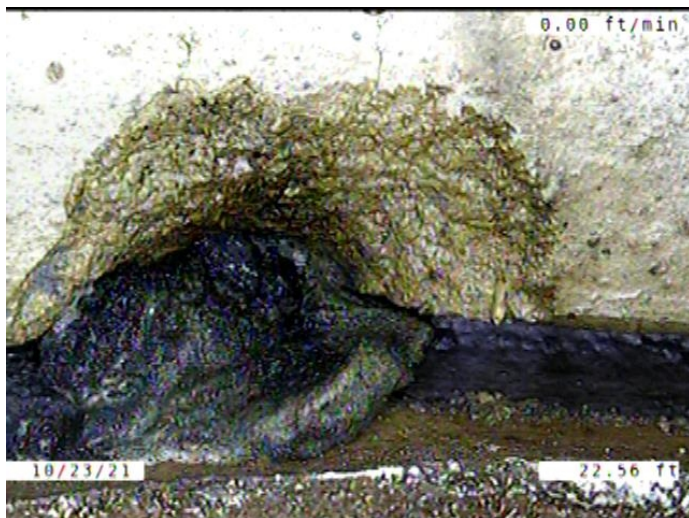
Code: **SZ**  
 Description: **Surface Damage Other**

Distance (ft): **22.6**  
 Structural Grade: **0**  
 O&M Grade: **0**  
 Clock Start/From: **9**  
 Clock To:  
 1st Value:  
 2nd Value:  
 Value Percent:  
 Continuous Index:  
 Within 8" of Joint: **YES**  
 Remarks: **A PIECE CHIPPED AWAY FROM THE JOINT**

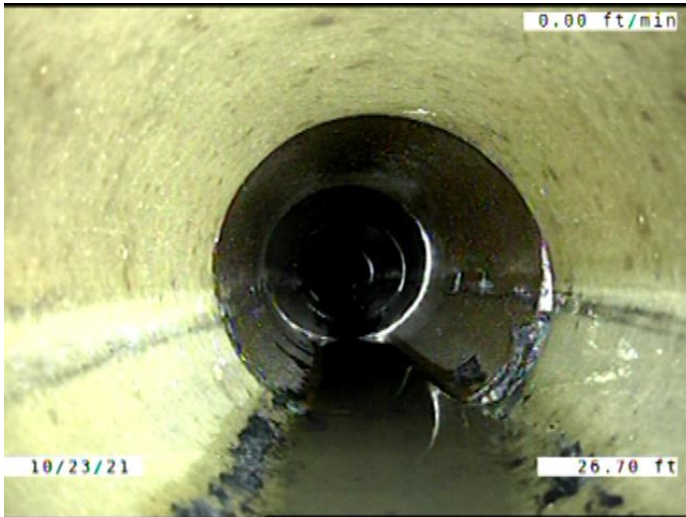
Code: **MWLS**  
 Description: **Miscellaneous Water Level Sag**

Distance (ft): **26.7**  
 Structural Grade: **2**  
 O&M Grade: **0**  
 Clock Start/From:  
 Clock To:  
 1st Value:  
 2nd Value:  
 Value Percent: **5.000**  
 Continuous Index:  
 Within 8" of Joint: **NO**  
 Remarks:

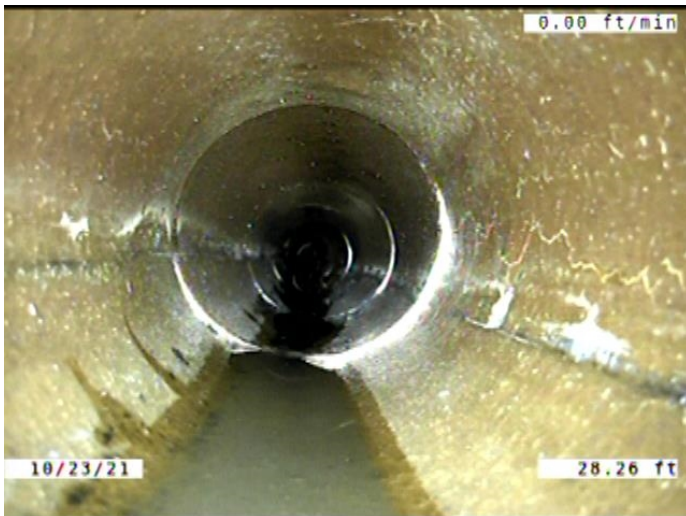
Code: **CM**  
 Description: **Crack Multiple**

Distance (ft): **28.3**  
 Structural Grade: **3**  
 O&M Grade: **0**  
 Clock Start/From: **10**  
 Clock To: **3**  
 1st Value:  
 2nd Value:  
 Value Percent:  
 Continuous Index:  
 Within 8" of Joint: **YES**  
 Remarks:

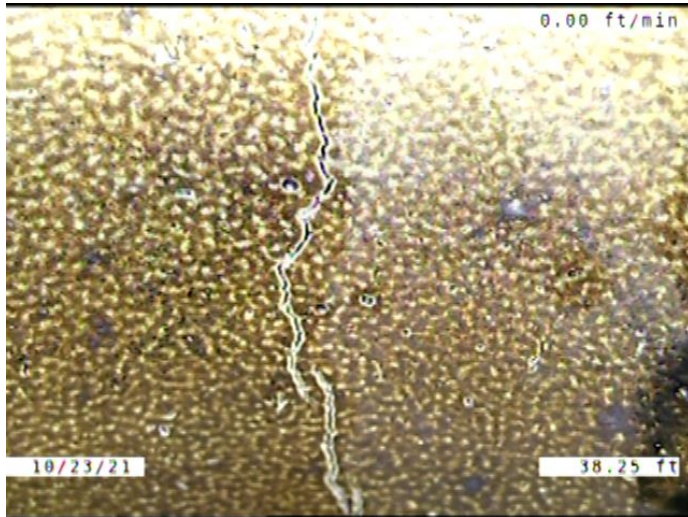
Code: **CL**  
 Description: **Crack Longitudinal**

Distance (ft): **38.3**  
 Structural Grade: **2**  
 O&M Grade: **0**  
 Clock Start/From: **2**  
 Clock To:  
 1st Value:  
 2nd Value:  
 Value Percent:  
 Continuous Index:  
 Within 8" of Joint: **YES**  
 Remarks:

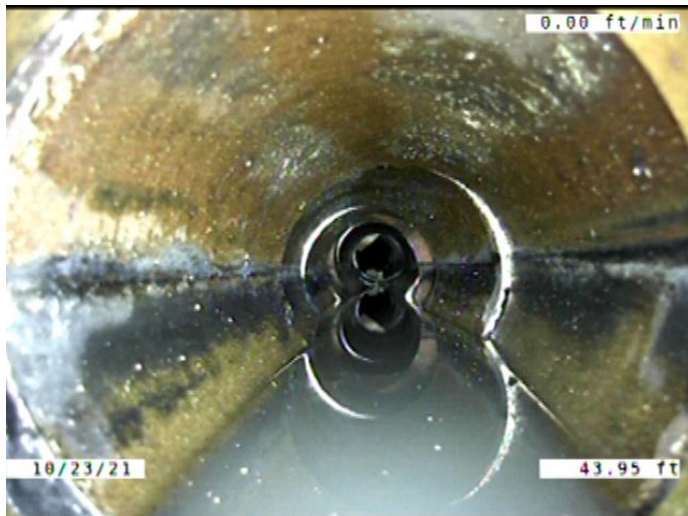
Code: **MWLS**  
 Description: **Miscellaneous Water Level Sag**

Distance (ft): **43.9**  
 Structural Grade: **2**  
 O&M Grade: **0**  
 Clock Start/From:  
 Clock To:  
 1st Value:  
 2nd Value:  
 Value Percent: **10.000**  
 Continuous Index: **S02**  
 Within 8" of Joint: **NO**  
 Remarks:

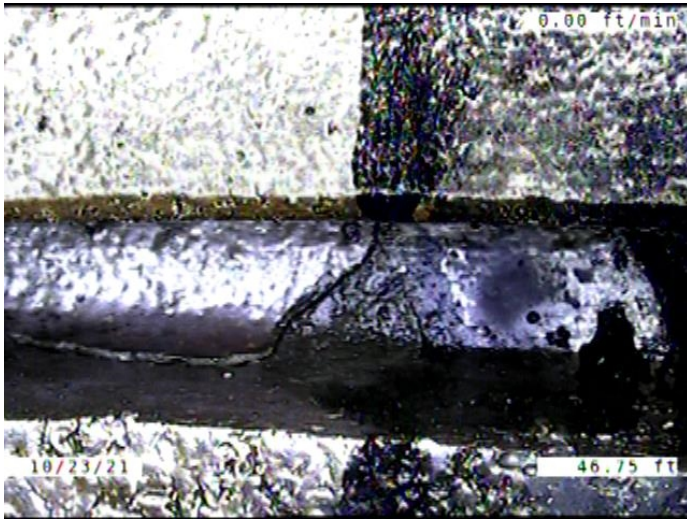
Code: **JAM**  
Description: **Joint Angular Medium**

Distance (ft): **46.8**  
Structural Grade: **3**  
O&M Grade: **0**  
Clock Start/From:  
Clock To:  
1st Value:  
2nd Value:  
Value Percent:  
Continuous Index:  
Within 8" of Joint: **NO**  
Remarks:

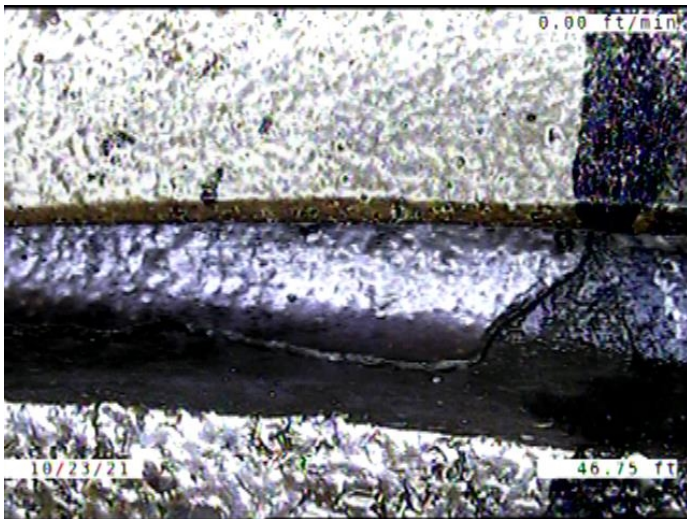
Code: **B**  
Description: **Broken**

Distance (ft): **46.8**  
Structural Grade: **4**  
O&M Grade: **0**  
Clock Start/From: **1**  
Clock To: **3**  
1st Value:  
2nd Value:  
Value Percent:  
Continuous Index:  
Within 8" of Joint: **NO**  
Remarks:

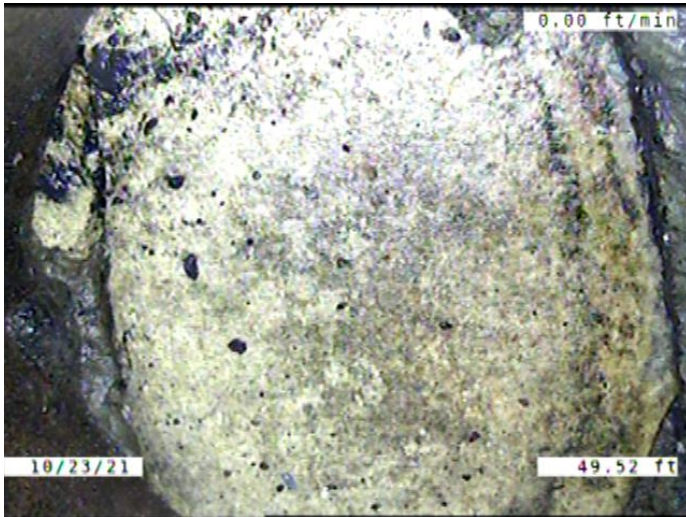
Code: **TFC**  
 Description: **Tap Factory Capped**

Distance (ft): **49.5**  
 Structural Grade: **0**  
 O&M Grade: **0**  
 Clock Start/From: **2**  
 Clock To:  
 1st Value: **4.000**  
 2nd Value:  
 Value Percent:  
 Continuous Index:  
 Within 8" of Joint: **YES**  
 Remarks:

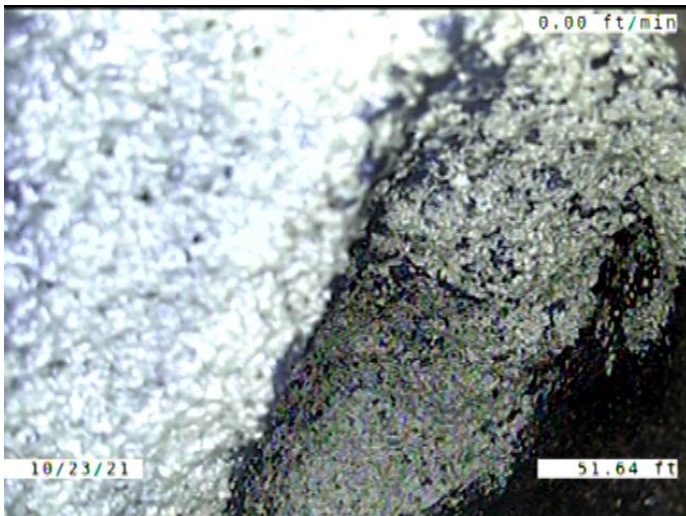
Code: **TFD**  
 Description: **Tap Factory Defective**

Distance (ft): **51.6**  
 Structural Grade: **0**  
 O&M Grade: **3**  
 Clock Start/From: **10**  
 Clock To:  
 1st Value: **4.000**  
 2nd Value:  
 Value Percent:  
 Continuous Index:  
 Within 8" of Joint: **YES**  
 Remarks: **100% PLUGGED**

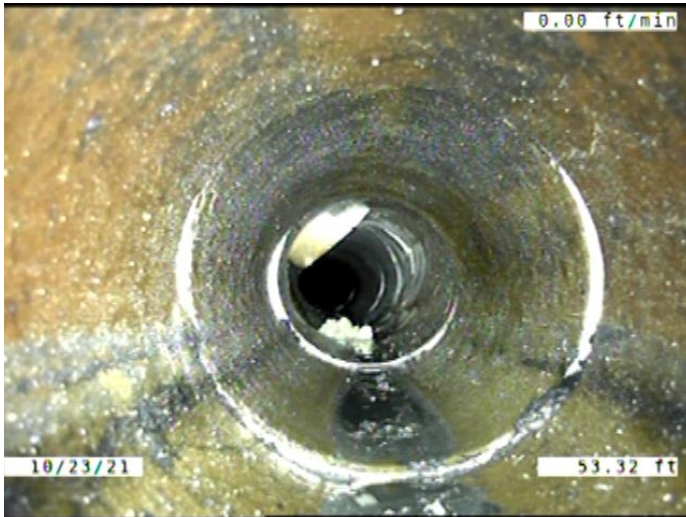
Code: **DSF**  
 Description: **Deposits Settled Fine**

Distance (ft): **53.3**  
 Structural Grade: **0**  
 O&M Grade: **2**  
 Clock Start/From: **5**  
 Clock To: **7**  
 1st Value:  
 2nd Value:  
 Value Percent: **5.000**  
 Continuous Index: **S03**  
 Within 8" of Joint: **YES**  
 Remarks:

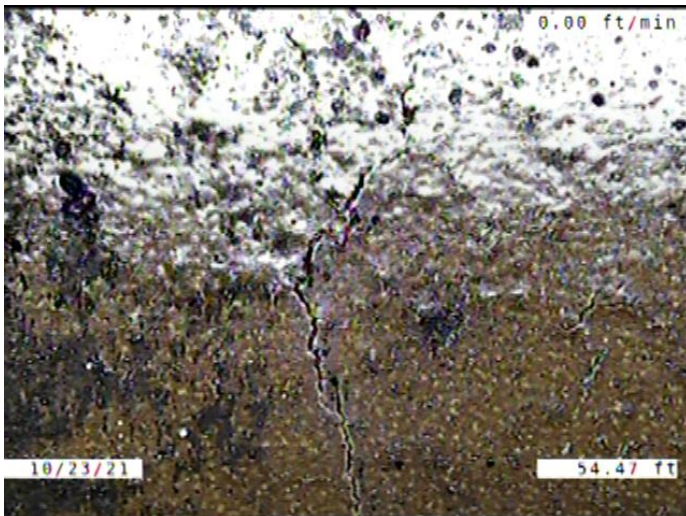
Code: **CL**  
 Description: **Crack Longitudinal**

Distance (ft): **54.5**  
 Structural Grade: **2**  
 O&M Grade: **0**  
 Clock Start/From: **2**  
 Clock To:  
 1st Value:  
 2nd Value:  
 Value Percent:  
 Continuous Index:  
 Within 8" of Joint: **YES**  
 Remarks:

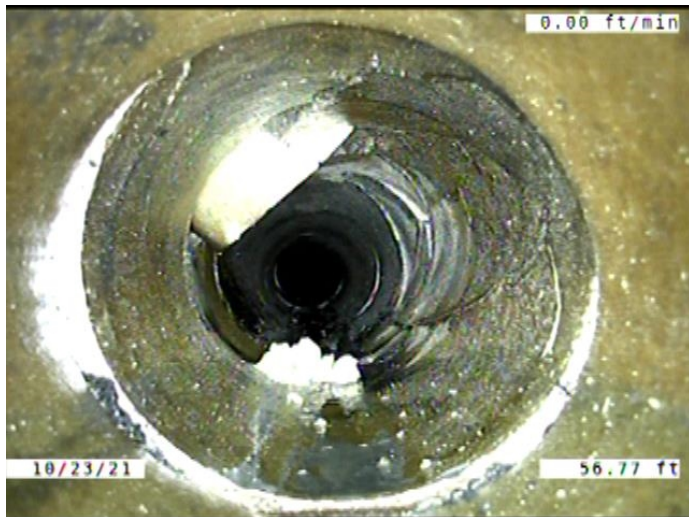
Code: **BSV**  
 Description: **Broken Soil Visible**

Distance (ft): **56.8**  
 Structural Grade: **5**  
 O&M Grade: **0**  
 Clock Start/From: **12**  
 Clock To: **12**  
 1st Value:  
 2nd Value:  
 Value Percent:  
 Continuous Index: **S04**  
 Within 8" of Joint: **YES**  
 Remarks:

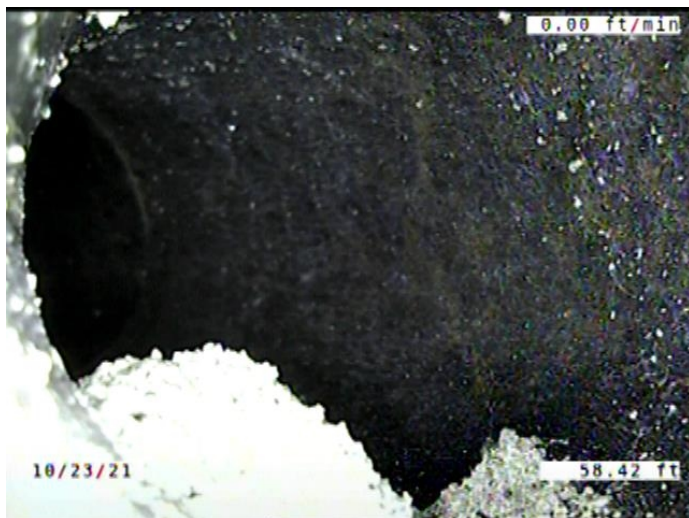
Code: **TBI**  
 Description: **Tap Break-in Intruding**

Distance (ft): **58.4**  
 Structural Grade: **0**  
 O&M Grade: **2**  
 Clock Start/From: **11**  
 Clock To:  
 1st Value: **4.000**  
 2nd Value: **2.000**  
 Value Percent:  
 Continuous Index:  
 Within 8" of Joint: **YES**  
 Remarks:

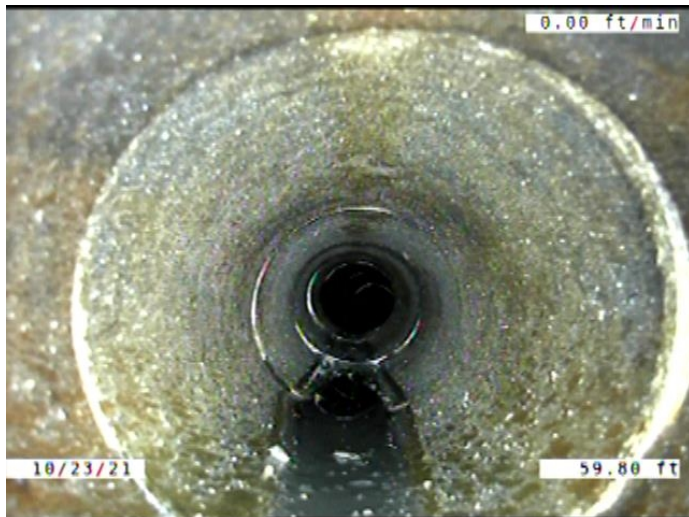
Code: **BSV**  
 Description: **Broken Soil Visible**

Distance (ft): **59.8**  
 Structural Grade: **5**  
 O&M Grade: **0**  
 Clock Start/From: **12**  
 Clock To: **12**  
 1st Value:  
 2nd Value:  
 Value Percent:  
 Continuous Index: **F04**  
 Within 8" of Joint: **YES**  
 Remarks:

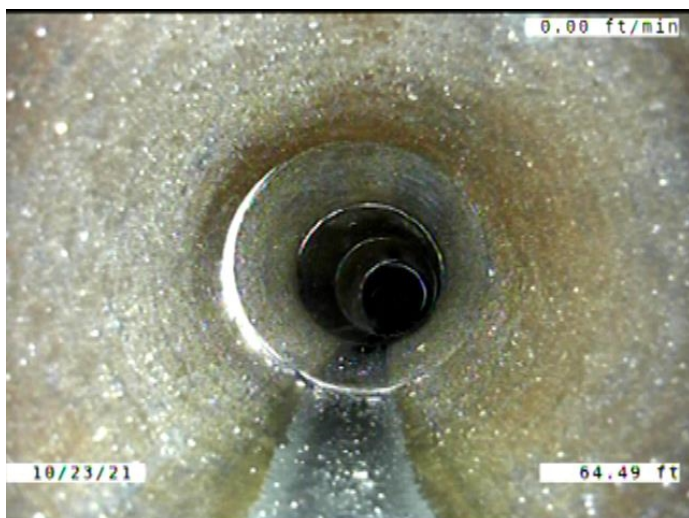
Code: **MWLS**  
 Description: **Miscellaneous Water Level Sag**

Distance (ft): **64.5**  
 Structural Grade: **2**  
 O&M Grade: **0**  
 Clock Start/From:  
 Clock To:  
 1st Value:  
 2nd Value:  
 Value Percent: **10.000**  
 Continuous Index: **F02**  
 Within 8" of Joint: **NO**  
 Remarks:

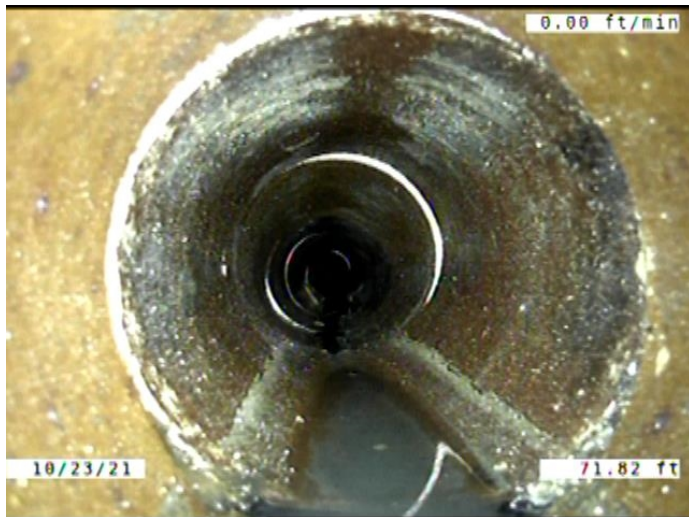
Code: **MWLS**  
 Description: **Miscellaneous Water Level Sag**

Distance (ft): **71.8**  
 Structural Grade: **2**  
 O&M Grade: **0**  
 Clock Start/From:  
 Clock To:  
 1st Value:  
 2nd Value:  
 Value Percent: **5.000**  
 Continuous Index:  
 Within 8" of Joint: **NO**  
 Remarks:

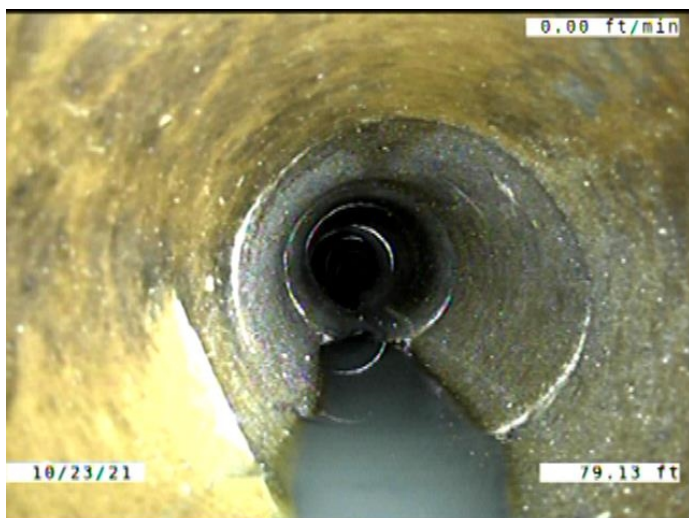
Code: **MWLS**  
 Description: **Miscellaneous Water Level Sag**

Distance (ft): **79.1**  
 Structural Grade: **2**  
 O&M Grade: **0**  
 Clock Start/From:  
 Clock To:  
 1st Value:  
 2nd Value:  
 Value Percent: **5.000**  
 Continuous Index: **S05**  
 Within 8" of Joint: **NO**  
 Remarks:

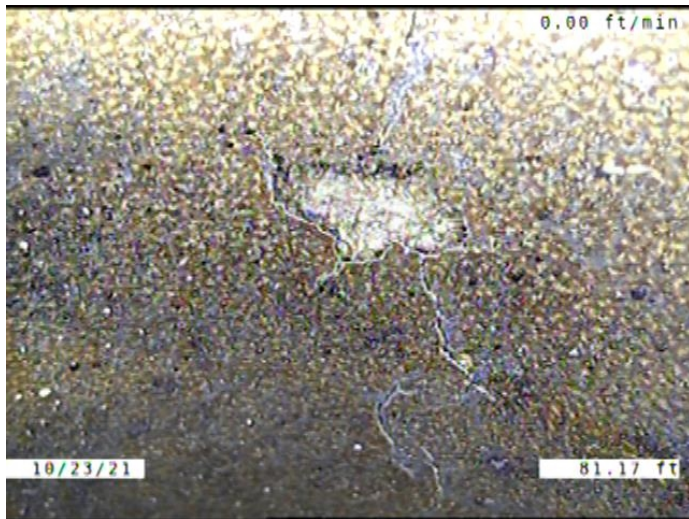
Code:	<b>SSS</b>
Description:	<b>Surface Damage Surface Spalling</b>
Distance (ft):	<b>81.2</b>
Structural Grade:	<b>2</b>
O&M Grade:	<b>0</b>
Clock Start/From:	<b>1</b>
Clock To:	
1st Value:	
2nd Value:	
Value Percent:	
Continuous Index:	
Within 8" of Joint:	<b>YES</b>
Remarks:

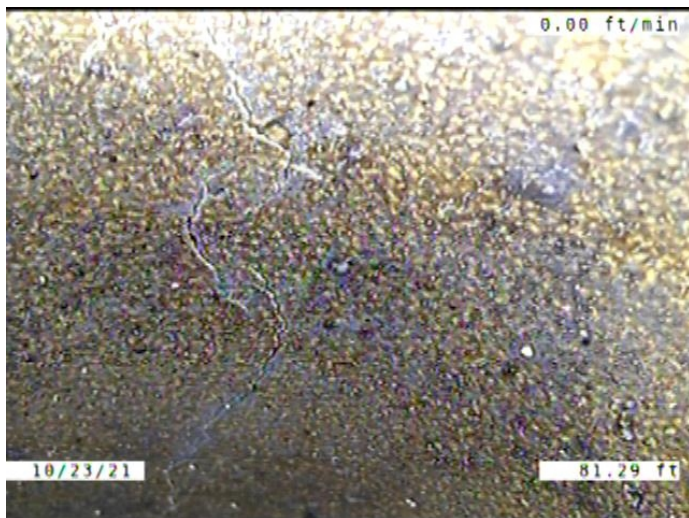
Code:	<b>CS</b>
Description:	<b>Crack Spiral</b>
Distance (ft):	<b>81.3</b>
Structural Grade:	<b>2</b>
O&M Grade:	<b>0</b>
Clock Start/From:	<b>1</b>
Clock To:	<b>2</b>
1st Value:	
2nd Value:	
Value Percent:	
Continuous Index:	
Within 8" of Joint:	<b>YES</b>
Remarks:

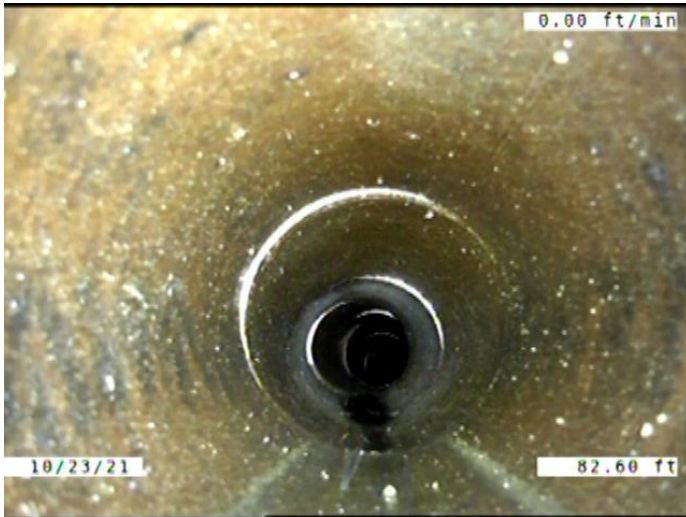
Code: **MWLS**  
Description: **Miscellaneous Water Level Sag**

Distance (ft): **82.6**  
Structural Grade: **2**  
O&M Grade: **0**  
Clock Start/From:  
Clock To:  
1st Value:  
2nd Value:  
Value Percent: **5.000**  
Continuous Index: **F05**  
Within 8" of Joint: **NO**  
Remarks:

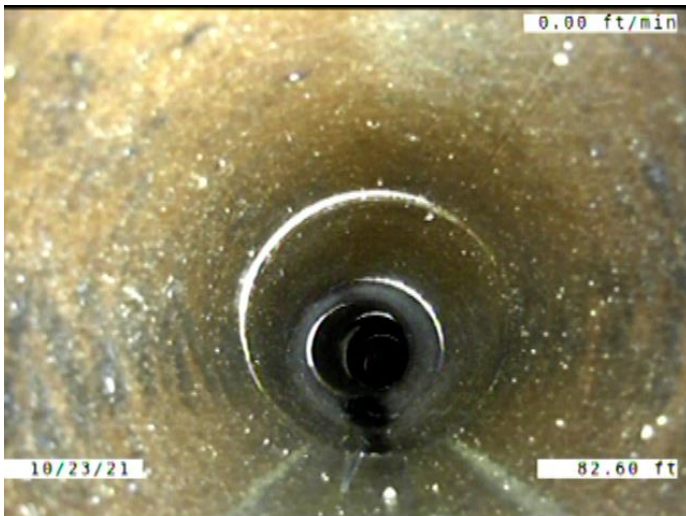
Code: **DAE**  
Description: **Deposits Attached Encrustation**

Distance (ft): **82.6**  
Structural Grade: **0**  
O&M Grade: **2**  
Clock Start/From: **3**  
Clock To: **9**  
1st Value:  
2nd Value:  
Value Percent: **5.000**  
Continuous Index: **F01**  
Within 8" of Joint: **YES**  
Remarks:

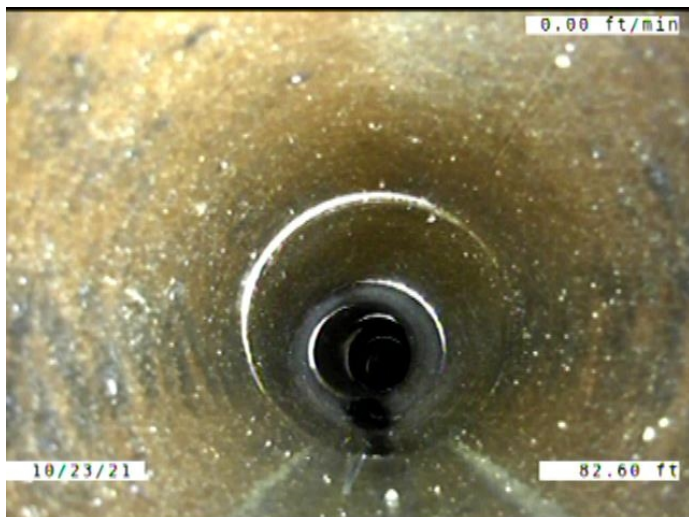
Code: **DSF**  
 Description: **Deposits Settled Fine**

Distance (ft): **82.6**  
 Structural Grade: **0**  
 O&M Grade: **2**  
 Clock Start/From: **5**  
 Clock To: **7**  
 1st Value:  
 2nd Value:  
 Value Percent: **5.000**  
 Continuous Index: **F03**  
 Within 8" of Joint: **YES**  
 Remarks:

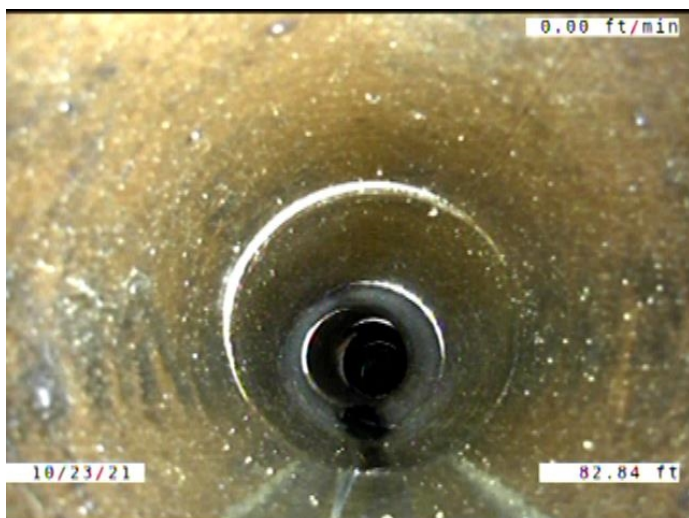
Code: **MSA**  
 Description: **Miscellaneous Survey Abandoned**

Distance (ft): **82.8**  
 Structural Grade: **0**  
 O&M Grade: **0**  
 Clock Start/From:  
 Clock To:  
 1st Value:  
 2nd Value:  
 Value Percent:  
 Continuous Index:  
 Within 8" of Joint: **NO**  
 Remarks: **MADE IT TO THE POINT OF OVERLAP.  
 REVERSAL COMPLETE.**
