# Profile/Photo Observation Report

Date:	10/18/2021	Weather:		Coding:	PACP 7.0
Pipe Length (ft):	288.5	Owner:	City of Hobart	Pre Clean:	Heavy Cleaning
P.O.#:	YES502259	Surveyor:	S. Bucklin	PSR:	P-804-023-024
Customer:	City of Hobart	Clean Date:	10/15/2021	Shape:	C

Street:	North Kelly Street	Flow Control:	Not Controlled
City:	Hobart, IN	Year Renewed:	
Location:	Local rural streets with light traffic, t	Tape/Media #:	
Purpose:	Routine Assessment	Dia/Height:	12"
Use:	Sanitary Sewage Pipe	Material:	VCP
Drain Area:		Lining:	
Category:	NA		
Comment:			
Location Details:		Direction of Survey:	Upstream
US MH:	M-804-024	DS MH:	M-804-023
		Total Length Surveyed (ft):	288.5

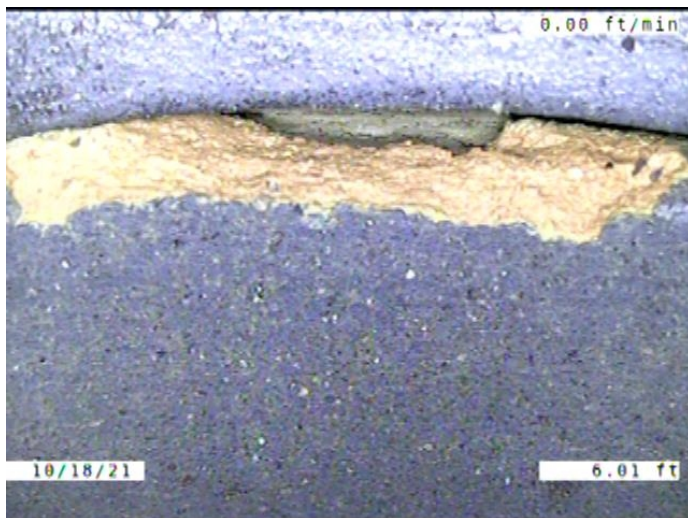
Code: **SZ**  
 Description: **Surface Damage Other**

Distance (ft): **6.0**  
 Structural Grade: **0**  
 O&M Grade: **0**  
 Clock Start/From: **12**  
 Clock To: **1**  
 1st Value:  
 2nd Value:  
 Value Percent:  
 Continuous Index:  
 Within 8" of Joint: **YES**  
 Remarks: **A PIECE CHIPPED AWAY FRO THE JOINT**

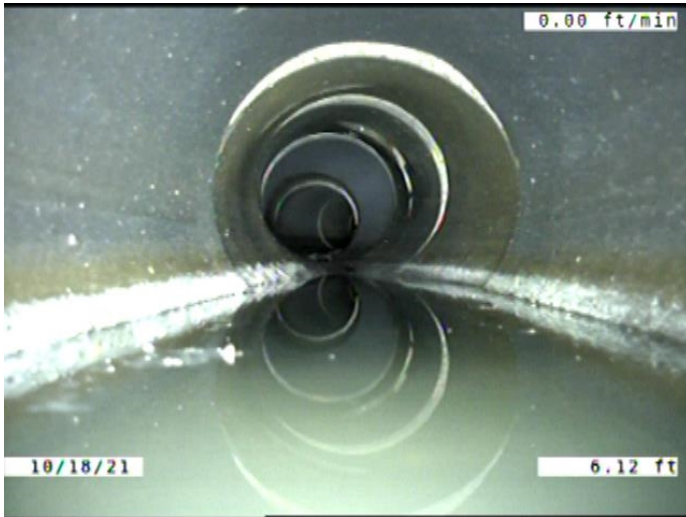
Code: **MWLS**  
Description: **Miscellaneous Water Level Sag**

Distance (ft): **6.1**  
Structural Grade: **2**  
O&M Grade: **0**  
Clock Start/From:  
Clock To:  
1st Value:  
2nd Value:  
Value Percent: **10.000**  
Continuous Index:  
Within 8" of Joint: **NO**  
Remarks:

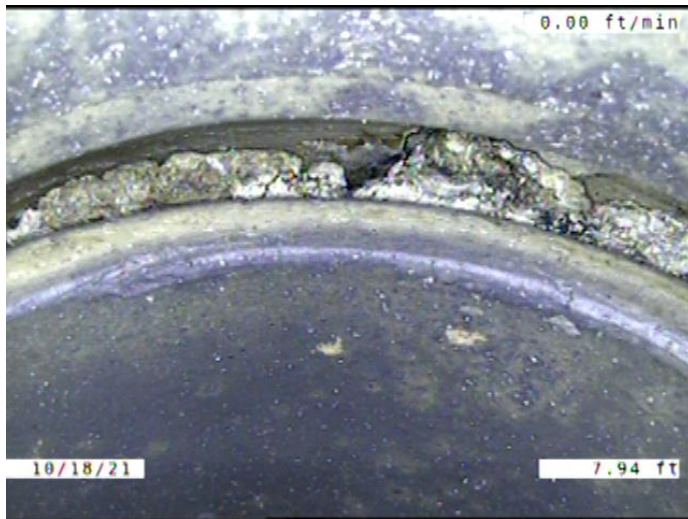
Code: **JOMD**  
Description: **Joint Offset Medium Defective**

Distance (ft): **7.9**  
Structural Grade: **3**  
O&M Grade: **0**  
Clock Start/From:  
Clock To:  
1st Value:  
2nd Value:  
Value Percent:  
Continuous Index: **S01**  
Within 8" of Joint: **NO**  
Remarks:

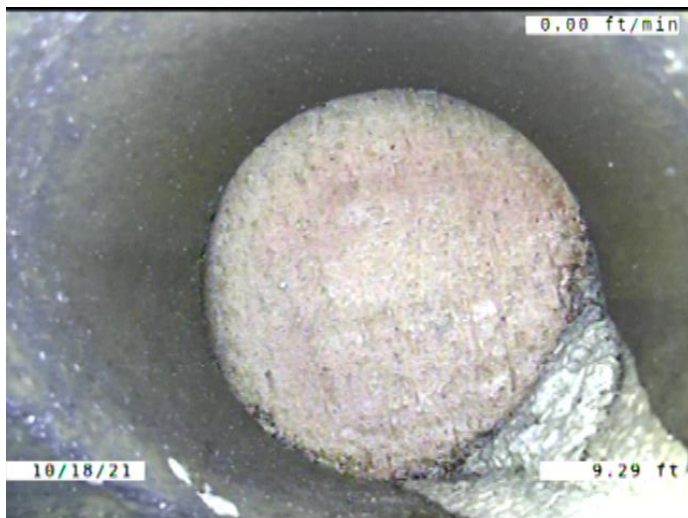
Code: **TFC**  
Description: **Tap Factory Capped**

Distance (ft): **9.3**  
Structural Grade: **0**  
O&M Grade: **0**  
Clock Start/From: **1**  
Clock To:  
1st Value: **4.000**  
2nd Value:  
Value Percent:  
Continuous Index:  
Within 8" of Joint: **YES**  
Remarks: **ENCRUSTATION AROUND THE CAP**

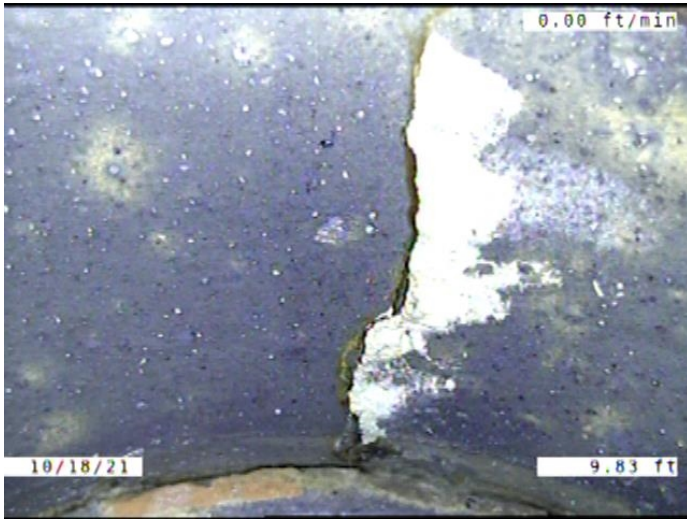
Code: **CL**  
Description: **Crack Longitudinal**

Distance (ft): **9.8**  
Structural Grade: **2**  
O&M Grade: **0**  
Clock Start/From: **12**  
Clock To:  
1st Value:  
2nd Value:  
Value Percent:  
Continuous Index:  
Within 8" of Joint: **YES**  
Remarks:

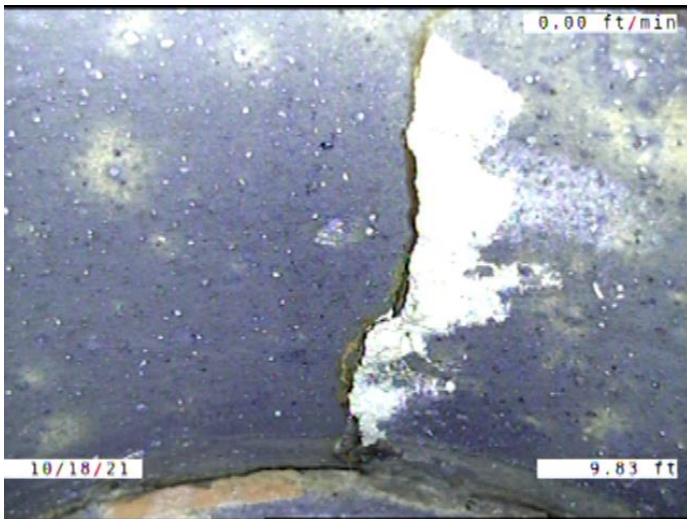
Code: **DAE**  
Description: **Deposits Attached Encrustation**

Distance (ft): **9.8**  
Structural Grade: **0**  
O&M Grade: **2**  
Clock Start/From: **12**  
Clock To:  
1st Value:  
2nd Value:  
Value Percent: **5.000**  
Continuous Index:  
Within 8" of Joint: **YES**  
Remarks:

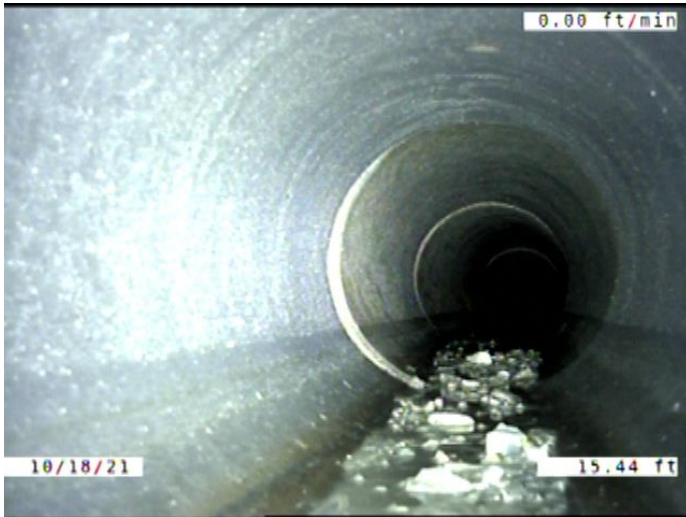
Code: **DSGV**  
Description: **Deposits Settled Gravel**

Distance (ft): **15.4**  
Structural Grade: **0**  
O&M Grade: **2**  
Clock Start/From: **5**  
Clock To: **7**  
1st Value:  
2nd Value:  
Value Percent: **5.000**  
Continuous Index: **S02**  
Within 8" of Joint: **YES**  
Remarks:

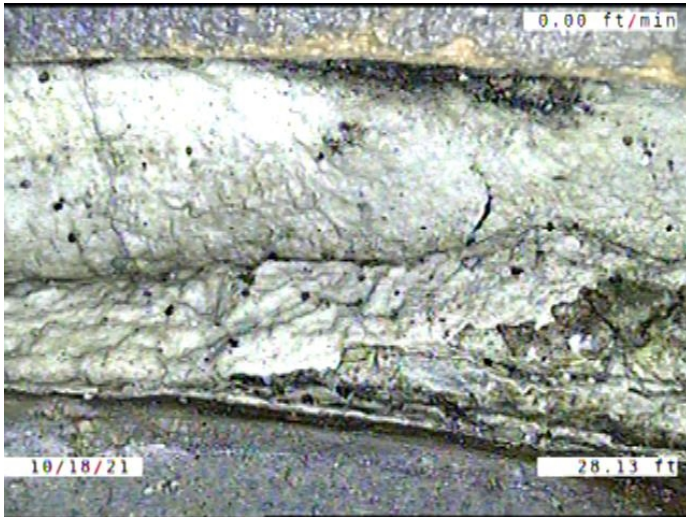
Code: **DAE**  
Description: **Deposits Attached Encrustation**

Distance (ft): **28.1**  
Structural Grade: **0**  
O&M Grade: **2**  
Clock Start/From: **12**  
Clock To: **5**  
1st Value:  
2nd Value:  
Value Percent: **5.000**  
Continuous Index:  
Within 8" of Joint: **YES**  
Remarks:

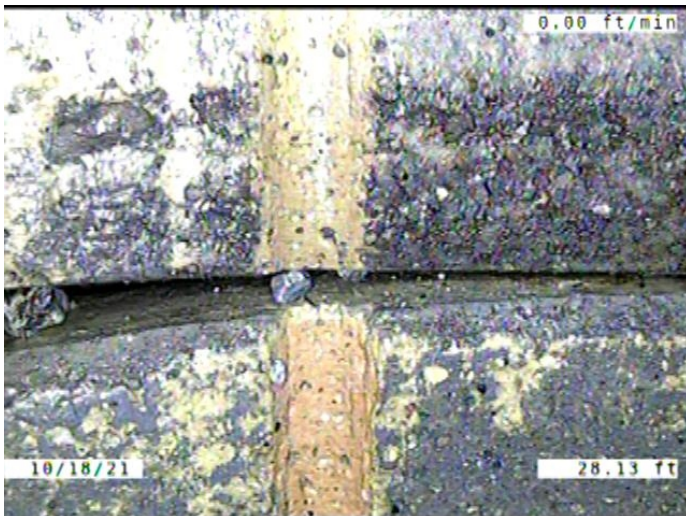
Code: **SZ**  
Description: **Surface Damage Other**

Distance (ft): **28.1**  
Structural Grade: **0**  
O&M Grade: **0**  
Clock Start/From: **9**  
Clock To:  
1st Value:  
2nd Value:  
Value Percent:  
Continuous Index:  
Within 8" of Joint: **YES**  
Remarks: **GROOVE IN THE WALL OF THE PIPE**

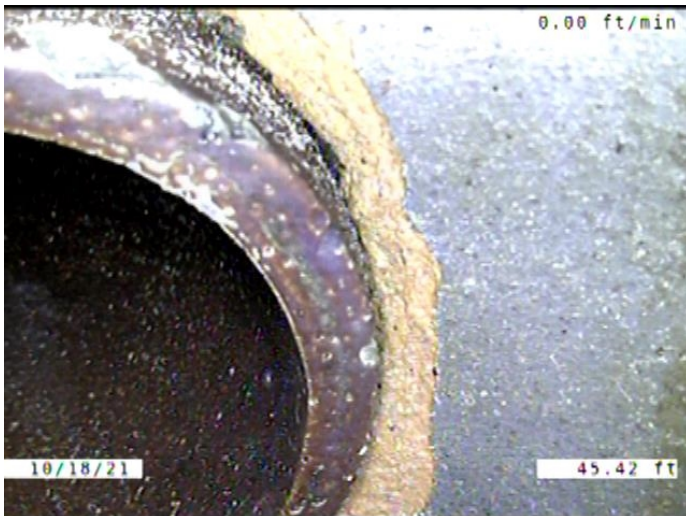
Code: **SSS**  
 Description: **Surface Damage Surface Spalling**

Distance (ft): **45.4**  
 Structural Grade: **2**  
 O&M Grade: **0**  
 Clock Start/From: **11**  
 Clock To: **1**  
 1st Value:  
 2nd Value:  
 Value Percent:  
 Continuous Index:  
 Within 8" of Joint: **NO**  
 Remarks:

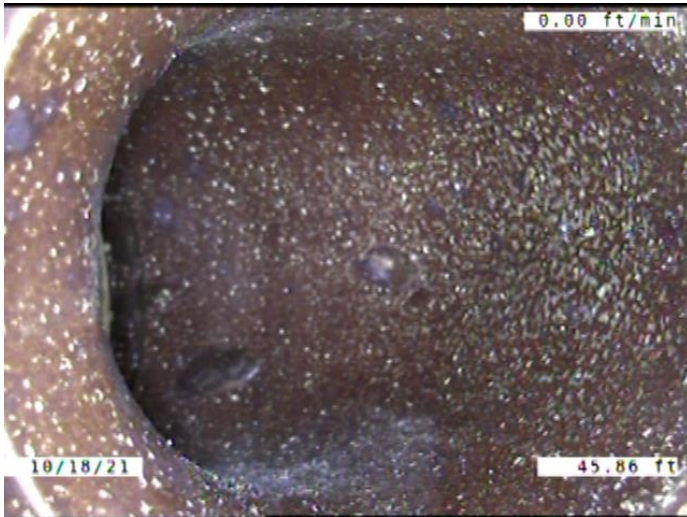
Code: **TBI**  
 Description: **Tap Break-in Intruding**

Distance (ft): **45.9**  
 Structural Grade: **0**  
 O&M Grade: **2**  
 Clock Start/From: **12**  
 Clock To:  
 1st Value: **4.000**  
 2nd Value: **1.000**  
 Value Percent:  
 Continuous Index:  
 Within 8" of Joint: **YES**  
 Remarks:

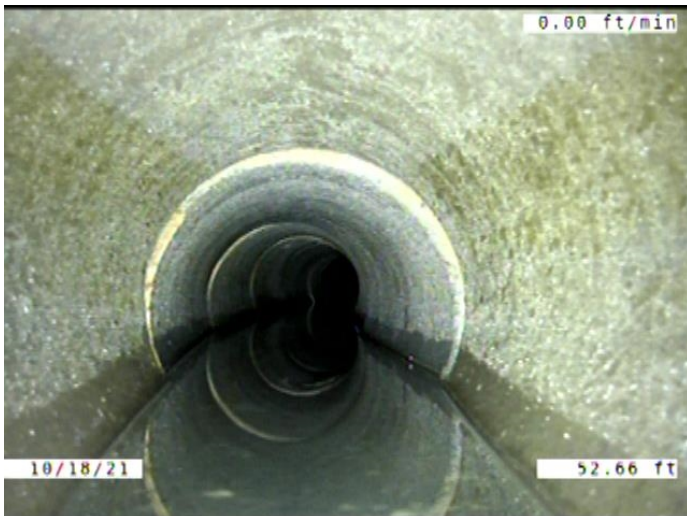
Code: **JOMD**  
 Description: **Joint Offset Medium Defective**

Distance (ft): **52.7**  
 Structural Grade: **3**  
 O&M Grade: **0**  
 Clock Start/From:  
 Clock To:  
 1st Value:  
 2nd Value:  
 Value Percent:  
 Continuous Index: **F01**  
 Within 8" of Joint: **NO**  
 Remarks:

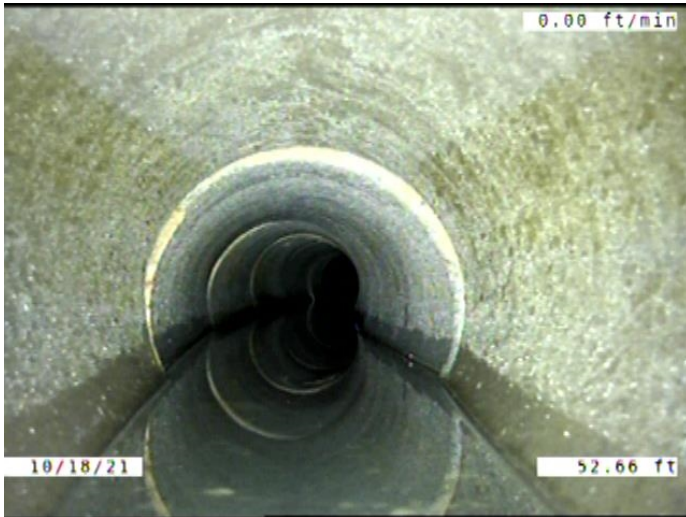
Code: **MWLS**  
Description: **Miscellaneous Water Level Sag**

Distance (ft): **52.7**  
Structural Grade: **2**  
O&M Grade: **0**  
Clock Start/From:  
Clock To:  
1st Value:  
2nd Value:  
Value Percent: **10.000**  
Continuous Index: **S03**  
Within 8" of Joint: **NO**  
Remarks:

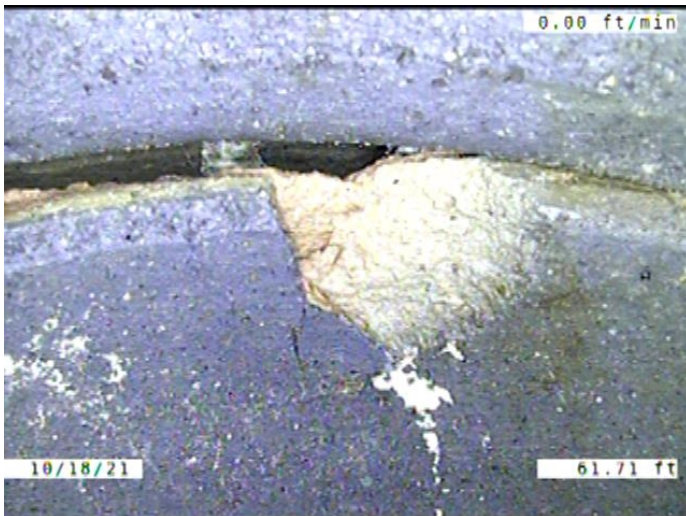
Code: **SSS**  
 Description: **Surface Damage Surface Spalling**

Distance (ft): **61.7**  
 Structural Grade: **2**  
 O&M Grade: **0**  
 Clock Start/From: **1**  
 Clock To:  
 1st Value:  
 2nd Value:  
 Value Percent:  
 Continuous Index:  
 Within 8" of Joint: **YES**  
 Remarks:

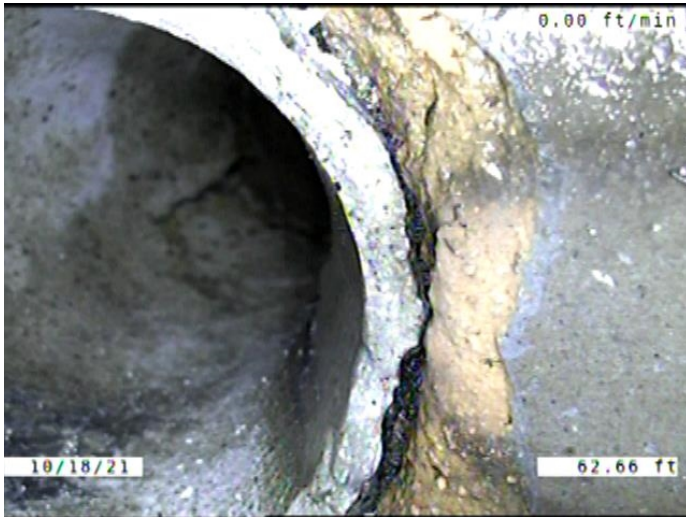
Code:	<b>SSS</b>
Description:	<b>Surface Damage Surface Spalling</b>
Distance (ft):	<b>62.7</b>
Structural Grade:	<b>2</b>
O&M Grade:	<b>0</b>
Clock Start/From:	<b>11</b>
Clock To:	<b>1</b>
1st Value:	
2nd Value:	
Value Percent:	
Continuous Index:	
Within 8" of Joint:	<b>NO</b>
Remarks:

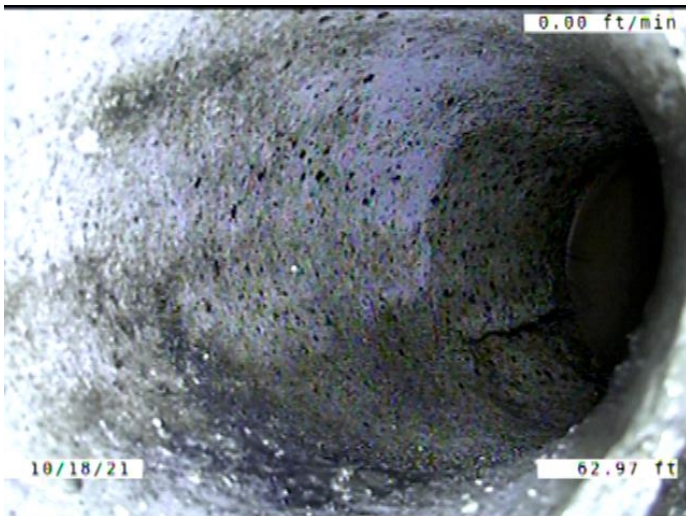
Code:	<b>TBD</b>
Description:	<b>Tap Break-in/Hammer Defective</b>
Distance (ft):	<b>63.0</b>
Structural Grade:	<b>0</b>
O&M Grade:	<b>3</b>
Clock Start/From:	<b>1</b>
Clock To:	
1st Value:	<b>4.000</b>
2nd Value:	
Value Percent:	
Continuous Index:	
Within 8" of Joint:	<b>YES</b>
Remarks:	<b>Defective</b>

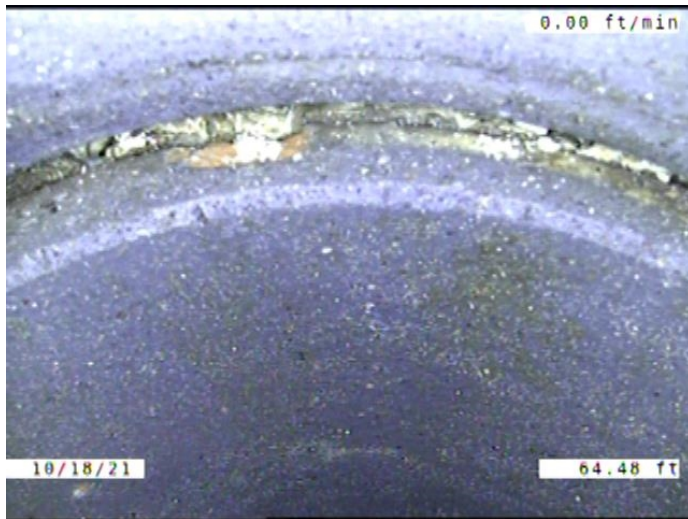
Code: **JOM**  
 Description: **Joint Offset Medium**

Distance (ft): **64.5**  
 Structural Grade: **3**  
 O&M Grade: **0**  
 Clock Start/From:  
 Clock To:  
 1st Value:  
 2nd Value:  
 Value Percent:  
 Continuous Index:  
 Within 8" of Joint: **NO**  
 Remarks:

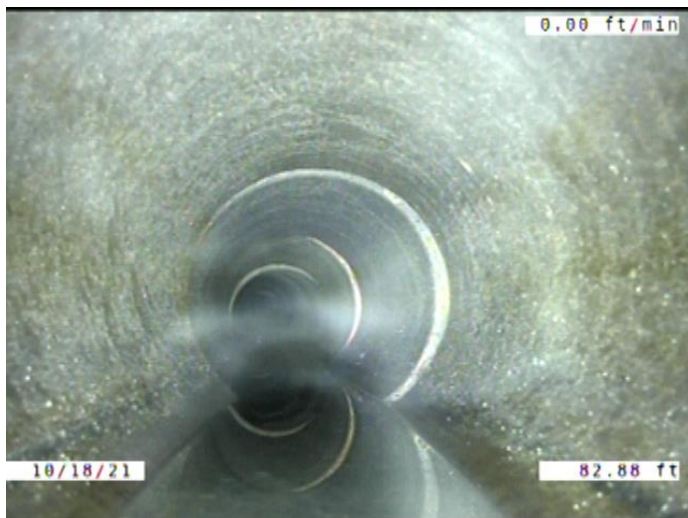
Code: **MWLS**  
 Description: **Miscellaneous Water Level Sag**

Distance (ft): **82.9**  
 Structural Grade: **2**  
 O&M Grade: **0**  
 Clock Start/From:  
 Clock To:  
 1st Value:  
 2nd Value:  
 Value Percent: **10.000**  
 Continuous Index: **F03**  
 Within 8" of Joint: **NO**  
 Remarks:

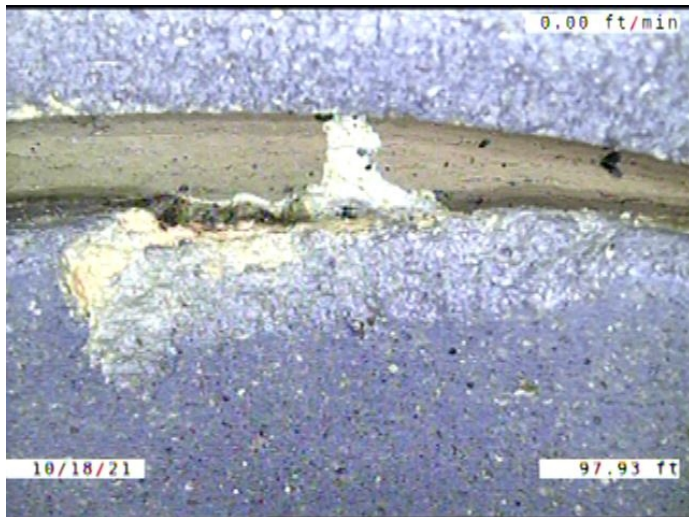
Code:	<b>SZ</b>
Description:	<b>Surface Damage Other</b>
Distance (ft):	<b>97.9</b>
Structural Grade:	<b>0</b>
O&M Grade:	<b>0</b>
Clock Start/From:	<b>1</b>
Clock To:	<b>2</b>
1st Value:	
2nd Value:	
Value Percent:	
Continuous Index:	
Within 8" of Joint:	<b>YES</b>
Remarks:	<b>A PIECE CHIPPED AWAY FROM THE JOINT</b>

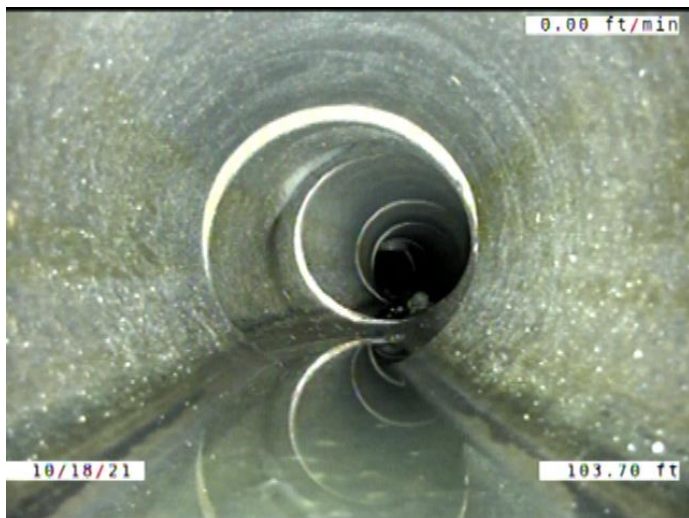
Code:	<b>DSGV</b>
Description:	<b>Deposits Settled Gravel</b>
Distance (ft):	<b>103.7</b>
Structural Grade:	<b>0</b>
O&M Grade:	<b>2</b>
Clock Start/From:	<b>5</b>
Clock To:	<b>7</b>
1st Value:	
2nd Value:	
Value Percent:	<b>5.000</b>
Continuous Index:	<b>F02</b>
Within 8" of Joint:	<b>YES</b>
Remarks:

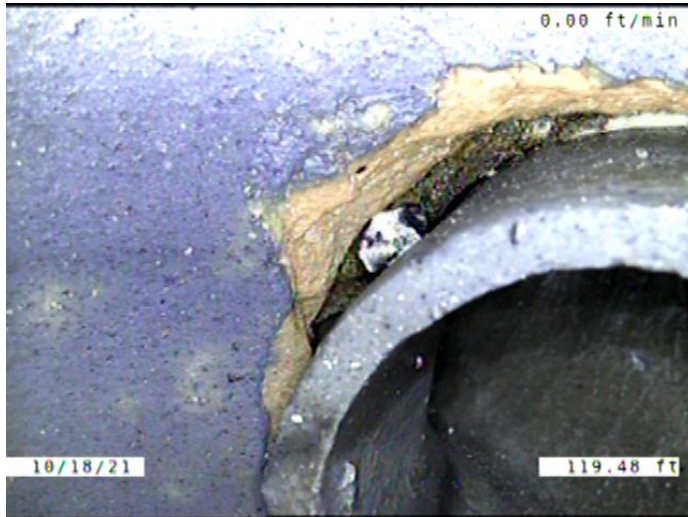
Code:	<b>SSS</b>
Description:	<b>Surface Damage Surface Spalling</b>
Distance (ft):	<b>119.5</b>
Structural Grade:	<b>2</b>
O&M Grade:	<b>0</b>
Clock Start/From:	<b>11</b>
Clock To:	<b>1</b>
1st Value:	
2nd Value:	
Value Percent:	
Continuous Index:	
Within 8" of Joint:	<b>NO</b>
Remarks:

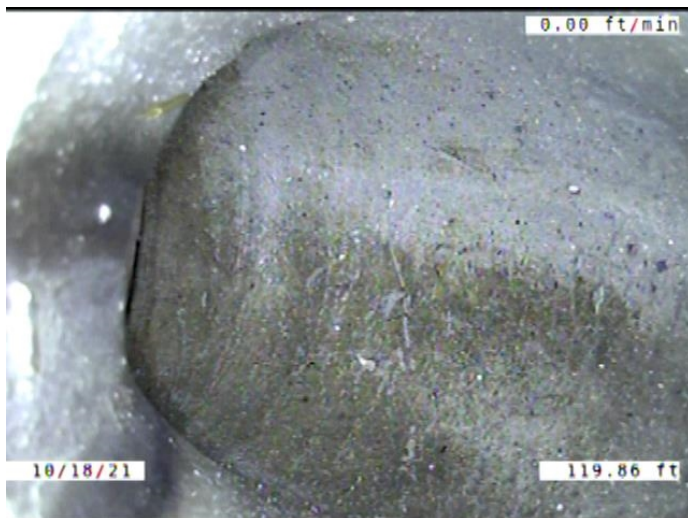
Code:	<b>TBI</b>
Description:	<b>Tap Break-in Intruding</b>
Distance (ft):	<b>119.9</b>
Structural Grade:	<b>0</b>
O&M Grade:	<b>2</b>
Clock Start/From:	<b>12</b>
Clock To:	
1st Value:	<b>4.000</b>
2nd Value:	<b>1.000</b>
Value Percent:	
Continuous Index:	
Within 8" of Joint:	<b>YES</b>
Remarks:

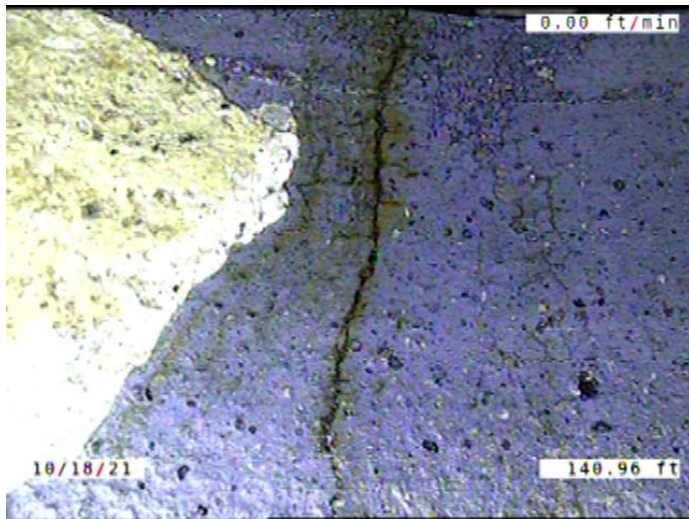
Code: **CL**  
 Description: **Crack Longitudinal**

Distance (ft): **141.0**  
 Structural Grade: **2**  
 O&M Grade: **0**  
 Clock Start/From: **3**  
 Clock To:  
 1st Value:  
 2nd Value:  
 Value Percent:  
 Continuous Index:  
 Within 8" of Joint: **YES**  
 Remarks:

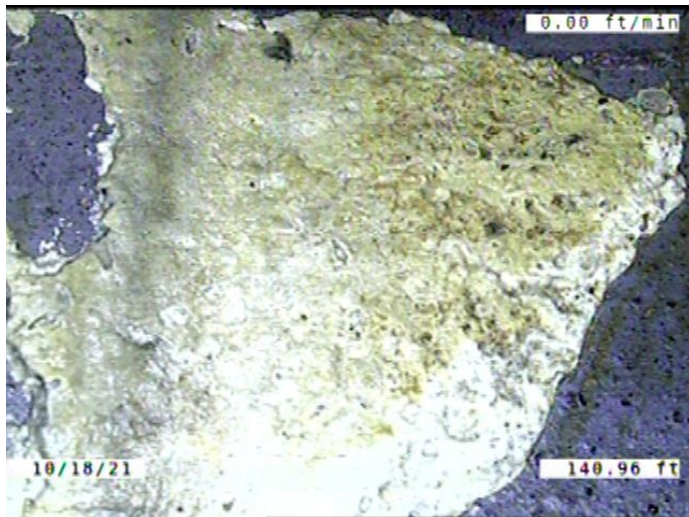
Code: **DAE**  
 Description: **Deposits Attached Encrustation**

Distance (ft): **141.0**  
 Structural Grade: **0**  
 O&M Grade: **2**  
 Clock Start/From: **3**  
 Clock To: **4**  
 1st Value:  
 2nd Value:  
 Value Percent: **5.000**  
 Continuous Index:  
 Within 8" of Joint: **YES**  
 Remarks:

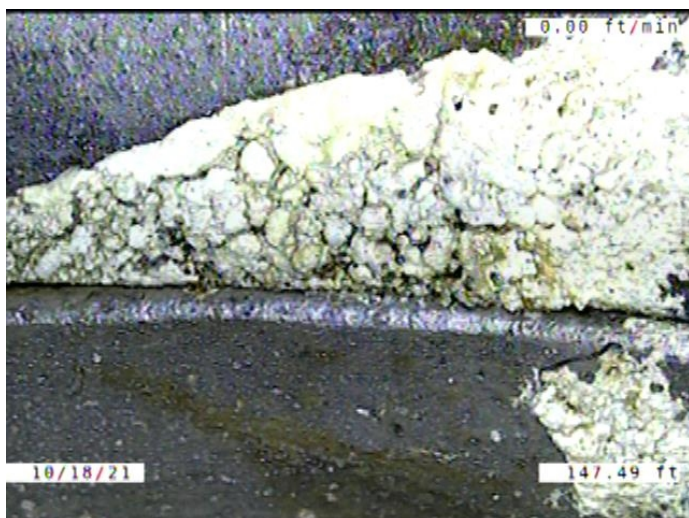
Code: **DAE**  
 Description: **Deposits Attached Encrustation**

Distance (ft): **147.5**  
 Structural Grade: **0**  
 O&M Grade: **2**  
 Clock Start/From: **2**  
 Clock To: **4**  
 1st Value:  
 2nd Value:  
 Value Percent: **5.000**  
 Continuous Index:  
 Within 8" of Joint: **YES**  
 Remarks:

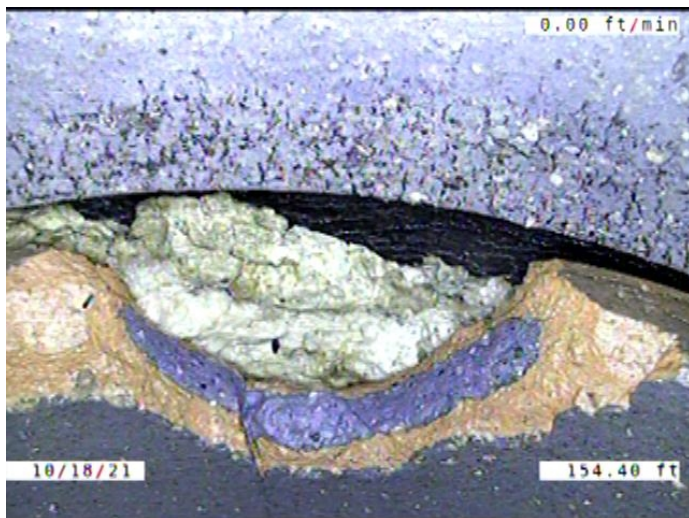
Code: **SMW**  
Description: **Surface Damage Missing Wall**

Distance (ft): **154.4**  
Structural Grade: **5**  
O&M Grade: **0**  
Clock Start/From: **11**  
Clock To: **2**  
1st Value:  
2nd Value:  
Value Percent:  
Continuous Index:  
Within 8" of Joint: **YES**  
Remarks: **INSIDE OF THE JOINT**

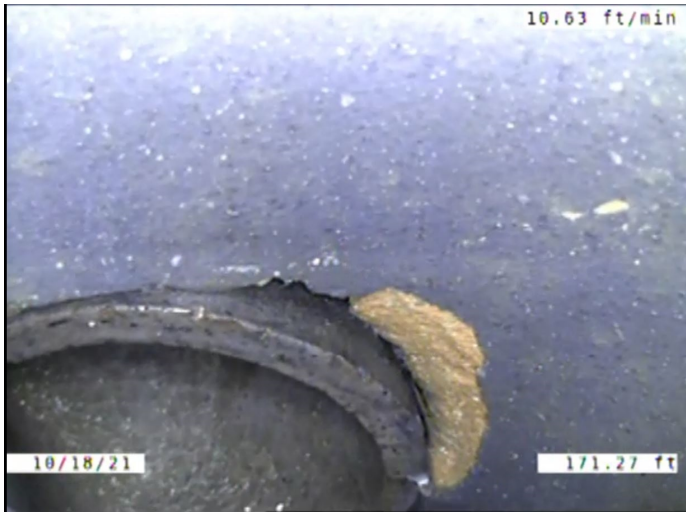
Code:	<b>SSS</b>
Description:	<b>Surface Damage Surface Spalling</b>
Distance (ft):	<b>171.3</b>
Structural Grade:	<b>2</b>
O&M Grade:	<b>0</b>
Clock Start/From:	<b>2</b>
Clock To:	
1st Value:	
2nd Value:	
Value Percent:	
Continuous Index:	
Within 8" of Joint:	<b>NO</b>
Remarks:

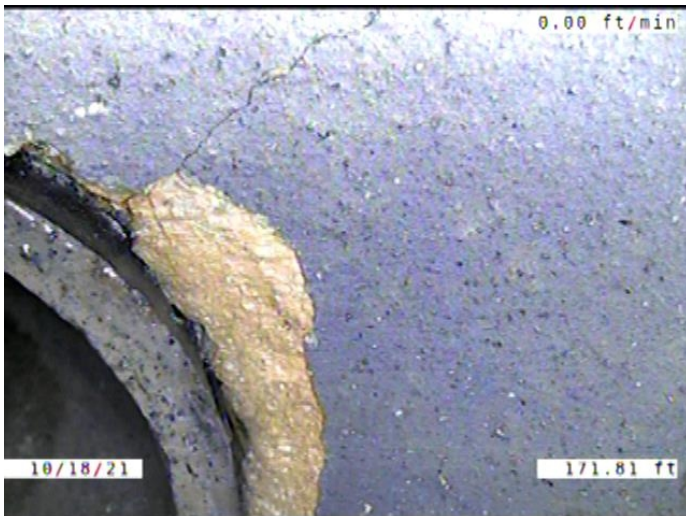
Code:	<b>FM</b>
Description:	<b>Fracture Multiple</b>
Distance (ft):	<b>171.8</b>
Structural Grade:	<b>4</b>
O&M Grade:	<b>0</b>
Clock Start/From:	<b>11</b>
Clock To:	<b>2</b>
1st Value:	
2nd Value:	
Value Percent:	
Continuous Index:	
Within 8" of Joint:	<b>YES</b>
Remarks:

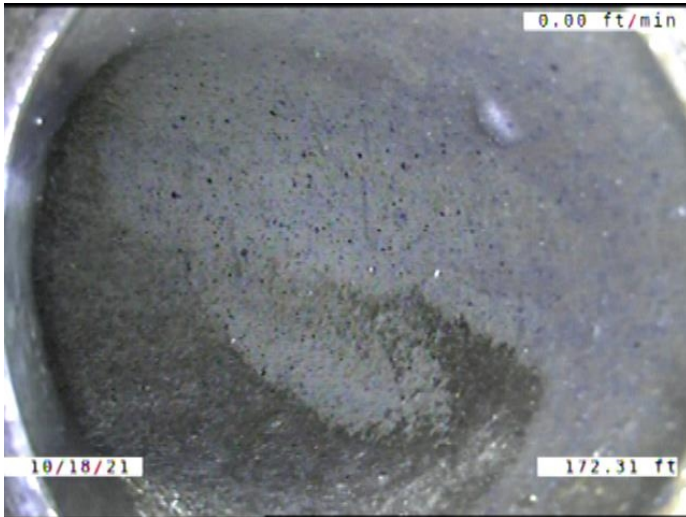
Code: **TBD**  
 Description: **Tap Break-in/Hammer Defective**

Distance (ft): **172.3**  
 Structural Grade: **0**  
 O&M Grade: **3**  
 Clock Start/From: **12**  
 Clock To:  
 1st Value: **4.000**  
 2nd Value:  
 Value Percent:  
 Continuous Index:  
 Within 8" of Joint: **YES**  
 Remarks: **Defective**

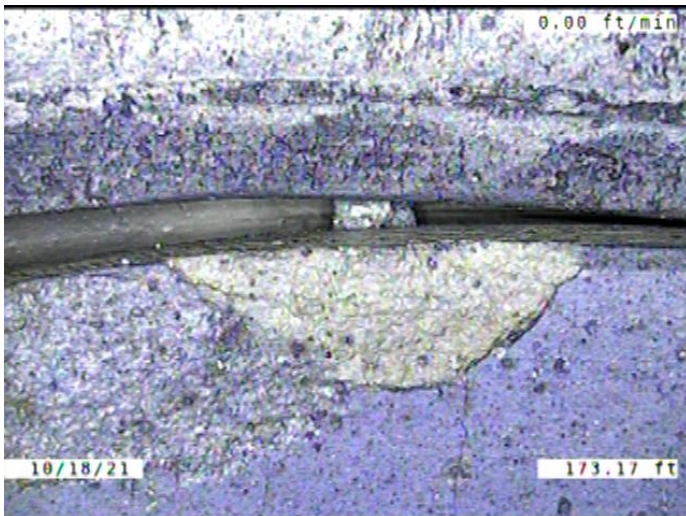
Code: **SZ**  
 Description: **Surface Damage Other**

Distance (ft): **173.2**  
 Structural Grade: **0**  
 O&M Grade: **0**  
 Clock Start/From: **3**  
 Clock To: **12**  
 1st Value:  
 2nd Value:  
 Value Percent:  
 Continuous Index:  
 Within 8" of Joint: **YES**  
 Remarks: **SEVERAL PIECES CHIPPED AWAY FROM THE JOINT**

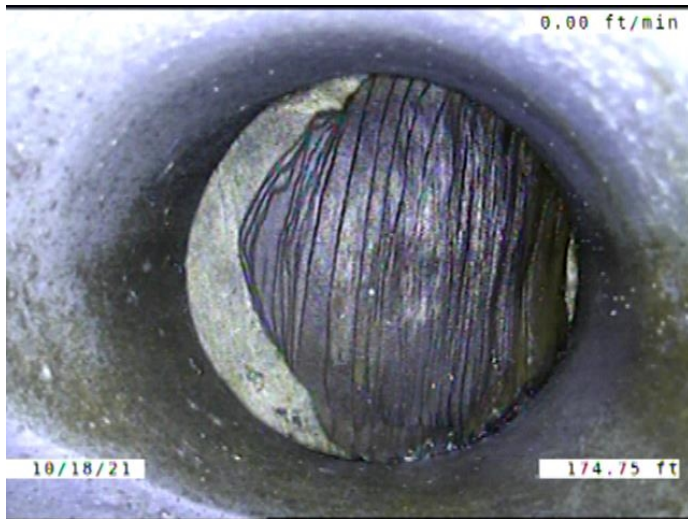
Code: **TFD**  
Description: **Tap Factory Defective**

Distance (ft): **174.8**  
Structural Grade: **0**  
O&M Grade: **3**  
Clock Start/From: **1**  
Clock To:  
1st Value: **4.000**  
2nd Value:  
Value Percent:  
Continuous Index:  
Within 8" of Joint: **YES**  
Remarks: **WOOD CAP ROTTING AWAY**

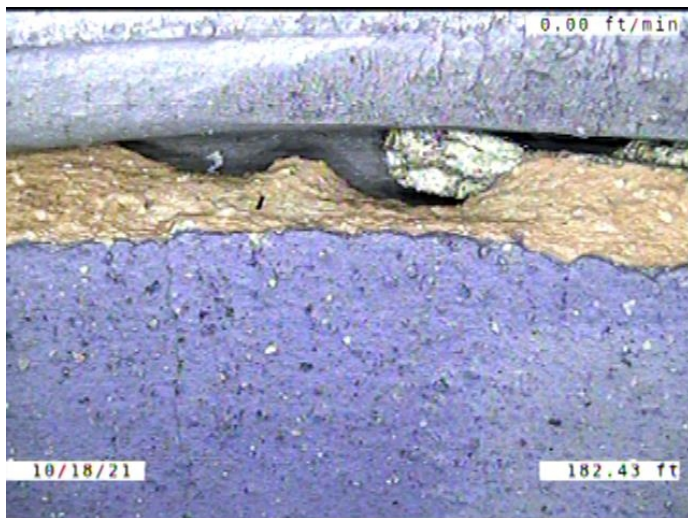
Code: **SZ**  
Description: **Surface Damage Other**

Distance (ft): **182.4**  
Structural Grade: **0**  
O&M Grade: **0**  
Clock Start/From: **10**  
Clock To: **12**  
1st Value:  
2nd Value:  
Value Percent:  
Continuous Index:  
Within 8" of Joint: **YES**  
Remarks: **A PIECE CHIPPED AWAY FROM THE JOINT**

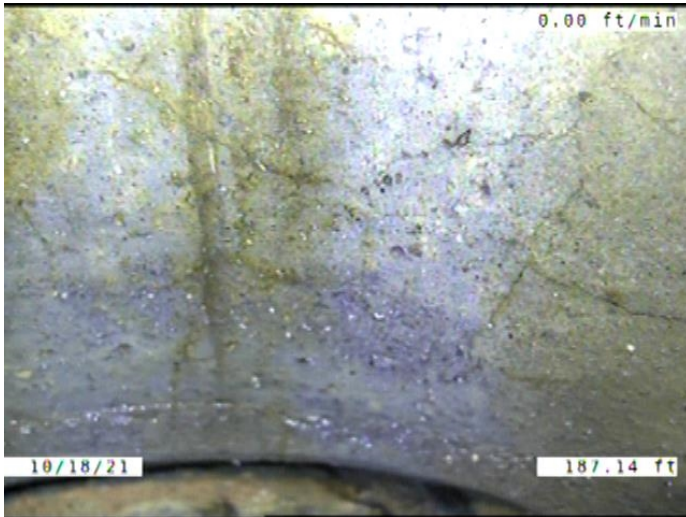
Code: **CM**  
 Description: **Crack Multiple**

Distance (ft): **187.1**  
 Structural Grade: **3**  
 O&M Grade: **0**  
 Clock Start/From: **12**  
 Clock To: **6**  
 1st Value:  
 2nd Value:  
 Value Percent:  
 Continuous Index:  
 Within 8" of Joint: **YES**  
 Remarks:

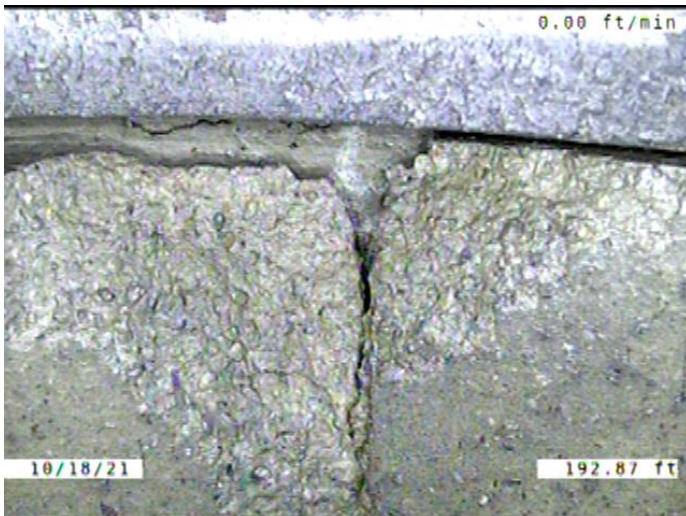
Code: **SMW**  
 Description: **Surface Damage Missing Wall**

Distance (ft): **192.9**  
 Structural Grade: **5**  
 O&M Grade: **0**  
 Clock Start/From: **1**  
 Clock To: **2**  
 1st Value:  
 2nd Value:  
 Value Percent:  
 Continuous Index:  
 Within 8" of Joint: **YES**  
 Remarks:

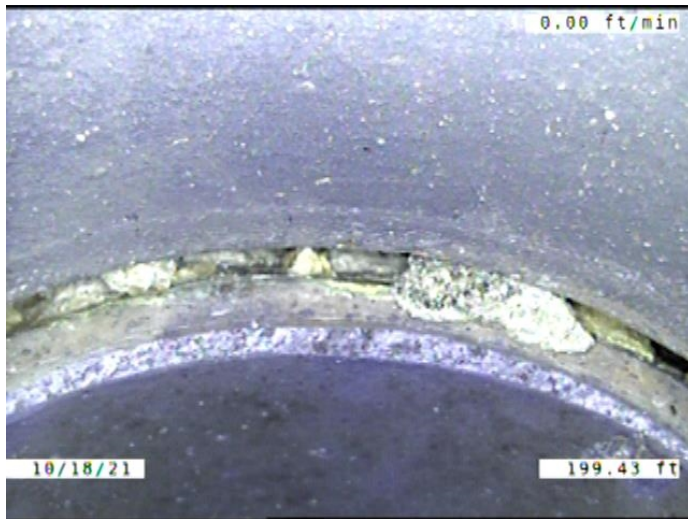
Code: **JOM**  
 Description: **Joint Offset Medium**

Distance (ft): **199.4**  
 Structural Grade: **3**  
 O&M Grade: **0**  
 Clock Start/From:  
 Clock To:  
 1st Value:  
 2nd Value:  
 Value Percent:  
 Continuous Index:  
 Within 8" of Joint: **NO**  
 Remarks:

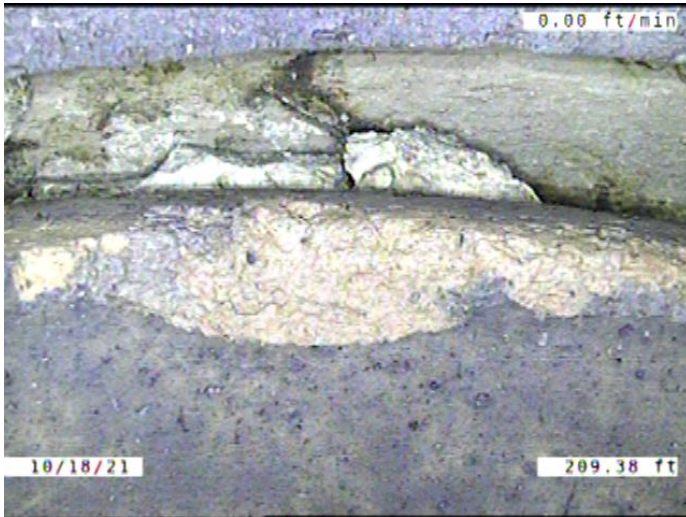
Code:	<b>SZ</b>
Description:	<b>Surface Damage Other</b>
Distance (ft):	<b>209.4</b>
Structural Grade:	<b>0</b>
O&M Grade:	<b>0</b>
Clock Start/From:	<b>9</b>
Clock To:	<b>1</b>
1st Value:	
2nd Value:	
Value Percent:	
Continuous Index:	
Within 8" of Joint:	<b>YES</b>
Remarks:	<b>SEVERAL PIECES CHIPPED AWAY FROM THE JOINT</b>

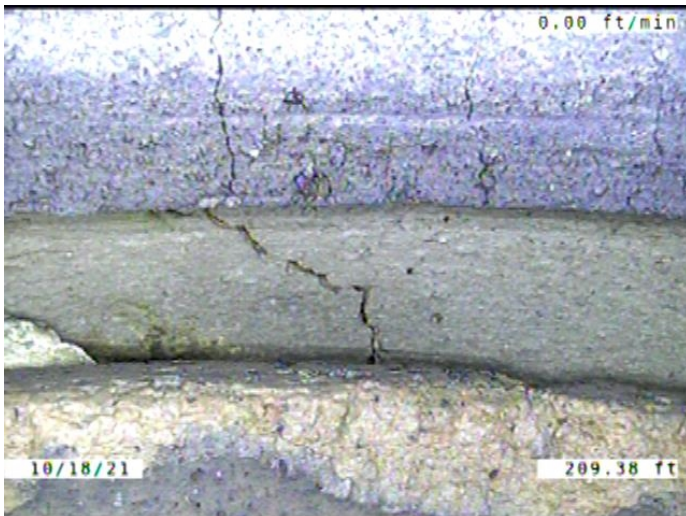
Code:	<b>FL</b>
Description:	<b>Fracture Longitudinal</b>
Distance (ft):	<b>209.4</b>
Structural Grade:	<b>3</b>
O&M Grade:	<b>0</b>
Clock Start/From:	<b>12</b>
Clock To:	
1st Value:	
2nd Value:	
Value Percent:	
Continuous Index:	
Within 8" of Joint:	<b>YES</b>
Remarks:

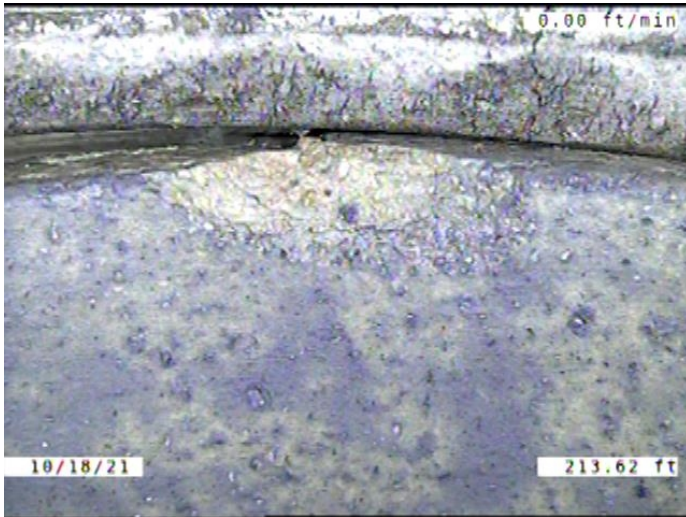
Code:	<b>SZ</b>
Description:	<b>Surface Damage Other</b>
Distance (ft):	<b>213.6</b>
Structural Grade:	<b>0</b>
O&M Grade:	<b>0</b>
Clock Start/From:	<b>12</b>
Clock To:	<b>1</b>
1st Value:	
2nd Value:	
Value Percent:	
Continuous Index:	
Within 8" of Joint:	<b>YES</b>
Remarks:	<b>A PIECE CHIPPED AWAY FROM THE JOINT</b>

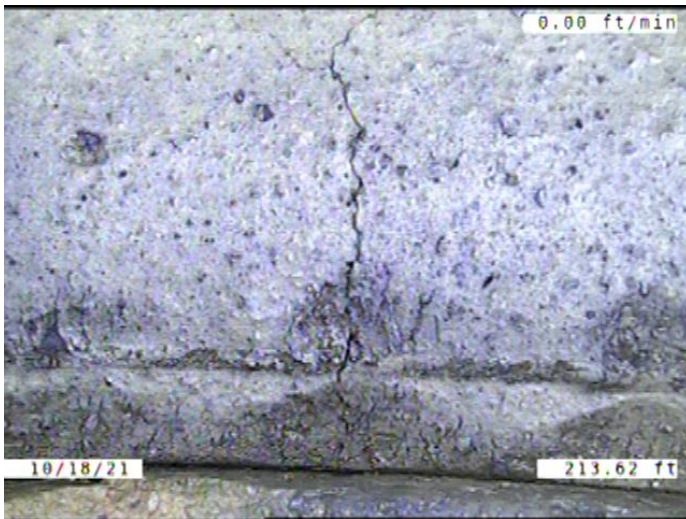
Code:	<b>CM</b>
Description:	<b>Crack Multiple</b>
Distance (ft):	<b>213.6</b>
Structural Grade:	<b>3</b>
O&M Grade:	<b>0</b>
Clock Start/From:	<b>12</b>
Clock To:	<b>1</b>
1st Value:	
2nd Value:	
Value Percent:	
Continuous Index:	
Within 8" of Joint:	<b>YES</b>
Remarks:

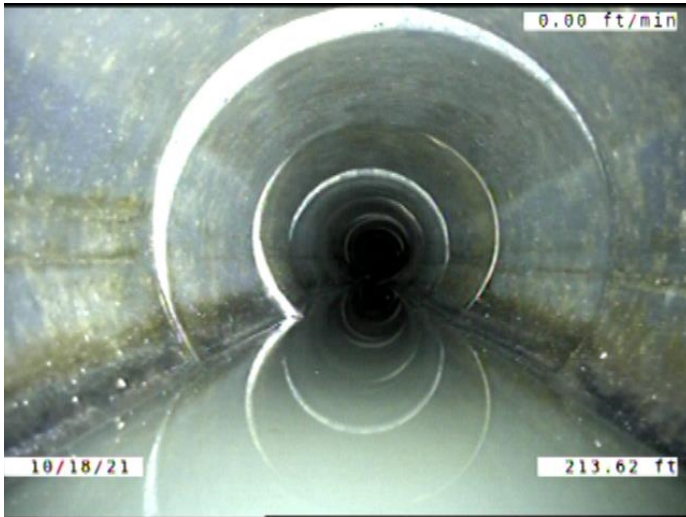
Code: **MWLS**  
Description: **Miscellaneous Water Level Sag**

Distance (ft): **213.6**  
Structural Grade: **2**  
O&M Grade: **0**  
Clock Start/From:  
Clock To:  
1st Value:  
2nd Value:  
Value Percent: **10.000**  
Continuous Index: **S05**  
Within 8" of Joint: **NO**  
Remarks:

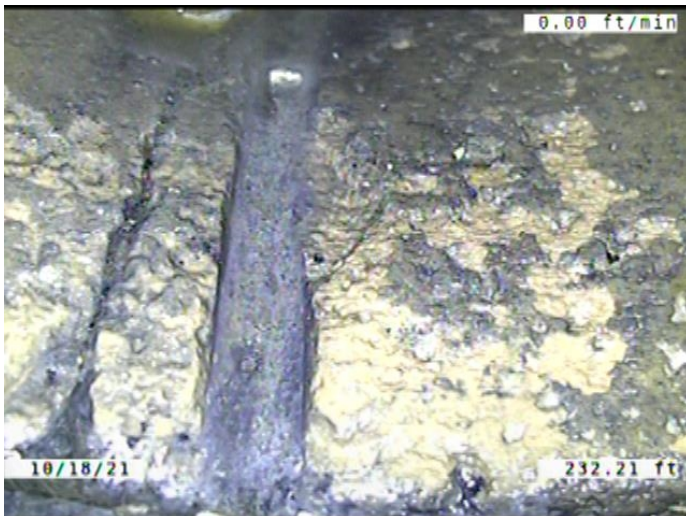
Code: **SZ**  
Description: **Surface Damage Other**

Distance (ft): **232.2**  
Structural Grade: **0**  
O&M Grade: **0**  
Clock Start/From: **5**  
Clock To: **7**  
1st Value:  
2nd Value:  
Value Percent:  
Continuous Index:  
Within 8" of Joint: **YES**  
Remarks: **PIECES CHIPPED AWAY**

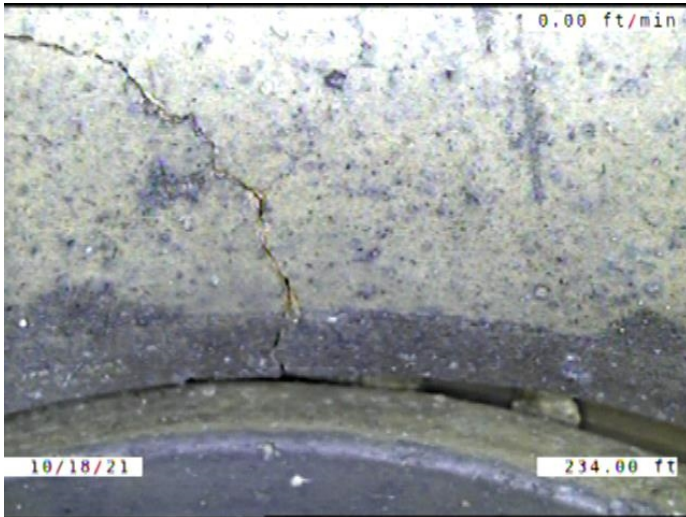
Code: **FM**  
 Description: **Fracture Multiple**

Distance (ft): **234.0**  
 Structural Grade: **4**  
 O&M Grade: **0**  
 Clock Start/From: **10**  
 Clock To: **1**  
 1st Value:  
 2nd Value:  
 Value Percent:  
 Continuous Index:  
 Within 8" of Joint: **YES**  
 Remarks:

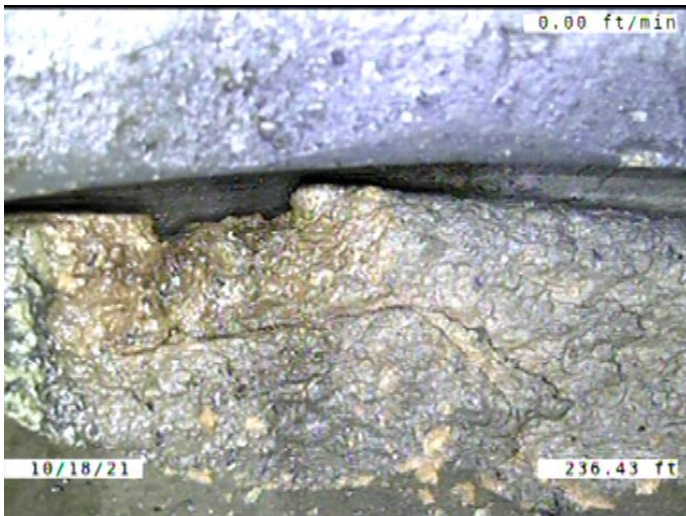
Code: **SZ**  
 Description: **Surface Damage Other**

Distance (ft): **236.4**  
 Structural Grade: **0**  
 O&M Grade: **0**  
 Clock Start/From: **9**  
 Clock To: **12**  
 1st Value:  
 2nd Value:  
 Value Percent:  
 Continuous Index:  
 Within 8" of Joint: **YES**  
 Remarks: **A PIECE CHIPPED AWAY FROM THE JOINT**

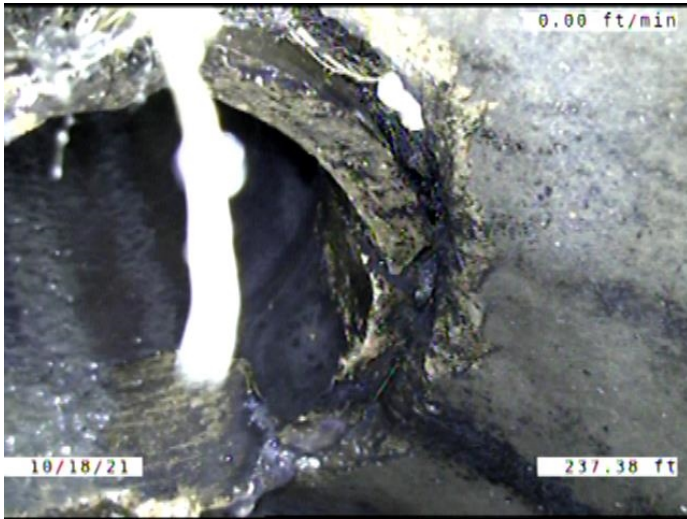
Code:	<b>SSS</b>
Description:	<b>Surface Damage Surface Spalling</b>
Distance (ft):	<b>237.4</b>
Structural Grade:	<b>2</b>
O&M Grade:	<b>0</b>
Clock Start/From:	<b>11</b>
Clock To:	<b>1</b>
1st Value:	
2nd Value:	
Value Percent:	
Continuous Index:	
Within 8" of Joint:	<b>YES</b>
Remarks:

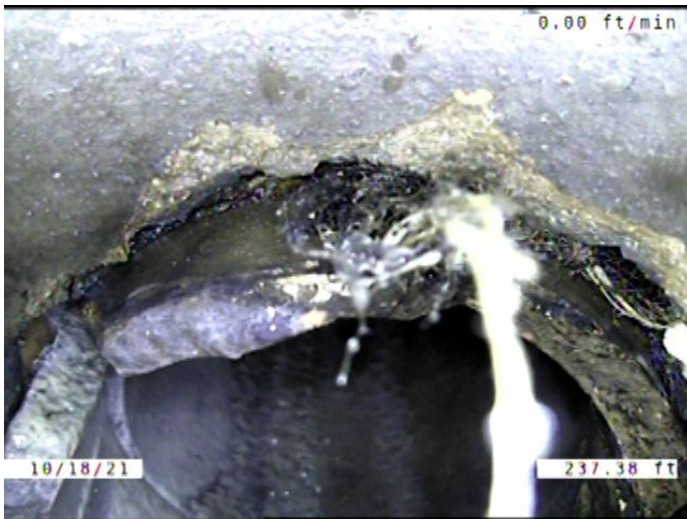
Code:	<b>RFB</b>
Description:	<b>Roots Fine Barrel</b>
Distance (ft):	<b>237.4</b>
Structural Grade:	<b>0</b>
O&M Grade:	<b>2</b>
Clock Start/From:	<b>11</b>
Clock To:	<b>1</b>
1st Value:	
2nd Value:	
Value Percent:	
Continuous Index:	
Within 8" of Joint:	<b>NO</b>
Remarks:

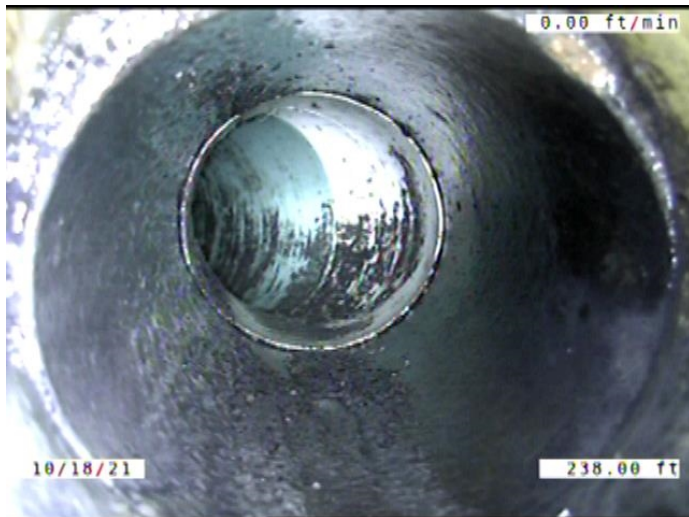
Code: **TFI**  
 Description: **Tap Factory Intruding**

Distance (ft): **238.0**  
 Structural Grade: **0**  
 O&M Grade: **2**  
 Clock Start/From: **12**  
 Clock To:  
 1st Value: **4.000**  
 2nd Value: **2.000**  
 Value Percent:  
 Continuous Index:  
 Within 8" of Joint: **YES**  
 Remarks:

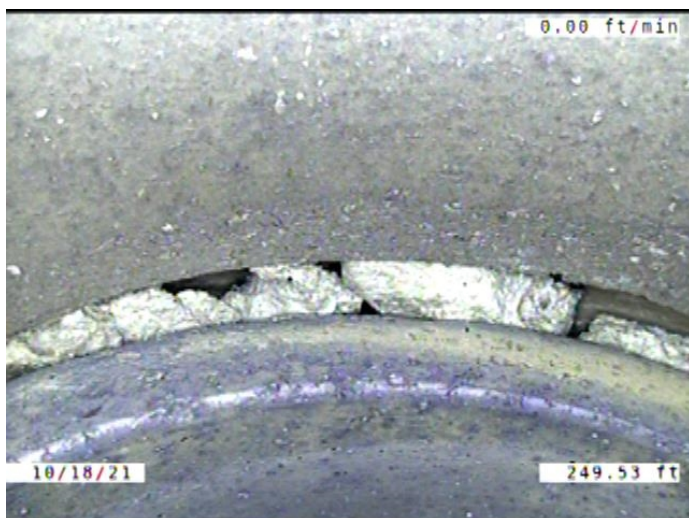
Code: **JOMD**  
 Description: **Joint Offset Medium Defective**

Distance (ft): **249.5**  
 Structural Grade: **3**  
 O&M Grade: **0**  
 Clock Start/From:  
 Clock To:  
 1st Value:  
 2nd Value:  
 Value Percent:  
 Continuous Index:  
 Within 8" of Joint: **NO**  
 Remarks:

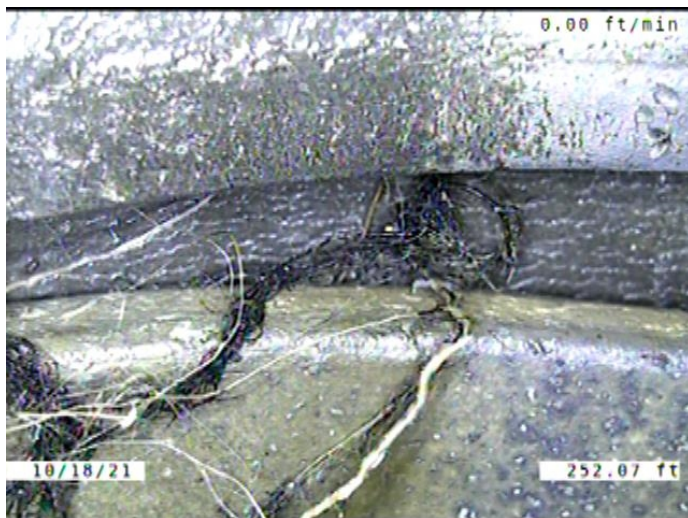
Code: **RFJ**  
 Description: **Roots Fine Joint**

Distance (ft): **252.1**  
 Structural Grade: **0**  
 O&M Grade: **1**  
 Clock Start/From: **8**  
 Clock To: **9**  
 1st Value:  
 2nd Value:  
 Value Percent:  
 Continuous Index:  
 Within 8" of Joint: **YES**  
 Remarks:

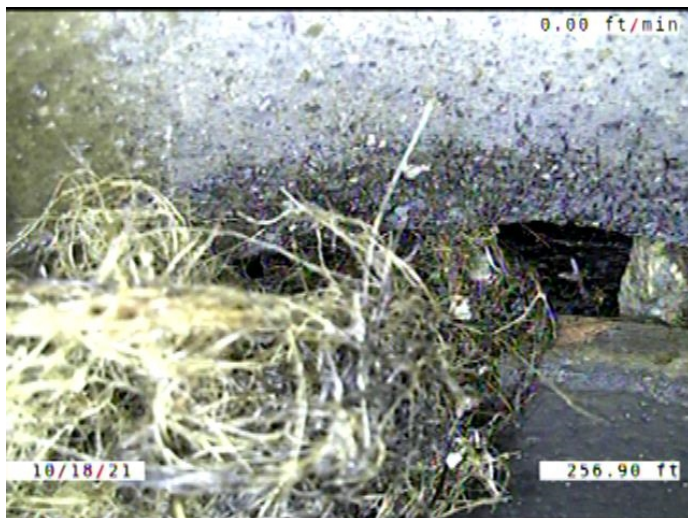
Code:	<b>RMJ</b>
Description:	<b>Roots Medium Joint</b>
Distance (ft):	<b>256.9</b>
Structural Grade:	<b>0</b>
O&M Grade:	<b>3</b>
Clock Start/From:	<b>7</b>
Clock To:	<b>10</b>
1st Value:	
2nd Value:	
Value Percent:	<b>10.000</b>
Continuous Index:	
Within 8" of Joint:	<b>YES</b>
Remarks:

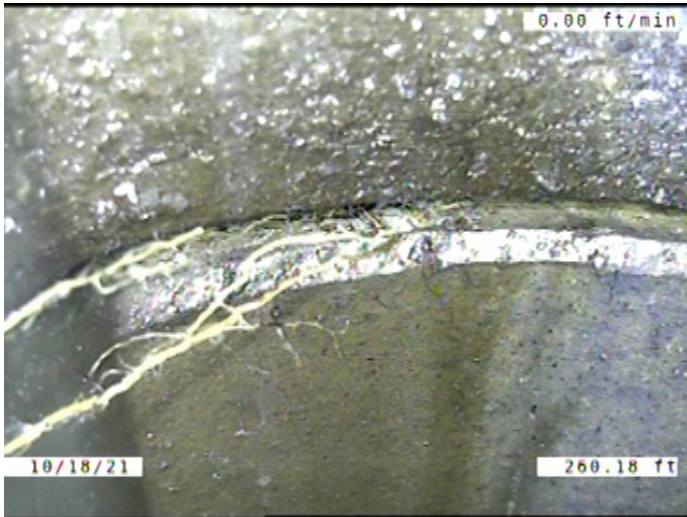
Code: **RFJ**  
 Description: **Roots Fine Joint**

Distance (ft): **260.2**  
 Structural Grade: **0**  
 O&M Grade: **1**  
 Clock Start/From: **9**  
 Clock To:  
 1st Value:  
 2nd Value:  
 Value Percent:  
 Continuous Index:  
 Within 8" of Joint: **YES**  
 Remarks:

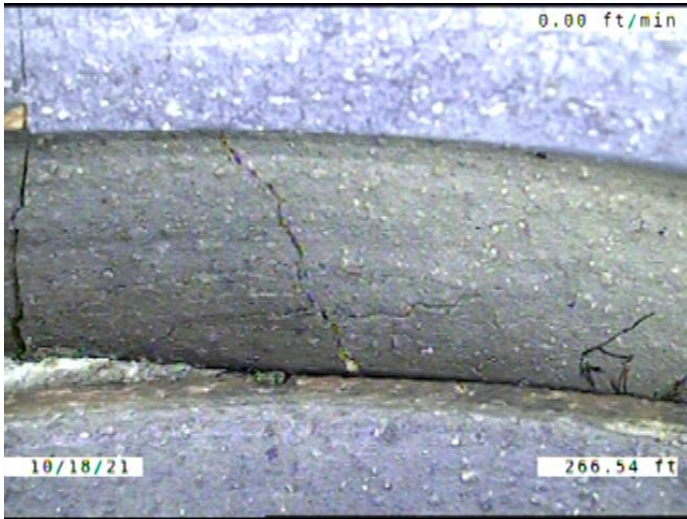
Code: **JAL**  
Description: **Joint Angular Large**

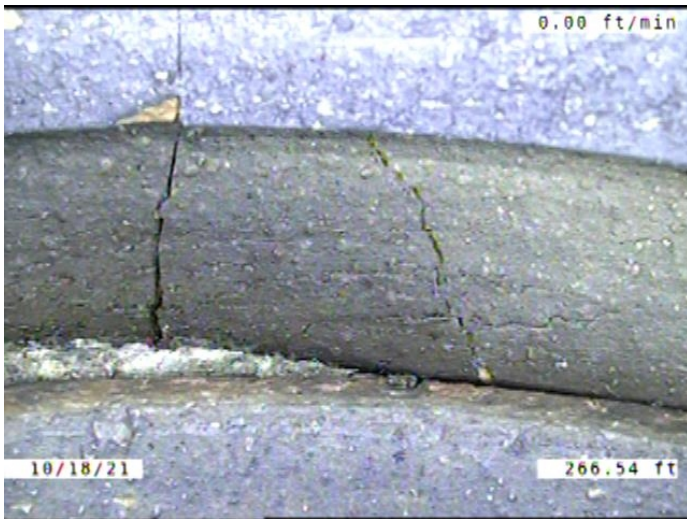
Code: **FM**  
Description: **Fracture Multiple**
