# Profile/Photo Observation Report

Date:	10/18/2021	Weather:		Coding:	PACP 7.0
Pipe Length (ft):	288.5	Owner:	City of Hobart	Pre Clean:	Heavy Cleaning
P.O.#:	YES502259	Surveyor:	S. Bucklin	PSR:	P-804-023-024
Customer:	City of Hobart	Clean Date:	10/15/2021	Shape:	C

Street:	North Kelly Street	Flow Control:	Not Controlled
City:	Hobart, IN	Year Renewed:	
Location:	Local rural streets with light traffic, t	Tape/Media #:	
Purpose:	Routine Assessment	Dia/Height:	12"
Use:	Sanitary Sewage Pipe	Material:	VCP
Drain Area:		Lining:	
Category:	NA		
Comment:			
Location Details:		Direction of Survey:	Upstream
US MH:	M-804-024	DS MH:	M-804-023
		Total Length Surveyed (ft):	288.5

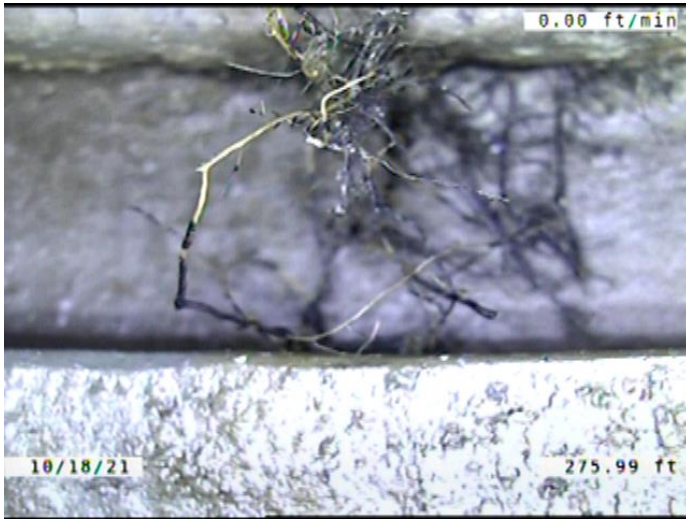
Code: **RFJ**  
 Description: **Roots Fine Joint**

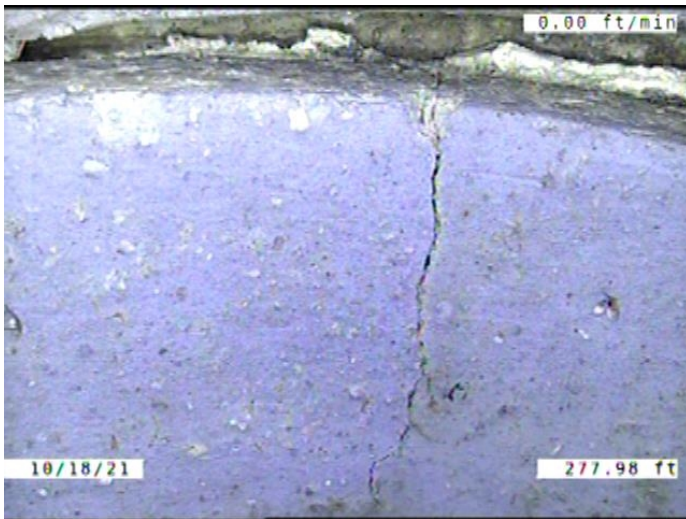
Code: **FM**  
 Description: **Fracture Multiple**

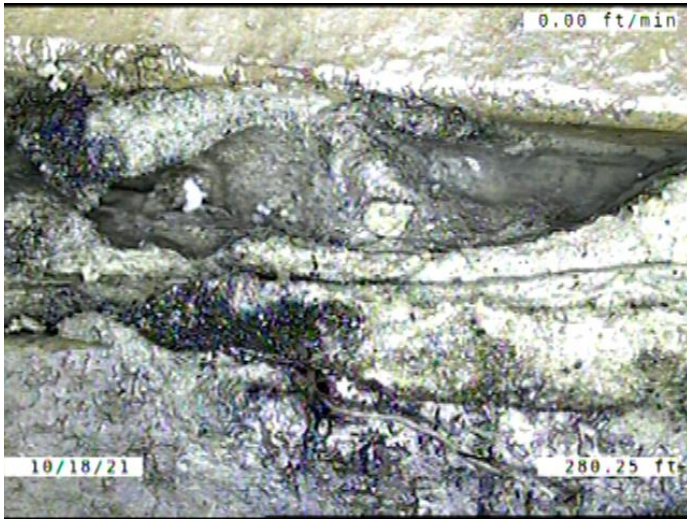
Code: **RFJ**  
 Description: **Roots Fine Joint**

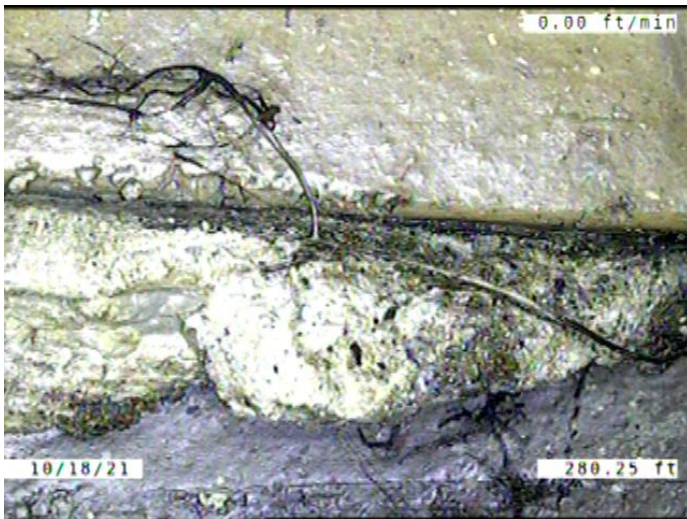
Code: **DAE**  
 Description: **Deposits Attached Encrustation**

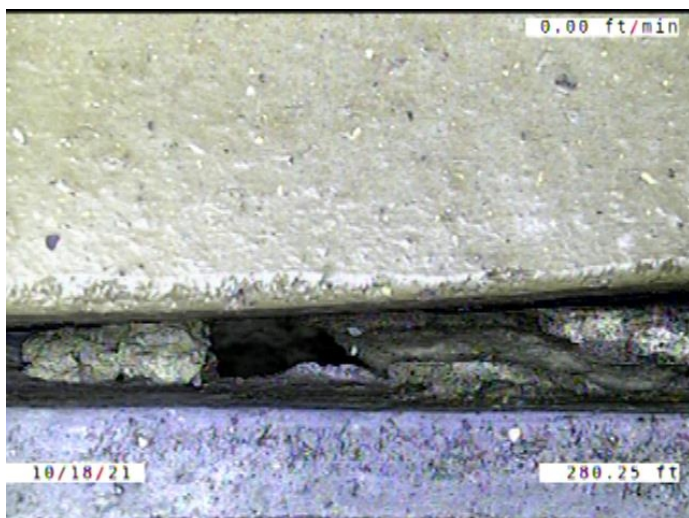
Code: **BSV**  
 Description: **Broken Soil Visible**

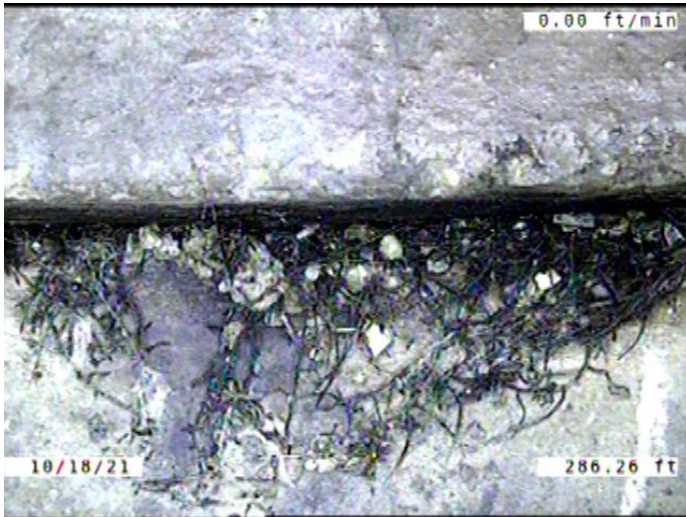
Code: **RFJ**  
Description: **Roots Fine Joint**

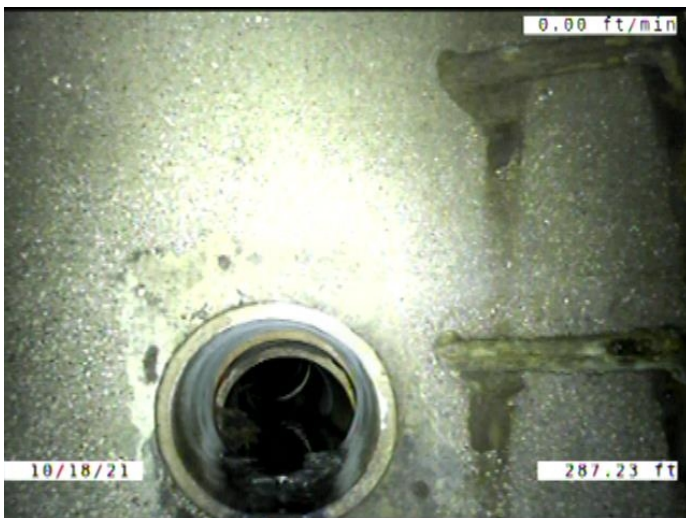
Code: **DSF**  
Description: **Deposits Settled Fine**
