Profile/Photo Observation Report

Date:	10/18/2021	Weather:		Coding:	PACP 7.0
Pipe Length (ft):	288.5	Owner:	City of Hobart	Pre Clean:	Heavy Cleaning
P.O.#:	YES502259	Surveyor:	S. Bucklin	PSR:	P-804-023-024
Customer:	City of Hobart	Clean Date:	10/15/2021	Shape:	C

Street:	North Kelly Street	Flow Control:	Not Controlled
City:	Hobart, IN	Year Renewed:	
Location:	Local rural streets with light traffic, t	Tape/Media #:	
Purpose:	Routine Assessment	Dia/Height:	12"
Use:	Sanitary Sewage Pipe	Material:	VCP
Drain Area:		Lining:	
Category:	NA		
Comment:			
Location Details:		Direction of Survey:	Upstream
US MH:	M-804-024	DS MH:	M-804-023
		Total Length Surveyed (ft):	288.5

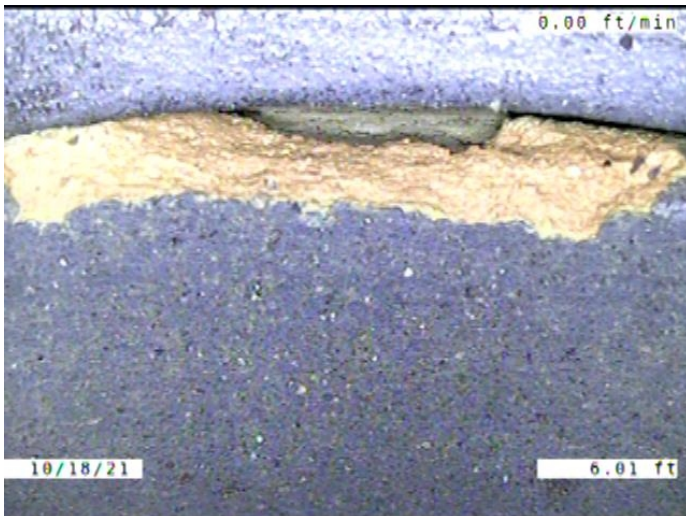
Code: **SZ**
 Description: **Surface Damage Other**

Distance (ft): **6.0**
 Structural Grade: **0**
 O&M Grade: **0**
 Clock Start/From: **12**
 Clock To: **1**
 1st Value:
 2nd Value:
 Value Percent:
 Continuous Index:
 Within 8" of Joint: **YES**
 Remarks: **A PIECE CHIPPED AWAY FRO THE JOINT**

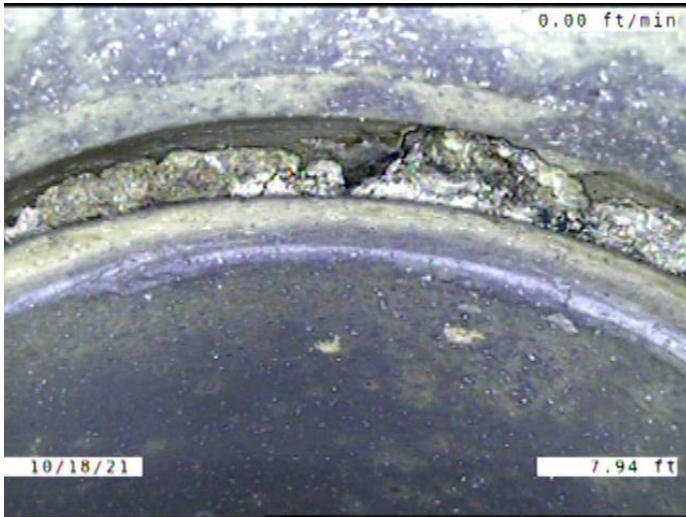
Code: **JOMD**
 Description: **Joint Offset Medium Defective**

Distance (ft): **7.9**
 Structural Grade: **3**
 O&M Grade: **0**
 Clock Start/From:
 Clock To:
 1st Value:
 2nd Value:
 Value Percent:
 Continuous Index: **S01**
 Within 8" of Joint: **NO**
 Remarks:

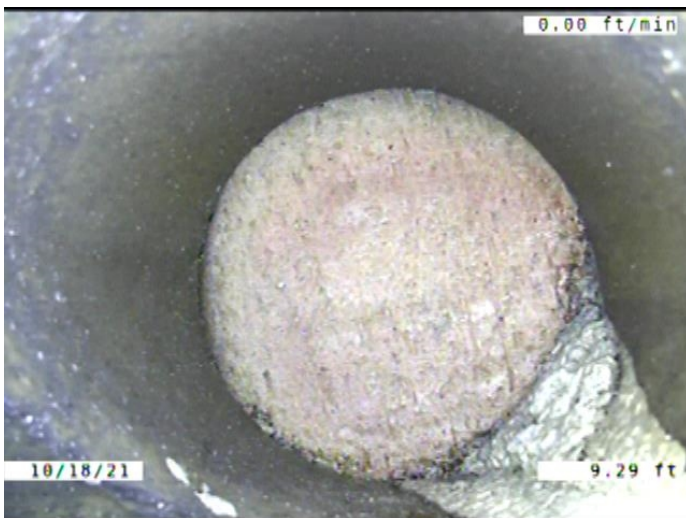
Code: **TFC**
 Description: **Tap Factory Capped**

Distance (ft): **9.3**
 Structural Grade: **0**
 O&M Grade: **0**
 Clock Start/From: **1**
 Clock To:
 1st Value: **4.000**
 2nd Value:
 Value Percent:
 Continuous Index:
 Within 8" of Joint: **YES**
 Remarks: **ENCRUSTATION AROUND THE CAP**

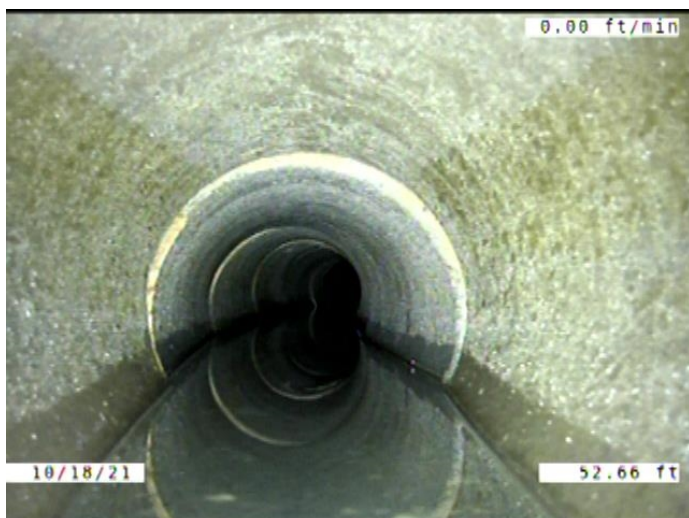
Code: **JOMD**
 Description: **Joint Offset Medium Defective**

Distance (ft): **52.7**
 Structural Grade: **3**
 O&M Grade: **0**
 Clock Start/From:
 Clock To:
 1st Value:
 2nd Value:
 Value Percent:
 Continuous Index: **F01**
 Within 8" of Joint: **NO**
 Remarks:

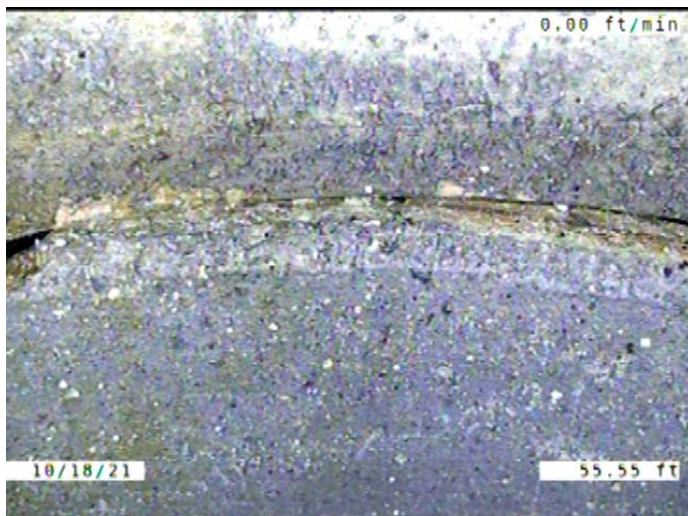
Code: **JAM**
 Description: **Joint Angular Medium**

Distance (ft): **55.6**
 Structural Grade: **3**
 O&M Grade: **0**
 Clock Start/From:
 Clock To:
 1st Value:
 2nd Value:
 Value Percent:
 Continuous Index:
 Within 8" of Joint: **NO**
 Remarks:

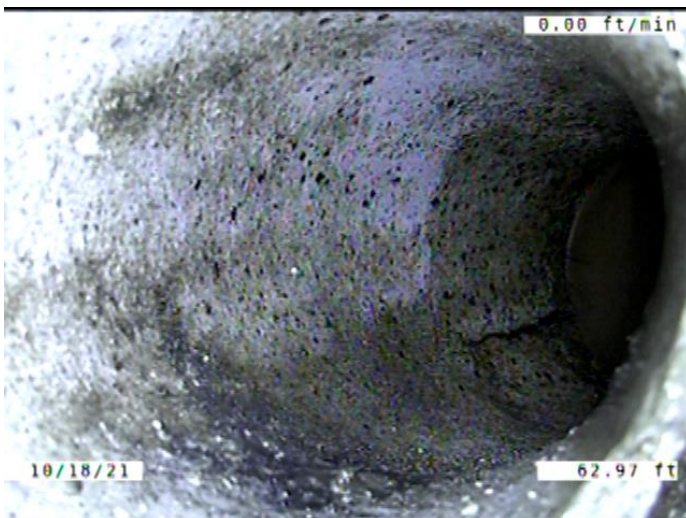
Code:	TBD
Description:	Tap Break-in/Hammer Defective
Distance (ft):	63.0
Structural Grade:	0
O&M Grade:	3
Clock Start/From:	1
Clock To:	
1st Value:	4.000
2nd Value:	
Value Percent:	
Continuous Index:	
Within 8" of Joint:	YES
Remarks:	Defective

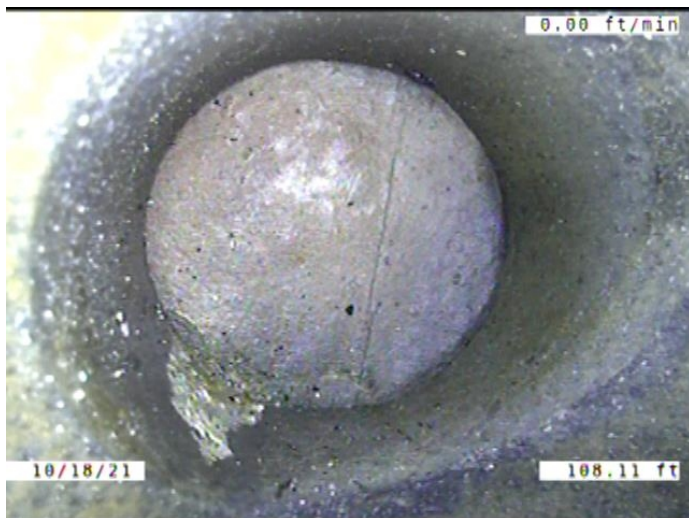
Code: **TFC**
 Description: **Tap Factory Capped**

Distance (ft): **108.1**
 Structural Grade: **0**
 O&M Grade: **0**
 Clock Start/From: **11**
 Clock To:
 1st Value: **4.000**
 2nd Value:
 Value Percent:
 Continuous Index:
 Within 8" of Joint: **YES**
 Remarks: **ENCRUSTATION AROUND THE CAP**

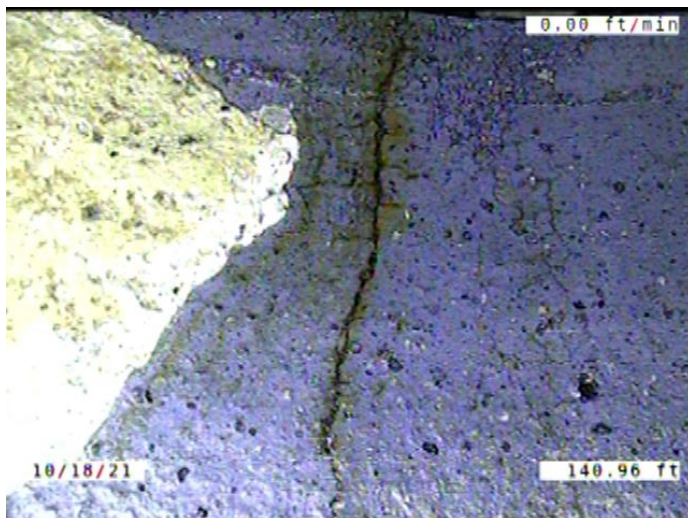
Code: **CL**
 Description: **Crack Longitudinal**

Distance (ft): **141.0**
 Structural Grade: **2**
 O&M Grade: **0**
 Clock Start/From: **3**
 Clock To:
 1st Value:
 2nd Value:
 Value Percent:
 Continuous Index:
 Within 8" of Joint: **YES**
 Remarks:

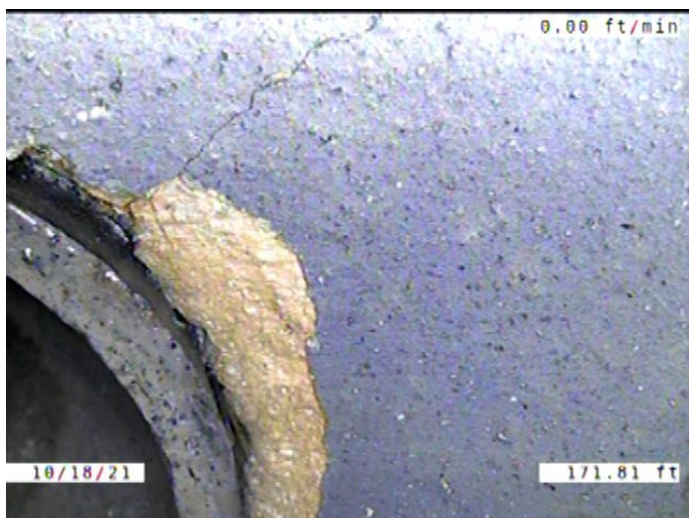
Code: **FM**
 Description: **Fracture Multiple**

Distance (ft): **171.8**
 Structural Grade: **4**
 O&M Grade: **0**
 Clock Start/From: **11**
 Clock To: **2**
 1st Value:
 2nd Value:
 Value Percent:
 Continuous Index:
 Within 8" of Joint: **YES**
 Remarks:

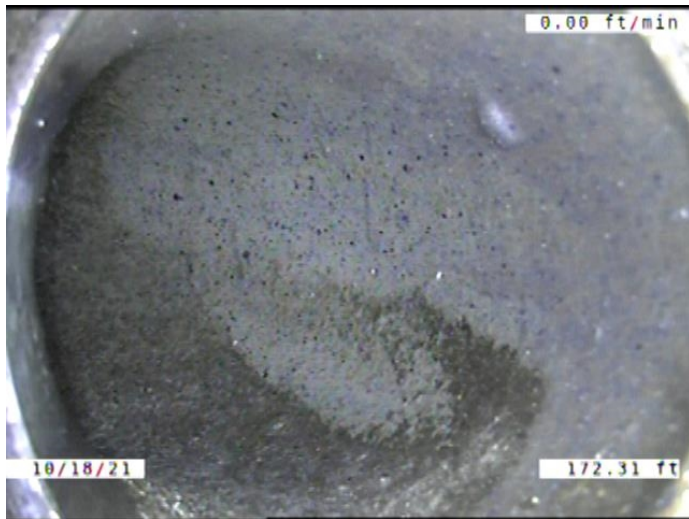
Code: **TBD**
 Description: **Tap Break-in/Hammer Defective**

Distance (ft): **172.3**
 Structural Grade: **0**
 O&M Grade: **3**
 Clock Start/From: **12**
 Clock To:
 1st Value: **4.000**
 2nd Value:
 Value Percent:
 Continuous Index:
 Within 8" of Joint: **YES**
 Remarks: **Defective**

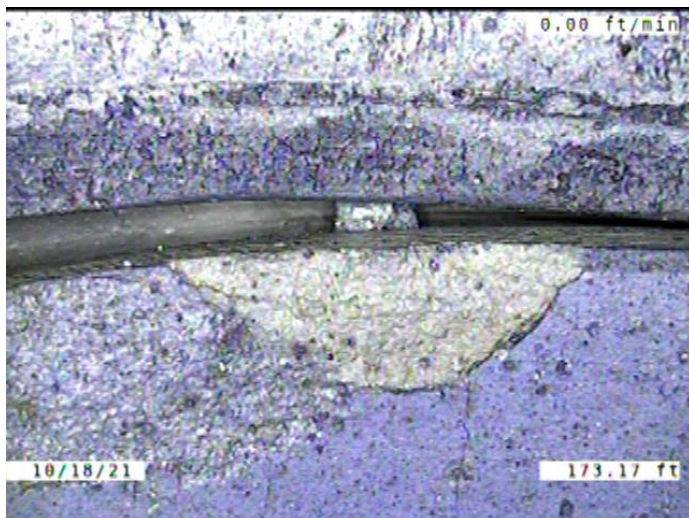
Code: **SZ**
 Description: **Surface Damage Other**

Distance (ft): **173.2**
 Structural Grade: **0**
 O&M Grade: **0**
 Clock Start/From: **3**
 Clock To: **12**
 1st Value:
 2nd Value:
 Value Percent:
 Continuous Index:
 Within 8" of Joint: **YES**
 Remarks: **SEVERAL PIECES CHIPPED AWAY FROM THE JOINT**

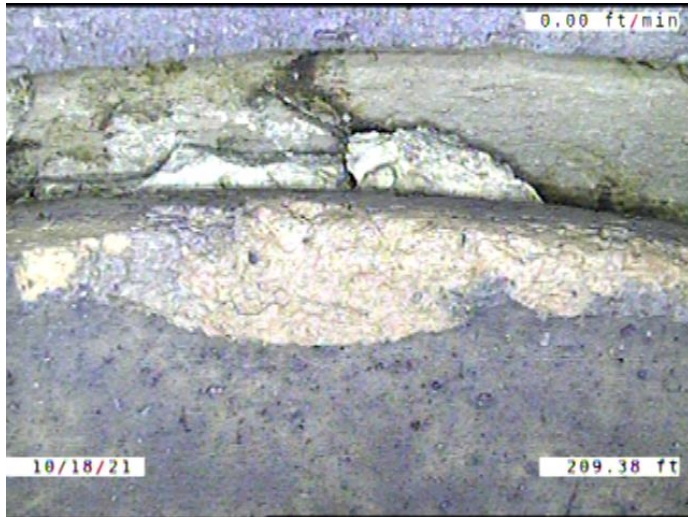
Code: **SZ**
 Description: **Surface Damage Other**

Distance (ft): **209.4**
 Structural Grade: **0**
 O&M Grade: **0**
 Clock Start/From: **9**
 Clock To: **1**
 1st Value:
 2nd Value:
 Value Percent:
 Continuous Index:
 Within 8" of Joint: **YES**
 Remarks: **SEVERAL PIECES CHIPPED AWAY FROM THE JOINT**

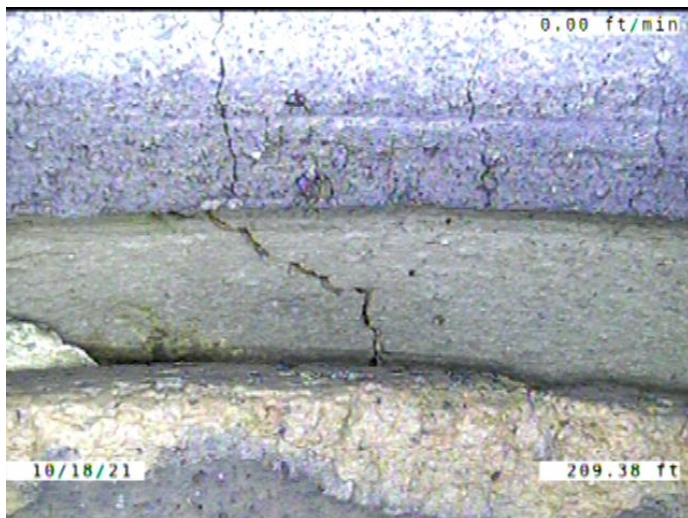
Code: **FL**
 Description: **Fracture Longitudinal**

Distance (ft): **209.4**
 Structural Grade: **3**
 O&M Grade: **0**
 Clock Start/From: **12**
 Clock To:
 1st Value:
 2nd Value:
 Value Percent:
 Continuous Index:
 Within 8" of Joint: **YES**
 Remarks:

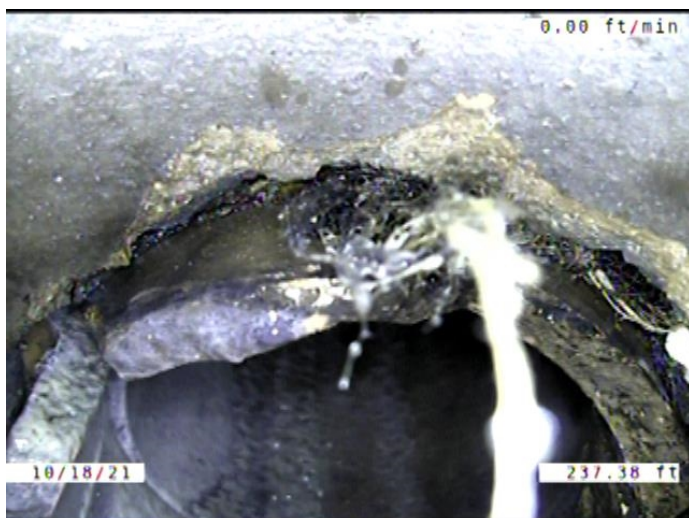
Code: **RFB**
 Description: **Roots Fine Barrel**

Distance (ft): **237.4**
 Structural Grade: **0**
 O&M Grade: **2**
 Clock Start/From: **11**
 Clock To: **1**
 1st Value:
 2nd Value:
 Value Percent:
 Continuous Index:
 Within 8" of Joint: **NO**
 Remarks:

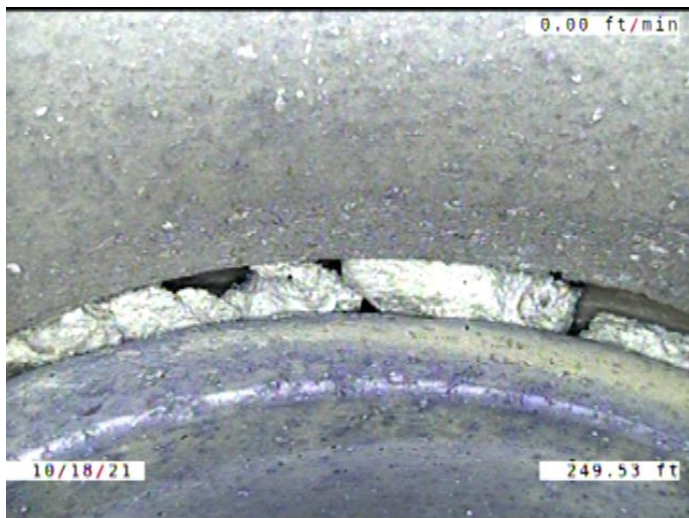
Code: **JOMD**
 Description: **Joint Offset Medium Defective**

Distance (ft): **249.5**
 Structural Grade: **3**
 O&M Grade: **0**
 Clock Start/From:
 Clock To:
 1st Value:
 2nd Value:
 Value Percent:
 Continuous Index:
 Within 8" of Joint: **NO**
 Remarks:
