Profile/Photo Observation Report

Date:	04/07/2018	Weather:		Coding:	PACP 6.0
Pipe Length (ft):	179.2	Owner:	NA	Pre Clean:	Not Known
P.O.#:		Surveyor:	Mark Ruby	PSR:	P-804-047-026
Customer:		Clean Date:	01/01/1900	Shape:	C

Street:	N OHIO ST	Flow Control:	Not Controlled
City:	Hobart, IN	Year Renewed:	
Location:	Other	Tape/Media #:	
Purpose:	Not Known	Dia/Height:	10"
Use:	Sanitary	Material:	VCP
Drain Area:	NA	Lining:	
Category:	NA		
Comment:

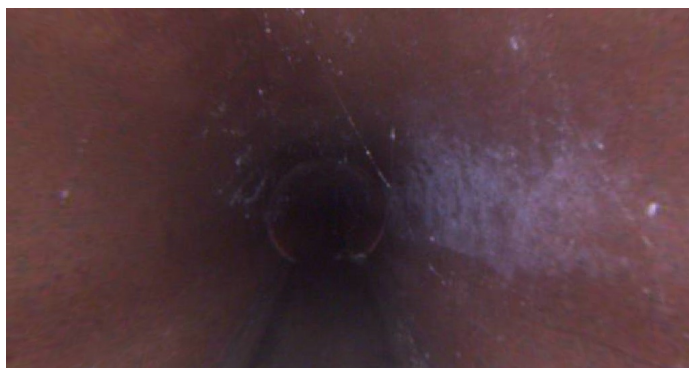
Code: **AMH**
Description: **Manhole**

Distance (ft): **.0**
Structural Grade: **0**
O&M Grade: **0**
Clock Start/From:
Clock To:
1st Value:
2nd Value:
Value Percent:
Continuous Index:
Within 8" of Joint: **NO**
Remarks: **M-804-047**

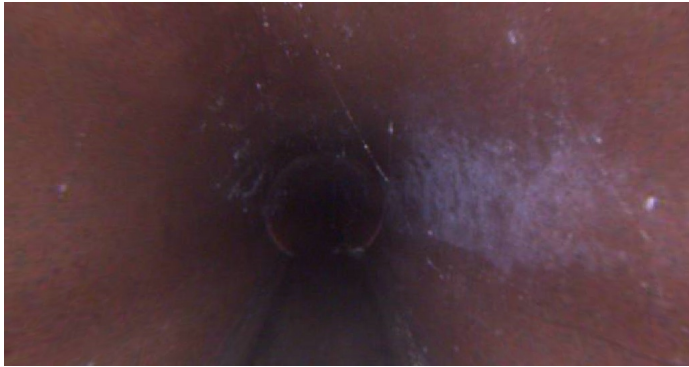
Code:	MWL
Description:	Water Level
Distance (ft):	.0
Structural Grade:	0
O&M Grade:	0
Clock Start/From:	
Clock To:	
1st Value:	
2nd Value:	
Value Percent:	10.000
Continuous Index:	
Within 8" of Joint:	NO
Remarks:

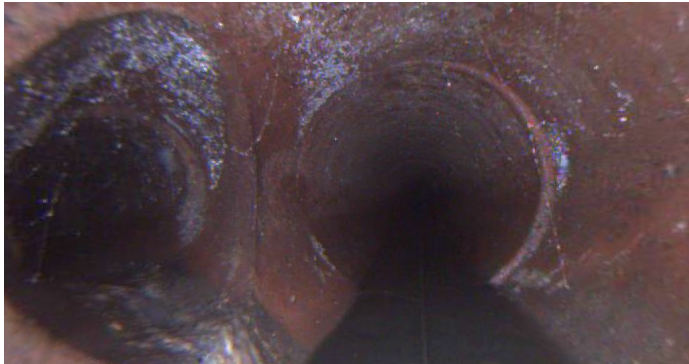
Code:	TF
Description:	Tap Factory
Distance (ft):	22.4
Structural Grade:	0
O&M Grade:	0
Clock Start/From:	4
Clock To:	
1st Value:	4.000
2nd Value:	
Value Percent:	
Continuous Index:	
Within 8" of Joint:	
Remarks:

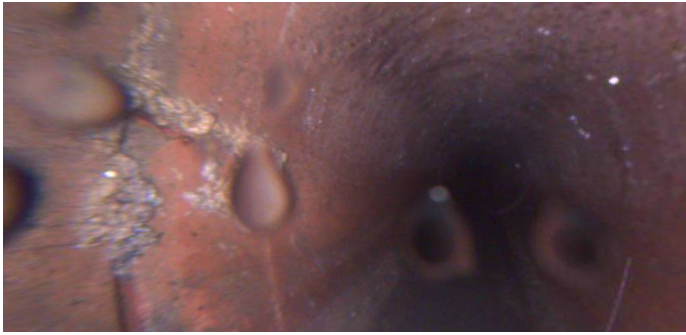
Code: **FC**
Description: **Fracture Circumferential**

Distance (ft): **23.0**
Structural Grade: **2**
O&M Grade: **0**
Clock Start/From: **7**
Clock To: **9**
1st Value:
2nd Value:
Value Percent:
Continuous Index:
Within 8" of Joint:
Remarks:

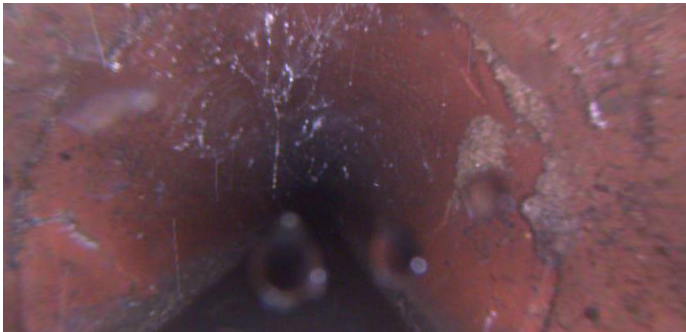
Code: **FM**
Description: **Fracture Multiple**

Distance (ft): **34.9**
Structural Grade: **4**
O&M Grade: **0**
Clock Start/From: **8**
Clock To: **4**
1st Value:
2nd Value:
Value Percent:
Continuous Index:
Within 8" of Joint: **YES**
Remarks:

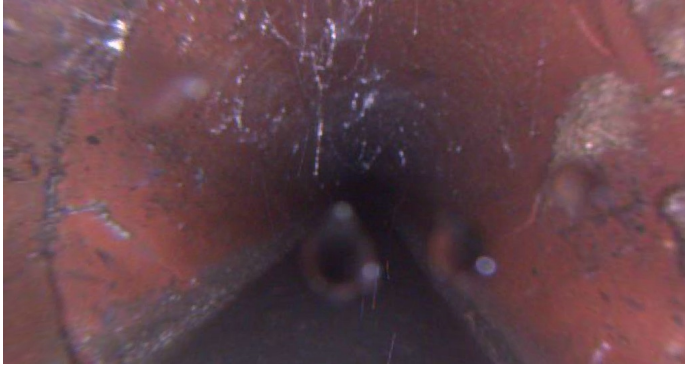
Code: **RFJ**
Description: **Roots Fine Joint**

Distance (ft): **34.9**
Structural Grade: **0**
O&M Grade: **1**
Clock Start/From: **4**
Clock To:
1st Value:
2nd Value:
Value Percent:
Continuous Index:
Within 8" of Joint: **YES**
Remarks:

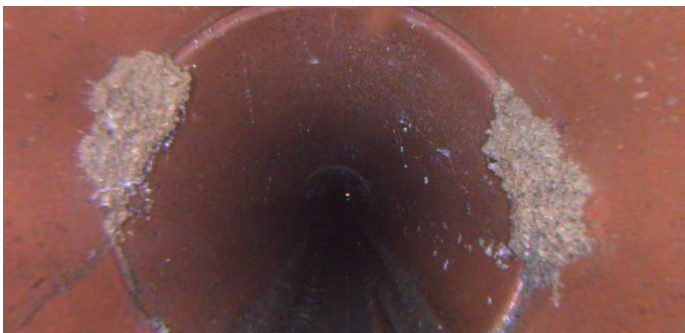
Code: **DAZ**
Description: **Deposits Attached Other**

Distance (ft): **87.2**
Structural Grade: **0**
O&M Grade: **2**
Clock Start/From: **8**
Clock To: **4**
1st Value:
2nd Value:
Value Percent: **5.000**
Continuous Index:
Within 8" of Joint: **YES**
Remarks:

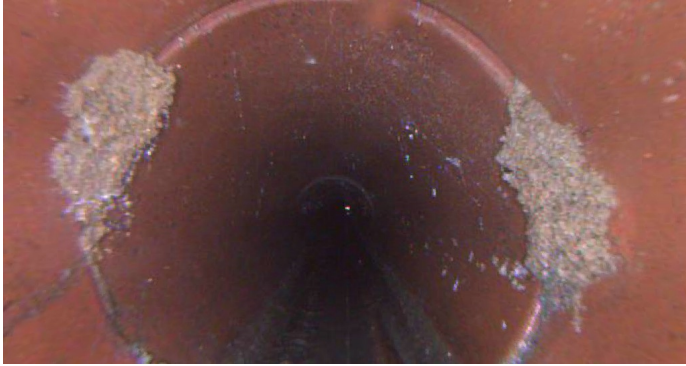
Code: **RFJ**
Description: **Roots Fine Joint**

Distance (ft): **87.2**
Structural Grade: **0**
O&M Grade: **1**
Clock Start/From: **4**
Clock To: **8**
1st Value:
2nd Value:
Value Percent:
Continuous Index:
Within 8" of Joint: **YES**
Remarks:

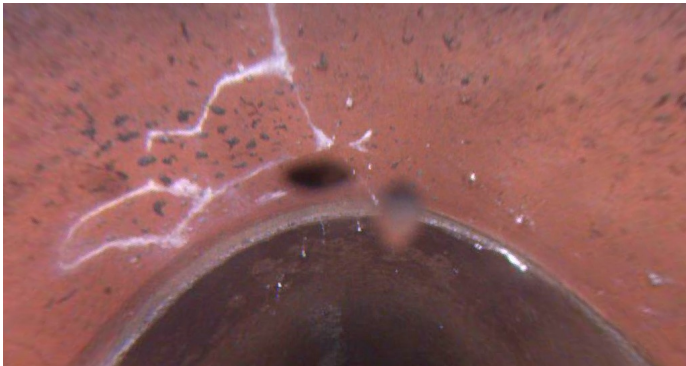
Code: **CM**
Description: **Crack Multiple**

Distance (ft): **129.3**
Structural Grade: **3**
O&M Grade: **0**
Clock Start/From: **2**
Clock To: **12**
1st Value:
2nd Value:
Value Percent:
Continuous Index:
Within 8" of Joint:
Remarks:

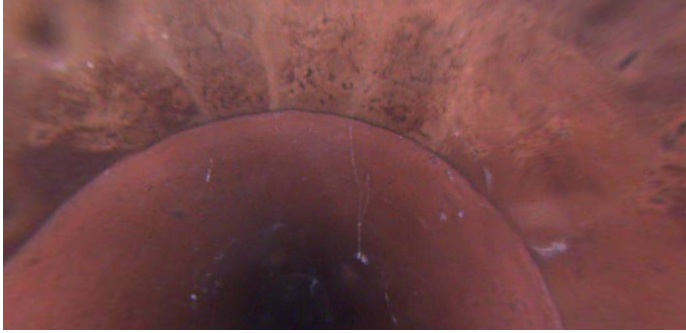
Code: **CM**
Description: **Crack Multiple**

Distance (ft): **131.4**
Structural Grade: **3**
O&M Grade: **0**
Clock Start/From: **10**
Clock To: **2**
1st Value:
2nd Value:
Value Percent:
Continuous Index:
Within 8" of Joint: **YES**
Remarks:

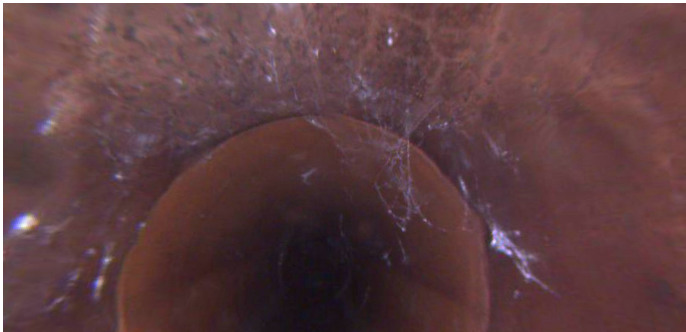
Code: **CM**
Description: **Crack Multiple**

Distance (ft): **137.2**
Structural Grade: **3**
O&M Grade: **0**
Clock Start/From: **8**
Clock To: **4**
1st Value:
2nd Value:
Value Percent:
Continuous Index:
Within 8" of Joint: **YES**
Remarks:

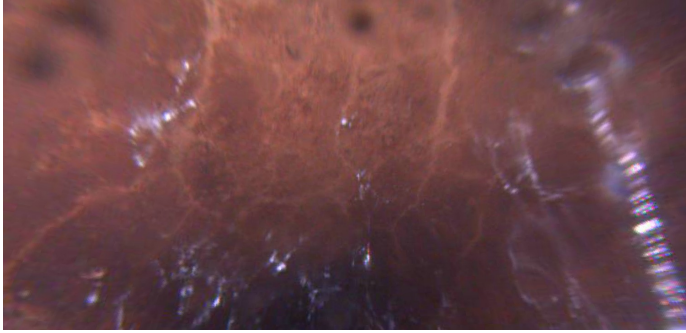
Code: **CM**
Description: **Crack Multiple**

Distance (ft): **148.6**
Structural Grade: **3**
O&M Grade: **0**
Clock Start/From: **8**
Clock To: **4**
1st Value:
2nd Value:
Value Percent:
Continuous Index:
Within 8" of Joint:
Remarks:

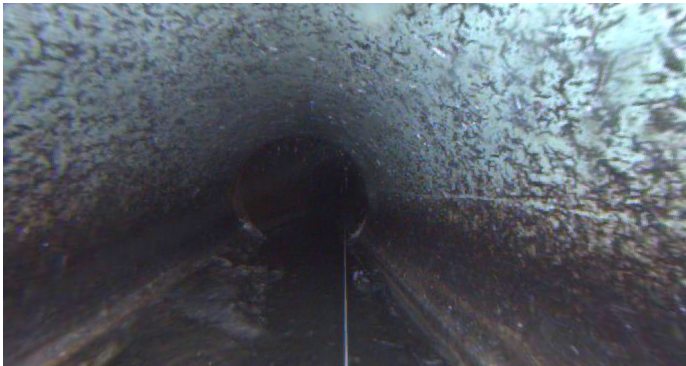
Code: **MMC**
Description: **Material Change**

Distance (ft): **163.2**
Structural Grade: **0**
O&M Grade: **0**
Clock Start/From:
Clock To:
1st Value:
2nd Value:
Value Percent:
Continuous Index:
Within 8" of Joint: **NO**
Remarks: **PVC**

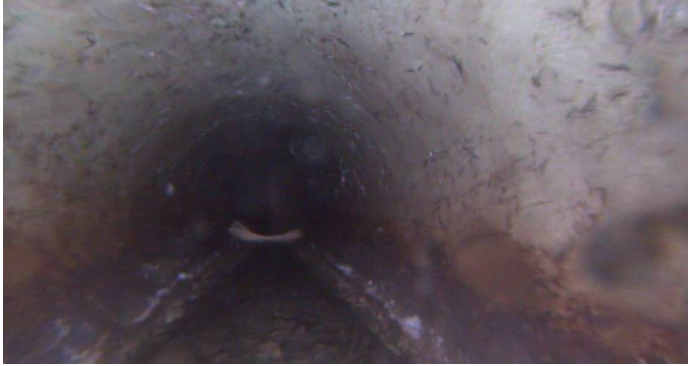
Code:	MSA
Description:	Abandoned Survey
Distance (ft):	169.7
Structural Grade:	0
O&M Grade:	0
Clock Start/From:	
Clock To:	
1st Value:	
2nd Value:	
Value Percent:	
Continuous Index:	
Within 8" of Joint:	NO
Remarks:	End of pipe insight
