Profile/Photo Observation Report

Date:	04/07/2018	Weather:		Coding:	PACP 6.0
Pipe Length (ft):	179.2	Owner:	NA	Pre Clean:	Not Known
P.O.#:		Surveyor:	Mark Ruby	PSR:	P-804-047-026
Customer:		Clean Date:	01/01/1900	Shape:	C

Street:	N Ohio St.	Flow Control:	Not Controlled
City:	Hobart, IN	Year Renewed:	
Location:	Other	Tape/Media #:	
Purpose:	Not Known	Dia/Height:	10"
Use:	Sanitary	Material:	VCP
Drain Area:	NA	Lining:	
Category:	NA		
Comment:

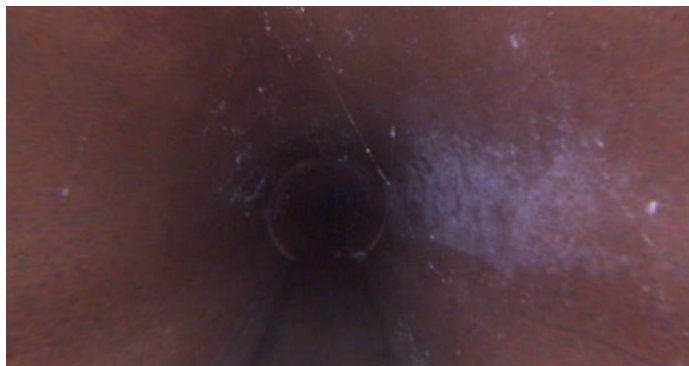
Code: **AMH**
 Description: **Manhole**

Distance (ft): **.0**
 Structural Grade: **0**
 O&M Grade: **0**
 Clock Start/From:
 Clock To:
 1st Value:
 2nd Value:
 Value Percent:
 Continuous Index:
 Within 8" of Joint: **NO**
 Remarks: **M-804-047**

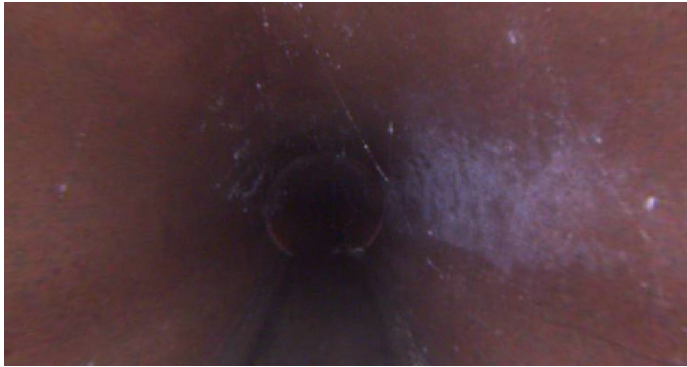
Code: **MWL**
Description: **Water Level**

Distance (ft): **.0**
Structural Grade: **0**
O&M Grade: **0**
Clock Start/From:
Clock To:
1st Value:
2nd Value:
Value Percent: **10.000**
Continuous Index:
Within 8" of Joint: **NO**
Remarks:

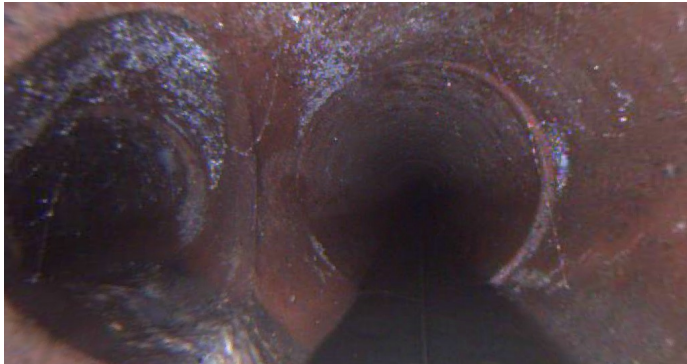
Code: **TF**
Description: **Tap Factory**

Distance (ft): **22.4**
Structural Grade: **0**
O&M Grade: **0**
Clock Start/From: **4**
Clock To:
1st Value: **4.000**
2nd Value:
Value Percent:
Continuous Index:
Within 8" of Joint:
Remarks:

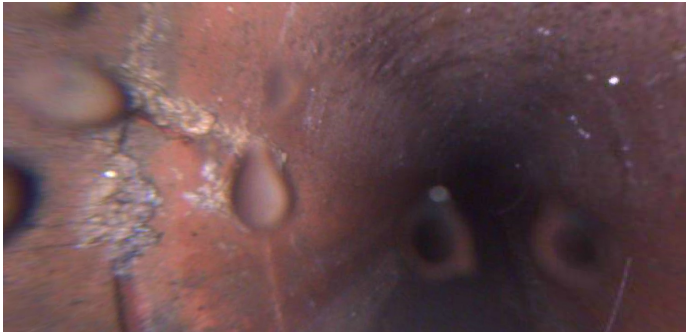
Code: **FC**
Description: **Fracture Circumferential**

Distance (ft): **23.0**
Structural Grade: **2**
O&M Grade: **0**
Clock Start/From: **7**
Clock To: **9**
1st Value:
2nd Value:
Value Percent:
Continuous Index:
Within 8" of Joint:
Remarks:

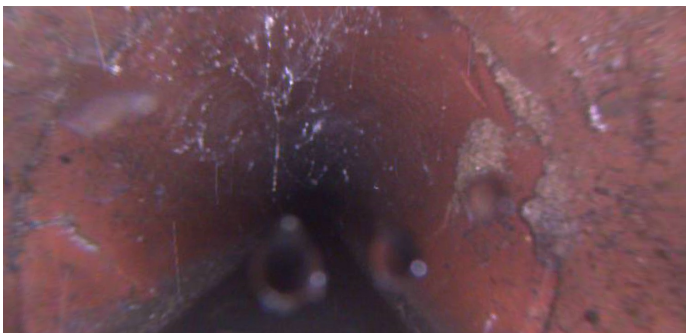
Code: **FM**
Description: **Fracture Multiple**

Distance (ft): **34.9**
Structural Grade: **4**
O&M Grade: **0**
Clock Start/From: **8**
Clock To: **4**
1st Value:
2nd Value:
Value Percent:
Continuous Index:
Within 8" of Joint: **YES**
Remarks:

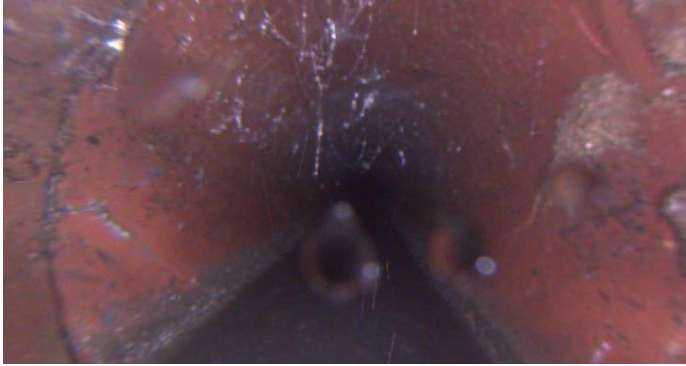
Code: **RFJ**
Description: **Roots Fine Joint**

Distance (ft): **34.9**
Structural Grade: **0**
O&M Grade: **1**
Clock Start/From: **4**
Clock To:
1st Value:
2nd Value:
Value Percent:
Continuous Index:
Within 8" of Joint: **YES**
Remarks:

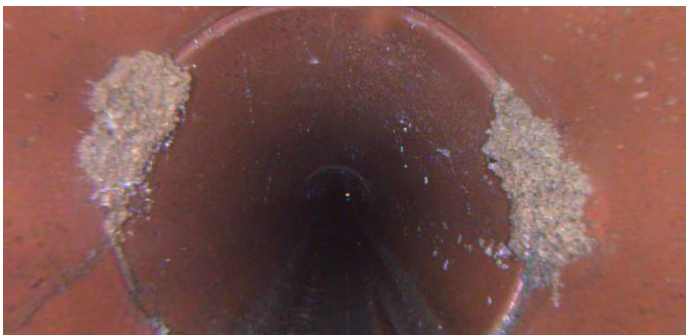
Code: **DAZ**
Description: **Deposits Attached Other**

Distance (ft): **87.2**
Structural Grade: **0**
O&M Grade: **2**
Clock Start/From: **8**
Clock To: **4**
1st Value:
2nd Value:
Value Percent: **5.000**
Continuous Index:
Within 8" of Joint: **YES**
Remarks:

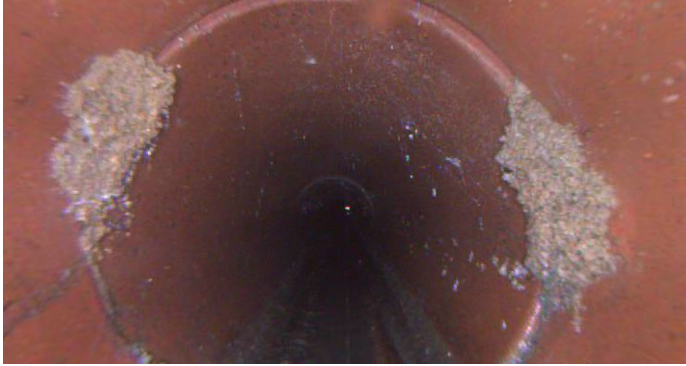
Code: **RFJ**
Description: **Roots Fine Joint**

Distance (ft): **87.2**
Structural Grade: **0**
O&M Grade: **1**
Clock Start/From: **4**
Clock To: **8**
1st Value:
2nd Value:
Value Percent:
Continuous Index:
Within 8" of Joint: **YES**
Remarks:

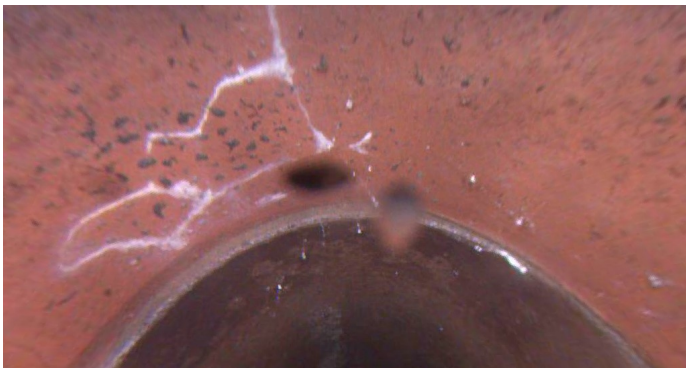
Code: **CM**
Description: **Crack Multiple**

Distance (ft): **129.3**
Structural Grade: **3**
O&M Grade: **0**
Clock Start/From: **2**
Clock To: **12**
1st Value:
2nd Value:
Value Percent:
Continuous Index:
Within 8" of Joint:
Remarks:

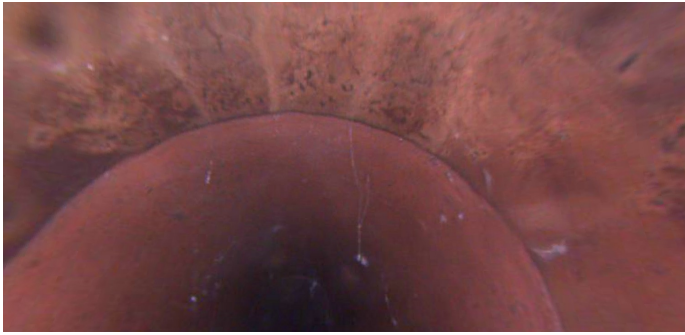
Code: **CM**
Description: **Crack Multiple**

Distance (ft): **131.4**
Structural Grade: **3**
O&M Grade: **0**
Clock Start/From: **10**
Clock To: **2**
1st Value:
2nd Value:
Value Percent:
Continuous Index:
Within 8" of Joint: **YES**
Remarks:

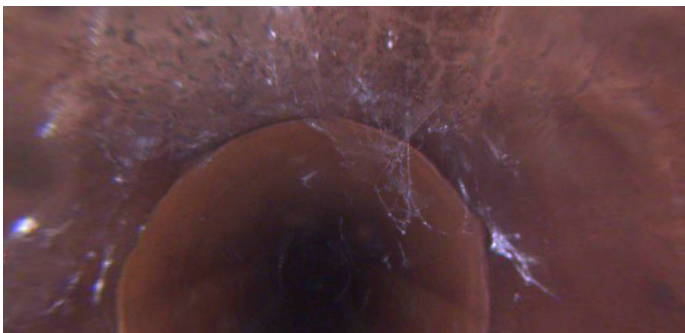
Code: **CM**
Description: **Crack Multiple**

Distance (ft): **137.2**
Structural Grade: **3**
O&M Grade: **0**
Clock Start/From: **8**
Clock To: **4**
1st Value:
2nd Value:
Value Percent:
Continuous Index:
Within 8" of Joint: **YES**
Remarks:

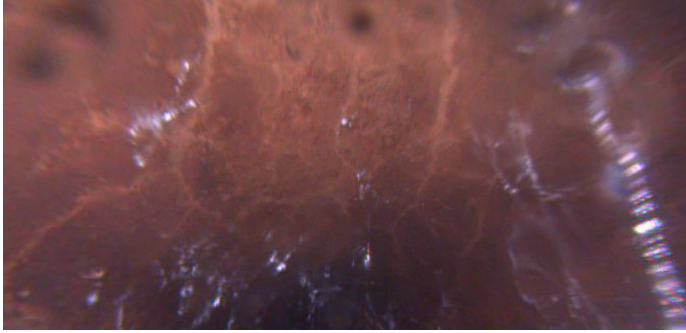
Code: **CM**
Description: **Crack Multiple**

Distance (ft): **148.6**
Structural Grade: **3**
O&M Grade: **0**
Clock Start/From: **8**
Clock To: **4**
1st Value:
2nd Value:
Value Percent:
Continuous Index:
Within 8" of Joint:
Remarks:

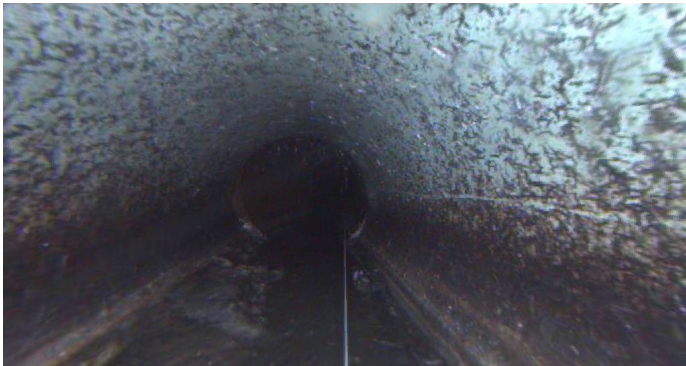
Code: **MMC**
Description: **Material Change**

Distance (ft): **163.2**
Structural Grade: **0**
O&M Grade: **0**
Clock Start/From:
Clock To:
1st Value:
2nd Value:
Value Percent:
Continuous Index:
Within 8" of Joint: **NO**
Remarks: **PVC**

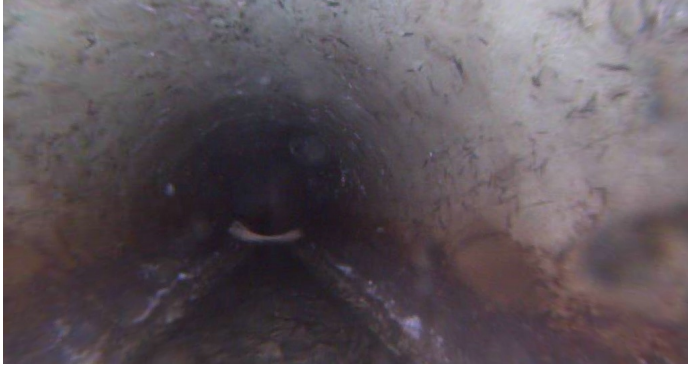
Code:	MSA
Description:	Abandoned Survey
Distance (ft):	169.7
Structural Grade:	0
O&M Grade:	0
Clock Start/From:	
Clock To:	
1st Value:	
2nd Value:	
Value Percent:	
Continuous Index:	
Within 8" of Joint:	NO
Remarks:	End of pipe insight
