Profile/Photo Observation Report

Date:	04/07/2018	Weather:		Coding:	PACP 6.0
Pipe Length (ft):	269.3	Owner:	NA	Pre Clean:	Not Known
P.O.#:		Surveyor:	Mark Ruby	PSR:	P-804-082-028
Customer:		Clean Date:	01/01/1900	Shape:	C

Street:	E HICKEY ST & N LIBERTY ST	Flow Control:	Not Controlled
City:	Hobart, IN	Year Renewed:	
Location:	Other	Tape/Media #:	
Purpose:	Not Known	Dia/Height:	8"
Use:	Sanitary	Material:	VCP
Drain Area:	NA	Lining:	
Category:	NA		
Comment:

Location Details:		Direction of Survey:	Upstream
US MH:	M-804-028	DS MH:	M-804-082
		Total Length Surveyed (ft):	235.4

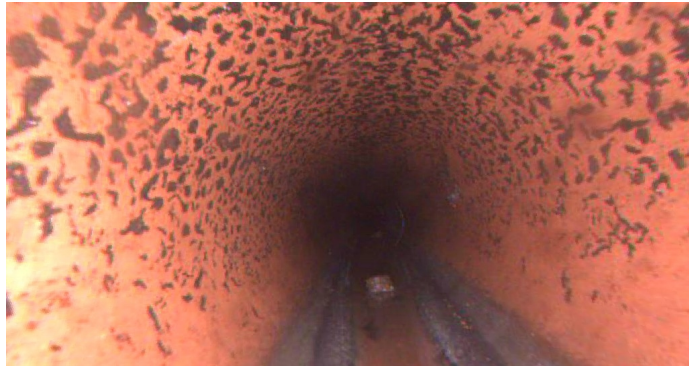
Code: **MWL**
Description: **Water Level**

Distance (ft): **.0**
Structural Grade: **0**
O&M Grade: **0**
Clock Start/From:
Clock To:
1st Value:
2nd Value:
Value Percent: **10.000**
Continuous Index:
Within 8" of Joint: **NO**
Remarks:

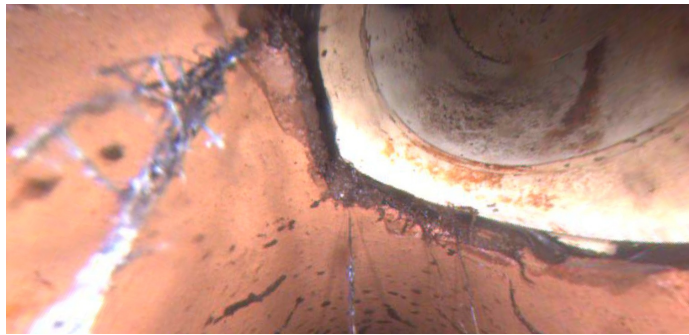
Code: **RFB**
Description: **Roots Fine Barrel**

Distance (ft): **38.1**
Structural Grade: **0**
O&M Grade: **2**
Clock Start/From: **12**
Clock To:
1st Value:
2nd Value:
Value Percent:
Continuous Index:
Within 8" of Joint: **NO**
Remarks:

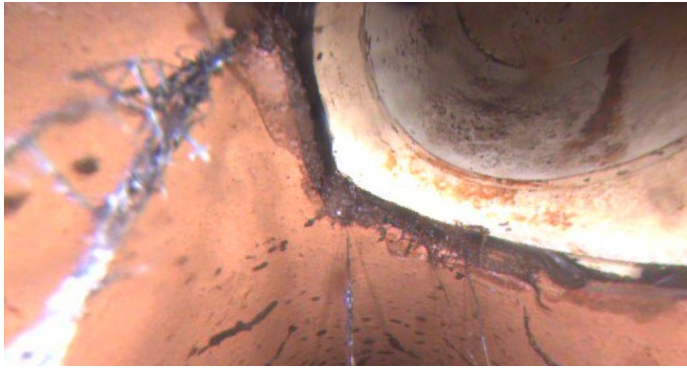
Code:	TBD
Description:	Tap Break-in Defective
Distance (ft):	38.1
Structural Grade:	0
O&M Grade:	3
Clock Start/From:	2
Clock To:	
1st Value:	4.000
2nd Value:	
Value Percent:	
Continuous Index:	
Within 8" of Joint:	
Remarks:	roots

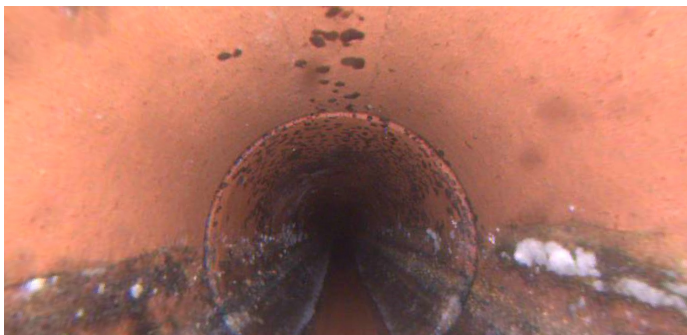
Code:	DAGS
Description:	Deposits Attached Grease
Distance (ft):	155.3
Structural Grade:	0
O&M Grade:	2
Clock Start/From:	8
Clock To:	4
1st Value:	
2nd Value:	
Value Percent:	5.000
Continuous Index:	S01
Within 8" of Joint:	NO
Remarks:

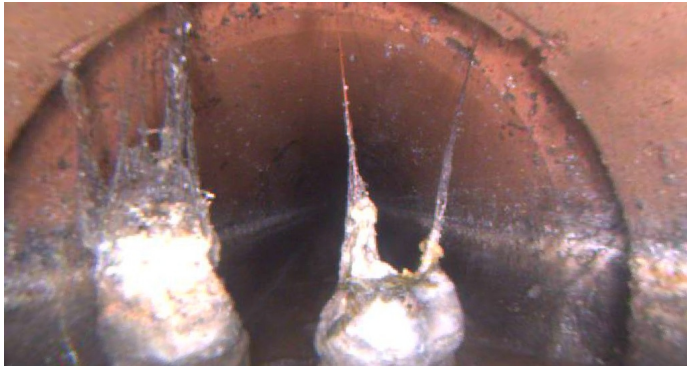
Code: **RMJ**
Description: **Roots Medium Joint**

Distance (ft): **196.0**
Structural Grade: **0**
O&M Grade: **3**
Clock Start/From: **7**
Clock To: **5**
1st Value:
2nd Value:
Value Percent: **15.000**
Continuous Index:
Within 8" of Joint: **YES**
Remarks:

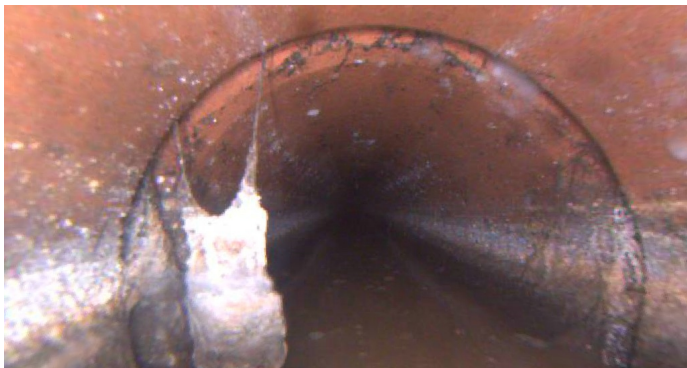
Code: **RMJ**
Description: **Roots Medium Joint**

Distance (ft): **206.1**
Structural Grade: **0**
O&M Grade: **3**
Clock Start/From: **7**
Clock To: **10**
1st Value:
2nd Value:
Value Percent: **10.000**
Continuous Index:
Within 8" of Joint: **YES**
Remarks:

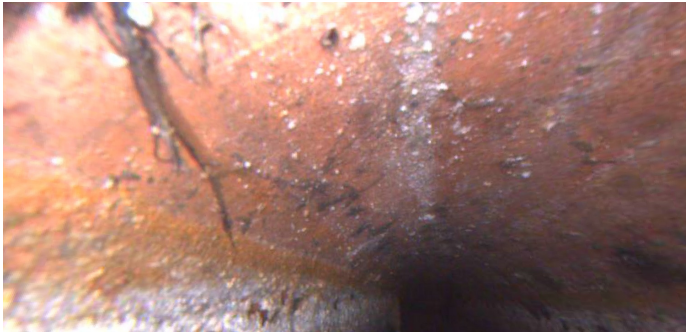
Code: **RFJ**
Description: **Roots Fine Joint**

Distance (ft): **227.0**
Structural Grade: **0**
O&M Grade: **1**
Clock Start/From: **10**
Clock To:
1st Value:
2nd Value:
Value Percent:
Continuous Index:
Within 8" of Joint: **YES**
Remarks:

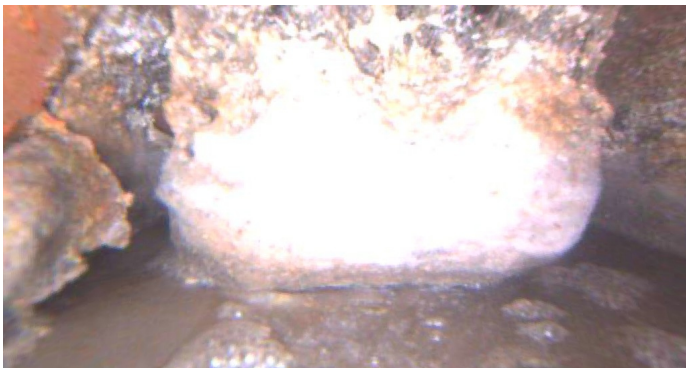
Code: **DAZ**
Description: **Deposits Attached Other**

Distance (ft): **231.7**
Structural Grade: **0**
O&M Grade: **3**
Clock Start/From: **12**
Clock To: **12**
1st Value:
2nd Value:
Value Percent: **15.000**
Continuous Index:
Within 8" of Joint: **NO**
Remarks:

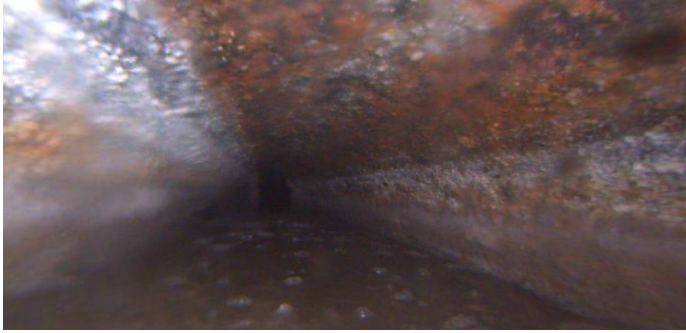
Code: **DAGS**
Description: **Deposits Attached Grease**

Distance (ft): **235.4**
Structural Grade: **0**
O&M Grade: **2**
Clock Start/From: **8**
Clock To: **4**
1st Value:
2nd Value:
Value Percent: **5.000**
Continuous Index: **F01**
Within 8" of Joint: **NO**
Remarks:

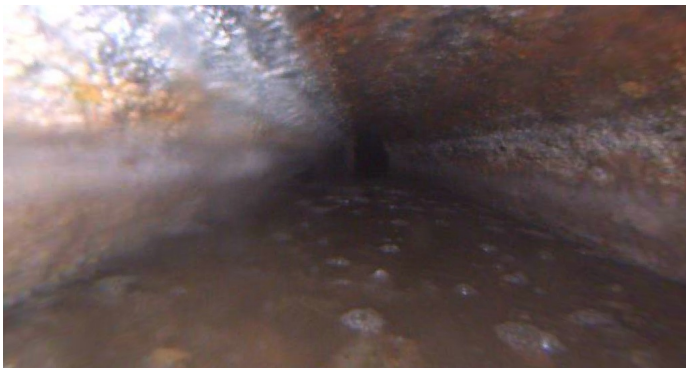
Code: **MSA**
Description: **Abandoned Survey**

Distance (ft): **235.4**
Structural Grade: **0**
O&M Grade: **0**
Clock Start/From:
Clock To:
1st Value:
2nd Value:
Value Percent:
Continuous Index:
Within 8" of Joint: **NO**
Remarks: **Debris**
